**WASTEWATER STUDY  
SADDLEHORN RANCH – FILING NO. 3  
CURTIS ROAD & JUDGE ORR ROAD  
EL PASO COUNTY, COLORADO**

November 15, 2022  
Revised May 17, 2023

- Figure 1: Vicinity Map
- Figure 2: USGS Map
- Figure 3: Site Plan/Testing Location Map
- Figure 4: Soil Survey Map
- Figure 5: Falcon Quadrangle Geology Map
- Figure 6: Geology Map/Engineering Geology
- Figure 7: Floodplain Map
- Figure 8: Septic Suitability Map

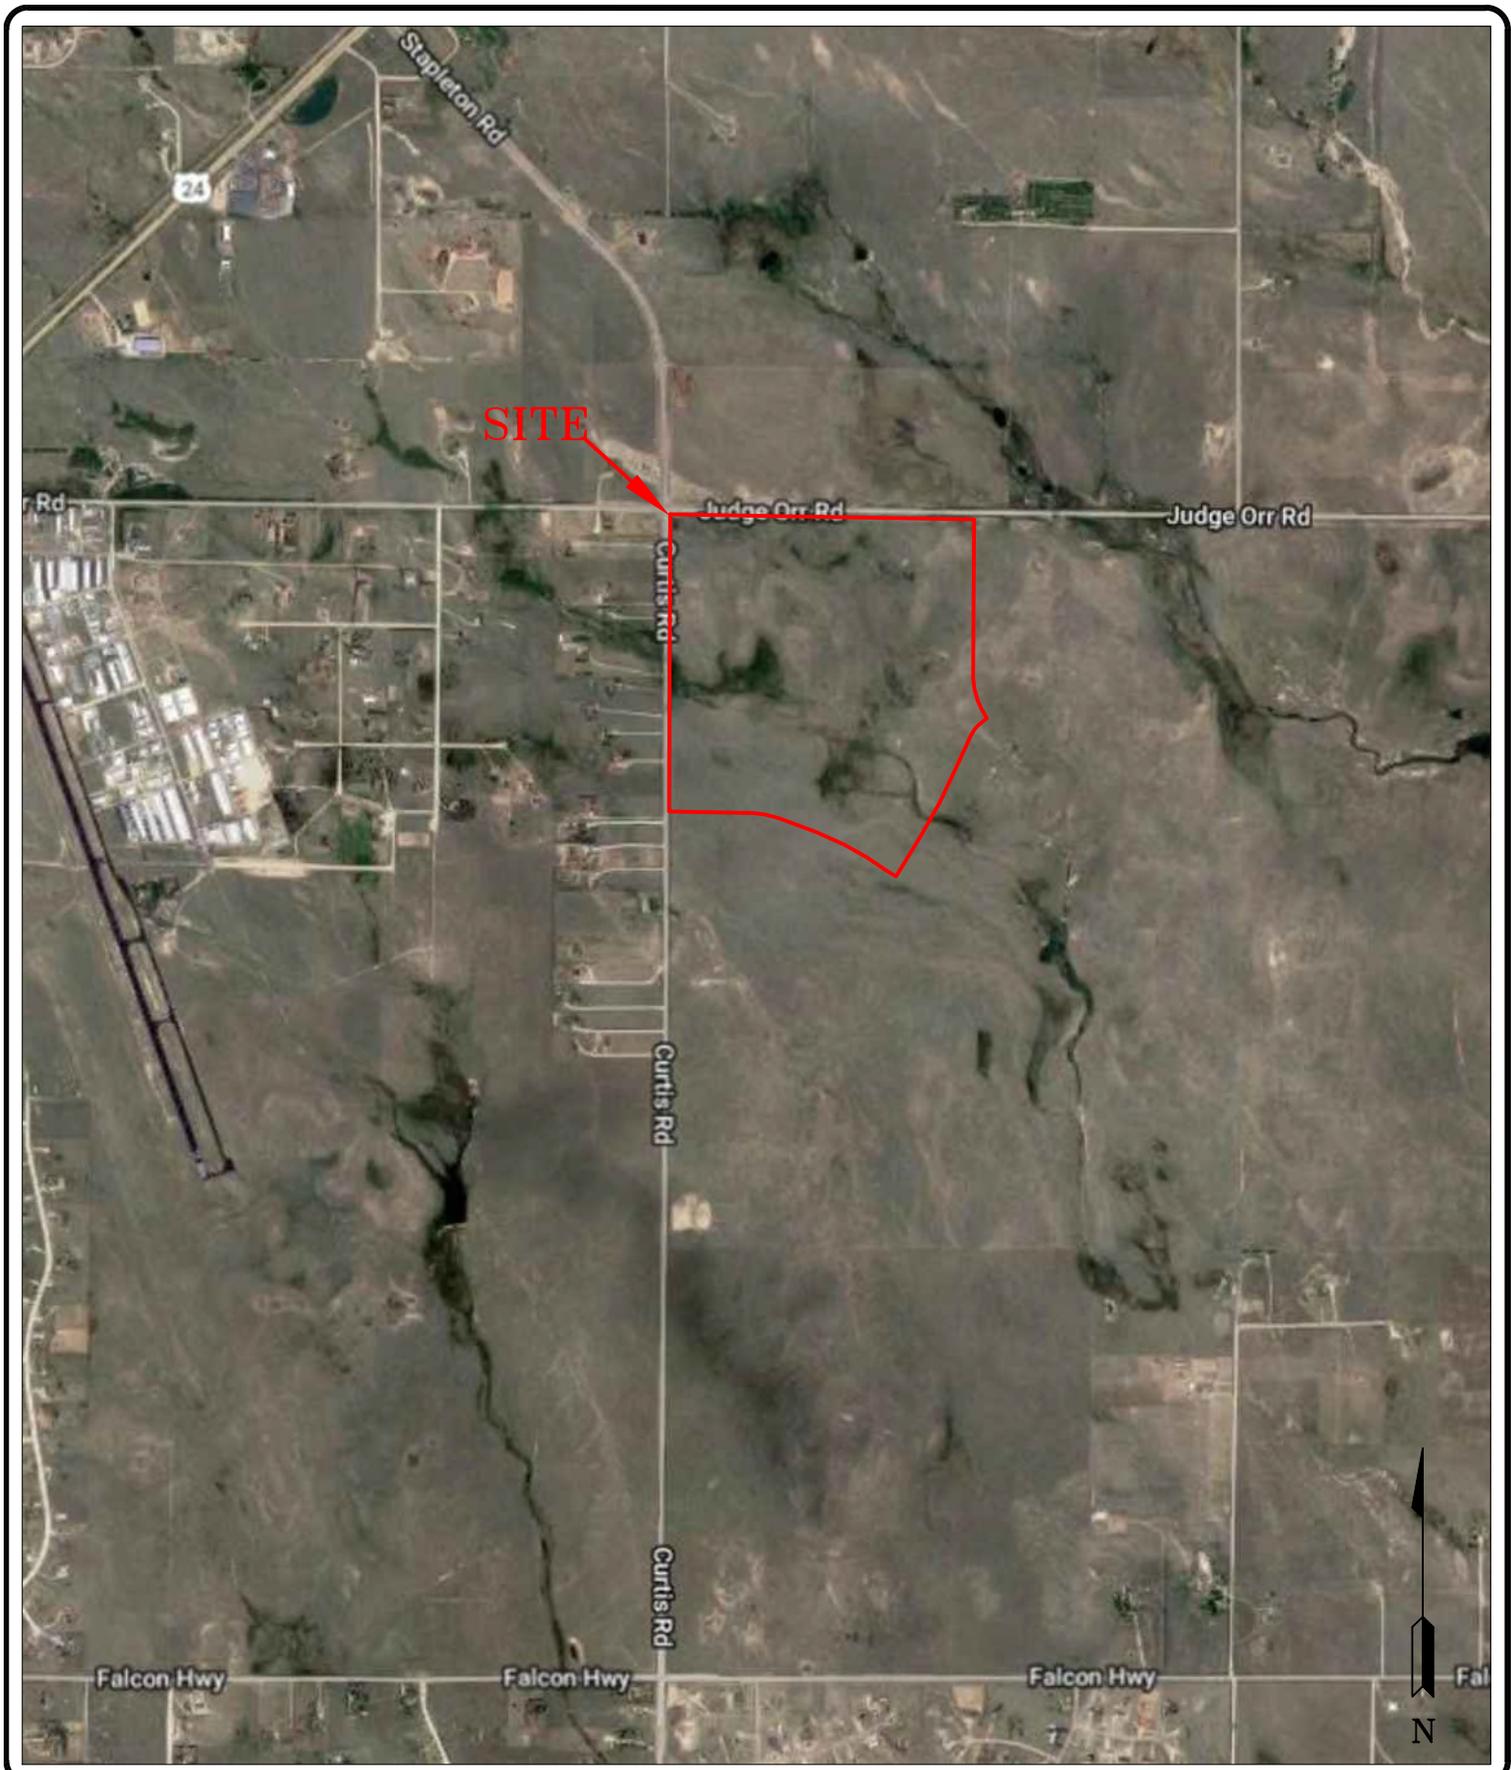
FIG NO.:  
**1**

VICINITY MAP  
SADDLEHORN RANCH FILING NO. 3  
CURTIS ROAD AND JUDGE ORR ROAD  
EL PASO COUNTY, CO.  
FOR: GORILLA CAPITAL, LLC

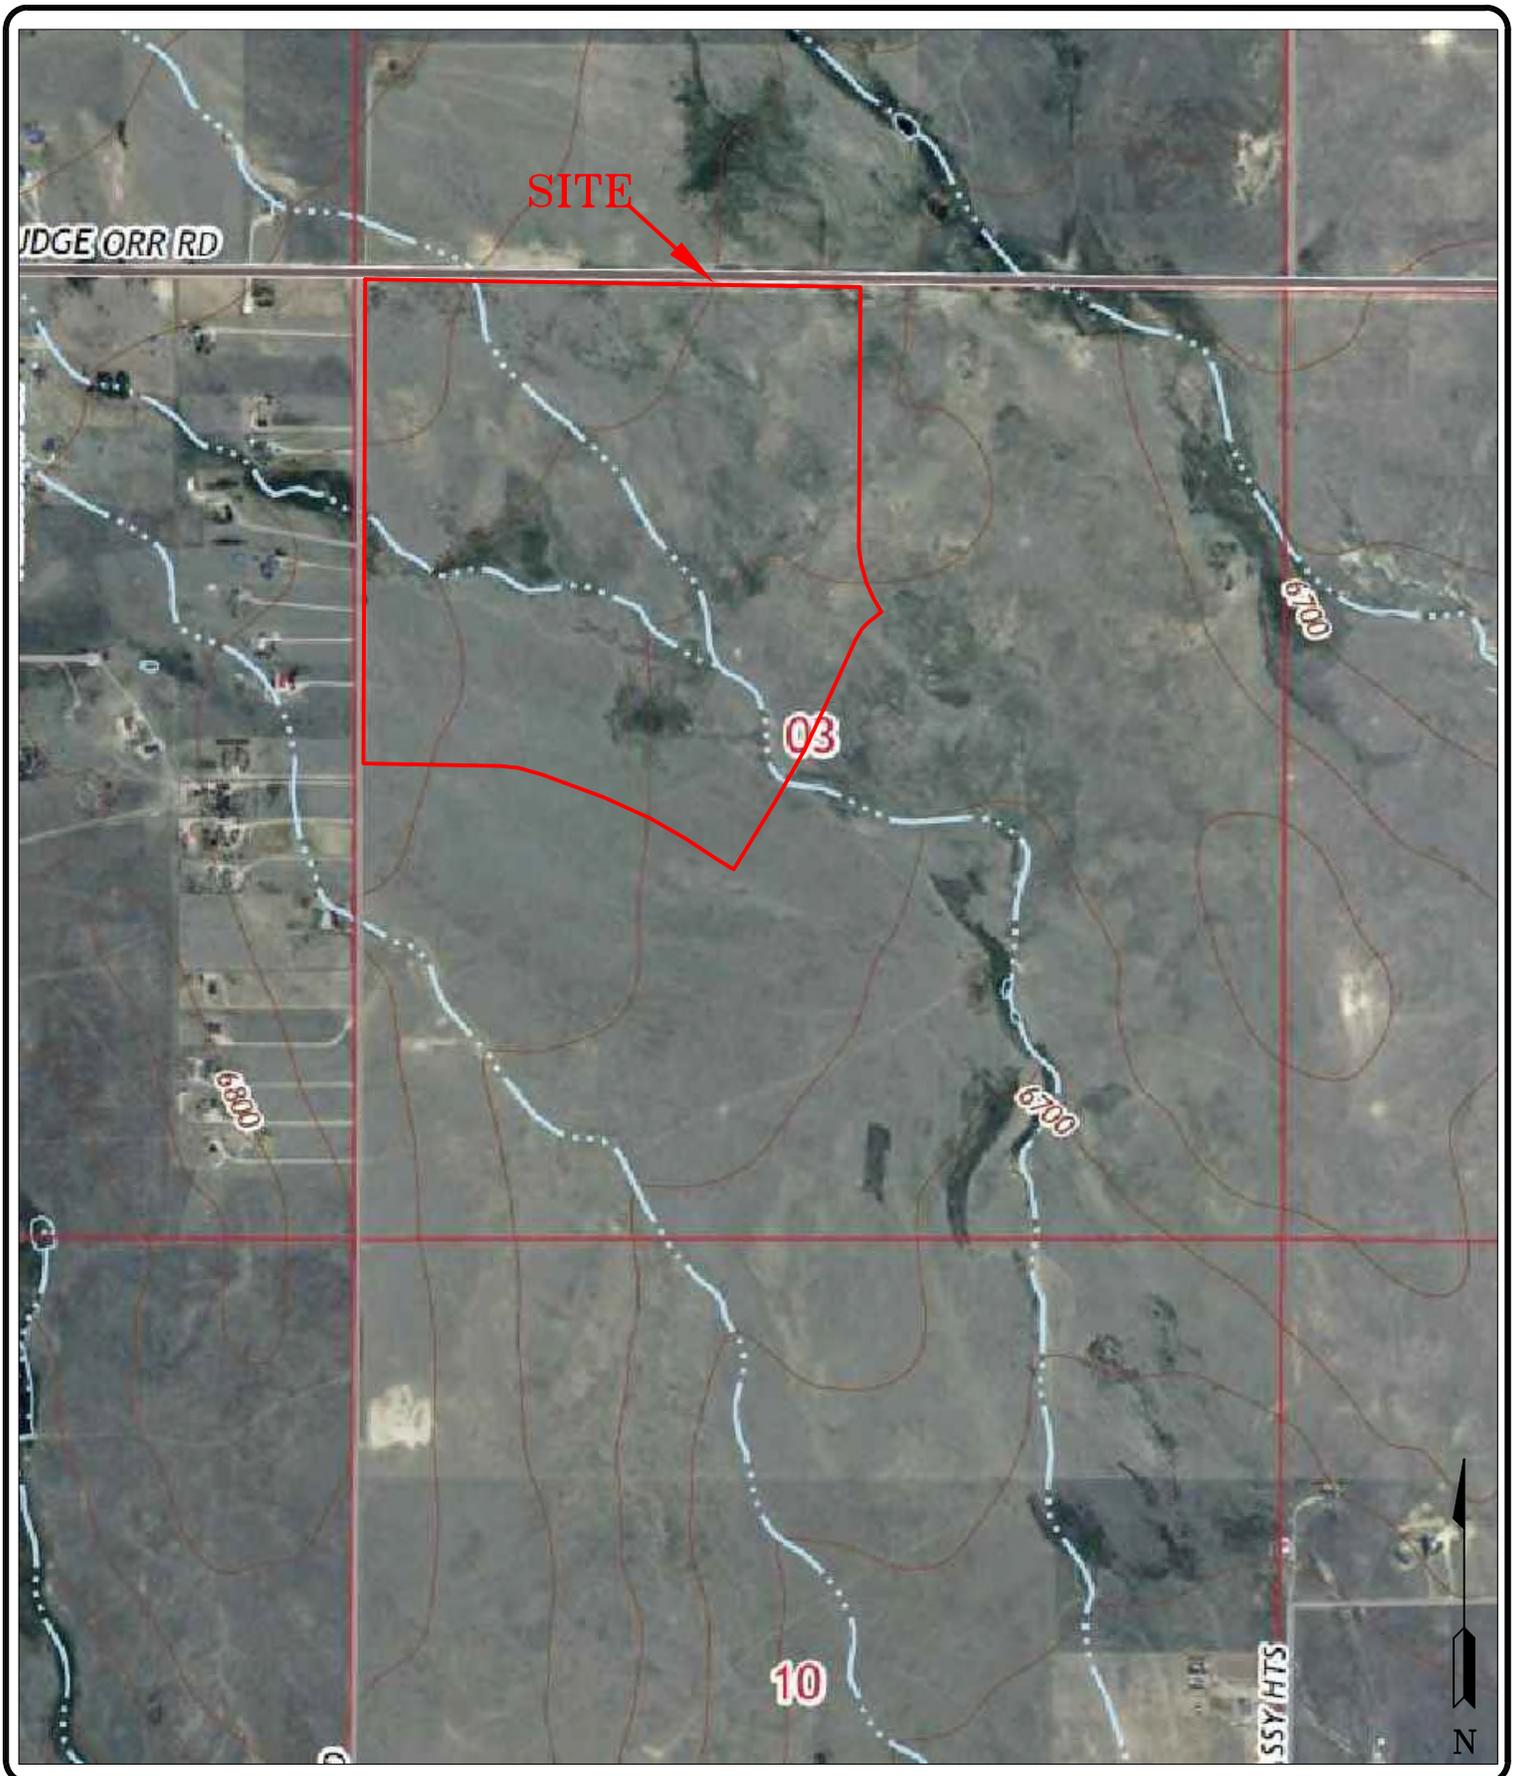
USGS MAP  
SADDLEHORN RANCH FILING NO. 3  
CURTIS ROAD AND JUDGE ORR ROAD  
EL PASO COUNTY, CO.  
FOR: GORILLA CAPITAL, LLC

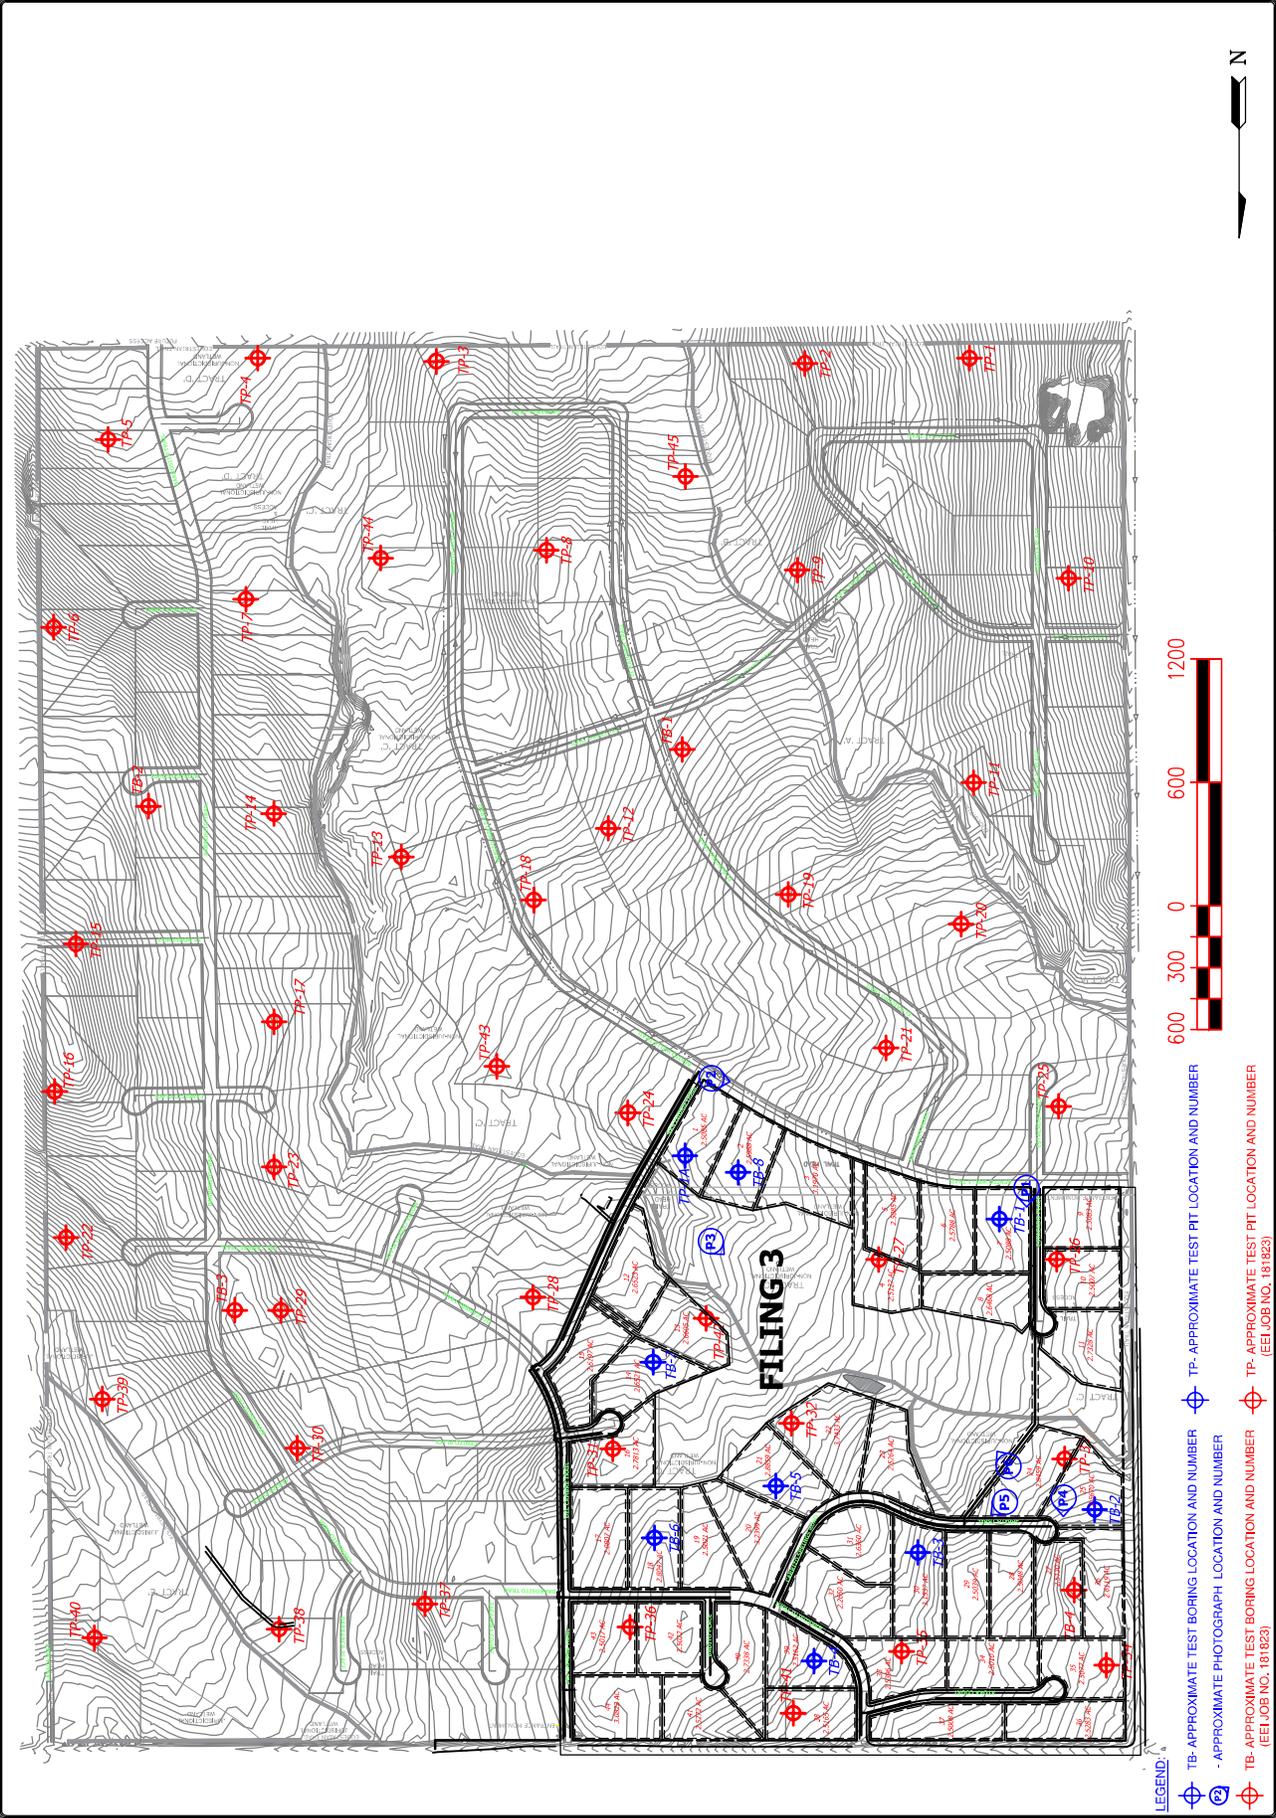
**SITE PLAN/TEST BORING LOCATION MAP**  
 SADDLEHORN RANCH FILING NO. 3  
 CURTIS ROAD AND JUDGE ORR ROAD  
 EL PASO COUNTY, CO.  
 FOR: GORILLA CAPITAL, LLC

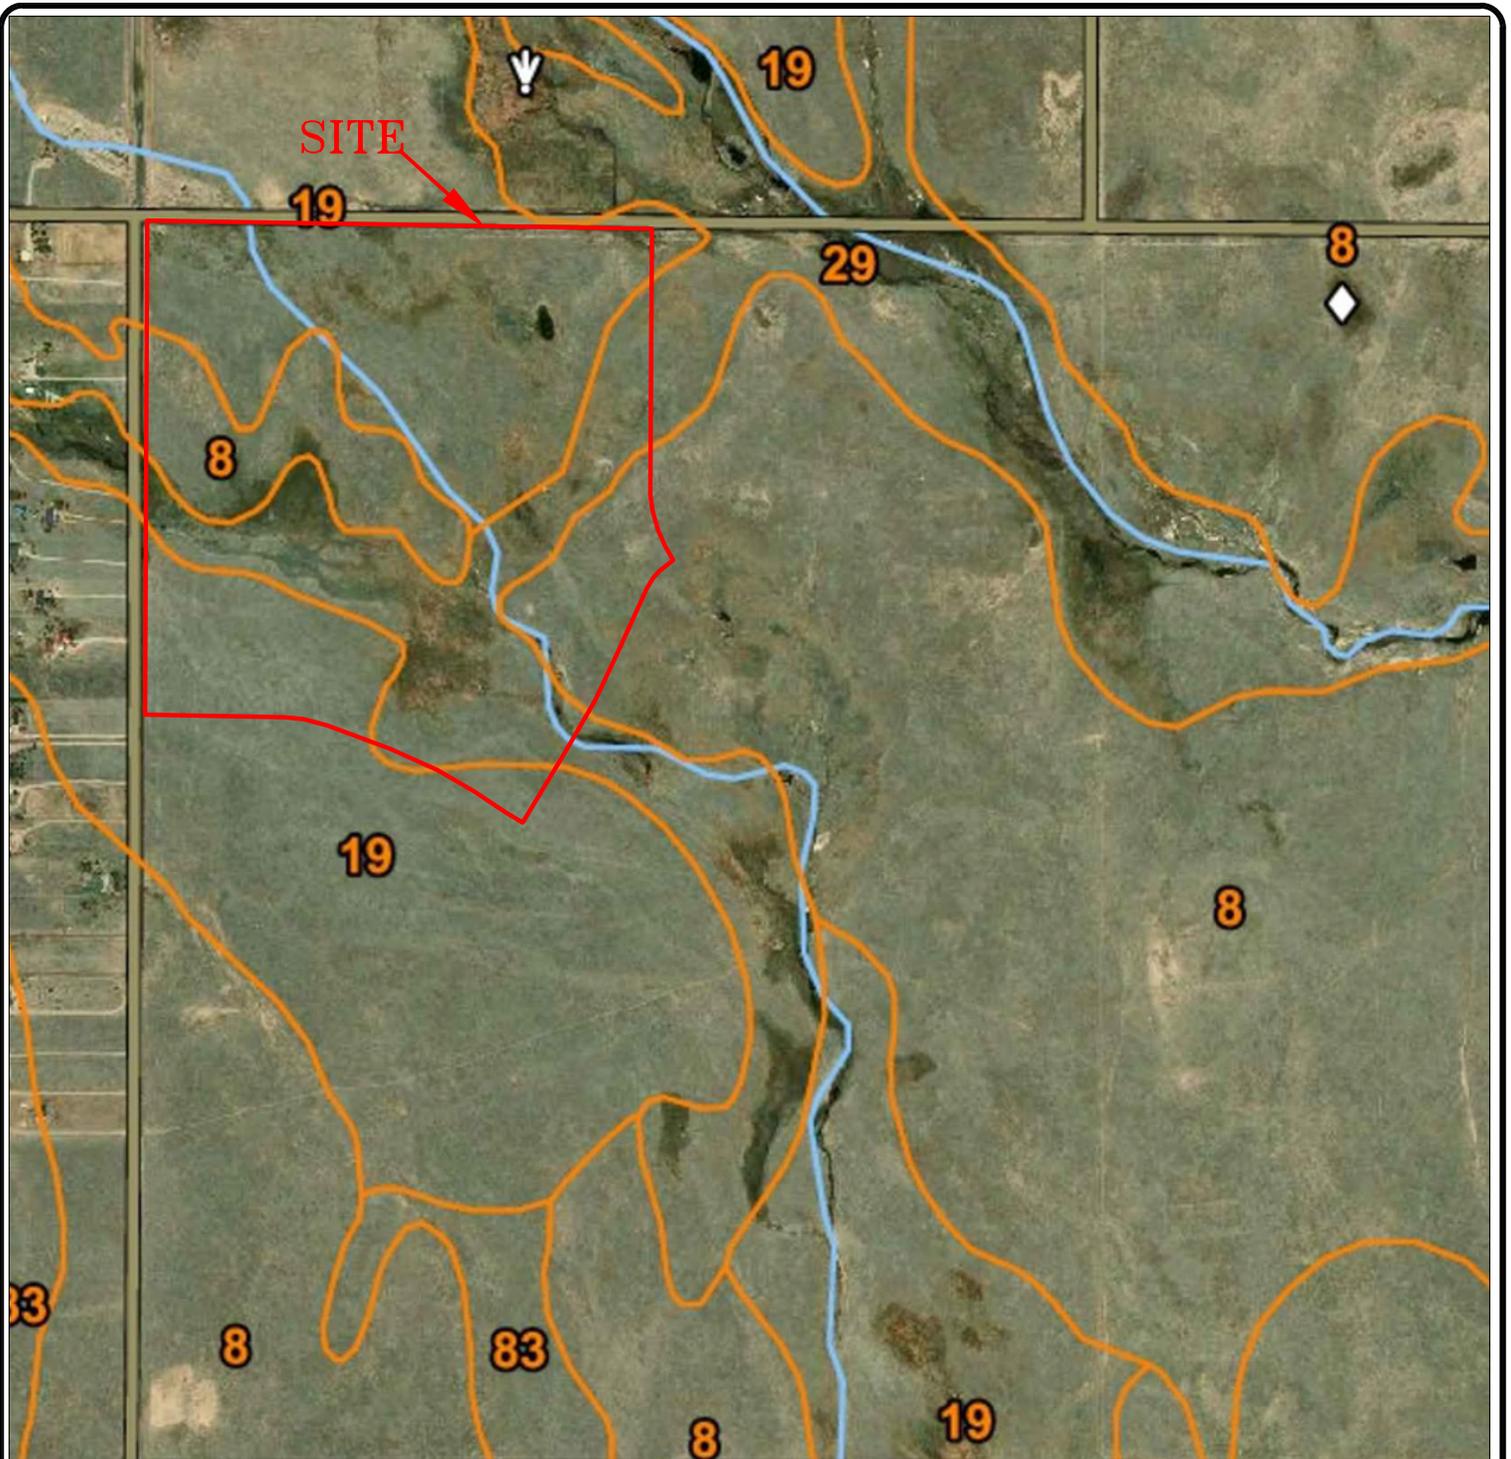
FIG NO.:  
 4

SOIL SURVEY MAP  
 SADDLEHORN RANCH FILING NO. 3  
 CURTIS ROAD AND JUDGE ORR ROAD  
 EL PASO COUNTY, CO.  
 FOR: GORILLA CAPITAL, LLC

Complete descriptions of each soil type are presented in Appendix D. The soils have generally been described to typically have moderate to very rapid permeabilities. The majority of the soils have rapid permeabilities. Limitations described for the soils include the hazard of flooding on Soil Type Nos. 19 and 29. Soil Type No. 29 is mapped in the floodplain zone that is designated as open space. Roads may need to be designed to minimize frost-heave potential. Possible hazards

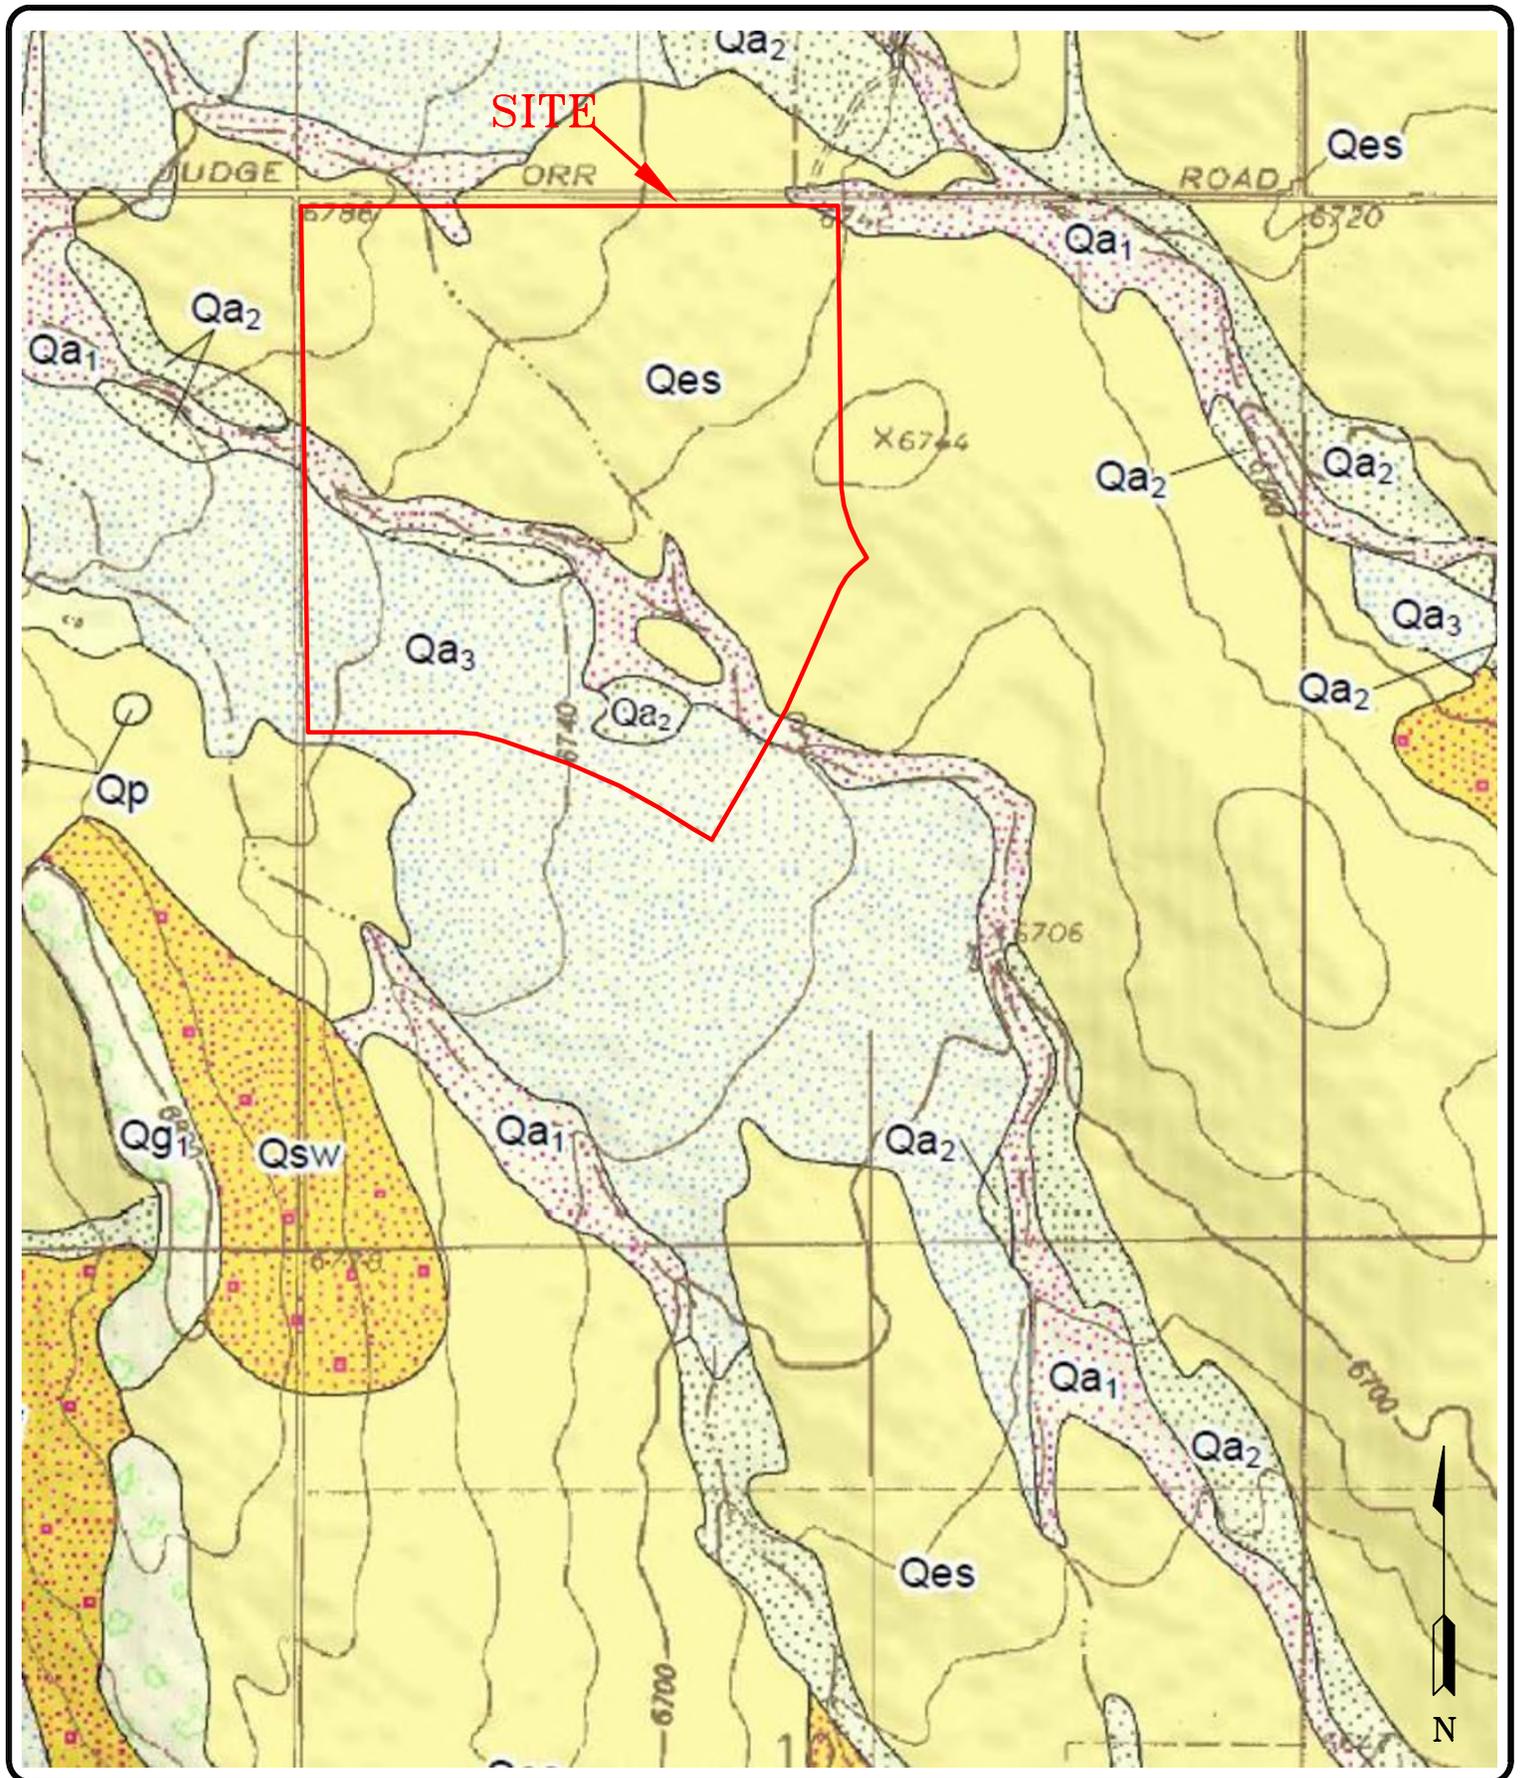
FALCON QUADRANGLE GEOLOGIC MAP  
SADDLEHORN RANCH FILING NO. 3  
CURTIS ROAD AND JUDGE ORR ROAD  
EL PASO COUNTY, CO.  
FOR: GORILLA CAPITAL, LLC

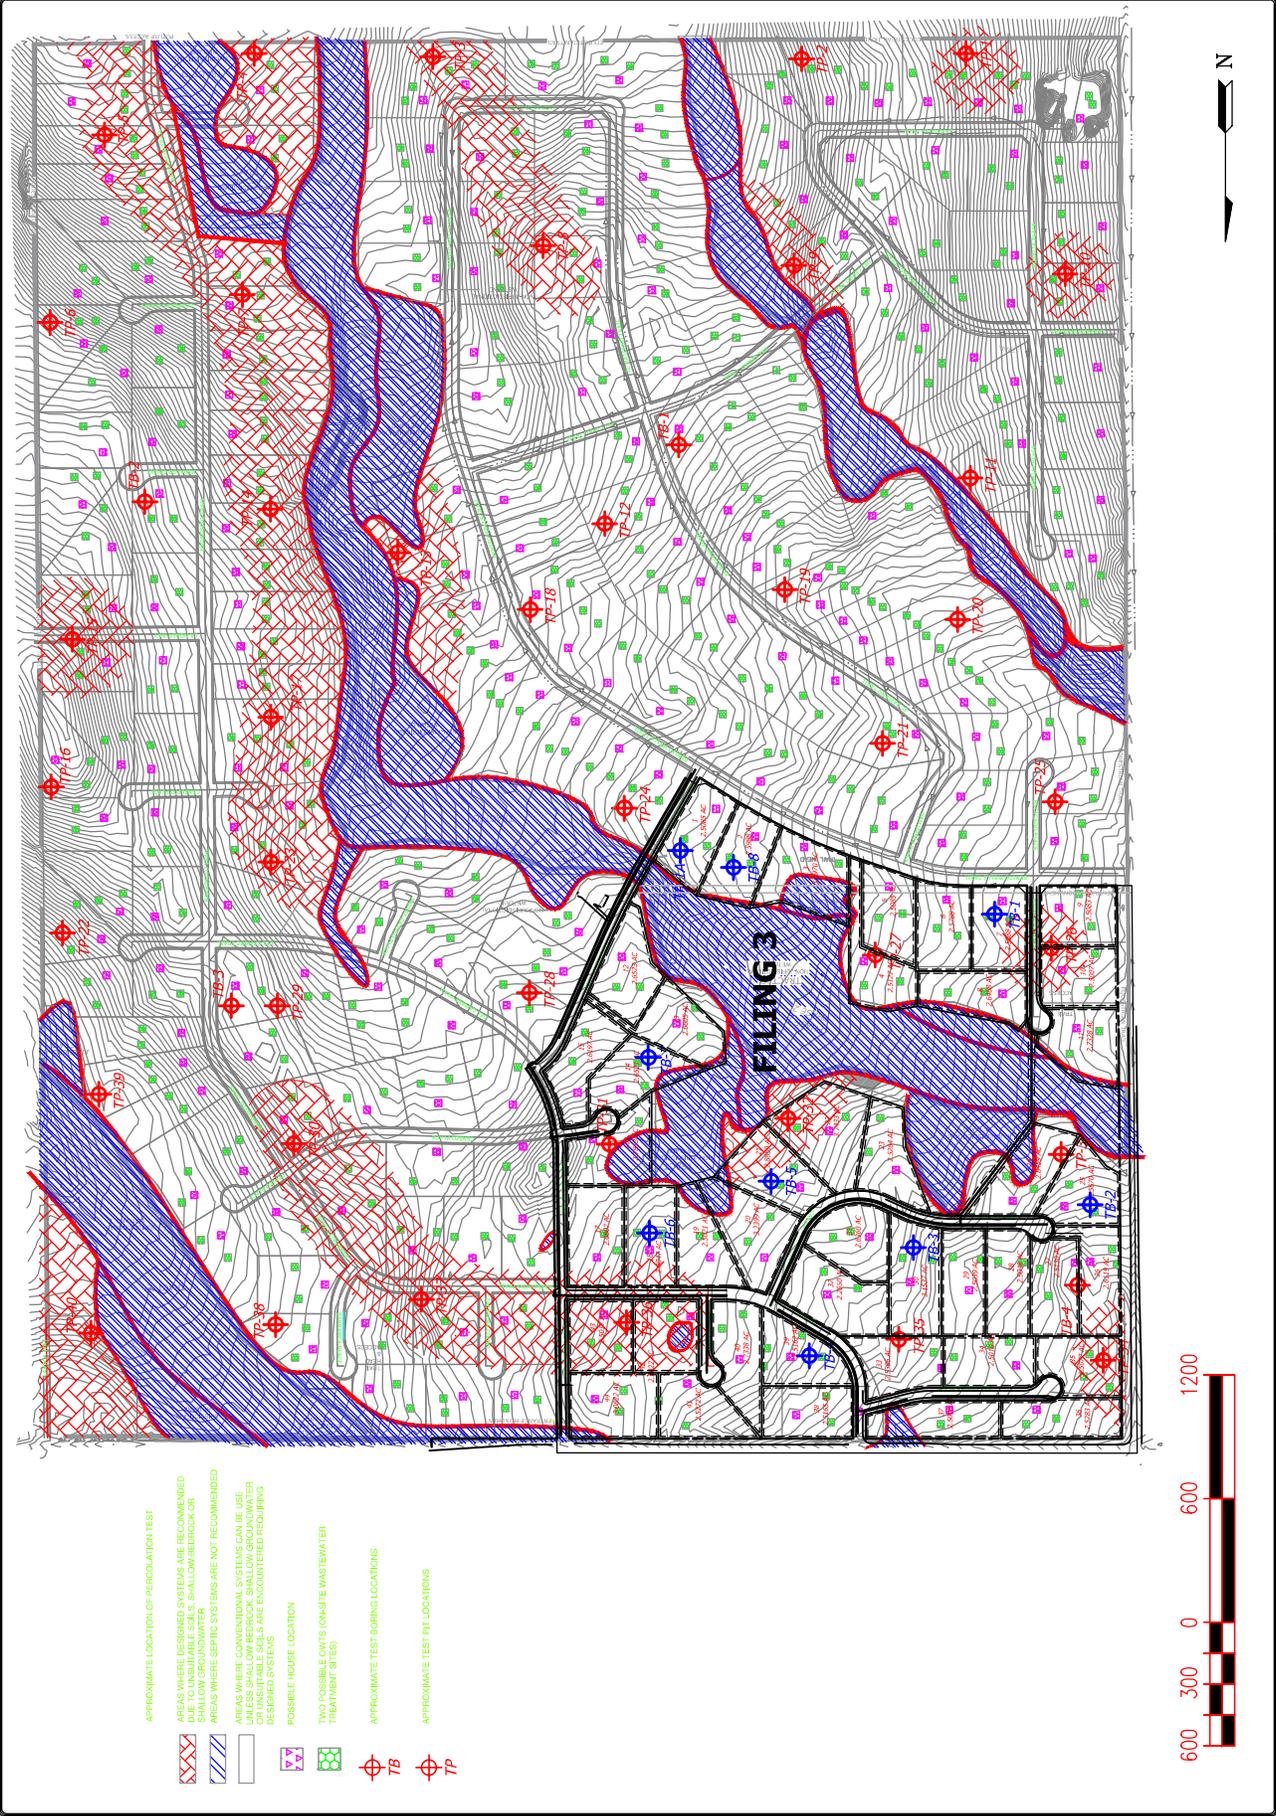
**SEPTIC SUITABILITY MAP**  
SADDLEHORN RANCH FILING NO. 3  
EL PASO COUNTY, CO.  
FOR: GORILLA CAPITAL, LLC

- APPROXIMATE LOCATION OF PERCOLATION TEST
- AREAS WHERE DESIGNED SYSTEMS ARE RECOMMENDED  
SHALLOW BEEROCK OR SHALLOW GROUNDWATER
- AREAS WHERE SEPTIC SYSTEMS ARE NOT RECOMMENDED
- AREAS WHERE CONVENTIONAL SYSTEMS CAN BE USED  
UNLESS SHALLOW BEEROCK, SHALLOW GROUNDWATER  
OR UNSUITABLE SOILS ARE ENCOUNTERED REQUIRING  
DESIGNED SYSTEMS
- POSSIBLE HOUSE LOCATION
- TWO POSSIBLE LOTS (ON-SITE WASTEWATER  
TREATMENT SITE)
- APPROXIMATE TEST BORING LOCATIONS
- APPROXIMATE TEST PIT LOCATIONS

In summary, it is our opinion the site is suitable for individual on-site wastewater treatment systems (OWTS) and that contamination of surface and subsurface water resources should not occur provided the OWTS sites are evaluated and installed according to El Paso County and State Guidelines and properly maintained. Based on the testing performed as part of this investigation designed systems will likely be required for the majority of the lots. A Septic Suitability Map is presented in Figure 8. Areas where OWTS sites are not recommended are also indicated on Figure 8. Individual soil testing is required on each lot prior to construction. Absorption fields must be located a minimum of 100 feet from any well, including those on adjacent properties. Absorption fields must also be located a minimum of 50 feet from any drainages, floodplains or ponded areas and 25 feet from dry gulches.

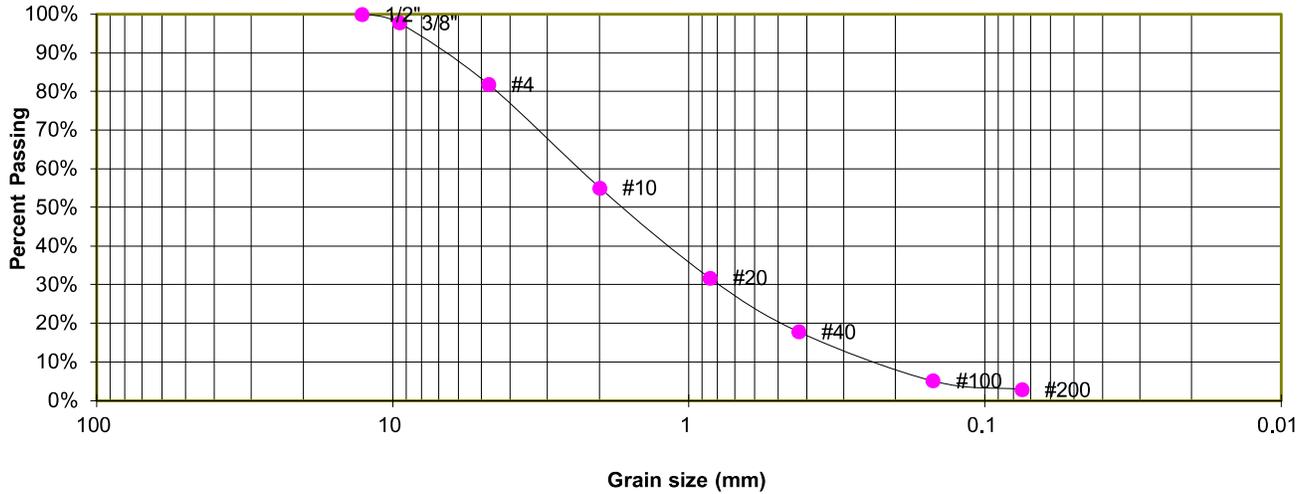
SOIL DESCRIPTION SAND, SLIGHTLY SILTY  
USCS CLASSIFICATION SW

U.S. Sieve #	Percent Finer
3"	
1 1/2"	
3/4"	
1/2"	100.0%
3/8"	97.8%
4	81.8%
10	55.0%
20	31.8%
40	17.8%
100	5.1%
200	2.9%

Soil Type 1 is a well-graded sand, slightly silty to silty sand and clayey to very clayey sand (SW, SM-SW, SM, SC). This material was encountered in all of the test pits. The sand was encountered at depths ranging from the existing surface to 4 feet, and extending to depths of 4 to 17 feet bgs. These soils were encountered at loose to medium dense states and at dry to moist conditions. Samples tested had 3 to 28 percent of the soil size particles passing the No. 200 Sieve. Atterberg Limits Testing resulted in non-plastic results.

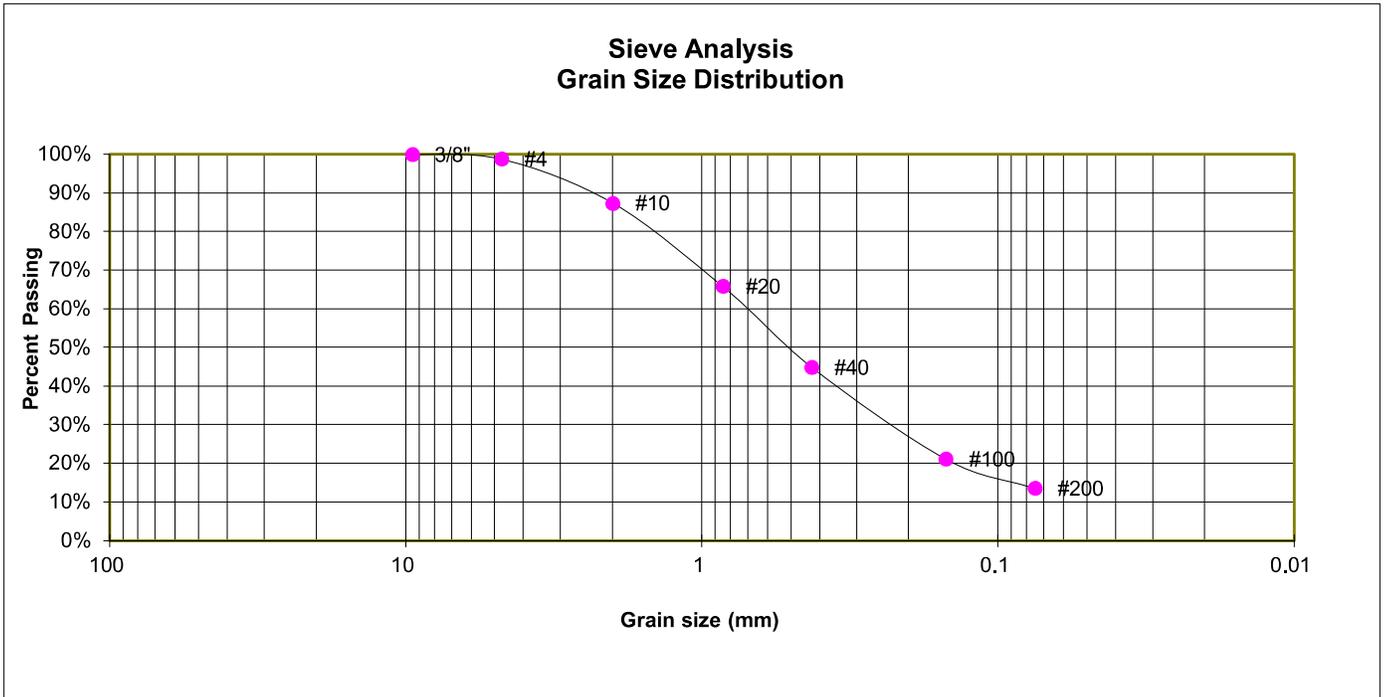
TEST BORING 5  
DEPTH (FT) 5  
SOIL TYPE 1

SOIL DESCRIPTION SAND, SILTY  
USCS CLASSIFICATION SM

<u>U.S. Sieve #</u>	<u>Percent Finer</u>
3"	
1 1/2"	
3/4"	
1/2"	
3/8"	100.0%
4	98.8%
10	87.4%
20	65.8%
40	44.9%
100	21.1%
200	13.6%

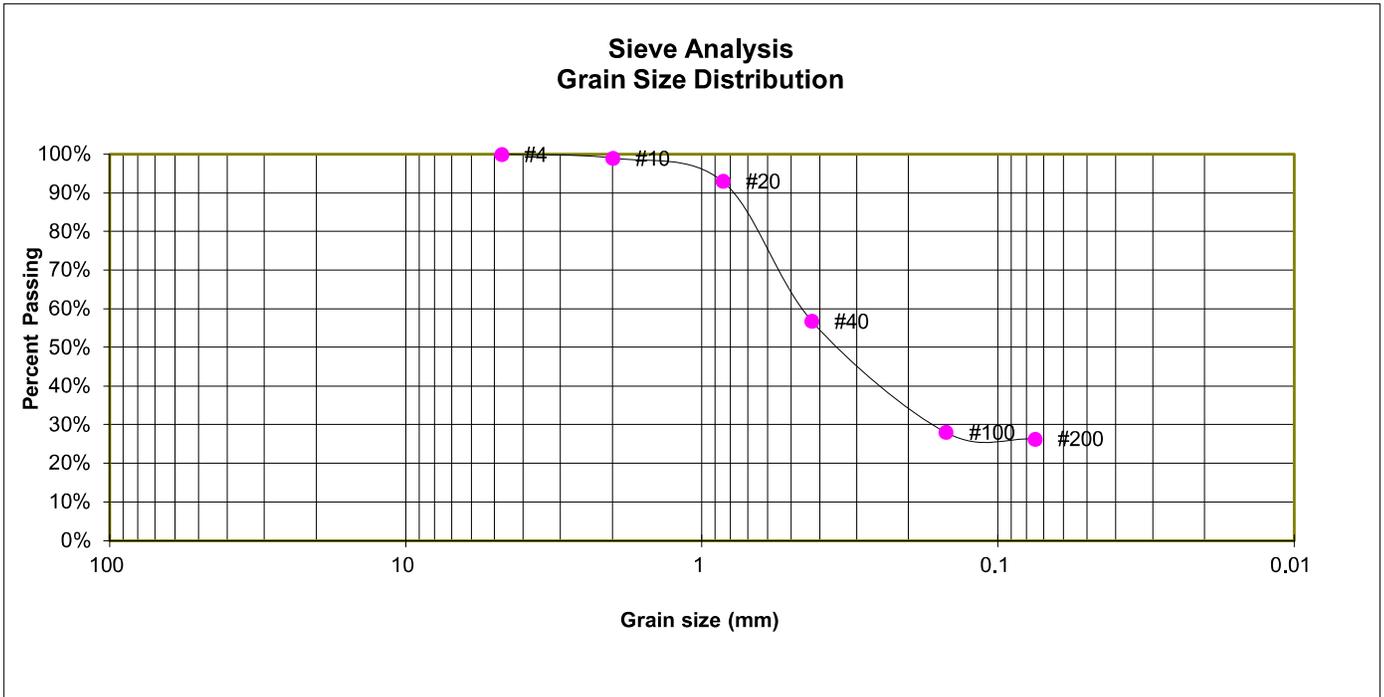
TEST BORING 6  
 DEPTH (FT) 2-3  
 SOIL TYPE 1

SOIL DESCRIPTION SAND, SILTY  
 USCS CLASSIFICATION SM

U.S. Sieve #	Percent Finer
3"	
1 1/2"	
3/4"	
1/2"	
3/8"	
4	100.0%
10	99.0%
20	93.0%
40	56.8%
100	28.1%
200	26.4%

**Atterberg Limits**  
 Plastic Limit NP  
 Liquid Limit NV  
 Plastic Index NP

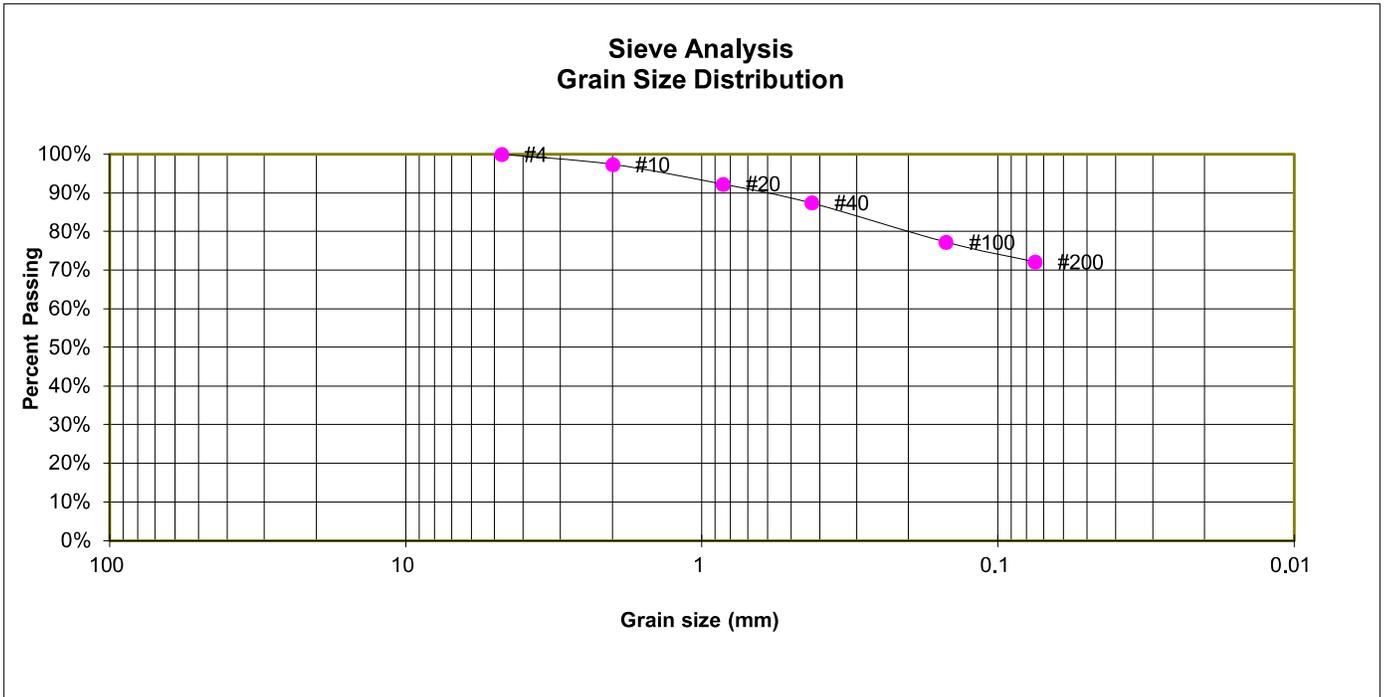
TEST BORING 1  
 DEPTH (FT) 2-3  
 SOIL TYPE 2

SOIL DESCRIPTION CLAY, WITH SAND  
 USCS CLASSIFICATION CL

U.S. Sieve #	Percent Finer
3"	
1 1/2"	
3/4"	
1/2"	
3/8"	
4	100.0%
10	97.4%
20	92.3%
40	87.4%
100	77.3%
200	72.1%

Atterberg Limits	
Plastic Limit	22
Liquid Limit	32
Plastic Index	10

Soil Type 2 is a sandy clay and very sandy silt (CL, ML). This material was encountered in Test Boring Nos. 1 and 2. The clays were encountered at depths ranging from the existing surface to 14 feet bgs and extended to depths of 4 to 17 feet. The clay was encountered at firm consistencies and moist conditions. The samples tested had 61 to 72 percent of the soil size particles passing the No. 200 sieve. Atterberg Limits Testing resulted in liquid limits of 32 to 41 and plastic indexes of 10 to 18. Swell/Consolidation Testing resulted in a volume change of 0.8 percent, indicating a low expansion potential. Sulfate testing resulted in less than 0.01 percent soluble sulfate by weight, indicating the sandstone exhibits negligible potential for below grade concrete degradation due to sulfate attack.

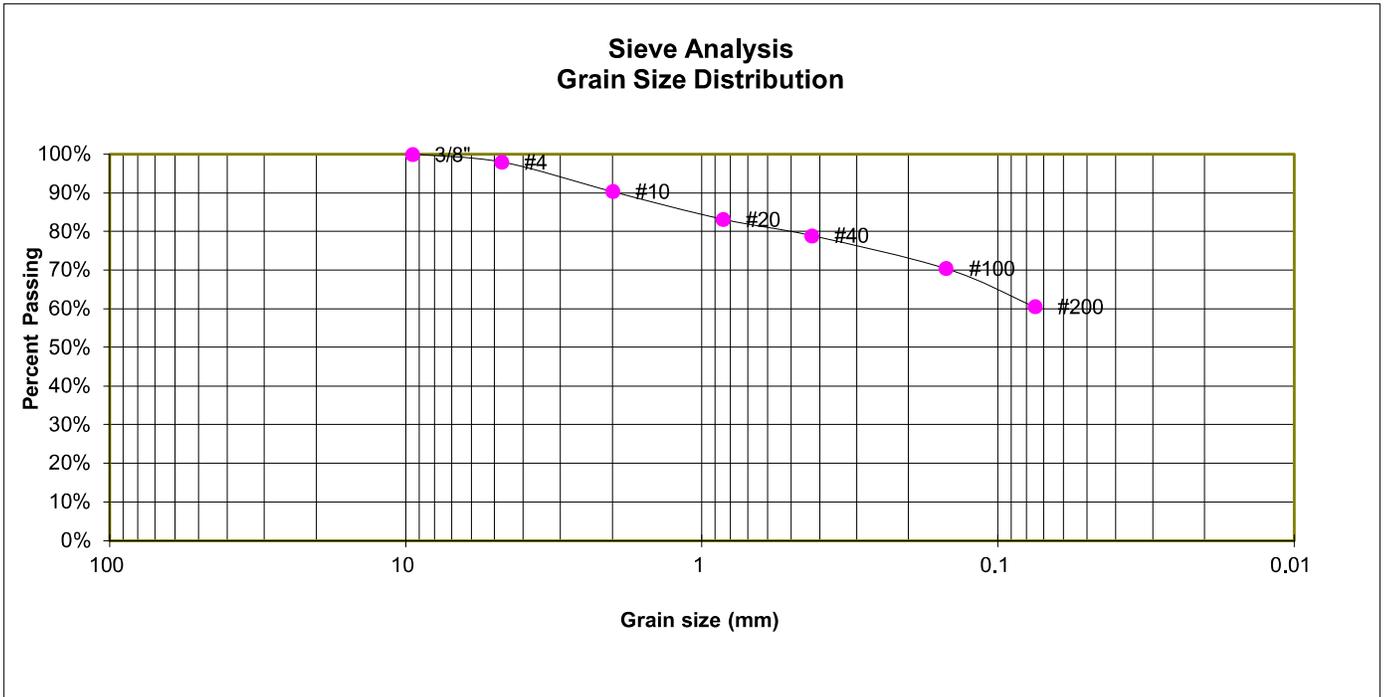
TEST BORING 2  
 DEPTH (FT) 15  
 SOIL TYPE 2

SOIL DESCRIPTION SILT, SANDY  
 USCS CLASSIFICATION ML

U.S. Sieve #	Percent Finer
3"	
1 1/2"	
3/4"	
1/2"	
3/8"	100.0%
4	98.0%
10	90.4%
20	83.2%
40	79.0%
100	70.4%
200	60.6%

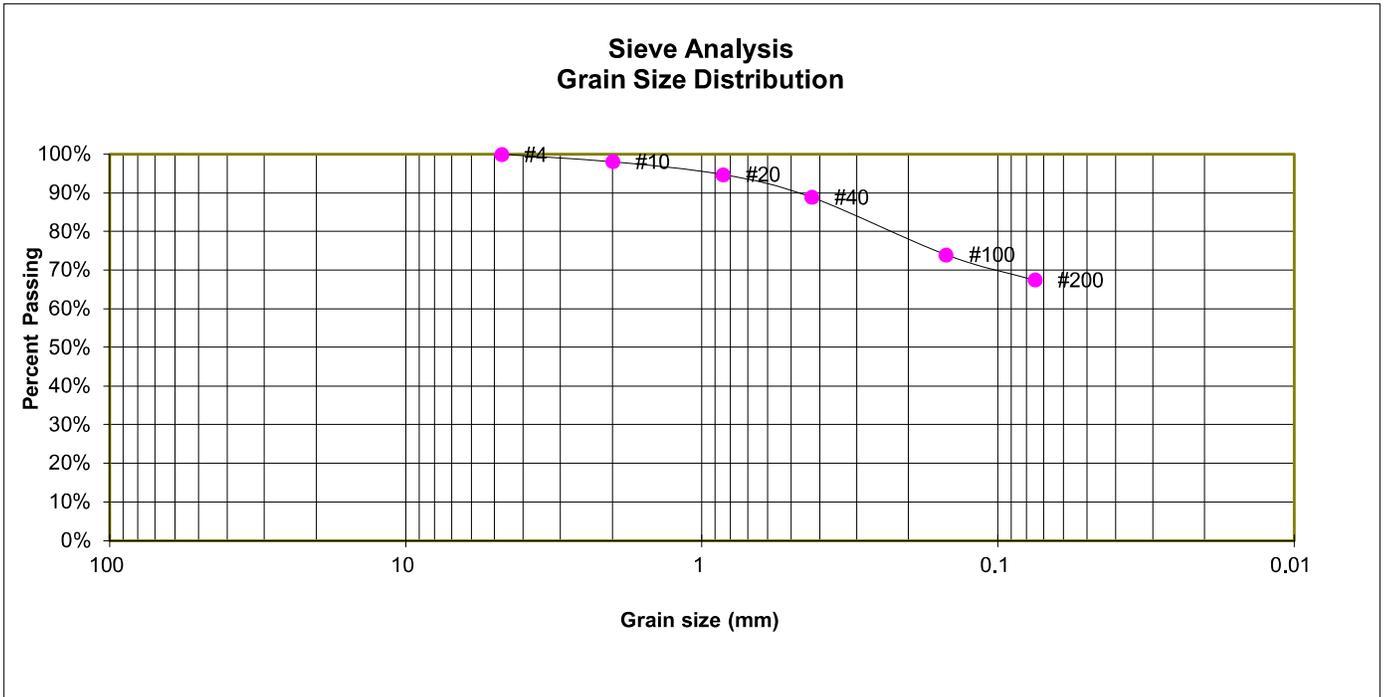
TEST BORING 6  
 DEPTH (FT) 10  
 SOIL TYPE 2

SOIL DESCRIPTION CLAY, SANDY  
 USCS CLASSIFICATION CL

U.S. Sieve #	Percent Finer
3"	
1 1/2"	
3/4"	
1/2"	
3/8"	
4	100.0%
10	98.1%
20	94.8%
40	88.9%
100	74.0%
200	67.4%

<u>Atterberg Limits</u>	
Plastic Limit	23
Liquid Limit	41
Plastic Index	18

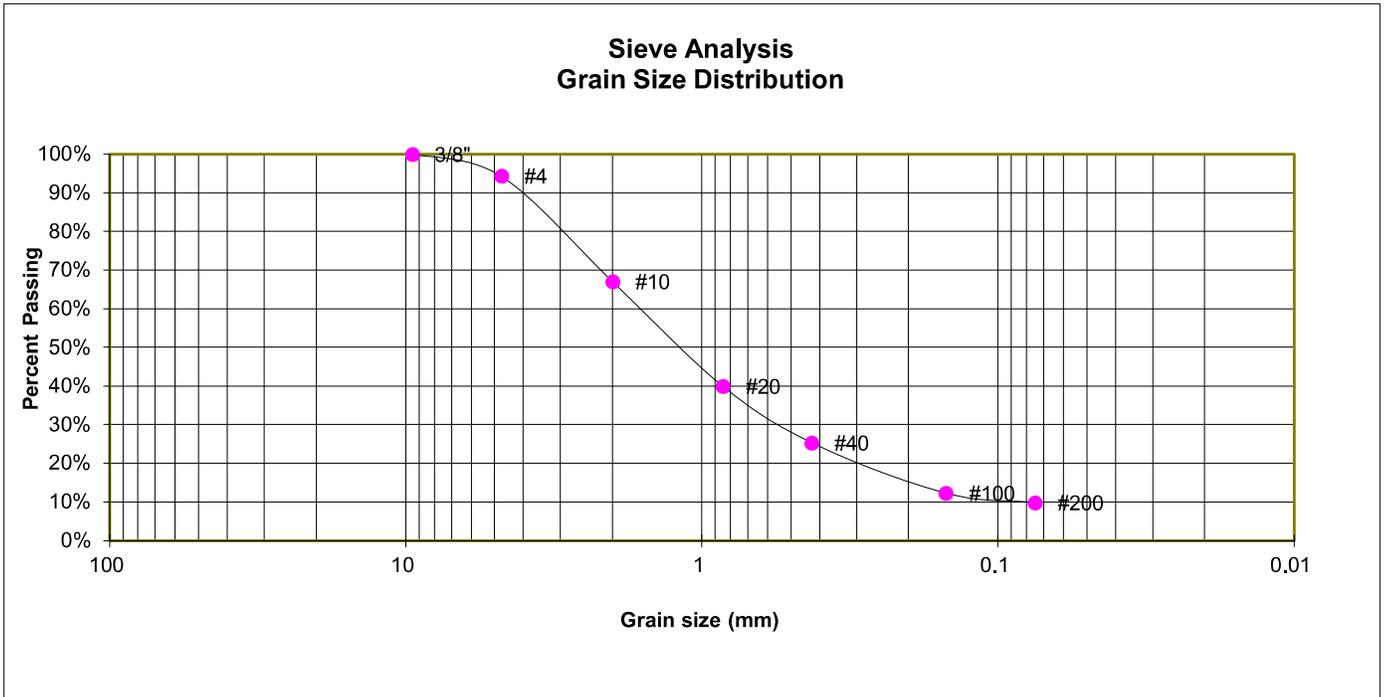
TEST BORING 3  
 DEPTH (FT) 15  
 SOIL TYPE 3

SOIL DESCRIPTION SANDSTONE, (SAND, WITH SILT)  
 USCS CLASSIFICATION SM-SW

U.S. Sieve #	Percent Finer
3"	
1 1/2"	
3/4"	
1/2"	
3/8"	100.0%
4	94.3%
10	67.0%
20	40.0%
40	25.3%
100	12.3%
200	9.8%

**Atterberg Limits**  
 Plastic Limit NP  
 Liquid Limit NV  
 Plastic Index NP

Soil Type 3 is a silty to very silty sandstone and clayey to very clayey sandstone (SM, SM-SW, SC). This material was encountered in eight of the test borings. The sandstone was encountered at depths ranging from 3 to 17 feet bgs and extended to termination of the test borings and pits (5 to 20 feet). The sandstone was encountered at dense to very dense states and moist conditions. Samples tested had 9 to 26 percent of the soil sized particles passing the No. 200
