**WASTEWATER STUDY  
SADDLEHORN RANCH – FILING NO. 3  
CURTIS ROAD & JUDGE ORR ROAD  
EL PASO COUNTY, COLORADO**

November 15, 2022  
Revised May 17, 2023

- Figure 1: Vicinity Map
- Figure 2: USGS Map
- Figure 3: Site Plan/Testing Location Map
- Figure 4: Soil Survey Map
- Figure 5: Falcon Quadrangle Geology Map
- Figure 6: Geology Map/Engineering Geology
- Figure 7: Floodplain Map
- Figure 8: Septic Suitability Map

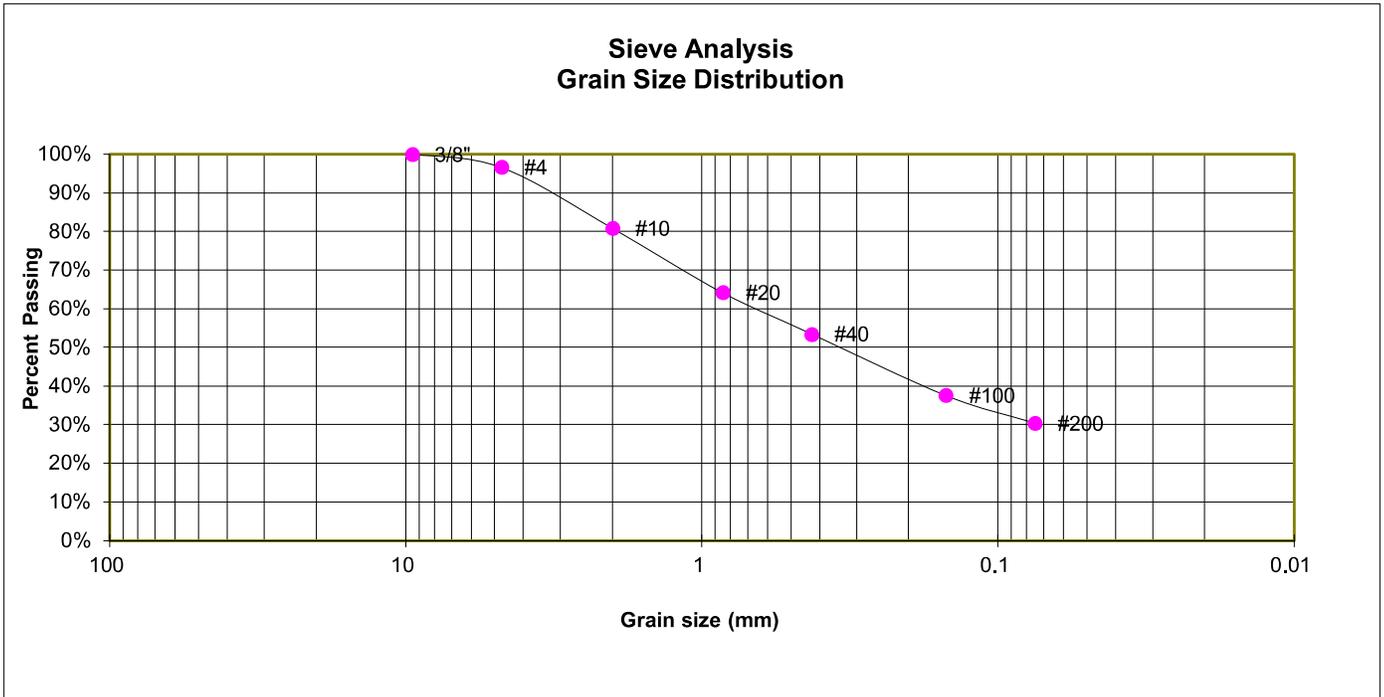
TEST BORING 2  
 DEPTH (FT) 20  
 SOIL TYPE 3

SOIL DESCRIPTION SANDSTONE, (SAND, CLAYEY)  
 USCS CLASSIFICATION SC

U.S. Sieve #	Percent Finer
3"	
1 1/2"	
3/4"	
1/2"	
3/8"	100.0%
4	96.6%
10	80.8%
20	64.2%
40	53.4%
100	37.6%
200	30.4%

Atterberg Limits	
Plastic Limit	18
Liquid Limit	30
Plastic Index	12

Soil Type 3 is a silty to very silty sandstone and clayey to very clayey sandstone (SM, SM-SW, SC). This material was encountered in eight of the test borings. The sandstone was encountered at depths ranging from 3 to 17 feet bgs and extended to termination of the test borings and pits (5 to 20 feet). The sandstone was encountered at dense to very dense states and moist conditions. Samples tested had 9 to 26 percent of the soil sized particles passing the No. 200

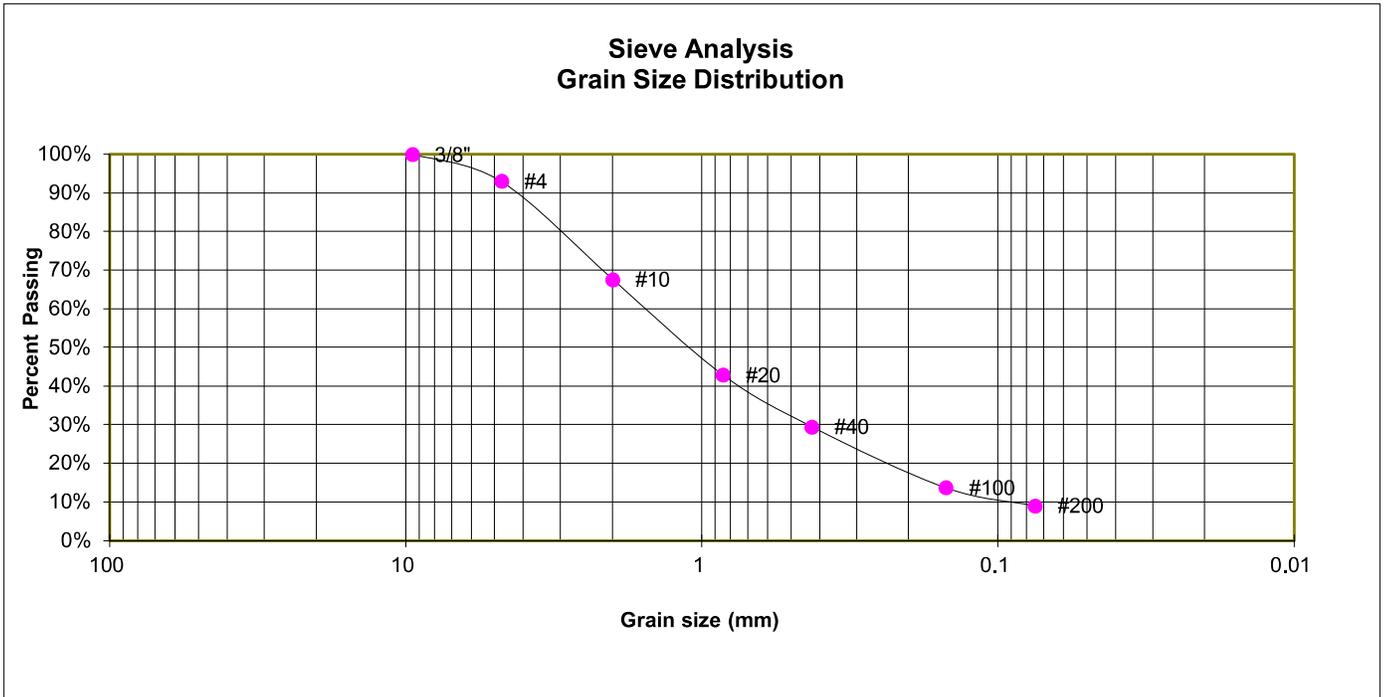
TEST BORING 7  
 DEPTH (FT) 15  
 SOIL TYPE 3

SOIL DESCRIPTION SANDSTONE, (SAND, WITH SILT)  
 USCS CLASSIFICATION SM-SW

U.S. Sieve #	Percent Finer
3"	
1 1/2"	
3/4"	
1/2"	
3/8"	100.0%
4	93.0%
10	67.6%
20	43.0%
40	29.5%
100	13.7%
200	9.0%

**Atterberg Limits**  
 Plastic Limit NP  
 Liquid Limit NV  
 Plastic Index NP

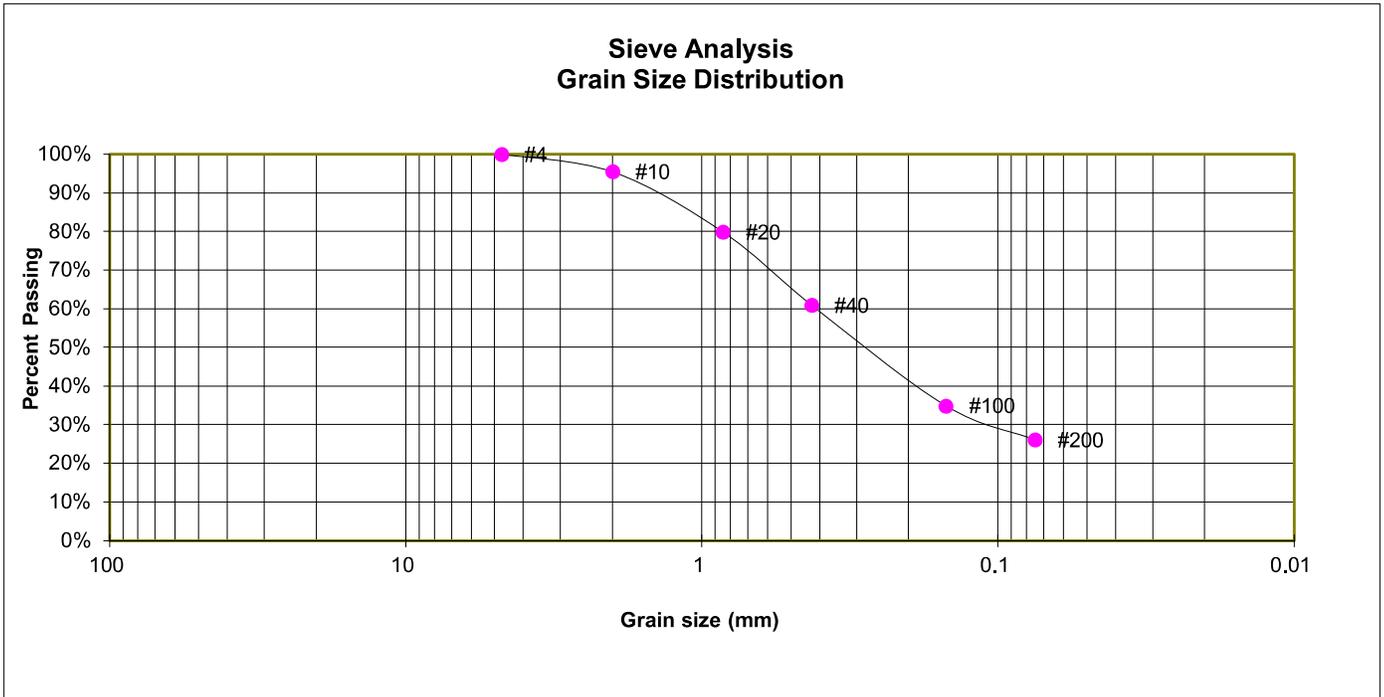
TEST BORING 8  
DEPTH (FT) 20  
SOIL TYPE 3

SOIL DESCRIPTION SANDSTONE, (SAND, SILTY)  
USCS CLASSIFICATION SM

U.S. Sieve #	Percent Finer
3"	
1 1/2"	
3/4"	
1/2"	
3/8"	
4	100.0%
10	95.5%
20	79.9%
40	60.9%
100	34.9%
200	26.1%

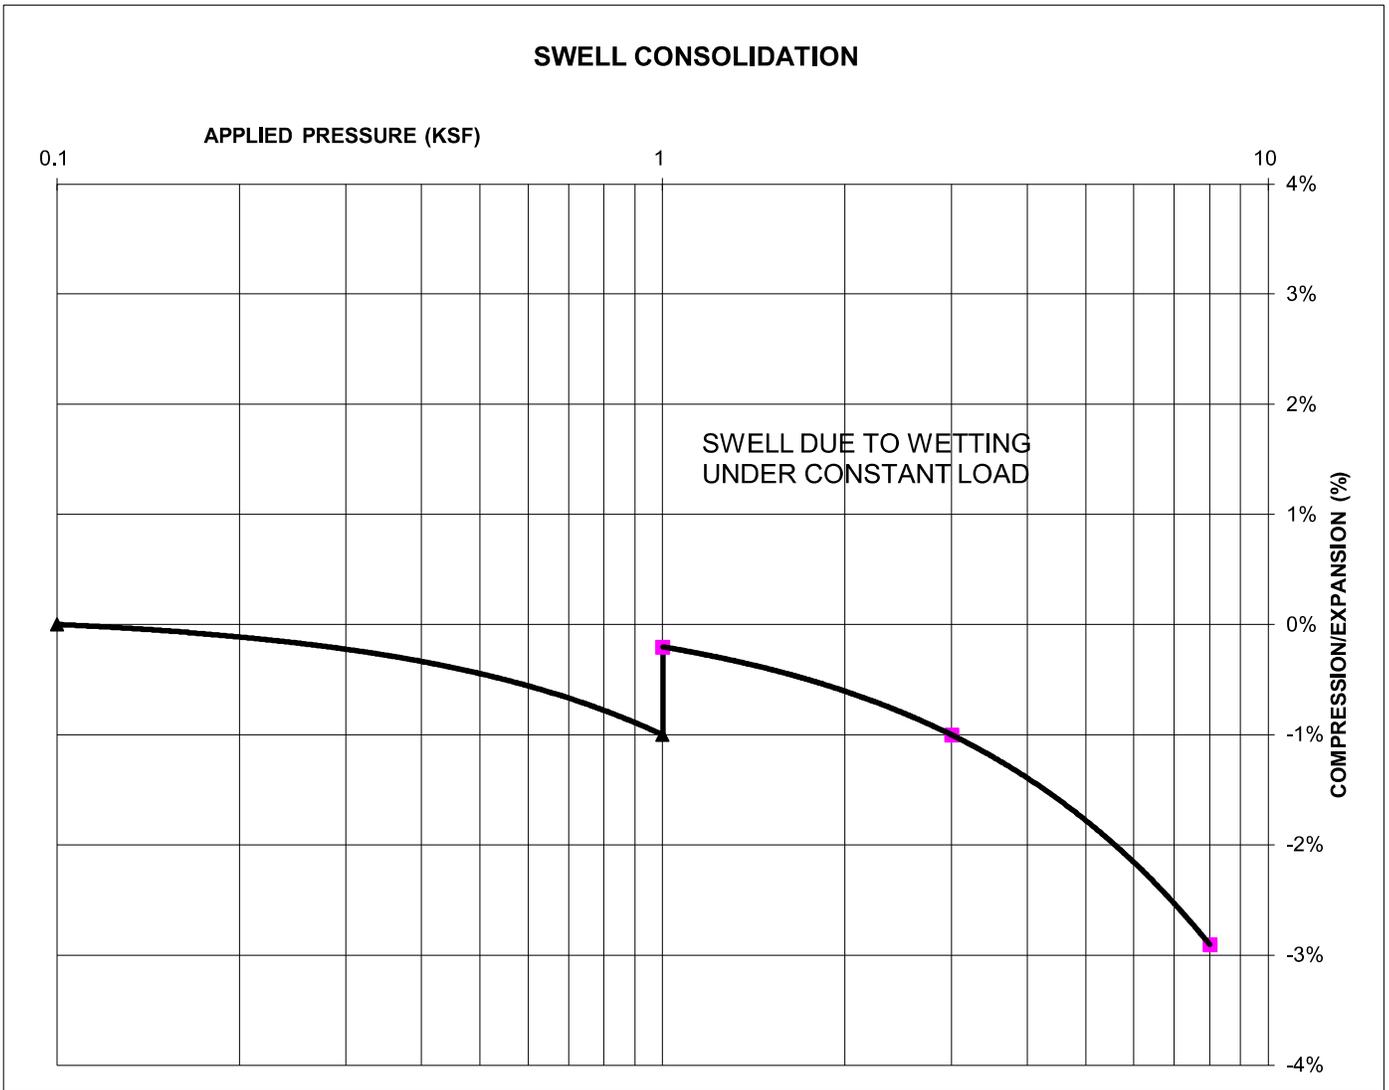
TEST BORING 2  
DEPTH (FT) 15

SOIL DESCRIPTION SILT, SANDY  
SOIL TYPE 2

**SWELL/CONSOLIDATION TEST RESULTS**

NATURAL UNIT DRY WEIGHT (PCF): 116  
NATURAL MOISTURE CONTENT: 15.0%  
SWELL/CONSOLIDATION (%): 0.8%

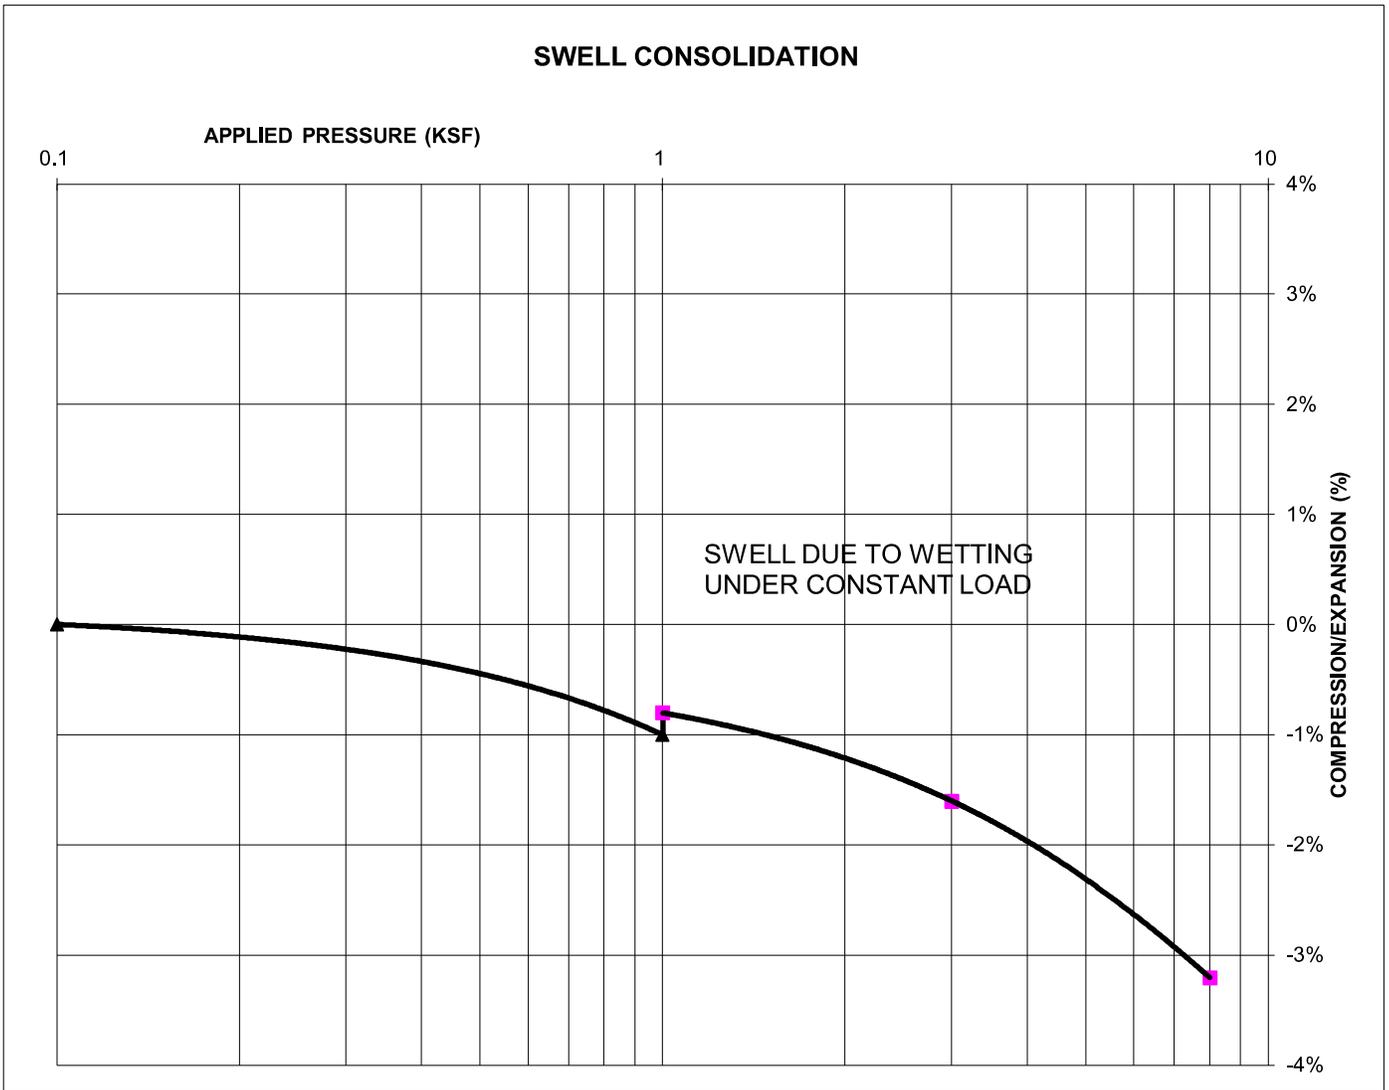
TEST BORING 2  
DEPTH (FT) 20

SOIL DESCRIPTION SANDSTONE, (SAND, CLAYEY)  
SOIL TYPE 3

**SWELL/CONSOLIDATION TEST RESULTS**

NATURAL UNIT DRY WEIGHT (PCF): 119  
NATURAL MOISTURE CONTENT: 12.4%  
SWELL/CONSOLIDATION (%): 0.2%

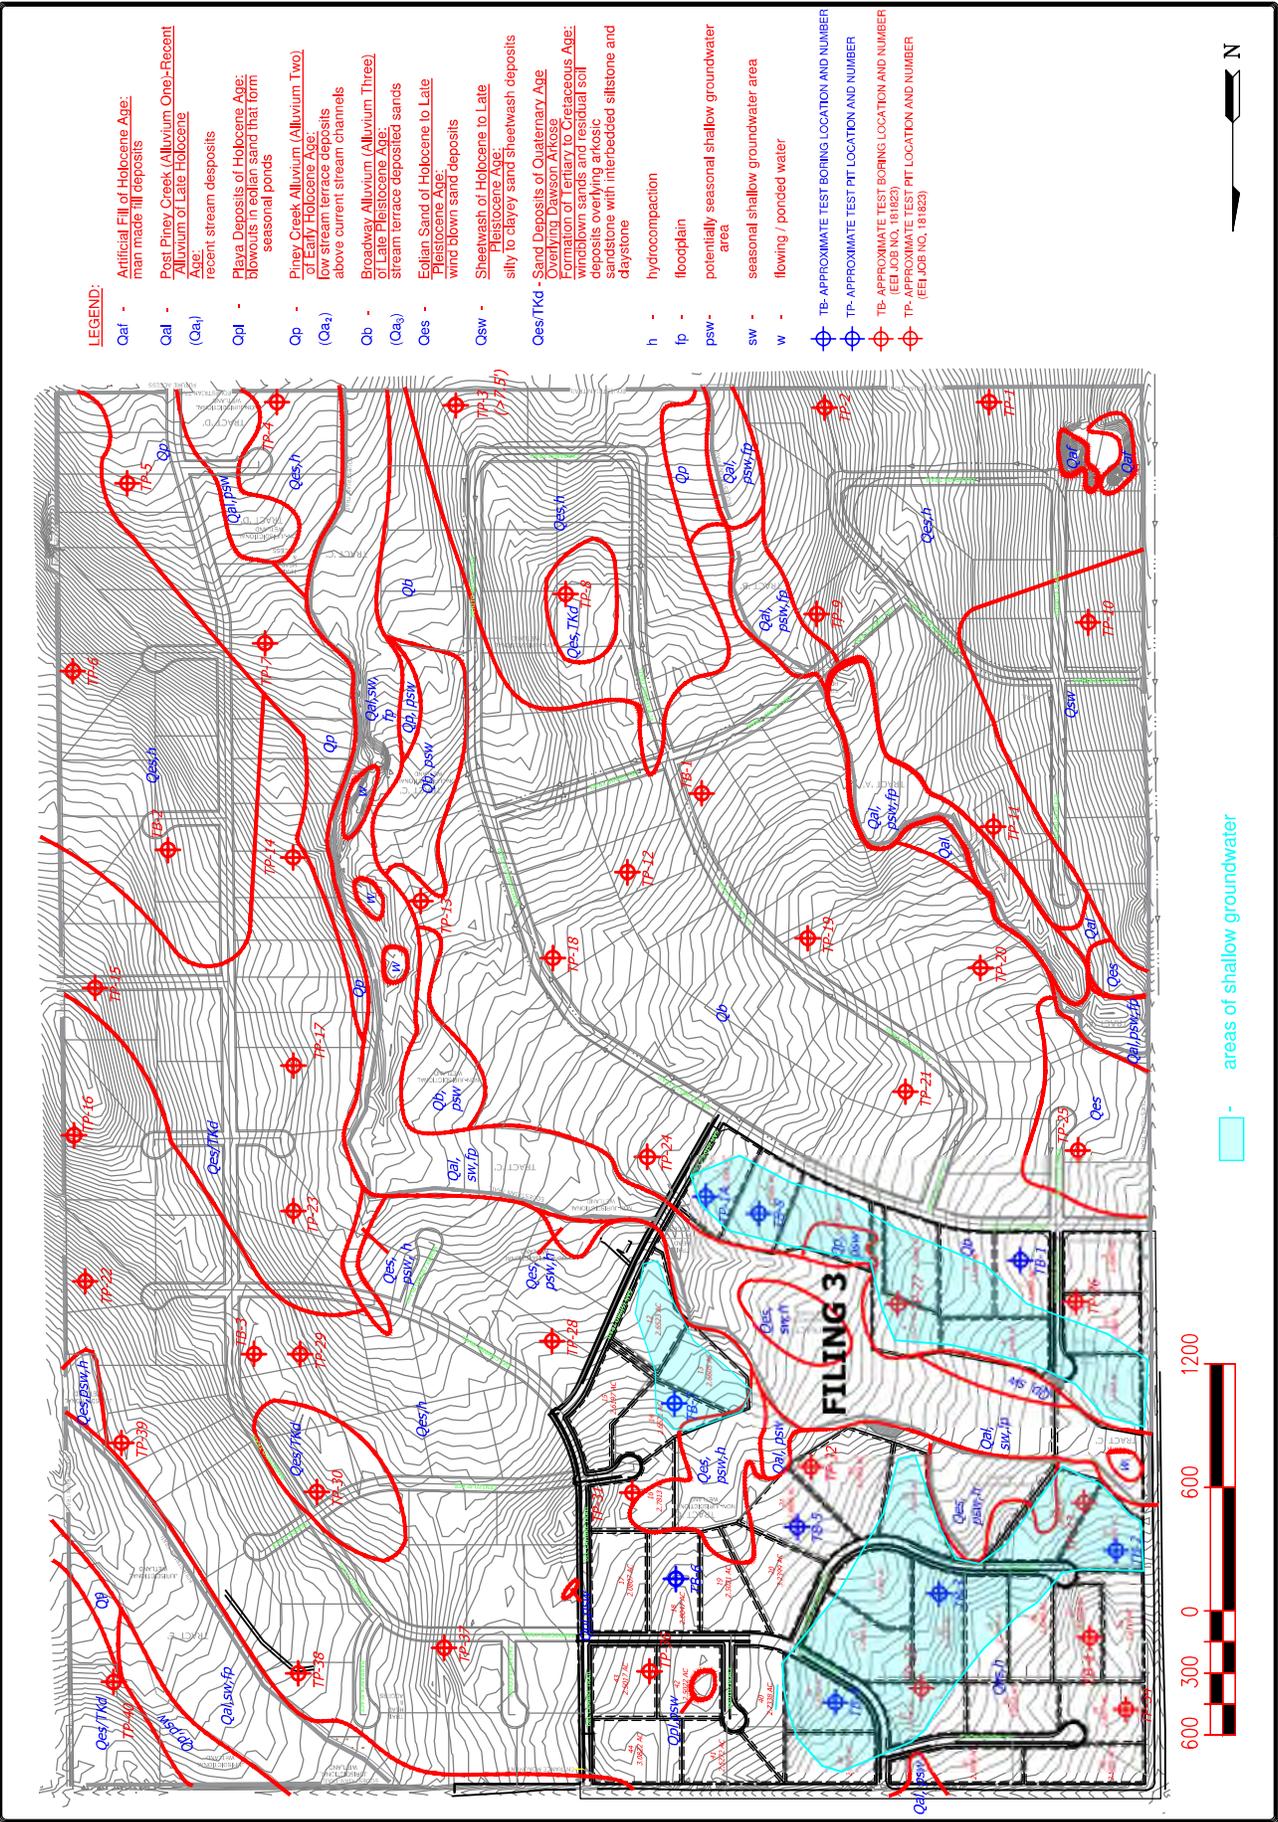
**GEOLOGY/ENGINEERING GEOLOGY MAP**  
SADLIEHORN RANCH FILING NO. 3  
CURTIS ROAD AND JUDE ORR ROAD  
EL PASO COUNTY, CO.  
FOR: WILLIAM GUMAN AND ASSOCIATES, LTD.

It is our opinion that the existing geologic engineering and geologic conditions will impose some minor constraints on development and construction of the site. The majority of these conditions can be avoided by construction. Others can be mitigated through proper engineering design and construction practices. The proposed development and use is consistent with anticipated geologic and engineering geologic conditions.
