**GEOLOGIC HAZARD/LAND USE STUDY, AND PRELIMINARY
SUBSURFACE SOIL INVESTIGATION – ADDENDUM
ORIGINAL REPORT ENTECH JOB NO. 98104, DATED FEBRUARY 24, 2004
MESA RIDGE PARKWAY AND SOUTH POWERS BOULEVARD
EL PASO COUNTY, COLORADO**

Re: Geologic Hazard/Land Use Study, and PSSI – Addendum
Original Report Entech Job No. 98104, dated February 24, 2004
Mesa Ridge – Overall Development Plan
Mesa Ridge Parkway and South Powers Boulevard
El Paso County, Colorado

**GEOLOGIC HAZARD / LAND USE STUDY
AND PRELIMINARY
SUBSURFACE SOIL INVESTIGATION
CROSS CREEK AT MESA RIDGE
EL PASO COUNTY, COLORADO**

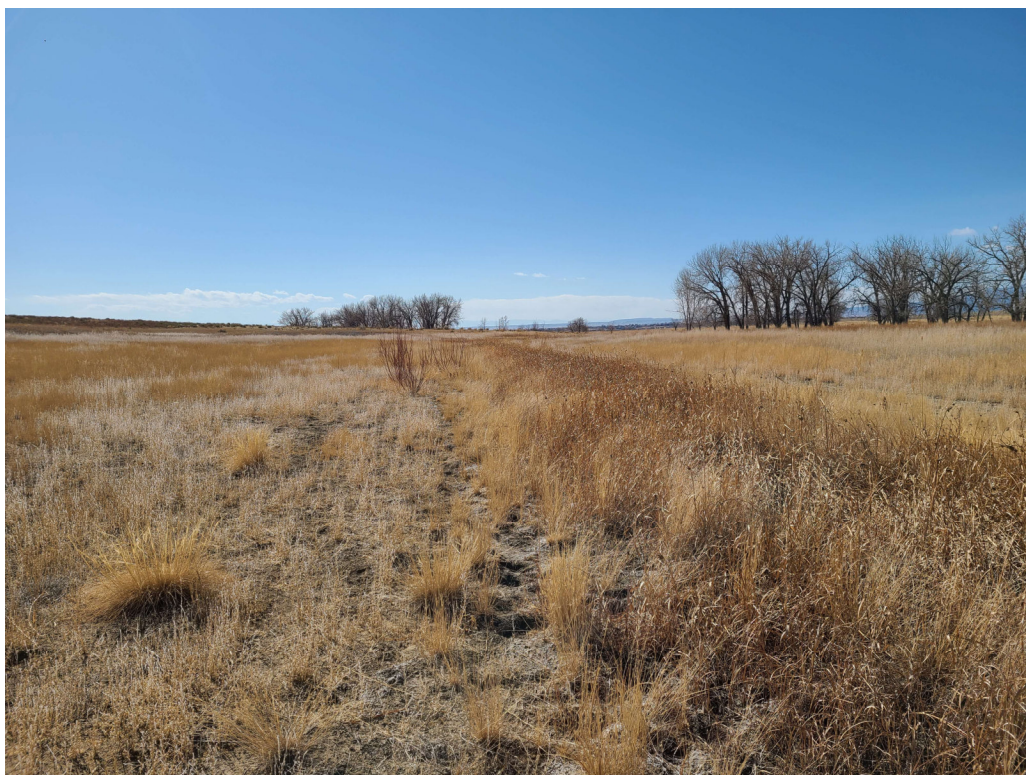
Looking south along drainage in the northeastern portion of the site.

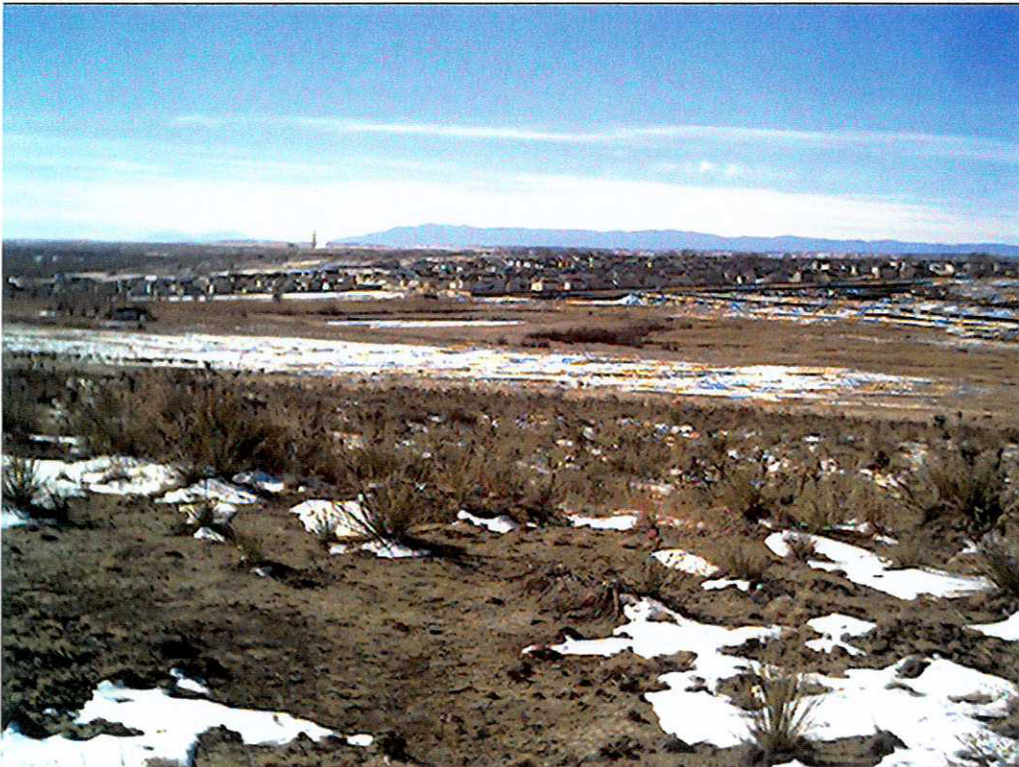
Looking south at ditch in central portion of site.

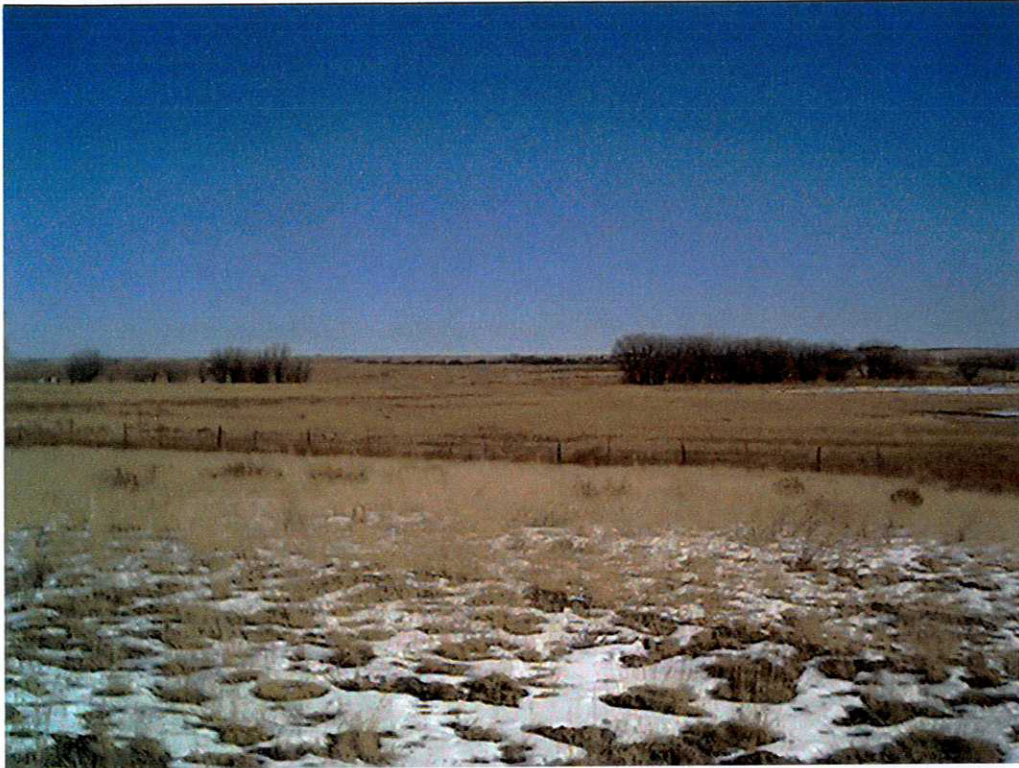
Looking southeast at filled gully in northern portion of site.
