## **SOILS AND GEOLOGY STUDY**

**Windermere Subdivision  
El Paso County, Colorado**

**JOB NO. 162062**

**October 26, 2020**

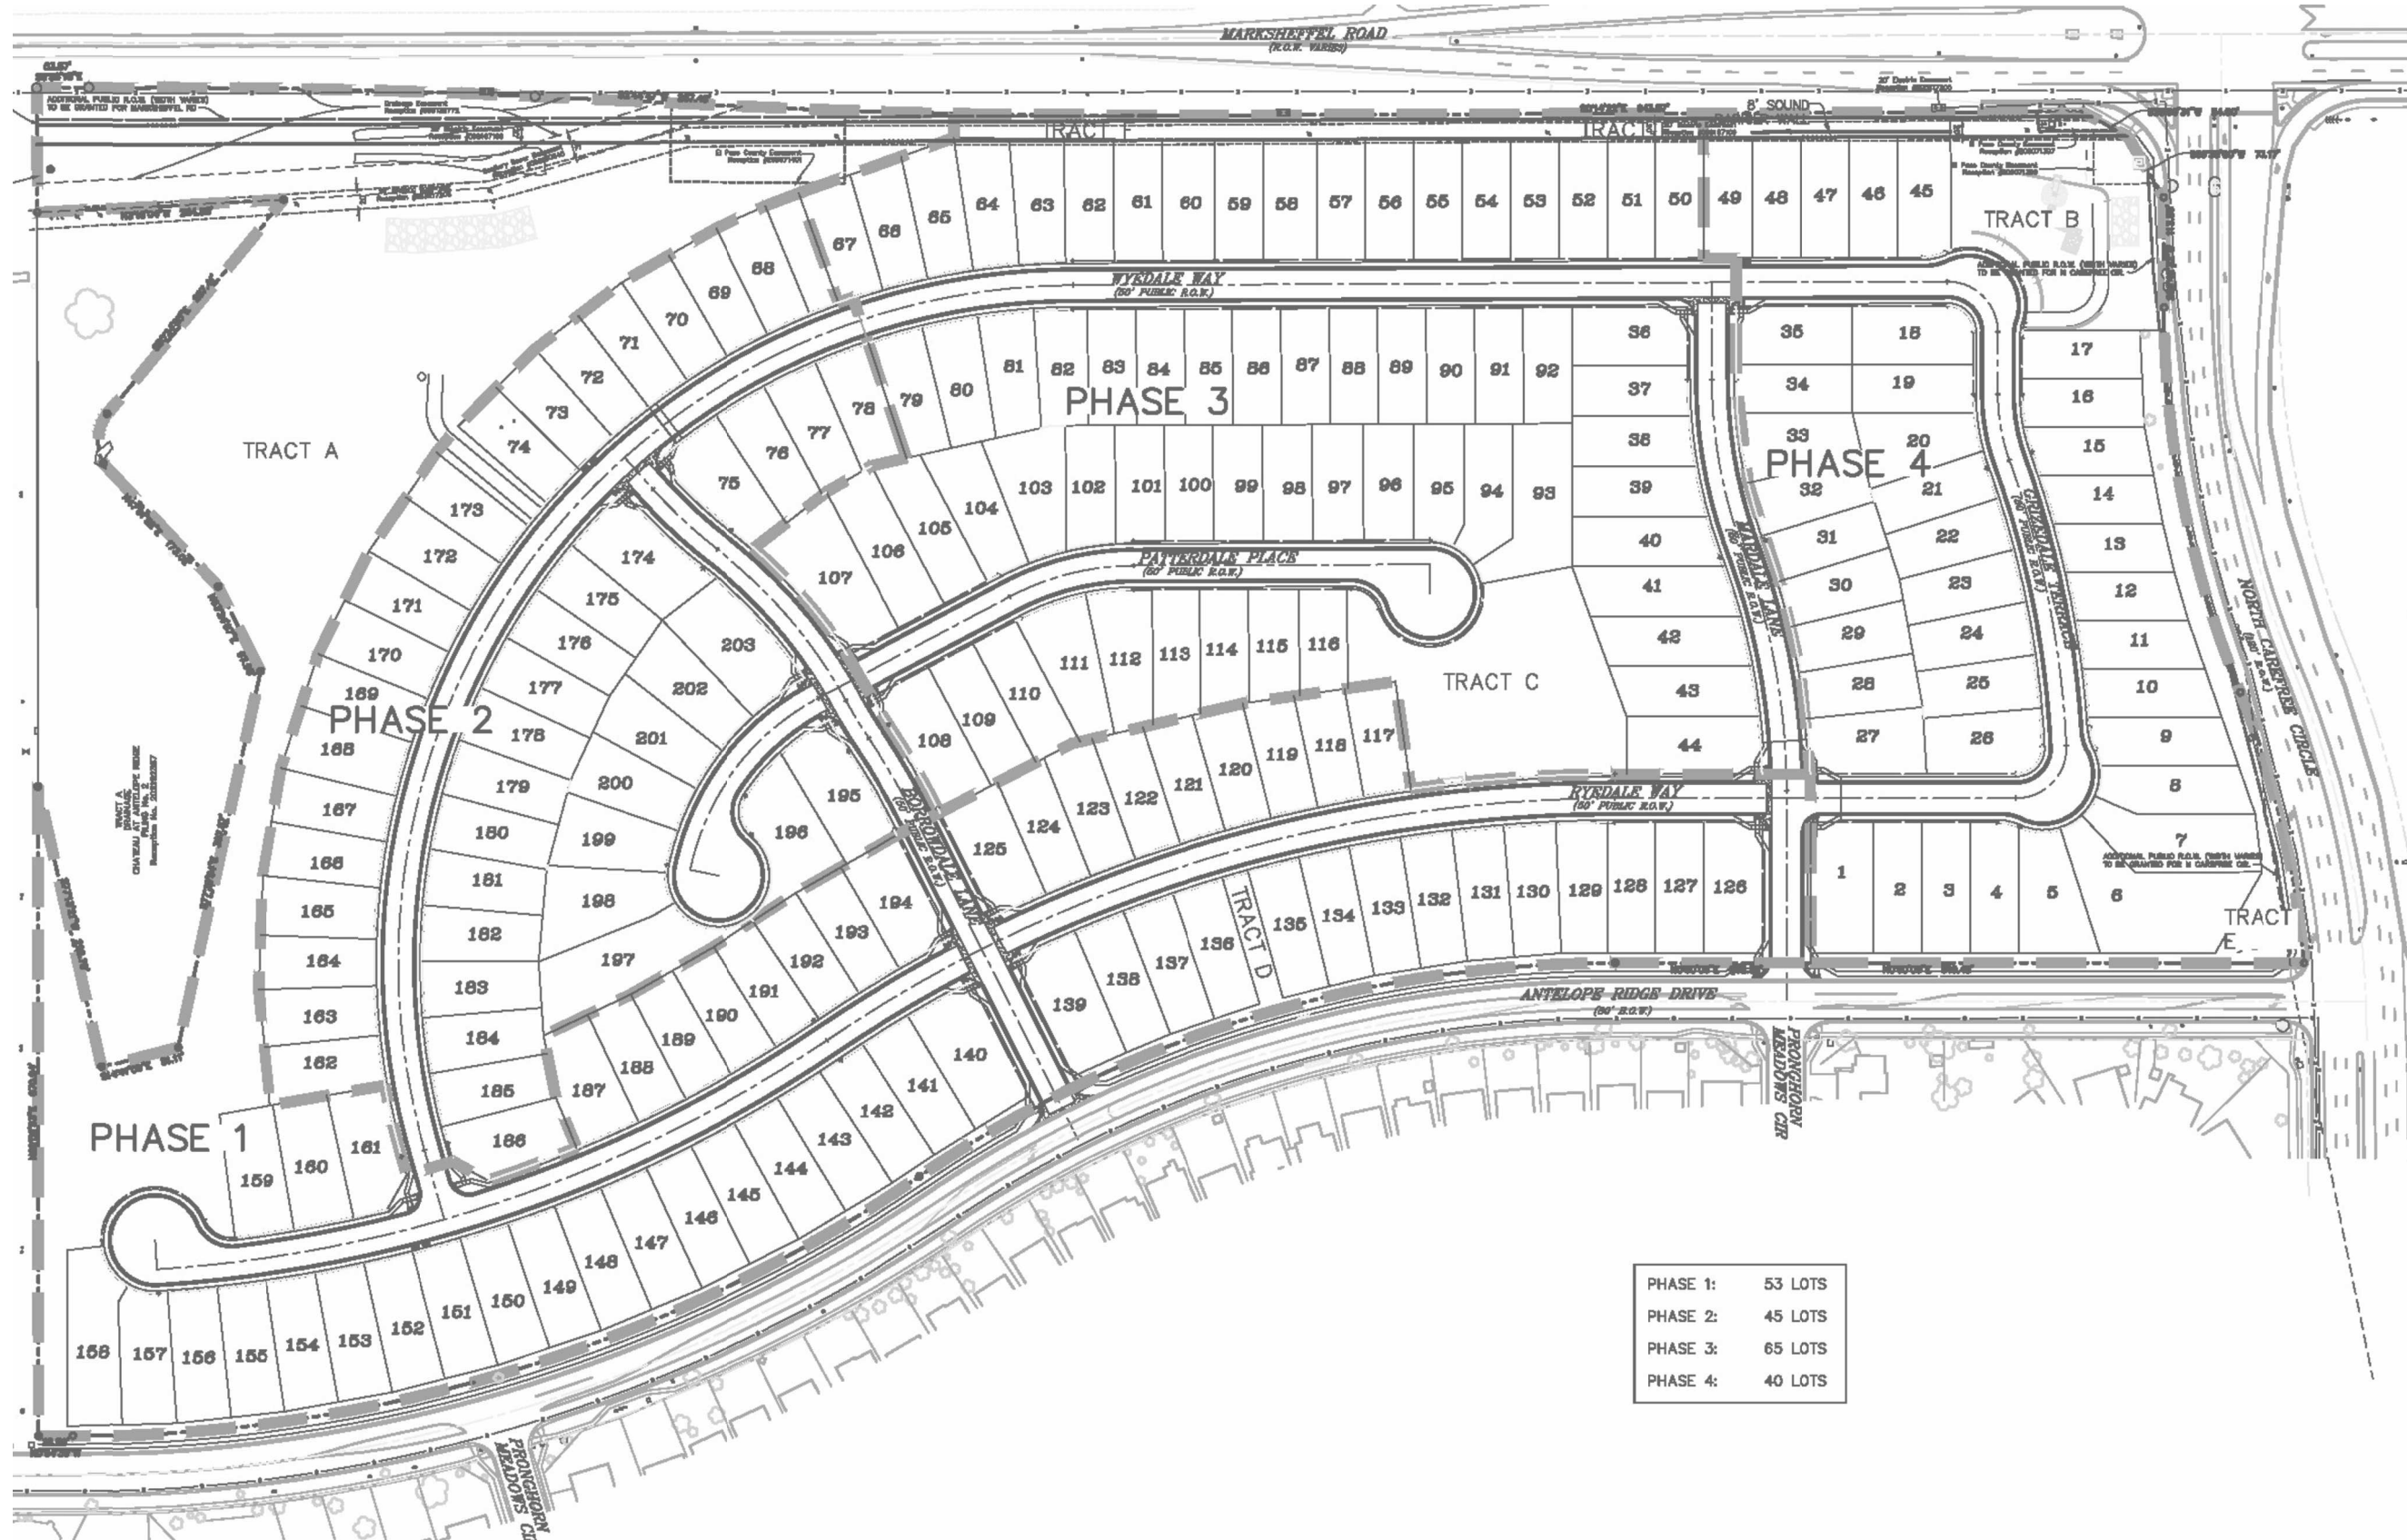
SHEET No.  
**FIG-2**

PHASE 1:	53 LOTS
PHASE 2:	45 LOTS
PHASE 3:	65 LOTS
PHASE 4:	40 LOTS

SITE PLAN

The purpose of this report is to provide a Soils and Geology Study that meets the current requirements outlined in the *El Paso County Land Development Code* (LDC), the *El Paso County Engineering Criteria Manual* (ECM). This report also addresses the Panning and Community Development Engineering review comments, dated March 21, 2019, in regards to the previous *Preliminary Soils and Geology Report* (2014), referenced below. The original *Soils and Geology Report* was also reviewed by the Colorado Geological Survey (CGS). The comments from CGS were posted on the El Paso County Electronic Development Application Review Program (EDARP) on July 28, 2020, and their comments have also been considered in preparation of this updated report. The general boundary of our investigation is presented in Figure 2.

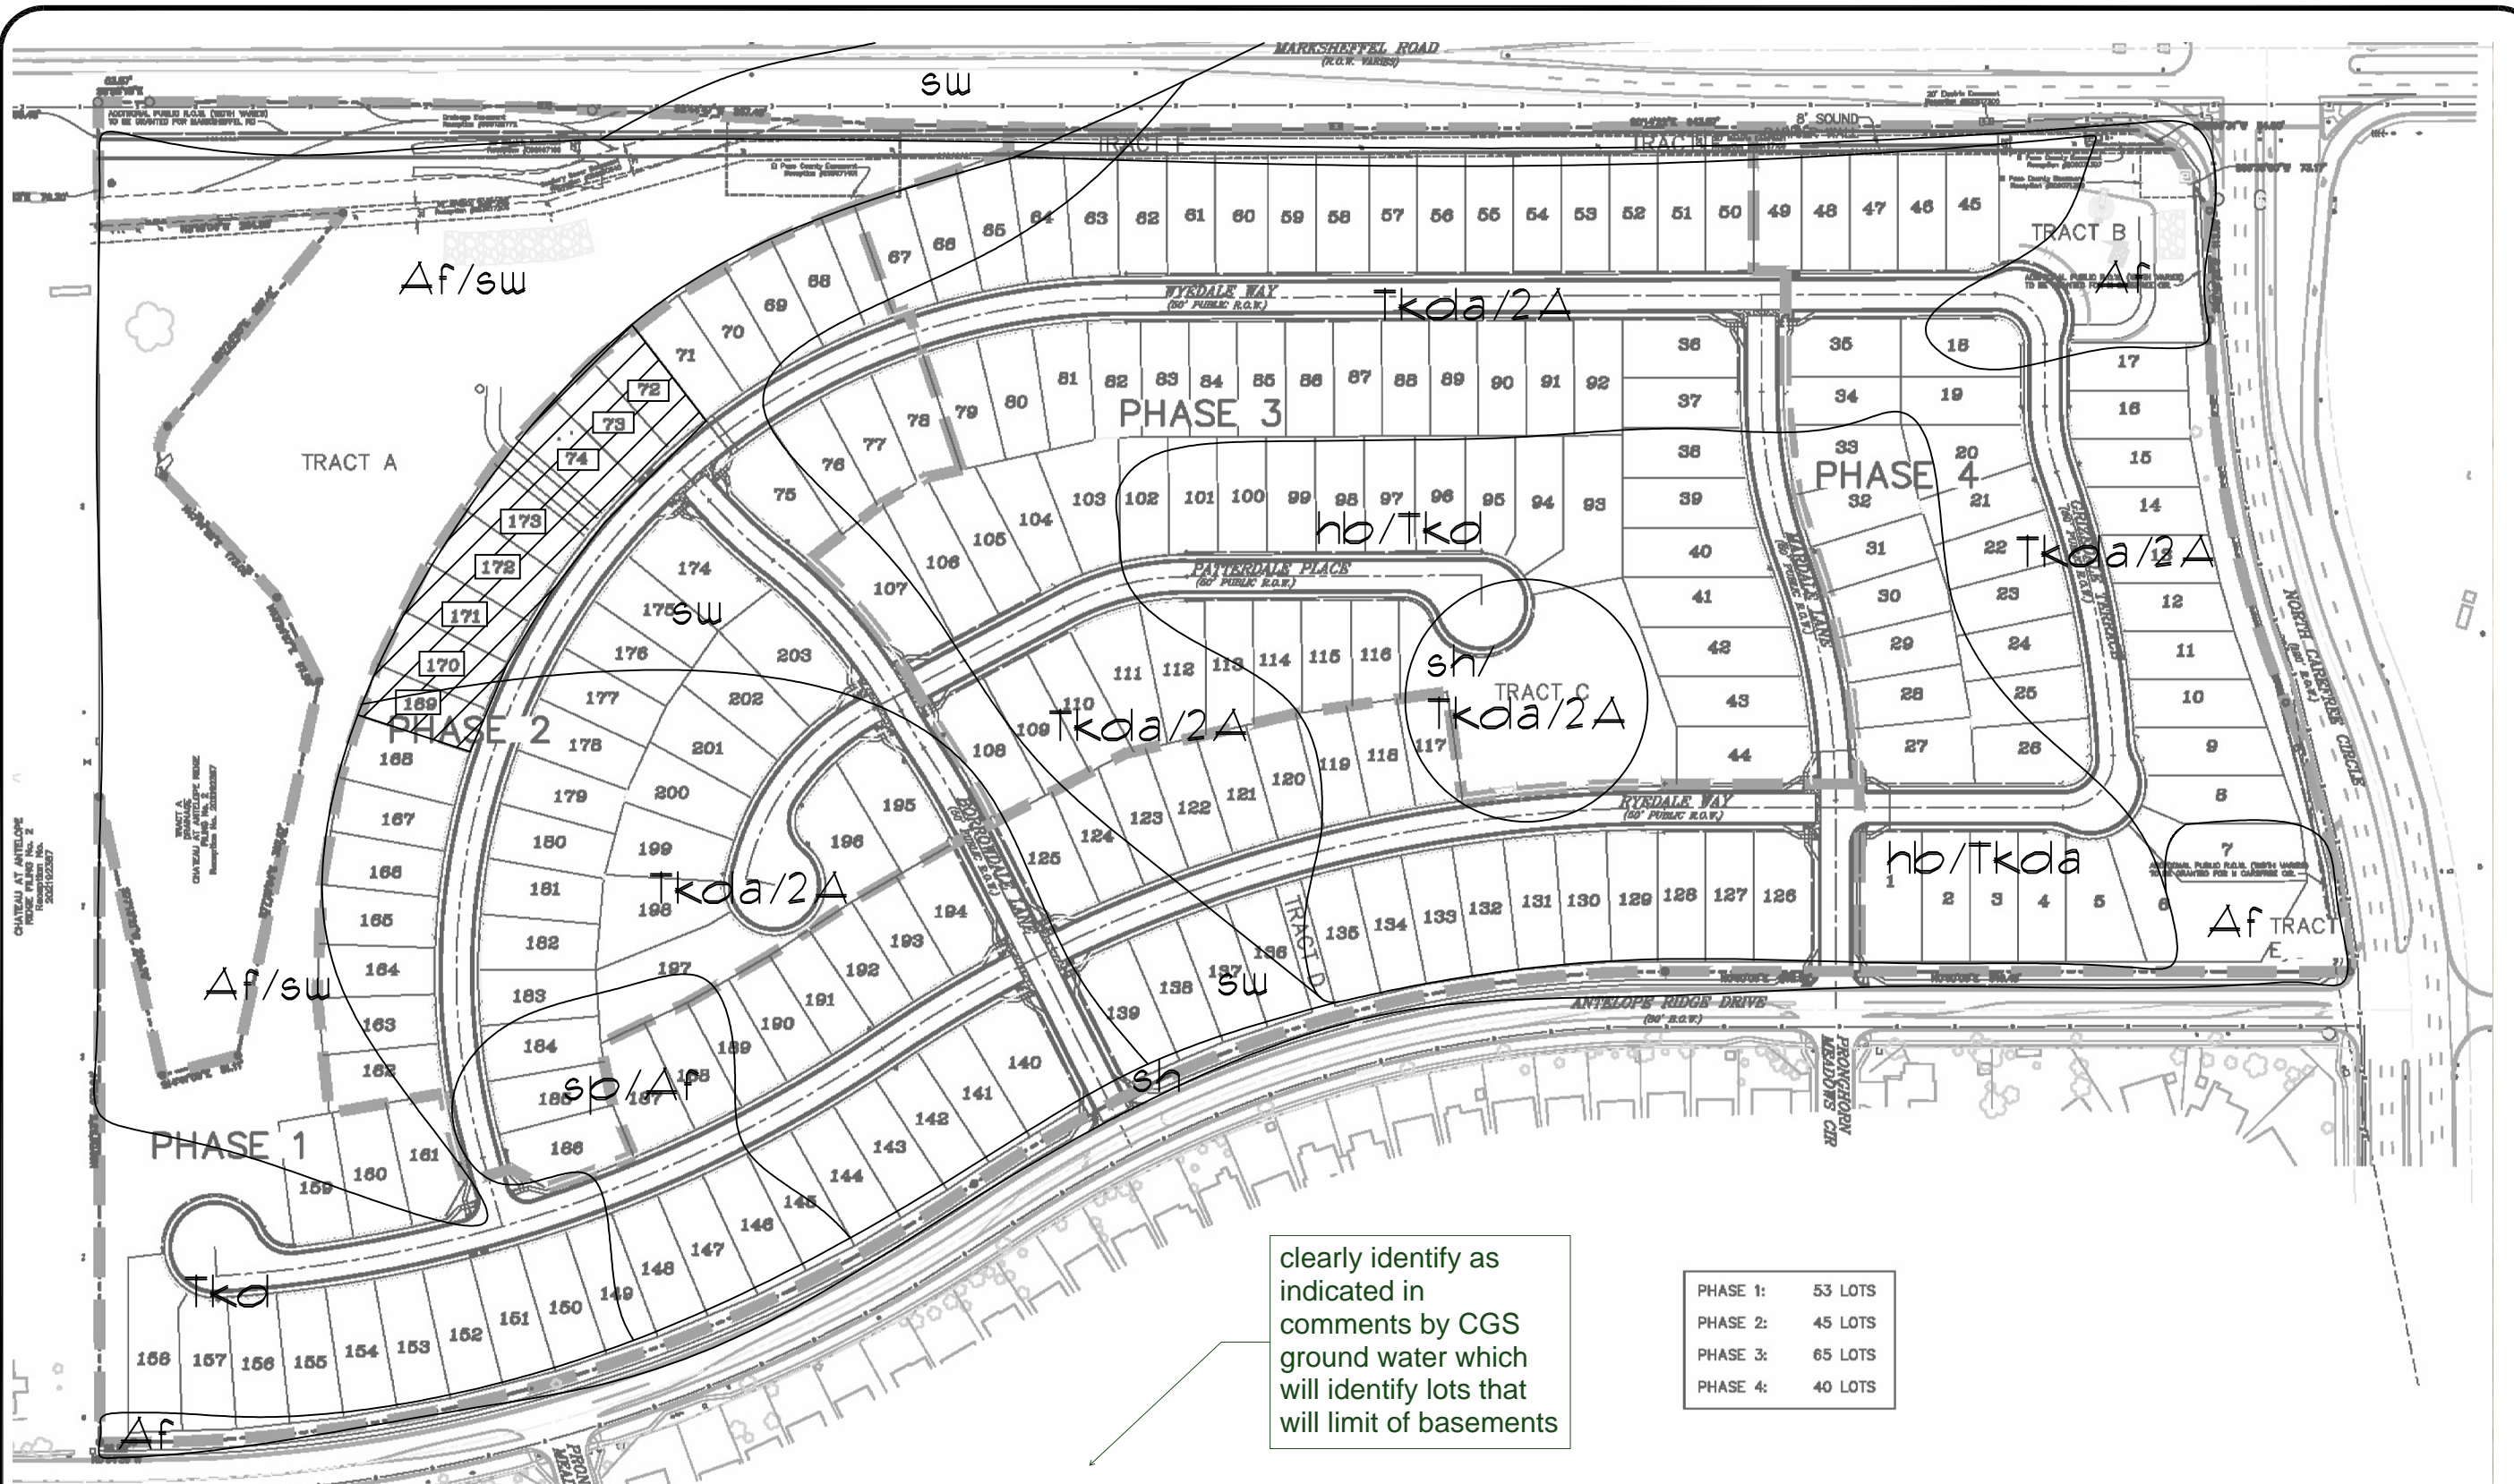
SHEET No. FIG-4

clearly identify as indicated in comments by CGS ground water which will identify lots that will limit of basements

ENGINEERING AND GEOLOGY MAP

Groundwater was not encountered in the remaining test borings. Areas of seasonal and potentially shallow groundwater are indicated on the Engineering and Geology Map, Figure 4 and is discussed in the following section.

Based on our field observations and review of relevant geologic maps, a geologic map was prepared which identifies the geologic conditions affecting the development. The geologic units present of the site are presented in the Engineering and Geology Map, Figure 4.

The sandstone “hill” and the area immediately surrounding the “hill” encountered hard cemented sandstone at the surface. This sandstone “hill” and area are mapped and presented in the Engineering and Geology Map, Figure 4. According to the *Cut/Fill Map*, referenced in Appendix A, the sandstone hill is to be reshaped to a limited degree. Relatively shallow cuts are proposed along the top of the "hill", but cuts along the sides may reach depths of approximately 15 to 16 feet in some areas.

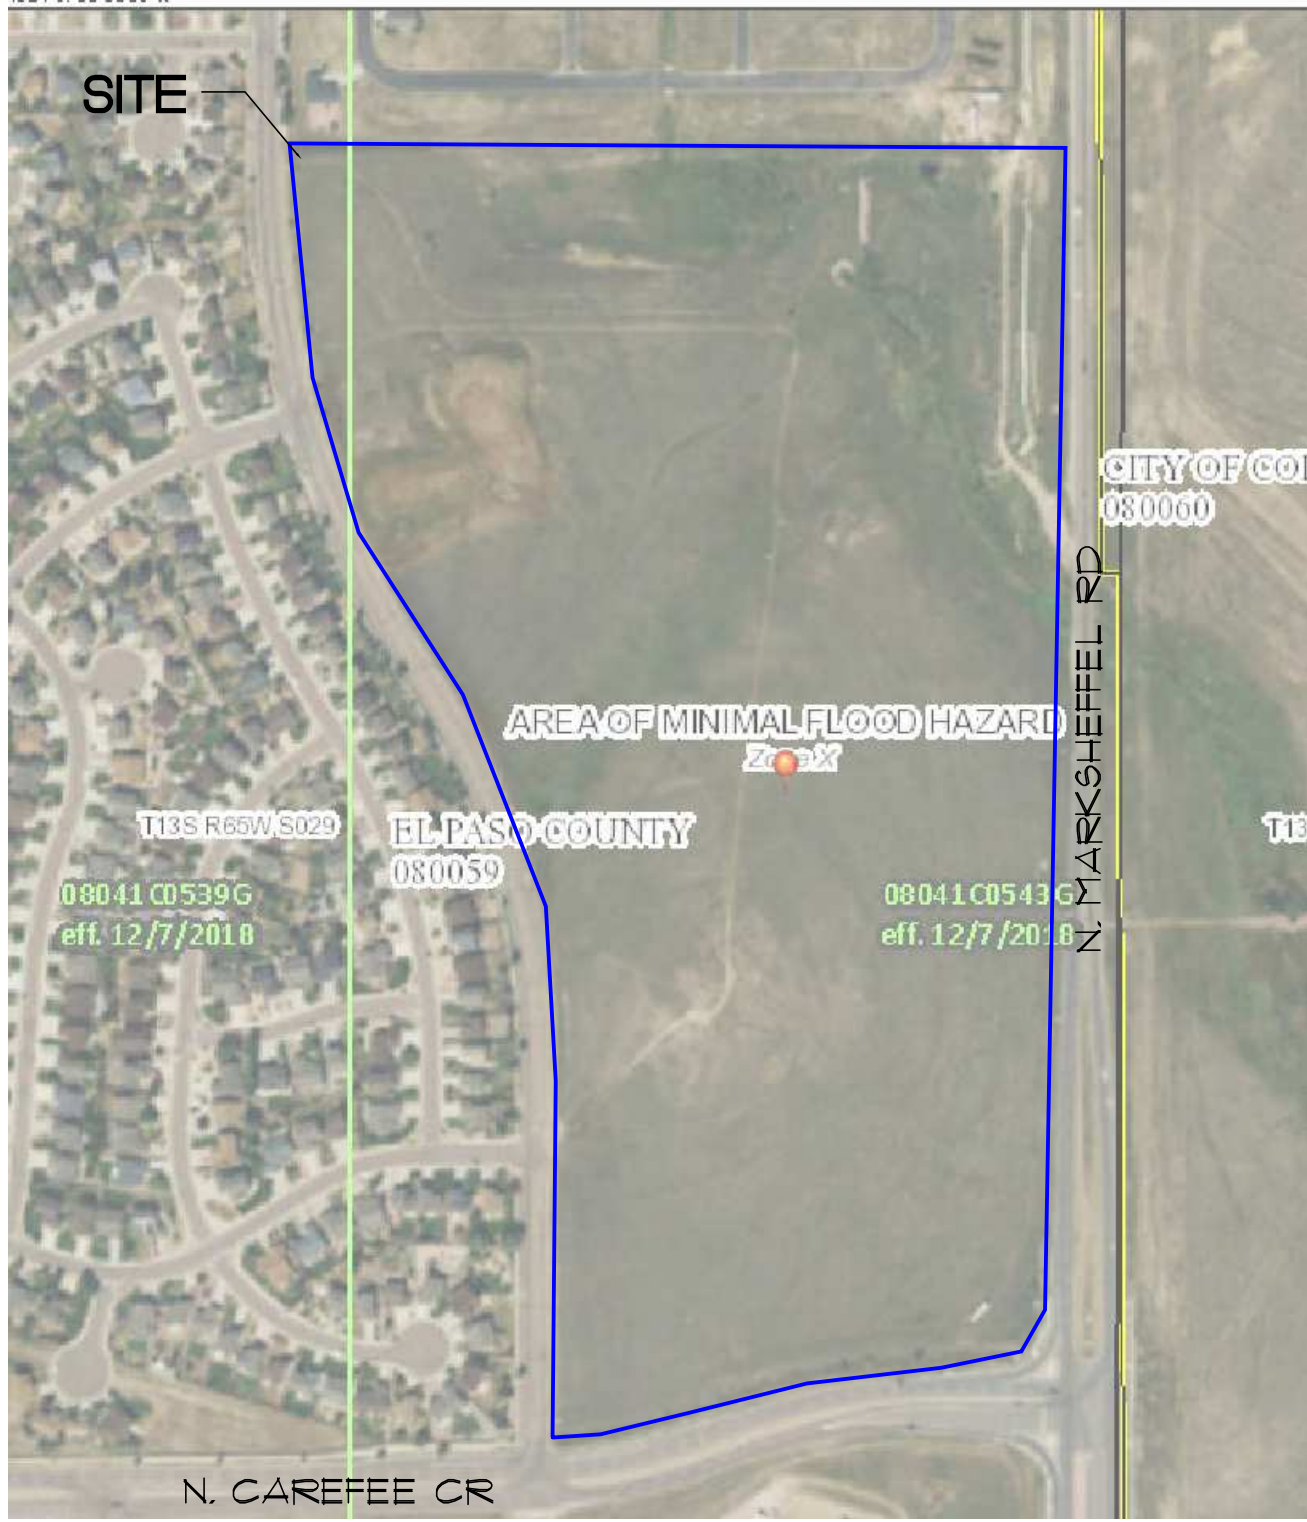
FIG No. 6

NOT TO SCALE  
 BASE MAP PROVIDED BY: FEMA

Based on our review of the Federal Emergency Management Agency (FEMA) Community Panel No. 08041C0539G and 08041C0543G effective December 7, 2018 and the online ArcGIS El Paso County Risk Map, the entire property lies outside of any designated 100-year and 500-year floodplains. The FEMA Map is presented in Figure 6.

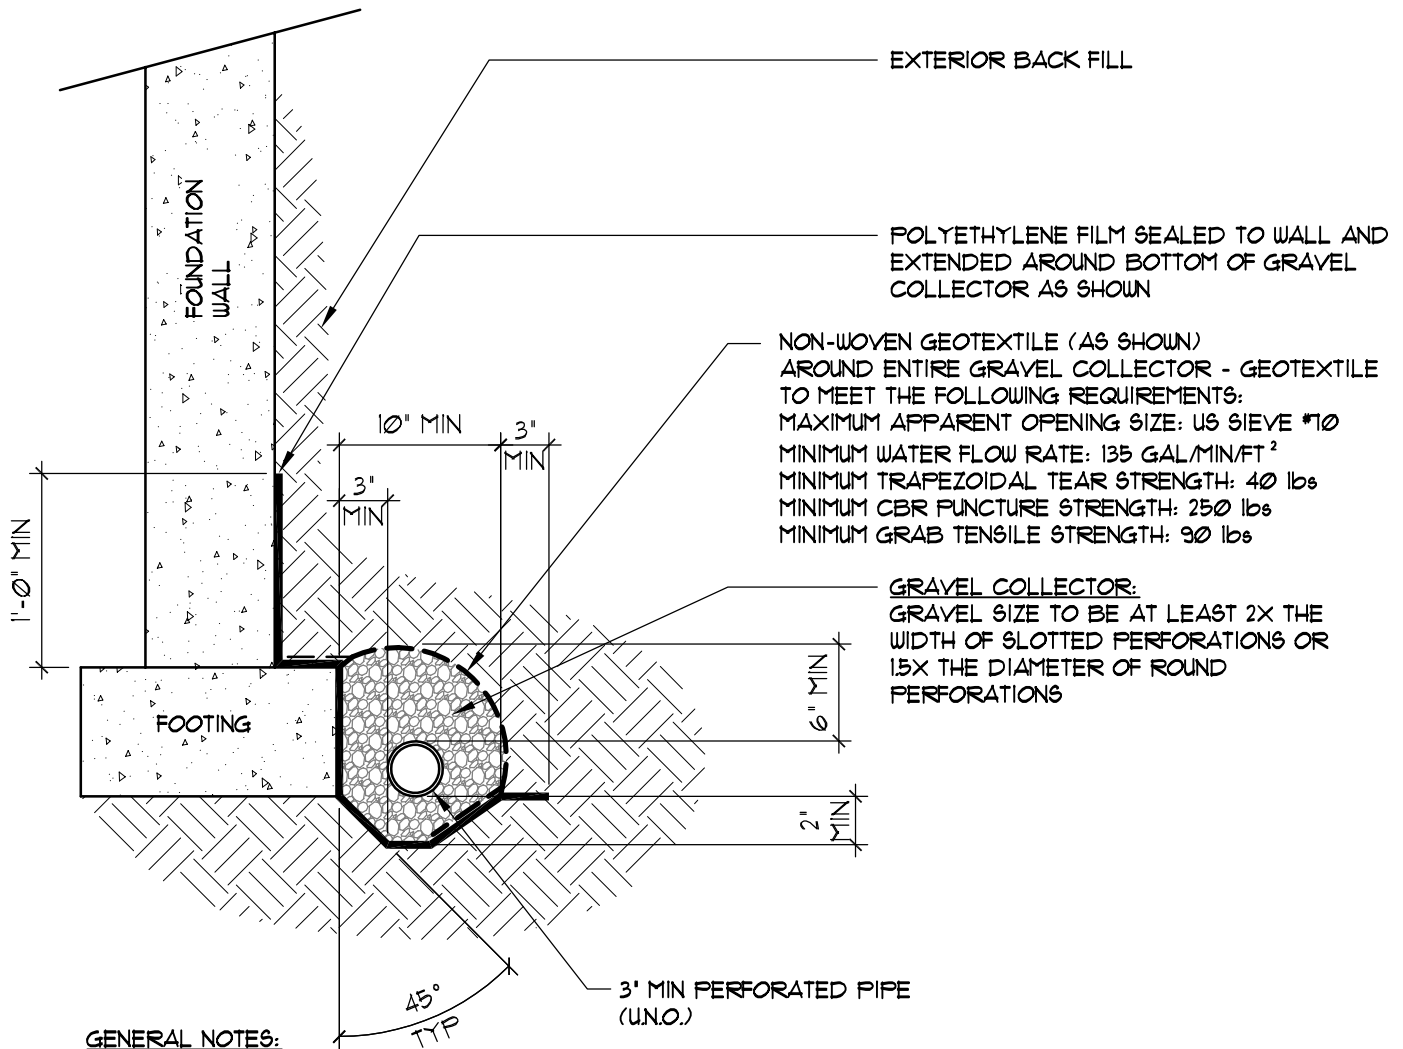
**FIG No. 7**

1. BOTTOM OF DRAIN PIPE SHALL BE AT OR BELOW BOTTOM OF FOOTING AT ALL LOCATIONS
2. ALL DRAIN PIPE SHALL BE PERFORATED PLASTIC, WITH THE EXCEPTION OF THE DISCHARGE PORTION WHICH SHALL BE SOLID, NON-PERFORATED PIPE.

**PERIMETER DRAIN**

Foundations are required to have a minimum 30-inch depth for frost protection. In areas where potentially high subsurface moisture conditions are anticipated, subsurface drains are recommended to help minimize the intrusion of water into areas below grade. Typical drain details are presented in Figures 7 and 8.

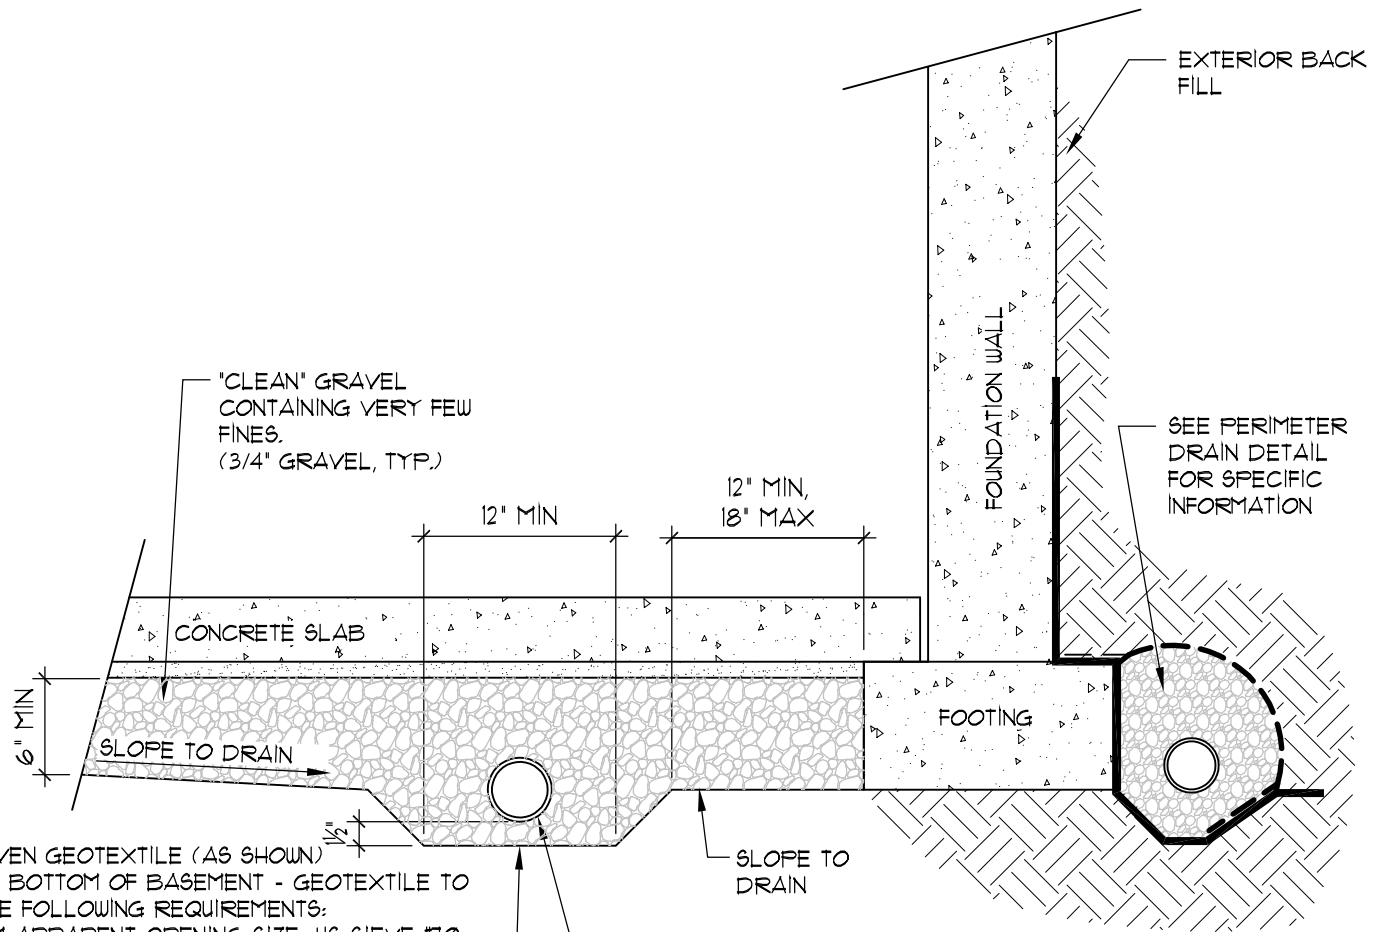
**FIG No. 8**

NON-WOVEN GEOTEXTILE (AS SHOWN) ACROSS BOTTOM OF BASEMENT - GEOTEXTILE TO MEET THE FOLLOWING REQUIREMENTS:  
 MAXIMUM APPARENT OPENING SIZE: US SIEVE #10  
 MINIMUM WATER FLOW RATE: 135 GAL/MIN/FT<sup>2</sup>  
 MINIMUM TRAPEZOIDAL TEAR STRENGTH: 40 lbs  
 MINIMUM CBR PUNCTURE STRENGTH: 250 lbs  
 MINIMUM GRAB TENSILE STRENGTH: 90 lbs

3' DIAMETER RIGID PERFORATED PIPE CONNECTED TO A SUITABLE GRAVITY OUTFALL SUCH AS AN UNDERDRAIN LOCATED IN THE UTILITY TRENCH IN THE STREET WITH A MIN. GRADE OF PIPE = 15%. IF A FREE GRAVITY OUTFALL CANNOT BE ACHIEVED, A SUMP PIT AND PUMP SHOULD BE PROVIDED.
