SOILS AND GEOLOGY STUDY

**Windermere Subdivision
El Paso County, Colorado**

**Windsor Ridge Homes
4164 Austin Bluffs Parkway, #361
Colorado Springs, CO 80918**

JOB NO. 162062

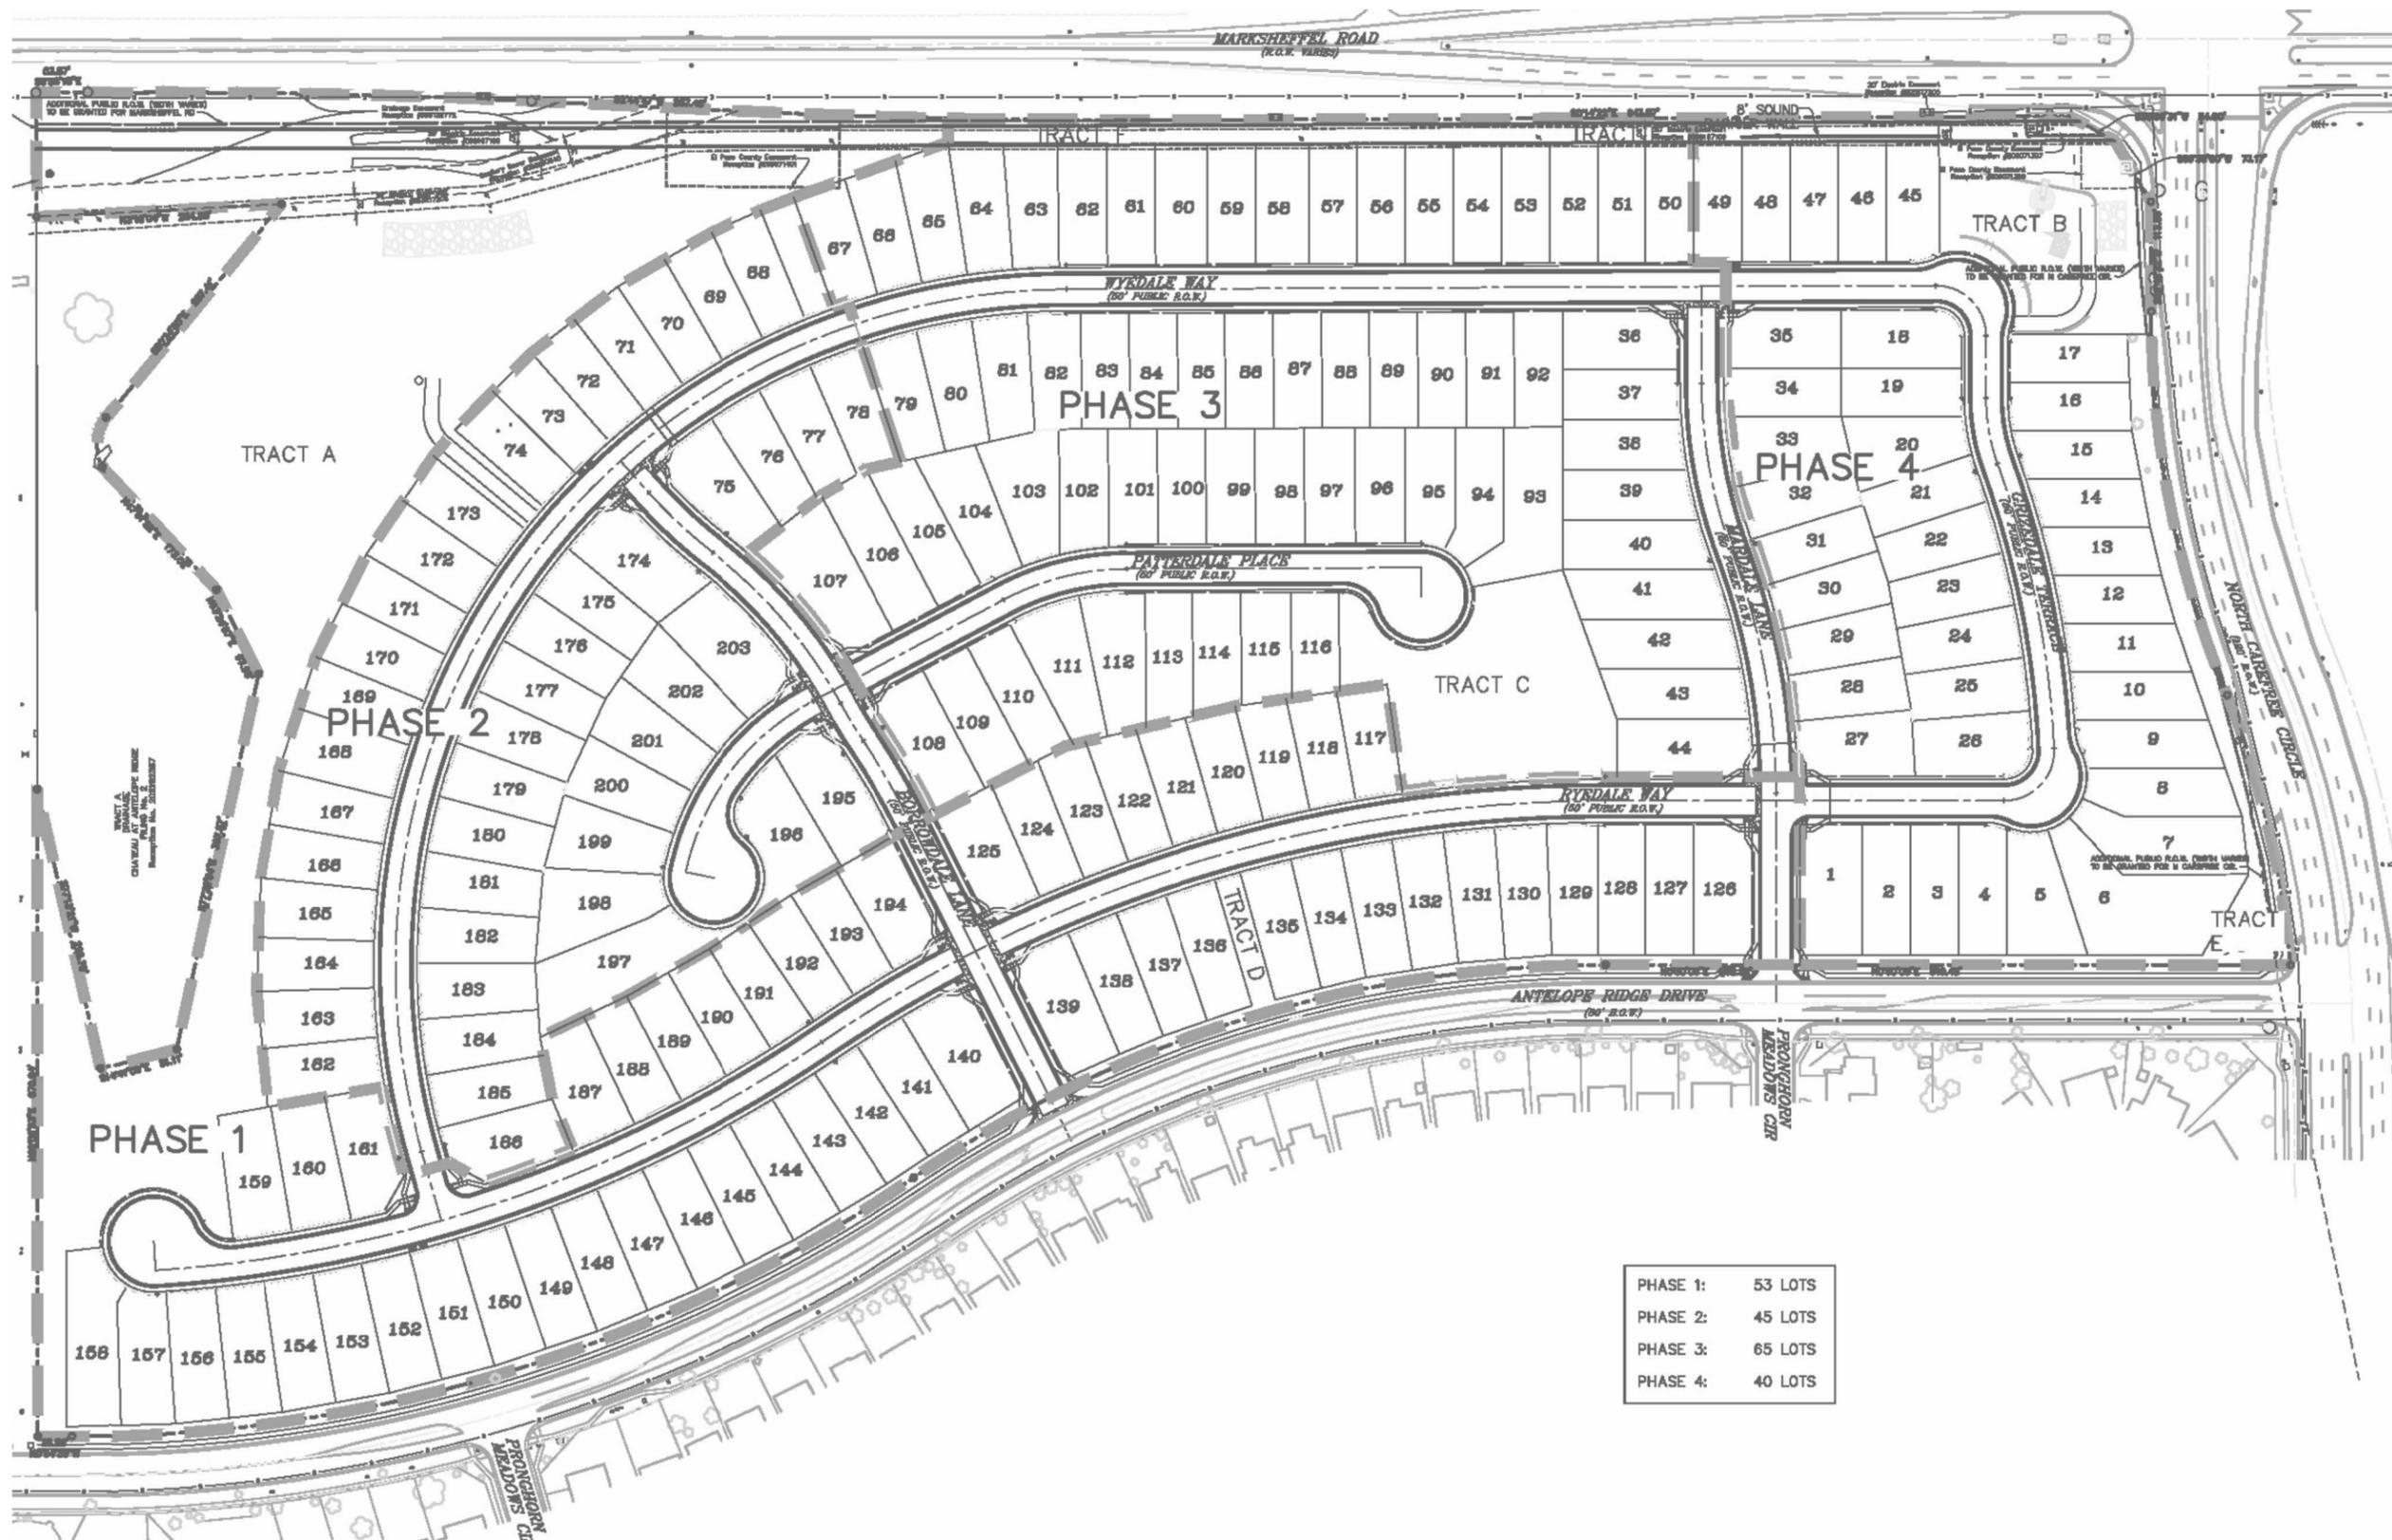
SHEET No.
FIG-2

PHASE 1:	53 LOTS
PHASE 2:	45 LOTS
PHASE 3:	65 LOTS
PHASE 4:	40 LOTS

SITE PLAN

The purpose of this report is to provide a Soils and Geology Study that meets the current requirements outlined in the *El Paso County Land Development Code* (LDC), the *El Paso County Engineering Criteria Manual* (ECM). This report also addresses the Panning and Community Development Engineering review comments, dated March 21, 2019, in regards to the previous *Preliminary Soils and Geology Report* (2014), referenced below. The original *Soils and Geology Report* was also reviewed by the Colorado Geological Survey (CGS). The comments from CGS were posted on the El Paso County Electronic Development Application Review Program (EDARP) on July 28, 2020, and their comments have also been considered in preparation of this updated report. The general boundary of our investigation is presented in Figure 2.

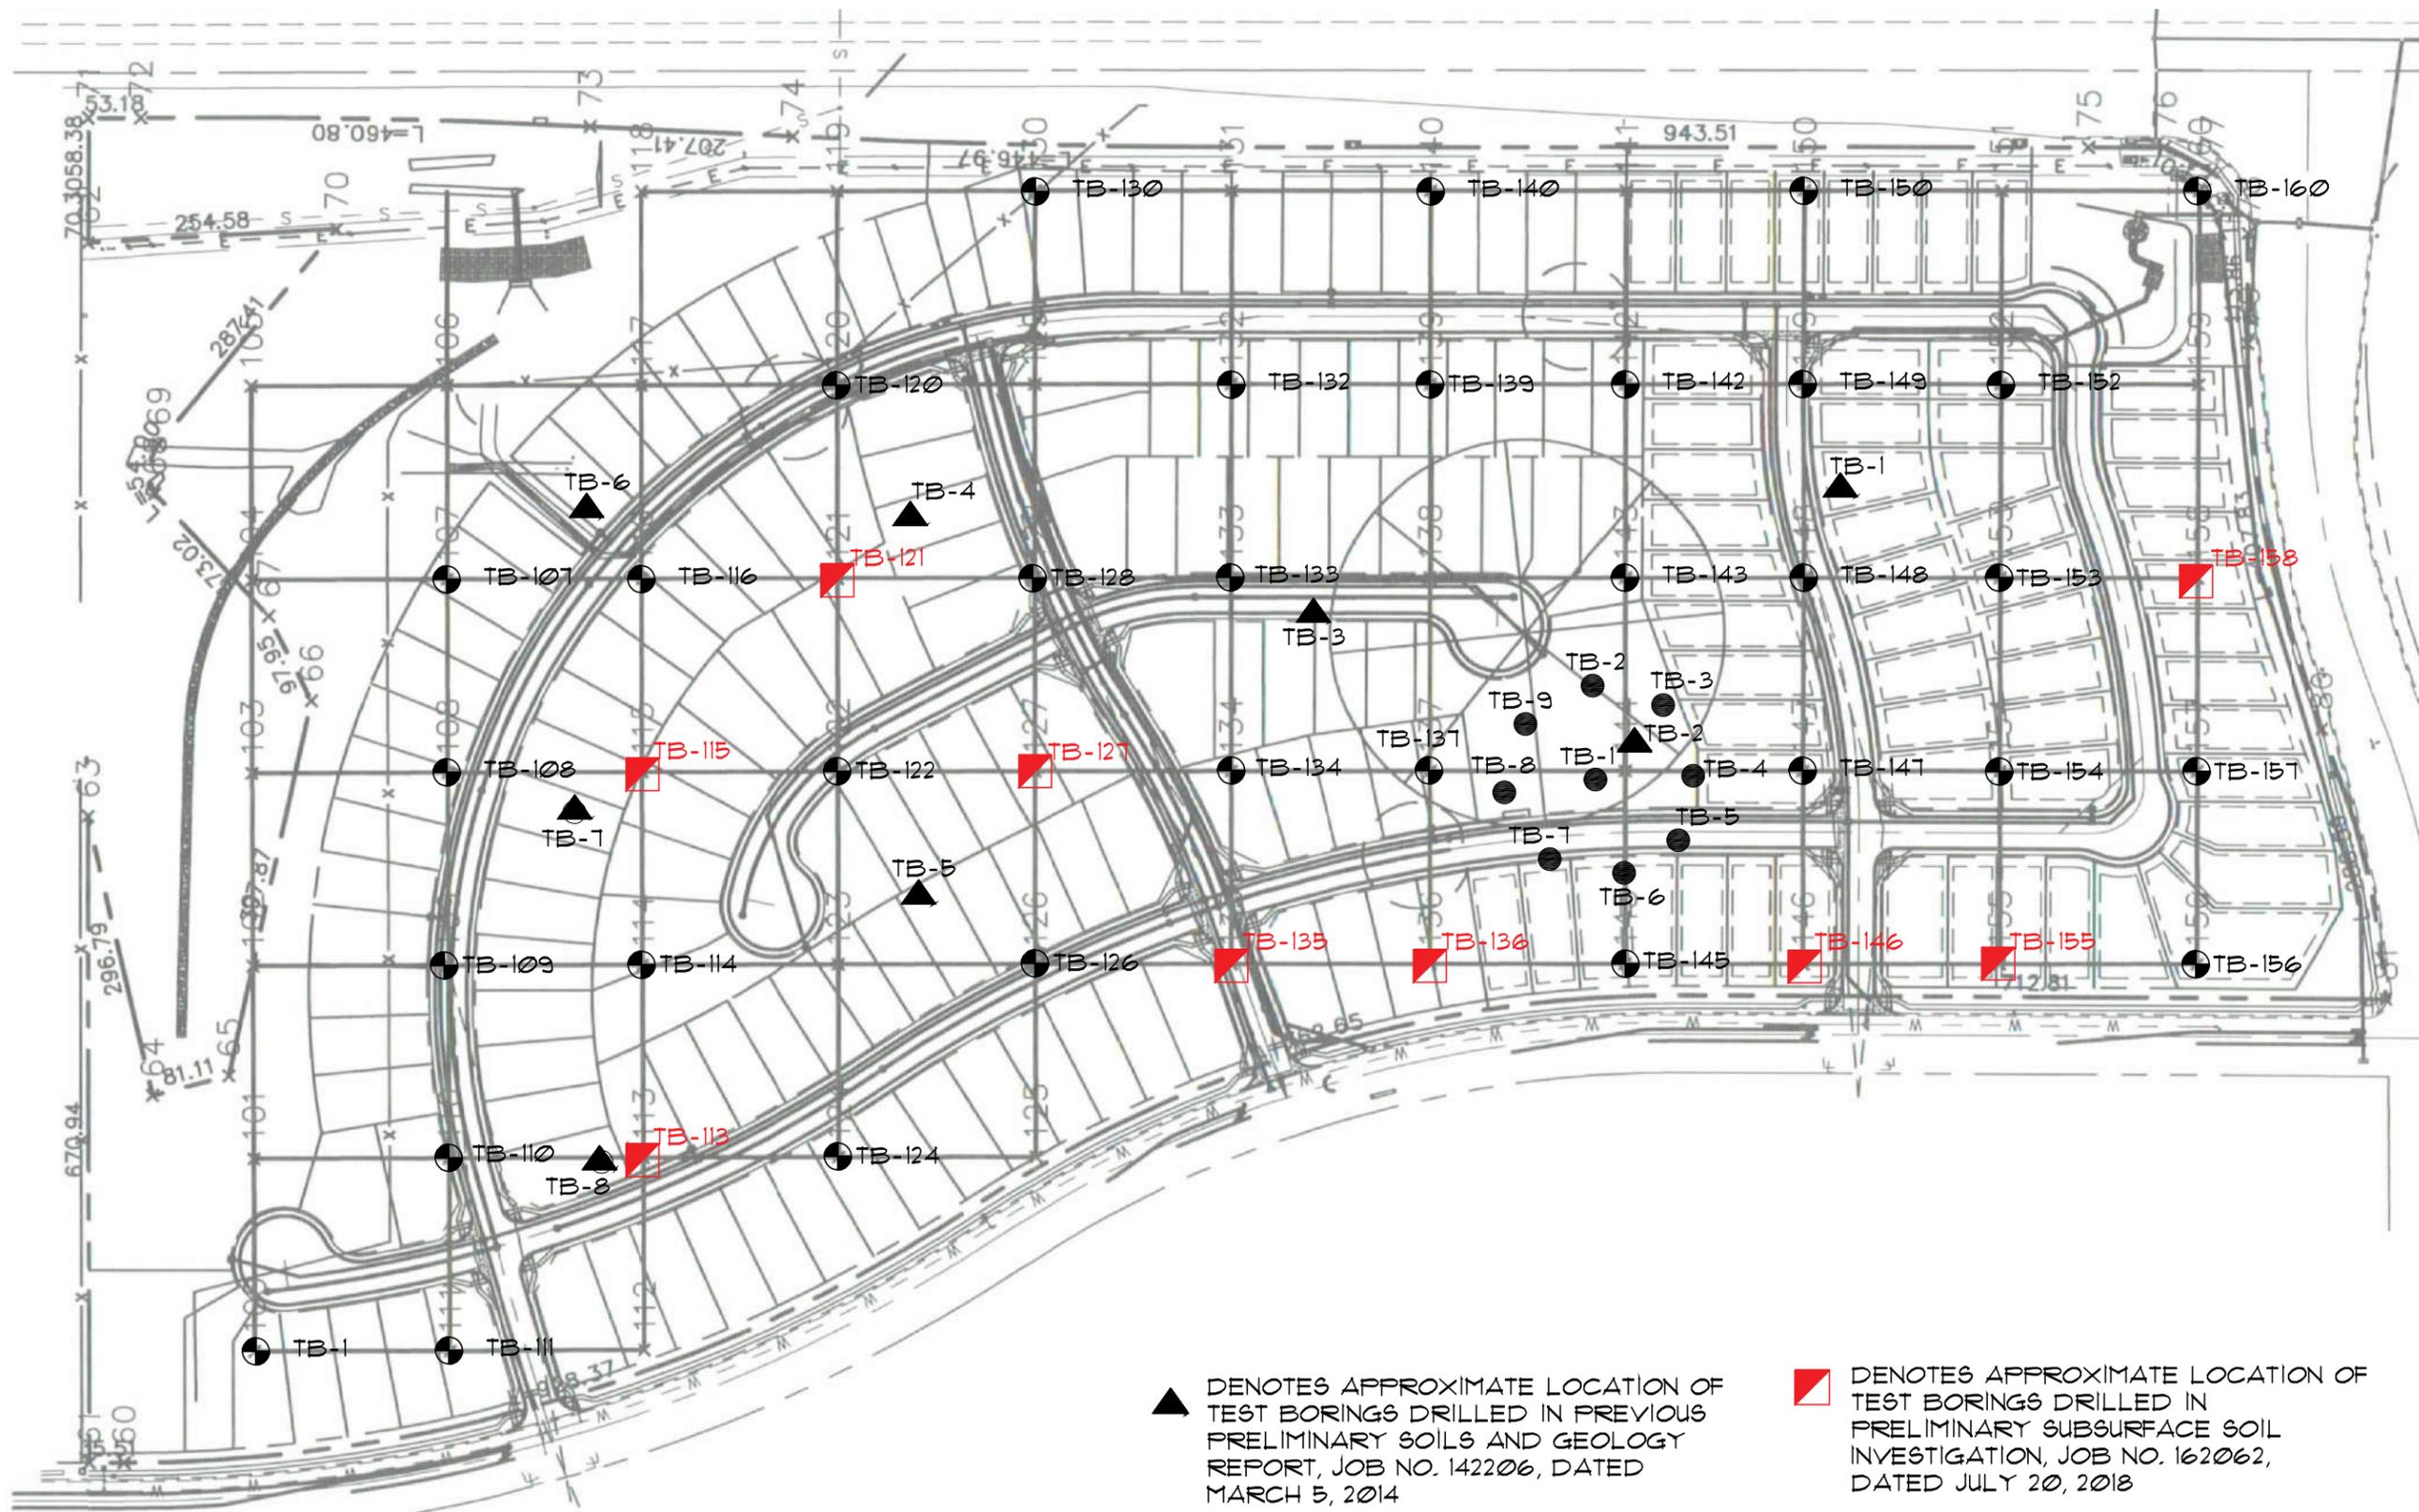
- ▲ DENOTES APPROXIMATE LOCATION OF TEST BORINGS DRILLED IN PREVIOUS PRELIMINARY SOILS AND GEOLOGY REPORT, JOB NO. 142206, DATED MARCH 5, 2014
- DENOTES APPROXIMATE LOCATION OF TEST BORINGS DRILLED IN PREVIOUS SUBSURFACE SOIL INVESTIGATION, JOB NO. 142206, DATED MAY 28, 2015
- ◻ DENOTES APPROXIMATE LOCATION OF TEST BORINGS DRILLED IN PRELIMINARY SUBSURFACE SOIL INVESTIGATION, JOB NO. 162062, DATED JULY 20, 2018
- DENOTES APPROXIMATE LOCATION OF TEST BORINGS DRILLED FOR PRELIMINARY SUBSURFACE SOIL INVESTIGATION, JOB NO. 162062, DATED APRIL 17, 2018

The subsurface conditions within the property were previously explored multiple times by RMG, by drilling a total of sixty (60) exploratory borings between March 2014 and March 2018. The test borings extended to depths of approximately 10 to 47 feet below the existing ground surface. The approximate locations of the test boring locations are presented on the Test Boring Location Plan, Figure 3.

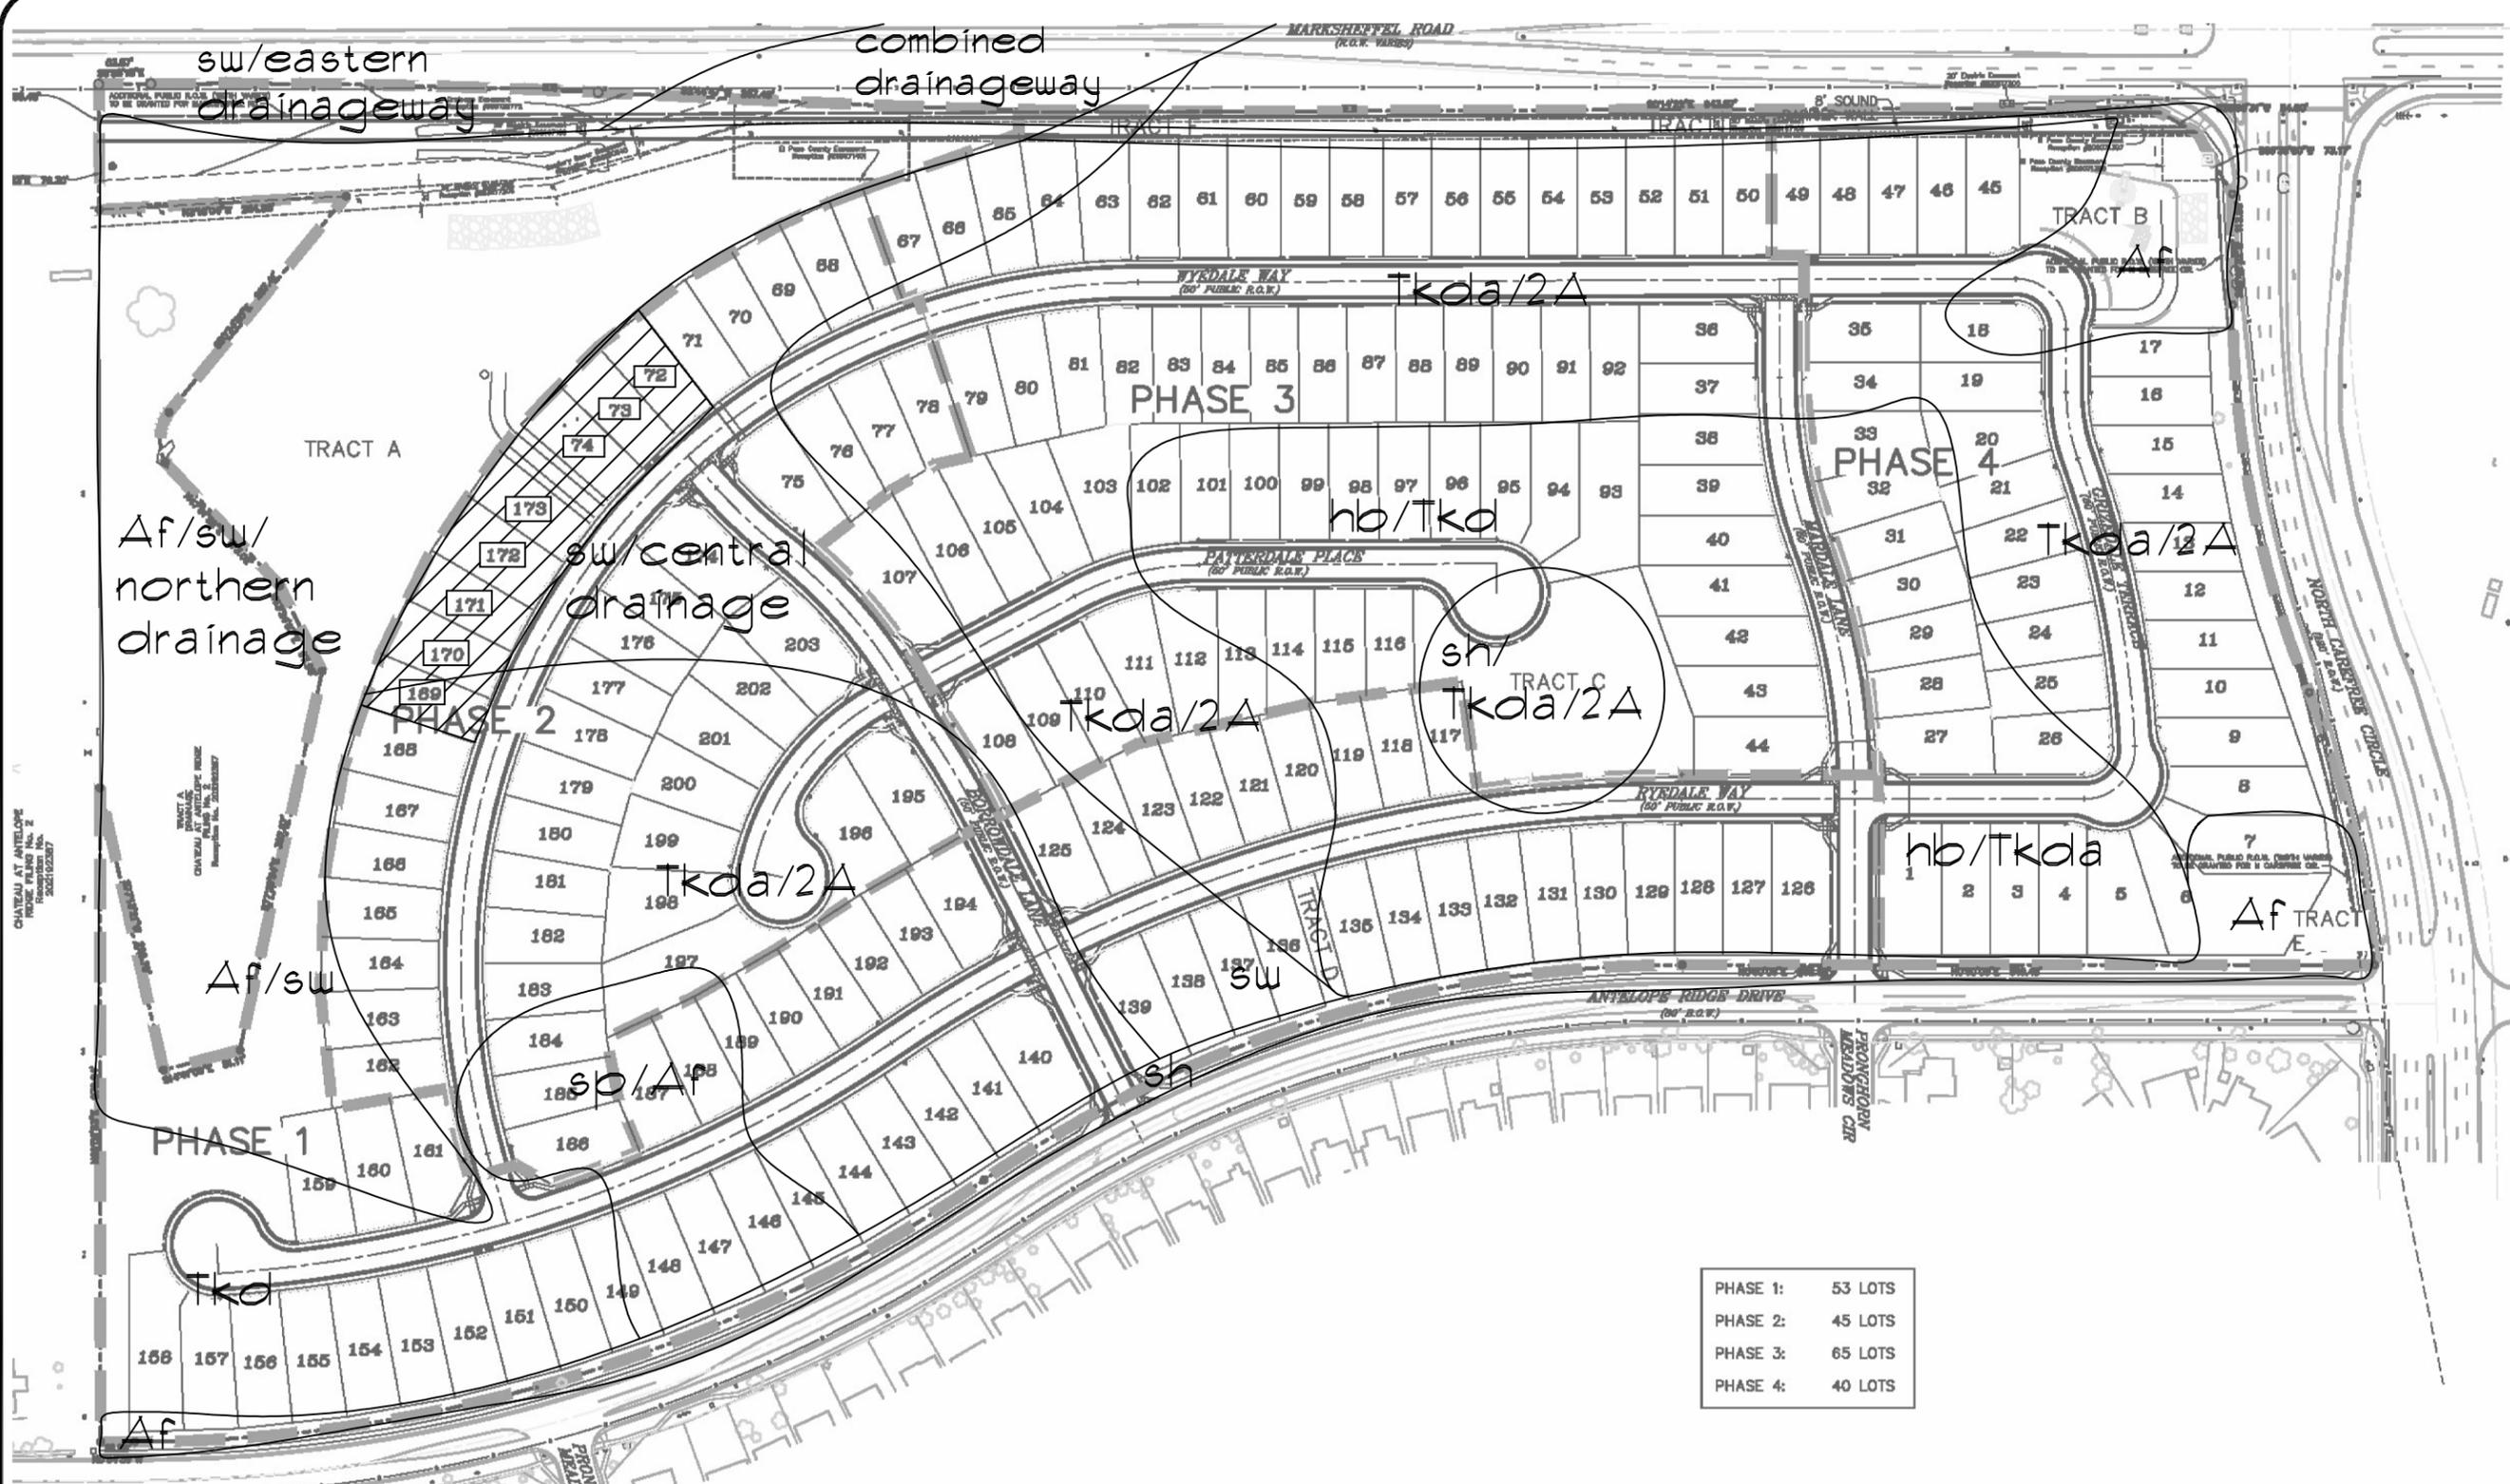
SHEET No.
FIG-4

ENGINEERING AND GEOLOGY MAP

Groundwater was not encountered in the remaining test borings. Areas of seasonal and potentially shallow groundwater are indicated on the Engineering and Geology Map, Figure 4 and is discussed in the following section.

Based on our field observations and review of relevant geologic maps, a geologic map was prepared which identifies the geologic conditions affecting the development. The geologic units present of the site are presented in the Engineering and Geology Map, Figure 4.

The sandstone “hill” and the area immediately surrounding the “hill” encountered hard cemented sandstone at the surface. This sandstone “hill” and area are mapped and presented in the Engineering and Geology Map, Figure 4. According to the *Cut/Fill Map*, referenced in Appendix A, the sandstone hill is to be reshaped to a limited degree. Relatively shallow cuts are proposed along the top of the "hill", but cuts along the sides may reach depths of approximately 15 to 16 feet in some areas.

The sandstone “hill” and the area immediately surrounding the “hill” encountered hard cemented sandstone at the surface. This sandstone “hill” and area are mapped and presented in the Engineering and Geology Map, Figure 4. According to the *Cut/Fill Map*, referenced in Appendix A, the sandstone hill is to be reshaped to a limited degree. Relatively shallow cuts are proposed along the top of the "hill", but cuts along the sides may reach depths of approximately 15 to 16 feet in some areas. Development within this area is anticipated to be difficult. The bedrock may require the use of specialized heavy-duty equipment and/or blasting to facilitate rock break-up and removal. In areas where the very hard sandstone bedrock is anticipated to be encountered, the builder is considering the use of stiffened slab-on-grade or crawlspace foundations to minimize the depth of excavations within the sandstone.

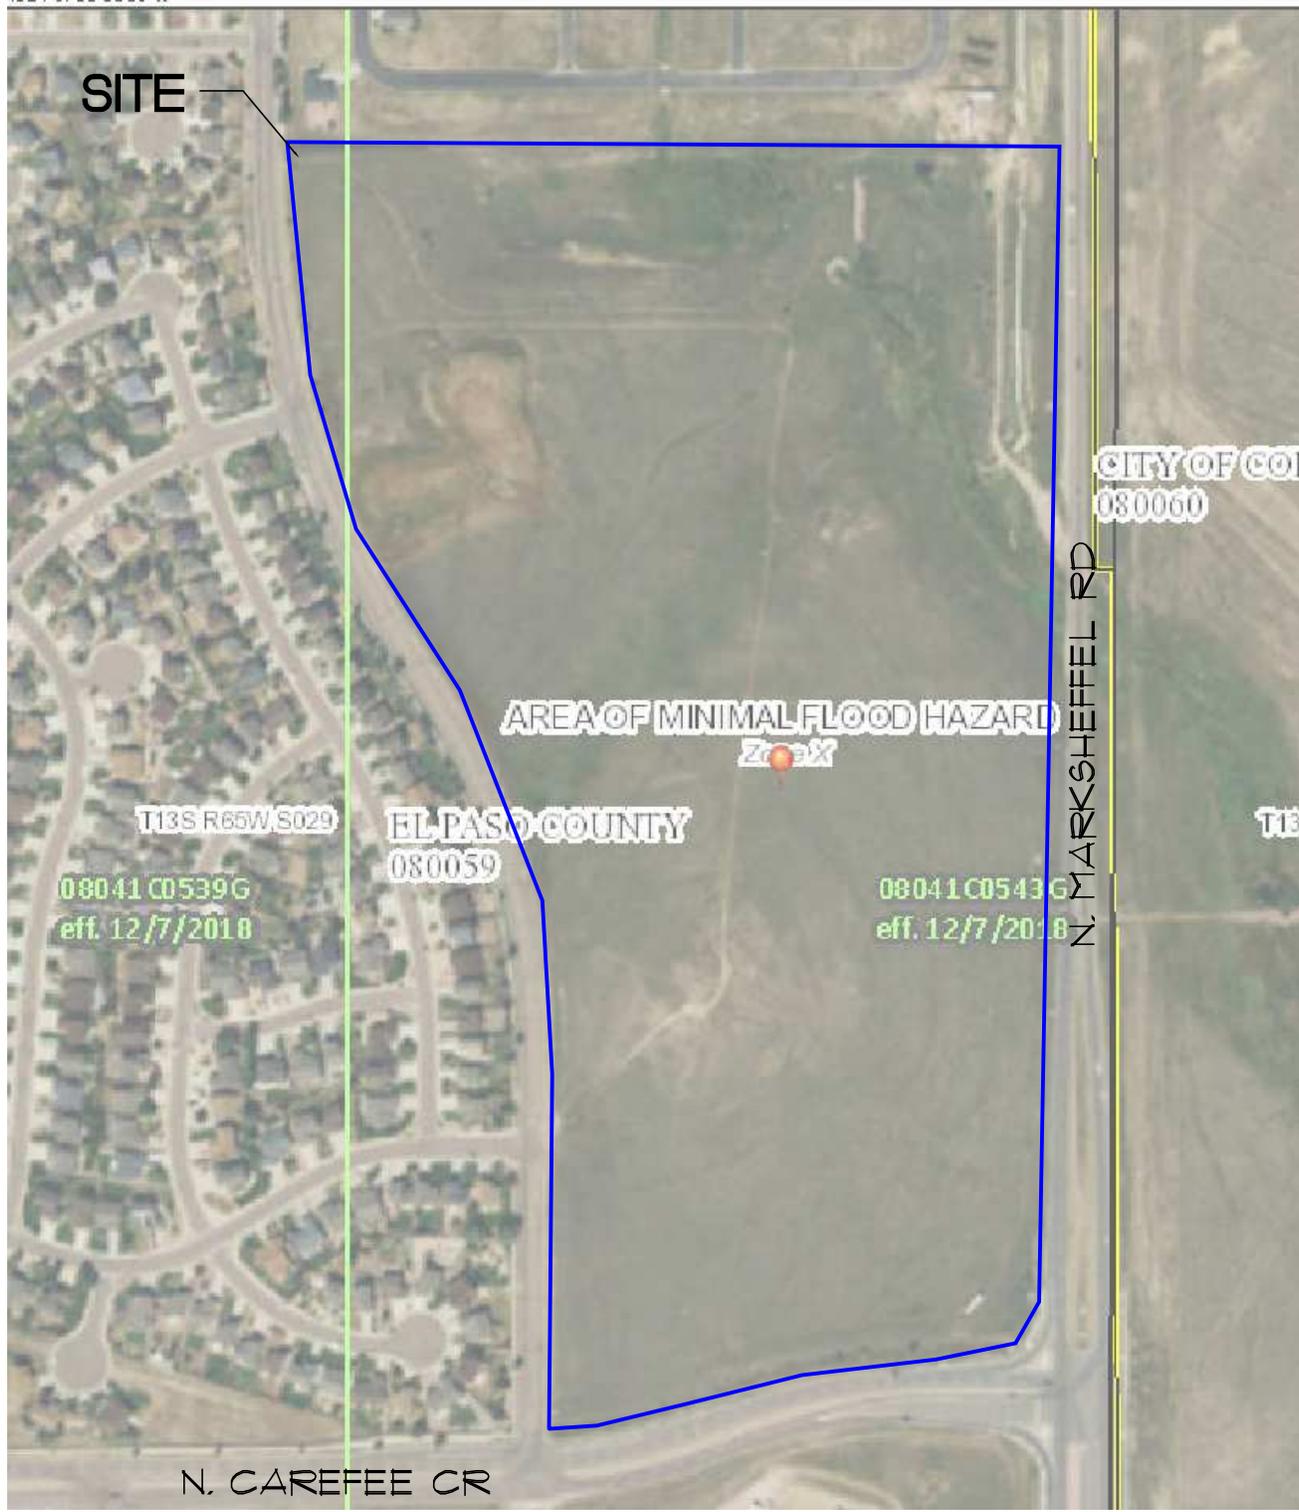
FIG No. 6

NOT TO SCALE
 BASE MAP PROVIDED BY: FEMA

Based on our review of the Federal Emergency Management Agency (FEMA) Community Panel No. 08041C0539G and 08041C0543G effective December 7, 2018 and the online ArcGIS El Paso County Risk Map, the entire property lies outside of any designated 100-year and 500-year floodplains. The FEMA Map is presented in Figure 6.

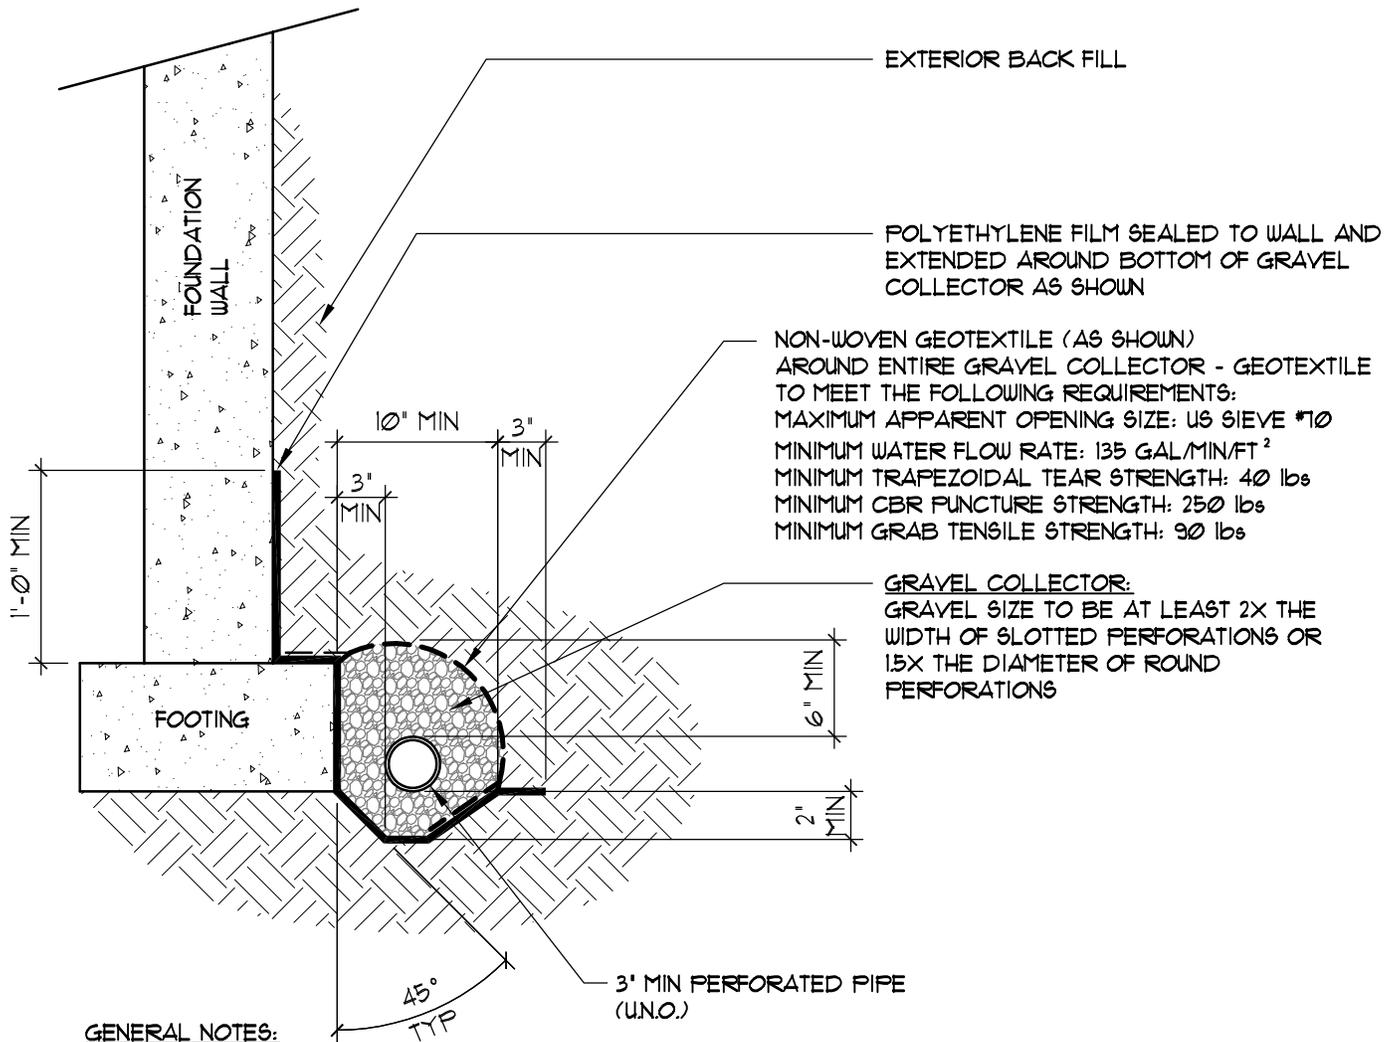
FIG No. 7

1. BOTTOM OF DRAIN PIPE SHALL BE AT OR BELOW BOTTOM OF FOOTING AT ALL LOCATIONS
2. ALL DRAIN PIPE SHALL BE PERFORATED PLASTIC, WITH THE EXCEPTION OF THE DISCHARGE PORTION WHICH SHALL BE SOLID, NON-PERFORATED PIPE.

PERIMETER DRAIN

Foundations are required to have a minimum 30-inch depth for frost protection. In areas where potentially high subsurface moisture conditions are anticipated, subsurface drains are recommended to help minimize the intrusion of water into areas below grade. Typical drain details are presented in Figures 7 and 8.

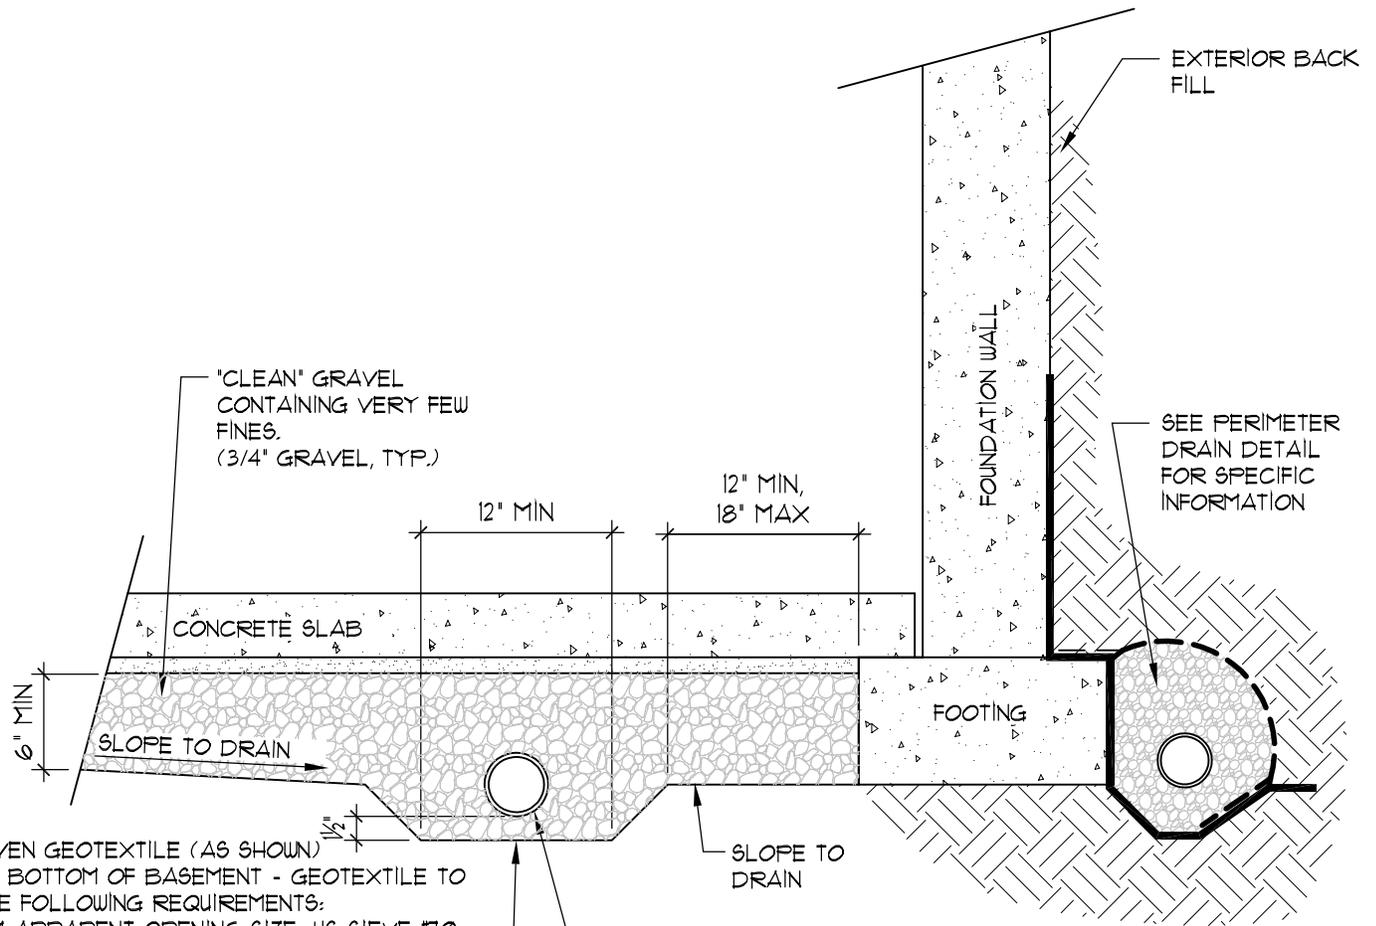
FIG No. 8

"CLEAN" GRAVEL
CONTAINING VERY FEW
FINES.
(3/4" GRAVEL, TYP.)

12" MIN, 18" MAX
