Final Drainage Report

Windermere Filing No. 2 El Paso County, Colorado

Kimley-Horn and Associates, Inc.
2 North Nevada Ave., Suite 900
Colorado Springs, CO 80903
(719) 435-0182
Contact: Noah Brehmer, P.E.

Prepared: November 2024

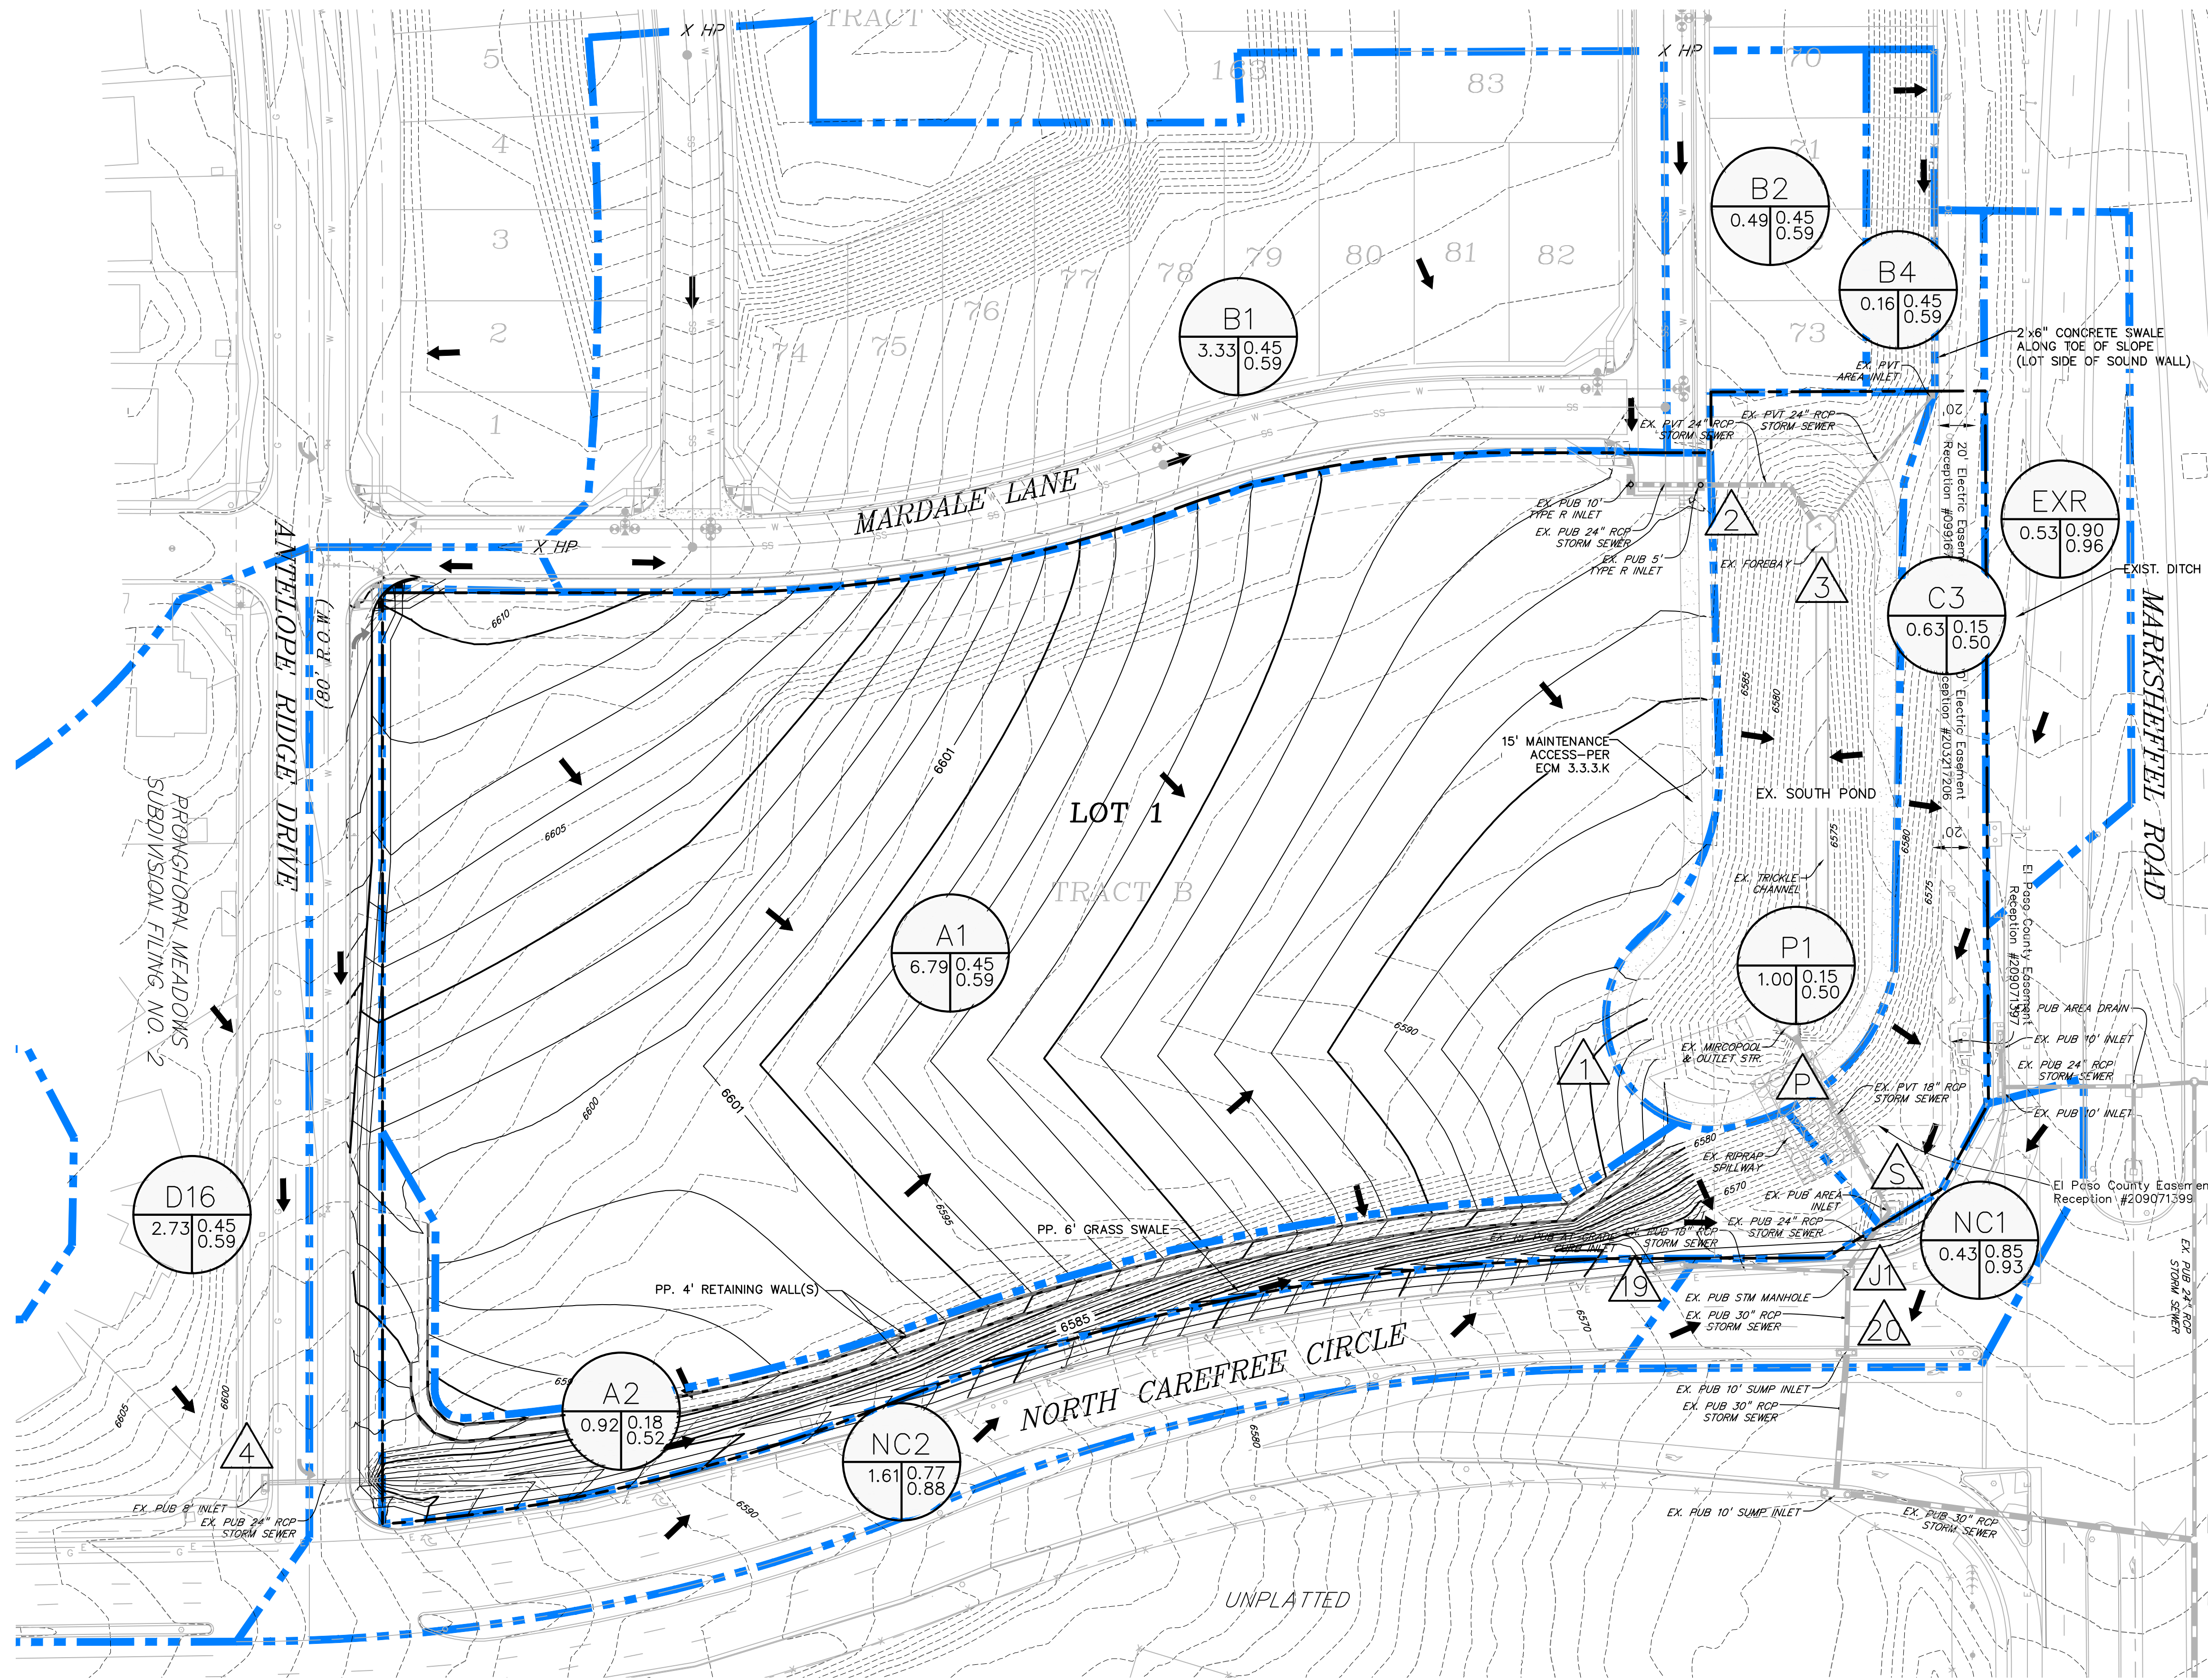
EXISTING CONDITIONS DRAINAGE MAP USED FOR THIS FDR

- PROPOSED INTERMEDIATE CONTOUR
- PROPOSED INDEX CONTOUR 5750
- EX. INTERMEDIATE CONTOUR
- EX. INDEX CONTOUR 5750
- PROPOSED STORM SEWER
- PROPOSED INLET
- PROPOSED FLARED END SECTION
- EX. MANHOLE
- EX. STORM SEWER
- BASIN BOUNDARY
- FLOW DIRECTION
- DESIGN POINT 1
- BASIN A1
- AREA (ACRE) 2.33
- Q5 (cfs) 12.6
- Q100 (cfs) 27.9

DESIGN POINT	TRIBUTARY BASINS	TRIBUTARY AREA (AC)	PEAK FLOWS (CFS)	
			Q5	Q100
On-Site Basins				
D1	P1	0.92	2.00	4.46
D2	P2	1.04	2.71	5.96
D3	P3	1.11	3.41	6.79
D4	P4	1.02	3.56	6.77
D5	P5	0.37	0.21	1.08
D6	P6	1.76	5.81	11.41
D7	P7	0.29	0.29	1.06
D8	P8	1.70	0.32	2.92
D9	P9	1.01	0.09	1.89
TOTAL		9.22	18.39	42.25
Off-Site Basins				
OD1	OP1	0.06	0.00	0.13
OD2	OP2	0.03	0.09	0.19
OD3	D16(EX.)	2.73	4.90	10.70
TOTAL		2.82	5.00	11.02

The following basin descriptions reference the Windermere Filing No. 2 Preliminary Drainage Report prepared by Drexel, Barrell & Co., dated August 2024. The proposed conditions map will be utilized as the Existing Conditions for this Final Drainage Report. Please reference the existing conditions drainage map, historic conditions drainage map, and Preliminary Drainage Report in the **Appendix**.

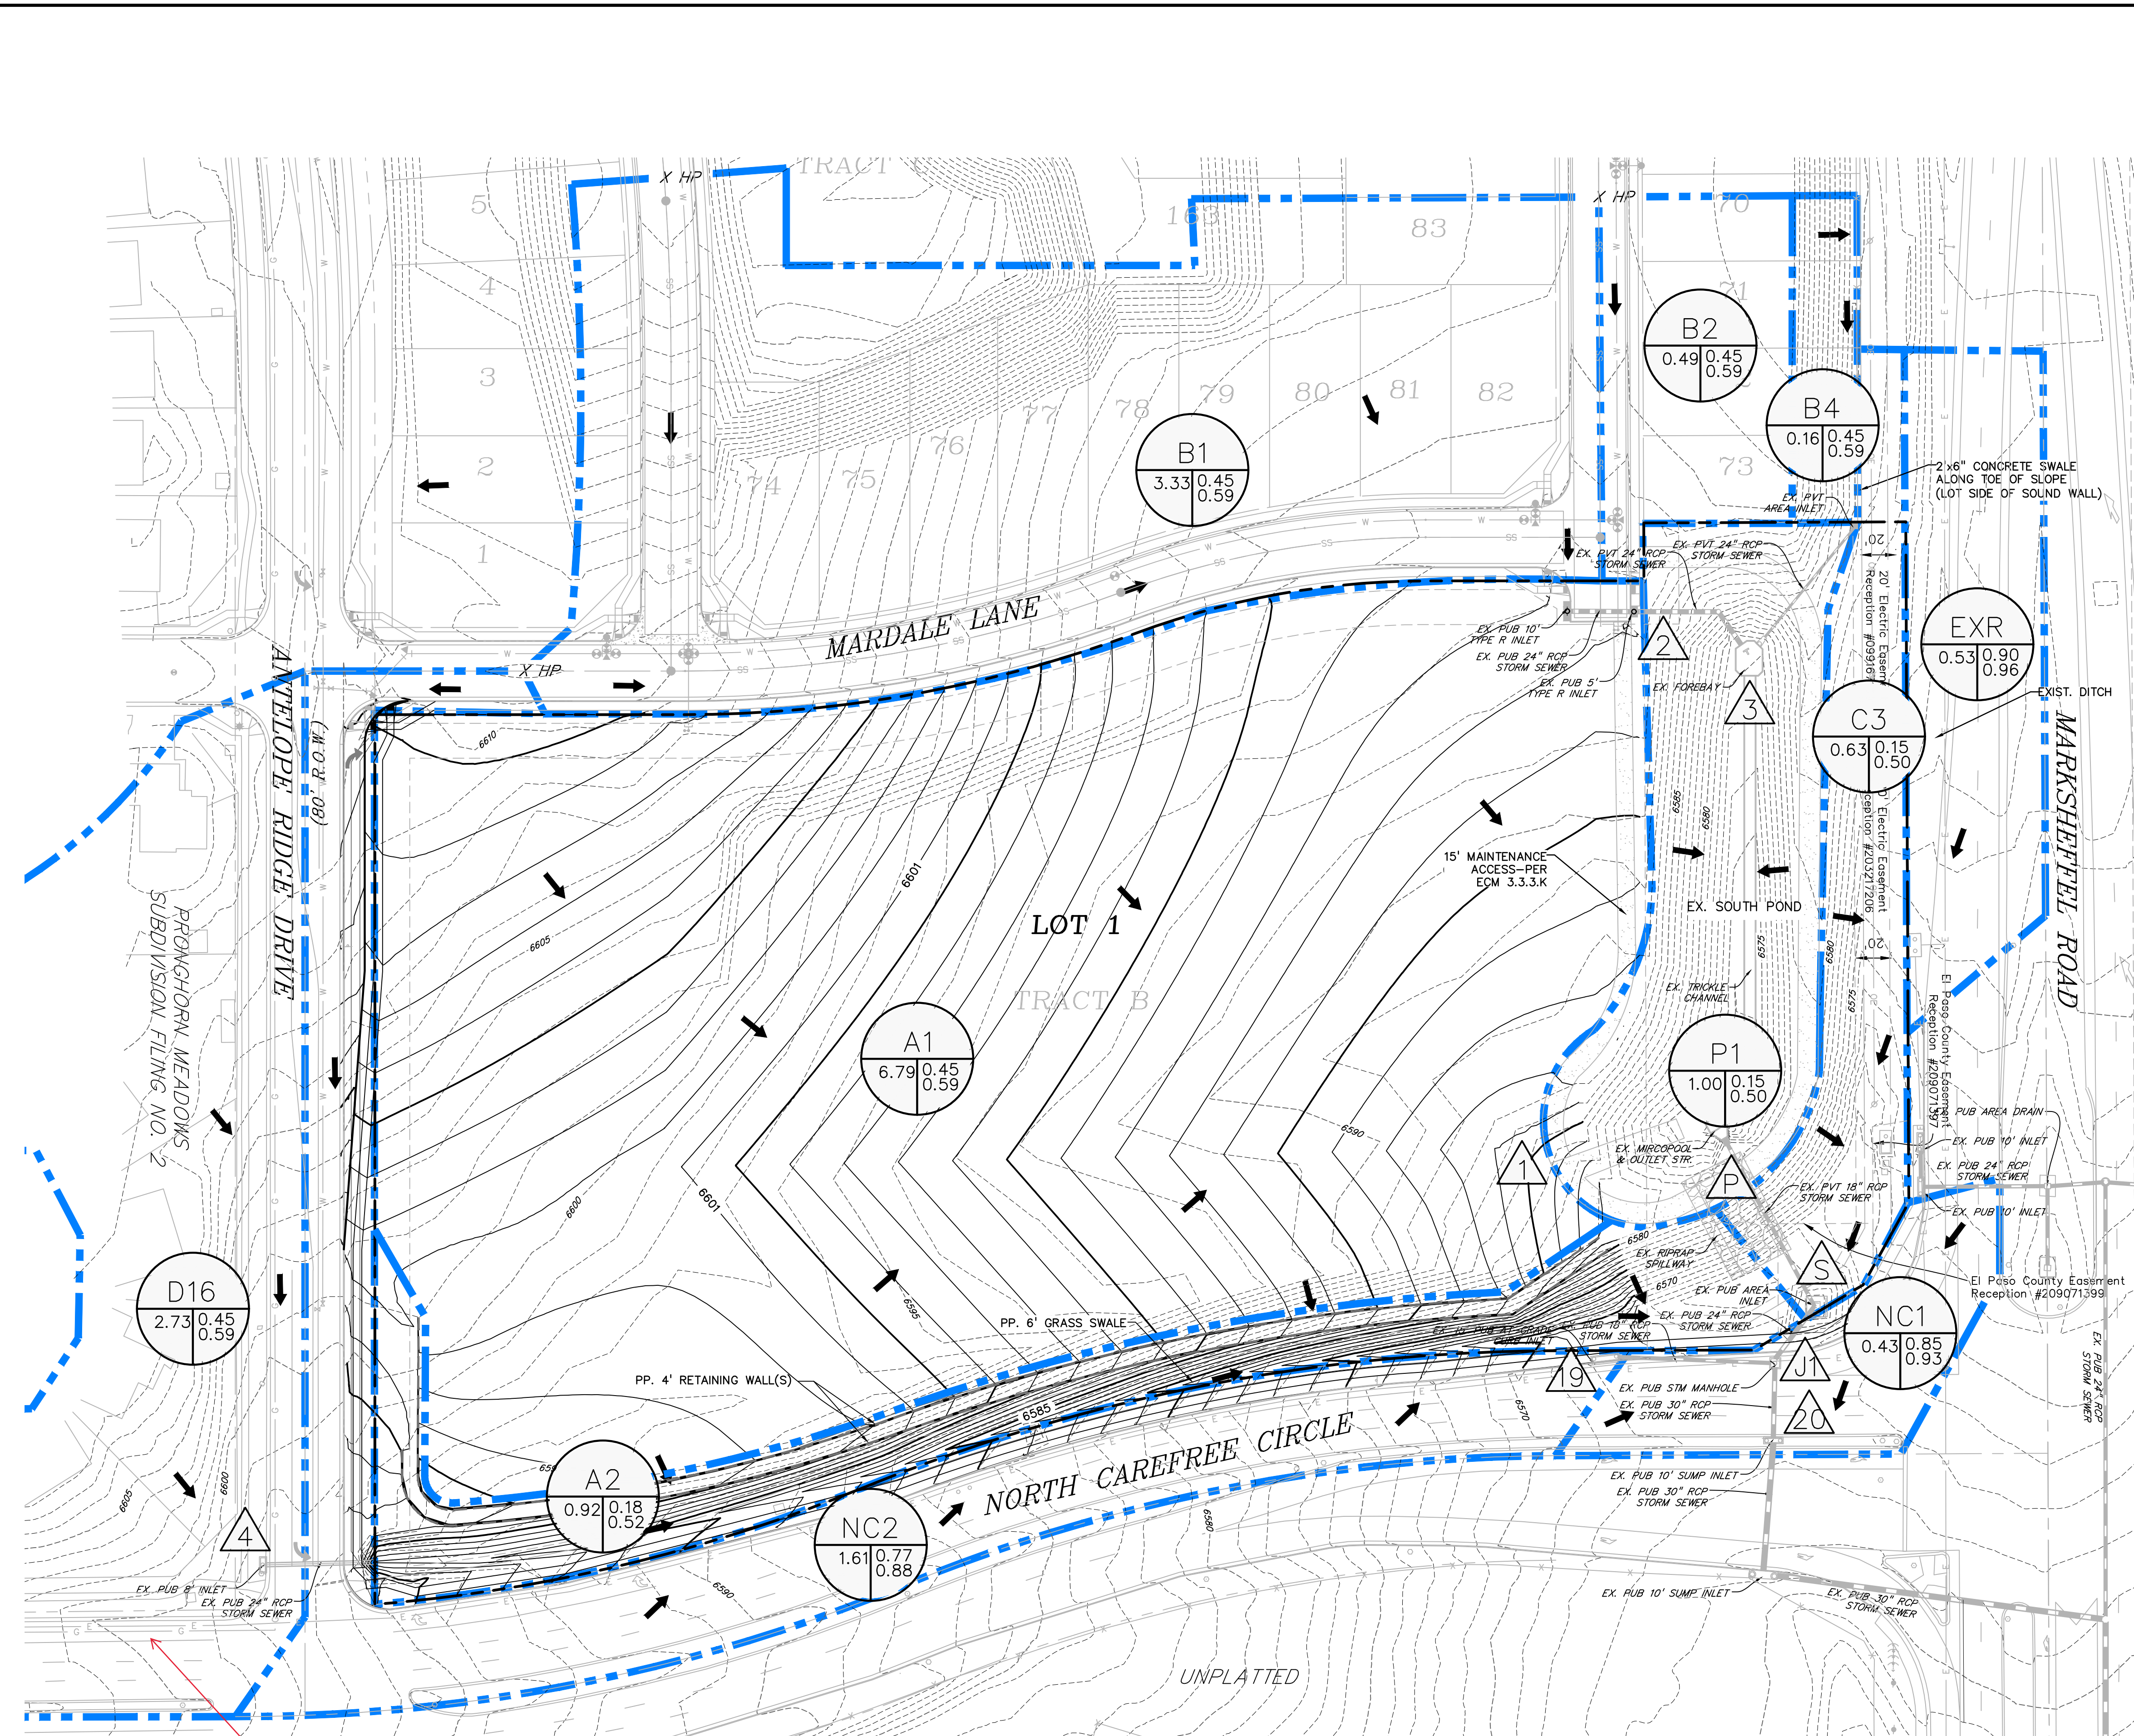
REFERENCE HISTORIC MAP FOR BASIN D16 EXTENTS

- PROPOSED INTERMEDIATE CONTOUR
- PROPOSED INDEX CONTOUR
- EX. INTERMEDIATE CONTOUR
- EX. INDEX CONTOUR
- PROPOSED STORM SEWER
- PROPOSED INLET
- PROPOSED FLARED END SECTION
- EX. MANHOLE
- EX. STORM SEWER
- BASIN BOUNDARY
- FLOW DIRECTION
- DESIGN POINT
- BASIN
- AREA (ACRE)
- Q5 (cfs)
- Q100 (cfs)

Design Point OD3 accounts for the off-site flows that travel on-site from existing sub-basin D16 as described in the existing conditions and in the preliminary drainage report. It is understood that these flows are generated from the existing Pronghorn Meadows Subdivision (Filing No. 2). The existing flows travel via curb and gutter to an existing Public 8' CDOT Type-R curb inlet and are then conveyed through an existing 24" culvert passing under Antelope Ridge Drive. Flows then enter the proposed site at DP OD3. Next, these flows are conveyed through the existing vegetated drainage swale which ultimately outfalls into the existing public CDOT Type C area
