Final Drainage Report

Windermere Filing No. 2 El Paso County, Colorado

Kimley-Horn and Associates, Inc.
2 North Nevada Ave., Suite 900
Colorado Springs, CO 80903
(719) 435-0182
Contact: Noah Brehmer, P.E.

Prepared: November 2024

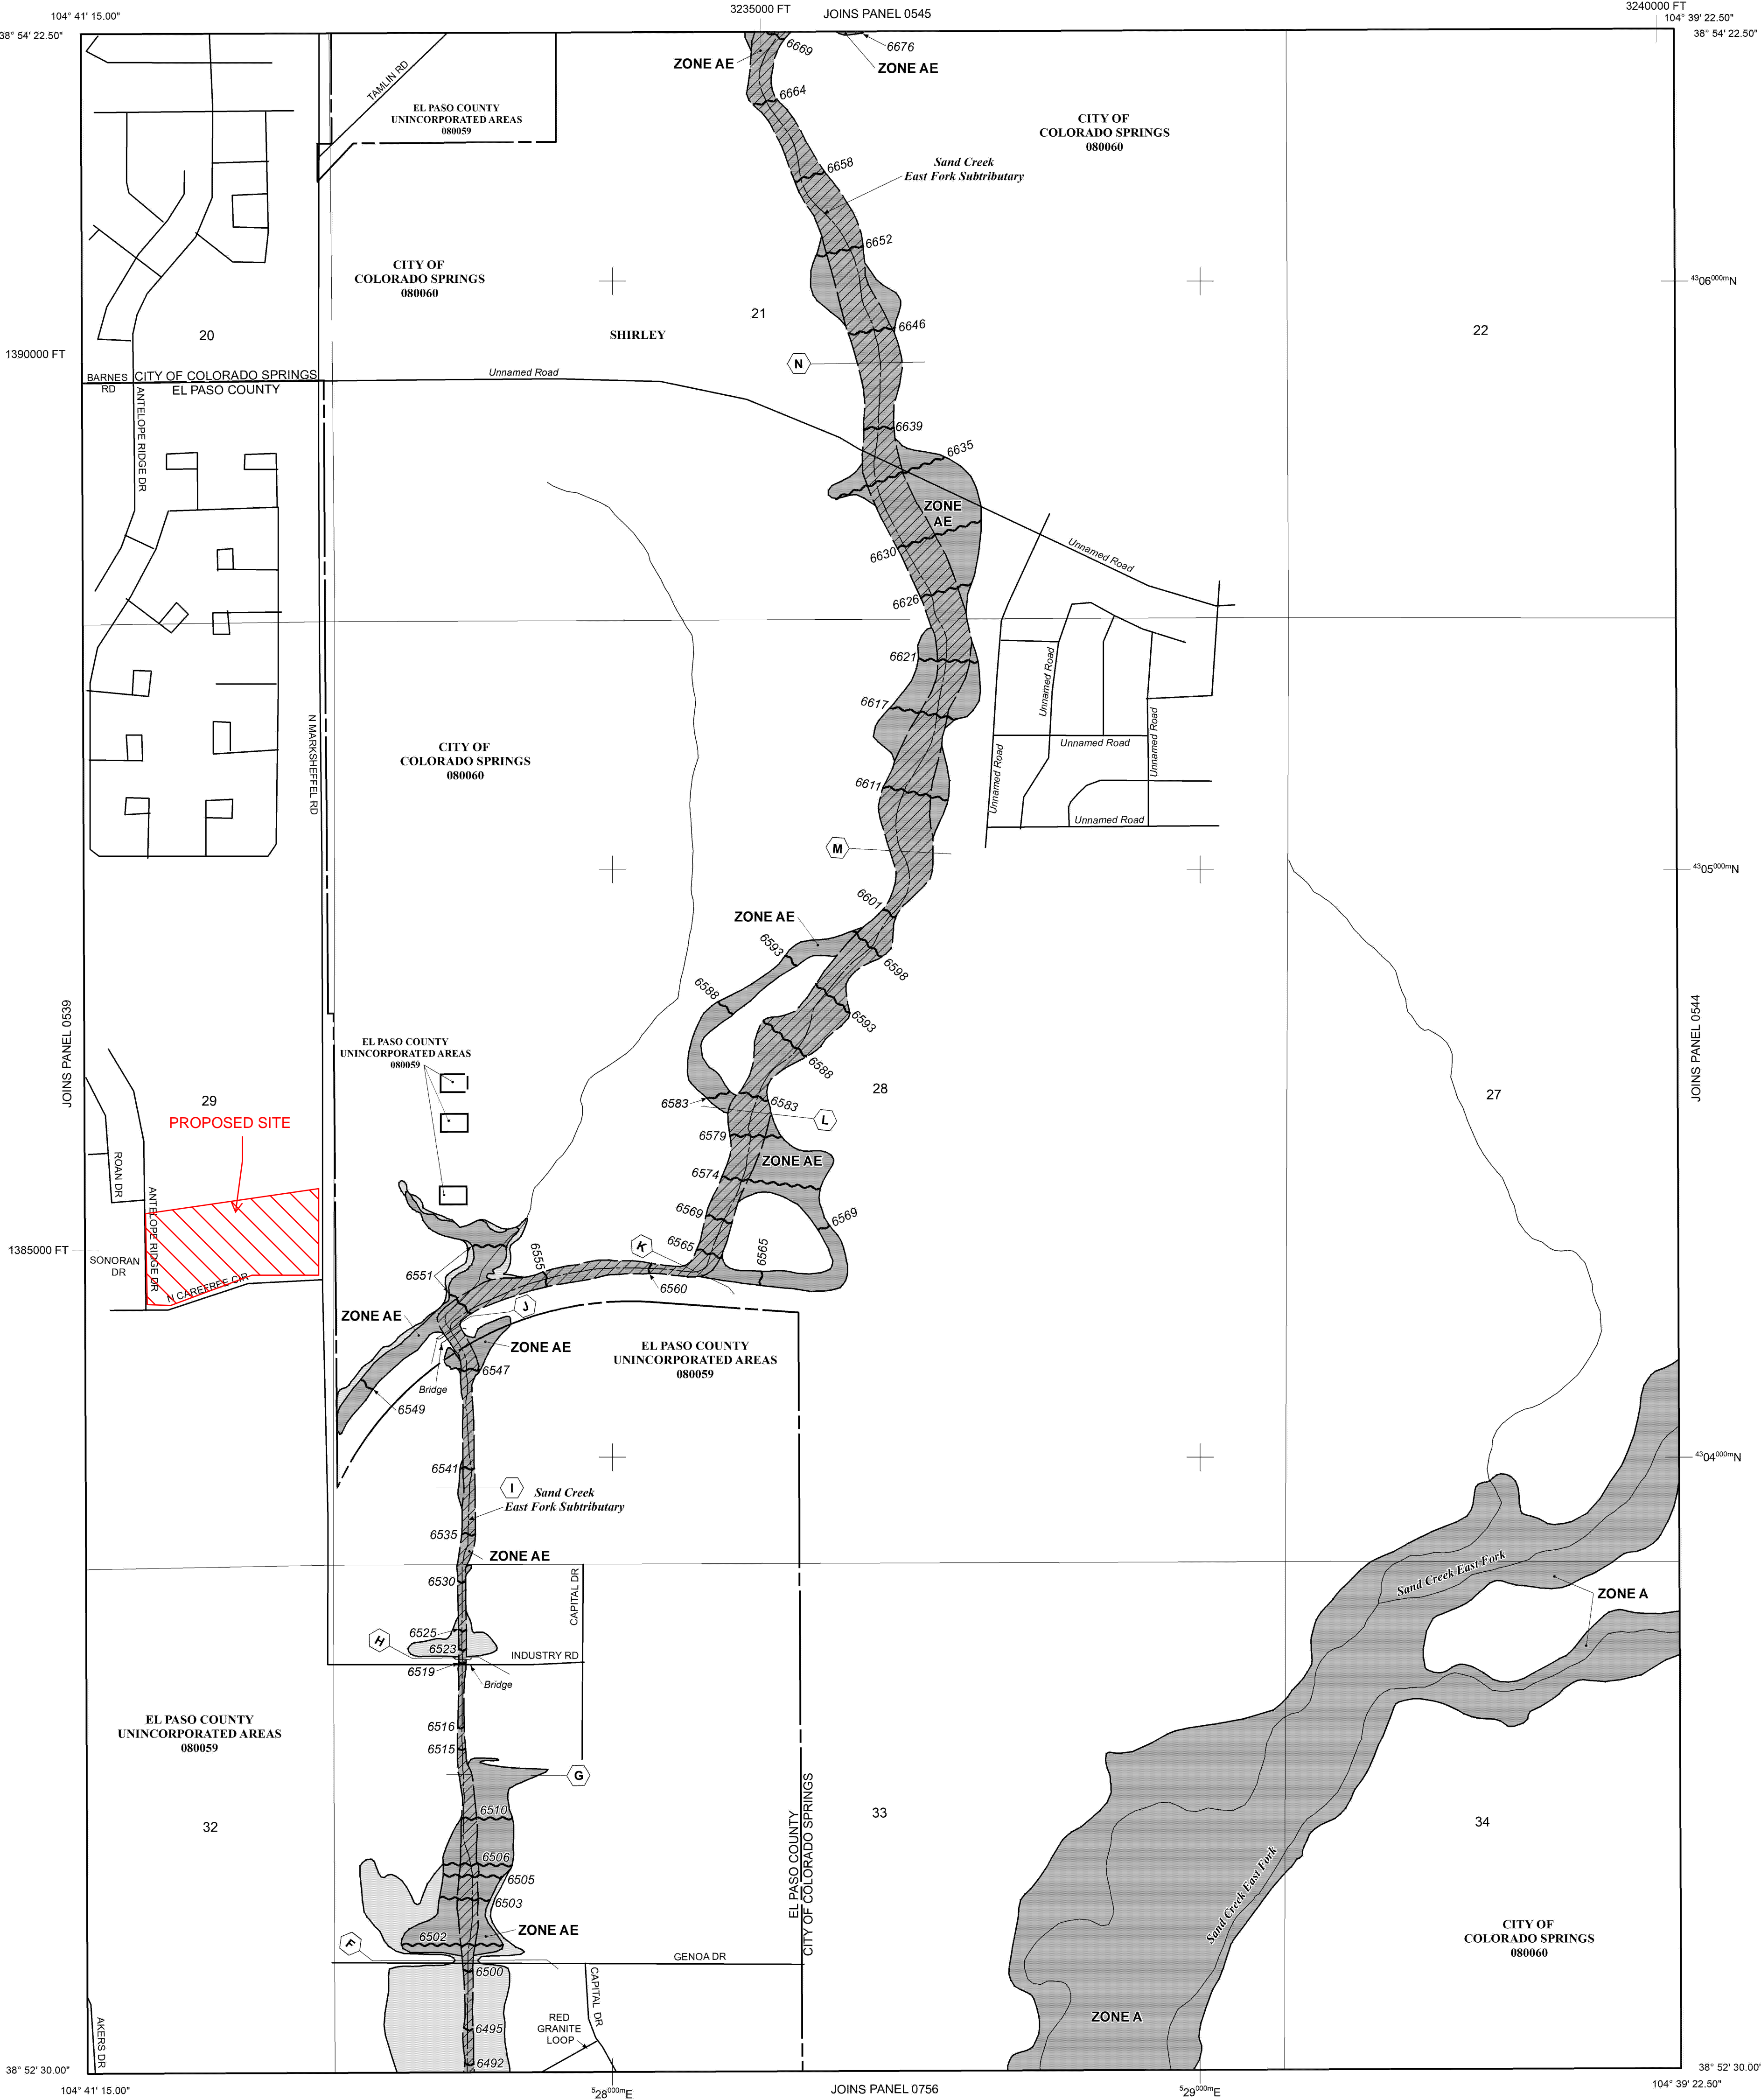
PANEL 0543G

FIRM
FLOOD INSURANCE RATE MAP
EL PASO COUNTY, COLORADO AND INCORPORATED AREAS

The Site is located outside the 100-year floodplain and within Zone X (an area of minimal flood hazard) as noted on the Federal Emergency Management Agency (FEMA) Flood Insurance Rate Map (FIRM) Panel #08041C0543G dated December 7, 2018 (See **Appendix**).

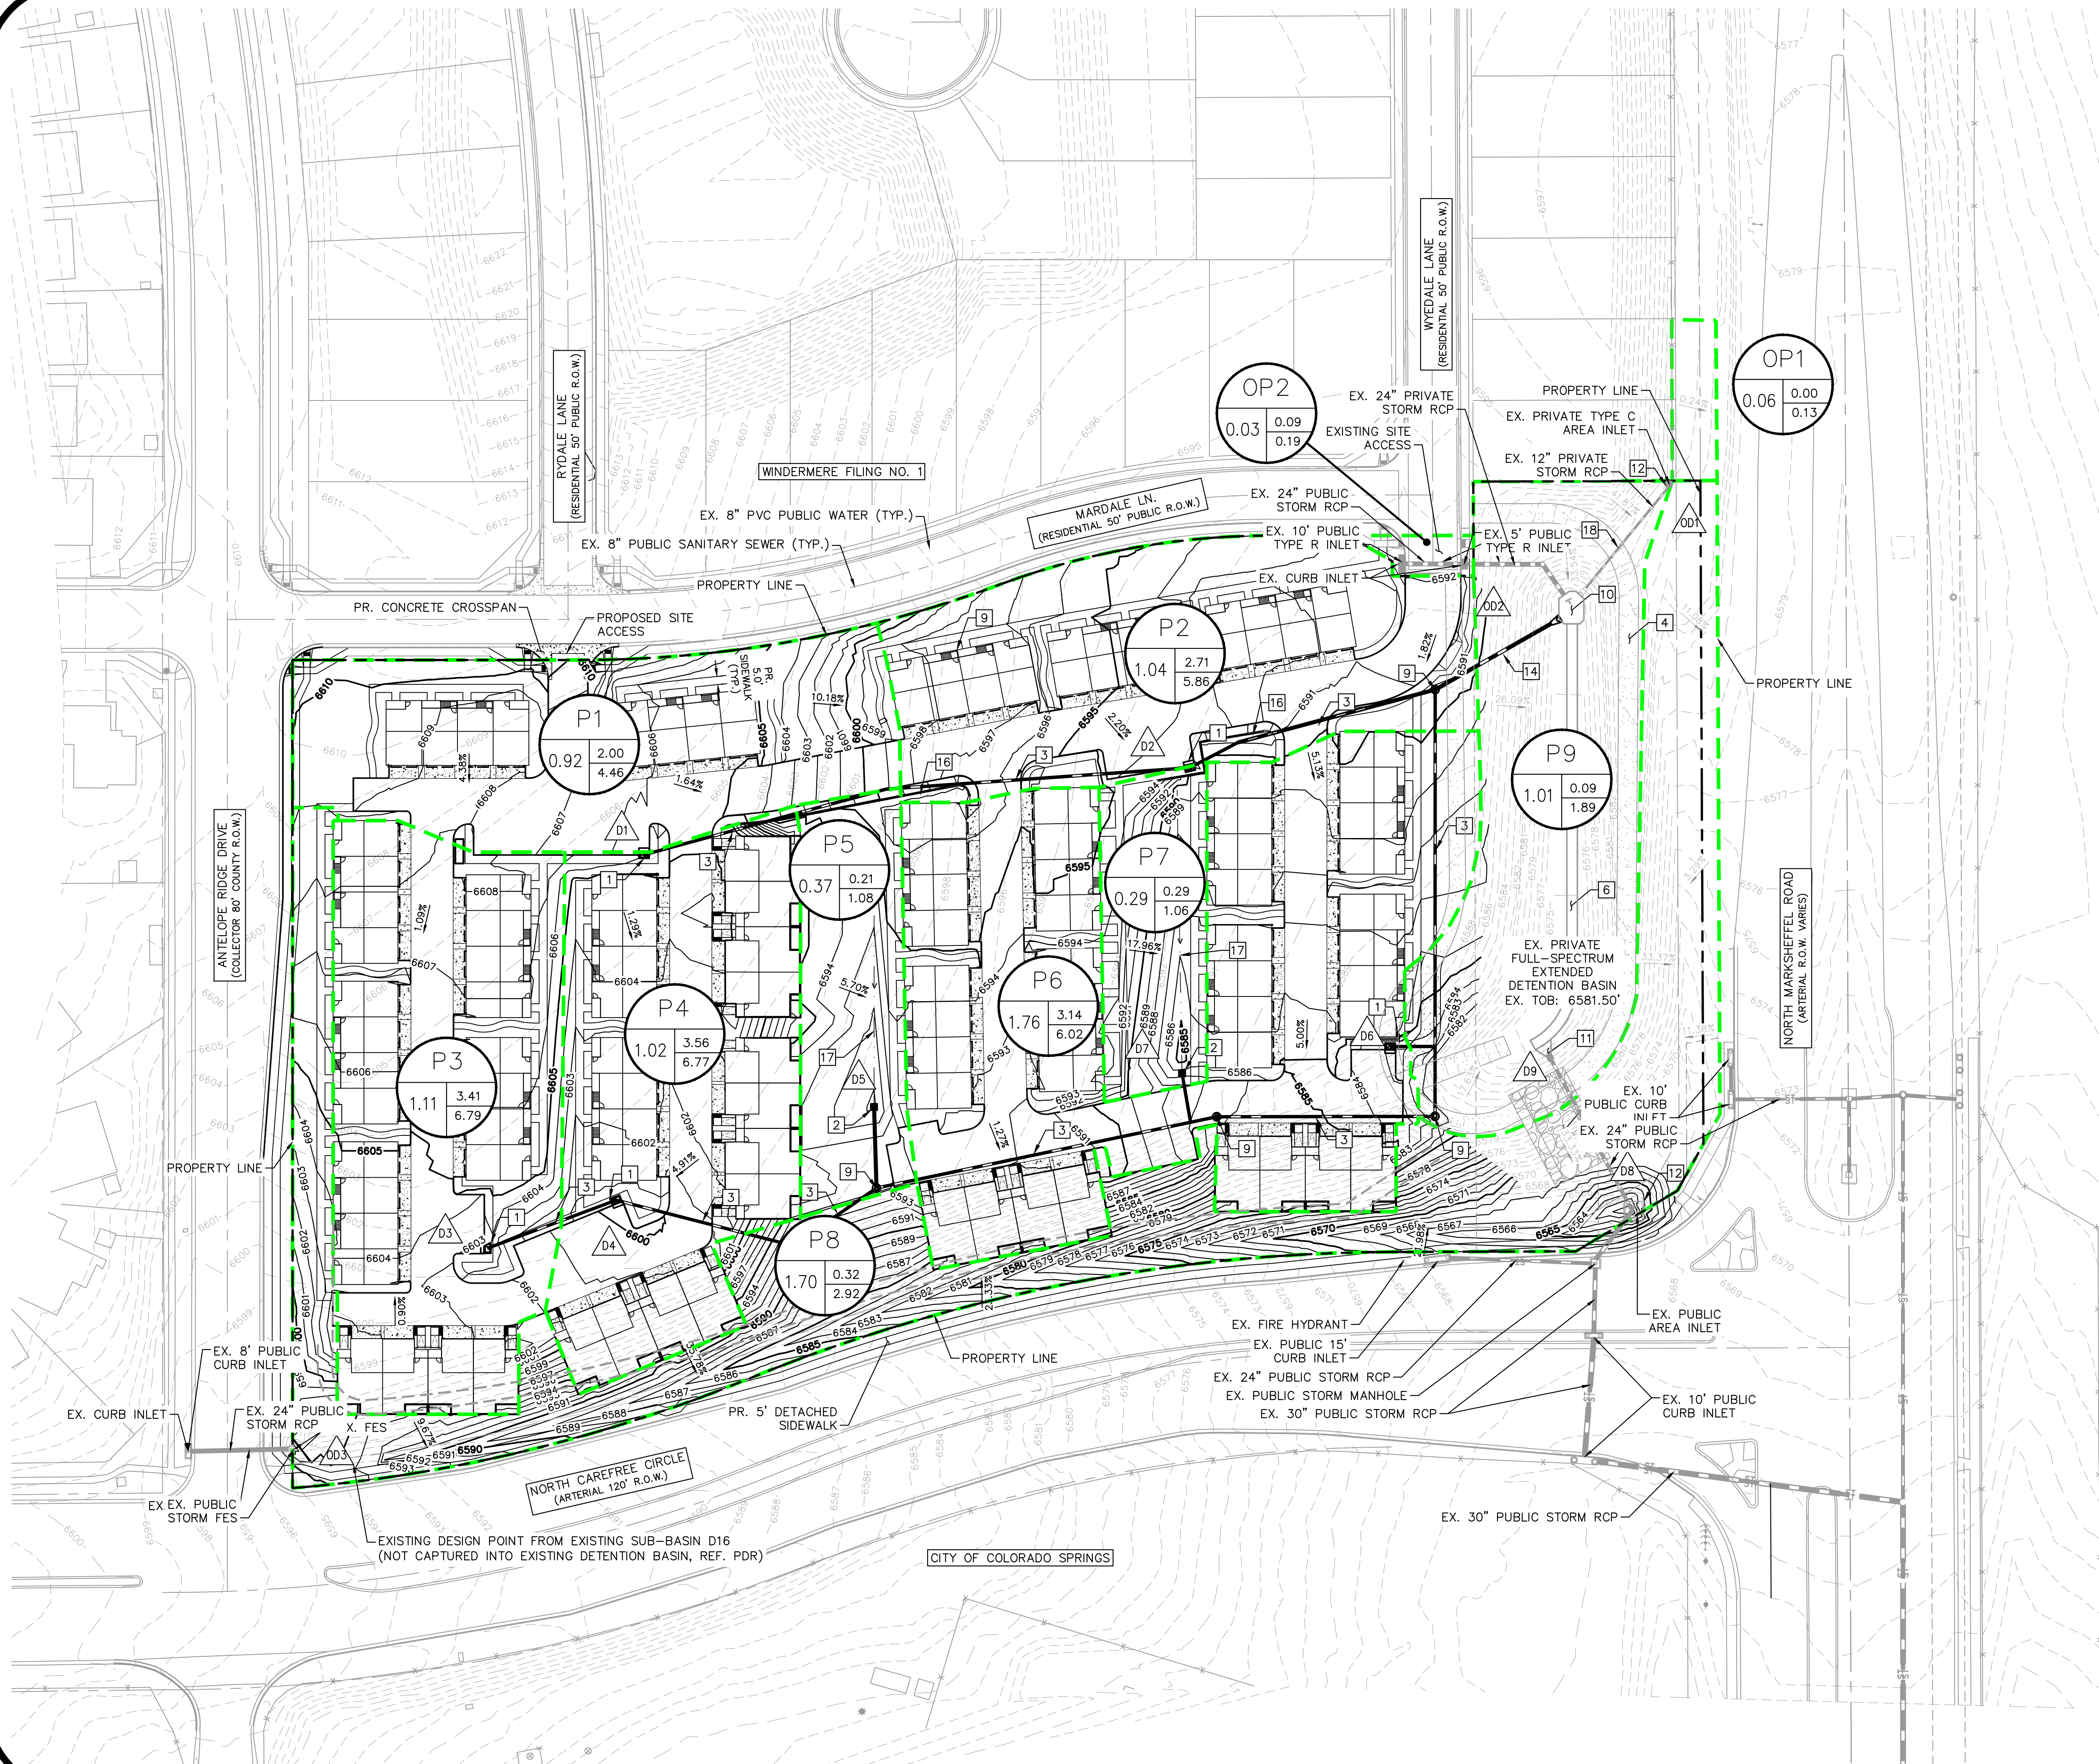
- KEY NOTES**
- 1 PROPOSED PRIVATE 5' CDOT TYPE-R CURB INLET
 - 2 PROPOSED PRIVATE CDOT TYPE-C AREA INLET
 - 3 PROPOSED PRIVATE 18" STORM PIPE
 - 4 EXISTING 15' WIDE POND MAINTENANCE ACCESS ROAD
 - 5 EXISTING 24" STORM PIPE
 - 6 EXISTING 6' WIDE CONCRETE TRICKLE CHANNEL
 - 7 EXISTING RIPRAP EMERGENCY SPILLWAY
 - 8 PROPOSED RESIDENTIAL TOWNHOUSE BUILDING
 - 9 PROPOSED STORM MANHOLE
 - 10 EXISTING CONCRETE FOREBAY WITH T-BAFFLES
 - 11 EXISTING PRIVATE MODIFIED CDOT TYPE-C OUTLET CONTROL STRUCTURE & MICROPOOL
 - 12 EXISTING PUBLIC CDOT TYPE-C AREA INLET
 - 13 EXISTING 18" STORM OUTFALL PIPE
 - 14 PROPOSED 24" STORM PIPE
 - 15 PROPOSED 18" STORM PIPE
 - 16 PROPOSED RETAINING WALL (BY OTHERS)
 - 17 PROPOSED DRAINAGE SWALE
 - 18 EXISTING 12" STORM PIPE

The proposed project site is approximately ± 9.22 acres in size and involves the construction of approximately 200 townhomes, site access, pedestrian ramps, curb and gutter, private roads, retaining walls, parking, wet and dry utilities, and stormwater infrastructure. Flows generated from the drainage area's proposed conditions are captured and conveyed via proposed stormwater infrastructure to an existing private above ground full spectrum extended detention basin. Flows are released from this pond from an existing outlet structure, existing orifice plate, and existing pipe with restrictor plate into an existing public stormwater infrastructure network. Flows generated from the proposed conditions with generally follow historic patterns. Under proposed conditions the entire drainage area associated with this project is approximately ± 12.04 acres with a 51% on-site weighted imperviousness and 22% off-site weighted imperviousness. The proposed on-site flows for the 5 and 100-yr storm event are 18.25 cfs and 41.95 cfs respectively while off-site is 5.00 cfs and 11.02 cfs respectively. The existing detention facility sizing, inlet capacity, and pipe sizing calculations can be found in the **Appendix**.

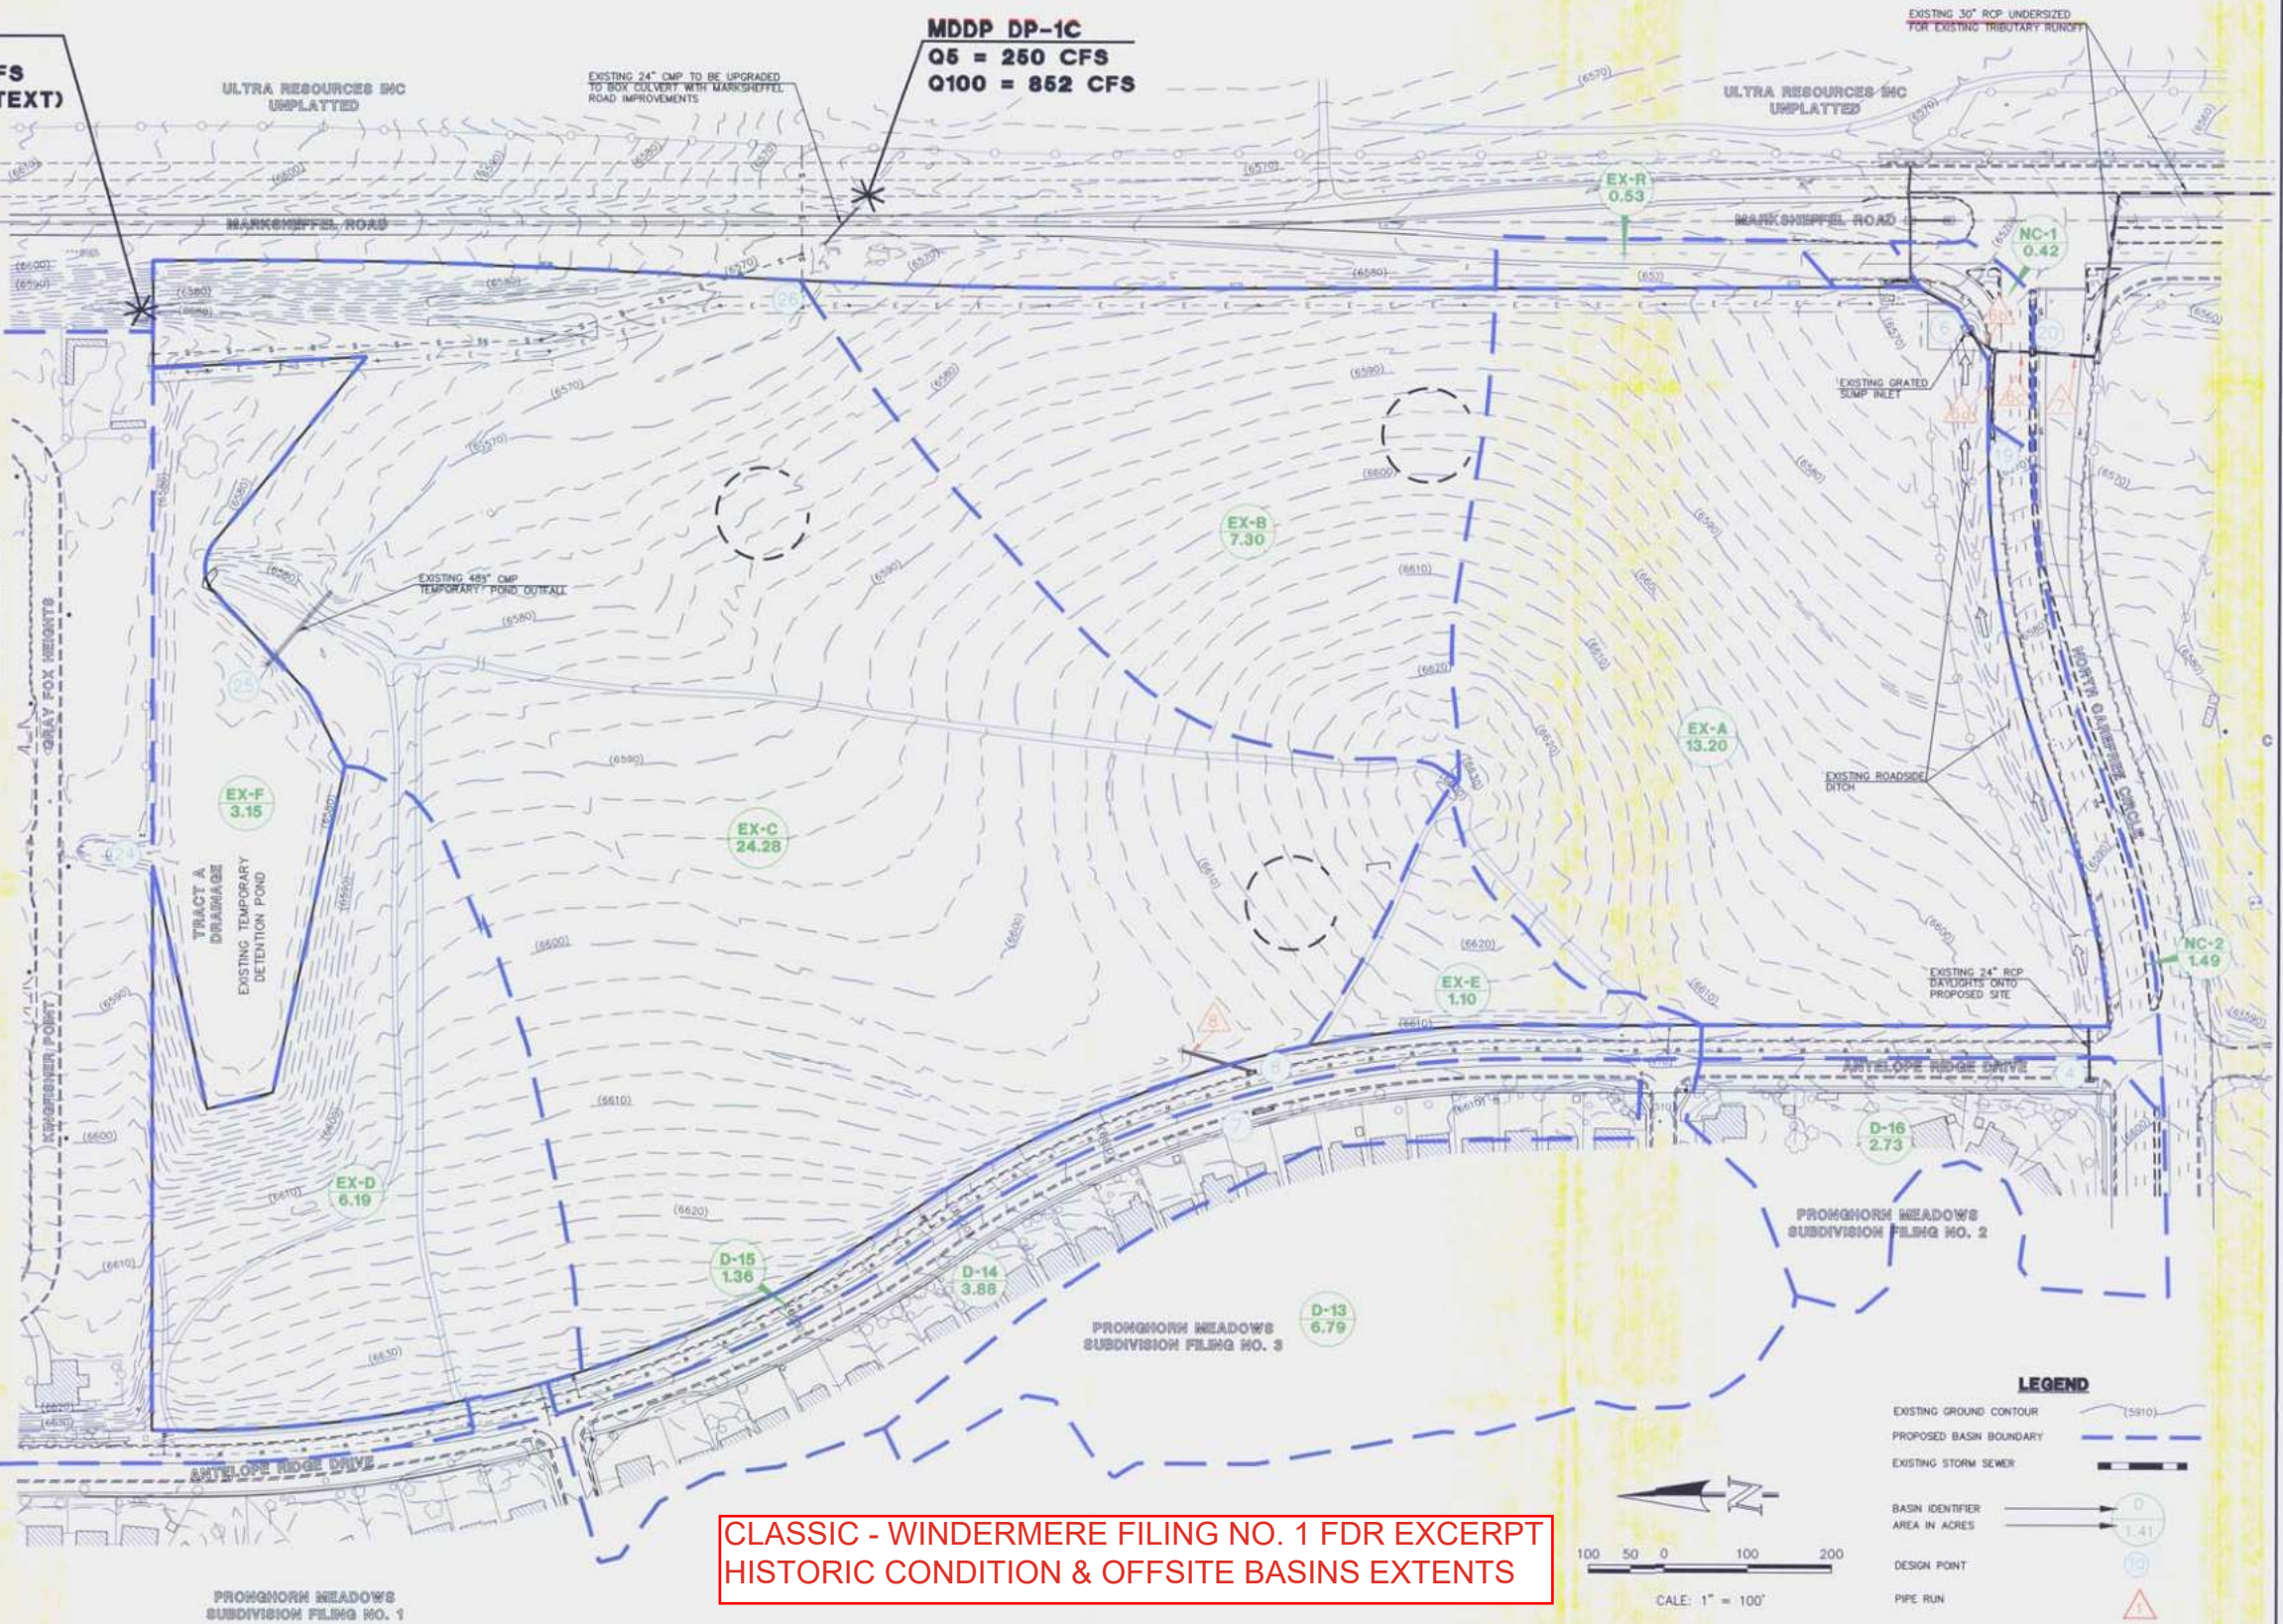
CLASSIC - WINDERMERE FILING NO. 1 FDR EXCERPT
HISTORIC CONDITION & OFFSITE BASINS EXTENTS

DESIGN POINT SUMMARY			
DESIGN POINT	Q5 (CFS)	Q100 (CFS)	FACILITY
4	7.2	14.6	EX. 8" SUMP INLET
6	18.4	42.6	EX. TYPE D GRATED INLET
7	20.0	41.6	EX. 25' SUMP INLET
8	5.6	11.2	EX. 10' SUMP INLET
19	6.7	12.5	EX. 15' AT-GRADE INLET
20	3.7	8.0	EX. 10' SUMP INLET
24	111.3	199.7	OFF-SITE RUNOFF TO POND
25	117.5	215.1	TOTAL EXISTING TO POND
26	138.3	266.9	EX. TO MARKSHEFFEL RD.

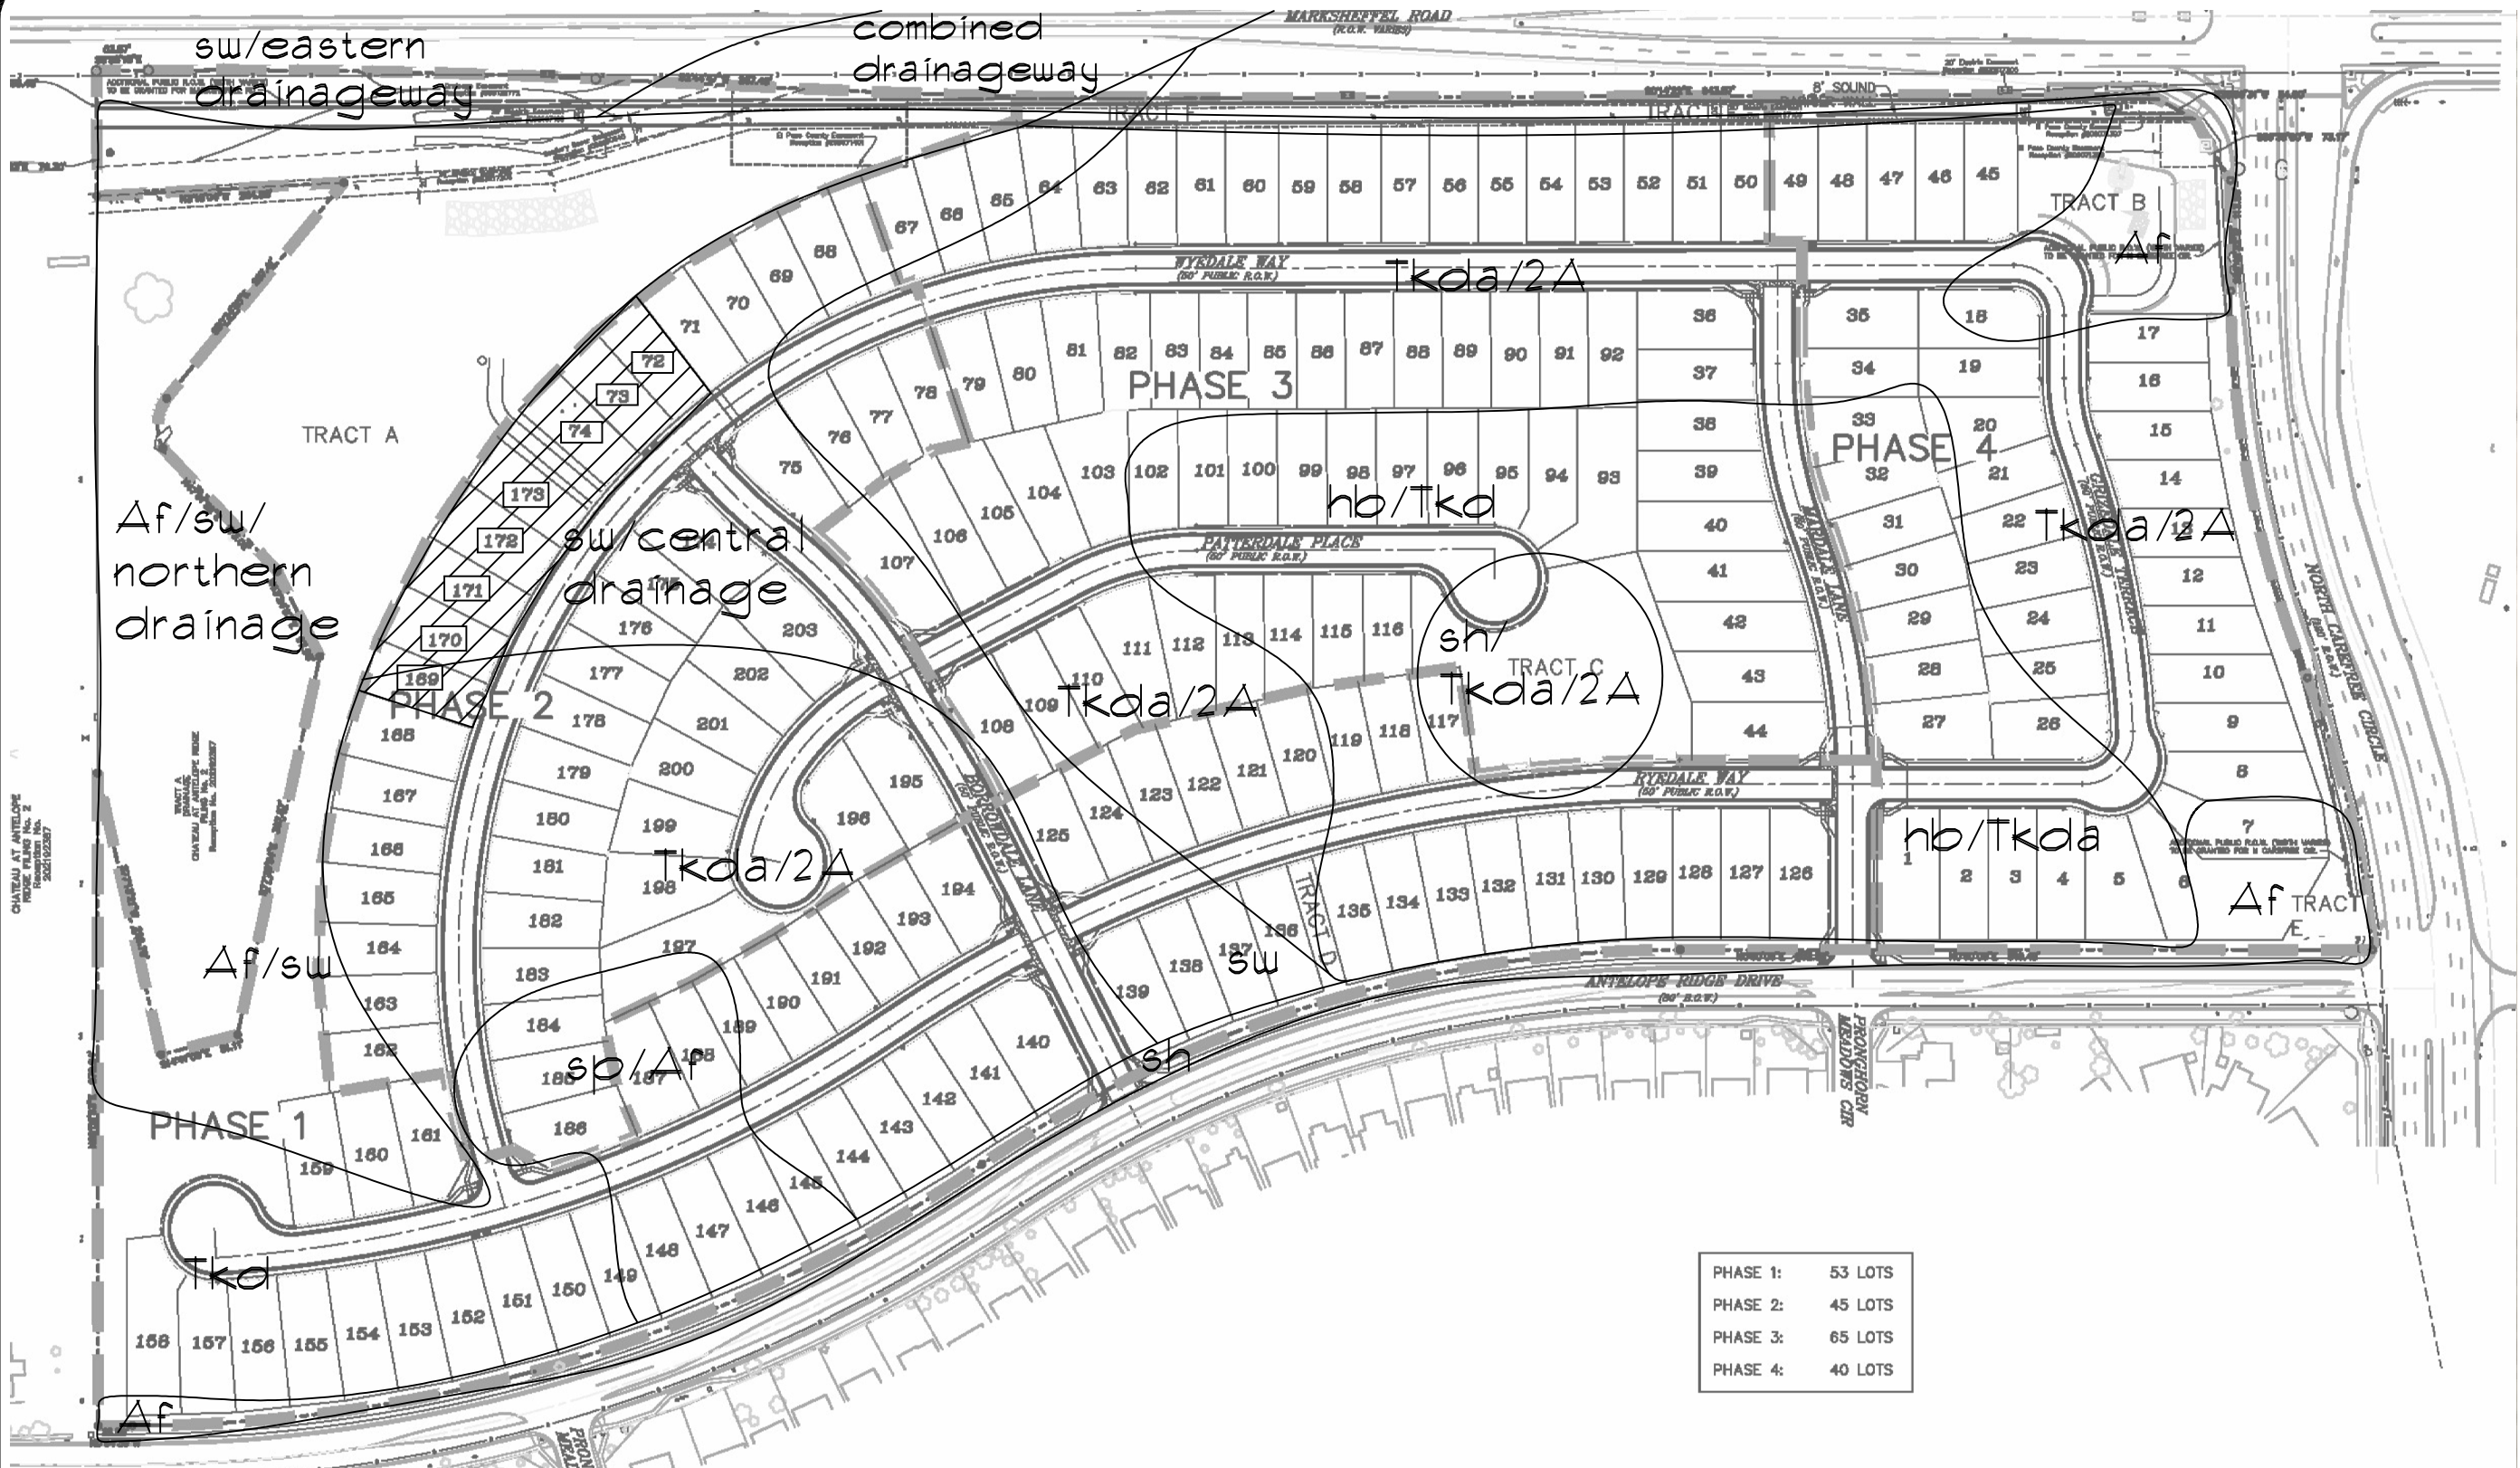
FIG-4

- *Tkda* - Dawson Arkose Formation (Eocene) - Dawson Sandstone consists of silty sandstone with interbedded layers of claystone/siltstone.
- *Af* - Artificial fill - areas of visible known fill to include: the existing detention pond banks, berms along the western and southern property lines, stockpile
- *sw* - seasonally wet areas where near-surface moisture conditions may seasonally occur, includes areas where shallow groundwater was encountered in the test borings
- *sh* - sandstone "hill"
- *hb* - hard to very hard sandstone bedrock encountered at the surface
- *sp* - stockpile

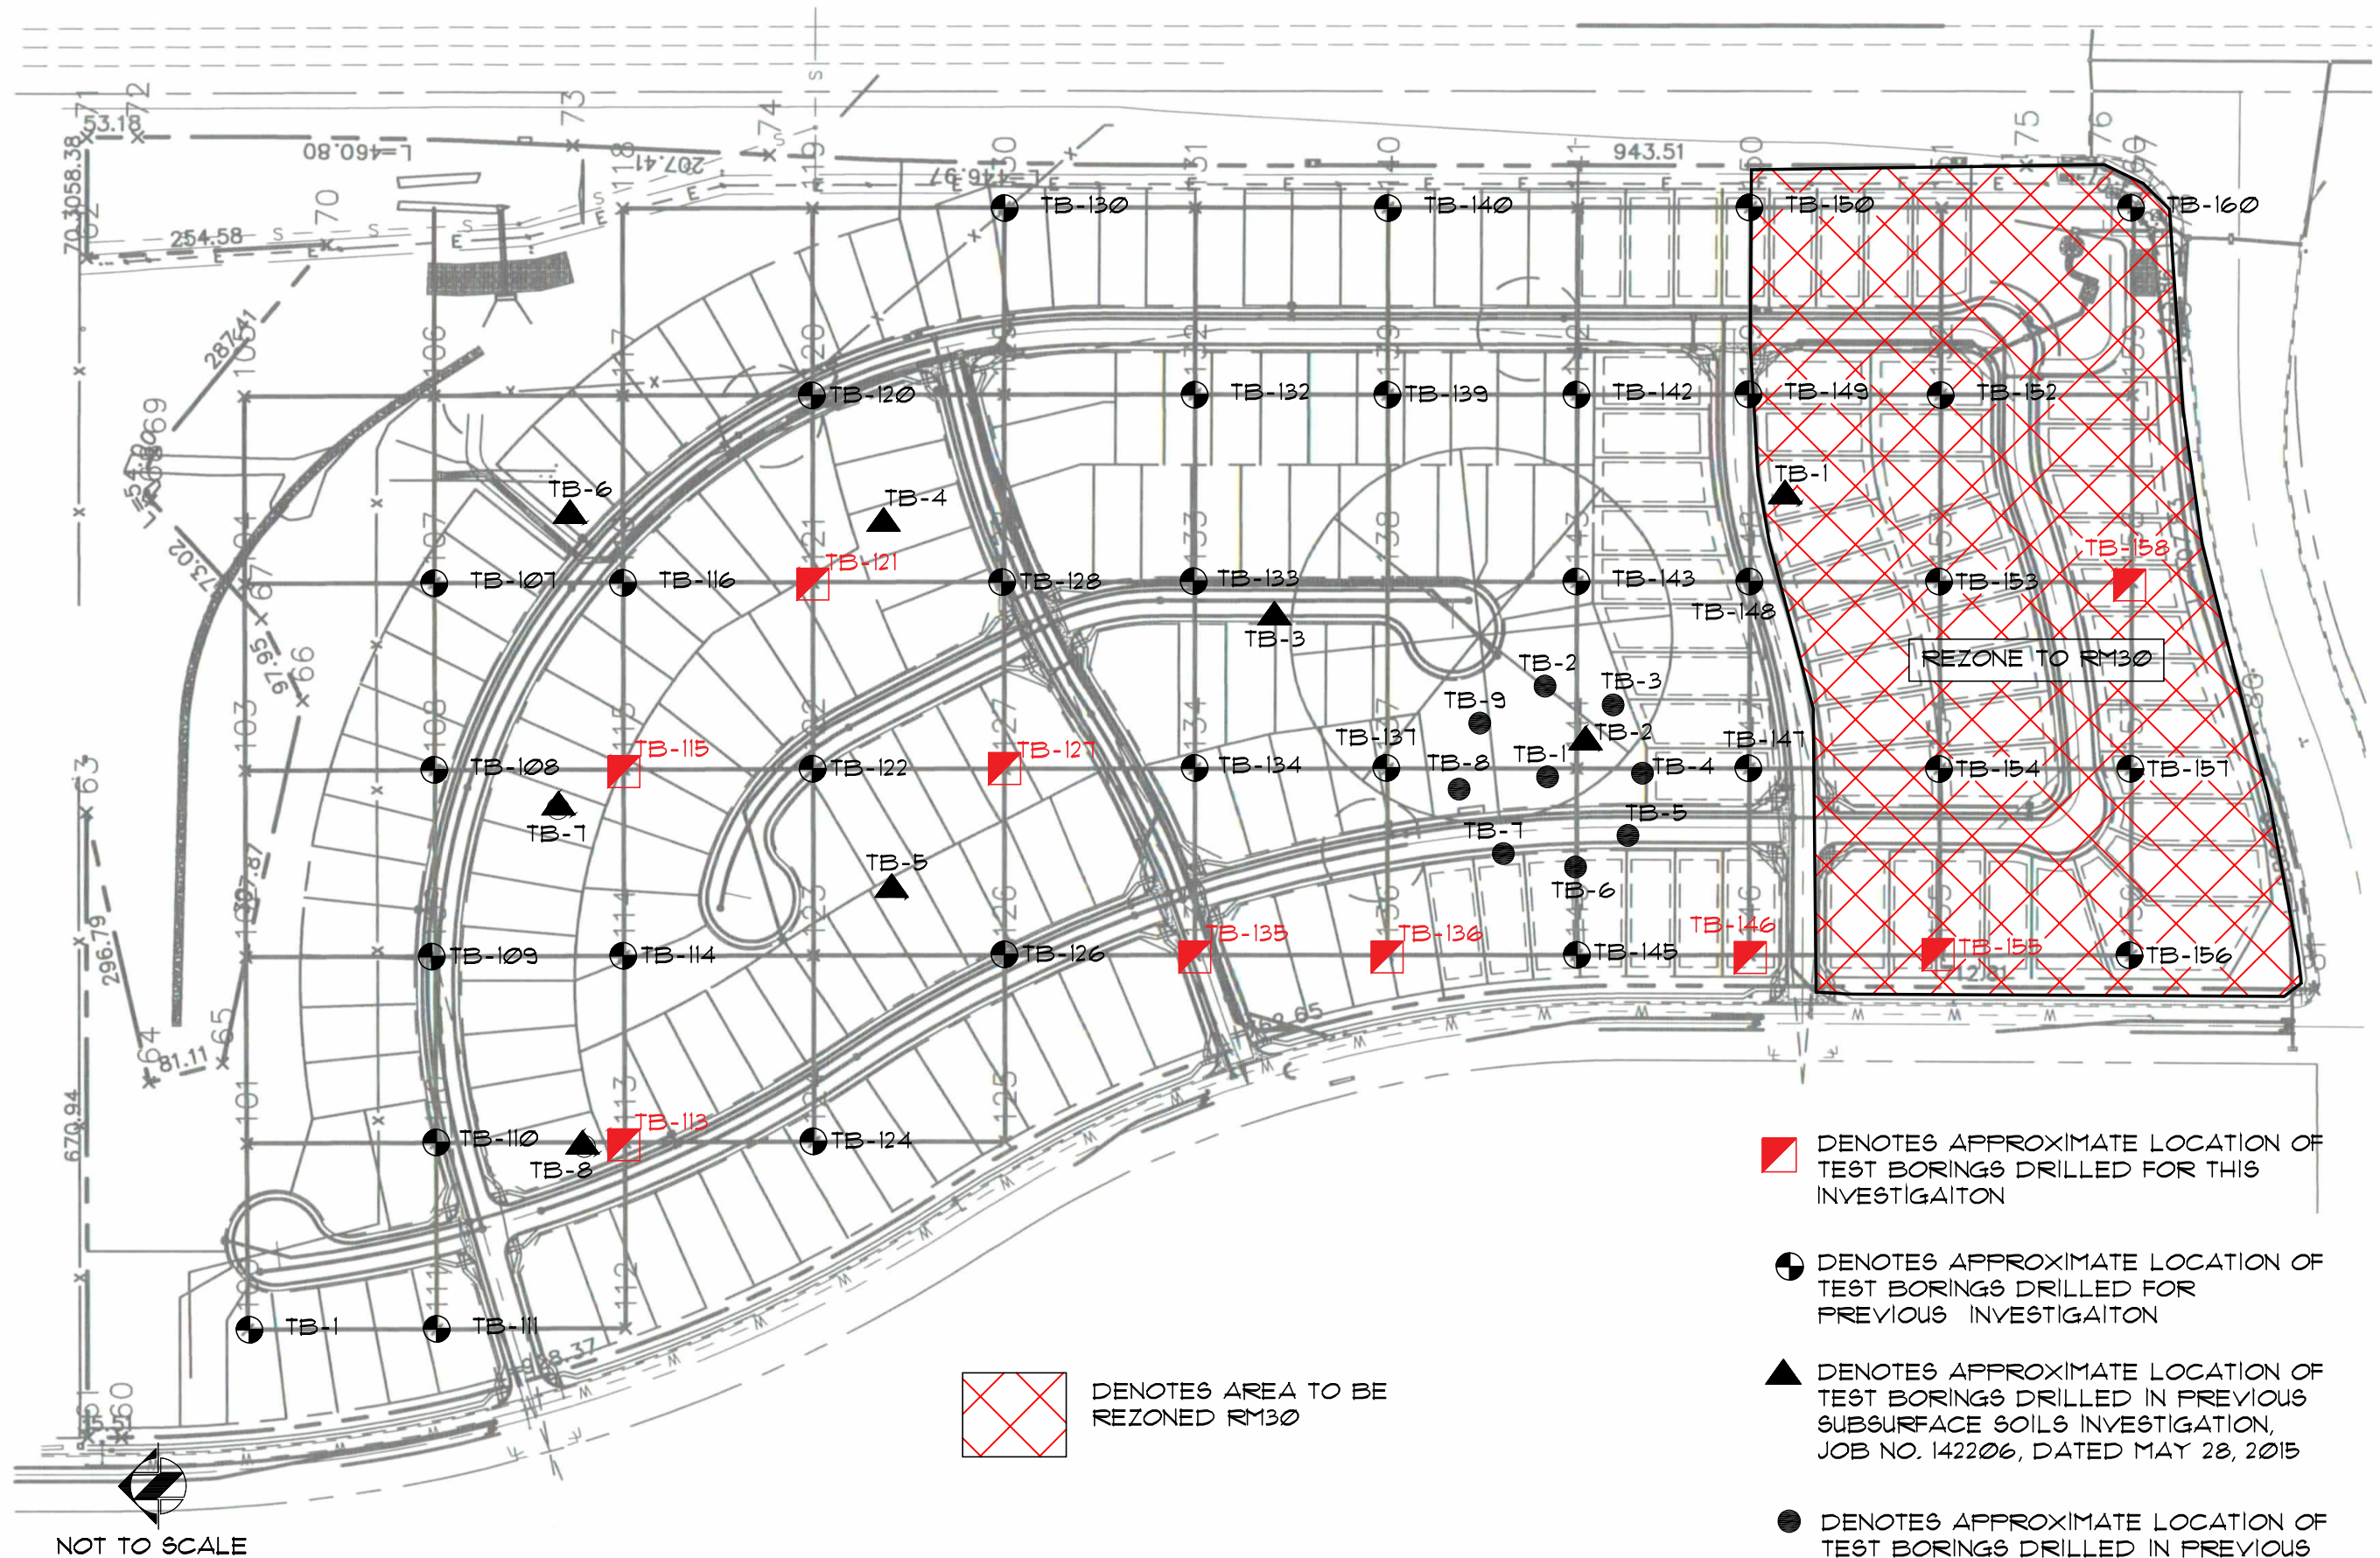
SHEET No.
FIG-2

SITE PLAN
