ENTECH
ENGINEERING, INC.

Re: Soil, Geology, and Geologic Hazard Study
Crowe Subdivision
Parcel No. 61280-00-001
15980 Roller Coaster Road
El Paso County, Colorado

GENERAL SITE CONDITIONS AND PROJECT DESCRIPTION

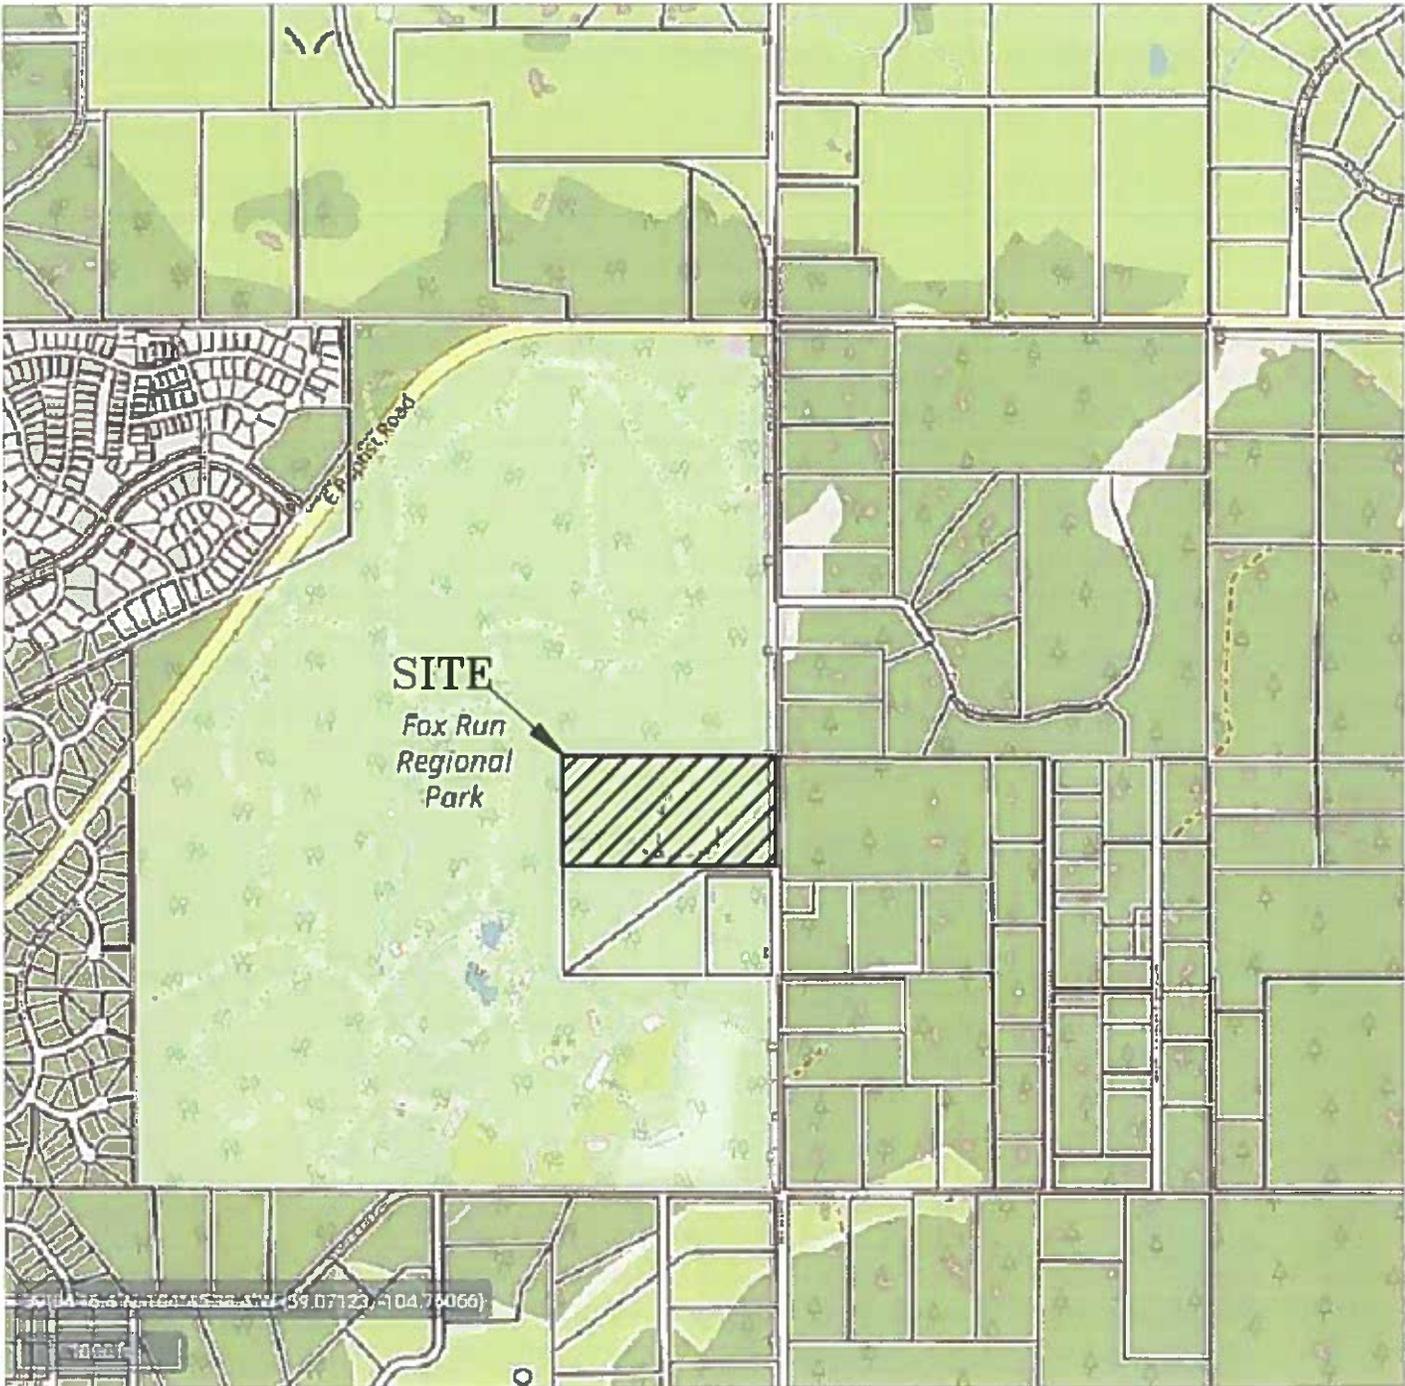
FIG NO.:
 1

VICINITY MAP
 CROWE SUBDIVISION
 15980 ROLLER COASTER ROAD
 EL PASO COUNTY, CO.
 FOR: MIKE AND RUTH CROWE

The site is located in a portion of the NE $\frac{1}{4}$ of SW $\frac{1}{4}$ of Section 28 Township 11 South, Range 66 West of the 6th Principal Meridian in El Paso County, Colorado. The site is located approximately 2-miles northeast of Colorado Springs city limits, southwest of Reveille Drive and Roller Coaster Road in El Paso County, Colorado. The location of the site is as shown on the Vicinity Map, Figure 1.

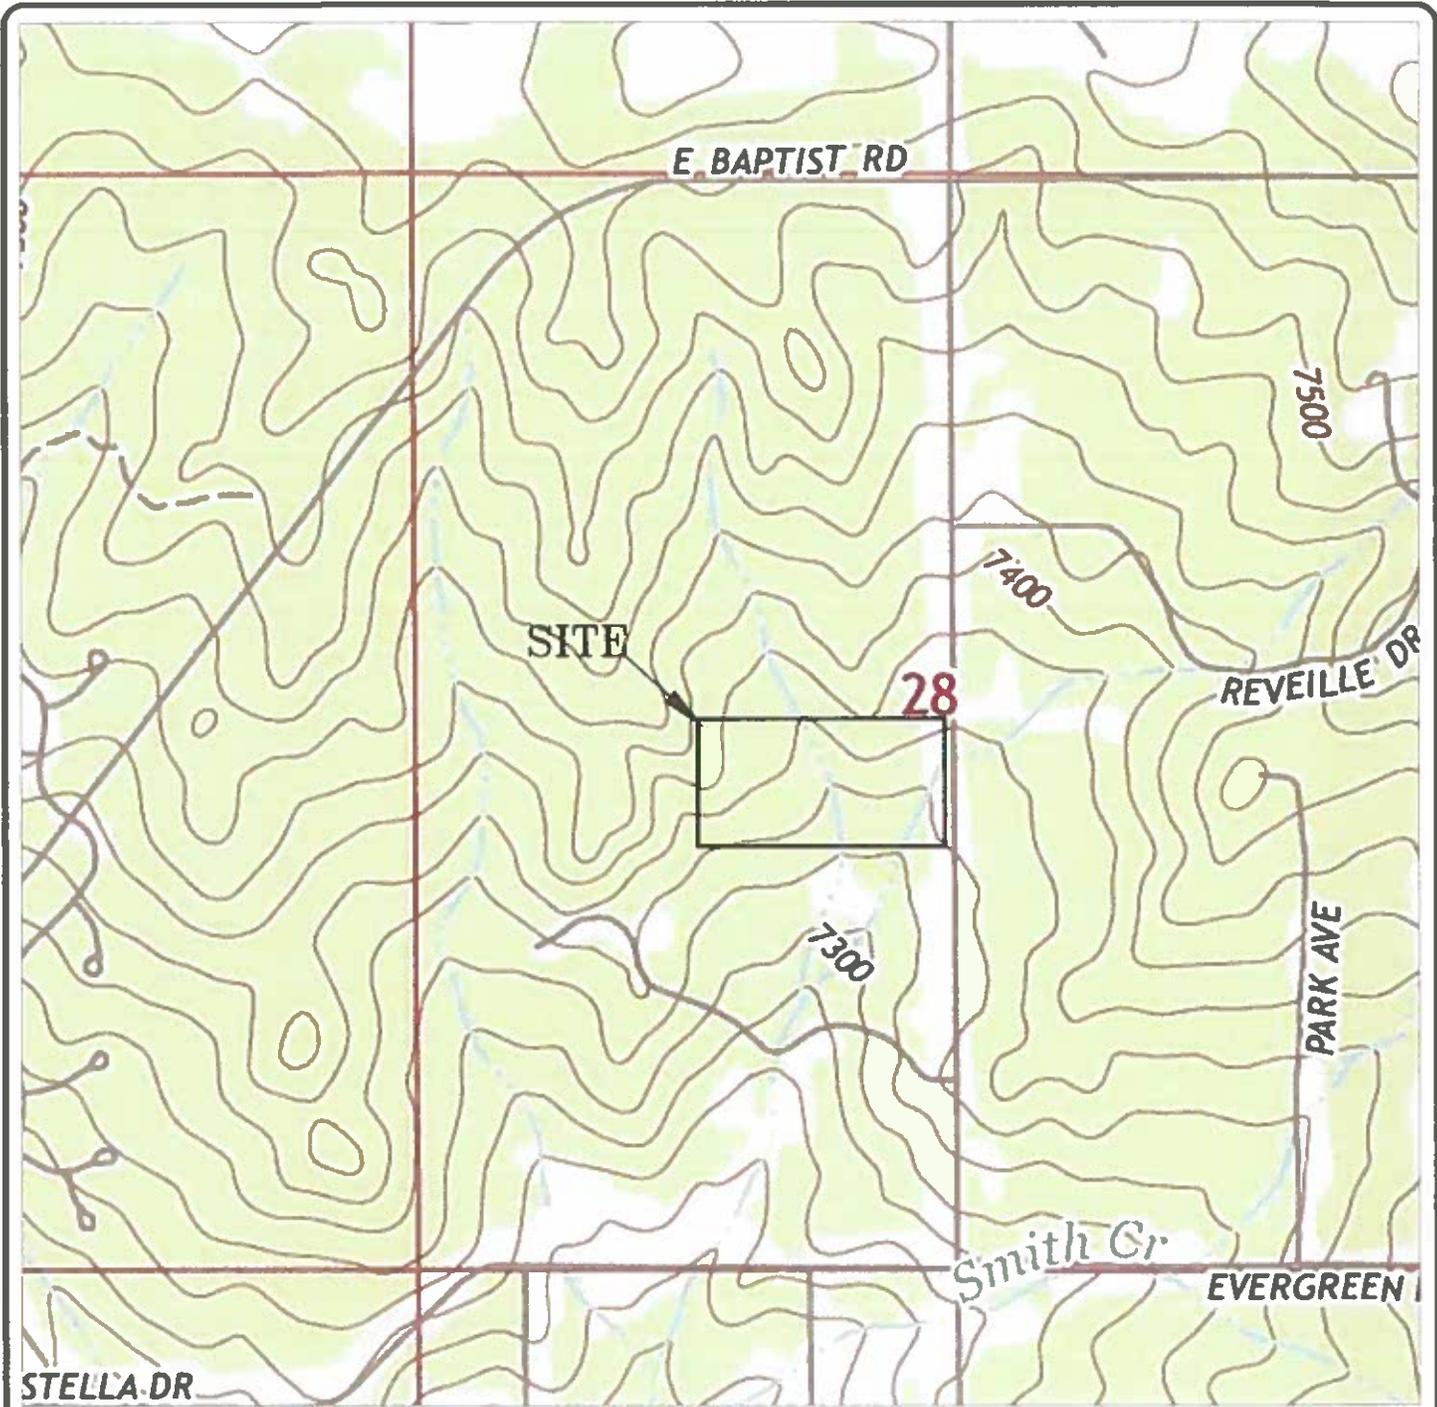
FIG NO.:
2

USGS TOPOGRAPHY MAP
CROWE SUBDIVISION
15980 ROLLER COASTER ROAD
EL PASO COUNTY, CO.
FOR: MIKE AND RUTH CROWE

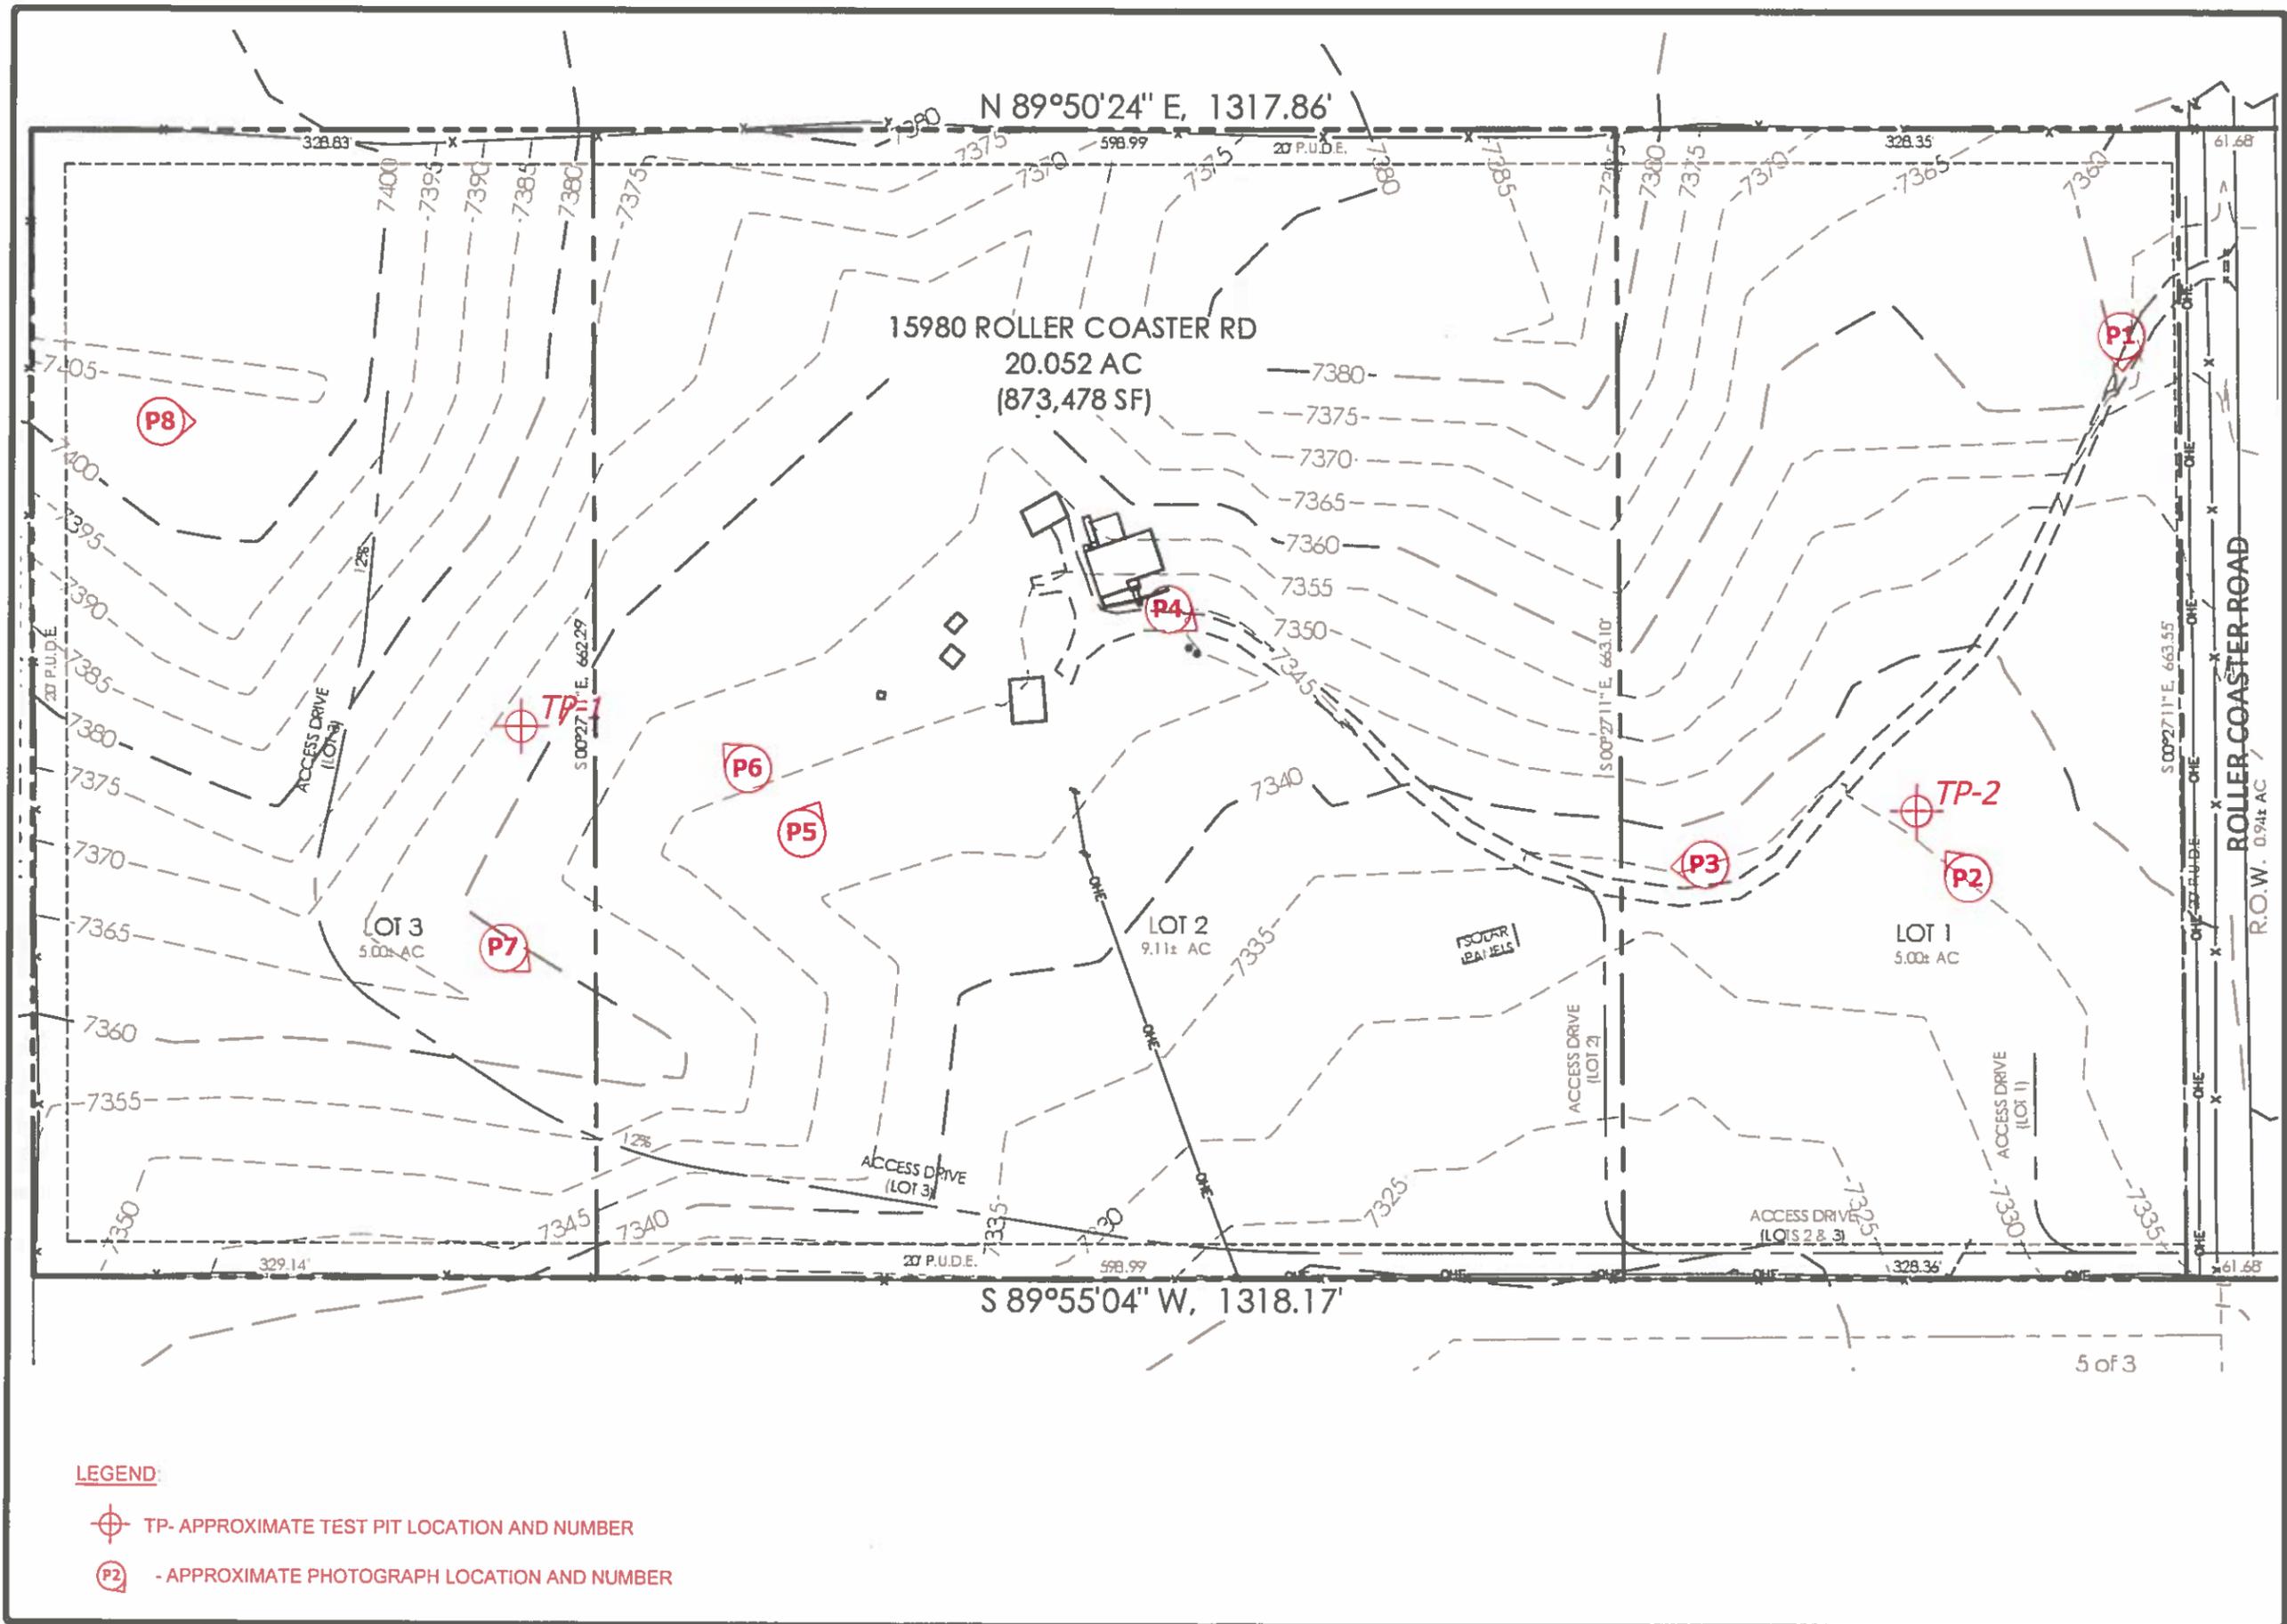
DRAWN LIT. CHECKED
DATE 5/22/21
SCALE AS SHOWN
JOB NO. 210825
FIGURE NO. 3

- TP- APPROXIMATE TEST PIT LOCATION AND NUMBER
- APPROXIMATE PHOTOGRAPH LOCATION AND NUMBER

SITE PLAN/TEST PIT LOCATION MAP
CROWE SUBDIVISION
15980 ROLLER COASTER ROAD
EL PASO COUNTY, CO.
FOR: MIKE AND RUTH CROWE

Total acreage involved in the proposed subdivision is 20-acres. Three rural residential lots are proposed as part of the replat. The proposed lot sizes range from 5-acres to 9.11-acres. Access to the lots will be along the southern side of the property. An existing house is located on Lot 2 which will remain. The new lots will be serviced by individual wells and on-site wastewater treatment systems. The Site Plan with the proposed replat is presented in Figure 3.

Two test pits were excavated on the two new proposed lots to determine general suitability of the soil characteristics for residential construction and for onsite wastewater treatment. The locations of the test pits are indicated on the Site Plan/Test Pit Location Map, Figure 3. The Test Pit Logs are presented in Appendix B. Results of this testing will be discussed later in this report.

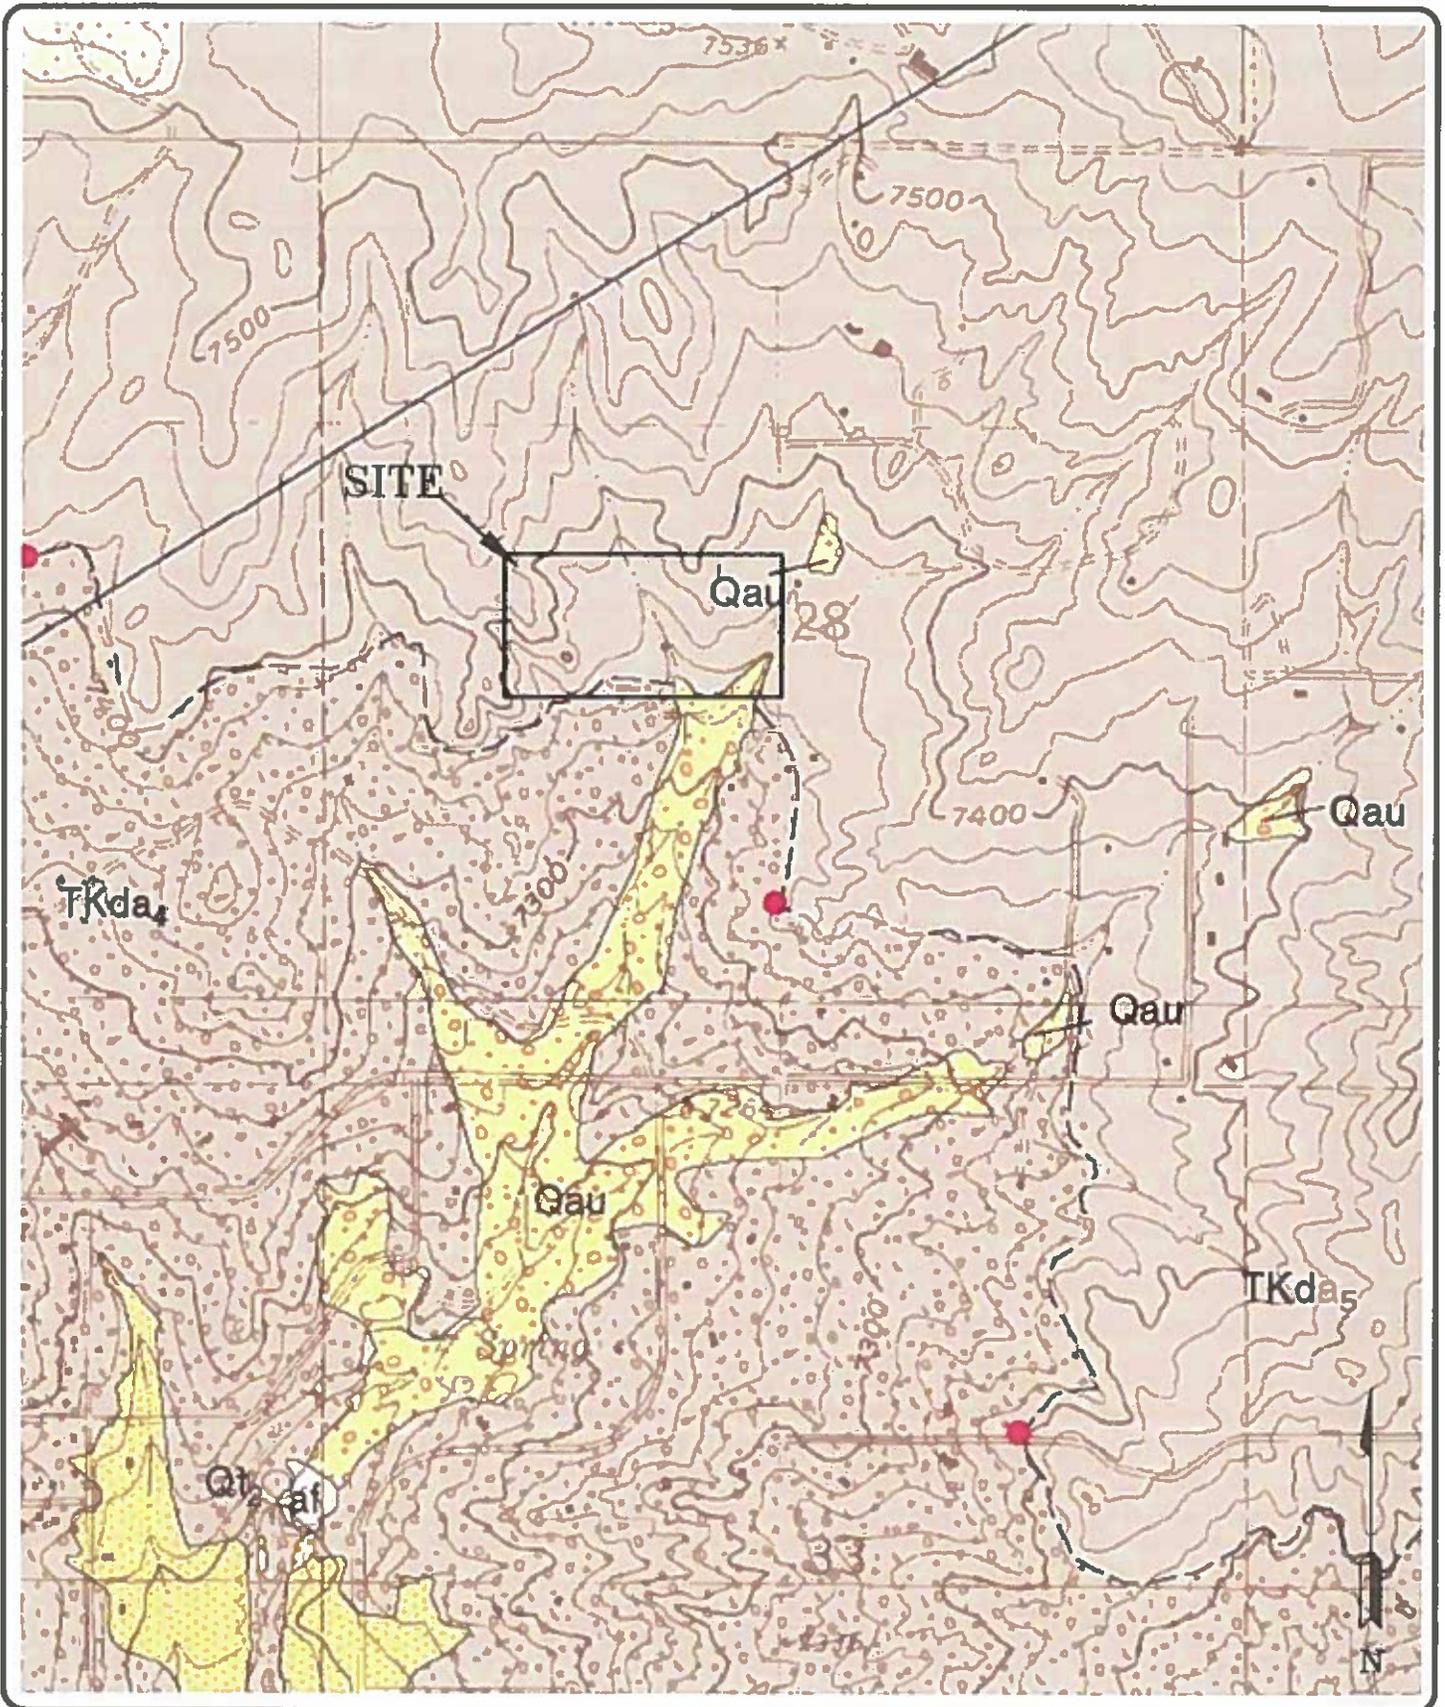
FIG NO.:
5

MONUMENT QUADRANGLE GEOLOGIC MAP
CROWE SUBDIVISION
15980 ROLLER COASTER ROAD
EL PASO COUNTY, CO.
FOR: MIKE AND RUTH CROWE

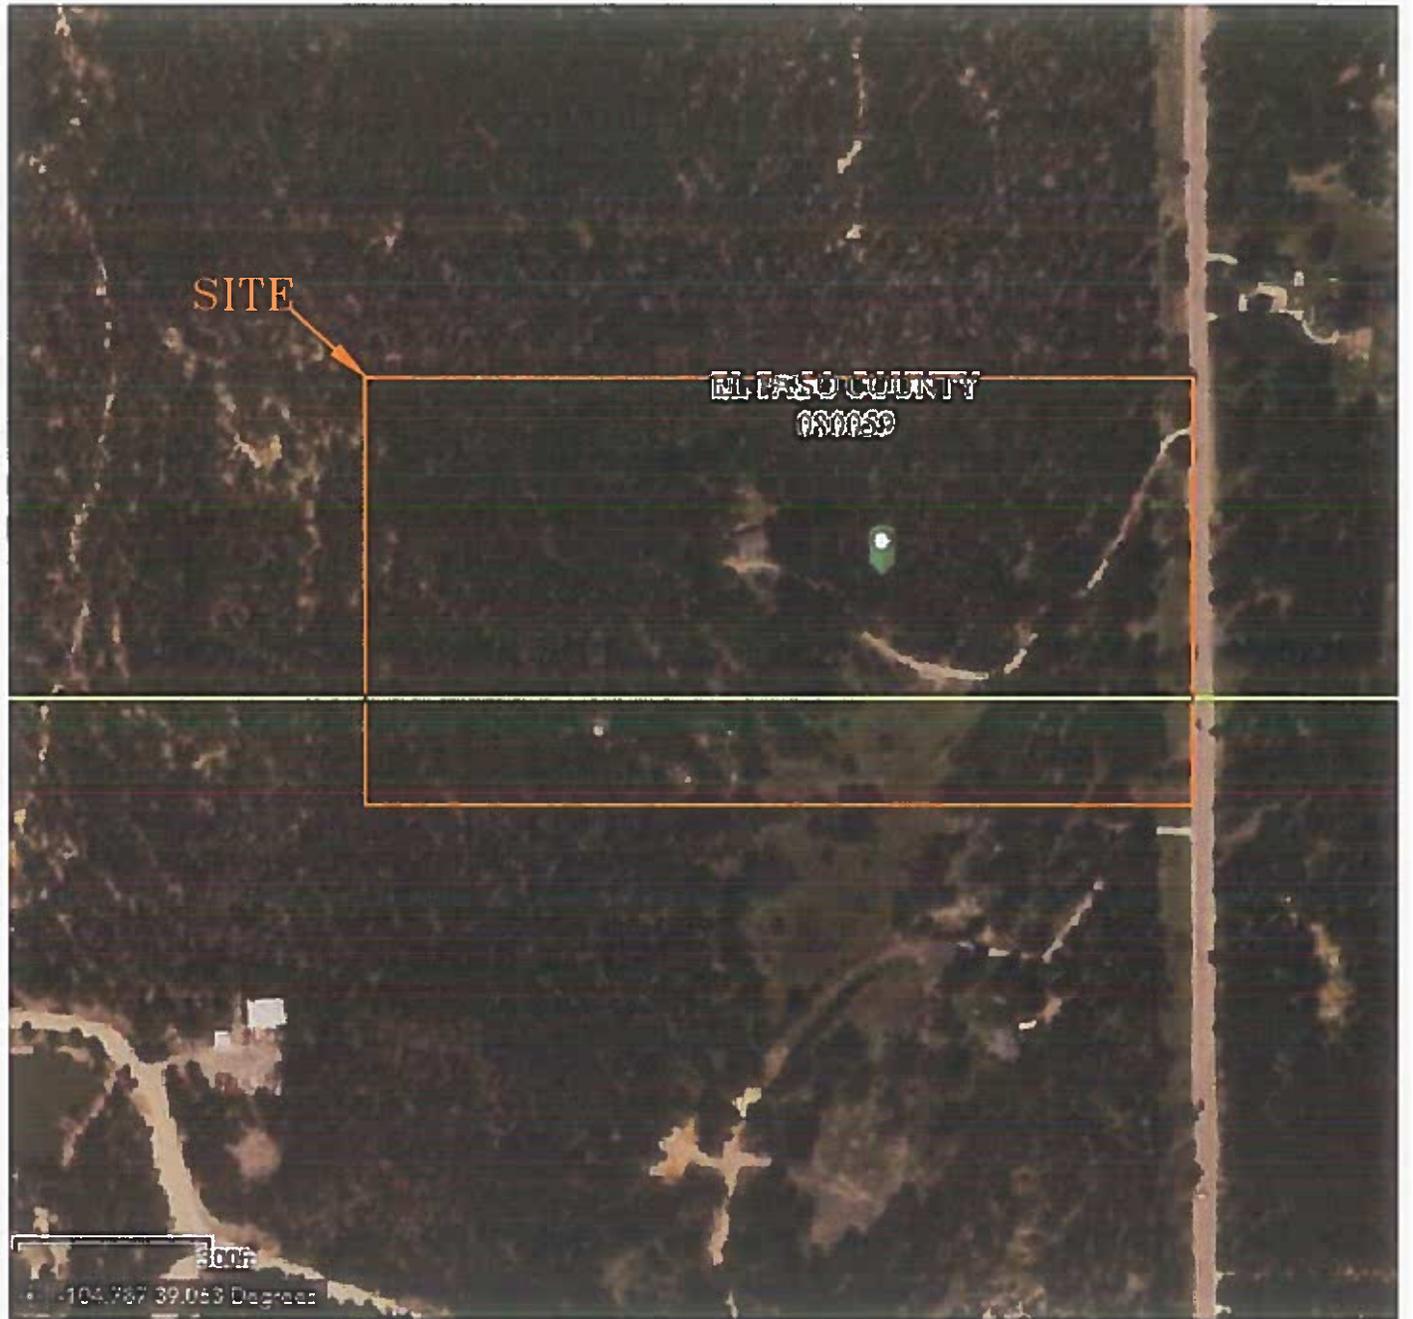
FIG NO.:
7

FEMA FLOODPLAIN MAP
CROWE SUBDIVISION
15980 ROLLER COASTER ROAD
EL PASO COUNTY, CO.
FOR: MIKE AND RUTH CROWE

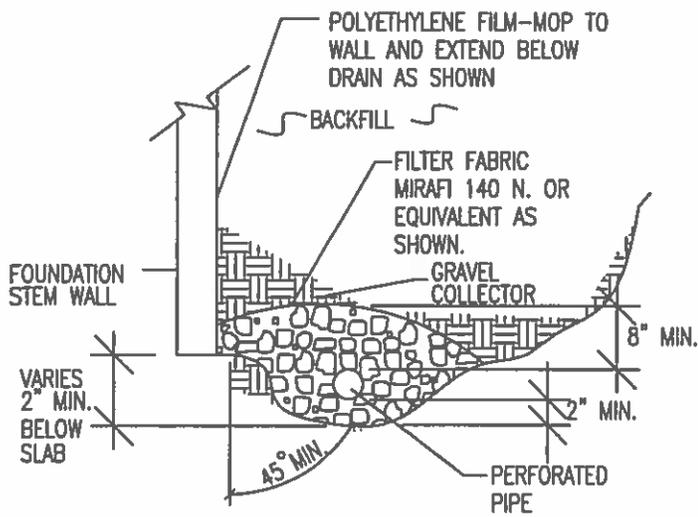
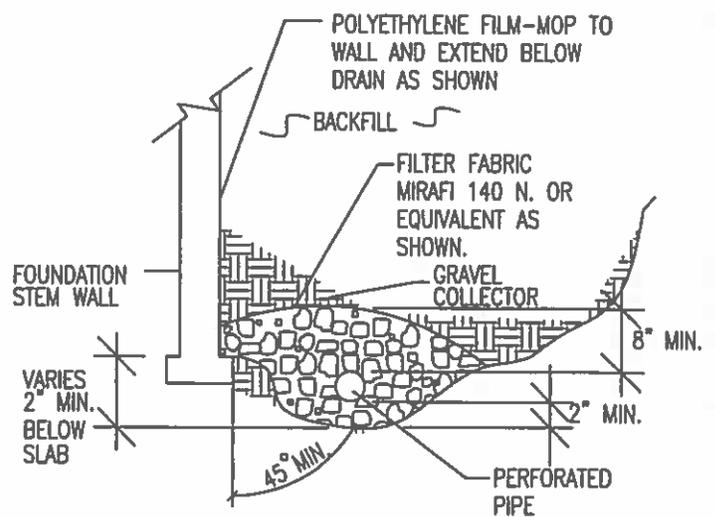
9

-GRAVEL SIZE IS RELATED TO DIAMETER OF PIPE PERFORATIONS-85% GRAVEL GREATER THAN 2x PERFORATION DIAMETER.

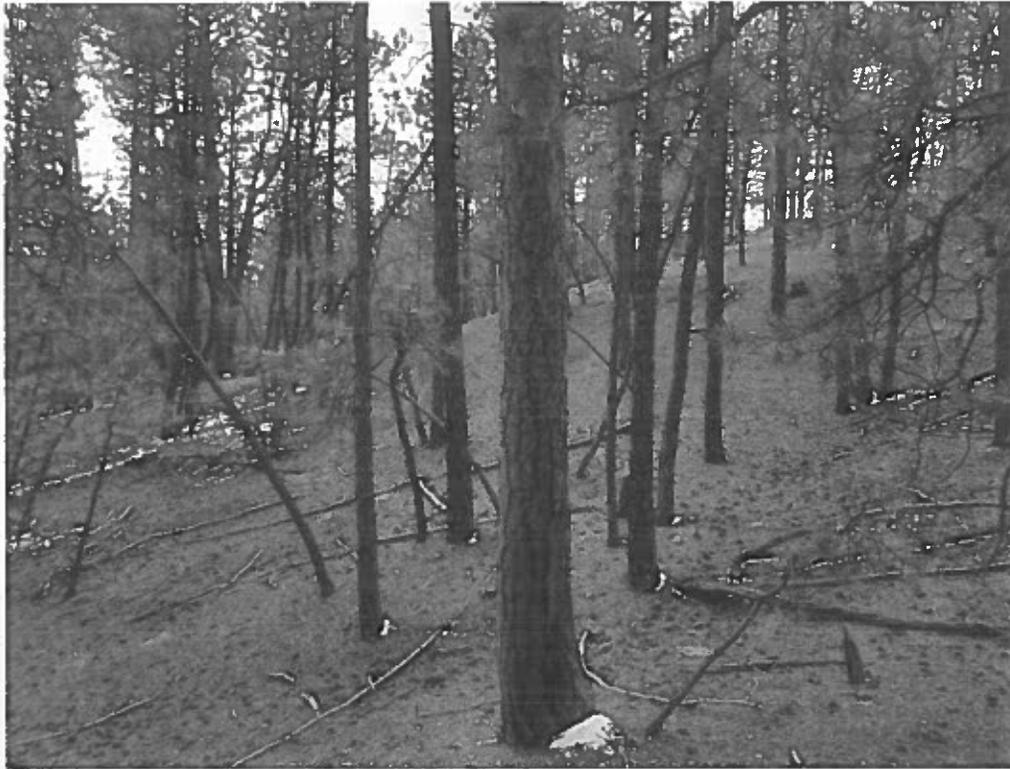
**Looking southeast
along at moderate
slope in the western
portion of the site.**

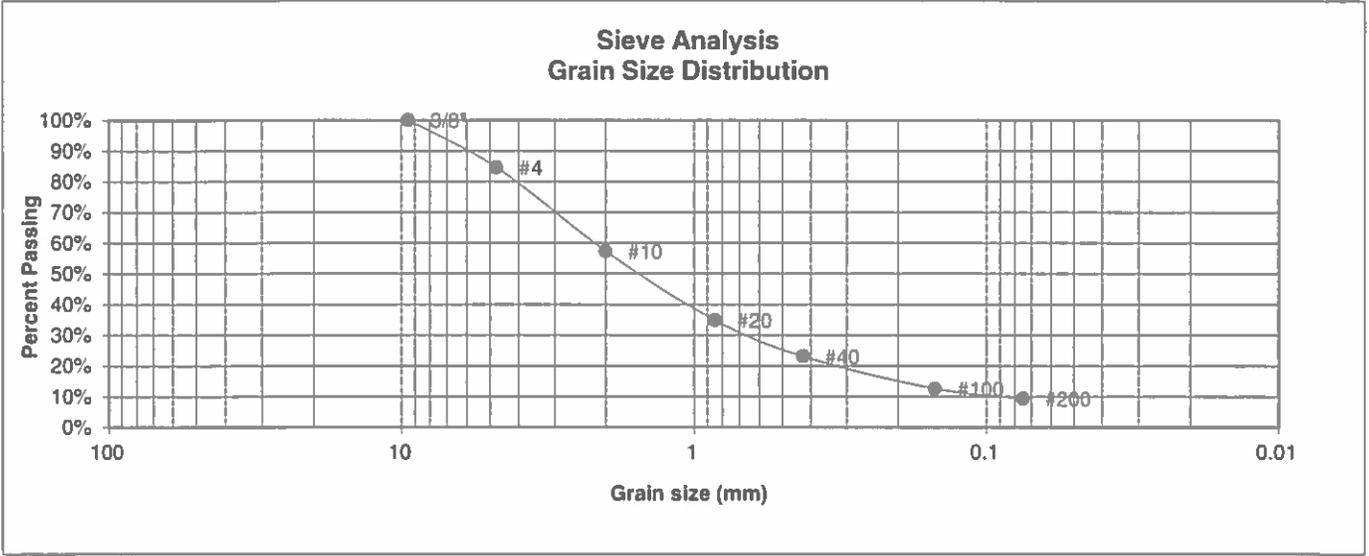
FIG NO:
C-1

BORING NO.	TP-1	UNIFIED CLASSIFICATION	SM-SW	TEST BY	BL
DEPTH(ft)	1	AASHTO CLASSIFICATION		JOB NO.	210825
CLIENT	MIKE AND RUTH CROWE				
PROJECT	15980 ROLLER COASTER RD

U.S. Sieve #	Percent Finer
3"	
1 1/2"	
3/4"	
1/2"	
3/8"	100.0%
4	84.6%
10	57.3%
20	34.9%
40	23.1%
100	12.6%
200	9.4%

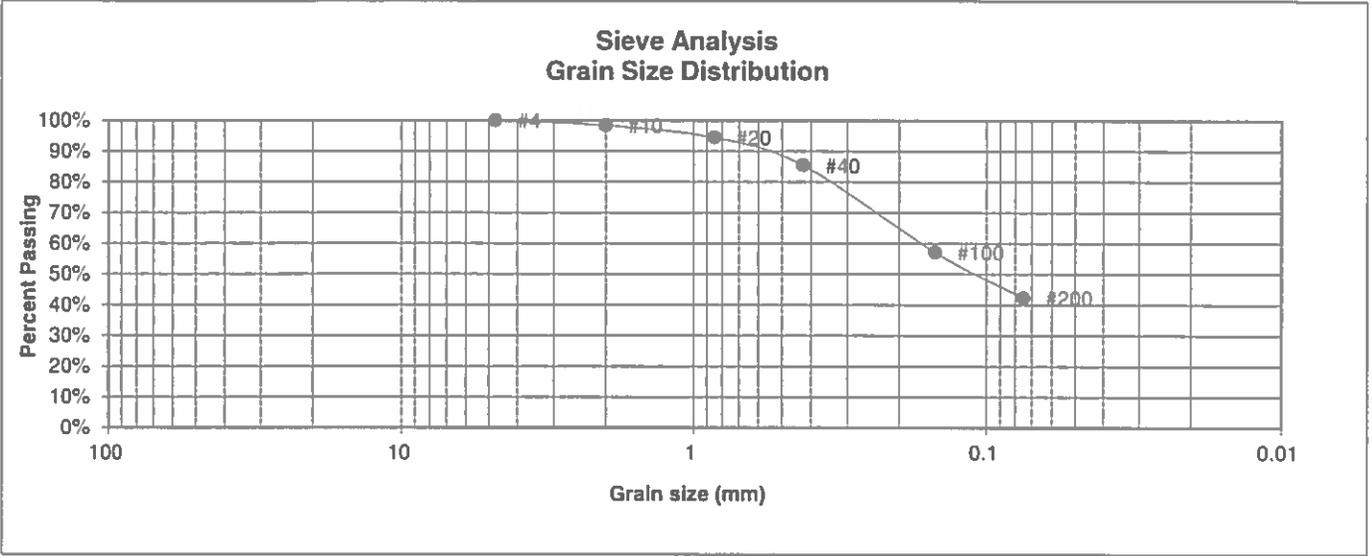
FIG NO:
L-2

BORING NO.	TP-1	UNIFIED CLASSIFICATION	SC	TEST BY	BL
DEPTH(ft)	5	AASHTO CLASSIFICATION		JOB NO.	210825
CLIENT	MIKE AND RUTH CROWE				
PROJECT	15980 ROLLER COASTER RD

U.S. Sieve #	Percent Finer
3"	
1 1/2"	
3/4"	
1/2"	
3/8"	
4	100.0%
10	98.4%
20	94.5%
40	85.4%
100	57.1%
200	42.3%

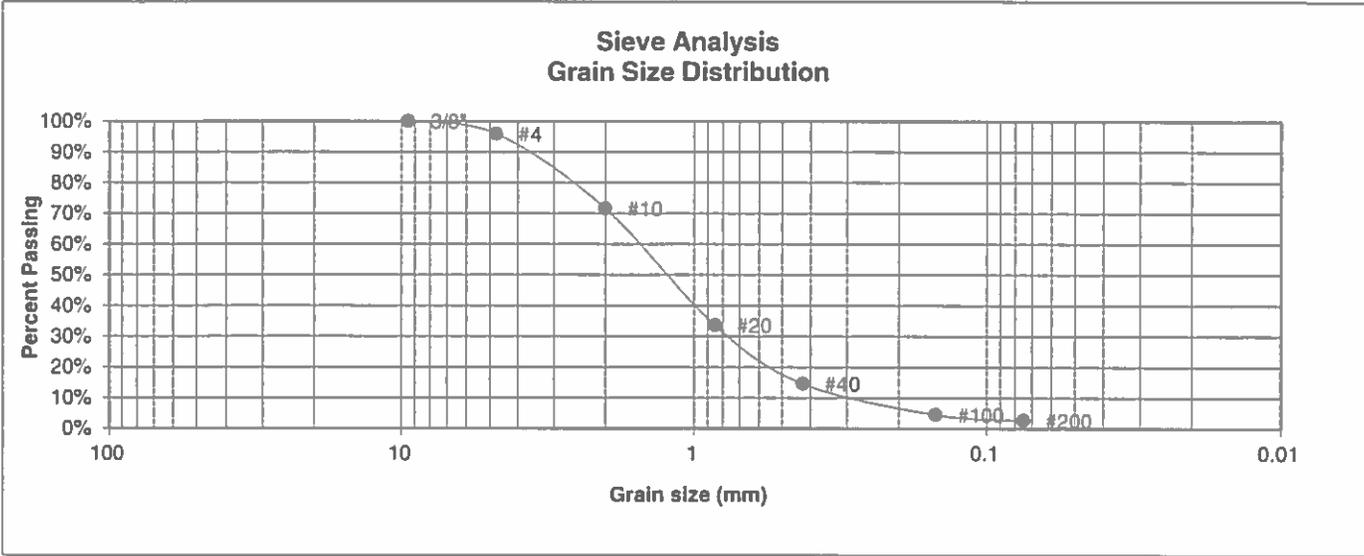
BORING NO.	TP-2	UNIFIED CLASSIFICATION	SW	TEST BY	BL
DEPTH(ft)	2-3	AASHTO CLASSIFICATION		JOB NO.	210825
CLIENT	MIKE AND RUTH CROWE				
PROJECT	15980 ROLLER COASTER RD

U.S. Sieve #	Percent Finer
3"	
1 1/2"	
3/4"	
1/2"	
3/8"	100.0%
4	95.9%
10	71.6%
20	33.6%
40	14.6%
100	4.5%
200	2.7%
