Re: Wastewater Study  
Crowe Subdivision  
Parcel No. 61280-00-001  
15980 Roller Coaster Road  
El Paso County, Colorado

Mike and Ruth Crowe  
OWTS – Wastewater Study  
Crowe Subdivision  
Parcel No. 61280-00-001  
15980 Roller Coaster Road  
El Paso County, Colorado

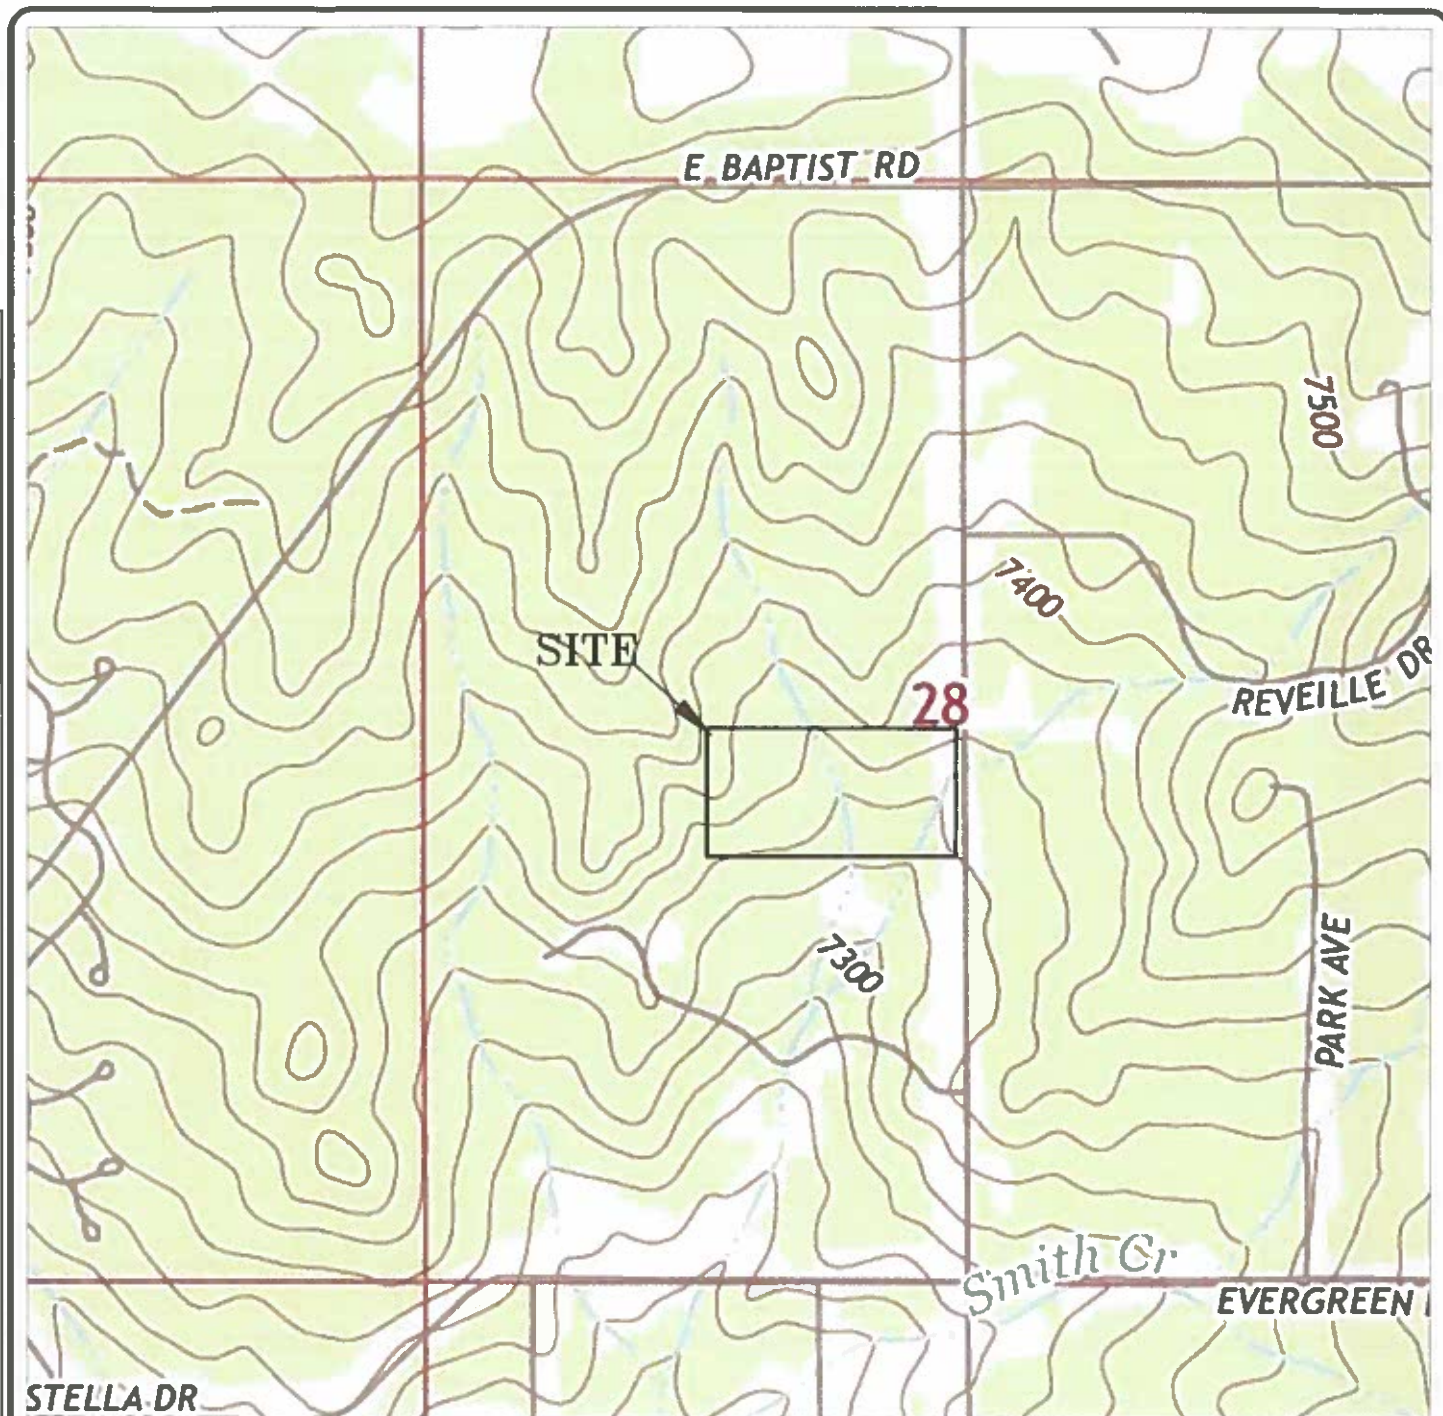
FIG NO.:  
2

USGS TOPOGRAPHY MAP  
CROWE SUBDIVISION  
15980 ROLLER COASTER ROAD  
EL PASO COUNTY, CO.  
FOR: MIKE AND RUTH CROWE

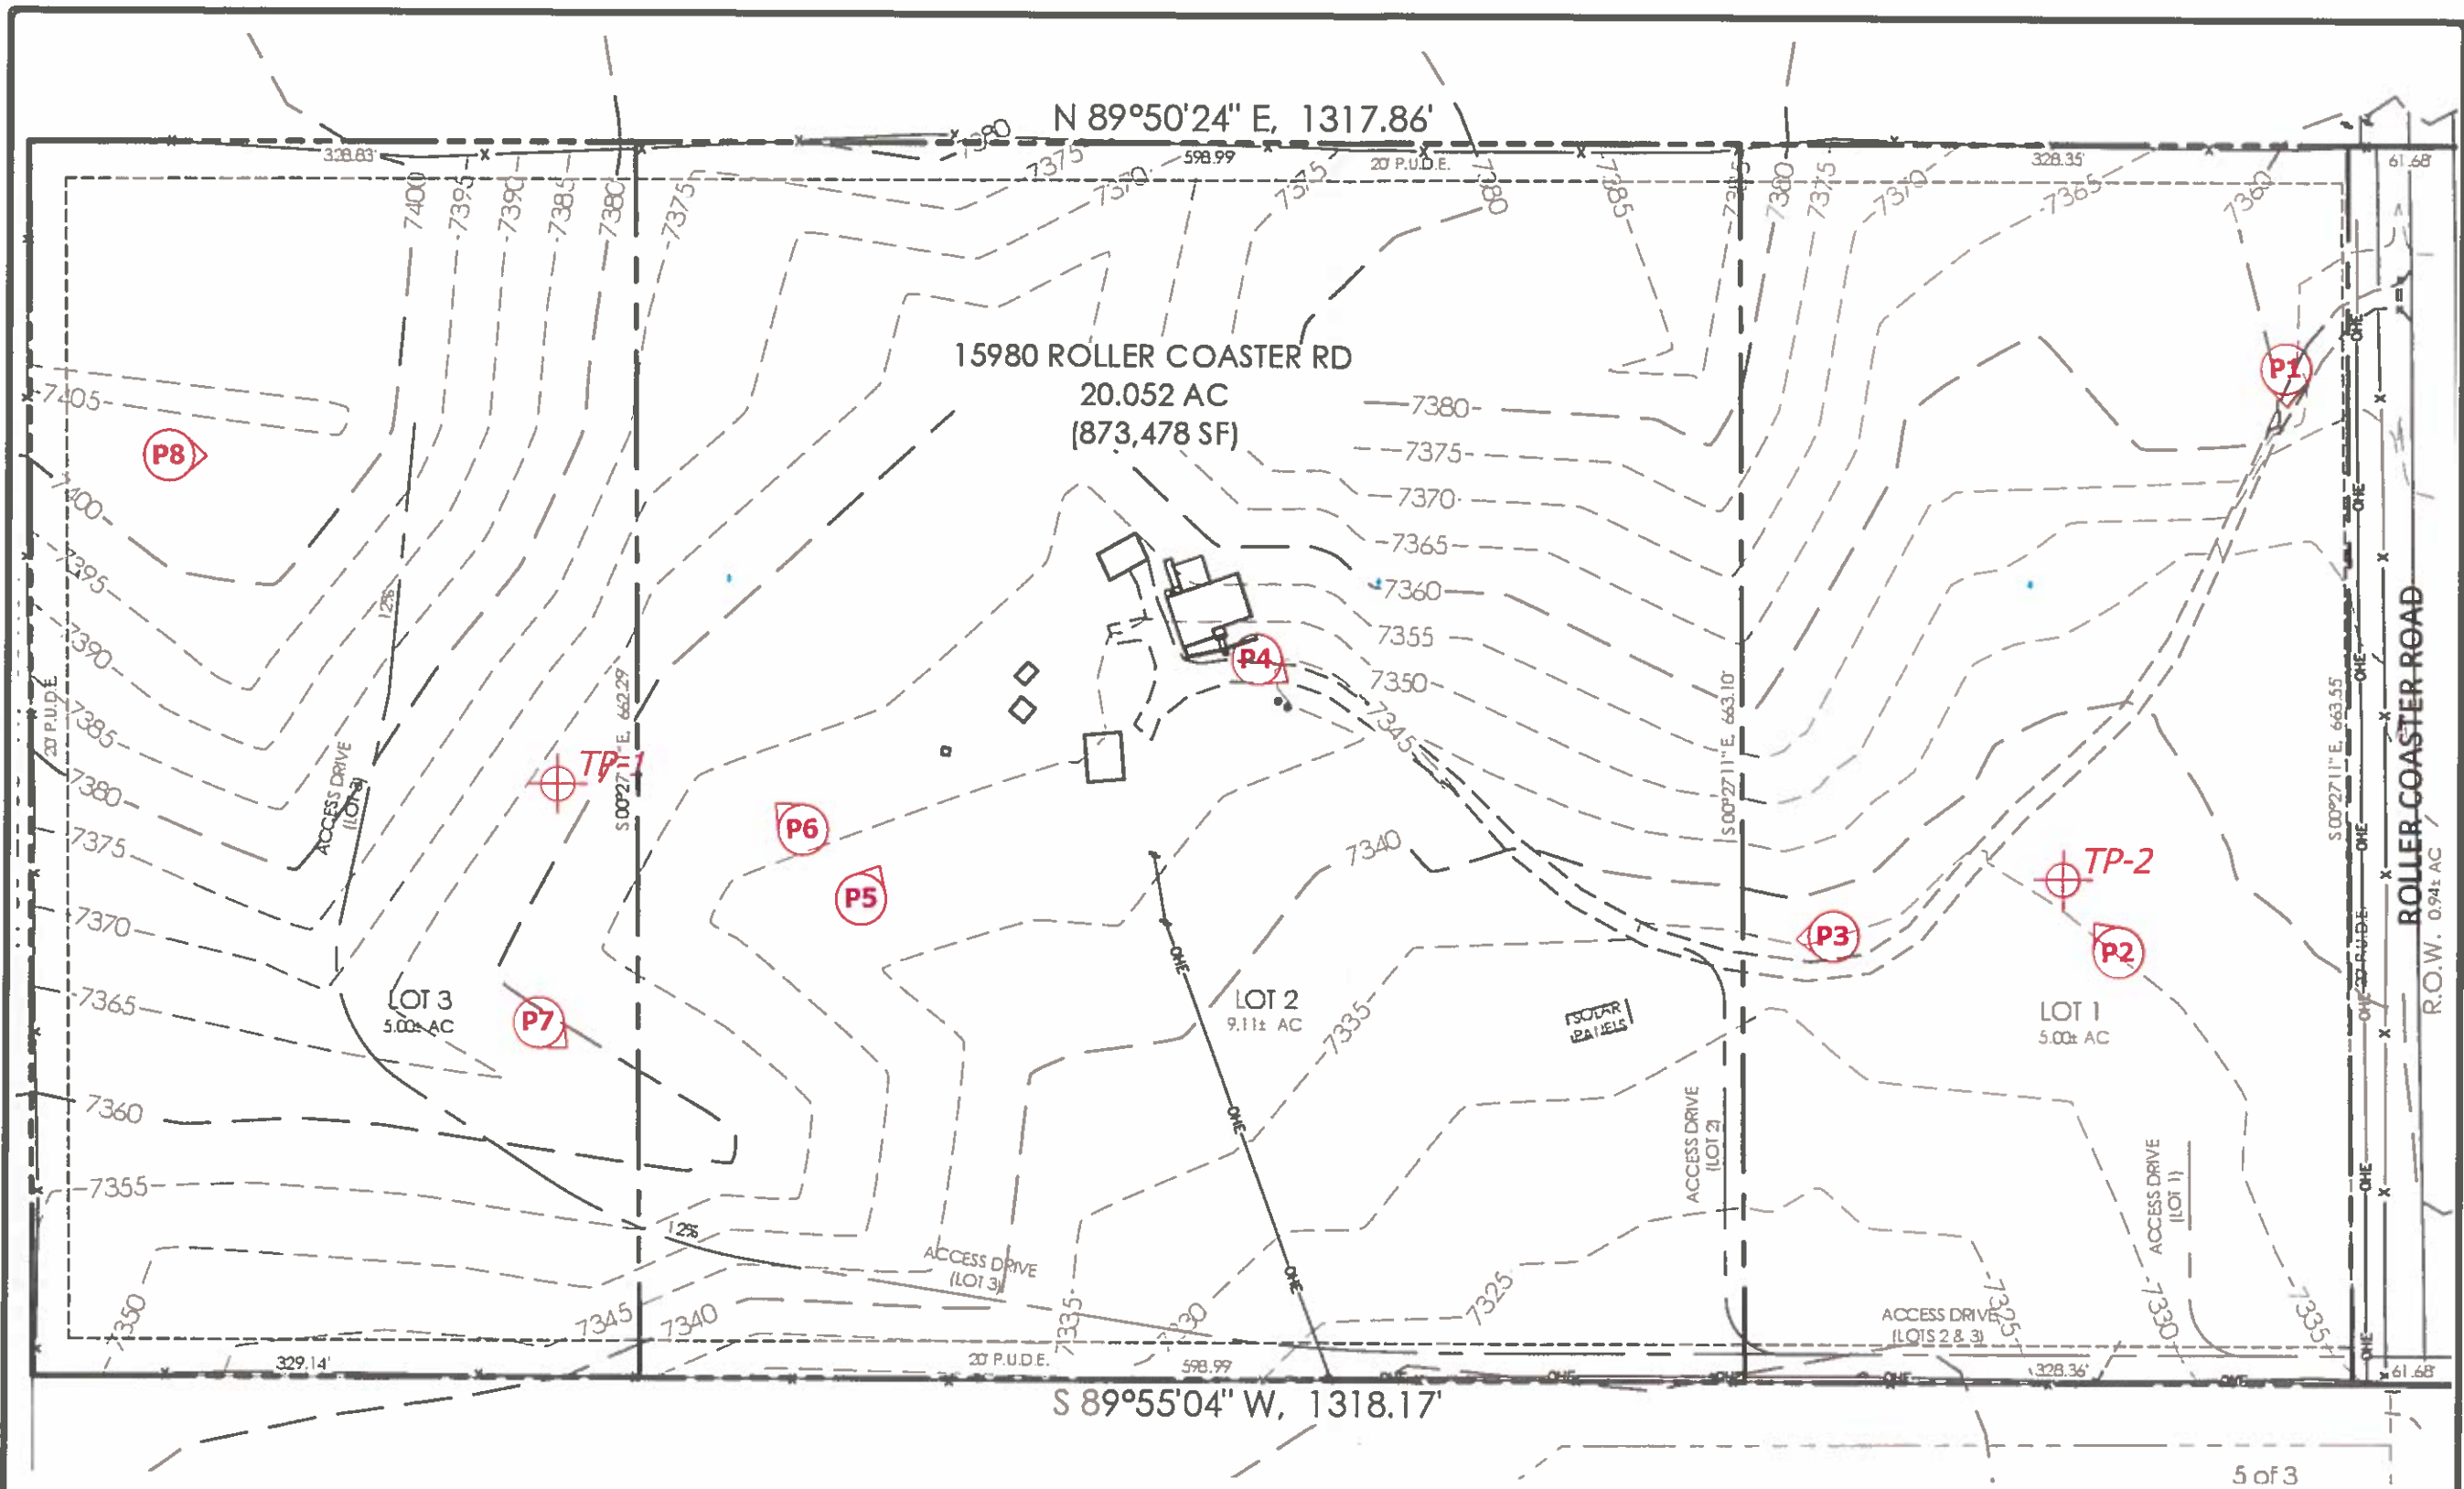
DATE	5/22/21
SCALE	AS SHOWN
JOB NO.	210825
FIGURE NO.	3

- ⊕ TP- APPROXIMATE TEST PIT LOCATION AND NUMBER
- (P2) - APPROXIMATE PHOTOGRAPH LOCATION AND NUMBER

SITE PLAN/TEST PIT LOCATION MAP  
CROWE SUBDIVISION  
15980 ROLLER COASTER ROAD  
EL PASO COUNTY, CO.  
FOR: MIKE AND RUTH CROWE

Total acreage involved in the proposed subdivision is 20-acres. Three rural residential lots are proposed as part of the replat. The proposed lot sizes range from 5-acres to 9.11-acres. Access to the lots will be along the southern side of the property. An existing house is located on Lot 2 which will remain. The new lots will be serviced by individual wells and on-site wastewater treatment systems. The Site Plan with the proposed replat is presented in Figure 3.

Two test pits were excavated on the two new proposed lots to determine general suitability of the soil characteristics for residential construction and for onsite wastewater treatment. The locations of the test pits are indicated on the Site Plan/Test Pit Location Map, Figure 3. The Test Pit Logs are presented in Appendix B. Results of this testing will be discussed later in this report.

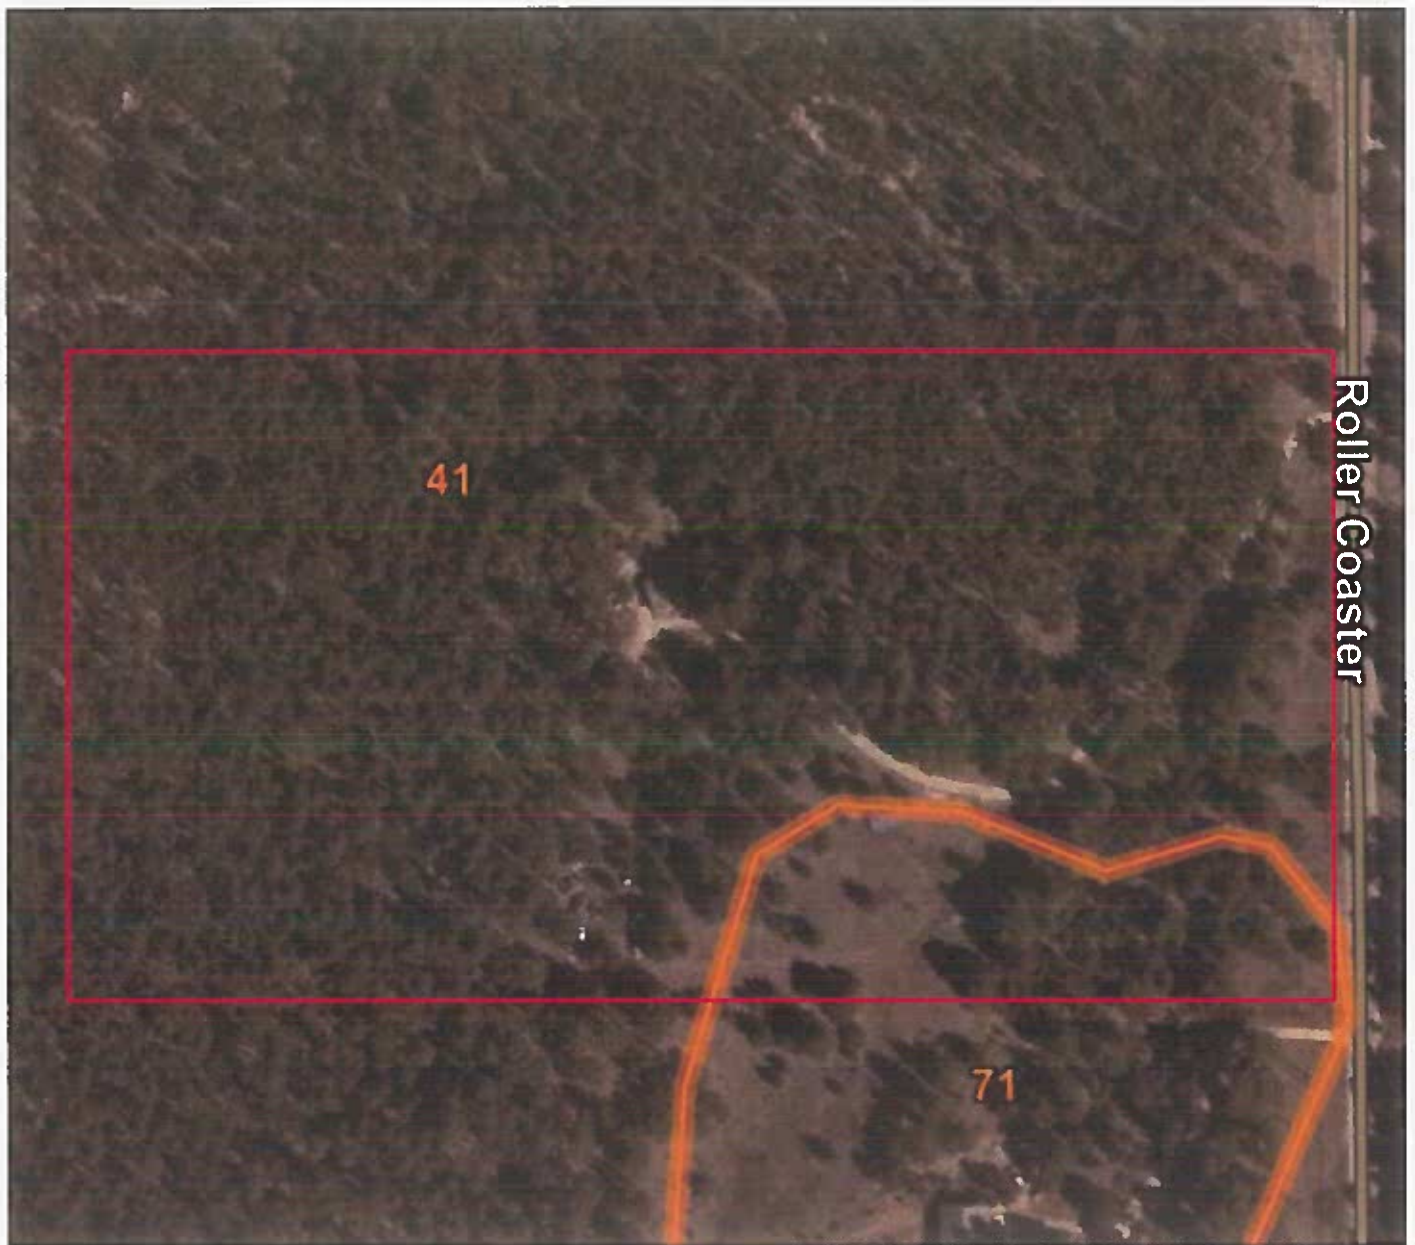
FIG NO.:  
4

SOIL SURVEY MAP  
CROWE SUBDIVISION  
15980 ROLLER COASTER ROAD  
EL PASO COUNTY, CO.  
FOR: MIKE AND RUTH CROWE

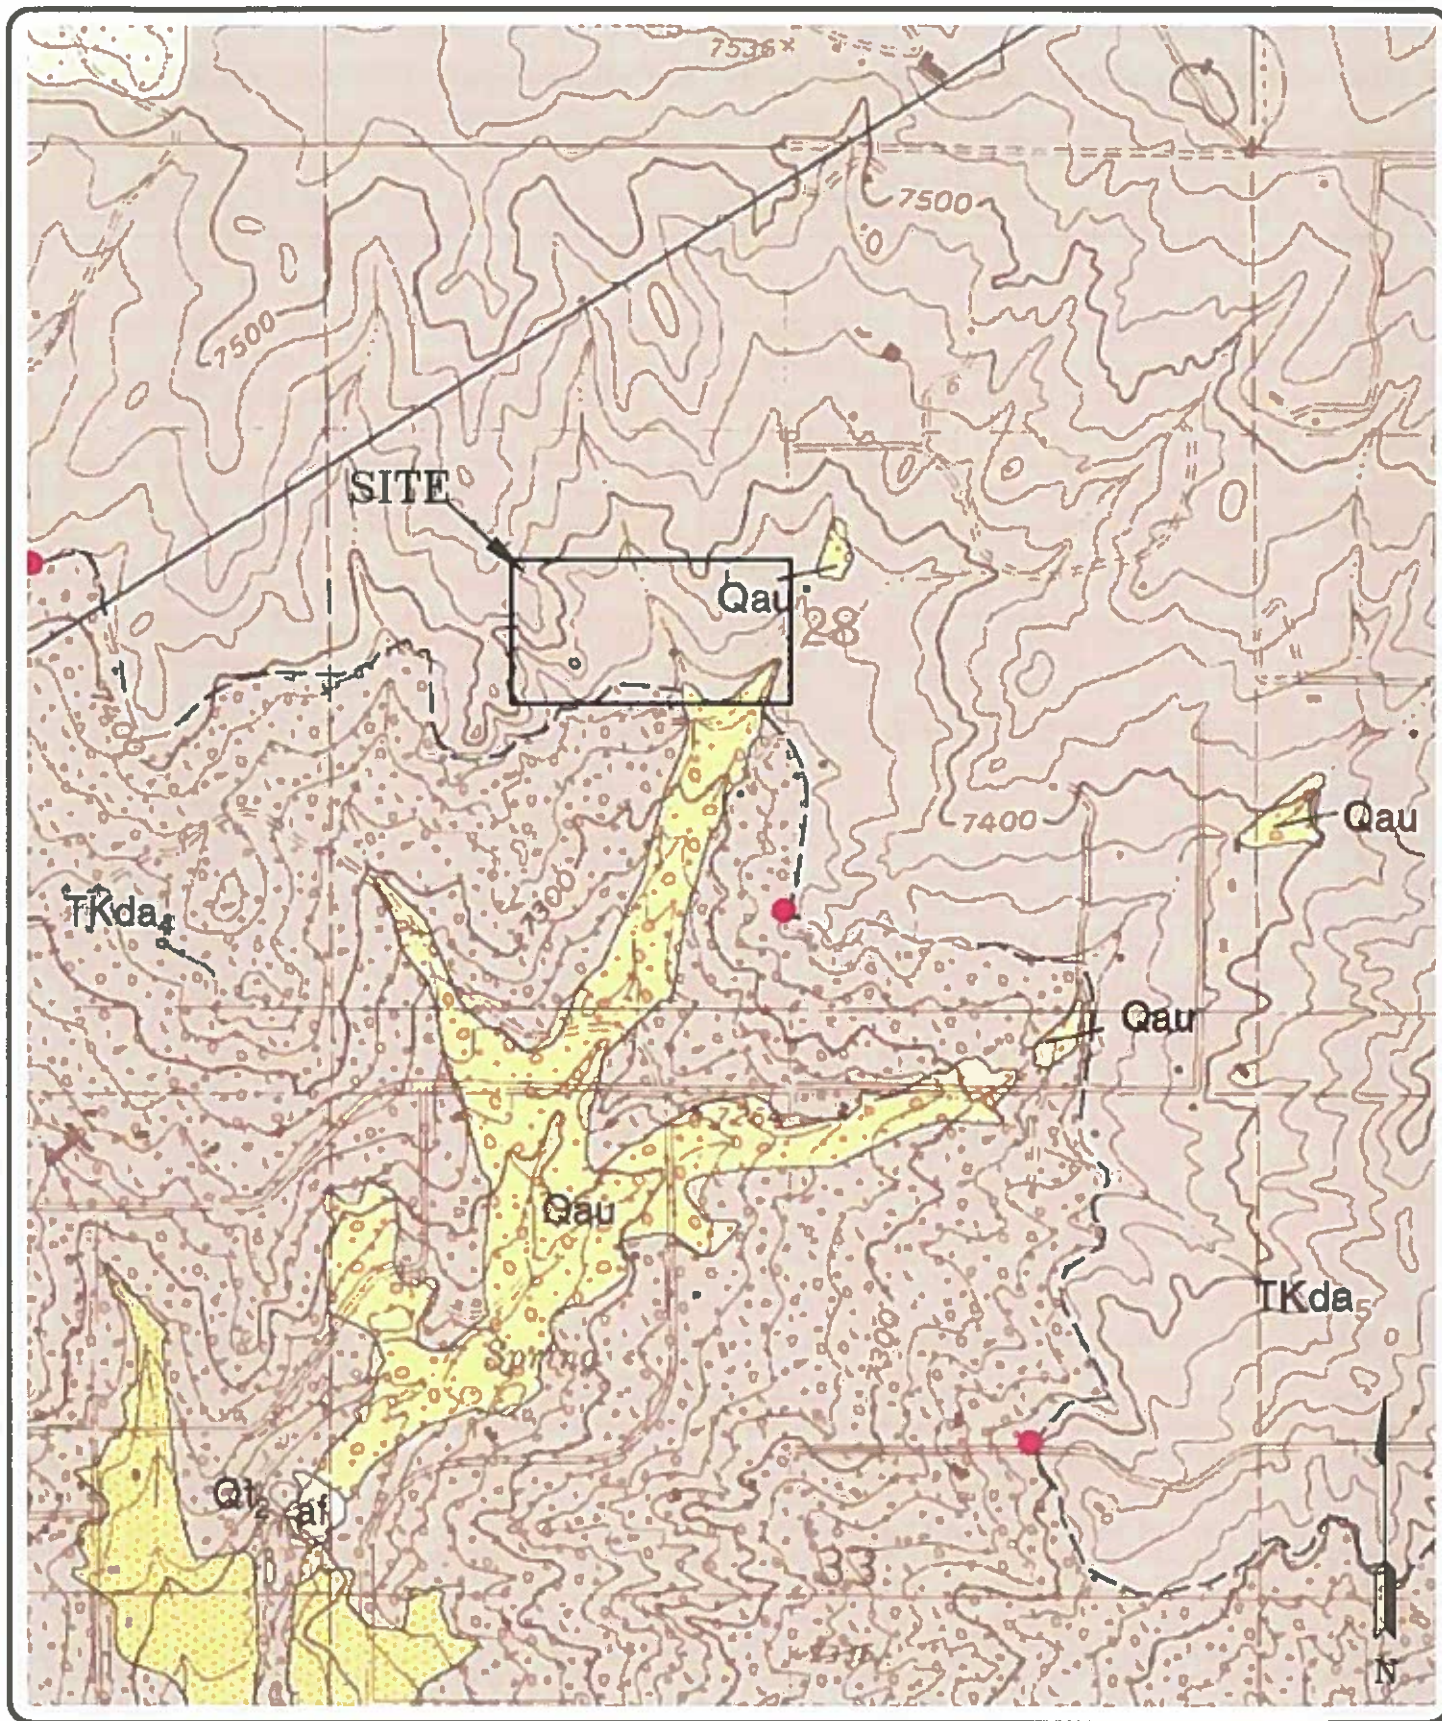
FIG NO:  
5

MONUMENT QUADRANGLE GEOLOGIC MAP  
CROWE SUBDIVISION  
15980 ROLLER COASTER ROAD  
EL PASO COUNTY, CO.  
FOR: MIKE AND RUTH CROWE

The geology of the site was evaluated using the *Geologic Map of the Monument Quadrangle*, by Thorson and Madole in 2003, (Reference 4, Figure 5). The Geology Map for the site is presented in Figure 6. Two mappable units were identified on this site which is described as follows:

The soils listed above were mapped from site-specific mapping, the *Geologic Map of the Monument Quadrangle* distributed by the Colorado Geologic Survey in 2003 (Reference 4, Figure 5), The *Geologic Map of the Colorado Springs-Castle Rock Area*, distributed by the US Geological Survey in 1979 (Reference 5), and the *Geologic Map of the Denver 1° x 2° Quadrangle*, distributed by the US Geological Survey in 1981 (Reference 6). The test borings were used in evaluating the site and are included in Appendix B. The Geology Map prepared for the site is presented in Figure 6.

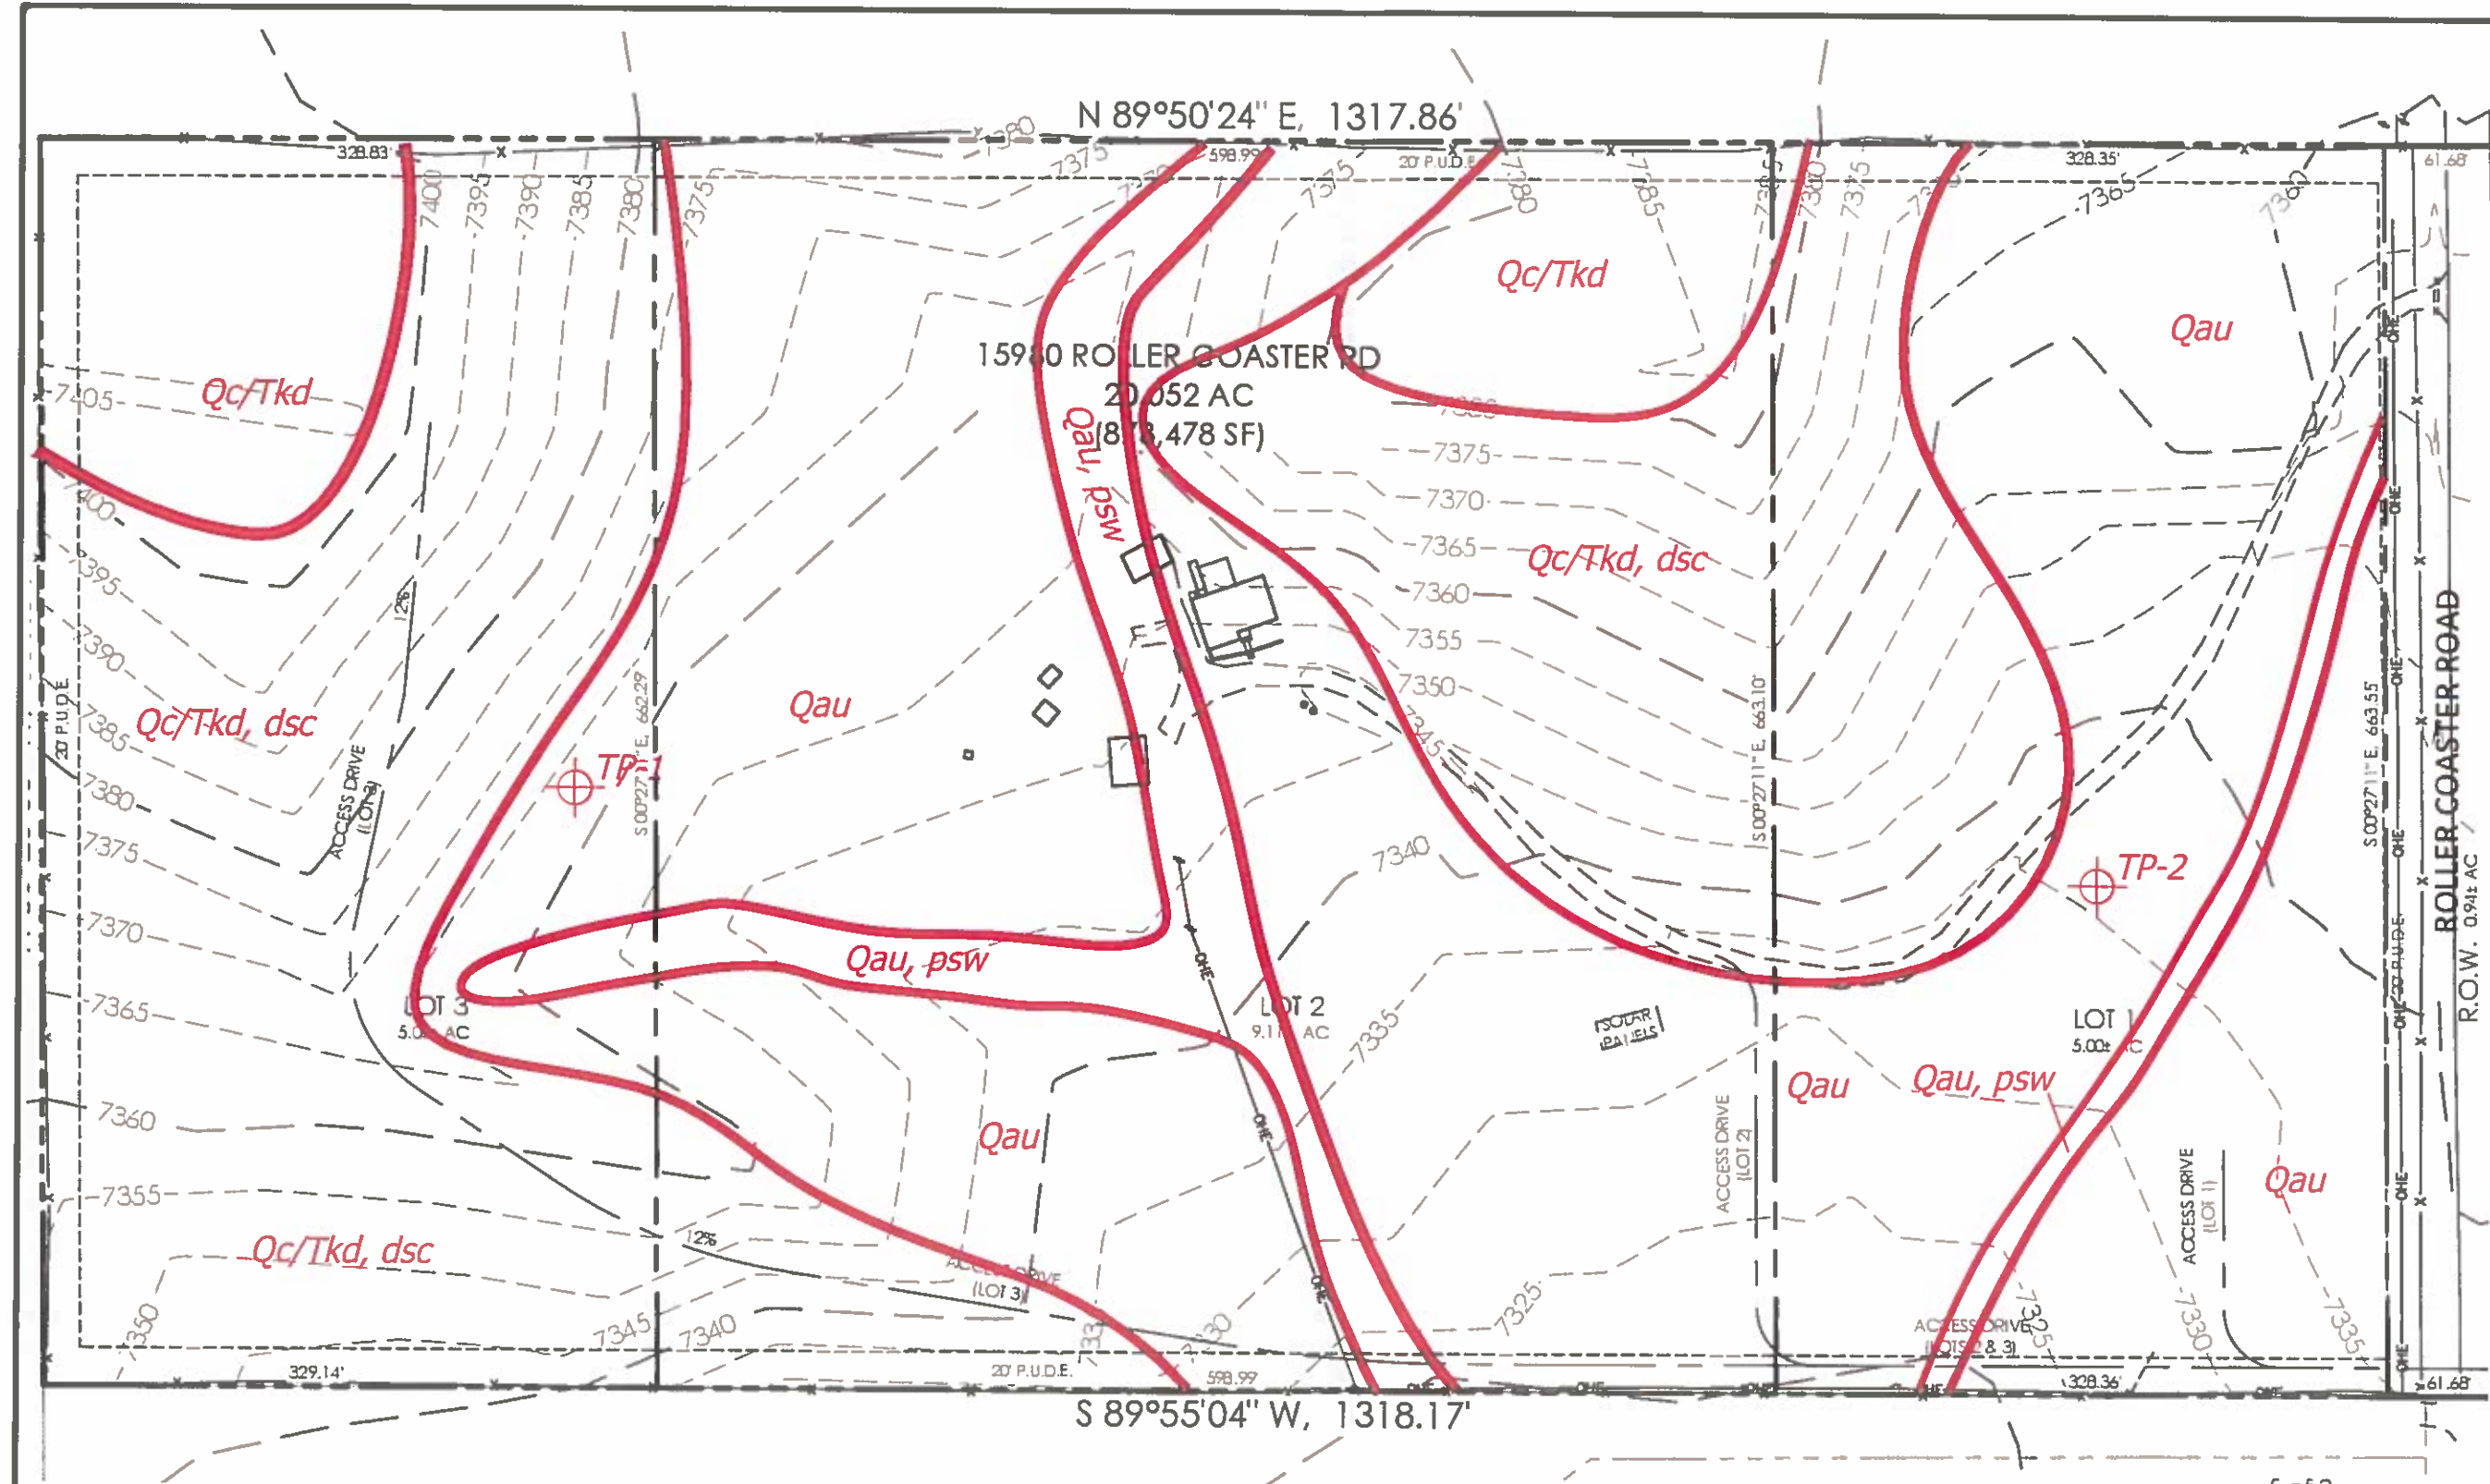
DRAWN	
CHECKED	
DATE	5/22/21
SCALE	AS SHOWN
JOB NO.	210825
FIGURE NO.	6

- QcTKd - Colluvium of Quaternary Age overlying Dawson Formation of Tertiary to Cretaceous Age; colluvial and residual soils overlying arkosic sandstone with interbedded fine-grained sandstone, siltstone and claystone
- dsc - downslope creep
- psw - potentially seasonal shallow groundwater area

GEOLOGY/ENGINEERING GEOLOGY MAP  
CROWE SUBDIVISION  
15980 ROLLER COASTER ROAD  
EL PASO COUNTY, CO.  
FOR: MIKE AND RUTH CROWE

Two minor dry drainages exist in the central and eastern portions of the site. No water was observed flowing in the drainages at the time of the investigation, however, these areas have the potential for seasonal shallow groundwater. These areas are indicated in the Geology/Engineering Geology Map (Figure 6). Due to the size of the proposed lots these areas can either be avoided or redirected around proposed structures or proposed soil treatment areas. The proposed building areas are not affected by these areas. The site does not lie within any floodplain zones according to the FEMA Map Nos. 08041CO285G and 08041CO295G dated December 7, 2018 (Figure 7, Reference 7). The two dry drainages mapped with these hazards have been identified in the National Wetland Inventory as a Freshwater Emergent Wetland habitat classified as Riverine habitat classified as R4SBC (Riverine – R, Intermittent – 4, Streambed – SB, Seasonally Flooded – C) (Figure 8, Reference 8).

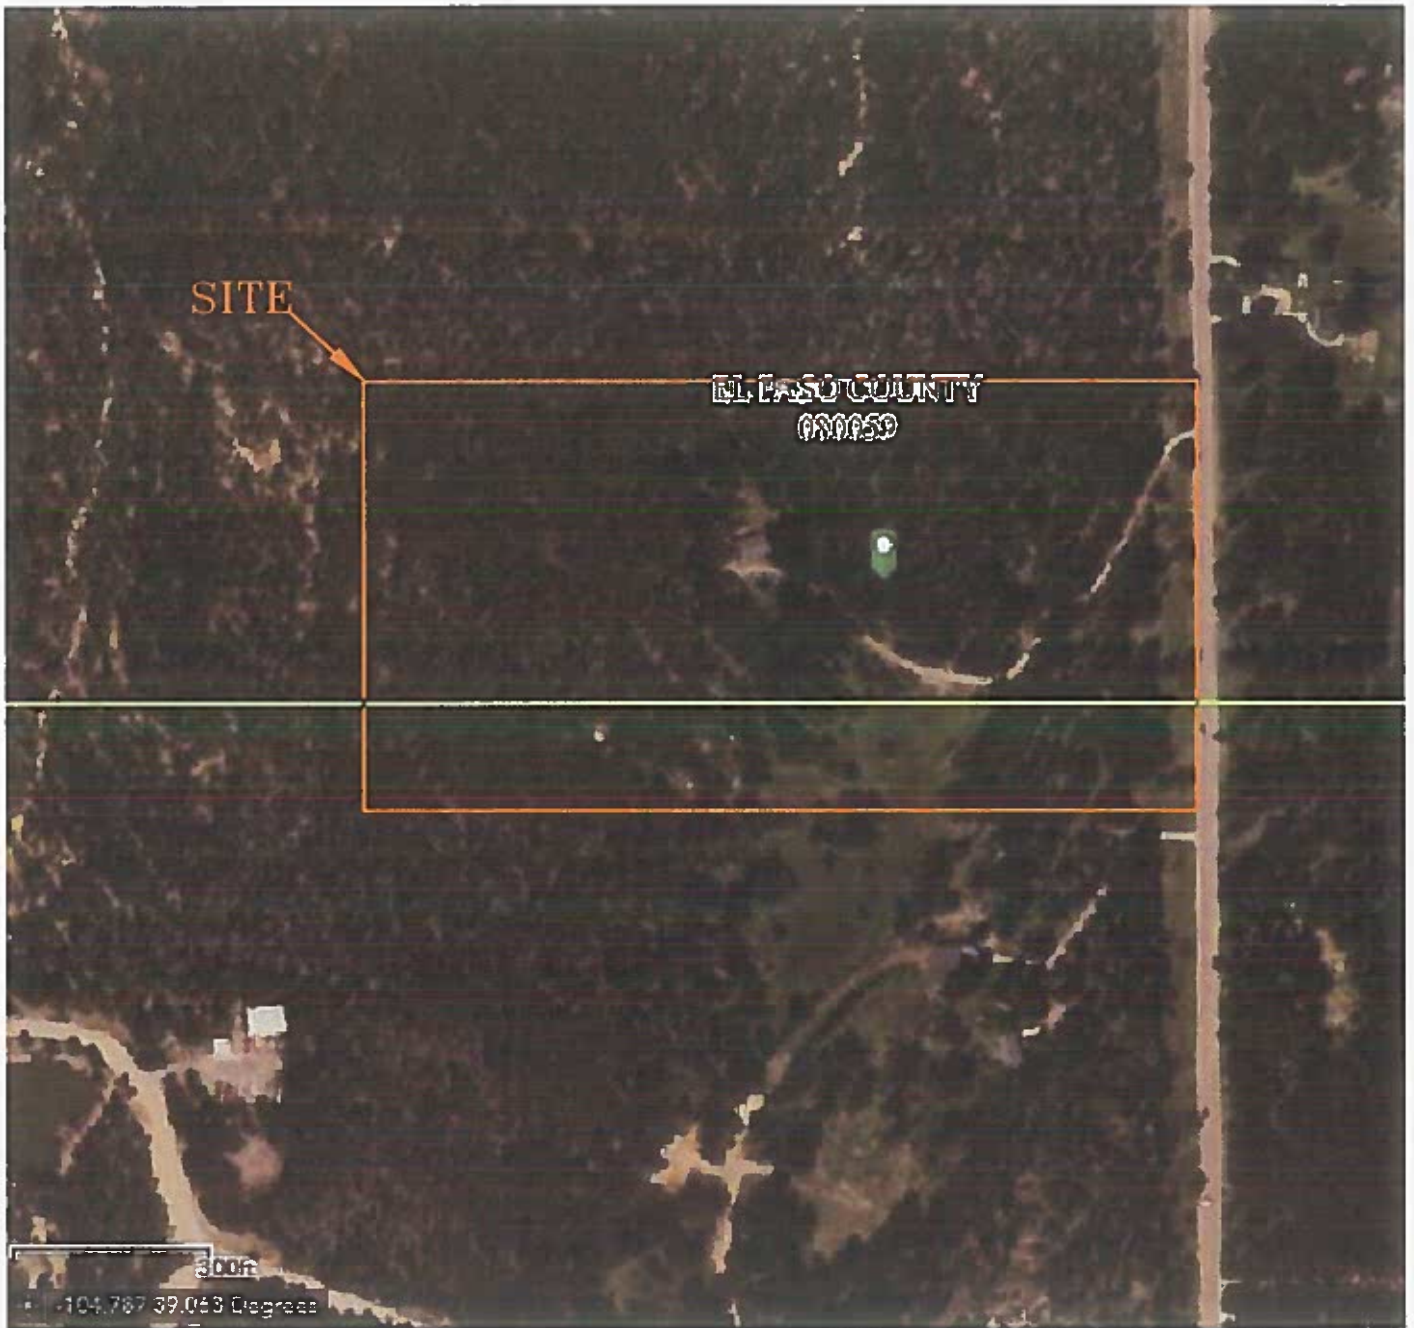
FIG NO.:  
7

FEMA FLOODPLAIN MAP  
CROWE SUBDIVISION  
15980 ROLLER COASTER ROAD  
EL PASO COUNTY, CO.  
FOR: MIKE AND RUTH CROWE

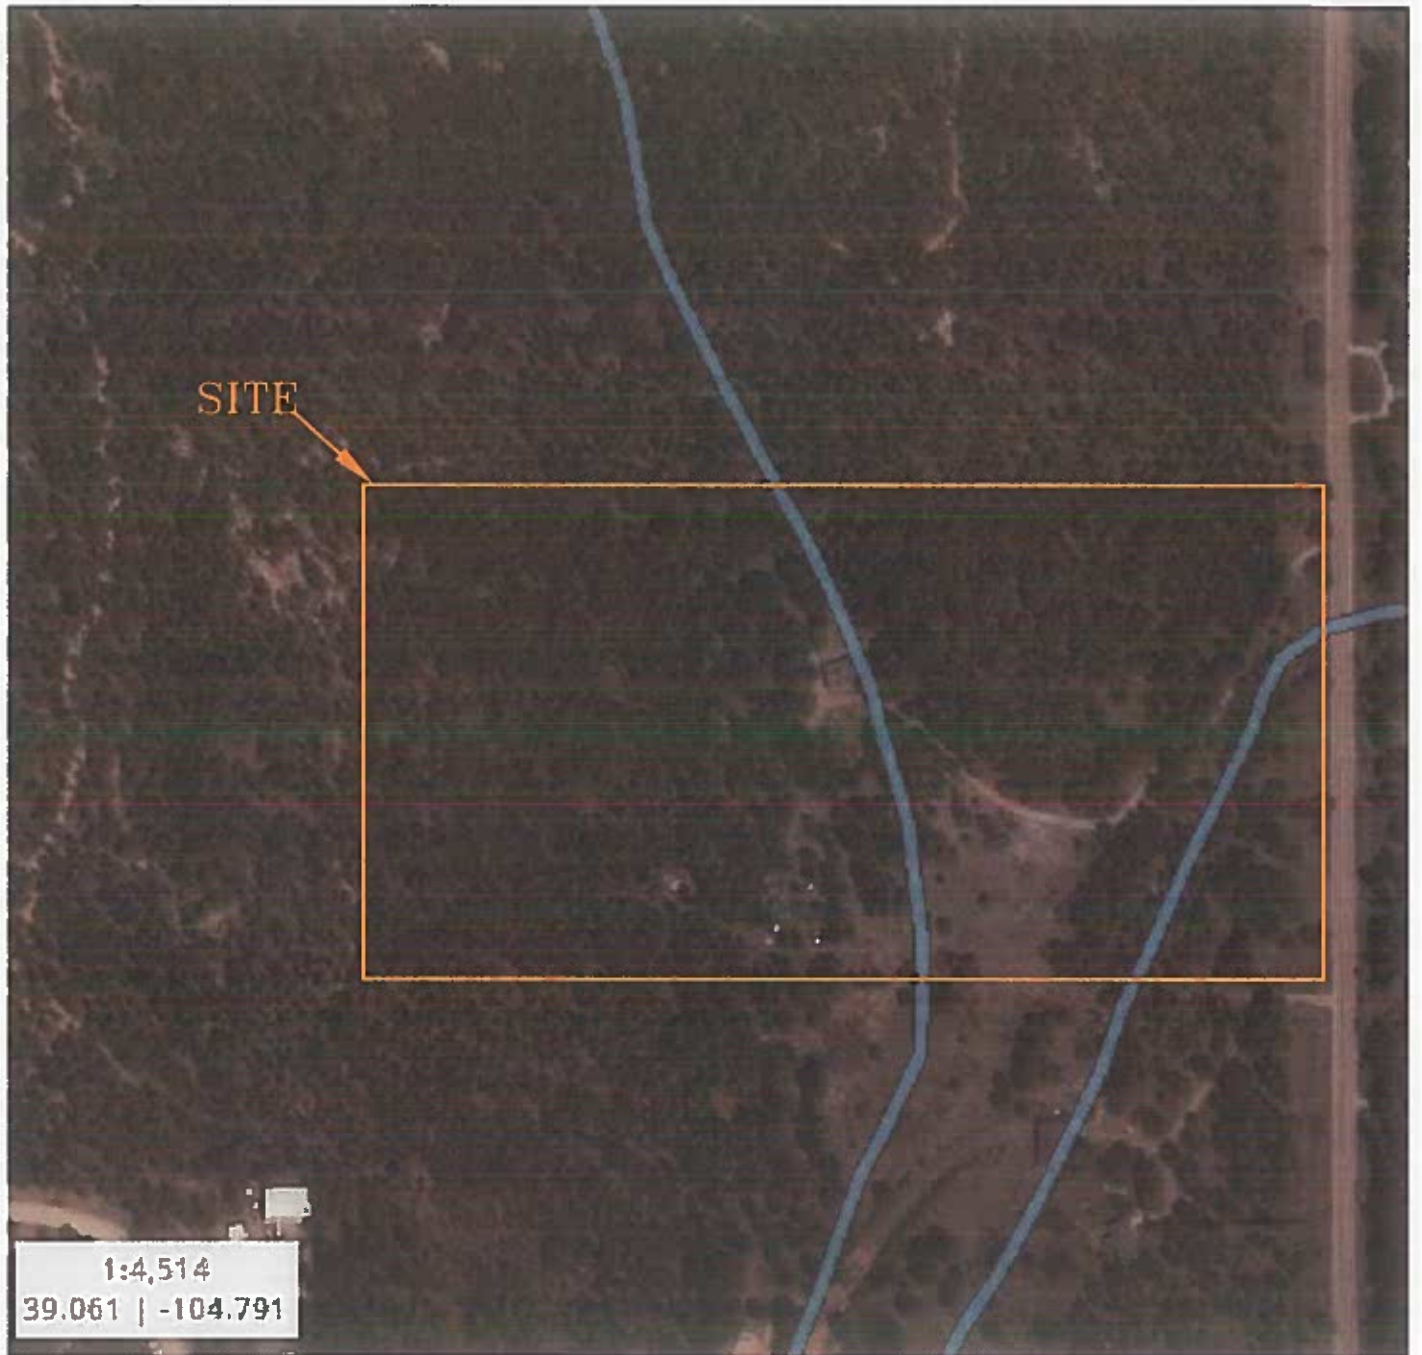
FIG NO.:  
8

NATIONAL WETLANDS INVENTORY MAP  
CROWE SUBDIVISION  
15980 ROLLER COASTER ROAD  
EL PASO COUNTY, CO.  
FOR: MIKE AND RUTH CROWE

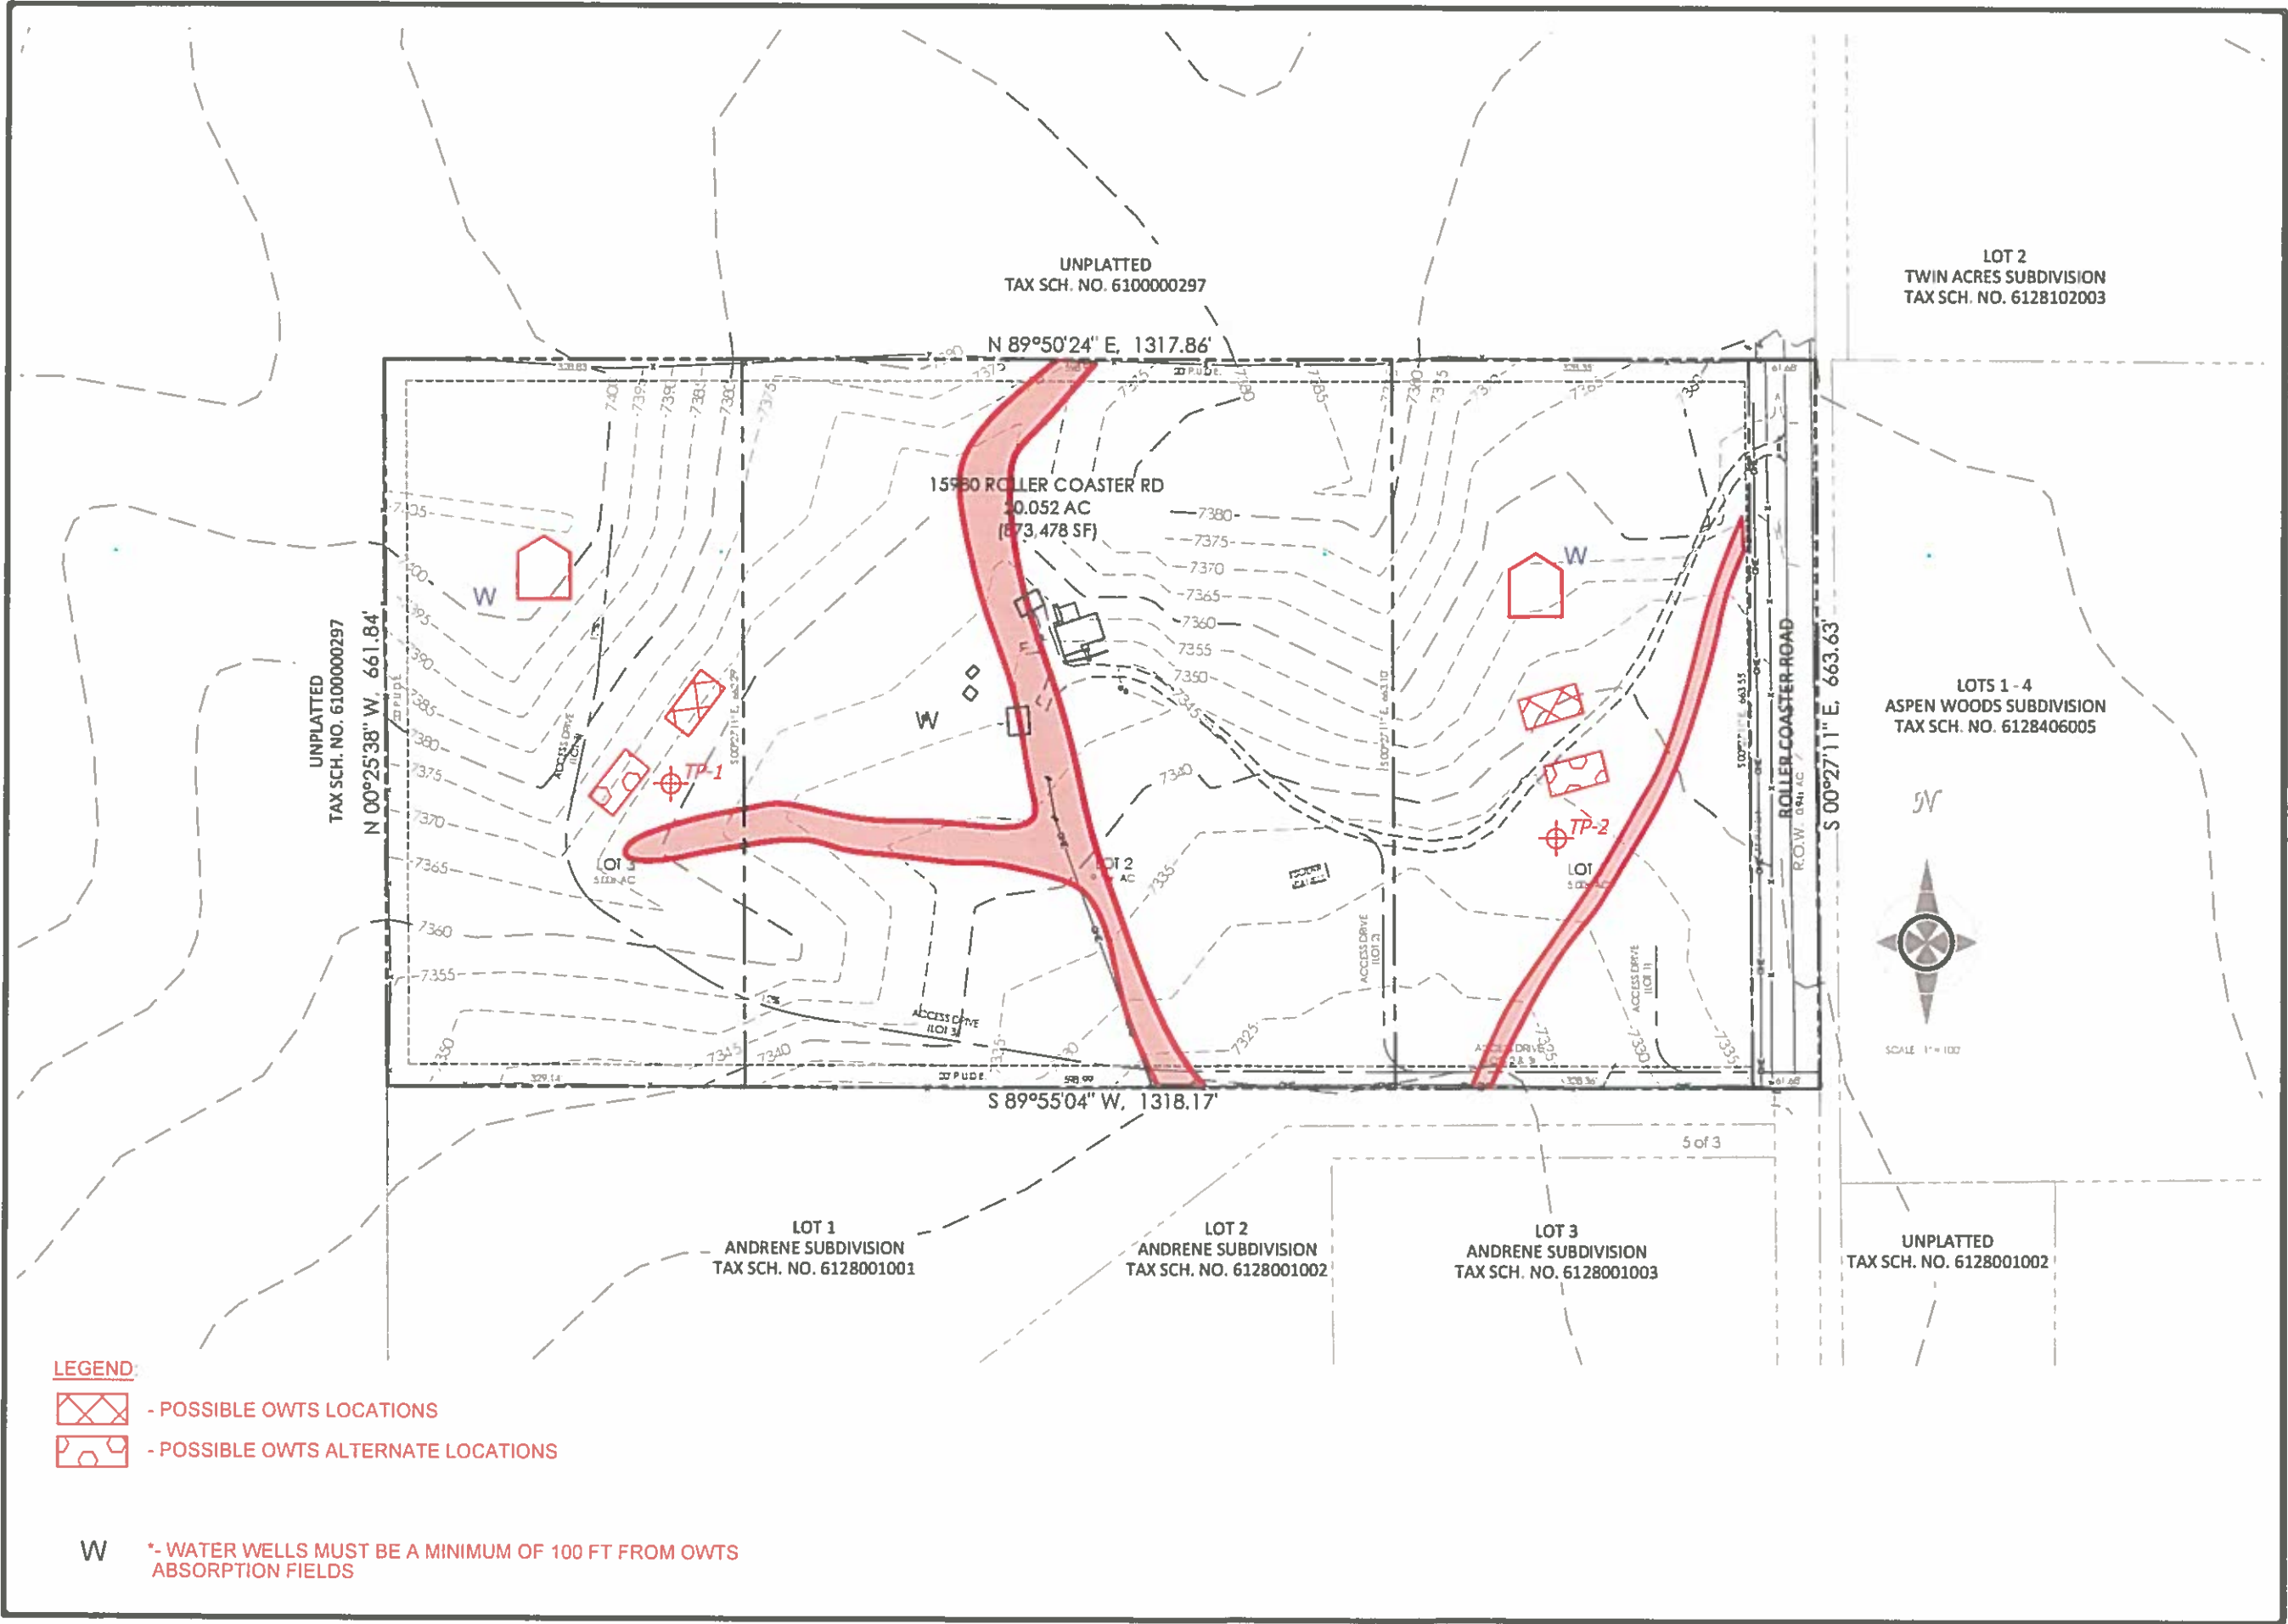
DRAWN L.L.L.
CHECKED
DATE 5/22/21
SCALE AS SHOWN
JOB NO. 210825
FIGURE NO. 9

- LEGEND:**
- POSSIBLE OWTS LOCATIONS
  - POSSIBLE OWTS ALTERNATE LOCATIONS

W \*- WATER WELLS MUST BE A MINIMUM OF 100 FT FROM OWTS ABSORPTION FIELDS
