Re: Wastewater Study  
Crowe Subdivision  
Parcel No. 61280-00-001  
15980 Roller Coaster Road  
El Paso County, Colorado

Mike and Ruth Crowe  
OWTS – Wastewater Study  
Crowe Subdivision  
Parcel No. 61280-00-001  
15980 Roller Coaster Road  
El Paso County, Colorado

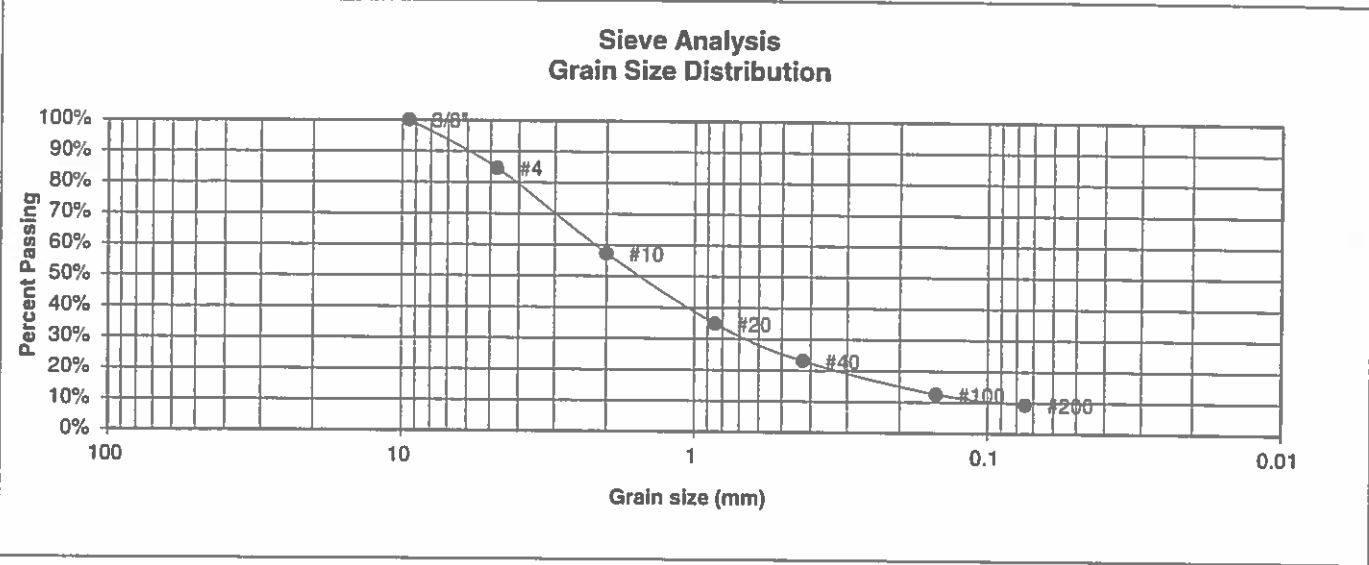
FIG NO.:  
C-1

BORING NO.	TP-1	UNIFIED CLASSIFICATION	SM-SW	TEST BY	BL
DEPTH(ft)	1	AASHTO CLASSIFICATION		JOB NO.	210825
CLIENT	MIKE AND RUTH CROWE				
PROJECT	15980 ROLLER COASTER RD

U.S. Sieve #	Percent Finer
3"	
1 1/2"	
3/4"	
1/2"	
3/8"	100.0%
4	84.6%
10	57.3%
20	34.9%
40	23.1%
100	12.6%
200	9.4%

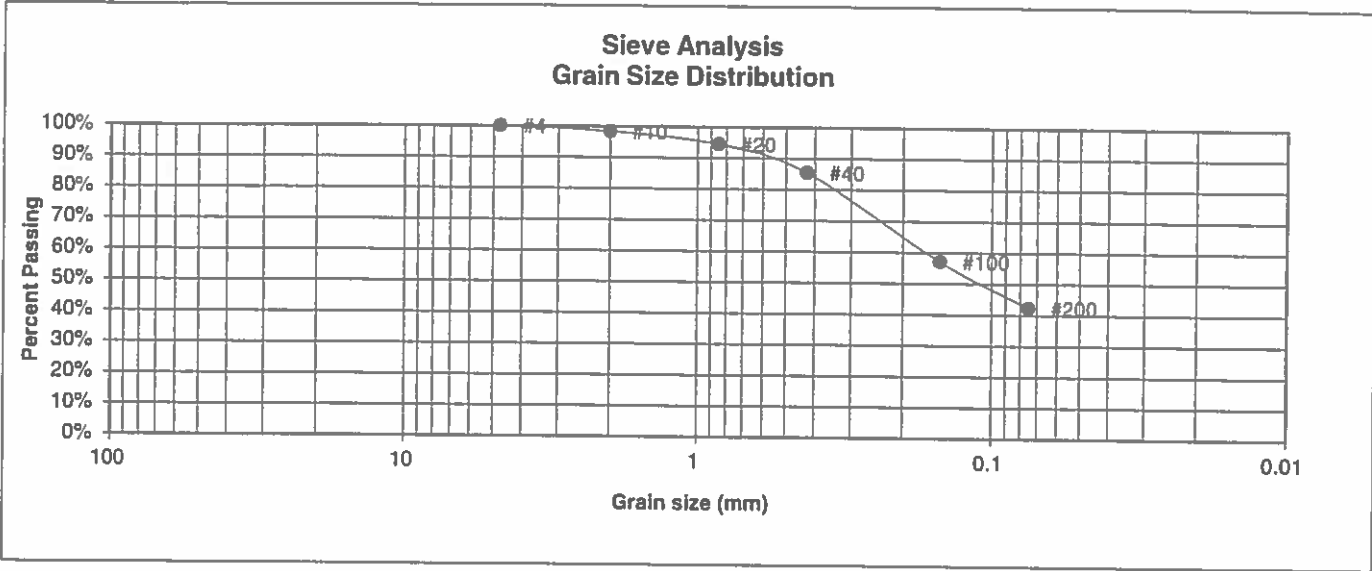
FIG NO.:  
L-2

BORING NO.	TP-1	UNIFIED CLASSIFICATION	SC	TEST BY	BL
DEPTH(ft)	5	AASHTO CLASSIFICATION		JOB NO.	210825
CLIENT	MIKE AND RUTH CROWE				
PROJECT	15980 ROLLER COASTER RD

U.S. Sieve #	Percent Finer	Atterberg Limits
3"		Plastic Limit
1 1/2"		Liquid Limit
3/4"		Plastic Index
1/2"		
3/8"		
4	100.0%	
10	98.4%	
20	94.5%	
40	85.4%	
100	57.1%	
200	42.3%

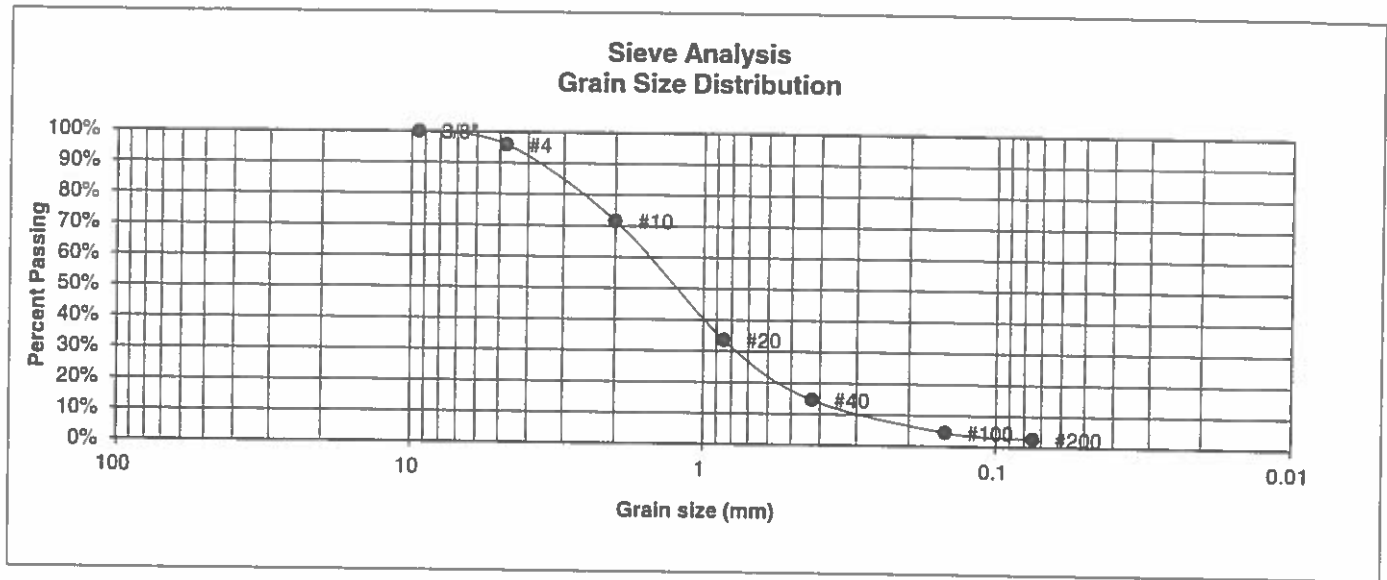
BORING NO.	TP-2	UNIFIED CLASSIFICATION	SW	TEST BY	BL
DEPTH(ft)	2-3	AASHTO CLASSIFICATION		JOB NO.	210825
CLIENT	MIKE AND RUTH CROWE				
PROJECT	15980 ROLLER COASTER RD

U.S. Sieve #	Percent Finer
3"	
1 1/2"	
3/4"	
1/2"	
3/8"	100.0%
4	95.9%
10	71.6%
20	33.6%
40	14.6%
100	4.5%
200	2.7%
