ENTECH ENGINEERING, INC.

SOIL, GEOLOGY, GEOLOGIC HAZARD, AND WASTEWATER STUDY JENNINGS SUBDIVISION JUDGE ORR ROAD AND CURTIS ROAD EL PASO COUNTY, COLORADO

April 24, 2017

Entech Job No. 170314

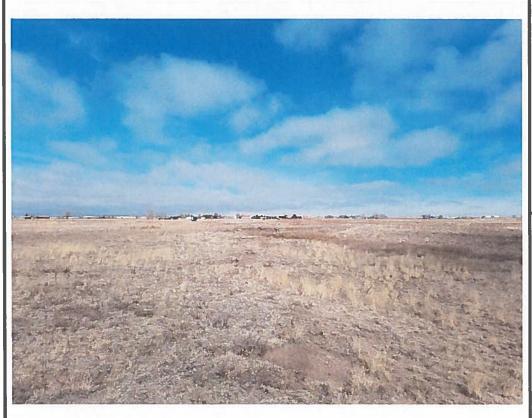
Looking north from the eastern portion of the site along the floodplain.
