WASTEWATER EVALUATION REPORT
FOR
HAY CREEK VALLEY DEVELOPMENT
AT
2855 HAY CREEK ROAD
EL PASO COUNTY, COLORADO

Project No. 22.886.076

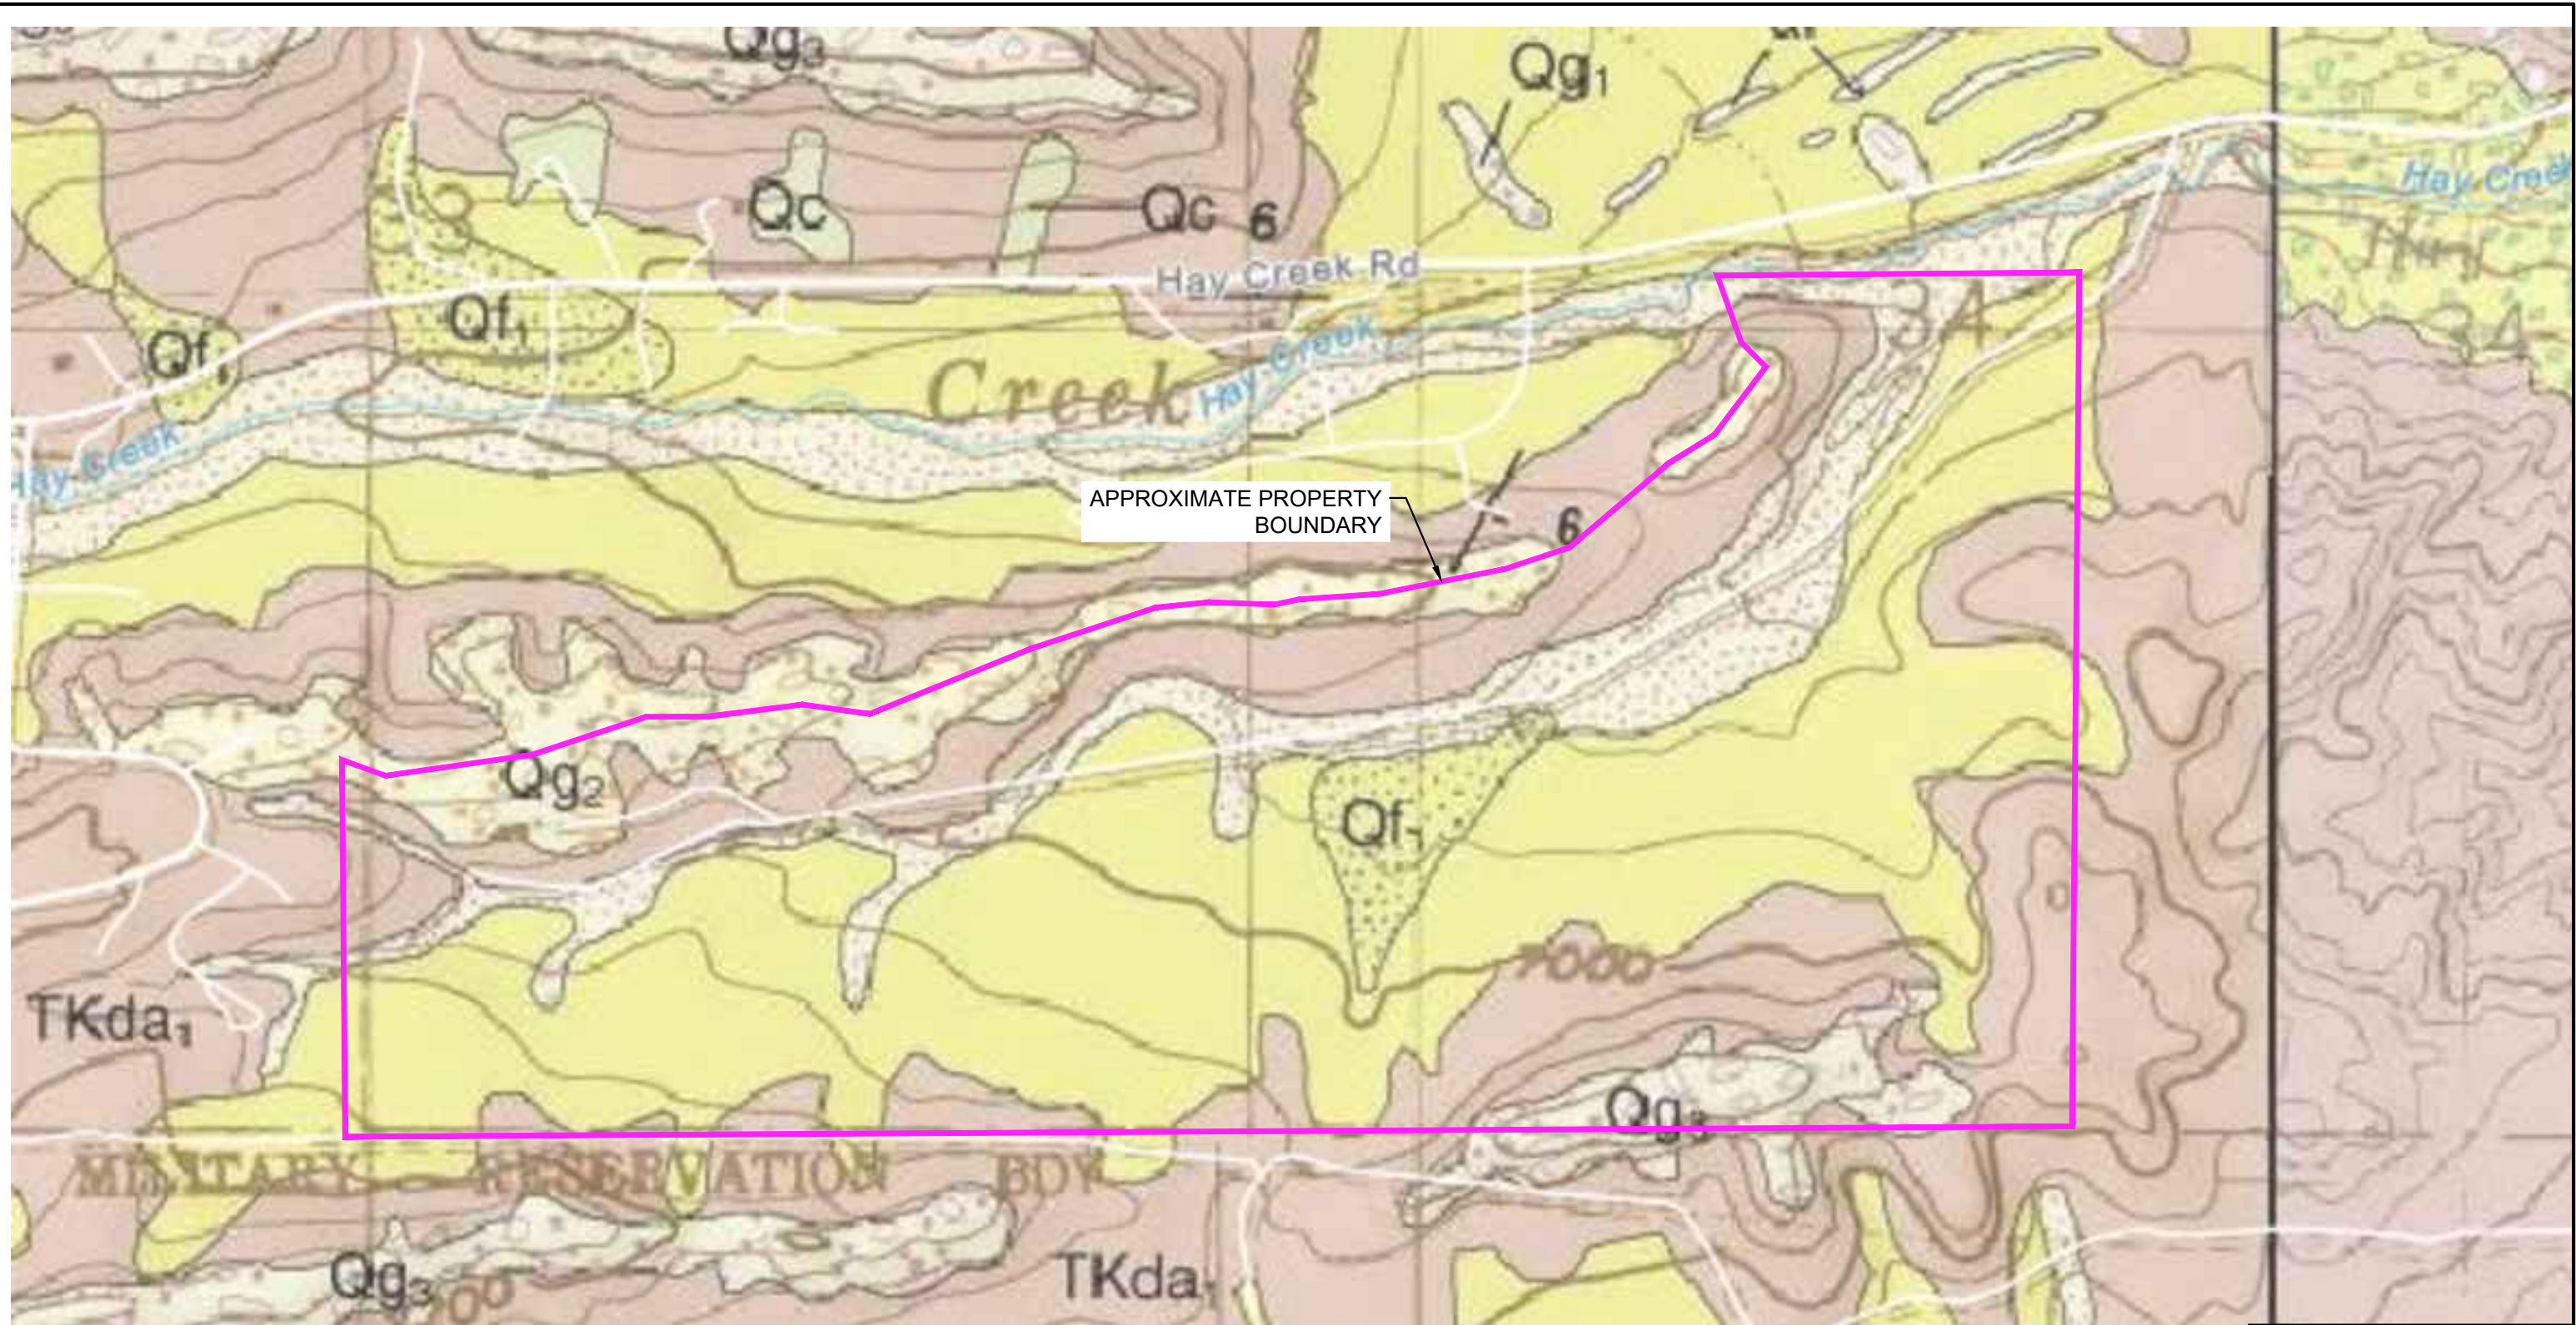
REGIONAL GEOLOGY MAP

Qf ₁	Alluvial fan deposit one (late Holocene)
	Qg ₁	Gravel deposit one (middle Pleistocene)
	Qg ₂	Gravel deposit two (early middle Pleistocene)
	Qg ₃	Gravel deposit three (early Pleistocene)
	Qc	Colluvium deposits, undivided (Holocene to late Pleistocene)
	TKda	Dawson Formation, undivided (Upper Cretaceous to middle? Eocene)—Shown only on cross sections
	TKda ₁	Dawson Formation, facies unit one (Upper Cretaceous to Paleocene)

- USDA NRCS Custom Soil Resource Report for El Paso County Area, Colorado.
- CGS Geologic Map of the Palmer Lake Quadrangle, El Paso County, Colorado by John W. Keller, Matthew L. Morgan, Jon P. Thorson, Neil R. Lindsay, and Peter E. Barkman, 2007
- Review of Available Geologic Hazard Studies in the surrounding area

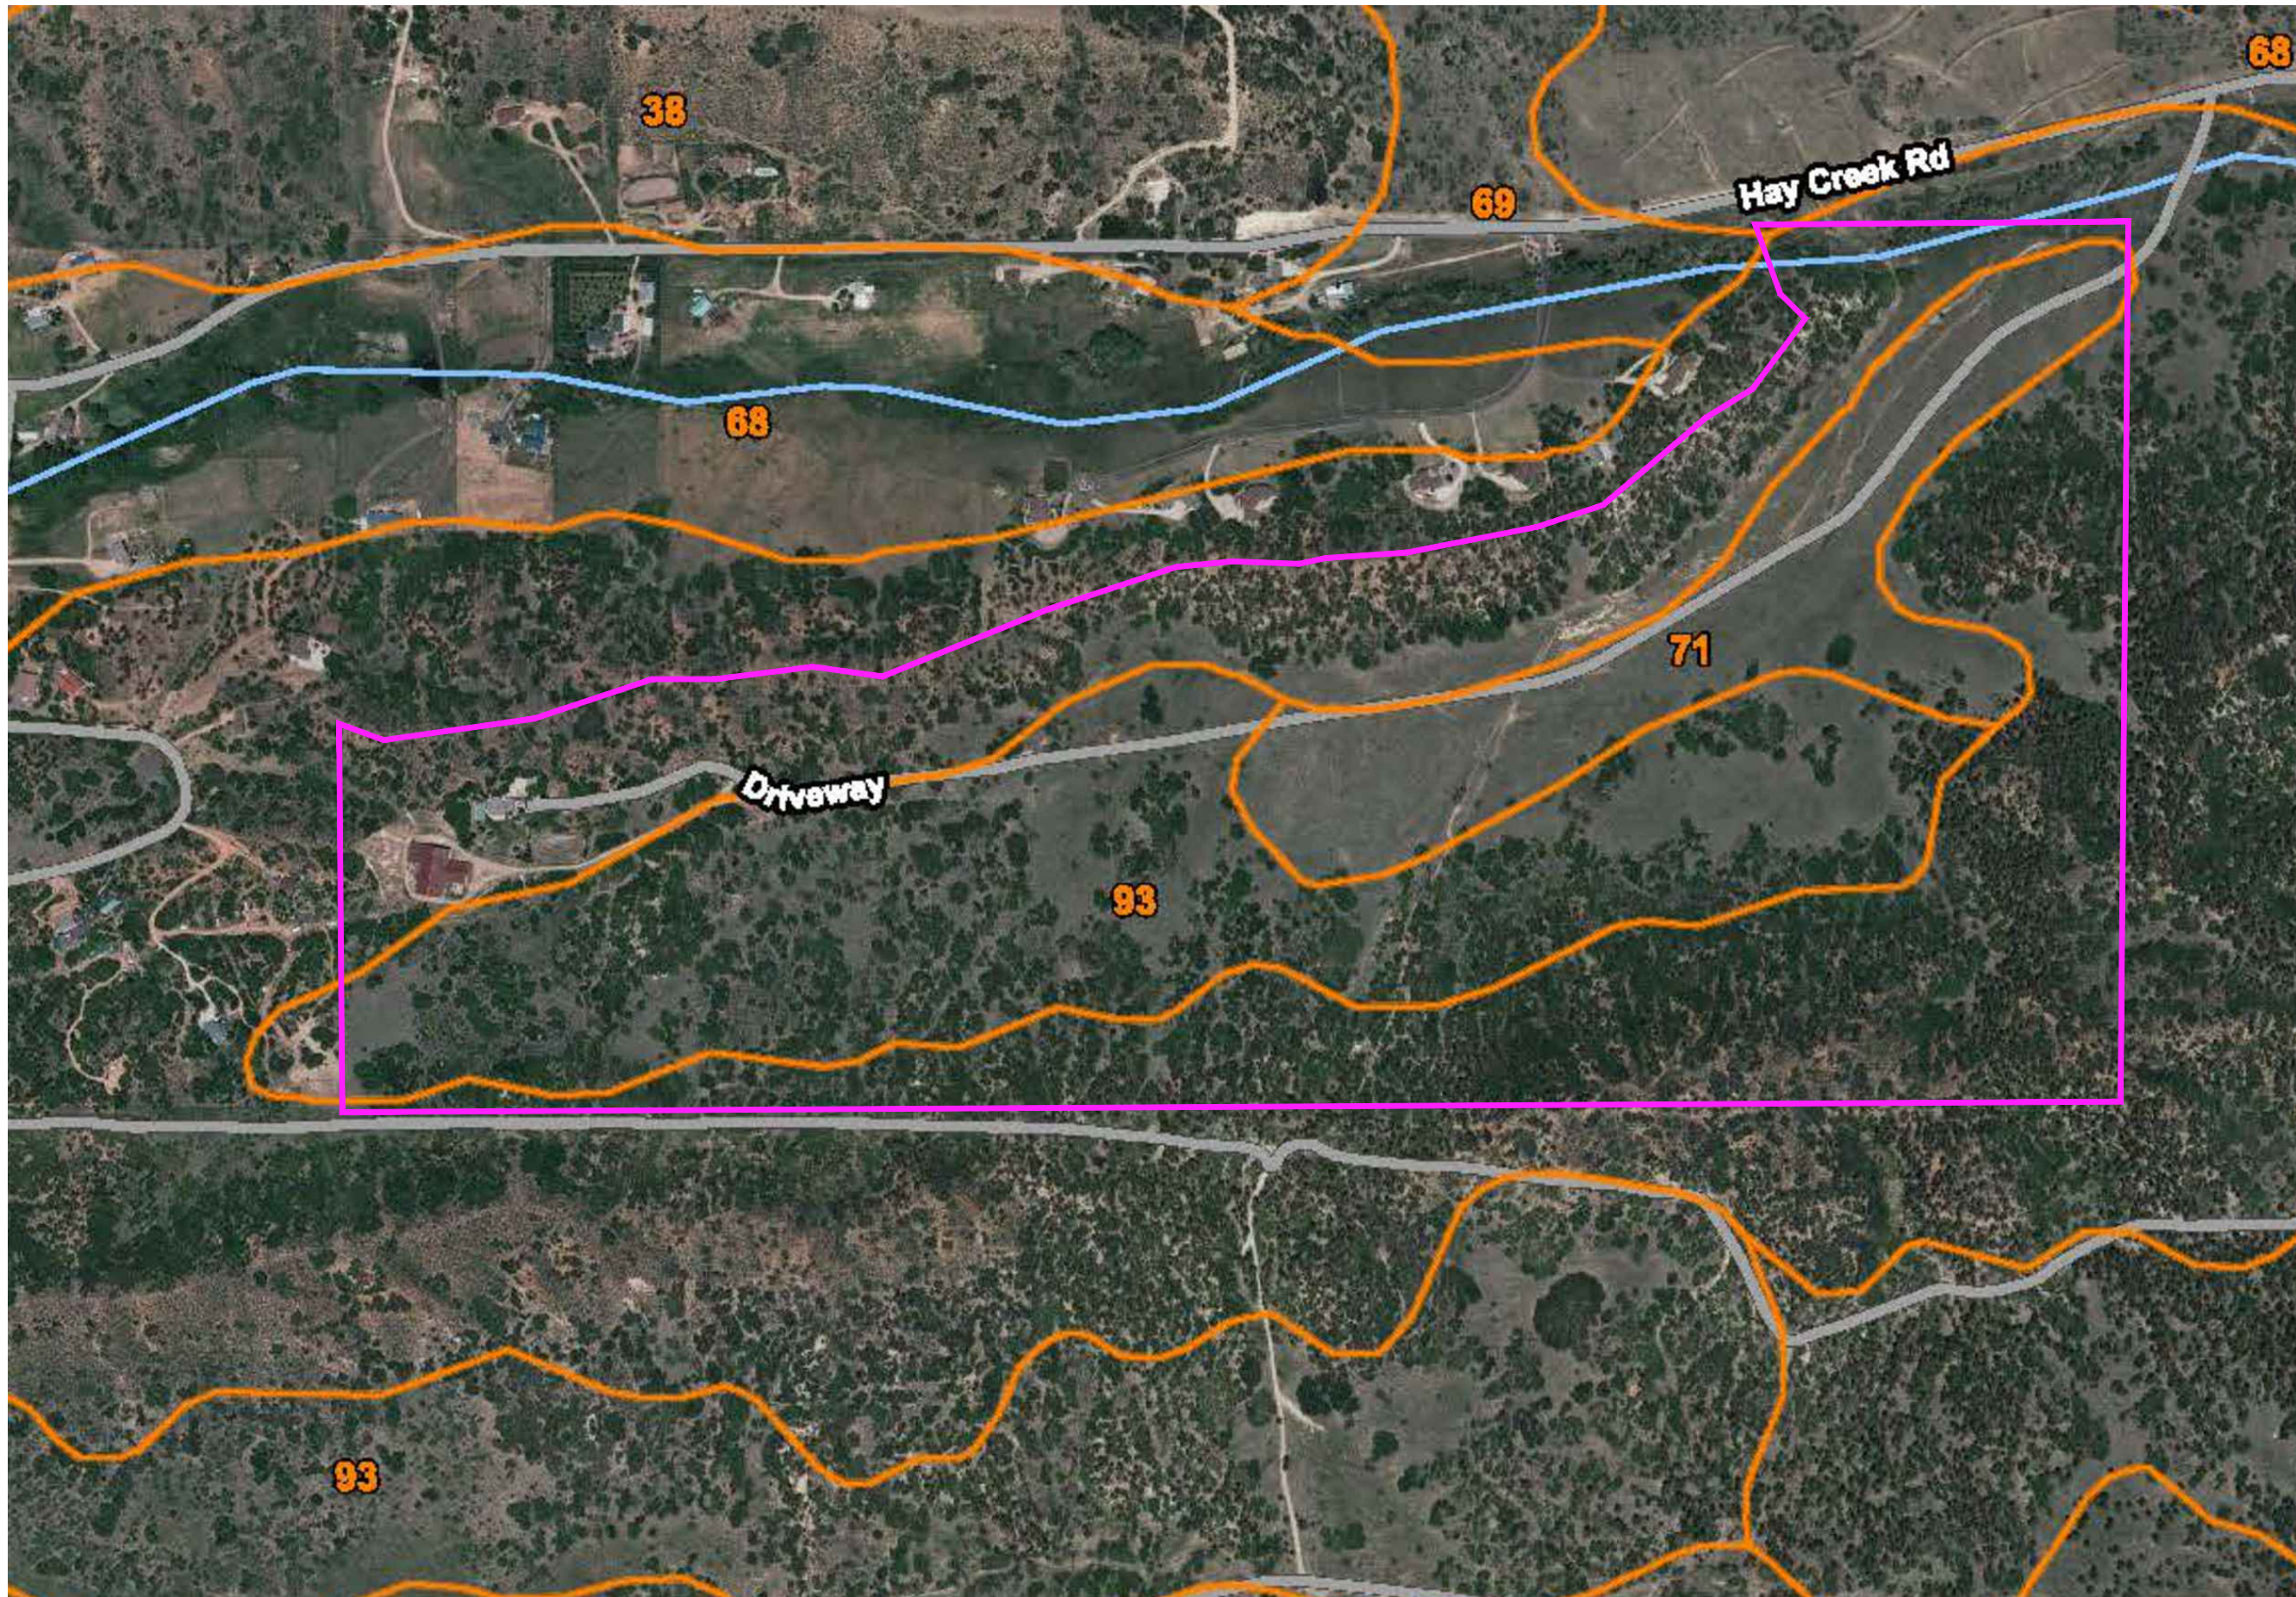
NRCS SOIL SURVEY MAP

Not to scale. Base image from <https://websoilsurvey.sc.egov.usda.gov/App/WebSoilSurvey.aspx>.

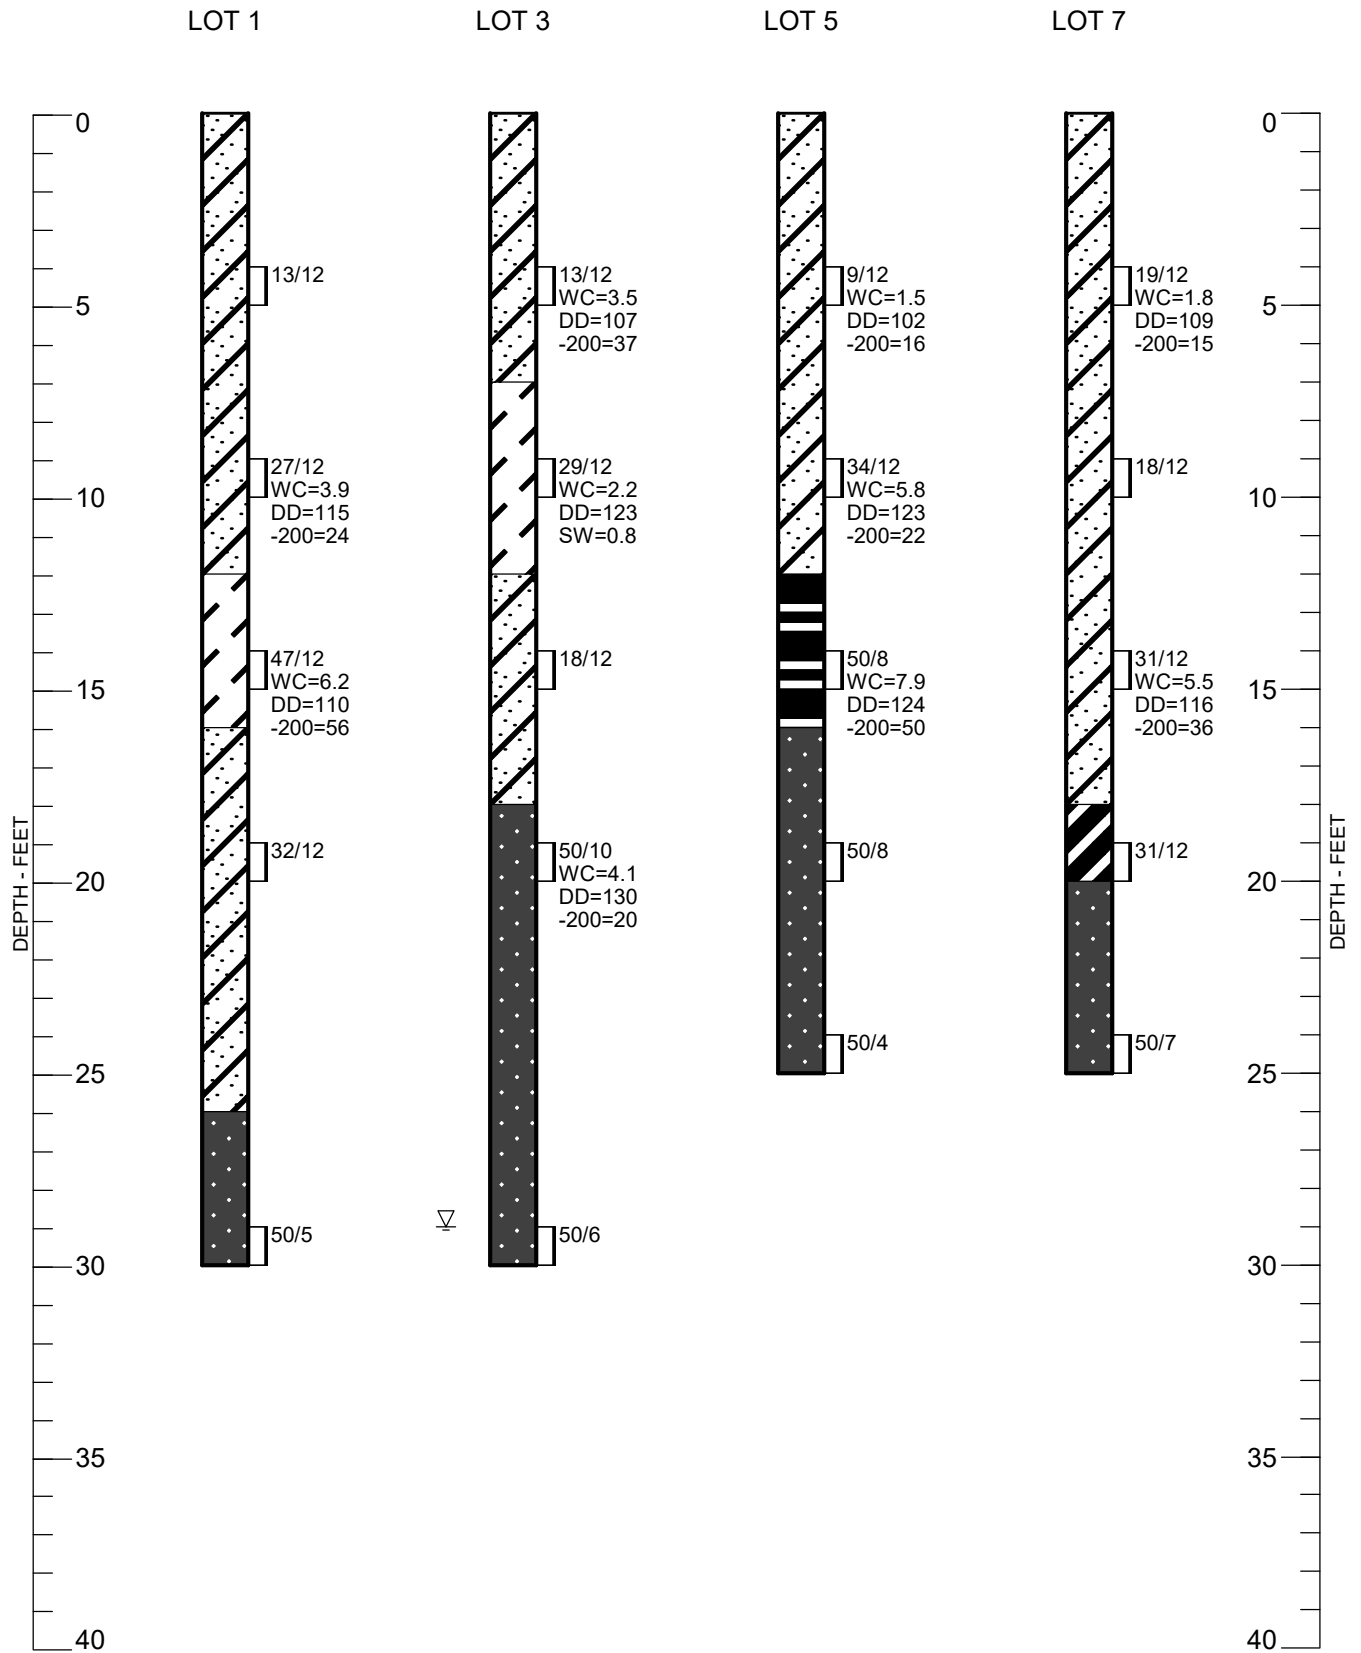
Logs of Explorations

- SAND, SLIGHTLY SILTY TO VERY SILTY, LOOSE TO VERY DENSE, SLIGHTLY MOIST TO MOIST, LIGHT BROWN TO BROWN, OCCASIONAL LENSES OF SANDY CLAY (SP-SM, SM).
- CLAY, SANDY TO VERY SANDY, VERY STIFF, SLIGHTLY MOIST TO MOIST, BROWN (CL).
- WEATHERED BEDROCK, CLAYSTONE AND SANDSTONE, SANDY (CLAYSTONE) OR SILTY TO CLAYEY (SANDSTONE), MEDIUM HARD, MOIST, LIGHT BROWN TO RED BROWN.
- BEDROCK. CLAYSTONE, SANDY TO VERY SANDY, MEDIUM HARD TO VERY HARD, MOIST, LIGHT BROWN TO BROWN, RED BROWN, GRAY BROWN.
- BEDROCK. SANDSTONE, SLIGHTLY SILTY TO SILTY, CLAYEY TO VERY CLAYEY, HARD TO VERY HARD, SLIGHTLY MOIST TO MOIST, LIGHT BROWN TO BROWN, RED BROWN, GRAY TO GRAY BROWN.
- DRIVE SAMPLE. THE SYMBOL 13/12 INDICATES 13 BLOWS OF A 140-POUND HAMMER FALLING 30 INCHES WERE REQUIRED TO DRIVE A 2.5-INCH O.D. SAMPLER 12 INCHES.
- GROUNDWATER LEVEL MEASURED AT TIME OF DRILLING.

1. THE BORINGS WERE DRILLED OCTOBER 3, 7, AND 14, 2022 USING A 4-INCH DIAMETER, CONTINUOUS-FLIGHT AUGER AND A DIEDRICH D-90, TRUCK-MOUNTED DRILL RIG.
2. THESE LOGS ARE SUBJECT TO THE EXPLANATIONS, LIMITATIONS, AND CONCLUSIONS AS CONTAINED IN THIS REPORT.
3. WC - INDICATES MOISTURE CONTENT. (%)
 DD - INDICATES DRY DENSITY. (PCF)
 SW - INDICATES SWELL WHEN WETTED UNDER APPROXIMATE OVERBURDEN PRESSURE. (%)
 -200 - INDICATES PASSING NO. 200 SIEVE. (%)
 SS - INDICATES WATER-SOLUBLE SULFATE CONTENT. (%)

Appendix A of this report includes logs of the borings describing the subsurface conditions. The lines defining boundaries between soil and rock types on the logs are based upon drill

The locations evaluated as part of this study found soils that are generally described as well drained and with percolation rates that are favorable for conventional septic system construction. The boring logs found two areas that have weathered bedrock less than five feet deep. These areas of shallow bedrock have lower percolation rates that may require engineered systems.

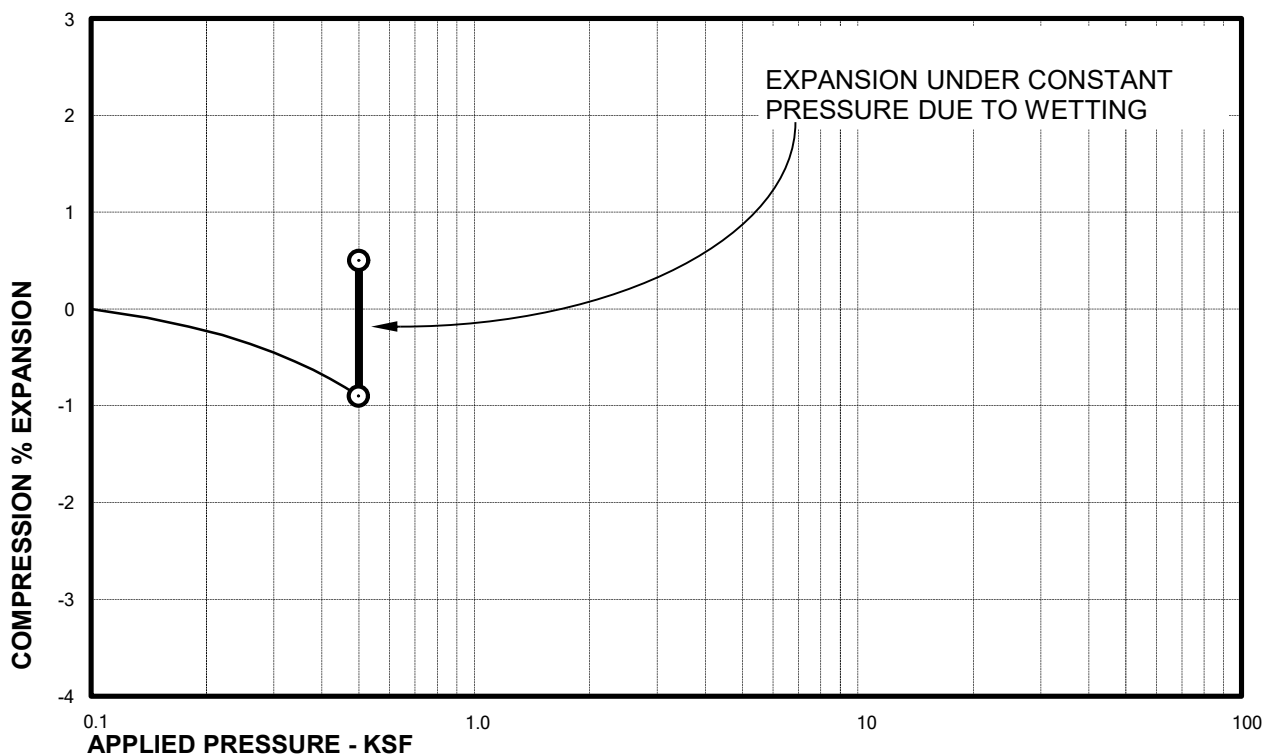
Sample of WEATHERED CLAYSTONE
From LOT 13 AT 9 FEET

DRY UNIT WEIGHT= 118 PCF
MOISTURE CONTENT= 7.6 %
