**GEOLOGIC HAZARDS EVALUATION AND
PRELIMINARY GEOTECHNICAL INVESTIGATION
HAY CREEK DEVELOPMENT
2855 HAY CREEK ROAD
EL PASO COUNTY, COLORADO**

CTL|T Project No. CS19573-115

December 27, 2022

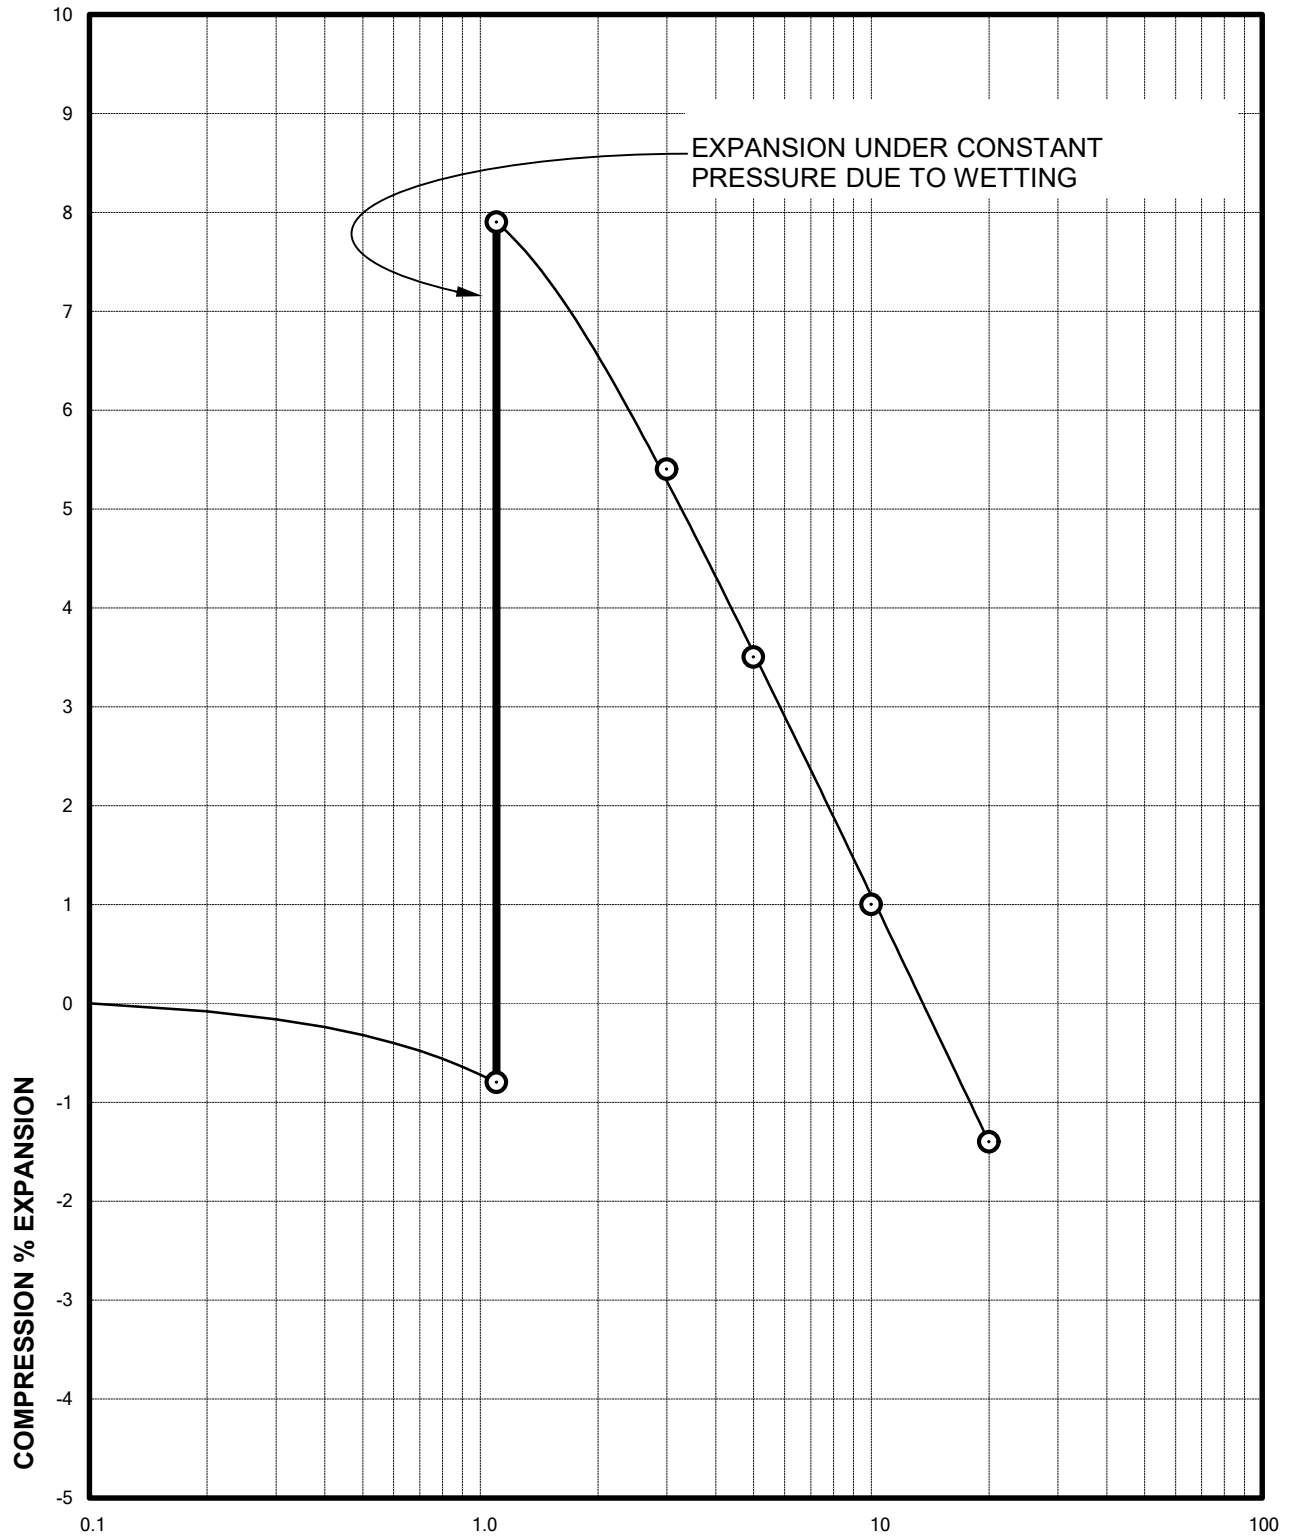
Swell Consolidation Test Results

APPLIED PRESSURE - KSF
Sample of CLAYSTONE, SANDY
From LOT 9 AT 9 FEET

DRY UNIT WEIGHT= 121 PCF
MOISTURE CONTENT= 8.0 %
