SOIL, GEOLOGY AND WASTEWATER STUDY

**10675 Hardy Road
EPC Schedule No. 511400007
El Paso County, Colorado**

JOB NO. 180667

January 8, 2021

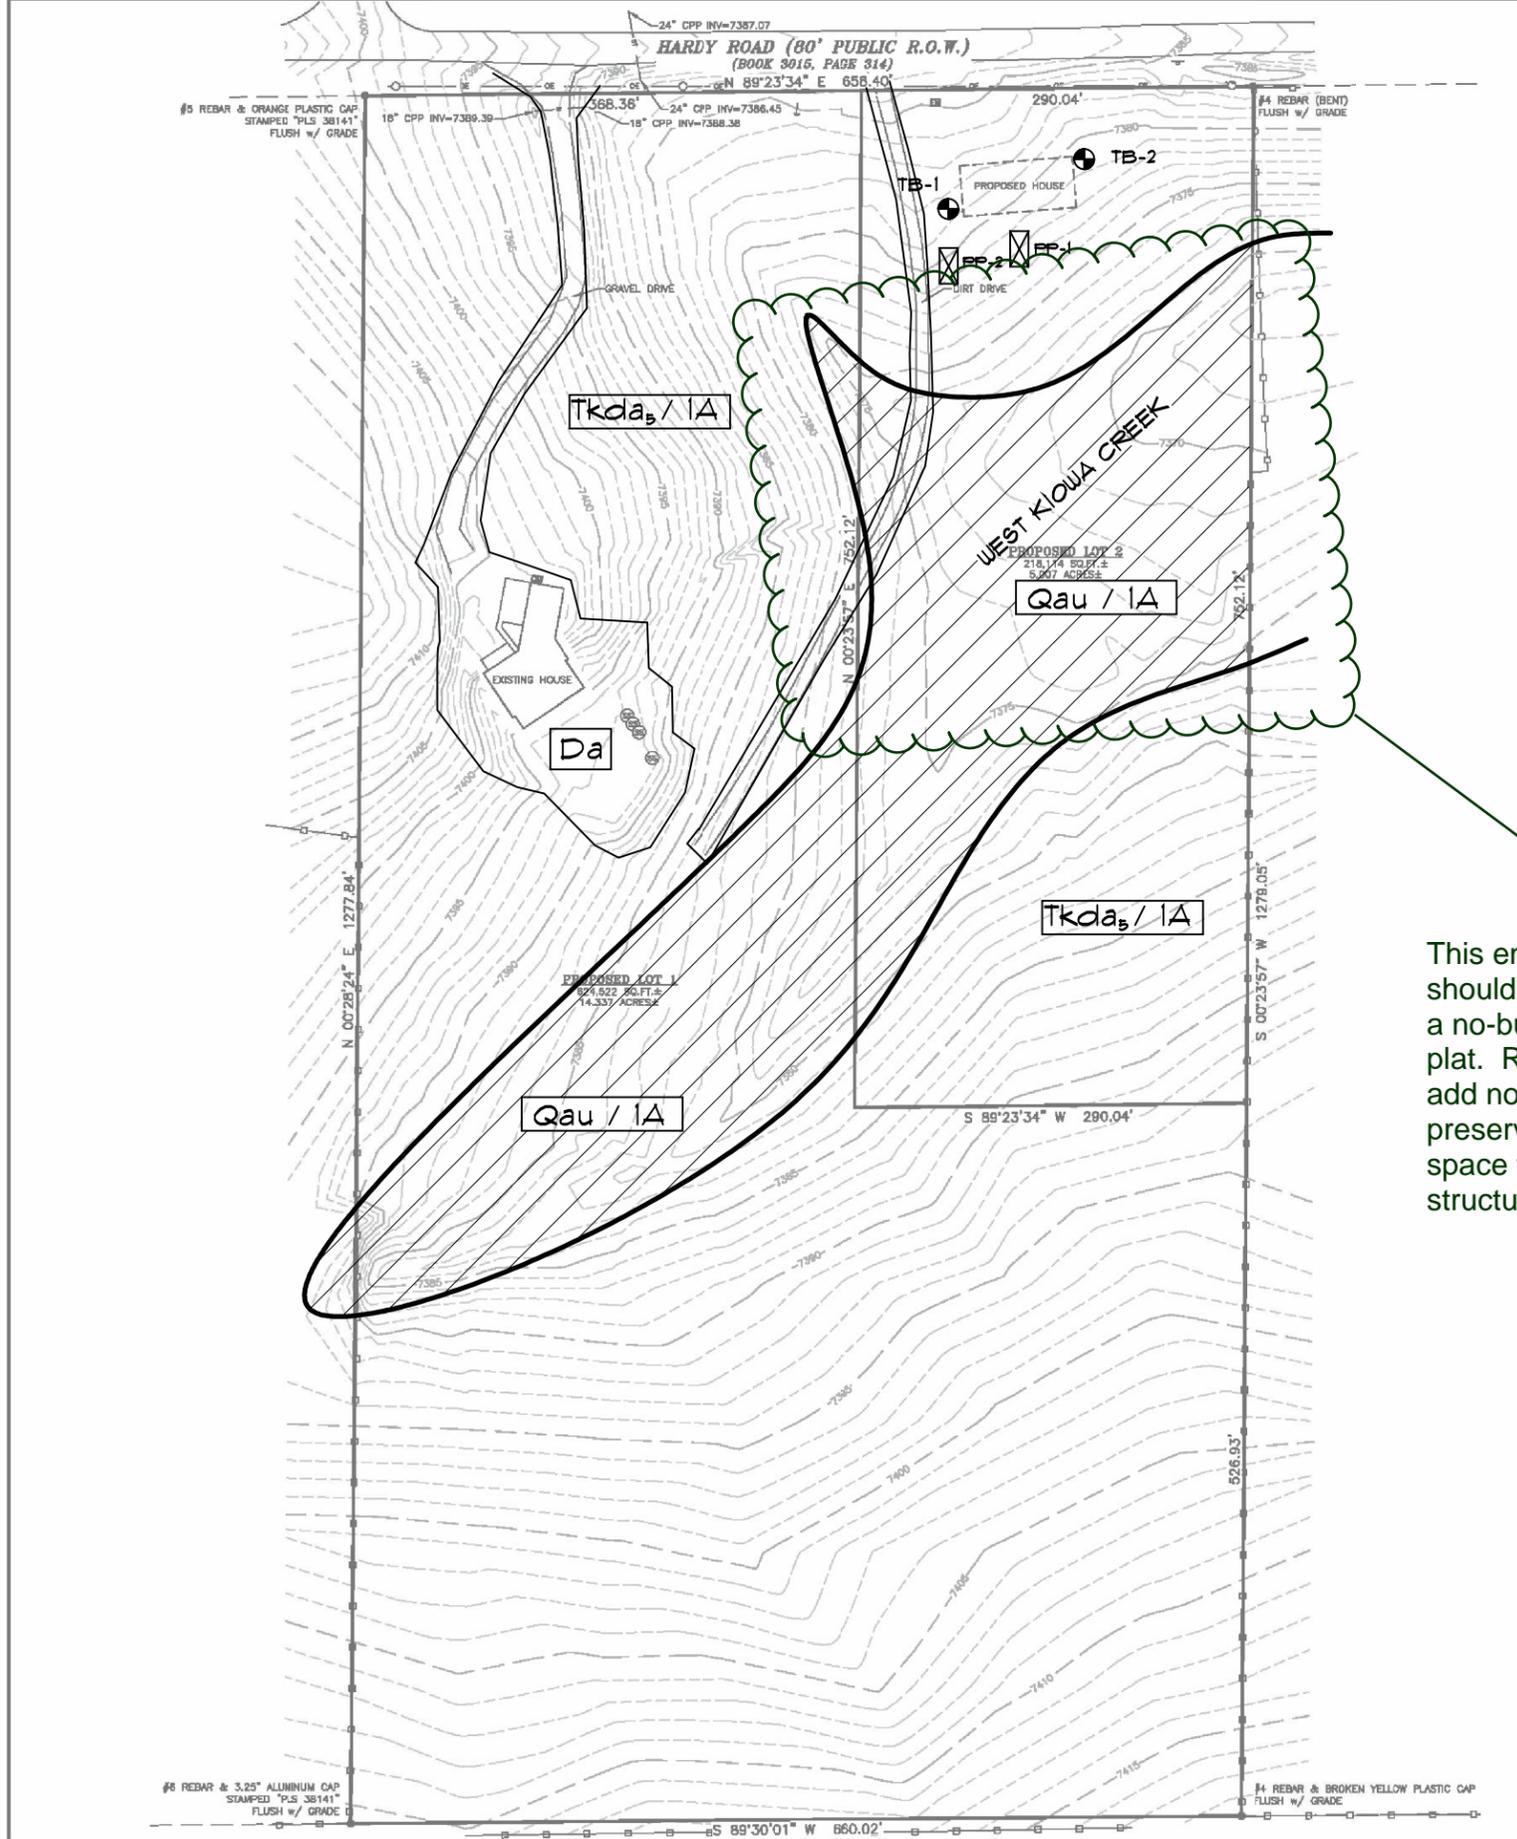
SHEET No.
FIG-3

Geologic

- *Qau* - alluvium, undivided (Holocene and Pleistocene)
 Total thickness of the unit is estimated between 10 to 20 feet. Alluvium sand was encountered in the test borings to depth of approximately 20 feet.
- *Tkda₅* - Dawson Formation, facies 5 (early to middle(?) Eocene) - Total thickness of the formation is 2,000 feet. Bedrock was not encountered in the test borings performed by RMG.
- *Da* - disturbed areas - areas that are no longer in their native state, soils have been removed and/or replaced for the existing driveway, existing residence and existing OWTS

ENGINEERING AND GEOLOGY MAP

The subsurface conditions within the area of the proposed new single-family residence was explored by RMG by drilling a total of two (2) exploratory borings, extending to 20 feet below the existing ground surface on July 8, 2020. Two (2) test pits were also observed on the same day by JDM Consulting, LLC. The approximate locations of the RMG test borings locations and the JDM Consulting, LCC test pits are presented on the General Engineering and Geology Map, Figure 3.

Based on our field observations and review of relevant geologic maps, a geologic map was prepared which identifies the geologic conditions affecting the development. The geologic units present on the site are presented in the Engineering and Geology Map, Figure 3.

The engineering geology is presented in the Engineering and Geology Map, Figure 3.

All construction should remain outside the West Kiowa Creek drainageway. It is recommended West Bijou Creek be identified as a “Preservation Area” unless additional studies are performed, in conjunction with the drainage engineer, prior to any new construction. This area is shown on Figure 3.

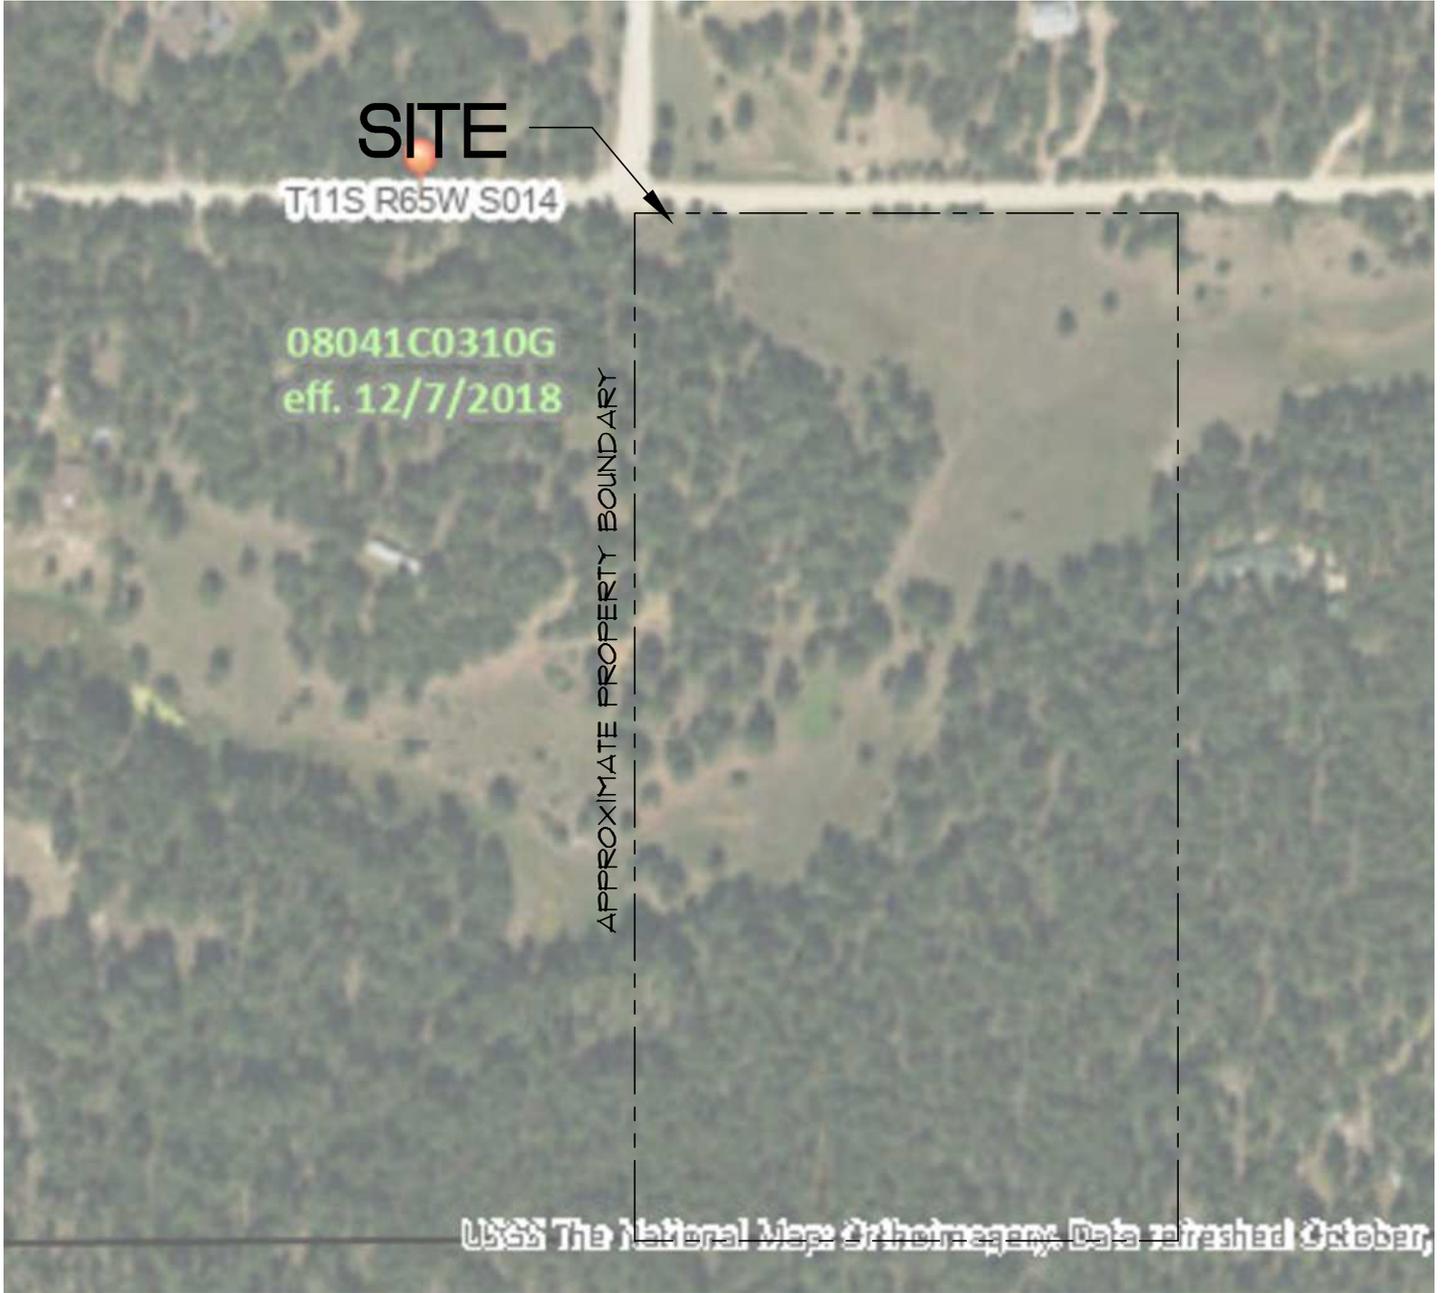
FIG No. 5

NOT TO SCALE
 BASE MAP PROVIDED BY: FEMA

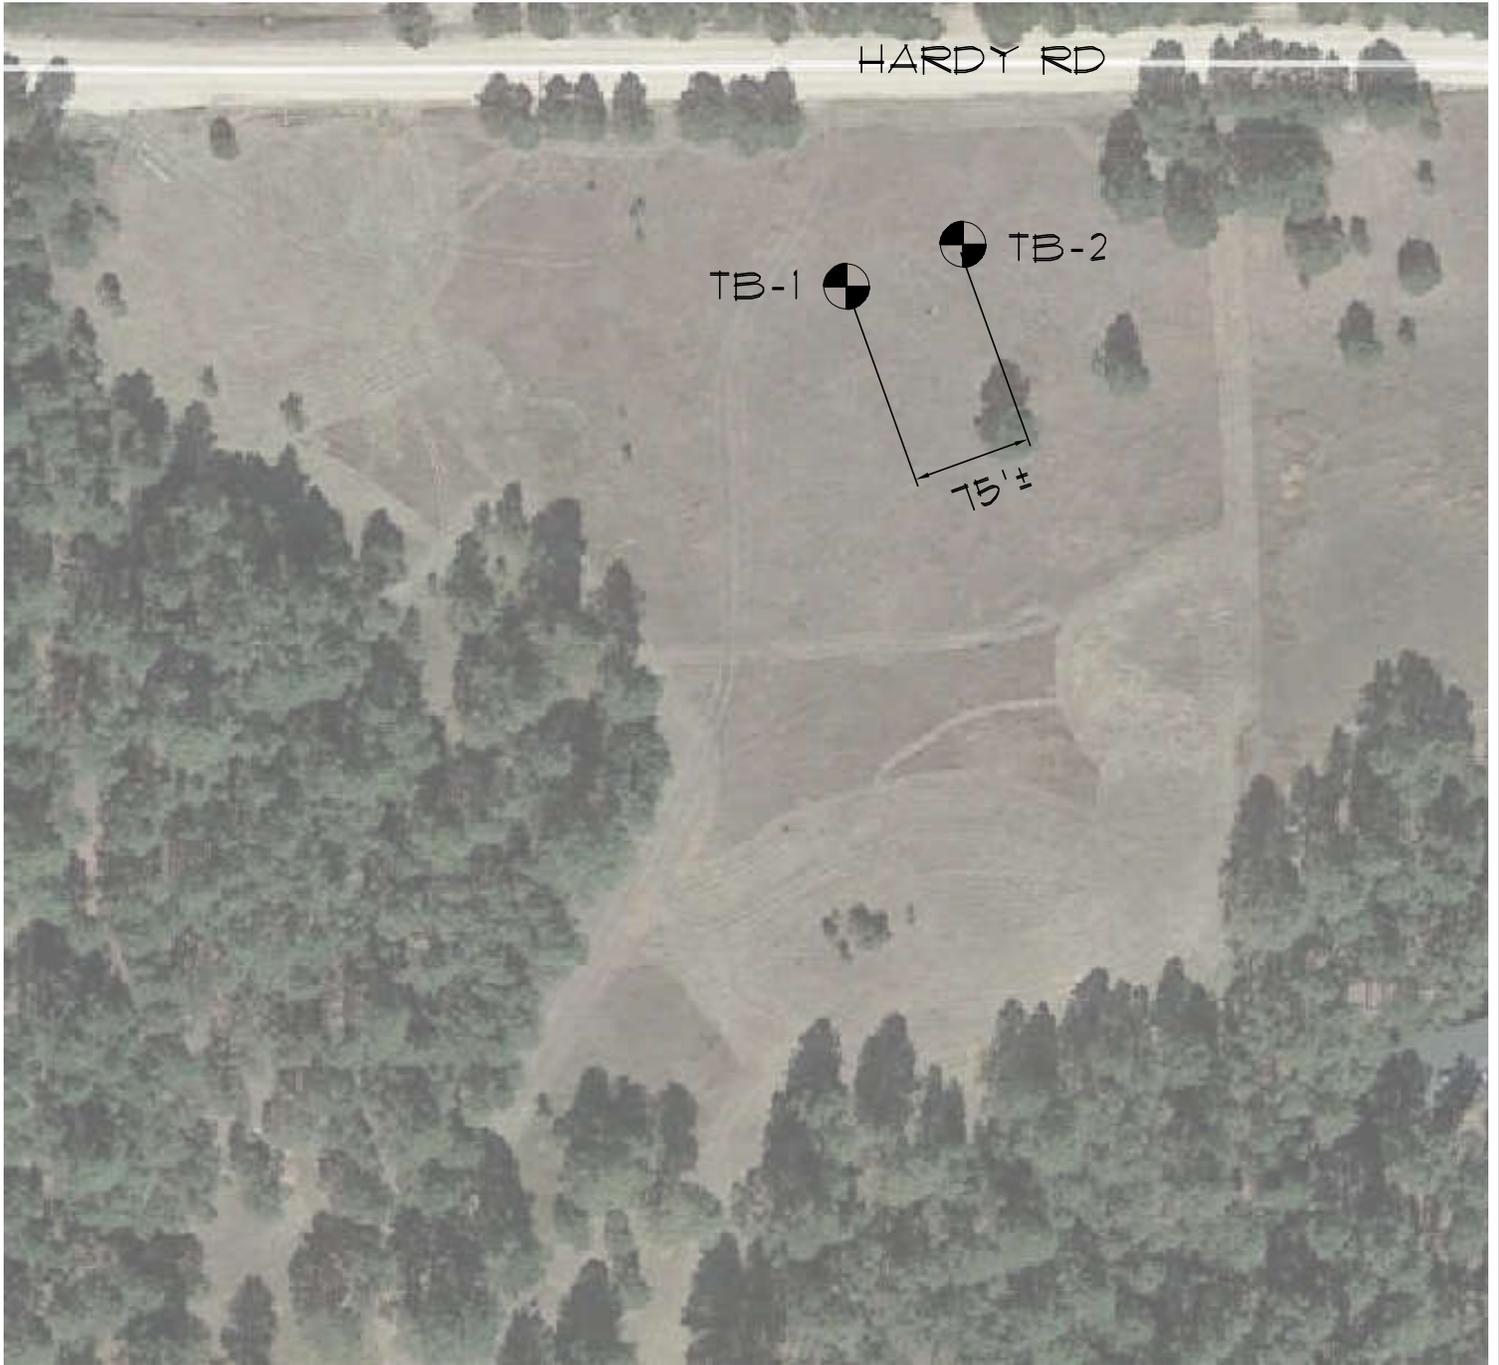
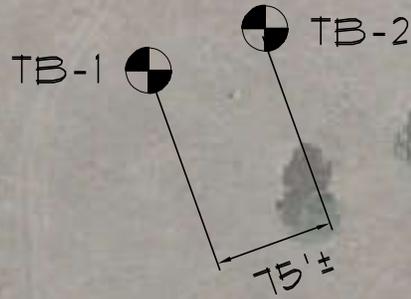
GPS LOCATION OF TB-1:
N 39.0890568, W-104.6287368
ACCURACY +/- 20 FEET

⊕ DENOTES APPROXIMATE
LOCATION OF TEST BORINGS

RMG – Rocky Mountain Group drilled two test borings for the proposed residence (a "modular" structure atop a basement foundation) at the above-referenced address on July 8, 2020. A Site Vicinity Map and Test Boring Location Plan are presented in Figures 1 and 2, respectively. Our findings, conclusions and recommendations are provided in this report.
