SOIL, GEOLOGY AND WASTEWATER STUDY

**10675 Hardy Road
EPC Schedule No. 511400007
El Paso County, Colorado**

JOB NO. 180667

January 8, 2021

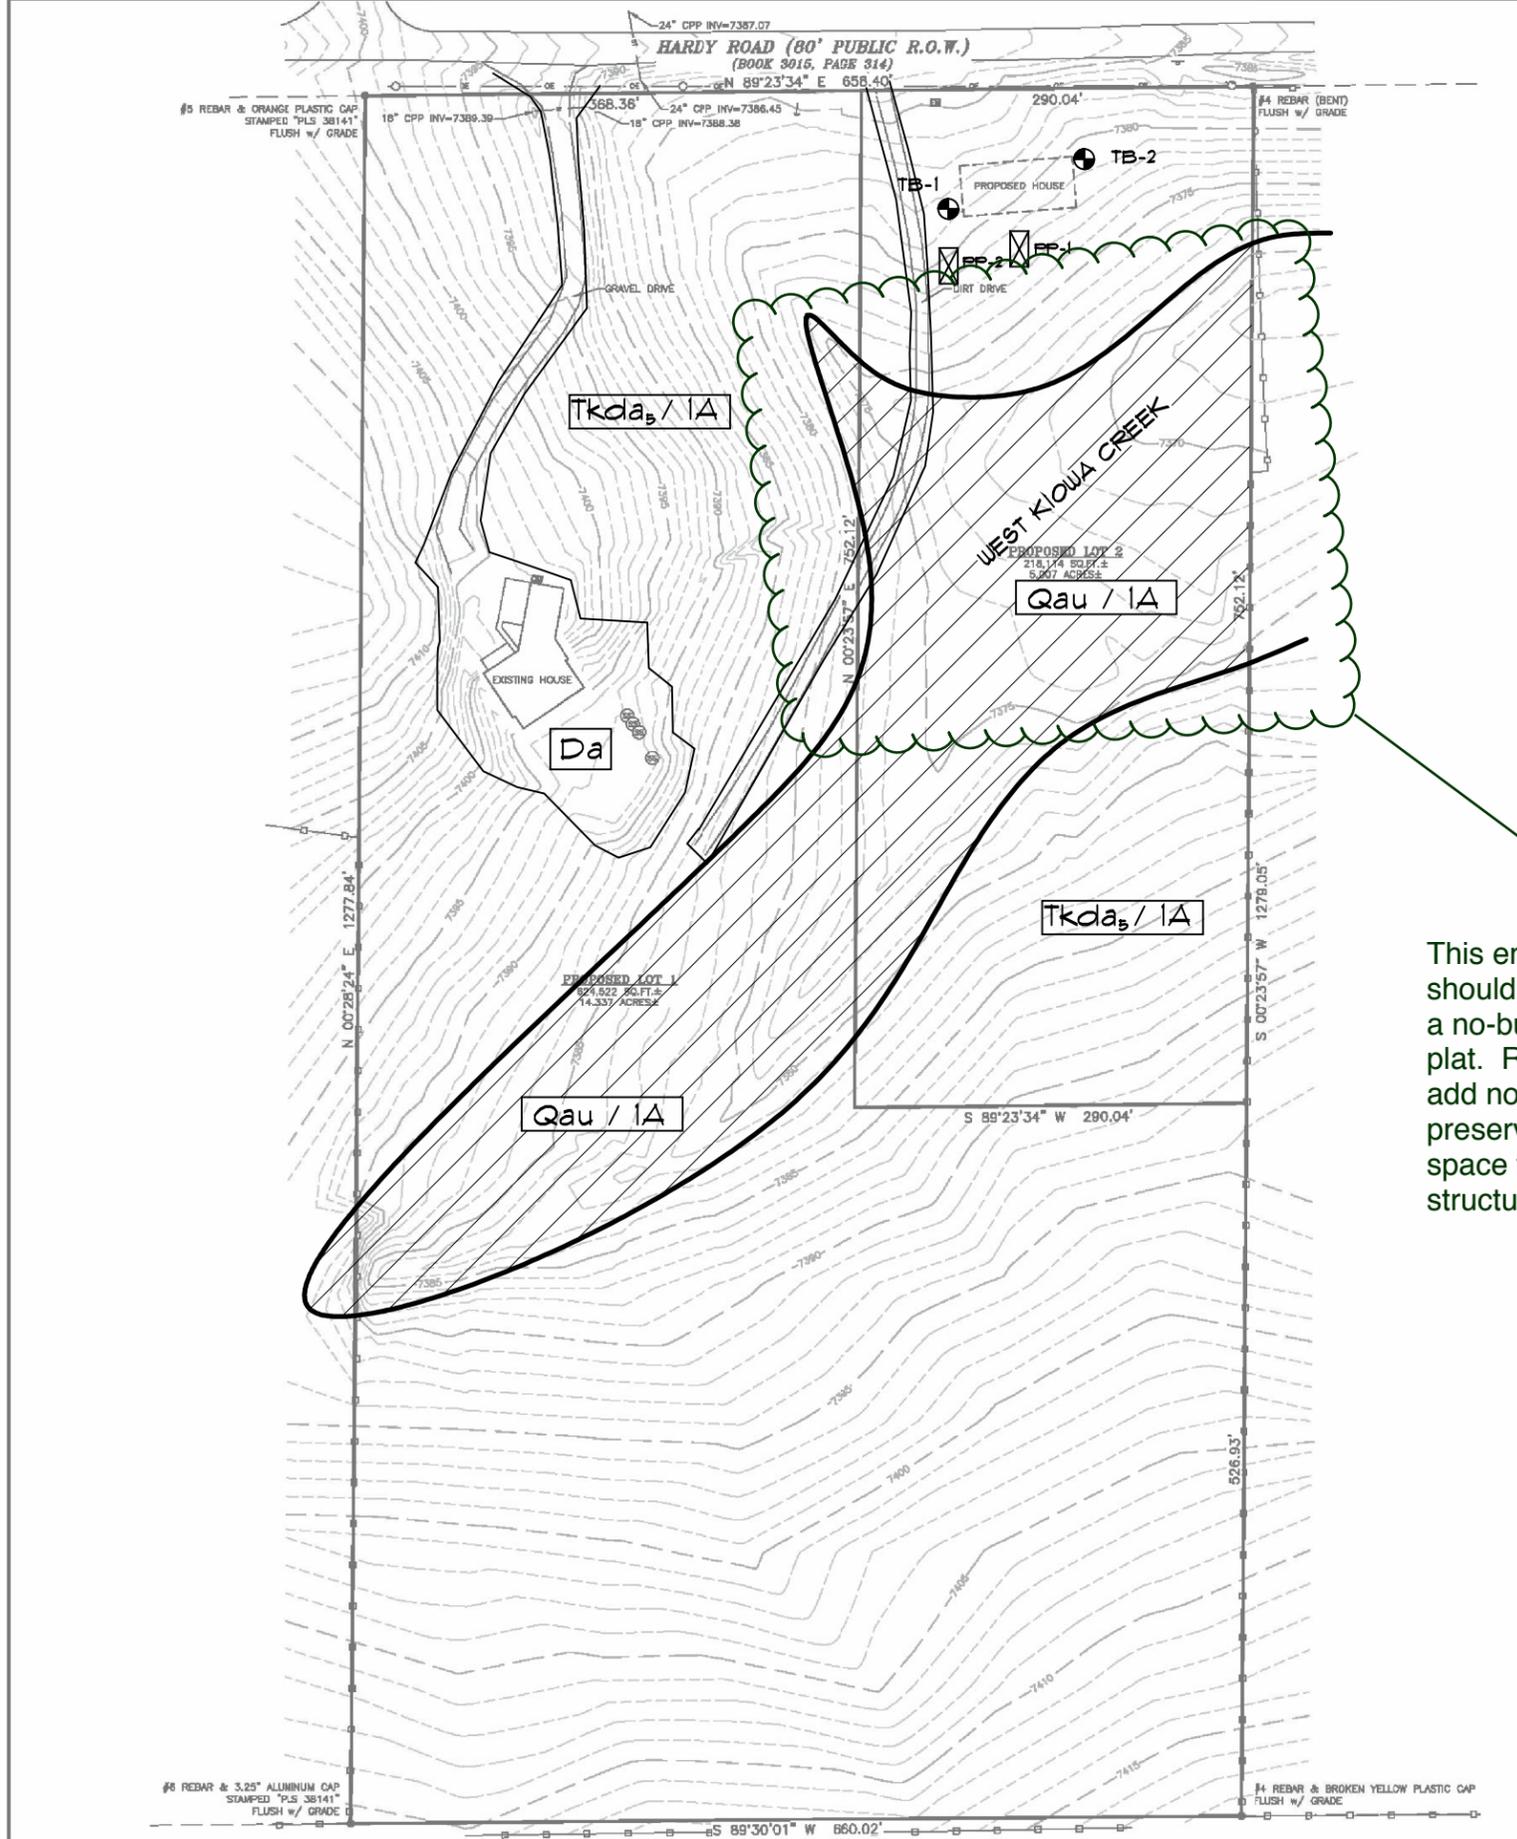
SHEET No.
FIG-3

- *Qau* - alluvium, undivided (Holocene and Pleistocene)
 Total thickness of the unit is estimated between 10 to 20 feet. Alluvium sand was encountered in the test borings to depth of approximately 20 feet.
- *Tkda₅* - Dawson Formation, facies 5 (early to middle(?) Eocene) - Total thickness of the formation is 2,000 feet. Bedrock was not encountered in the test borings performed by RMG.
- *Da* - disturbed areas - areas that are no longer in their native state, soils have been removed and/or replaced for the existing driveway, existing residence and existing OWTS

ENGINEERING AND GEOLOGY MAP

The subsurface conditions within the area of the proposed new single-family residence was explored by RMG by drilling a total of two (2) exploratory borings, extending to 20 feet below the existing ground surface on July 8, 2020. Two (2) test pits were also observed on the same day by JDM Consulting, LLC. The approximate locations of the RMG test borings locations and the JDM Consulting, LCC test pits are presented on the General Engineering and Geology Map, Figure 3.

Based on our field observations and review of relevant geologic maps, a geologic map was prepared which identifies the geologic conditions affecting the development. The geologic units present on the site are presented in the Engineering and Geology Map, Figure 3.

The engineering geology is presented in the Engineering and Geology Map, Figure 3.

All construction should remain outside the West Kiowa Creek drainageway. It is recommended West Bijou Creek be identified as a “Preservation Area” unless additional studies are performed, in conjunction with the drainage engineer, prior to any new construction. This area is shown on Figure 3.

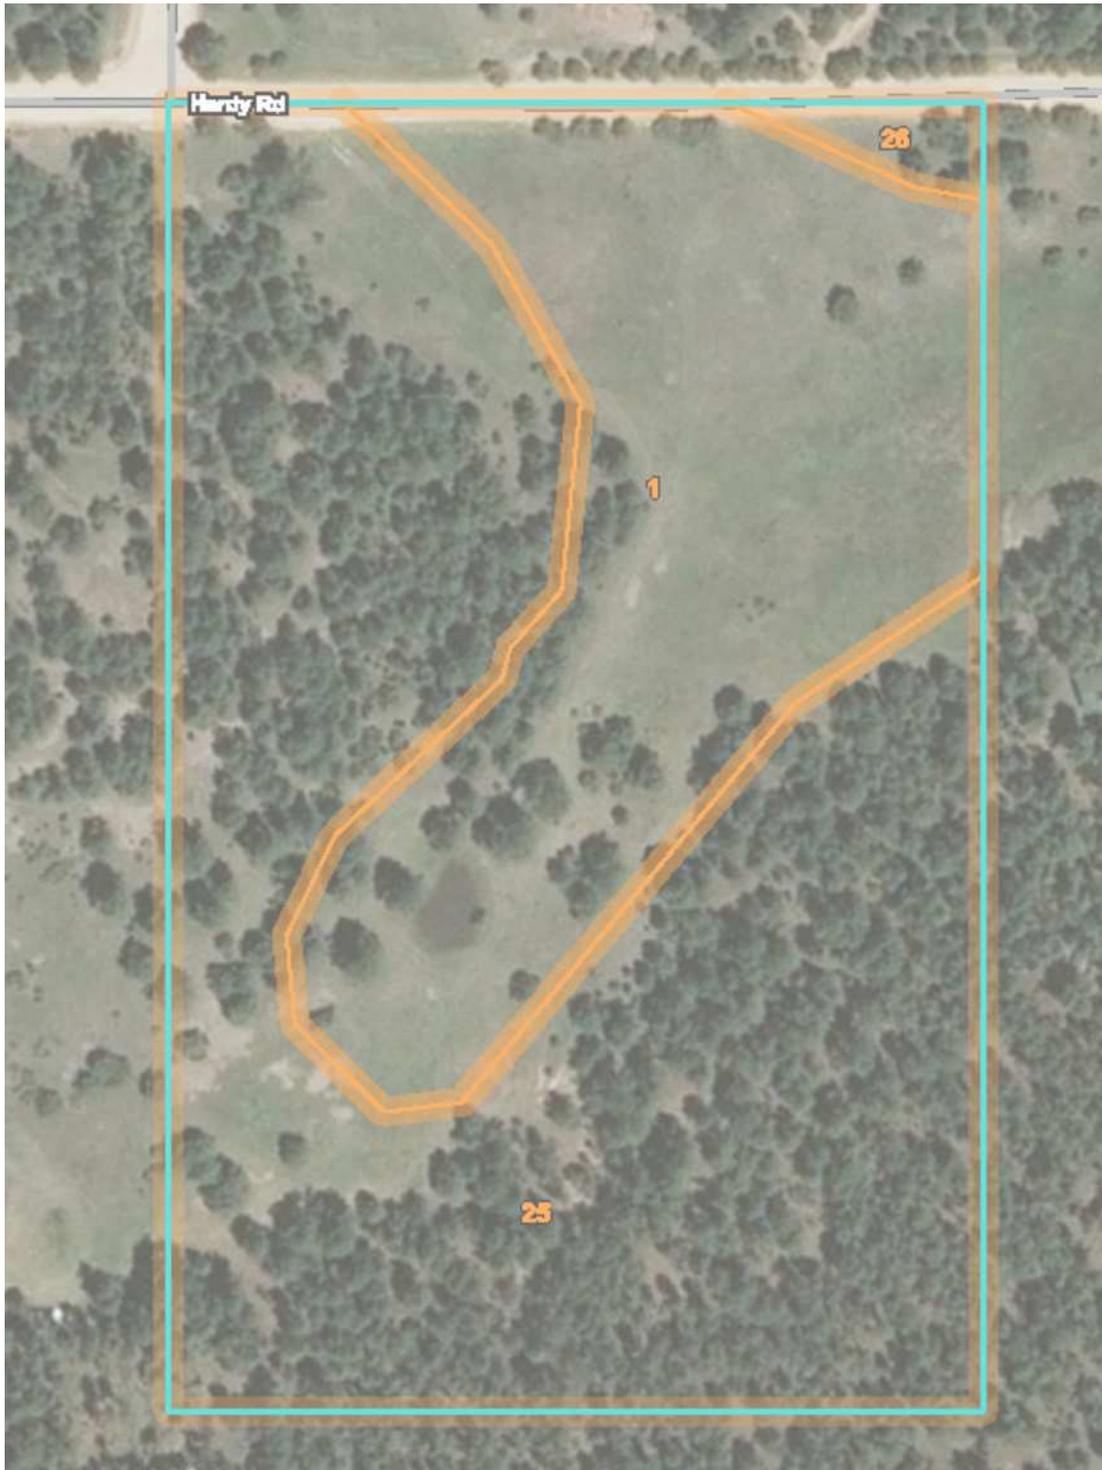
FIG No. 4

- 1 - Alamosa loam
- 25 -Elbeth sandy loam, 3 to 8 percent slopes

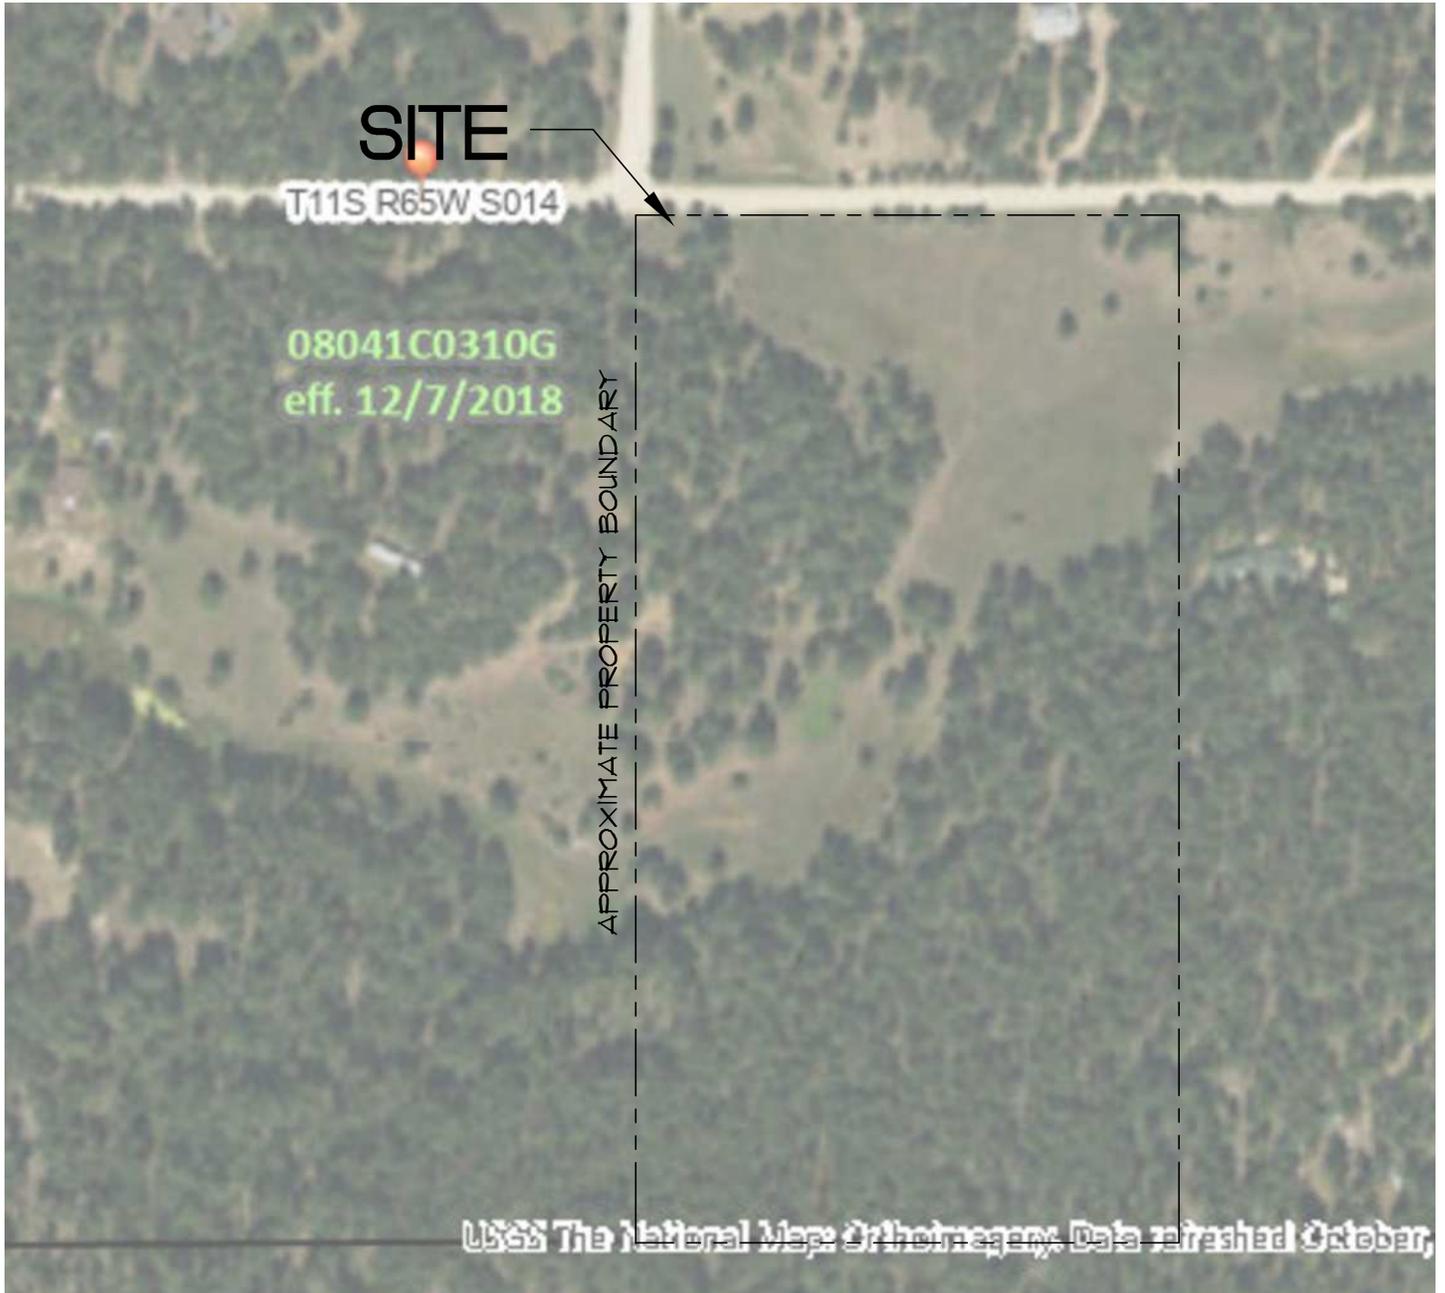
FIG No. 5

NOT TO SCALE
 BASE MAP PROVIDED BY: FEMA

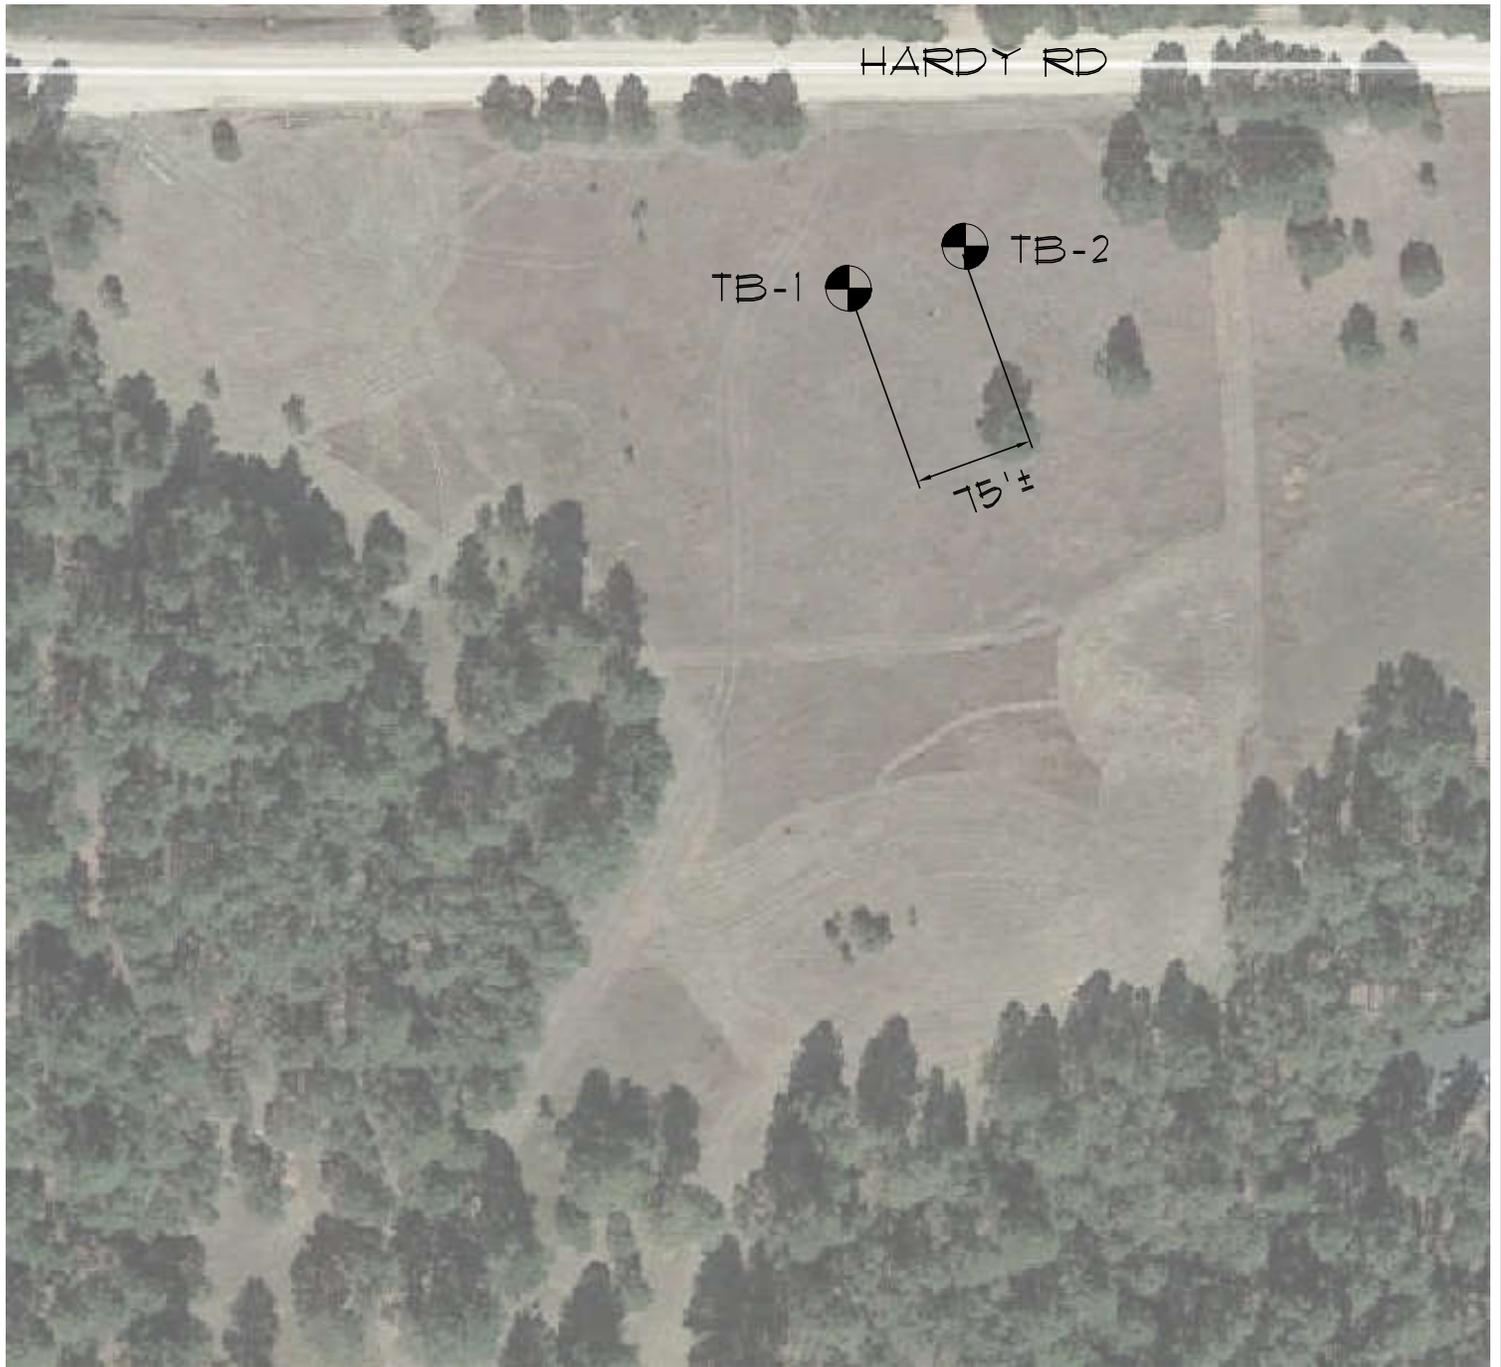
GPS LOCATION OF TB-1:
 N 39.0890568, W-104.6287368
 ACCURACY +/- 20 FEET

⊕ DENOTES APPROXIMATE
 LOCATION OF TEST BORINGS

RMG – Rocky Mountain Group drilled two test borings for the proposed residence (a "modular" structure atop a basement foundation) at the above-referenced address on July 8, 2020. A Site Vicinity Map and Test Boring Location Plan are presented in Figures 1 and 2, respectively. Our findings, conclusions and recommendations are provided in this report.

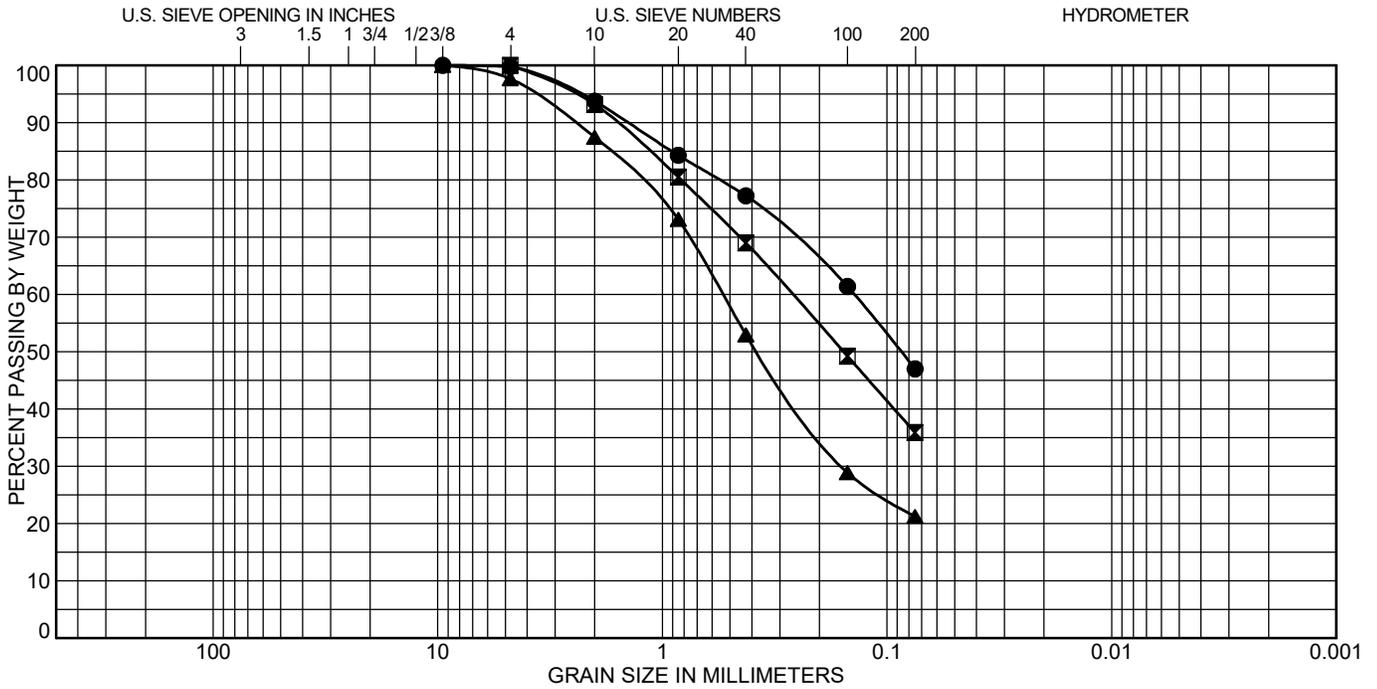
FIGURE No. 6

COBBLES	GRAVEL		SAND			SILT OR CLAY
	coarse	fine	coarse	medium	fine

Test Boring	Depth (ft)	Classification	LL	PL	PI
● 1	4.0	CLAYEY SAND(SC)	26	13	13
◻ 2	9.0	SILTY SAND(SM)	NP	NP	NP
▲ 2	14.0	CLAYEY SAND(SC)	32	15	17

An Explanation of the Test Boring Logs, the Test Boring Logs, and a Summary of Laboratory Test Results are presented in Figures 3 through 5. Soil Classification Data is presented in Figure 6. Swell/Consolidation Test Results are presented in Figure 7.

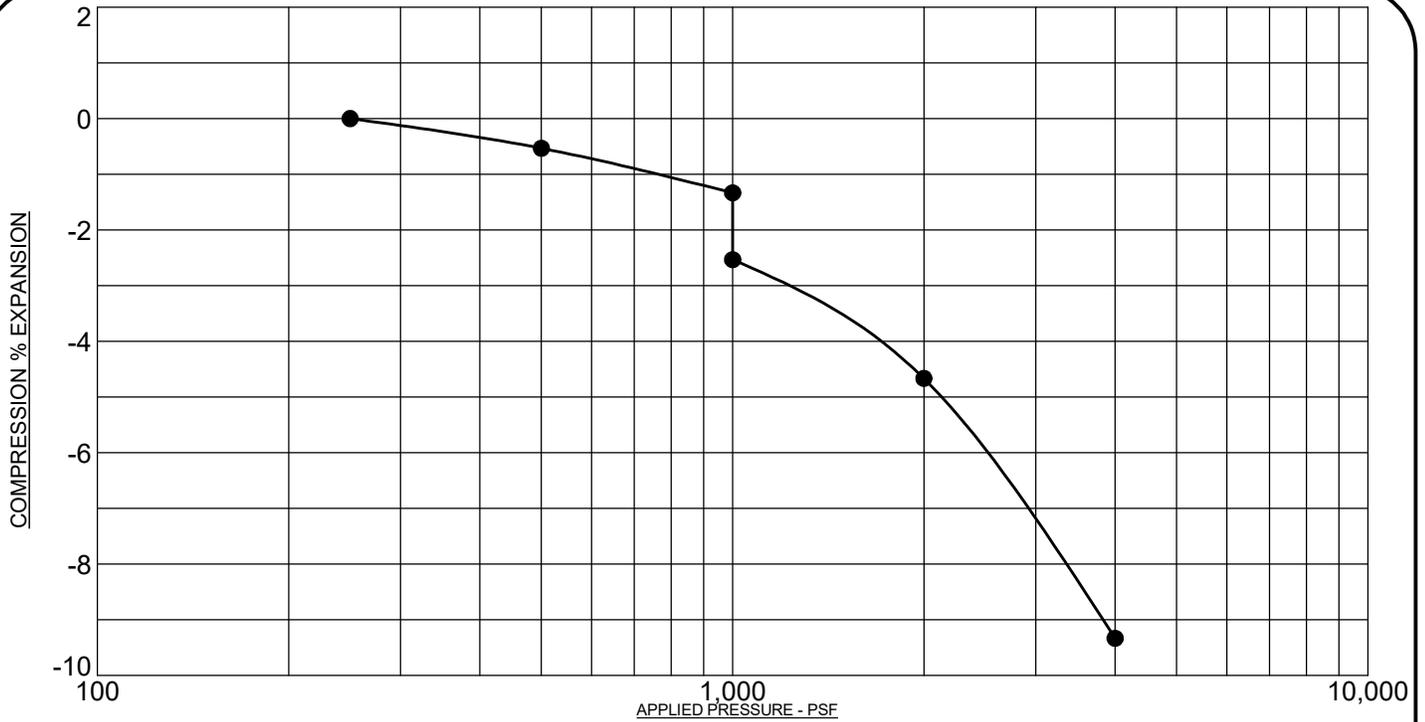
FIGURE No. 7

PROJECT: 10675 Hardy Road, El Paso County, Colorado
 SAMPLE DESCRIPTION: SANDSTONE, SILTY TO CLAYEY
 NOTE: SAMPLE WAS INUNDATED WITH WATER AT 1,000 PSF

SAMPLE LOCATION: 2 @ 14 FT
 NATURAL DRY UNIT WEIGHT: 119.3 PCF
 NATURAL MOISTURE CONTENT: 9.0%
 PERCENT SWELL/COMPRESSION: - 1.2

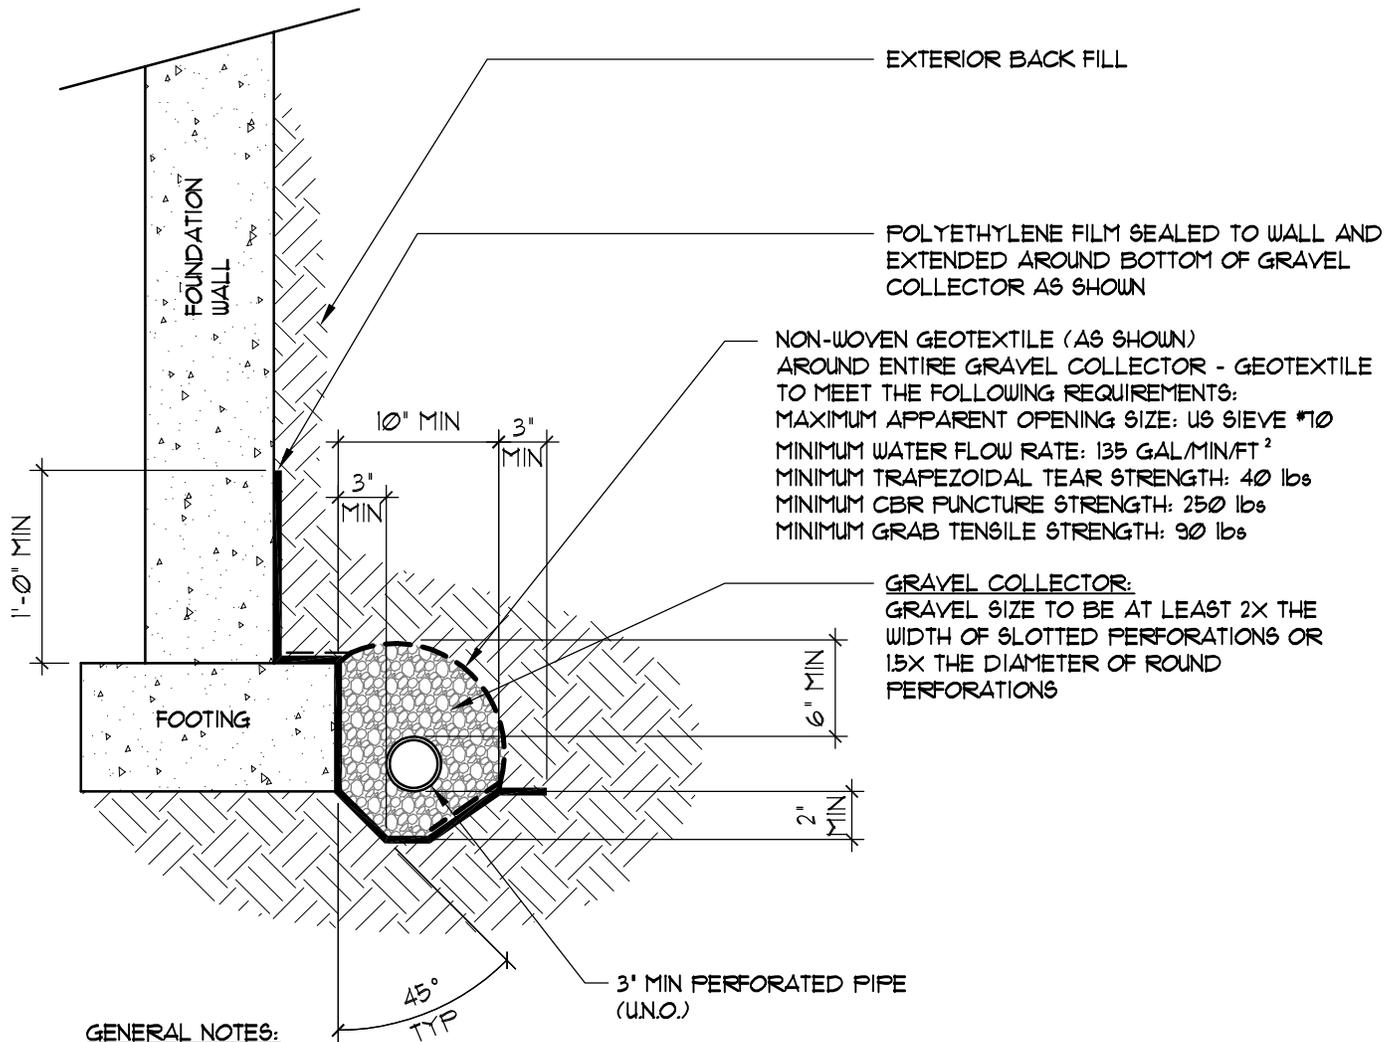
1. BOTTOM OF DRAIN PIPE SHALL BE AT OR BELOW BOTTOM OF FOOTING AT ALL LOCATIONS
2. ALL DRAIN PIPE SHALL BE PERFORATED PLASTIC, WITH THE EXCEPTION OF THE DISCHARGE PORTION WHICH SHALL BE SOLID, NON-PERFORATED PIPE.

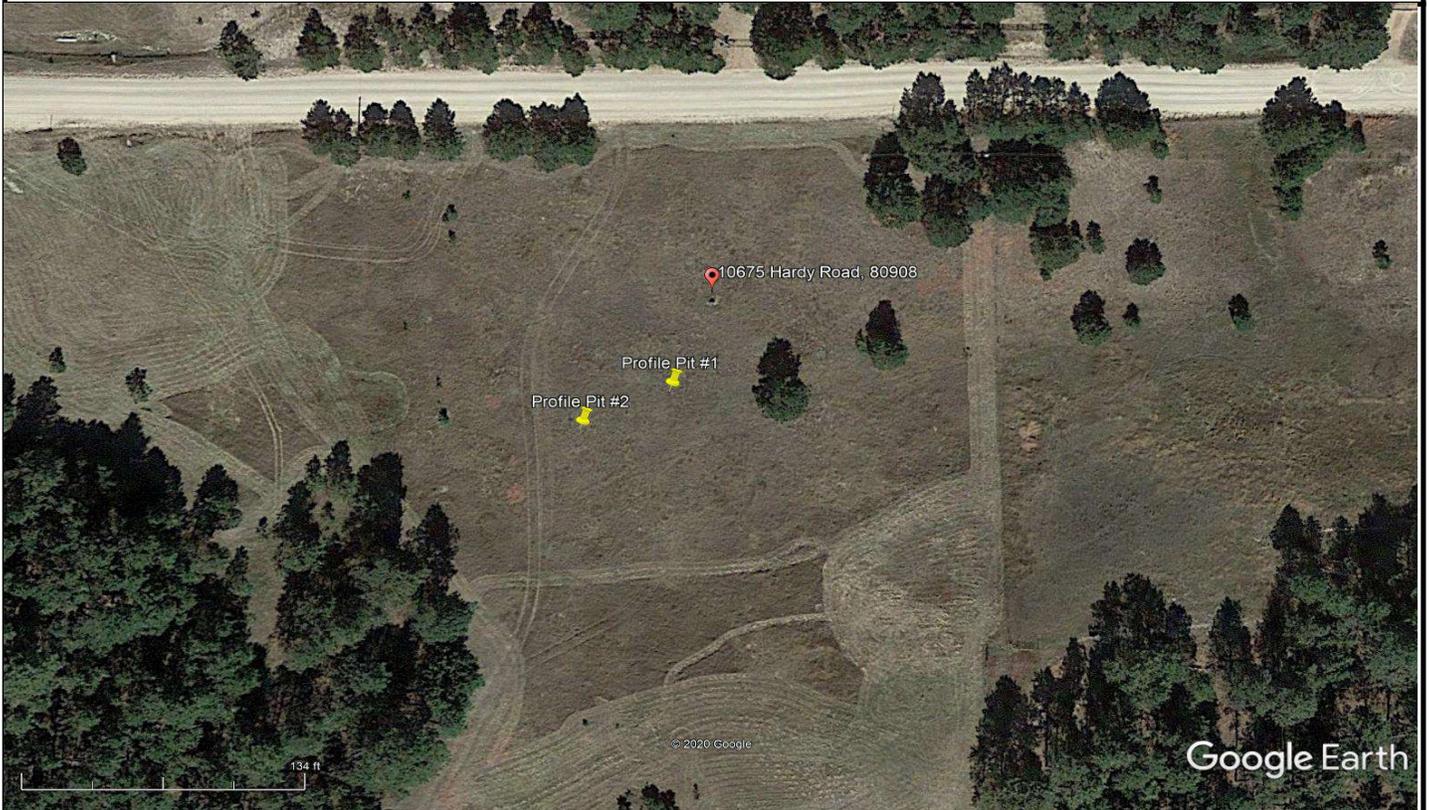
Site Map:

Profile Pit Summary	
Profile Pit #1	
Lat:	39° 5'19.90"N
Long:	104°37'42.97"W
0 - 0'-6"	Topsoil
0'-6" - 3'-0"	Soil Type 4A
3'-0" - 5'-0"	Soil Type 2
5'-0" - 7'-0"	Soil Type 4
-	-
Profile Pit #2	
Lat:	39° 5'19.68"N
Long:	104°37'43.58"W
0 - 0'-6"	Topsoil
0'-6" - 4'-6"	Soil Type 4A
4'-6" - 5'-6"	Soil Type 2
5'-6" - 7'-6"	Soil Type 4
-	-
Existing Well (If applicable)	
Lat:	N/A
Long:	N/A
