WASTEWATER DISPOSAL REPORT

RAPSON SUBDIVISION

EPC Parcel # 5114000007

**February 2021
(revised April 2021)**

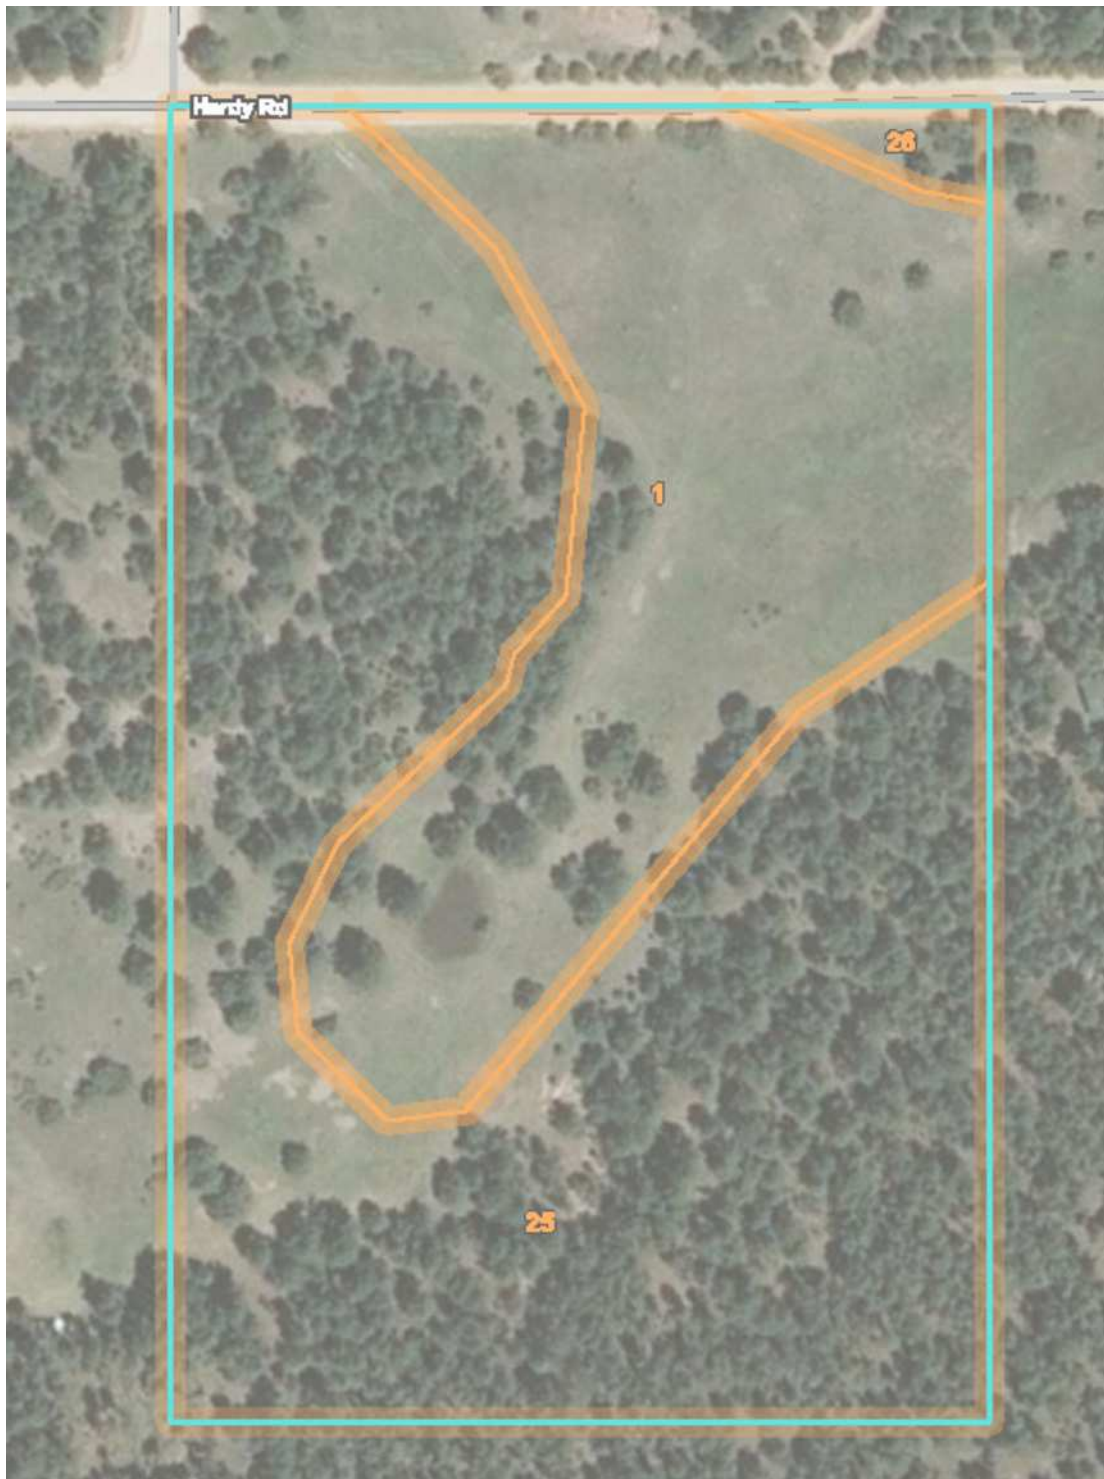
FIG No. 4

NOT TO SCALE
BASE MAP PROVIDED BY: USDA

- 1 - Alamosa loam
- 25 -Elbeth sandy loam, 3 to 8 percent slopes

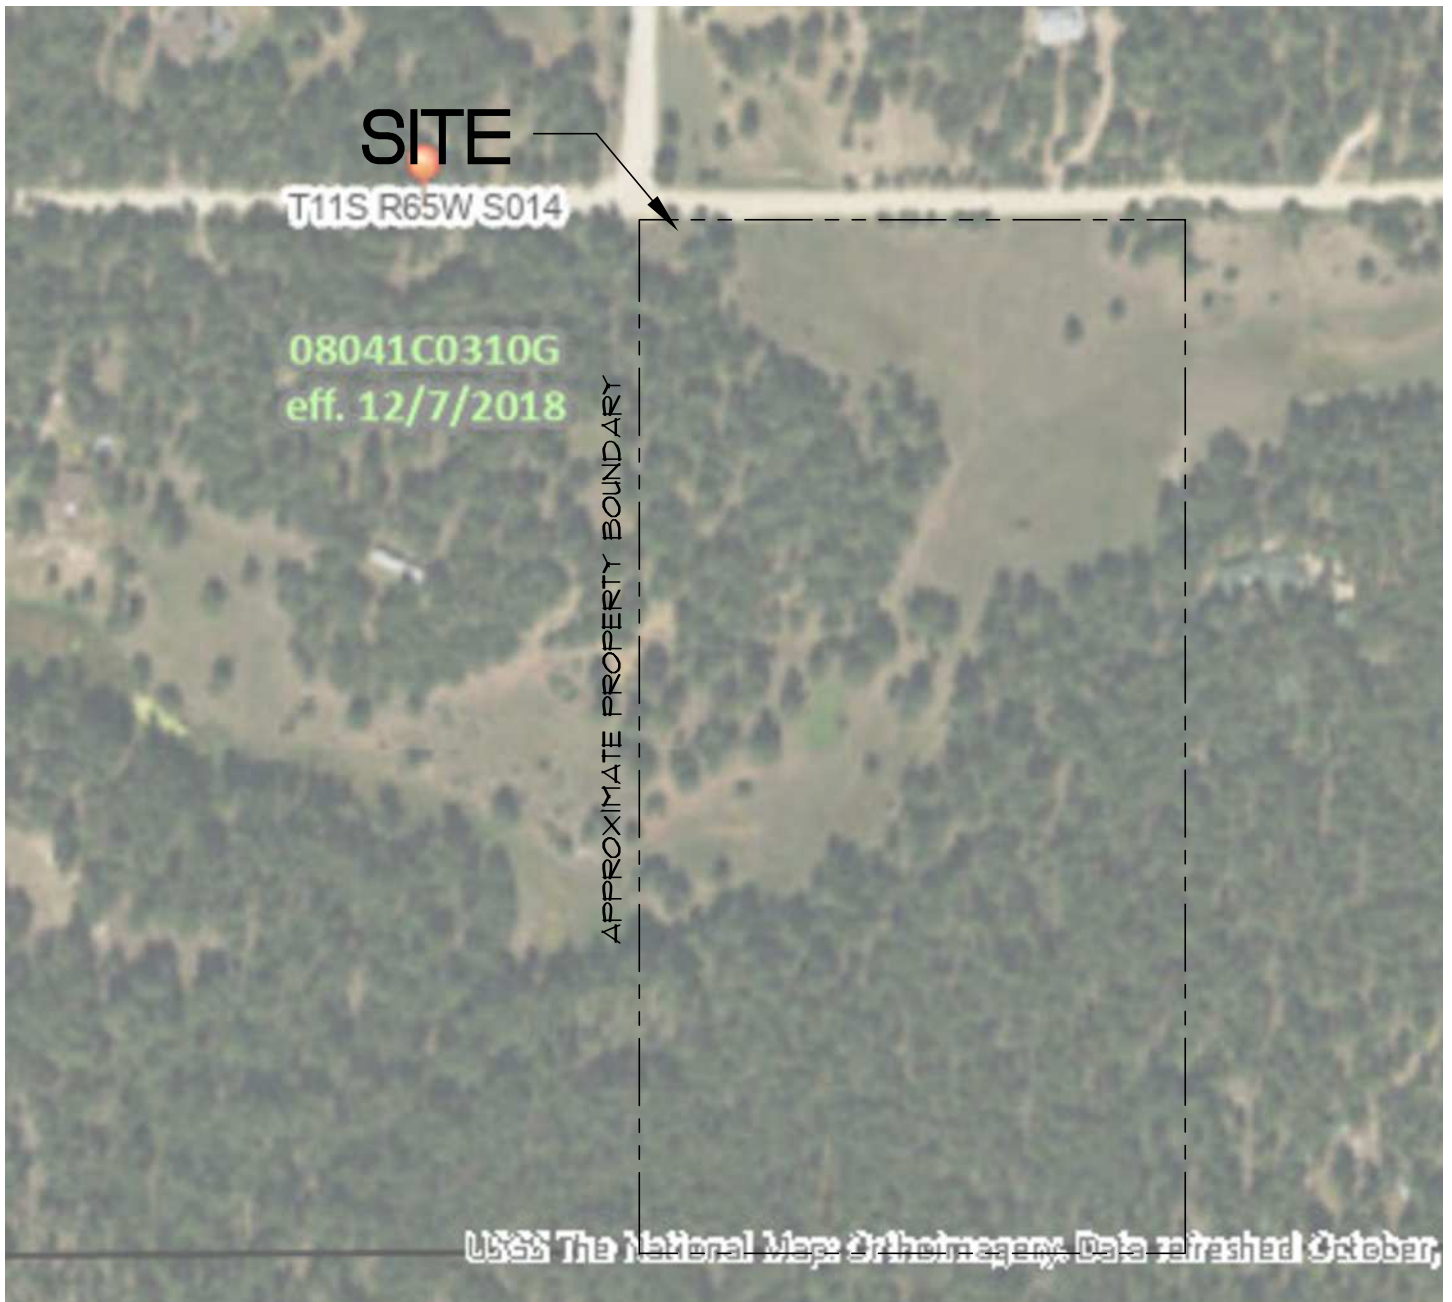
FIG No. 5

NOT TO SCALE
BASE MAP PROVIDED BY: FEMA

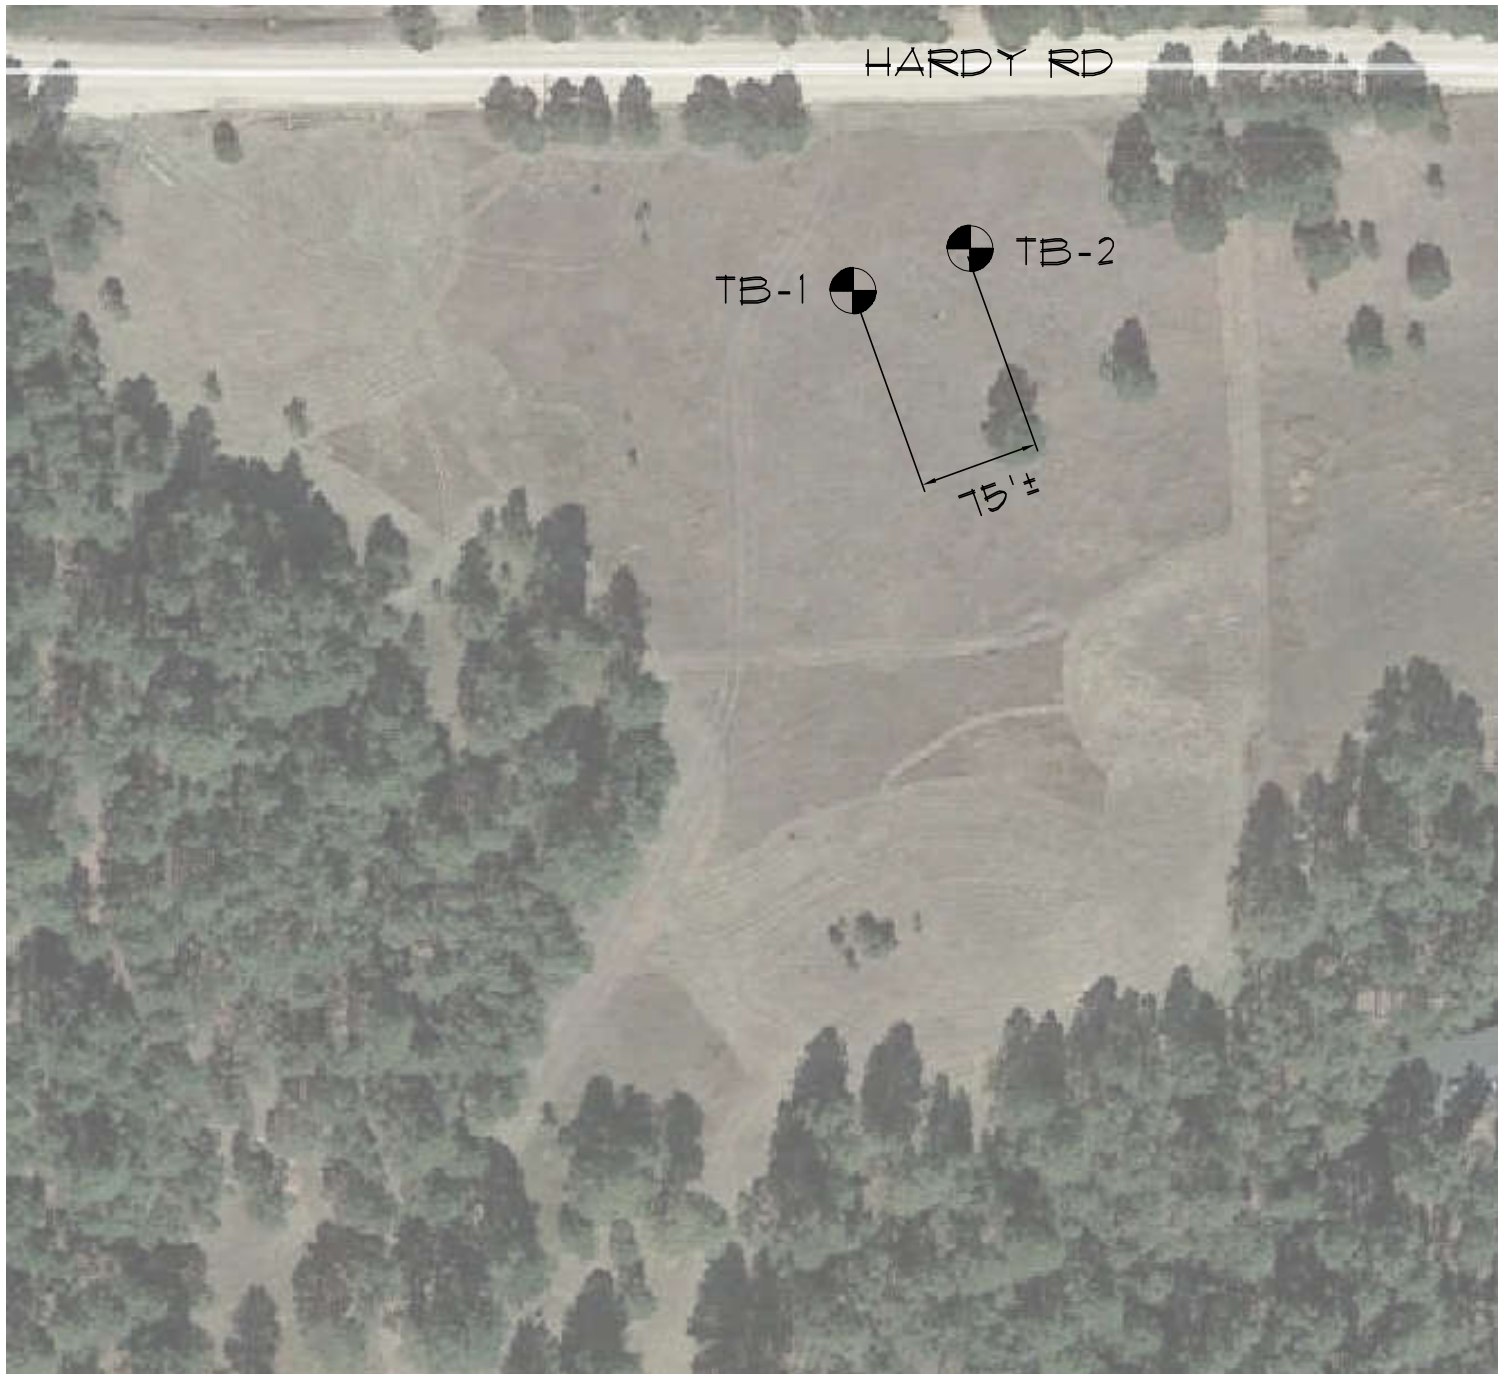
FIG No. 2

GPS LOCATION OF TB-1:
N 39.0890568, W-104.6287368
ACCURACY +/- 20 FEET

RMG – Rocky Mountain Group drilled two test borings for the proposed residence (a "modular" structure atop a basement foundation) at the above-referenced address on July 8, 2020. A Site Vicinity Map and Test Boring Location Plan are presented in Figures 1 and 2, respectively. Our findings, conclusions and recommendations are provided in this report.

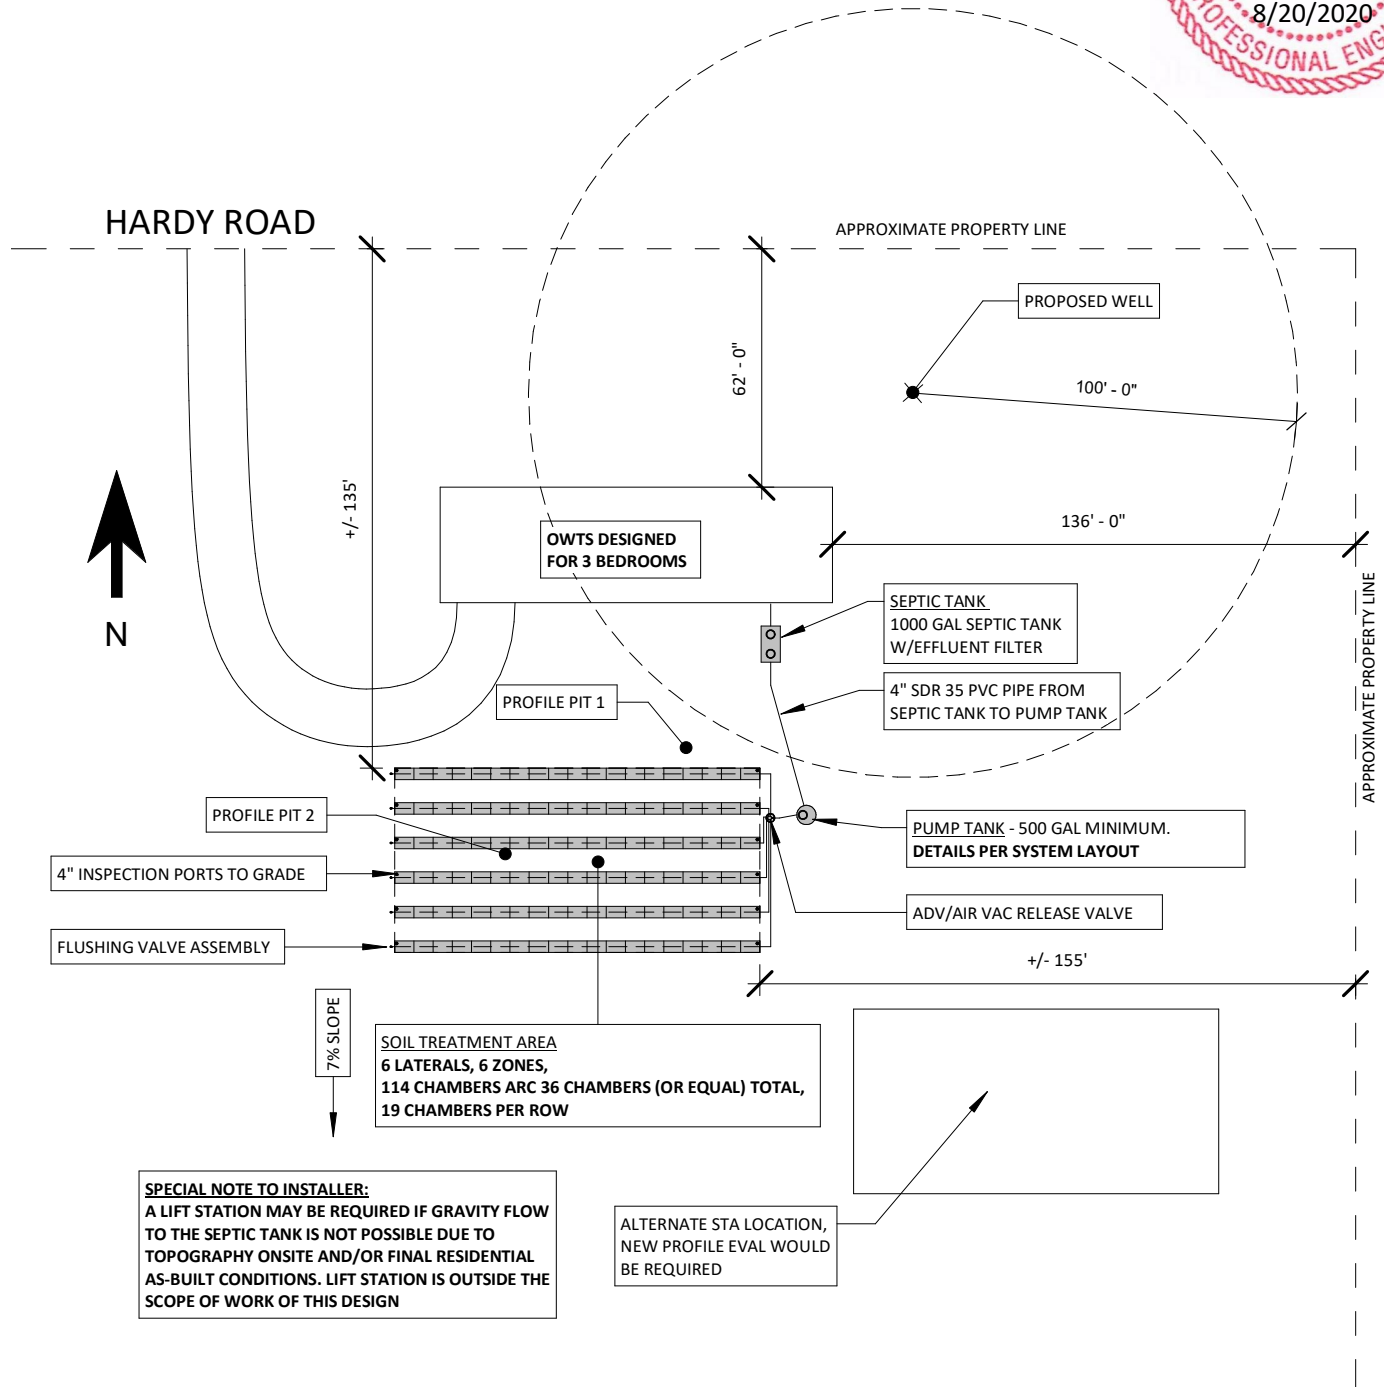
C2 of 5

① 01- Site Plan
1" = 50'-0"
