Re: Infiltration Rate Testing (Percolation Test Method)
10707 Maltese Point
El Paso County, Colorado
Entech Job No. 240324

SITE AND EXPLORATION PLAN

10707 MALTESE POINT
WD CONSTRUCTION

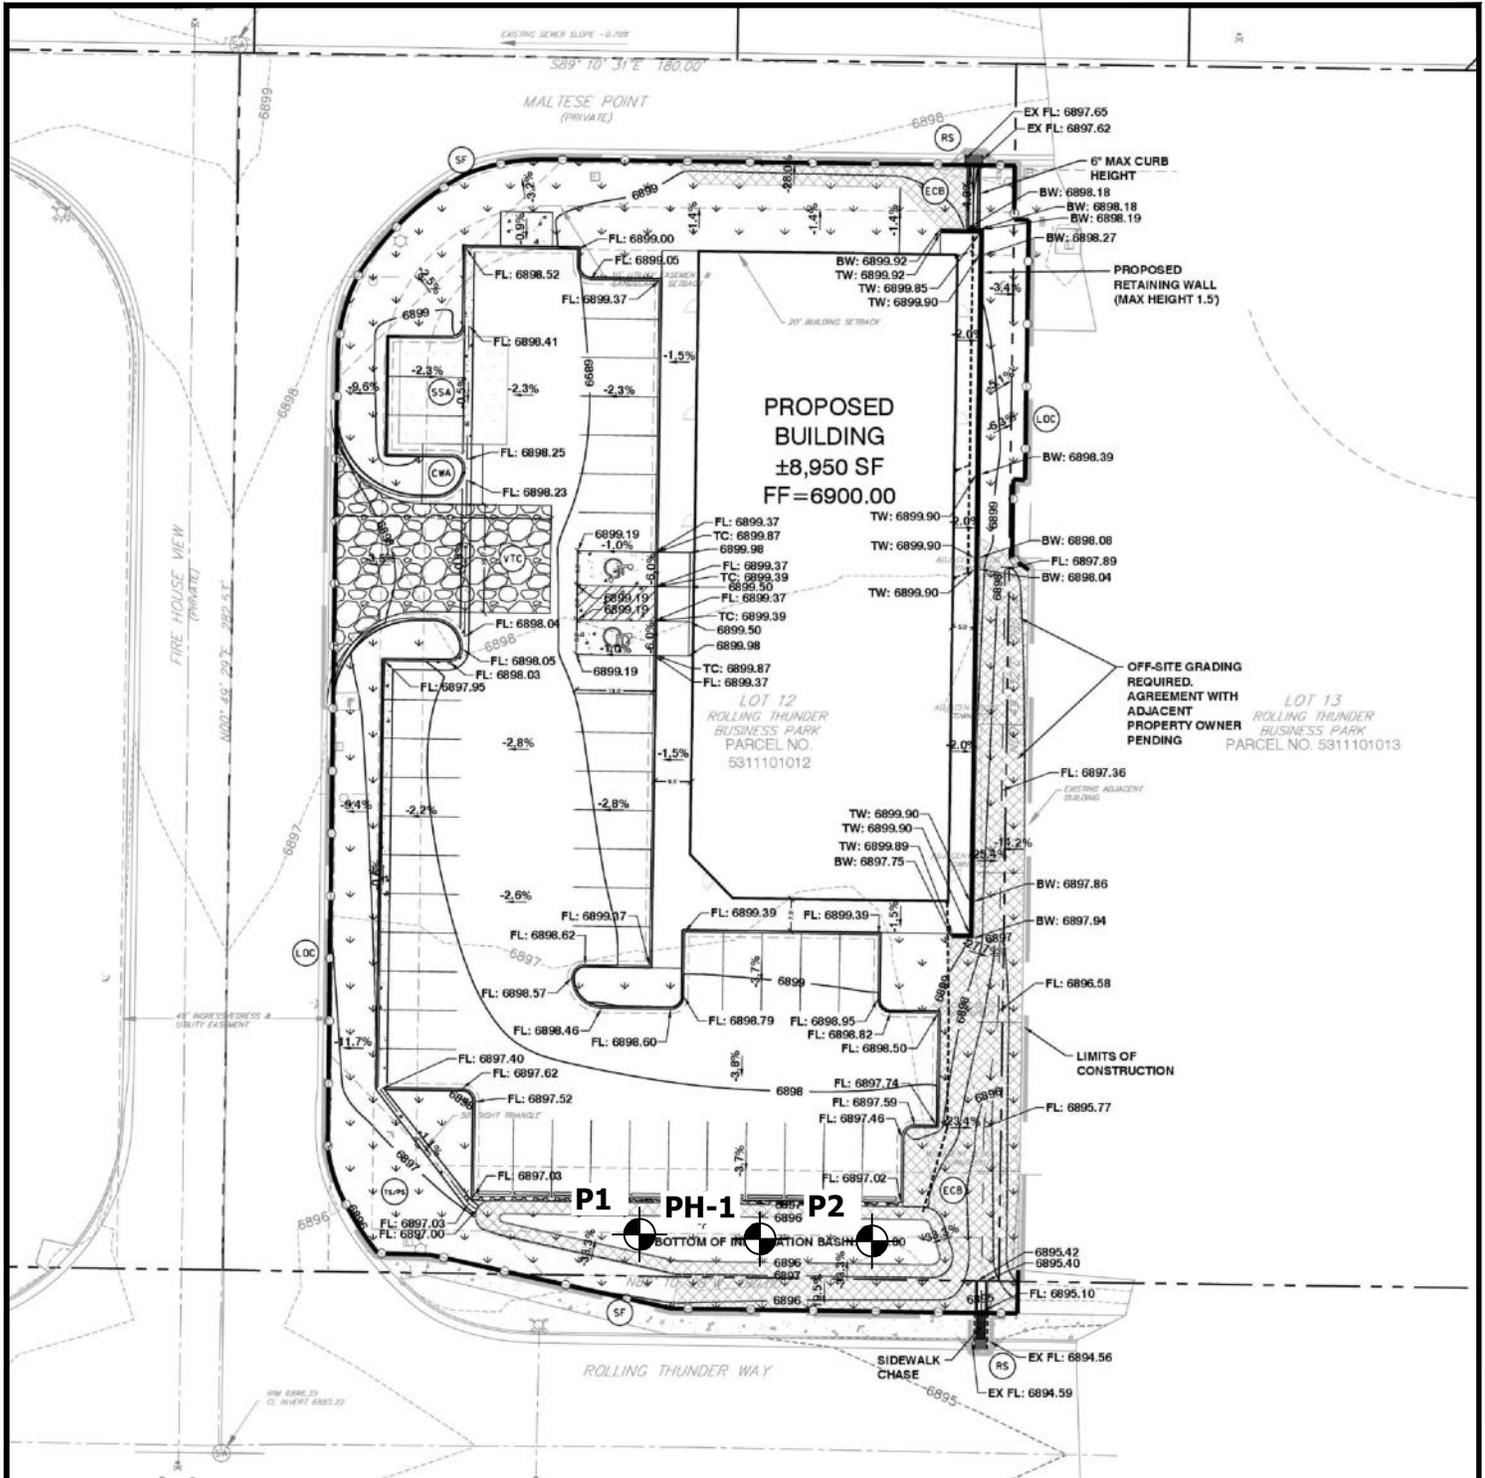
FIG. 1

**PH-** APPROXIMATE PROFILE HOLE LOCATION AND NUMBER

**P-** APPROXIMATE PERCOLATION TEST HOLE LOCATION

The testing was performed on June 6, 2024. The test locations are shown on Figure 1. The profile hole was placed in the center of the proposed infiltration garden, and the percolation holes (P1 and P2) were placed in the eastern and western sides of the infiltration garden. The Site and Exploration Plan is shown on Figure 1, the profile hole log, laboratory test results, and percolation test results, and infiltration rates are shown in Figures 2 through 5. Soils encountered in the profile and percolation holes consisted of silty sand overlying sand clay. Bedrock and groundwater were not encountered in the profile hole which was drilled to approximately 10 feet.

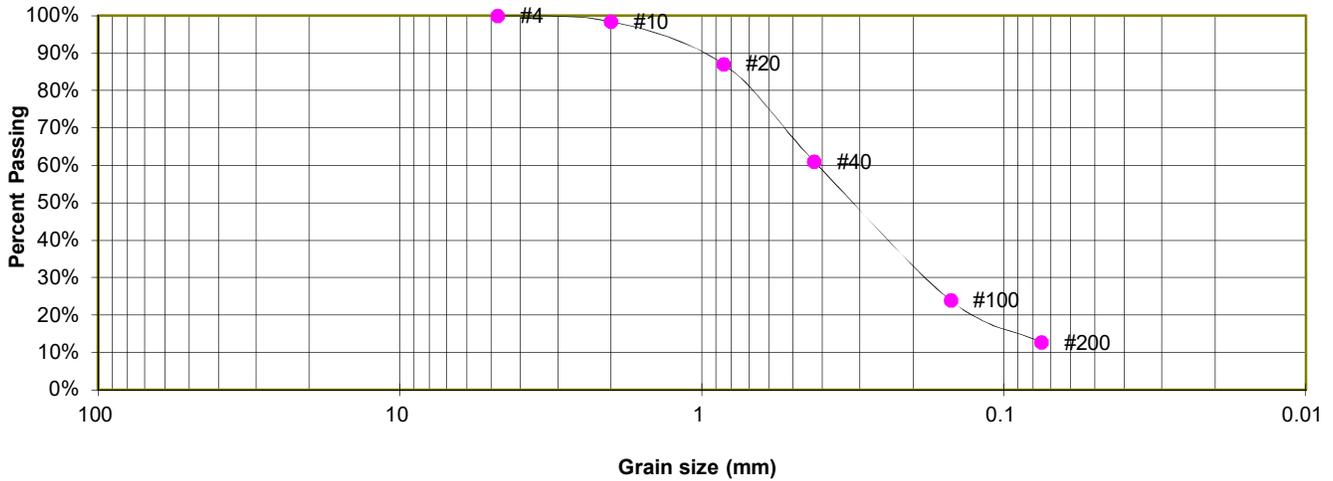
GRAIN SIZE ANALYSIS

TEST BORING 1
DEPTH (FT) 2-3

SOIL DESCRIPTION SAND, SILTY

Sieve Analysis Grain Size Distribution

U.S. Sieve #	Percent Finer
3"	
1 1/2"	
3/4"	
1/2"	
3/8"	
4	100.0%
10	98.5%
20	87.1%
40	61.1%
100	23.9%
200	12.7%
