Re: Soil, Geology, and Geologic Hazard Study
4-Lot Minor Subdivision
Parcel No. 43330-00-016
14090 Davis Road
El Paso County, Colorado
Entech Job No. 221987

Ginger Spence
Soil, Geology, and Geologic Hazard Study
4-Lot Minor Subdivision
Parcel No. 43330-00-016
14090 Davis Road
El Paso County, Colorado
Entech Job No. 221987

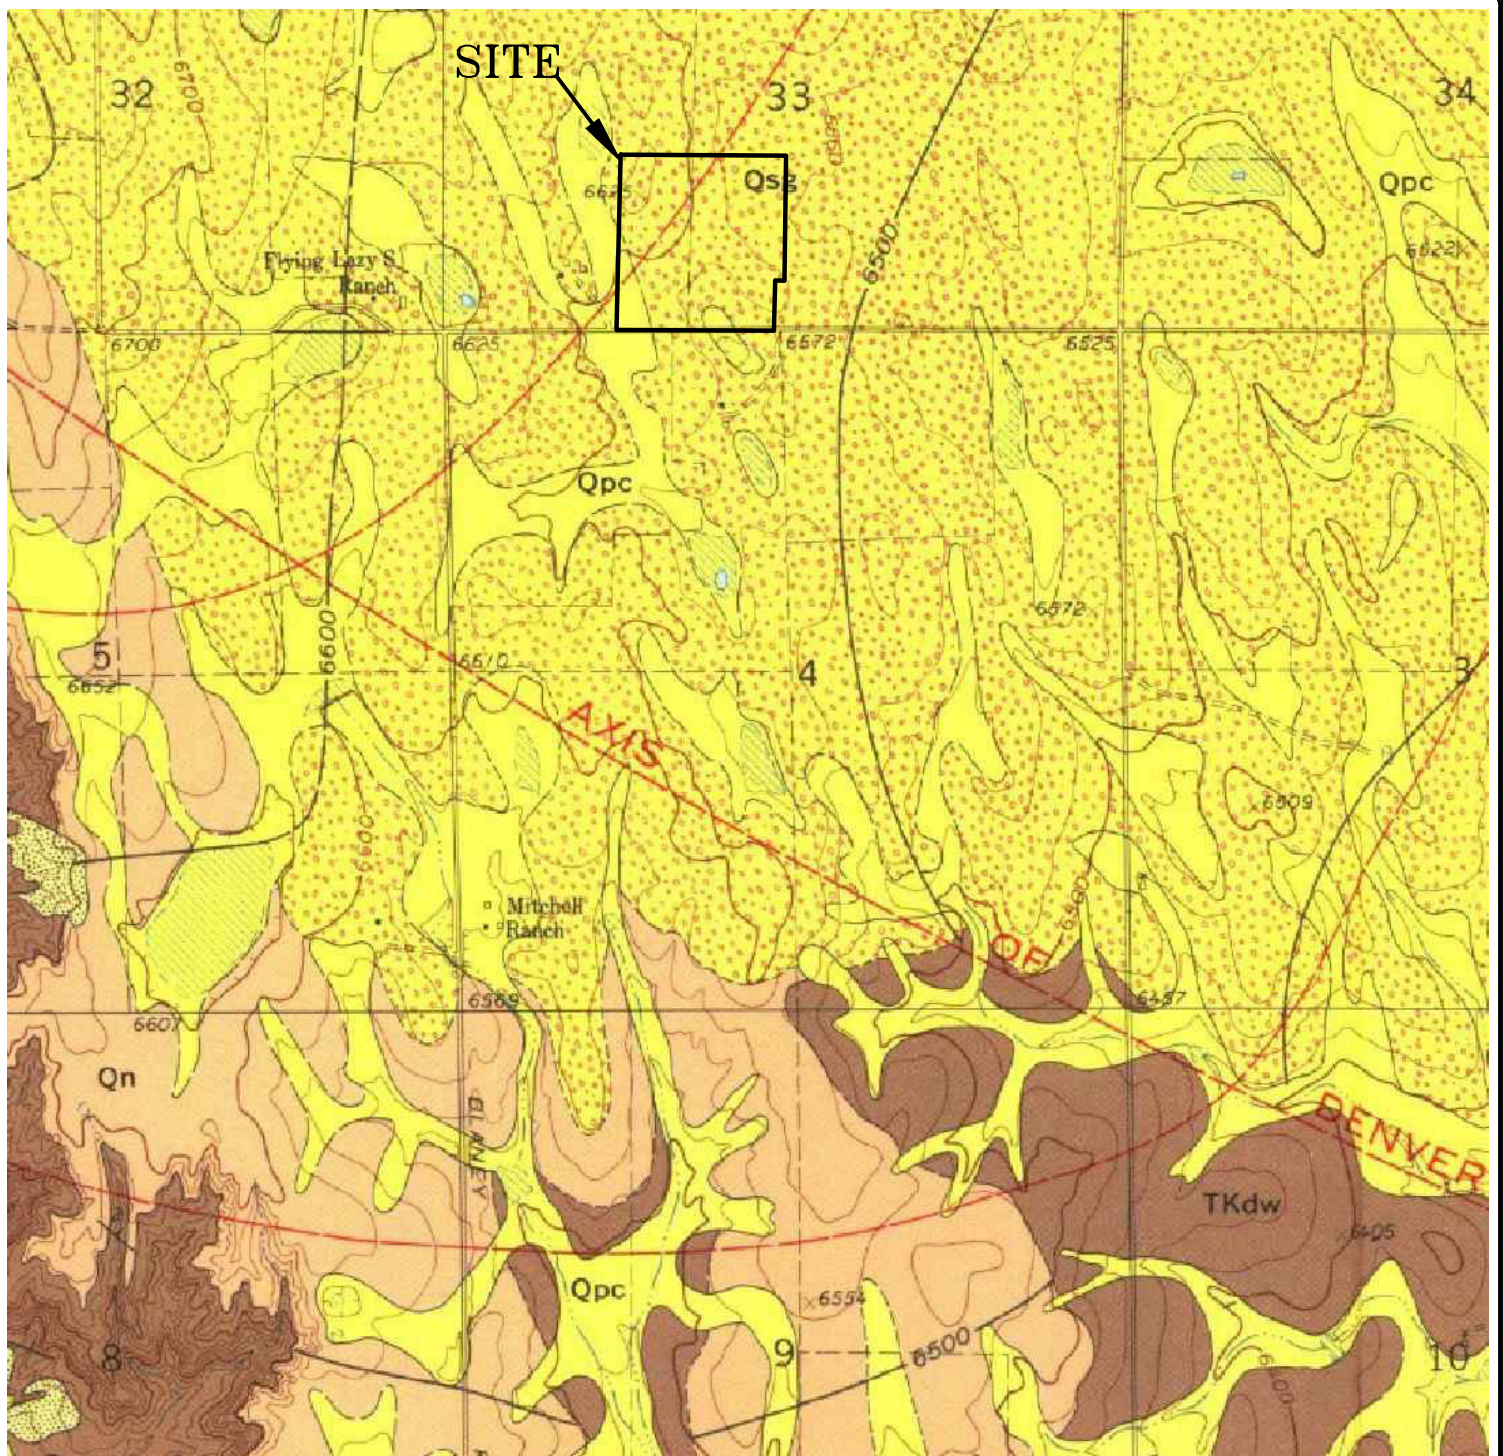
FIG NO.:
5

CORRAL BLUFFS QUADRANGLE GEOLOGIC MAP
4-Lot MINOR SUBDIVISION
14090 DAVIS ROAD
EL PASO COUNTY, CO.
FOR: GINGER SPENCE

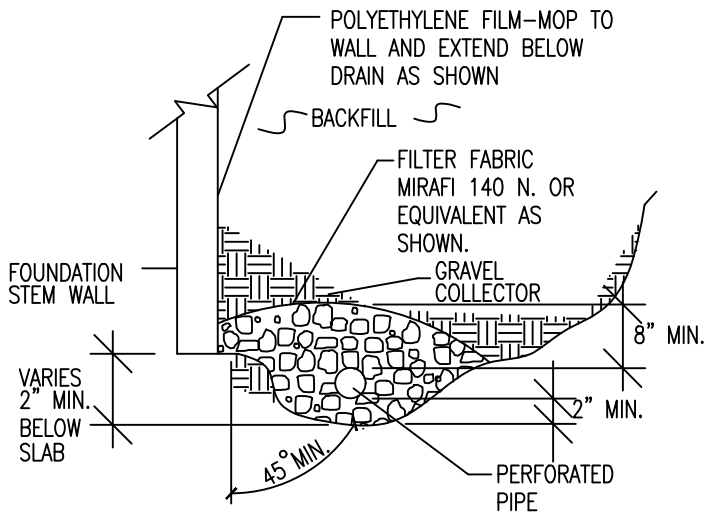
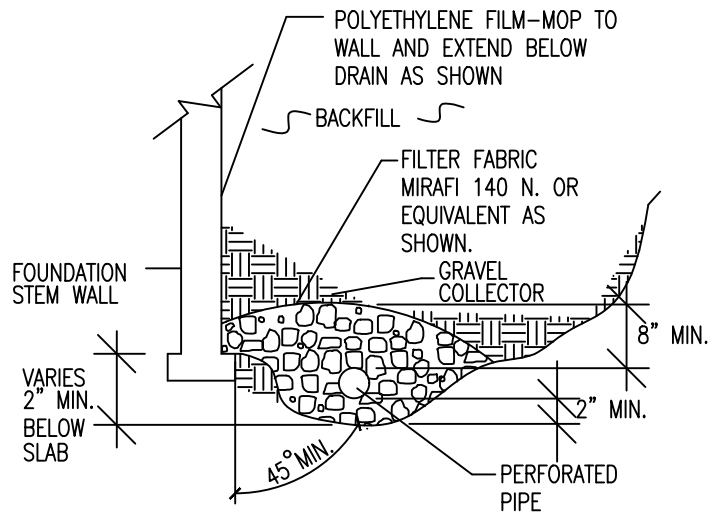
-GRAVEL SIZE IS RELATED TO DIAMETER OF PIPE PERFORATIONS-85% GRAVEL GREATER THAN 2x PERFORATION DIAMETER.

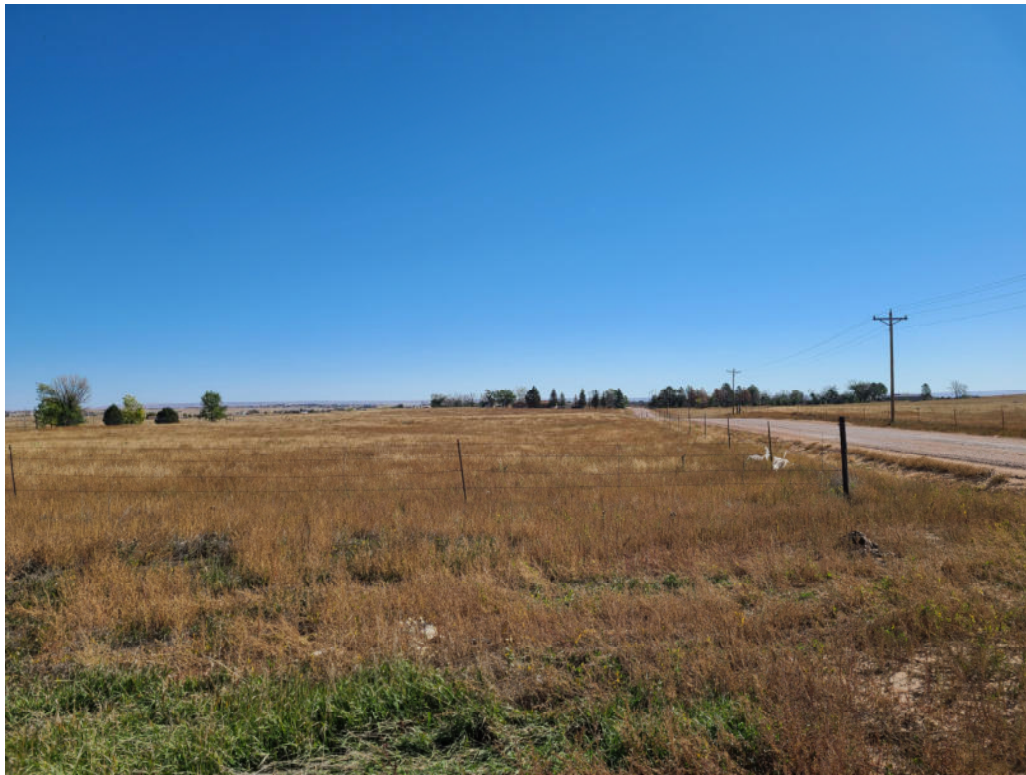
Looking east from the southwest side of the site.

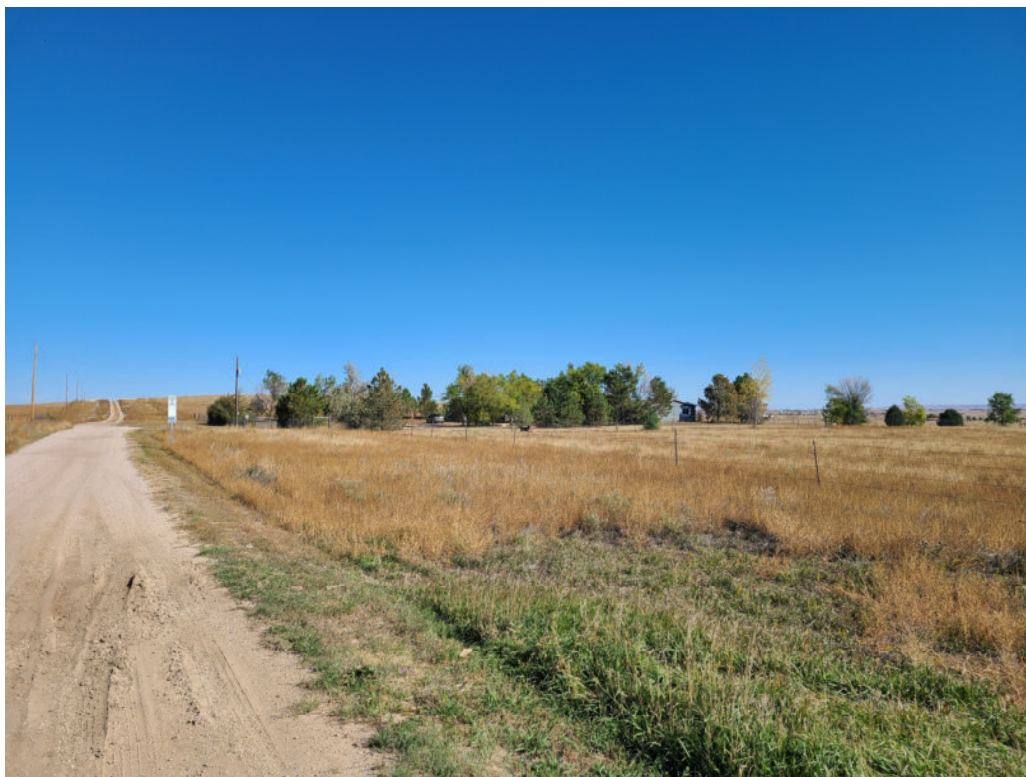
Looking north from the southwest side of the site.

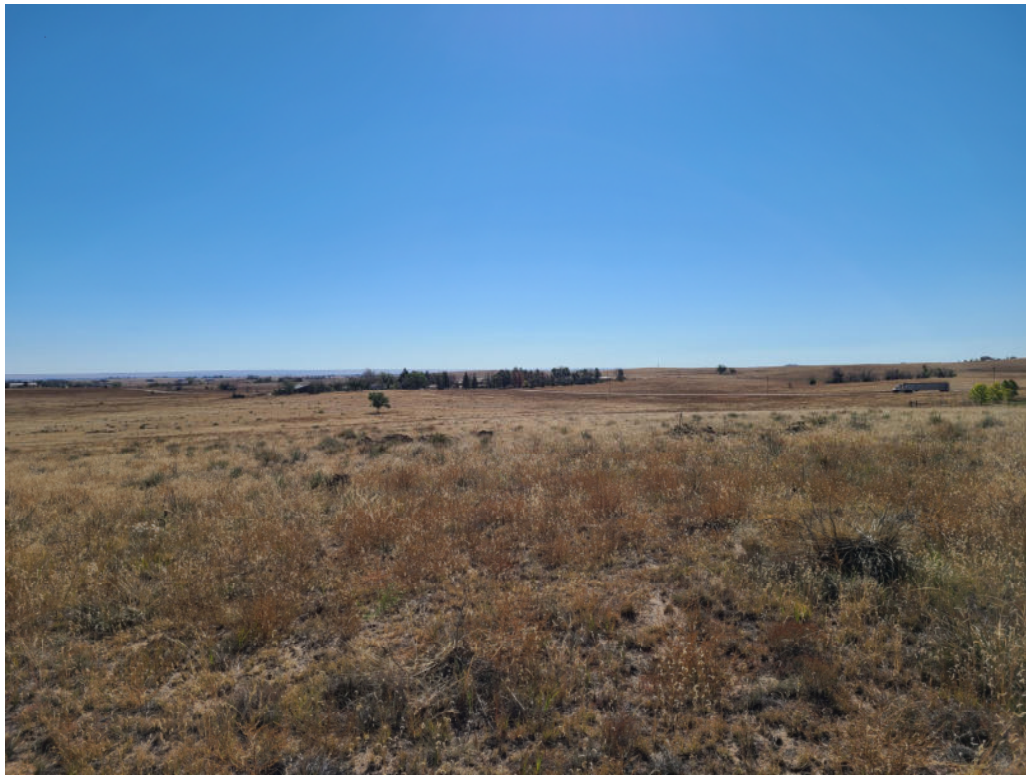
**Looking southeast
from the northwest
portion of the site.**

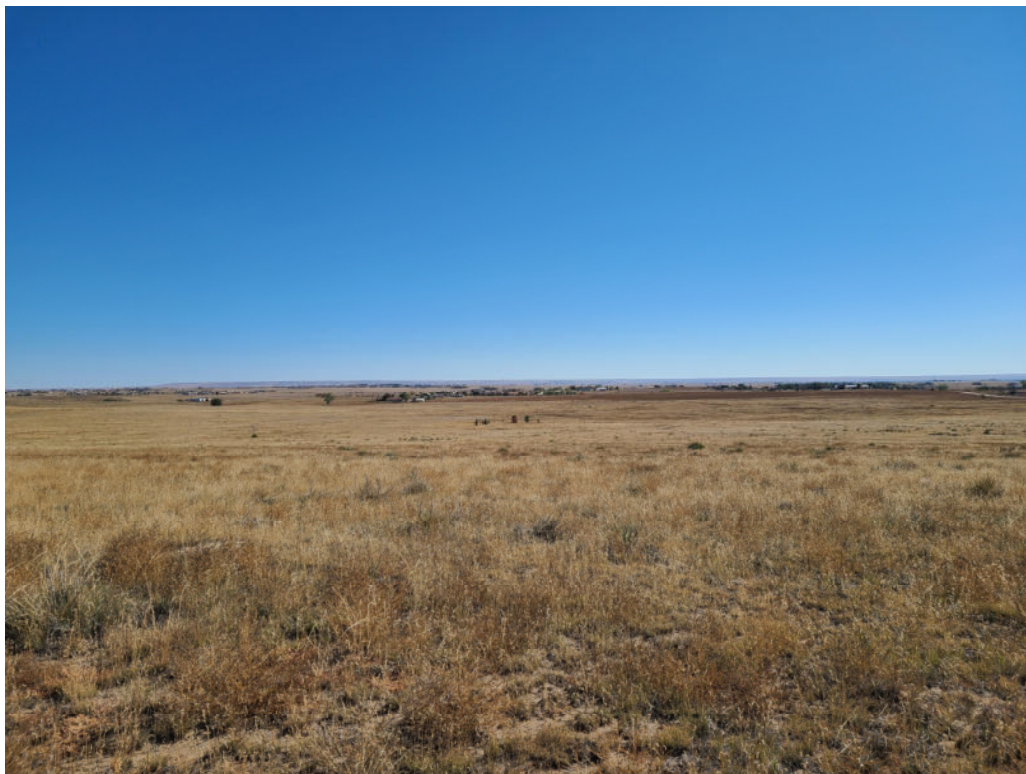
**Looking east from the
northwest portion of
the site.**

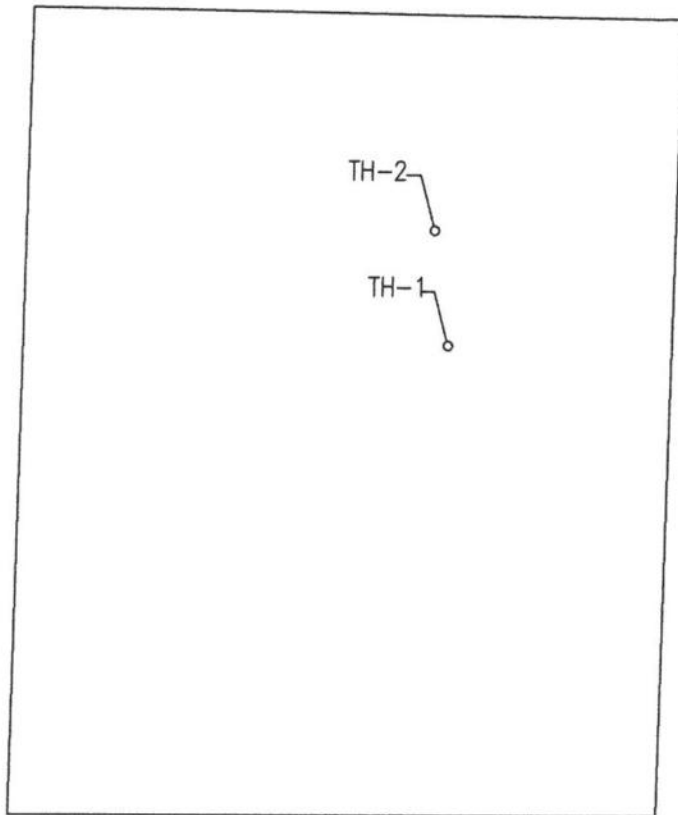
SITE MAP

0 Davis Road
El Paso County
Colorado
Job #22-0662
By: MJD

Two exploratory holes were drilled on July 14, 2022, at the locations shown on the enclosed site map. The location of these test holes was determined by Ginger Spence. The test holes were drilled with a 4-inch diameter auger. At intervals anticipated to be the foundation depths, and as determined by the soils conditions, the drill tools were removed, and samples were taken by the use of a 2-inch split barrel sampler connected to a 140-pound drop-hammer. This hammer is dropped 30 inches to drive the penetration sampler into the soil (**ASTM D-1586**). The depths and descriptions of the materials encountered in each test boring at which the samples were taken are shown on the enclosed log sheets. All samples were classified both in the field and in the laboratory to evaluate the physical and mechanical properties of the materials encountered.

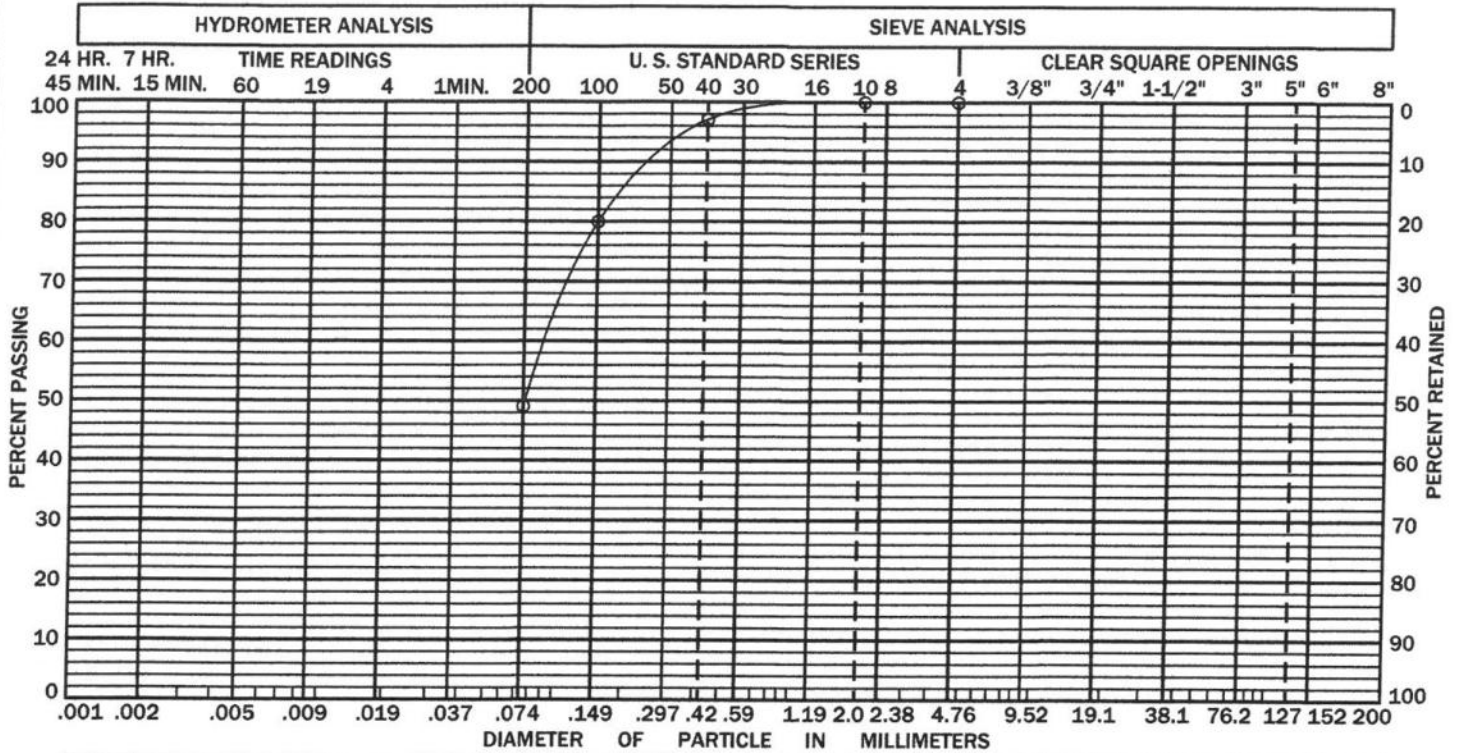
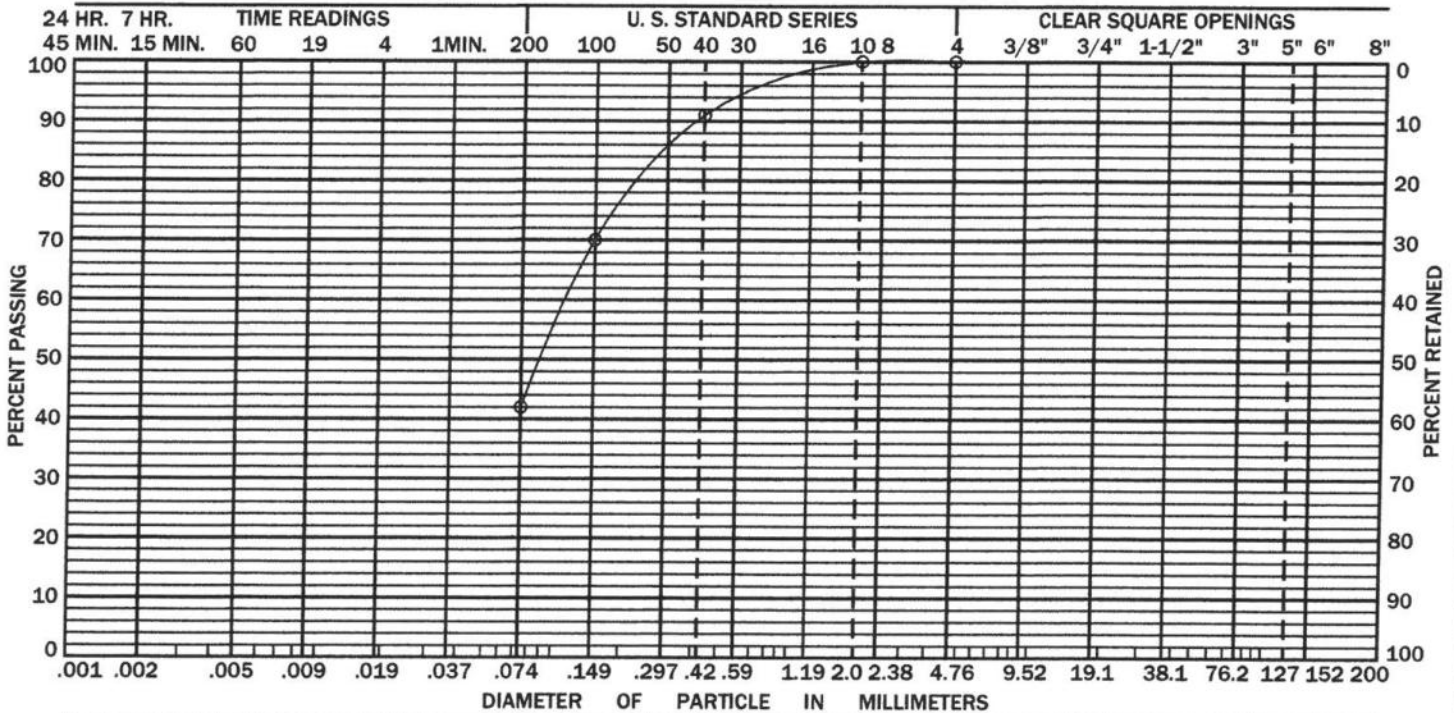
GEOQUEST LLC
GRADATION TEST RESULTS

CLAY TO SILT	SAND			GRAVEL		COBBLES
	FINE	MEDIUM	COARSE	FINE	COARSE	
CLASSIFICATION <u>SC</u>	NOTES: <u>5.42 % Moisture content</u>					
GRAVEL <u>0.00 %</u>	<u>Cu = 3.68</u>					
SAND <u>58.29 %</u>	<u>Non Plastic</u>					
FINES <u>41.71 %</u>						
SAMPLE# <u>2</u> HOLE# <u>TH-1</u> DEPTH <u>9</u> FEET	<u>Job: 22-0662</u>		<u>By: acm</u>		<u>08/03/2022</u>

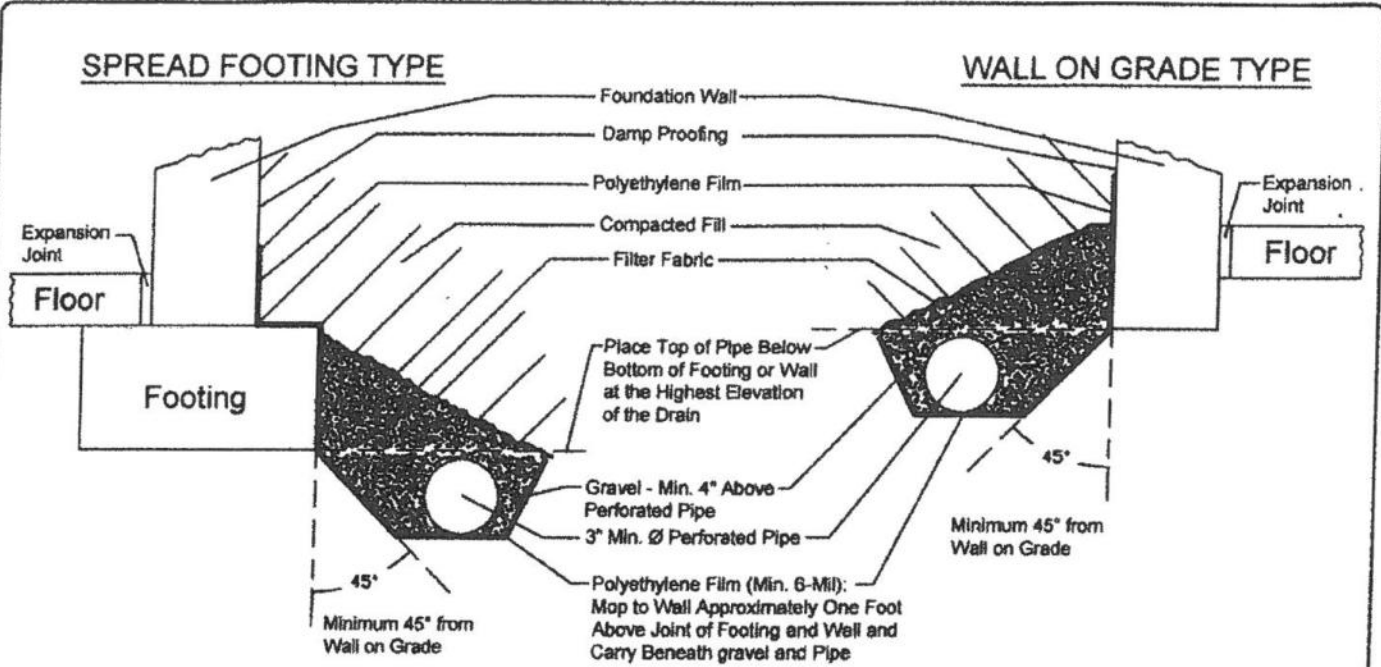
EXTERIOR DRAIN DETAIL

1. Gravel to be Not More Than 1-1/2" and Not Less Than 1/2" Diameter.
2. Perforated Pipe Diameter Varies With Expected Seepage. 3"Ø and 4"Ø are Most Common. ABS and PVC are Most Common Materials for Pipe. We approve the use of an "EZ Flow Drainage System" by Infiltrator. All specifications in this drain detail are still applicable.

3. Pipe to be Laid out in a Minimum Slope of 1" in 10'.
4. Gravity Outfall is Desired if Possible. Portion of Pipe in Area Not Drained Shall be Non-Perforated. Daylight Must be Maintained Clear of Debris in Order to Function Properly.

7. Filter Fabric to be Mirafi 140s or Approved Equivalent. Roofing Felt and Sheet Plastic are Not Acceptable.
8. Drain Pipe Shall be Laid Below Protected Area, as Shown in The Detail Above.

9. Mop Polyethylene Film to Wall Approximately One Foot Above Joint of Footing and Wall (Do Not Pull Plastic Tight) and Carry Beneath Gravel and Pipe.
10. The Polyethylene Film Shall be Continued to the Edge of the Excavation.

Perimeter drains are required around all walls of the habitable or usable area portion of the structure that are below finished grade including all common wall(s) adjacent to the basement. Crawlspace, slab on grade, and walkout areas need not be drained unless specified at the time of the Open Hole Observation. Perimeter drains may be required during the open hole due to high moisture or grade that slopes toward the excavation. The final determination of the necessity for perimeter drains will be made at the time of the Open Hole Observation. An Exterior Drain Detail is provided in this report. Drains should daylight away from the structure or discharge to a sump pump. Even if drains are not required, areas below grade may experience moisture problems if unusual conditions are present in the future.

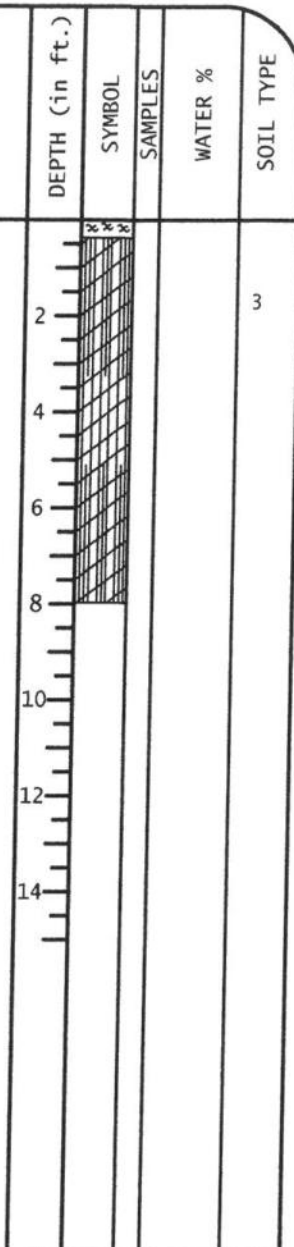
Fine-coarse Grained
 High Density
 Low Moisture Content
 Moderate Clay Content
 Low-moderate Cohesion
 Low-moderate Plasticity
 Dark Yellowish Brown Color
 10YR 4/4

USDA Soil Texture: Sandy Clay Loam
 USDA Soil Type: 3
 USDA Structure Shape: Blocky
 USDA Structure Grade: 2
 Cementation Class: Non-cemented
 Long Term Acceptance Rate (LTAR, Treatment Level 1):0.35
 0% Rock

LTAR to be Used for OWTS Sizing: 0.35GPD/SF (USDA Type 3, Treatment soil, Treatment Level 1)
Depth to Groundwater (Permanent or Seasonal): Not Encountered
Depth to Bedrock and Type: Not Encountered
Depth to Proposed Infiltrative Surface from Ground Surface: Unknown (Maximum 4ft Below Existing Ground Surface)
Soil Treatment Area Slope and Direction: East @ 4%

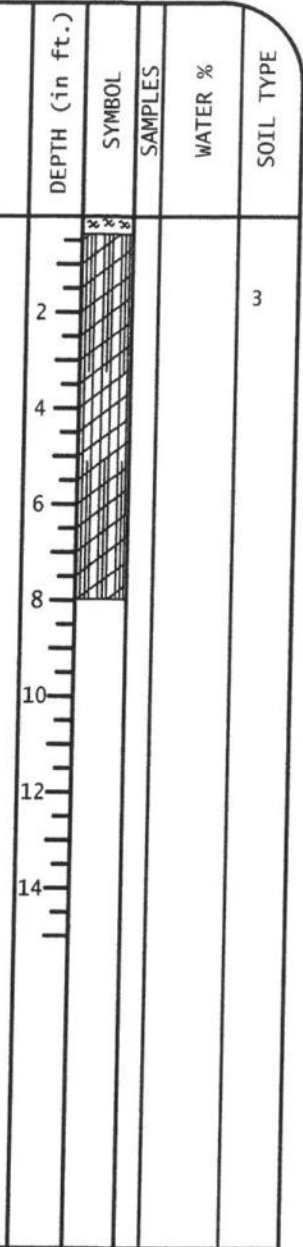
Fine-coarse Grained
 High Density
 Low Moisture Content
 Low-moderate Clay Content
 Low-moderate Cohesion
 Low-moderate Plasticity
 Dark Yellowish Brown Color
 10YR 4/4

USDA Soil Texture: Sandy Clay Loam
 USDA Soil Type: 3
 USDA Structure Shape: Blocky
 USDA Structure Grade: 2
 Cementation Class: Non-cemented
 Long Term Acceptance Rate (LTAR, Treatment Level 1): 0.35
 0% Rock

LTAR to be Used for OWTS Sizing: 0.35GPD/SF (USDA Type 3, Treatment soil, Treatment Level 1)
Depth to Groundwater (Permanent or Seasonal): Not Encountered
Depth to Bedrock and Type: Not Encountered
Depth to Proposed Infiltrative Surface from Ground Surface: Unknown (Maximum 4ft Below Existing Ground Surface)
Soil Treatment Area Slope and Direction: East @ 4%

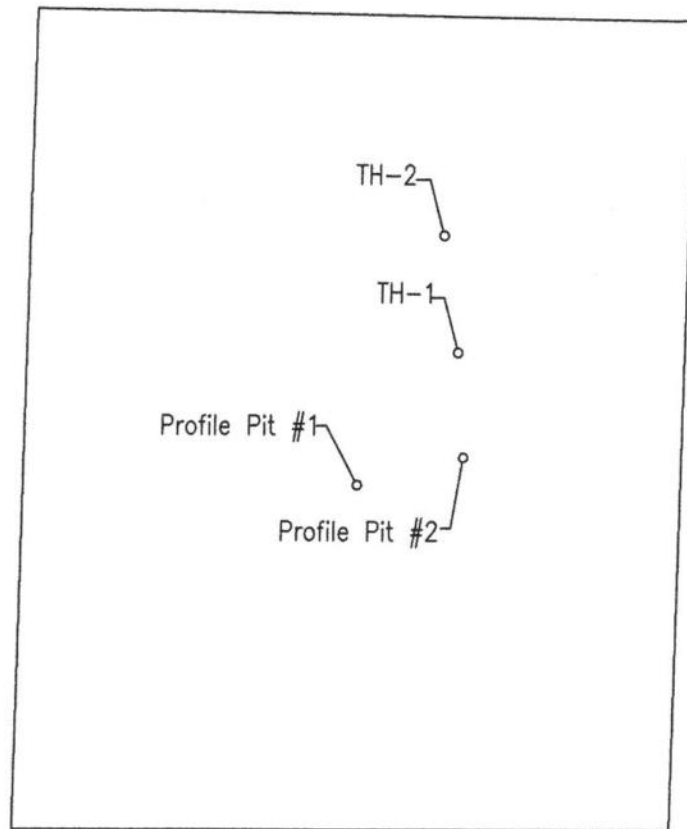
GEOQUEST LLC
SITE MAP

0 Davis Road
El Paso County
Colorado
Job #22-0662

Enclosed are the results of the profile pit for the septic system to be installed at **0 Davis Road, El Paso County, Colorado**. The location of the test pits was determined by Ginger Spence. The residence will not be on a public water system. The number of bedrooms in the design for the residence is unknown. Due to the natural slope of the property, the entire system will feed to the east at approximately 4% at least 20 feet. All applicable portions of the El Paso County Public Health Department Onsite Wastewater Treatment System Regulations (OWTS) must be complied with for the installation of the treatment system.
