OWTS FEASABILITY REPORT

**JOB #23-060
14090 DAVIS ROAD,
SCHEDULE NUMBER: 4333000016
EL PASO COUNTY,
COLORADO**

PREPARED BY: D&D ENGINEERING, LLC

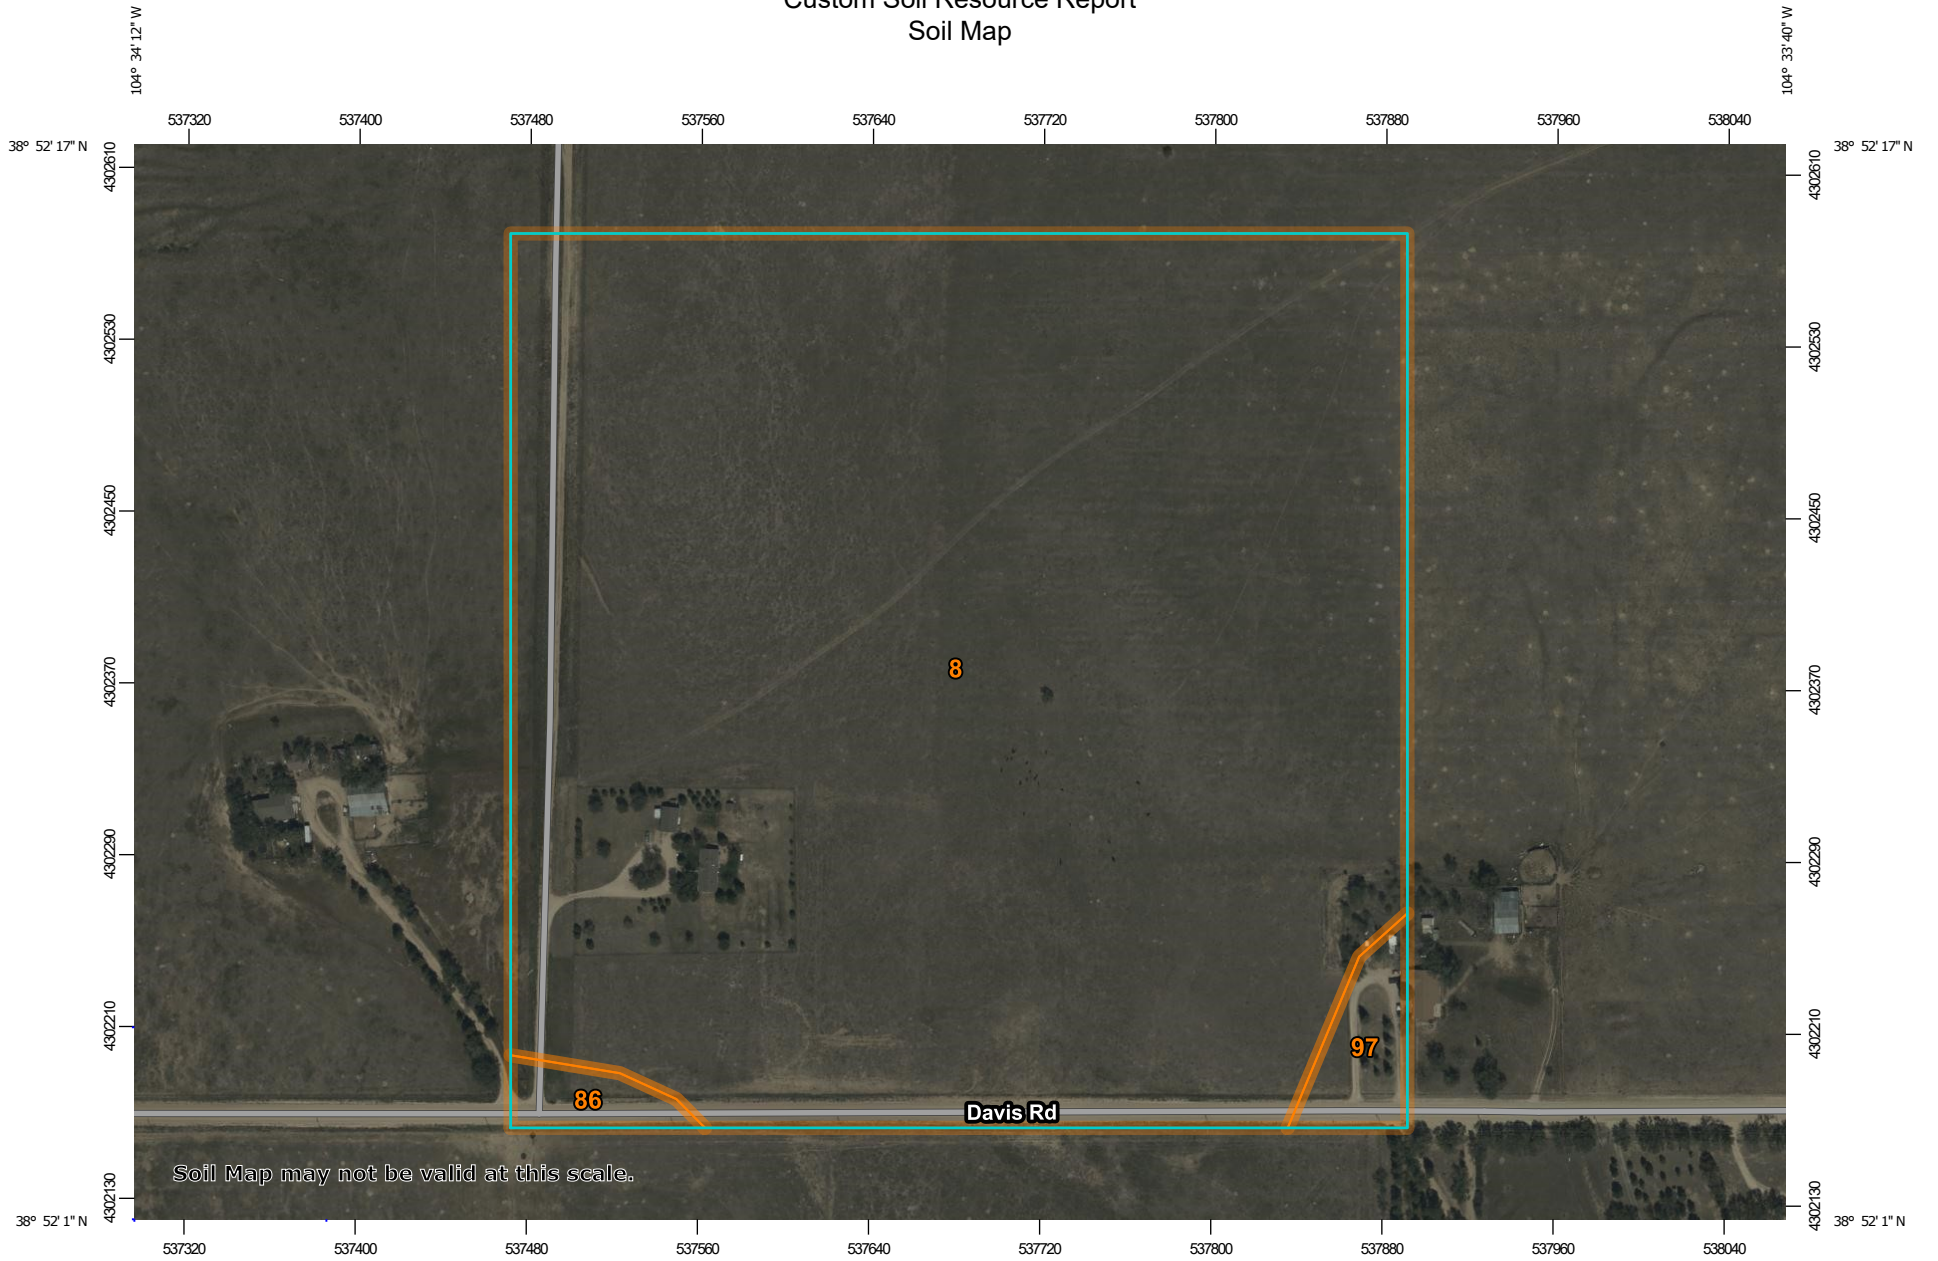
Custom Soil Resource Report Soil Map

Map Scale: 1:3,530 if printed on A landscape (11" x 8.5") sheet.

The USDA soil survey indicates the majority of the proposed development is located in the Blakeland loamy sand formation (Reference 3, Appendix B). The formation typically has slopes of 1 to 9 percent. The typical profile is loamy sand with underlying sand. No restrictive features or water table are expected within 80 inches. Other formations exist at the southeast and southwest corners of Lot 4, outside the proposed development. The USDA describes the site a very limited for Septic Tank Absorption Fields. See the soil investigation, soil descriptions, and conclusions below.
