Subject: Pond Embankment Requirements
Haven Valley (formerly Patriot Village)
Alturas Drive and Cable Lane
Security-Widefield, Colorado
Project No. CS18980.001-115

Subject: Geologic Hazard Evaluation and Preliminary Geotechnical Investigation
Haven Valley (formerly Patriot Village)
Alturas Drive and Cable Lane
Security-Widefield, Colorado
CTL|T Project No. CS18980-115

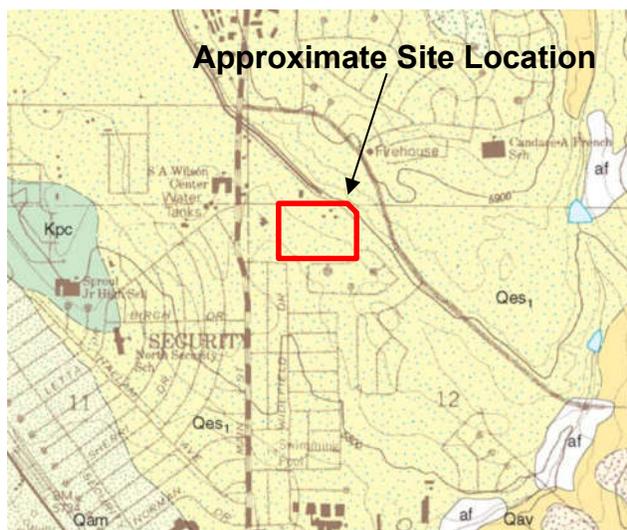
Geologic Map

The site is mapped as late Pleistocene-age eolian sand (wind-deposited sediment) consisting of very pale-brown, pale-brown, and light yellowish-brown sand with silt deposited as sand sheets, overlying the Dawson Formation. The Dawson Formation typically consists of sandstone interbedded with claystone in this area. Our subsurface investigation and observations generally confirm the mapping, although bedrock was not encountered to the depths explored of 20 and 30 feet. No significant geologic features were identified at the site. A map of the site specific surficial geologic conditions is shown on Figure 1.

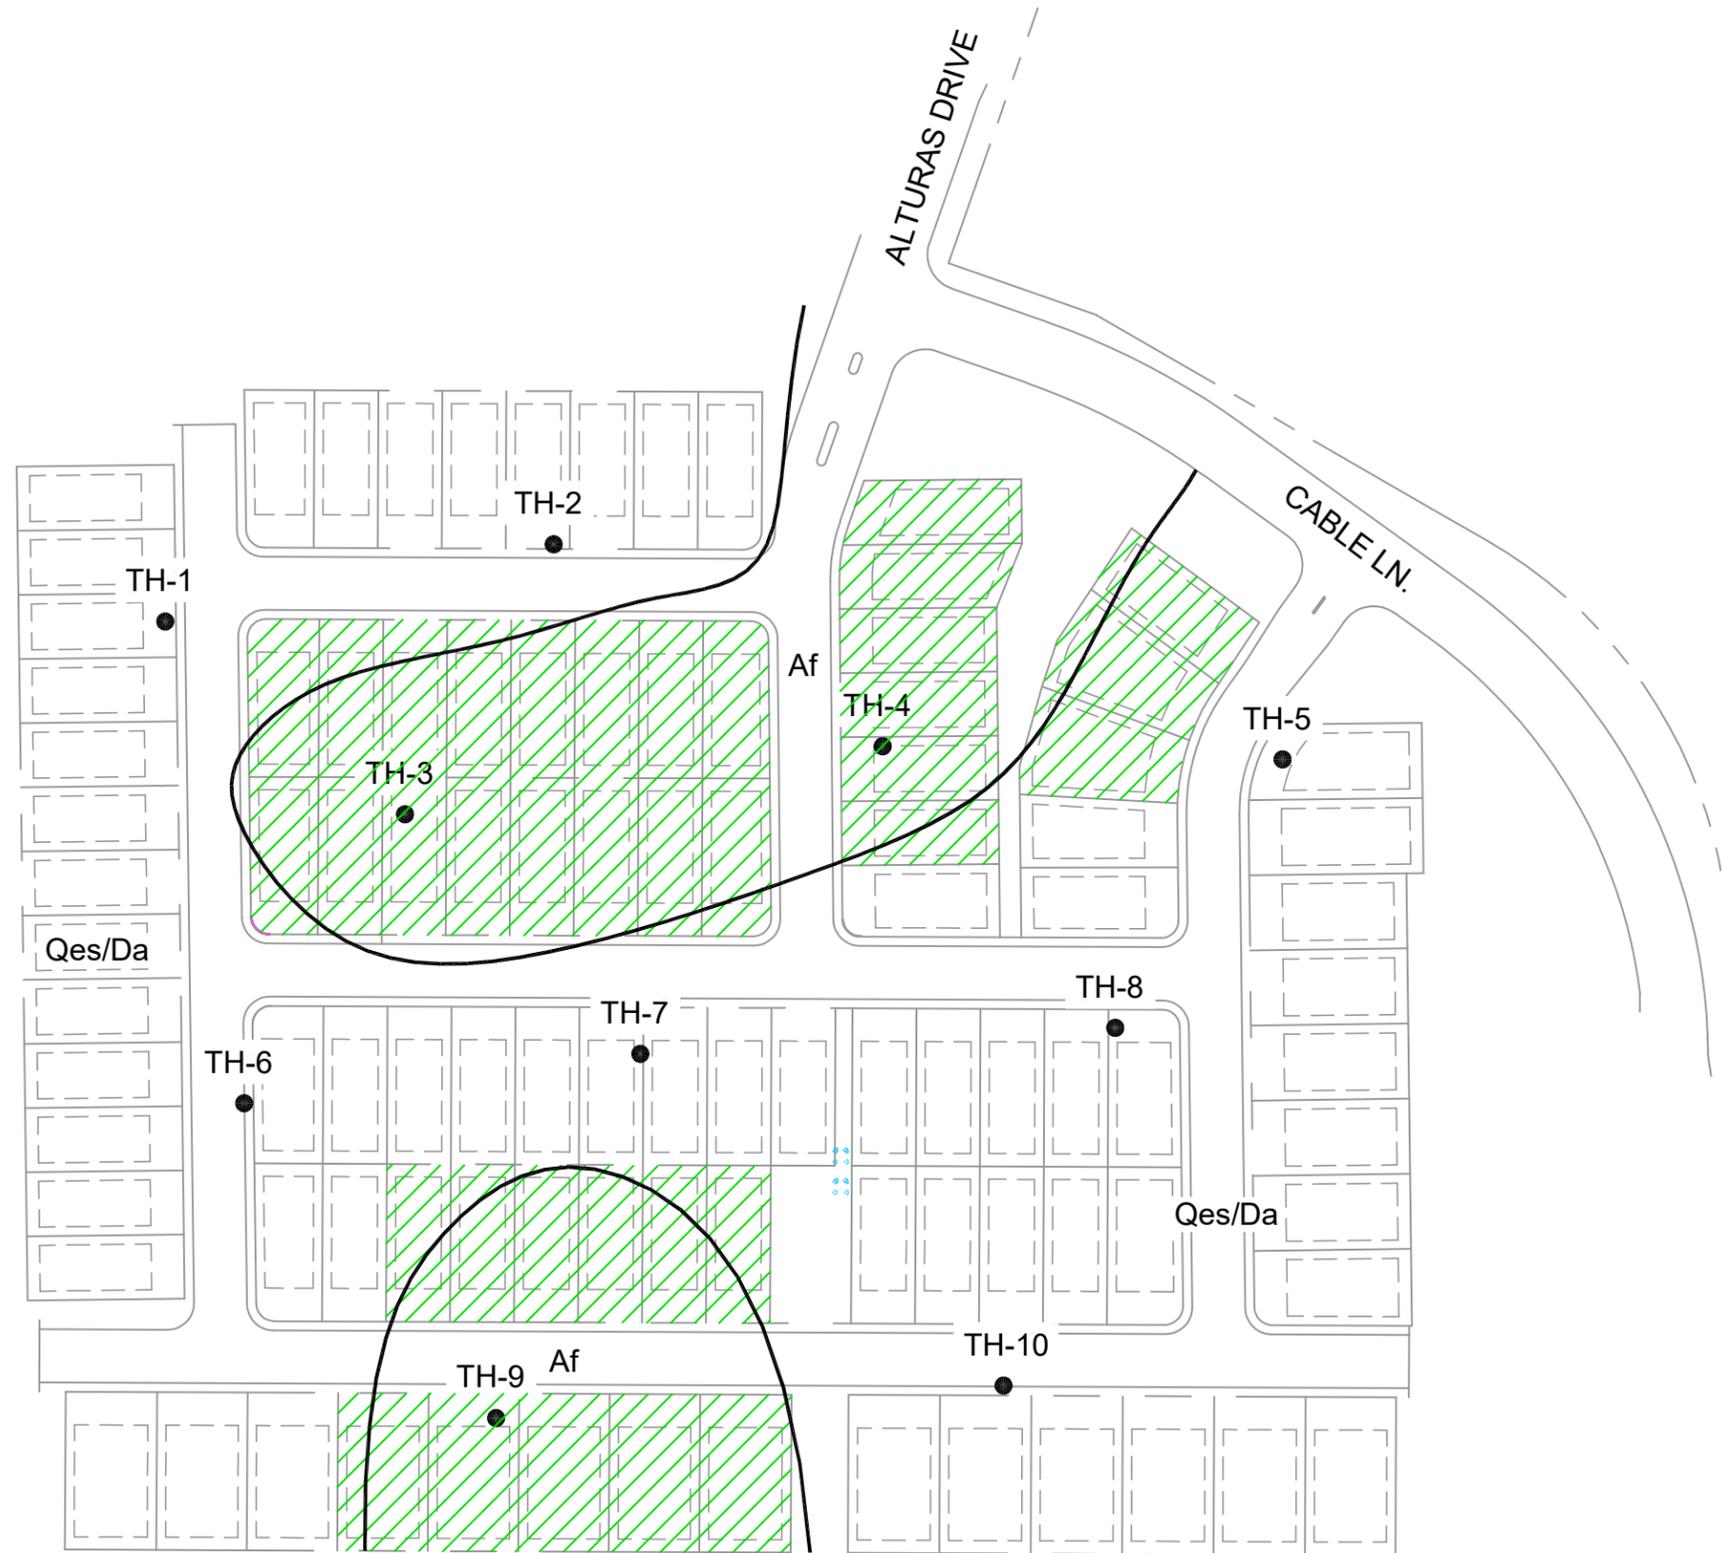
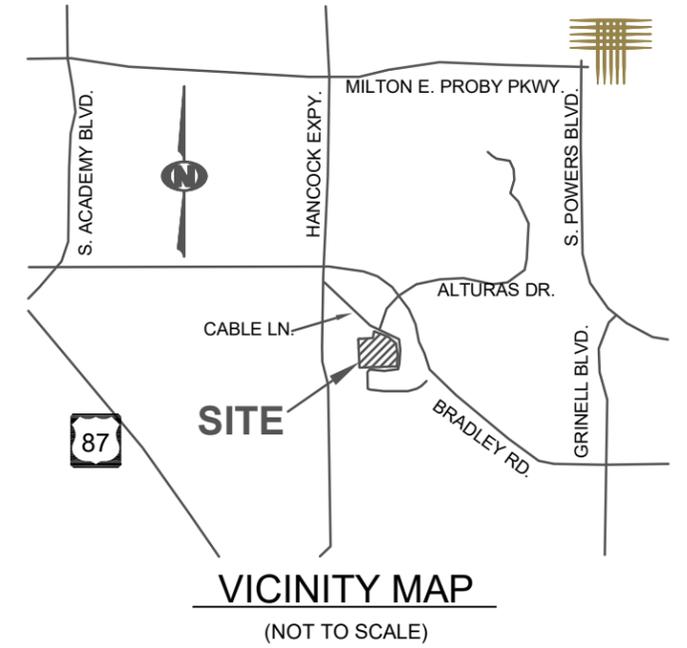
- LEGEND:**
- TH-1 APPROXIMATE LOCATION OF EXPLORATORY BORING.
 - APPROXIMATE GEOLOGIC BOUNDARY.
 - Af AREA WHERE MANMADE FILL MAY BE PRESENT.
 - Qes/Da AREA WHERE EOLIAN SAND MAY BE PRESENT WITH SURFICIAL DISTURBANCE.
 - ▨ INDICATES LOTS WHERE MITIGATION OF EXISTING FILL MAY BE REQUIRED, BASED ON CURRENT DATA.

This letter presents the results of our Geologic Hazard Evaluation and Preliminary Geotechnical Investigation for Haven Valley. The site is located south of the intersection of Alturas Drive and Cable Lane in Security-Widefield, Colorado (Fig. 1).

Subsurface conditions in the area of the subject lots were investigated by our firm by drilling ten exploratory borings spread across the site, to depths between 20 and 30 feet. The approximate locations of the borings are shown in Fig. 1.

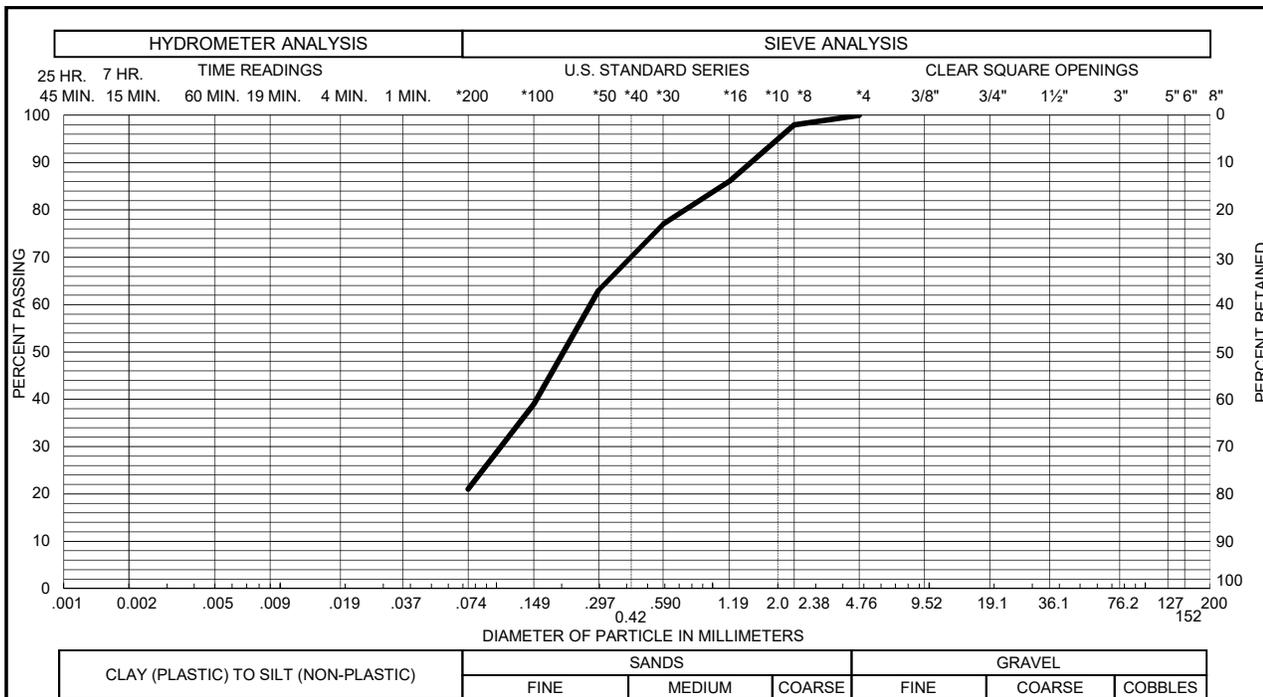
Sample of **SAND, SILTY (SM)** GRAVEL **0 %** SAND **79 %**
 From **TH - 1 AT 4 FEET** SILT & CLAY **21 %** LIQUID LIMIT **%
 PLASTICITY INDEX **%****

Natural, slightly silty to silty sand was encountered at the ground surface in seven of the borings and below the fill in three of the borings. The sand was loose to dense. Eleven samples of the sand tested in our laboratory contained 6 to 21 percent silt and clay-sized particles (passing the No. 200 sieve).

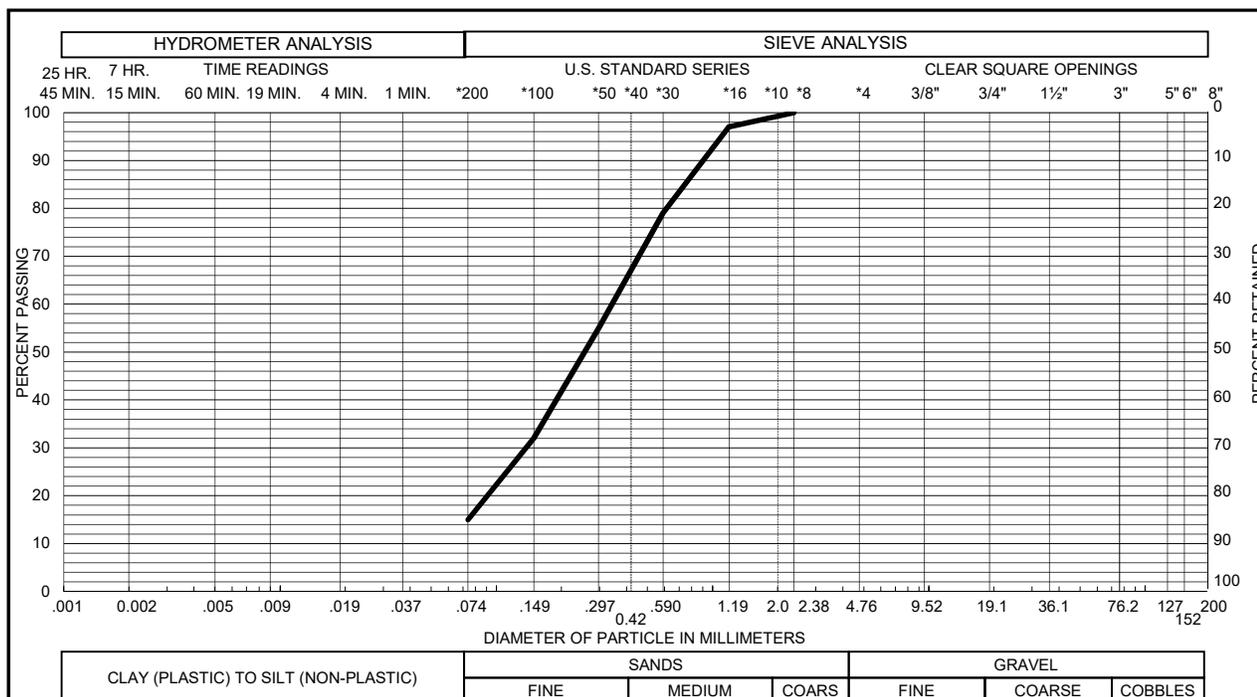
Sample of **SAND, SILTY (SM)** GRAVEL **0 %** SAND **85 %**
 From **TH - 2 AT 9 FEET** SILT & CLAY **15 %** LIQUID LIMIT **%
 PLASTICITY INDEX **%****

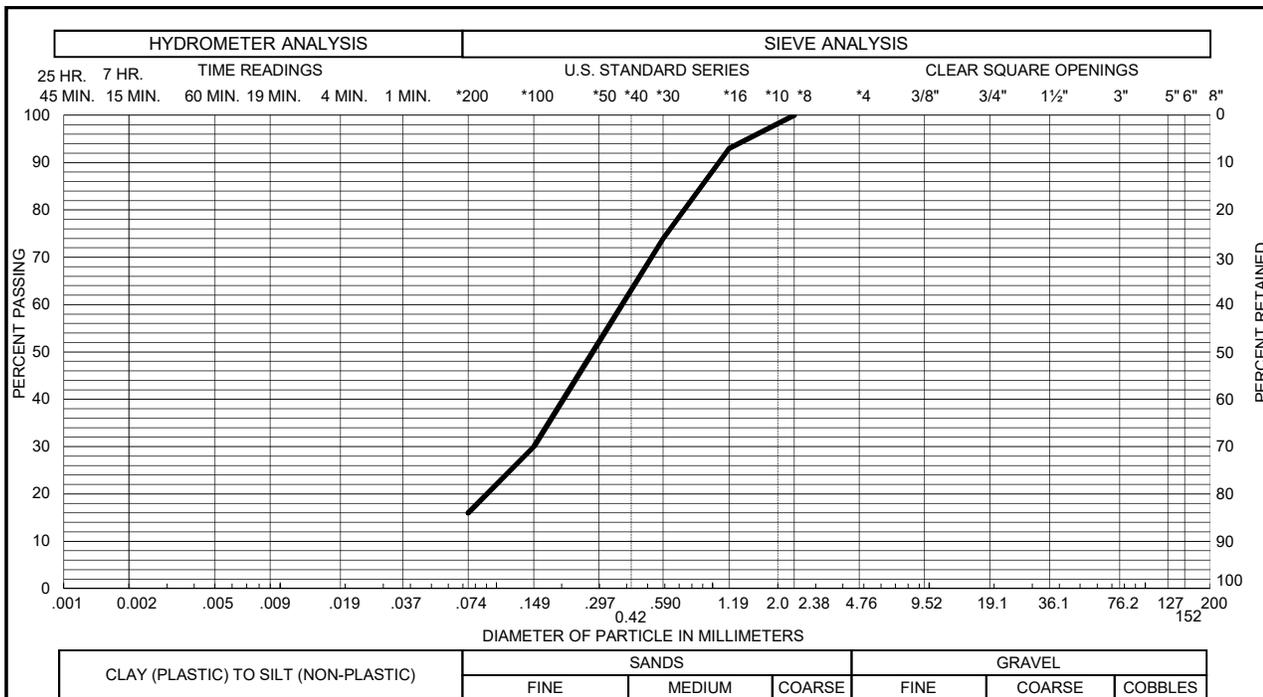
Sample of **SAND, SILTY (SM)** GRAVEL 0 % SAND 84 %
 From **TH - 5 AT 4 FEET** SILT & CLAY 16 % LIQUID LIMIT **NP** %
 PLASTICITY INDEX **NP** %

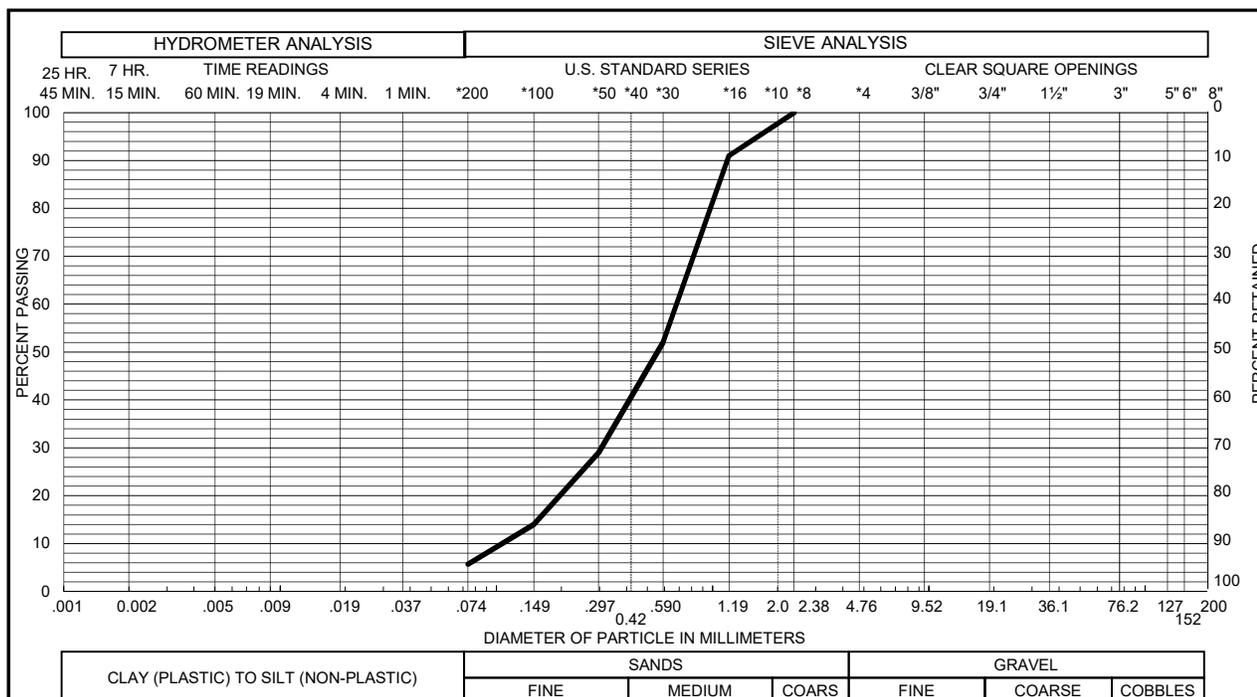
Sample of **SAND, SLIGHTLY SILTY (SP-SM)** GRAVEL 0 % SAND 94 %
 From **TH - 7 AT 9 FEET** SILT & CLAY 6 % LIQUID LIMIT %
 PLASTICITY INDEX %

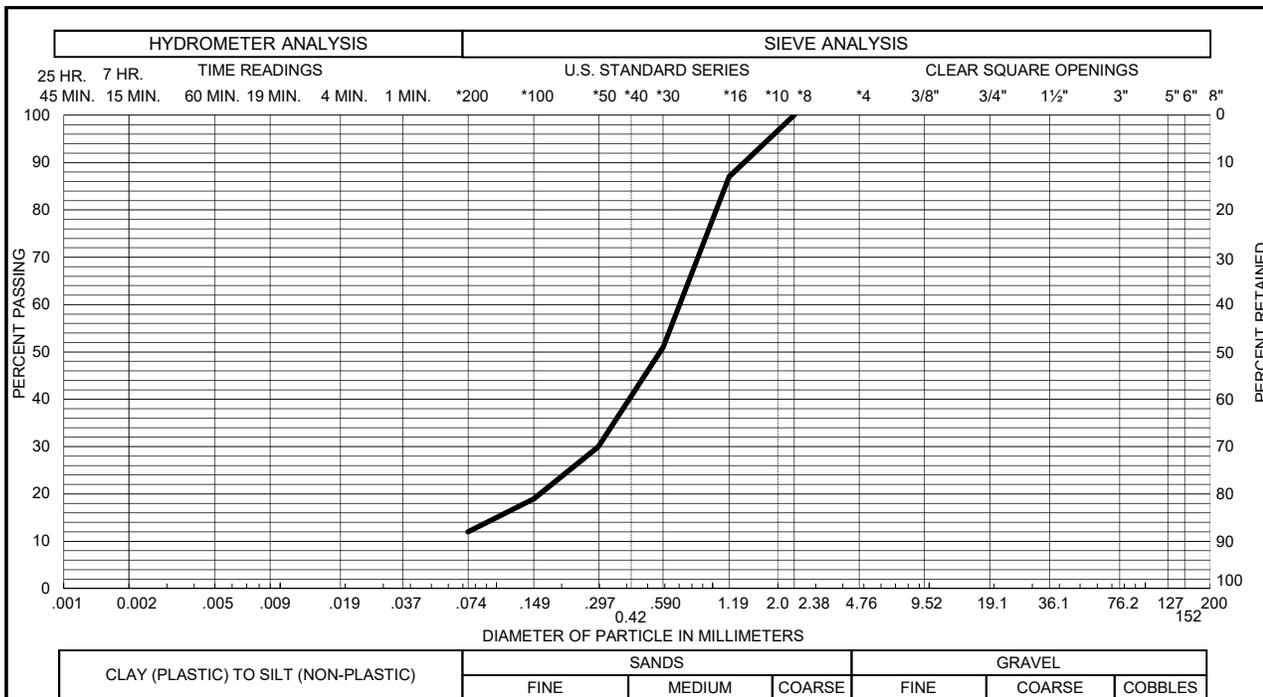
Sample of **SAND, SLIGHTLY SILTY (SP-SM)** GRAVEL 0 % SAND 88 %
 From TH - 9 AT 9 FEET SILT & CLAY 12 % LIQUID LIMIT _____ %
 PLASTICITY INDEX _____ %
