Subject: Geologic Hazard Evaluation and Preliminary Geotechnical Investigation  
Haven Valley (formerly Patriot Village)  
Alturas Drive and Cable Lane  
Security-Widefield, Colorado  
CTL|T Project No. CS18980-115

This letter presents the results of our Geologic Hazard Evaluation and Preliminary Geotechnical Investigation for Haven Valley. The site is located south of the intersection of Alturas Drive and Cable Lane in Security-Widefield, Colorado (Fig. 1).

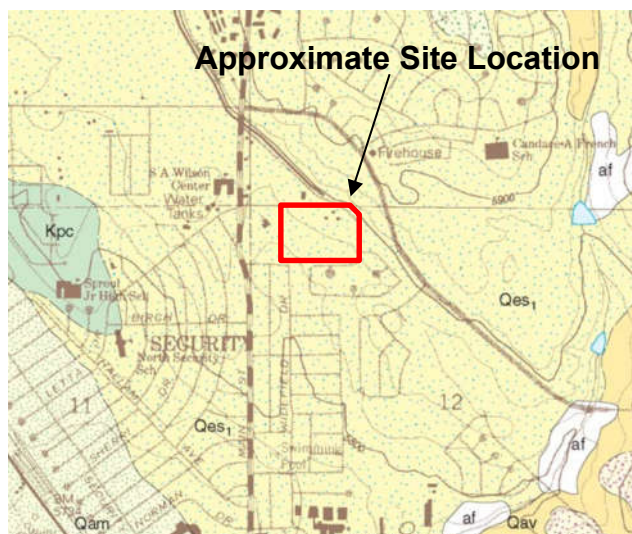
**Geologic Map**

The site is mapped as late Pleistocene-age eolian sand (wind-deposited sediment) consisting of very pale-brown, pale-brown, and light yellowish-brown sand with silt deposited as sand sheets, overlying the Dawson Formation. The Dawson Formation typically consists of sandstone interbedded with claystone in this area. Our subsurface investigation and observations generally confirm the mapping, although bedrock was not encountered to the depths explored of 20 and 30 feet. No significant geologic features were identified at the site. A map of the site specific surficial geologic conditions is shown on Figure 1.

The surficial geology at the site was evaluated by reviewing published geologic maps. The Geologic Map of the Elsmere Quadrangle published by the Colorado Geological Survey in (Madole and Thorson, 2002) covers the project site.

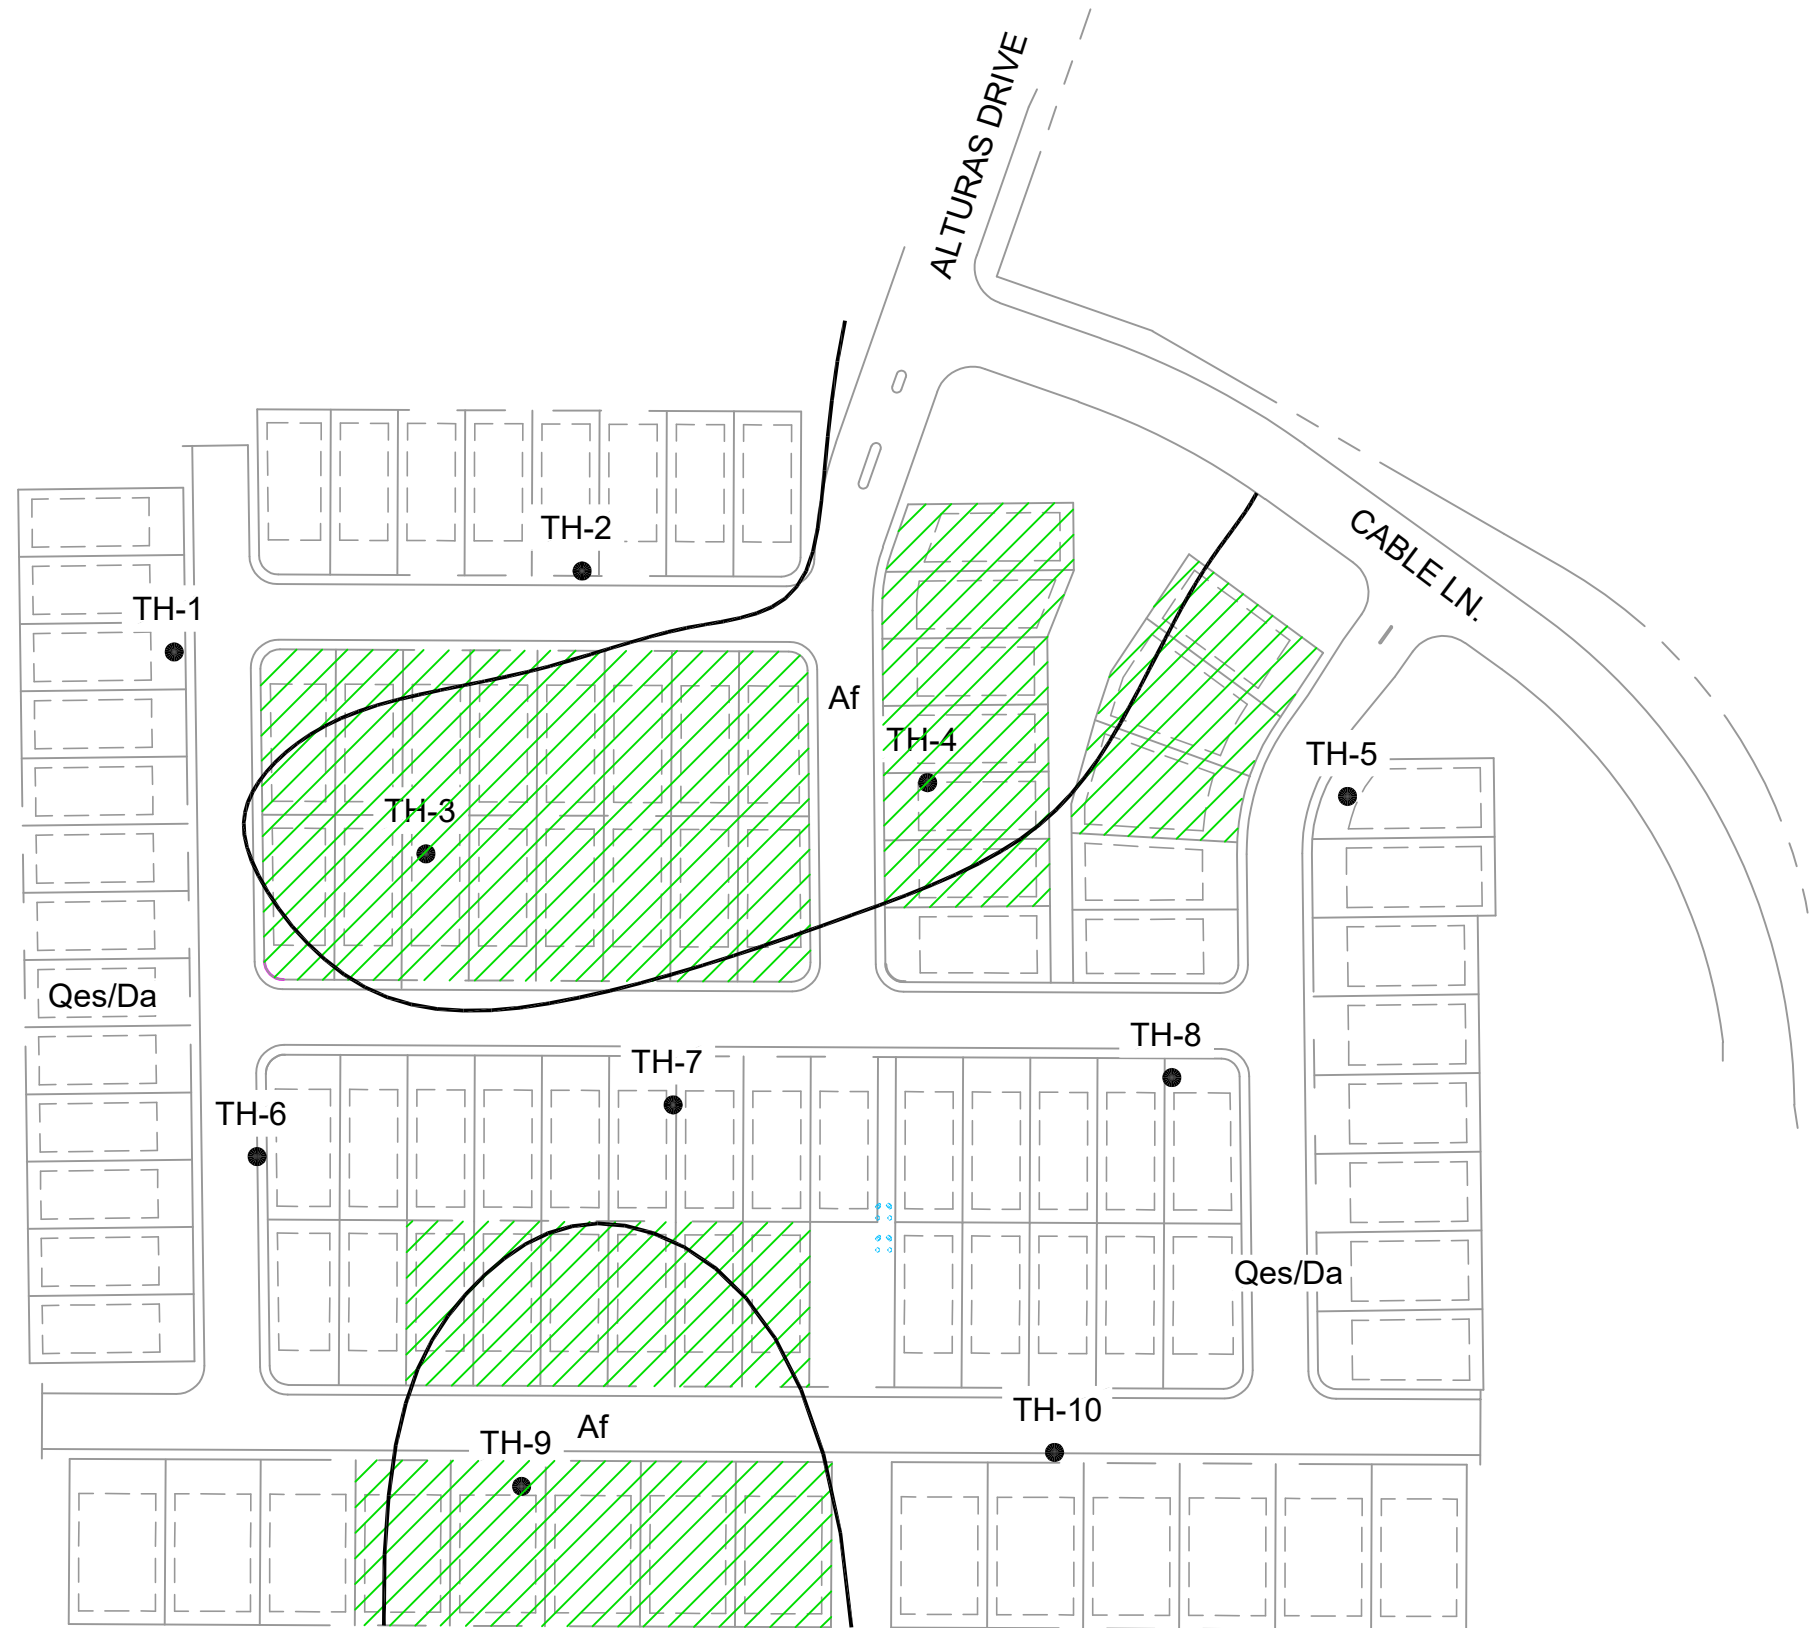
**Location of  
Exploratory  
Borings**

- LEGEND:**
- TH-1 APPROXIMATE LOCATION OF EXPLORATORY BORING.
  - APPROXIMATE GEOLOGIC BOUNDARY.
  - Af AREA WHERE MANMADE FILL MAY BE PRESENT.
  - Qes/Da AREA WHERE EOLIAN SAND MAY BE PRESENT WITH SURFICIAL DISTURBANCE.
  - ▨ INDICATES LOTS WHERE MITIGATION OF EXISTING FILL MAY BE REQUIRED, BASED ON CURRENT DATA.

The site has been previously disturbed, and there were structures located at the northeast corner of the site. Aerial photos indicate the structures were razed between 2006 and 2011. We encountered fill in three of the borings. Two of these borings were near the previous structures and one boring was near the southwest corner of the site. The approximate extents of undocumented fill are shown on Figure 1. The remainder of the site has likely been surficially disturbed and there is evidence of contouring to control surface water. Undocumented fill should be removed and re-worked or replaced, according to the recommendations set forth in the **SITE GRADING** section of this report. Design-level geotechnical studies should be undertaken to confirm the presence of fill and depths of fill and to provide recommendations for reworking. If documentation of the fill, such as density test records are found, we should review them to determine if they are adequate for the proposed construction.
