Subject: Geologic Hazard Evaluation and Preliminary Geotechnical Investigation  
Haven Valley (formerly Patriot Village)  
Alturas Drive and Cable Lane  
Security-Widefield, Colorado  
CTL|T Project No. CS18980-115

This letter presents the results of our Geologic Hazard Evaluation and Preliminary Geotechnical Investigation for Haven Valley. The site is located south of the intersection of Alturas Drive and Cable Lane in Security-Widefield, Colorado (Fig. 1).

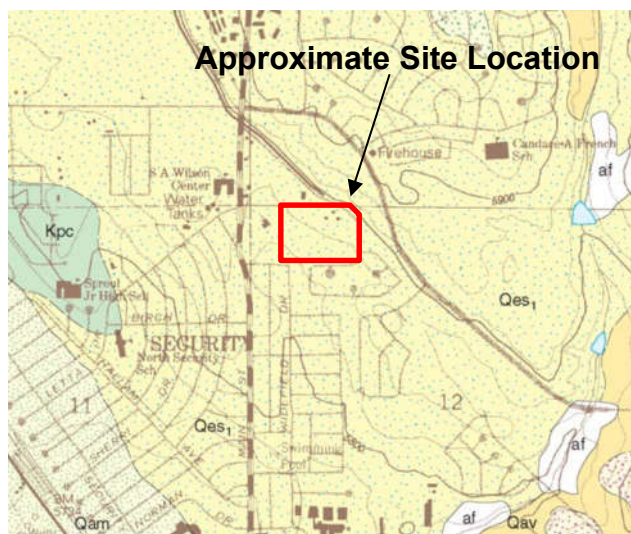
**Geologic Map**

The site is mapped as late Pleistocene-age eolian sand (wind-deposited sediment) consisting of very pale-brown, pale-brown, and light yellowish-brown sand with silt deposited as sand sheets, overlying the Dawson Formation. The Dawson Formation typically consists of sandstone interbedded with claystone in this area. Our subsurface investigation and observations generally confirm the mapping, although bedrock was not encountered to the depths explored of 20 and 30 feet. No significant geologic features were identified at the site. A map of the site specific surficial geologic conditions is shown on Figure 1.

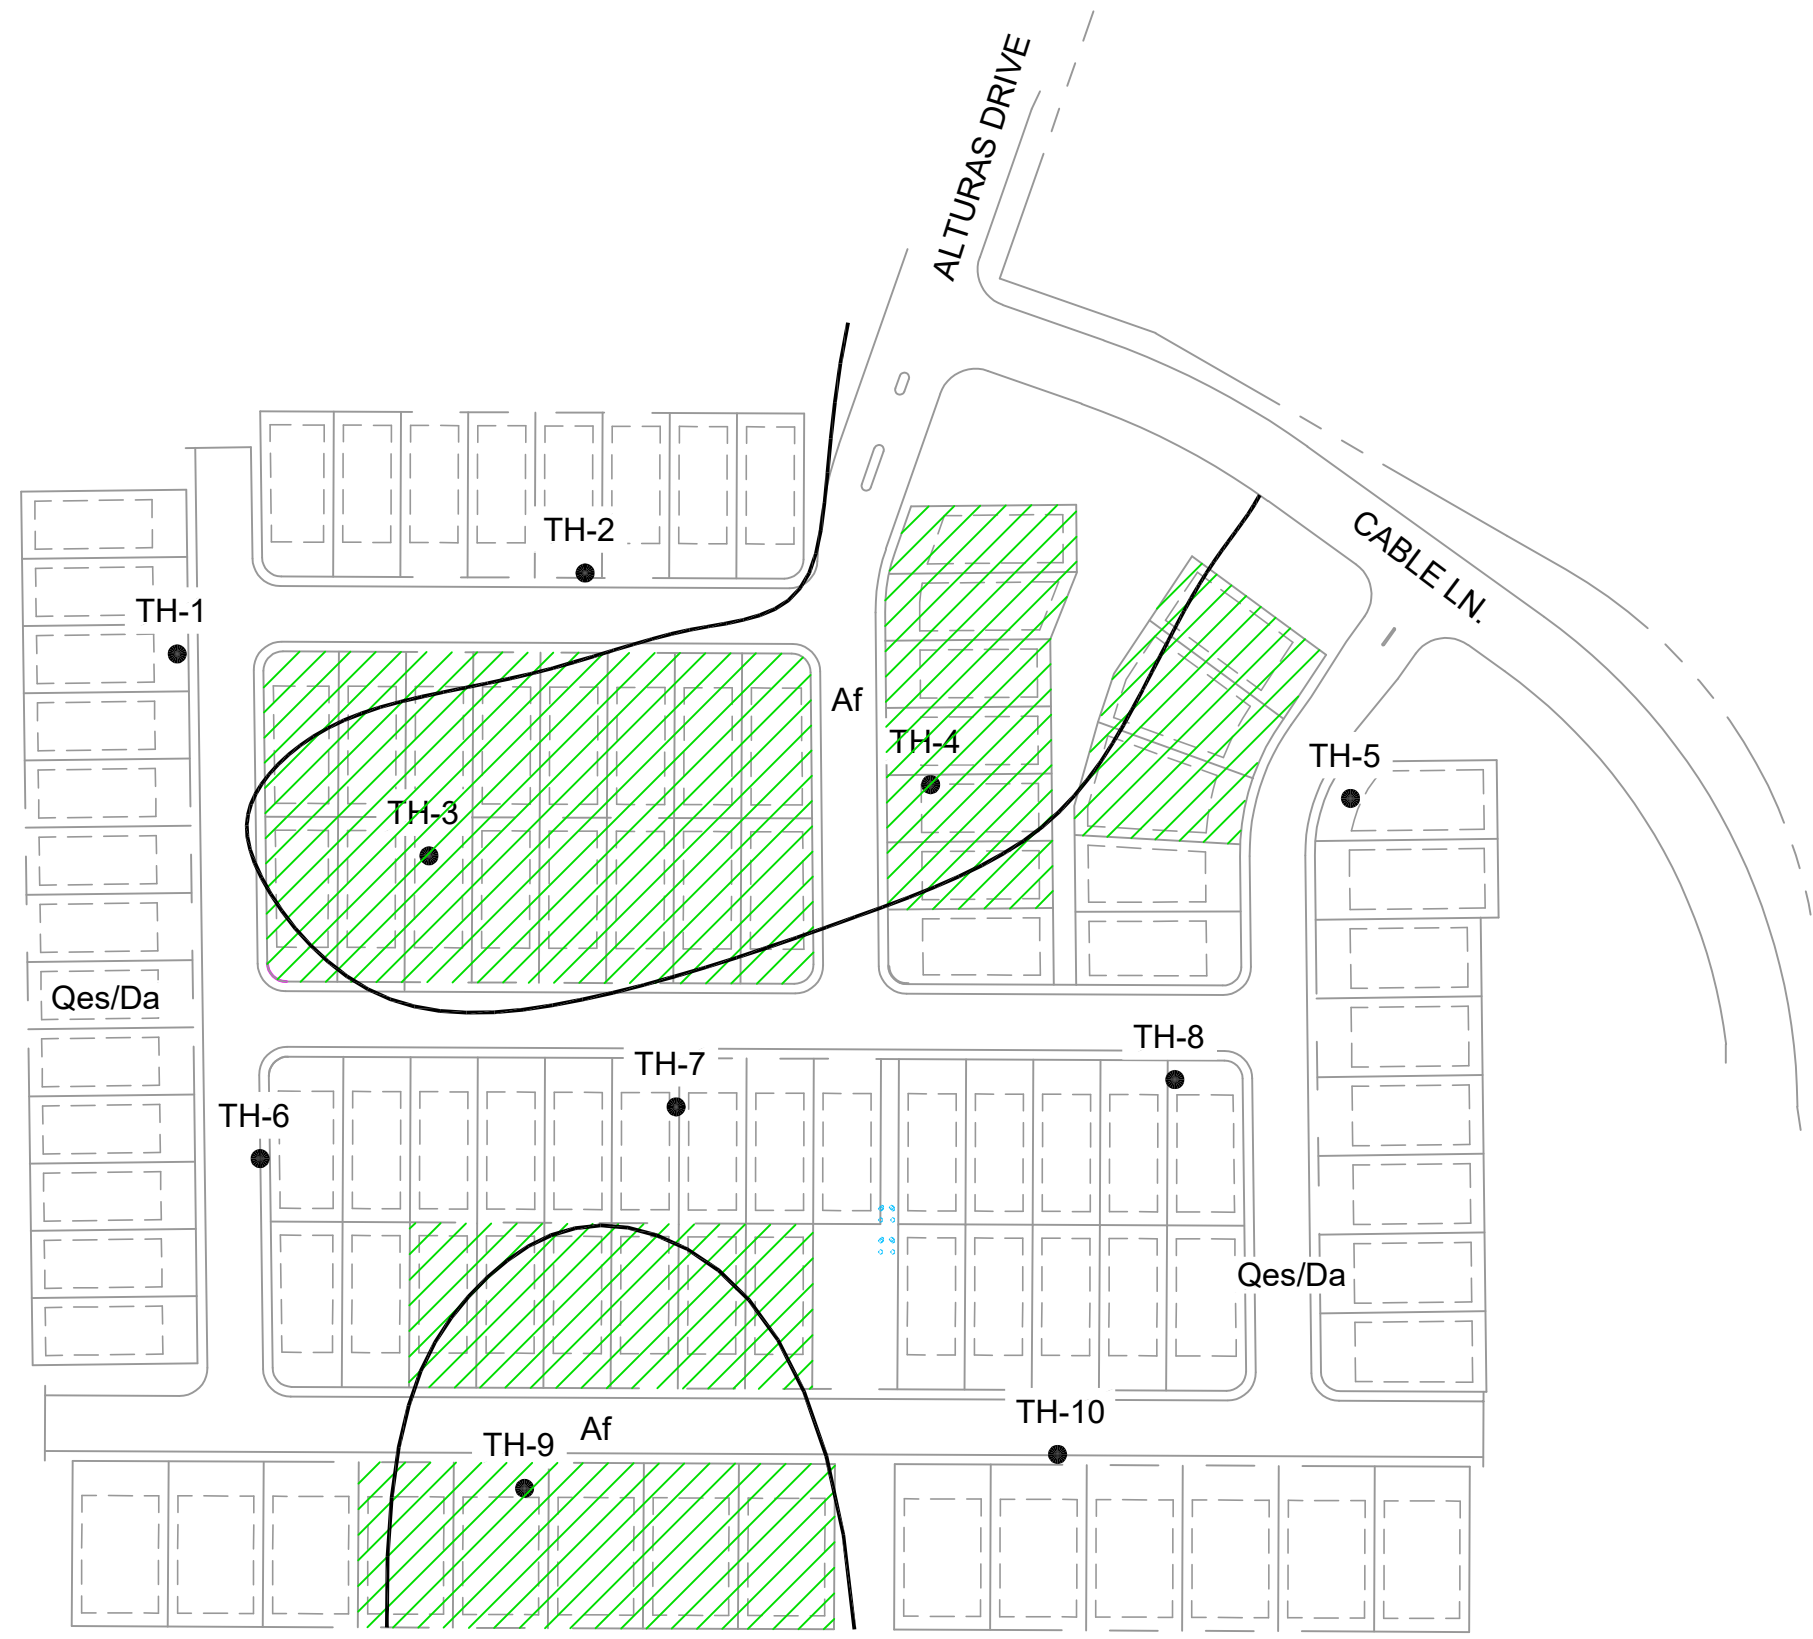
**Location of  
Exploratory  
Borings**

- LEGEND:**
- TH-1 APPROXIMATE LOCATION OF EXPLORATORY BORING.
  - APPROXIMATE GEOLOGIC BOUNDARY.
  - Af AREA WHERE MANMADE FILL MAY BE PRESENT.
  - Qes/Da AREA WHERE EOLIAN SAND MAY BE PRESENT WITH SURFICIAL DISTURBANCE.
  - ▨ INDICATES LOTS WHERE MITIGATION OF EXISTING FILL MAY BE REQUIRED, BASED ON CURRENT DATA.

The site has been previously disturbed, and there were structures located at the northeast corner of the site. Aerial photos indicate the structures were razed between 2006 and 2011. We encountered fill in three of the borings. Two of these borings were near the previous structures and one boring was near the southwest corner of the site. The approximate extents of undocumented fill are shown on Figure 1. The remainder of the site has likely been surficially disturbed and there is evidence of contouring to control surface water. Undocumented fill should be removed and re-worked or replaced, according to the recommendations set forth in the **SITE GRADING** section of this report. Design-level geotechnical studies should be undertaken to confirm the presence of fill and depths of fill and to provide recommendations for reworking. If documentation of the fill, such as density test records are found, we should review them to determine if they are adequate for the proposed construction.

Relatively loose materials were also encountered in five of the ten borings. We anticipate these soils may result in somewhat lower bearing capacities for a portion of the lots, or that a relatively thin layer of fill may be used to improve bearing capacities.

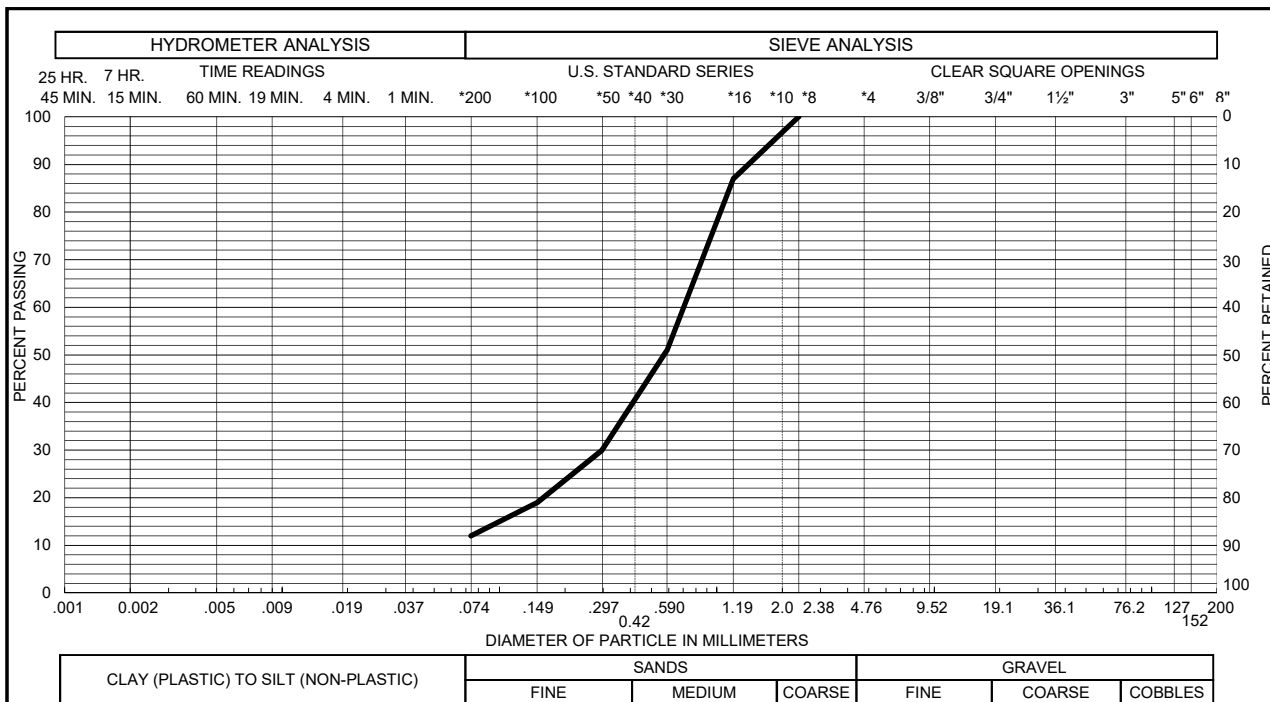
Sample of **SAND, SLIGHTLY SILTY (SP-SM)** GRAVEL 0 % SAND 88 %  
 From TH - 9 AT 9 FEET SILT & CLAY 12 % LIQUID LIMIT \_\_\_\_\_ %  
 PLASTICITY INDEX \_\_\_\_\_ %
