**GEOTECHNICAL EVALUATION
MONUMENT WATER TANK
744 FOREST VIEW WAY
MONUMENT, COLORADO**

November 18, 2016
Project No. 501233001

Subject: Geotechnical Evaluation
Monument Water Tank
744 Forest View Way
Monument, Colorado

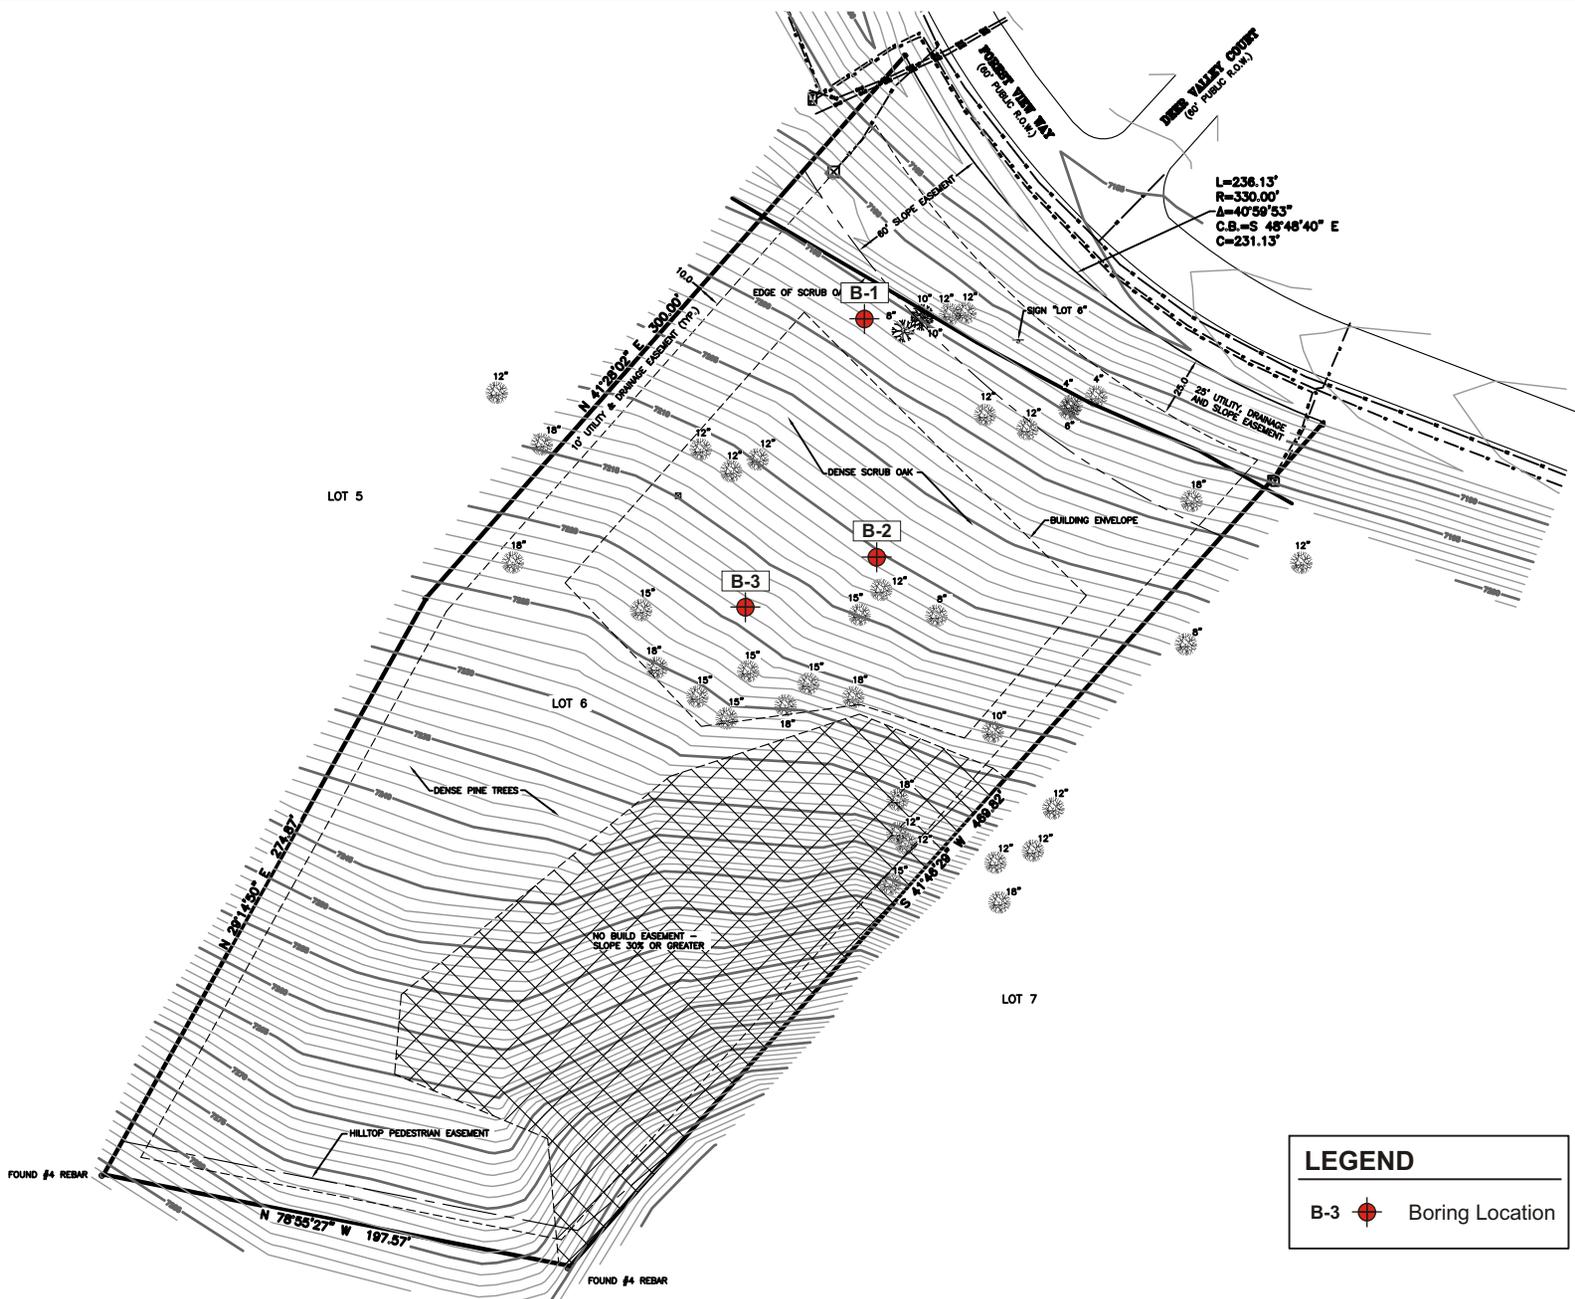
Ningo & Moore		BORING LOCATIONS		FIGURE 2
PROJECT NO: 501233001	DATE: 11/16	MONUMENT WATER TANK 744 FOREST VIEW WAY MONUMENT, COLORADO

LEGEND	
B-3	Boring Location

- Drilling, logging, and sampling of three (3) small-diameter exploratory borings within the project site to depths ranging from 24.4 to 29.3 feet below ground surface (bgs). One of the borings was completed as a temporary groundwater monitoring well. The boring logs are presented in Appendix A. Boring locations are presented on Figure 2.

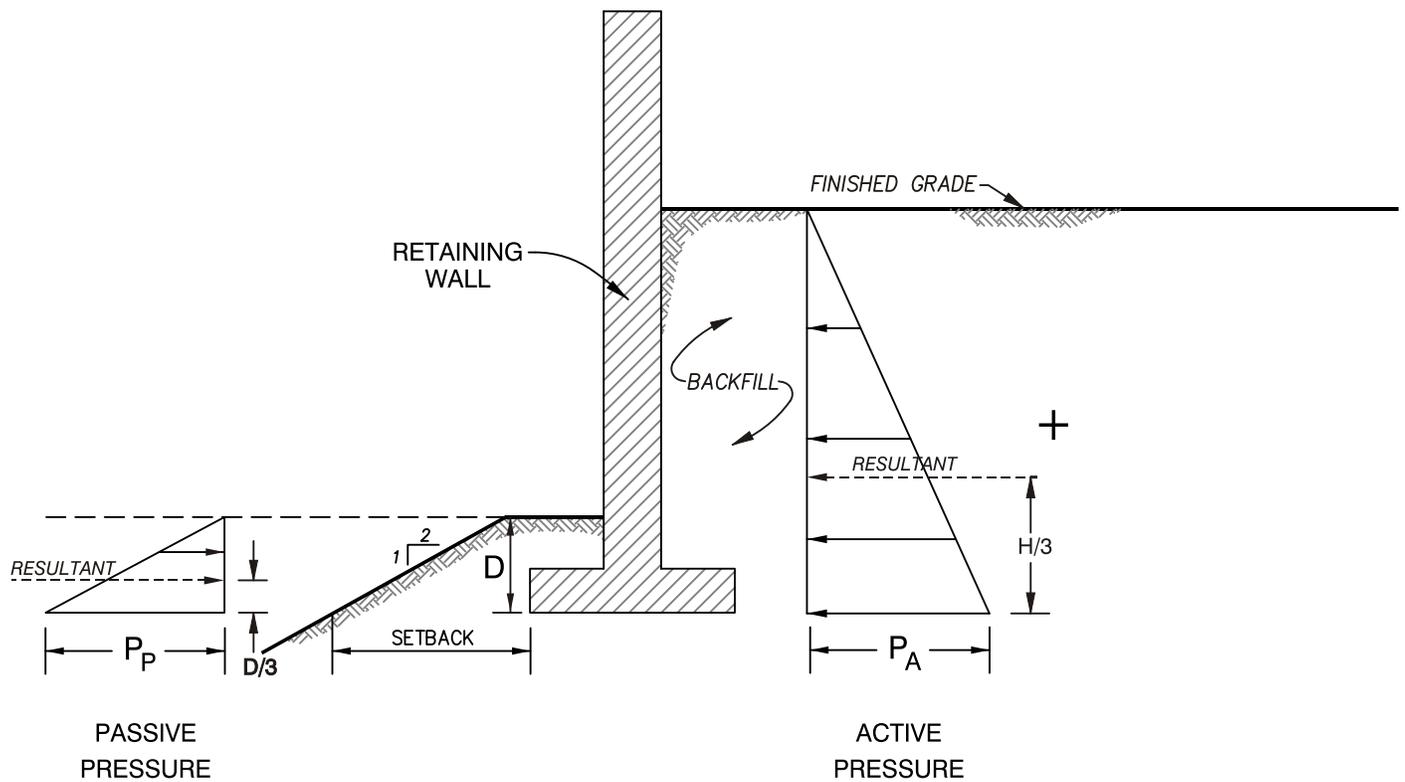
1. ASSUMES NO HYDROSTATIC PRESSURE BUILD-UP BEHIND THE RETAINING WALL
2. STRUCTURAL, GRANULAR BACKFILL MATERIALS AS SPECIFIED IN SECTION 9.1 SHOULD BE USED FOR RETAINING WALL BACKFILL
3. DRAINS AS RECOMMENDED IN THE RETAINING WALL DRAINAGE DETAIL SHOULD BE INSTALLED BEHIND THE RETAINING WALL
4. SURCHARGE PRESSURES CAUSED BY VEHICLES OR NEARBY STRUCTURES ARE NOT INCLUDED
5. H AND D ARE IN FEET
6. SETBACK SHOULD BE IN ACCORDANCE WITH FIGURE 1808.7.1 OF THE IBC (2015)

- Figure 1 – Site Location
- Figure 2 – Boring Locations
- Figure 3 – Lateral Earth Pressures for Yielding Retaining Walls
- Figure 4 – Lateral Earth Pressures for Restrained Retaining Walls
- Figure 5 – Retaining Wall Drainage Detail

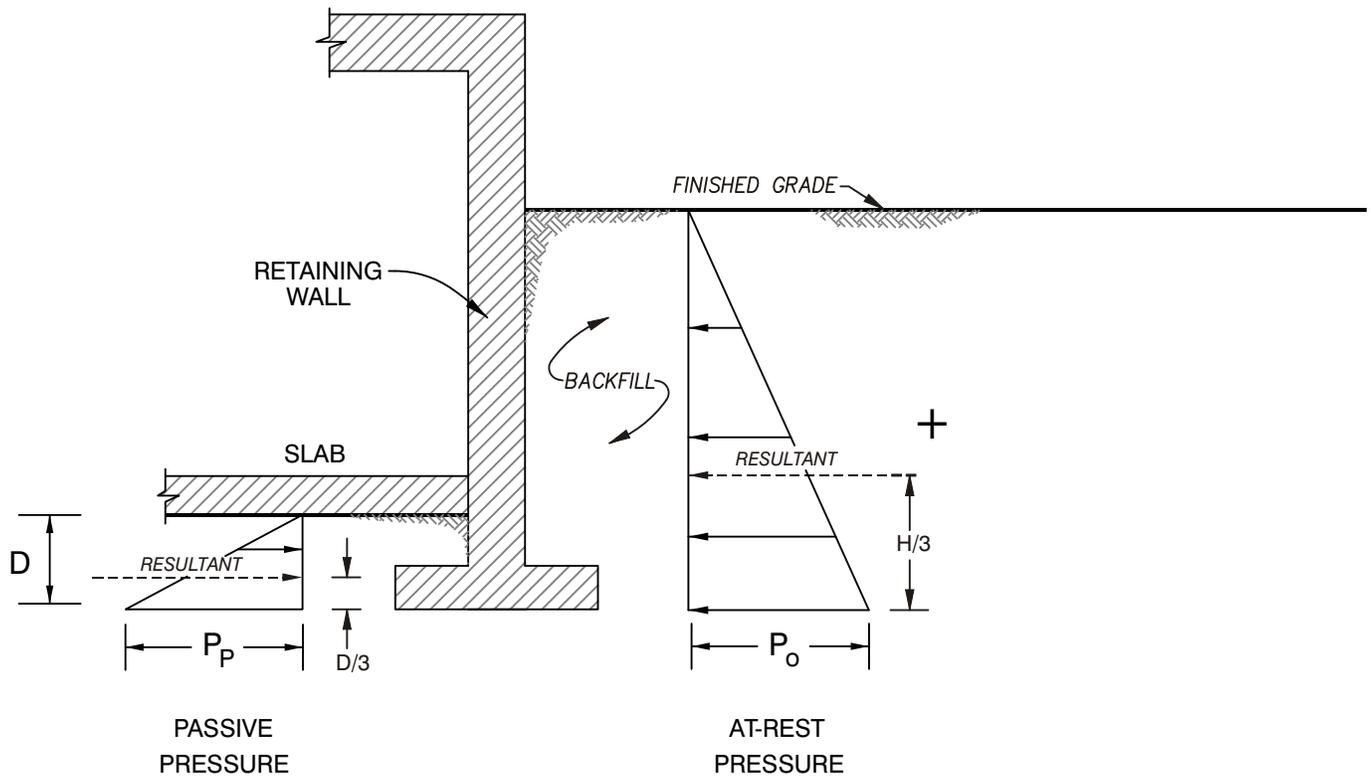
4

1. ASSUMES NO HYDROSTATIC PRESSURE BUILD-UP BEHIND THE RETAINING WALL
2. STRUCTURAL, GRANULAR BACKFILL MATERIALS AS SPECIFIED IN SECTION 9.1 SHOULD BE USED FOR RETAINING WALL BACKFILL
3. DRAINS AS RECOMMENDED IN THE RETAINING WALL DRAINAGE DETAIL SHOULD BE INSTALLED BEHIND THE RETAINING WALL
4. SURCHARGE PRESSURES CAUSED BY VEHICLES OR NEARBY STRUCTURES ARE NOT INCLUDED
5. H AND D ARE IN FEET

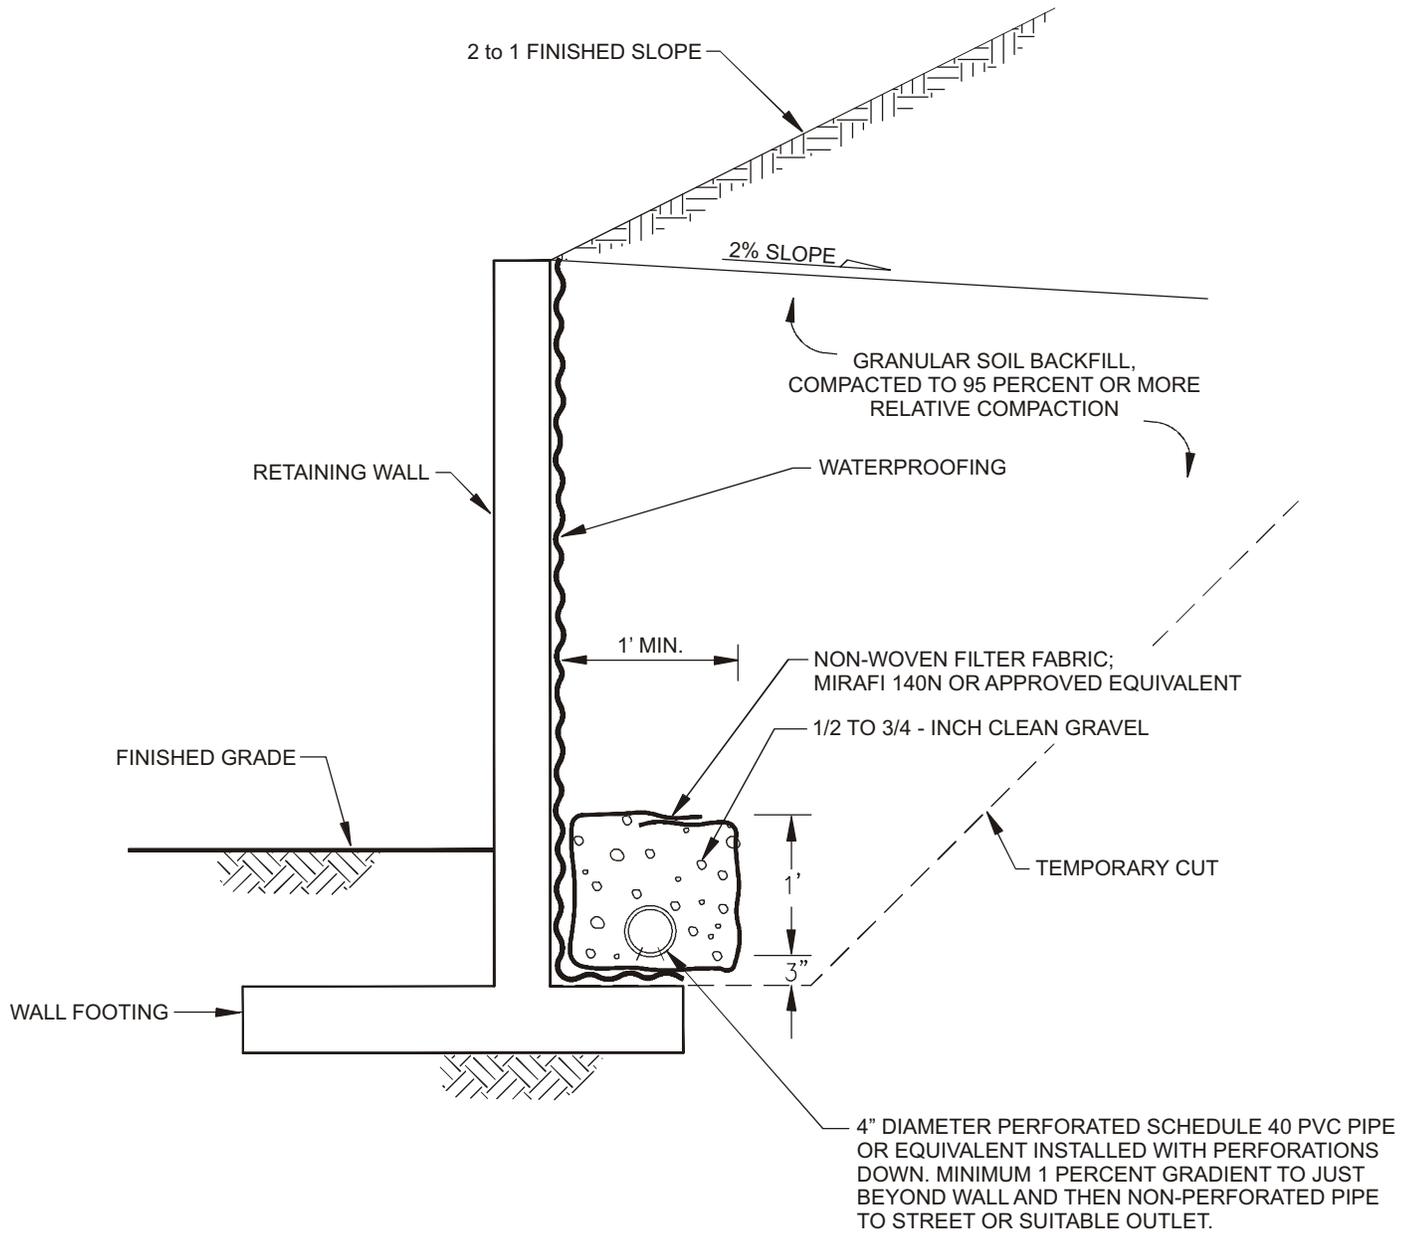
NOT TO SCALE

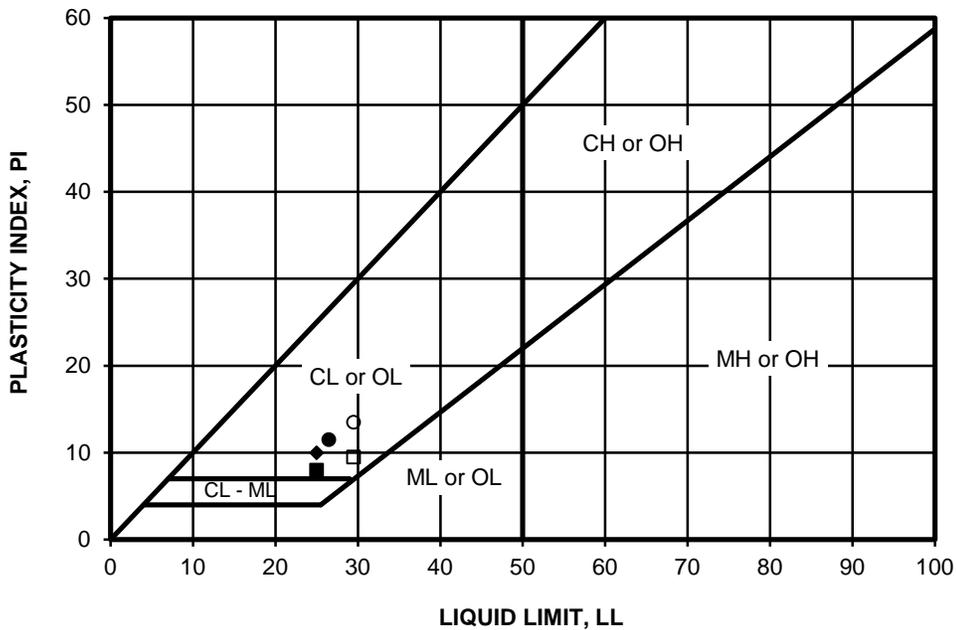
Ninyo & Moore		ATTERBERG LIMITS TEST RESULTS		FIGURE B-1
PROJECT NO.	DATE	MONUMENT WATER TANK		
501233001	11/16	744 FOREST VIEW WAY MONUMENT, COLORADO

SYMBOL	LOCATION	DEPTH (FT)	LIQUID LIMIT, LL	PLASTIC LIMIT, PL	PLASTICITY INDEX, PI	USCS CLASSIFICATION (Fraction Finer Than No. 40 Sieve)	USCS (Entire Sample)
●	B-1	2.0-3.5	27	15	12	CL	SC
■	B-1	4.0-5.0	25	17	8	CL	SC
◆	B-1	19.0-19.5	25	15	10	CL	--
○	B-2	14.0-14.5	30	16	14	CL	--
□	B-3	9.0-10.5	30	20	10	CL	SC

PERFORMED IN GENERAL ACCORDANCE WITH ASTM D 4318

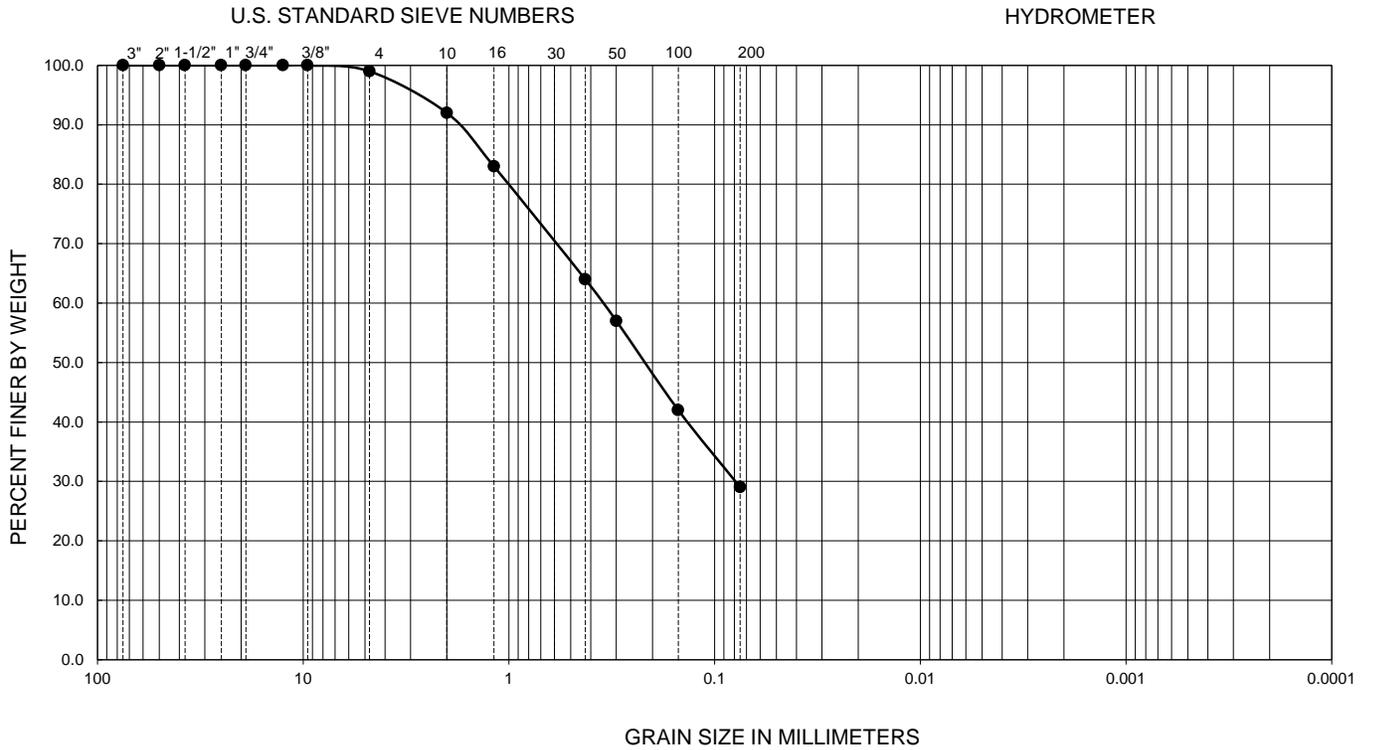
GRADATION TEST RESULTS MONUMENT WATER TANK 744 FOREST VIEW WAY MONUMENT, COLORADO		FIGURE B-3
501233001		11/16

Symbol	Sample Location	Depth (ft)	Liquid Limit	Plastic Limit	Plasticity Index	D ₁₀	D ₃₀	D ₆₀	C _u	C _c	Passing No. 200 (%)	USCS
●	B-1	4.0-5.0	25	17	8	--	--	--	--	--	29	SC

PERFORMED IN GENERAL ACCORDANCE WITH ASTM D 422

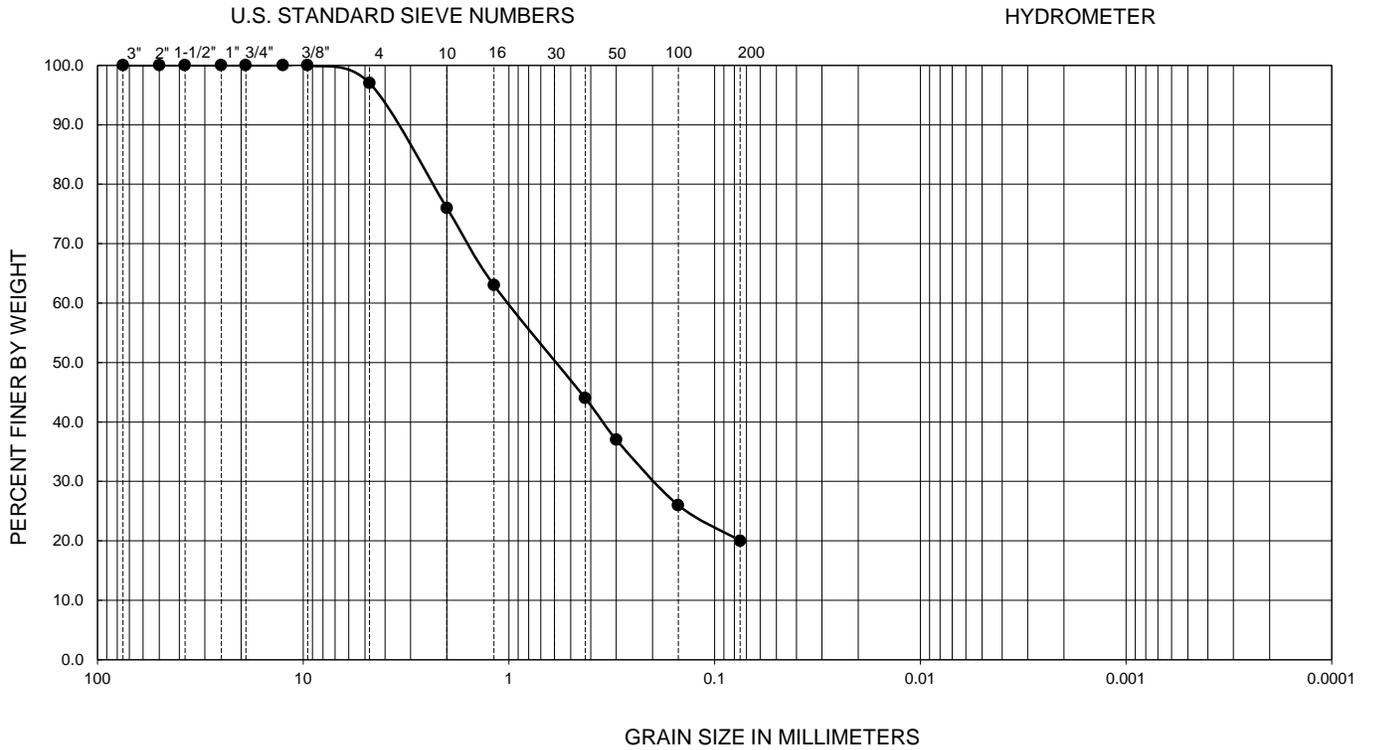
Ninyo & Moore		GRADATION TEST RESULTS	MONUMENT WATER TANK 744 FOREST VIEW WAY MONUMENT, COLORADO	FIGURE B-4
PROJECT NO.	DATE			
501233001	11/16

Symbol	Sample Location	Depth (ft)	Liquid Limit	Plastic Limit	Plasticity Index	D ₁₀	D ₃₀	D ₆₀	C _u	C _c	Passing No. 200 (%)	USCS
●	B-3	9.0-10.5	30	20	10	--	--	--	--	--	20	SC

PERFORMED IN GENERAL ACCORDANCE WITH ASTM D 422

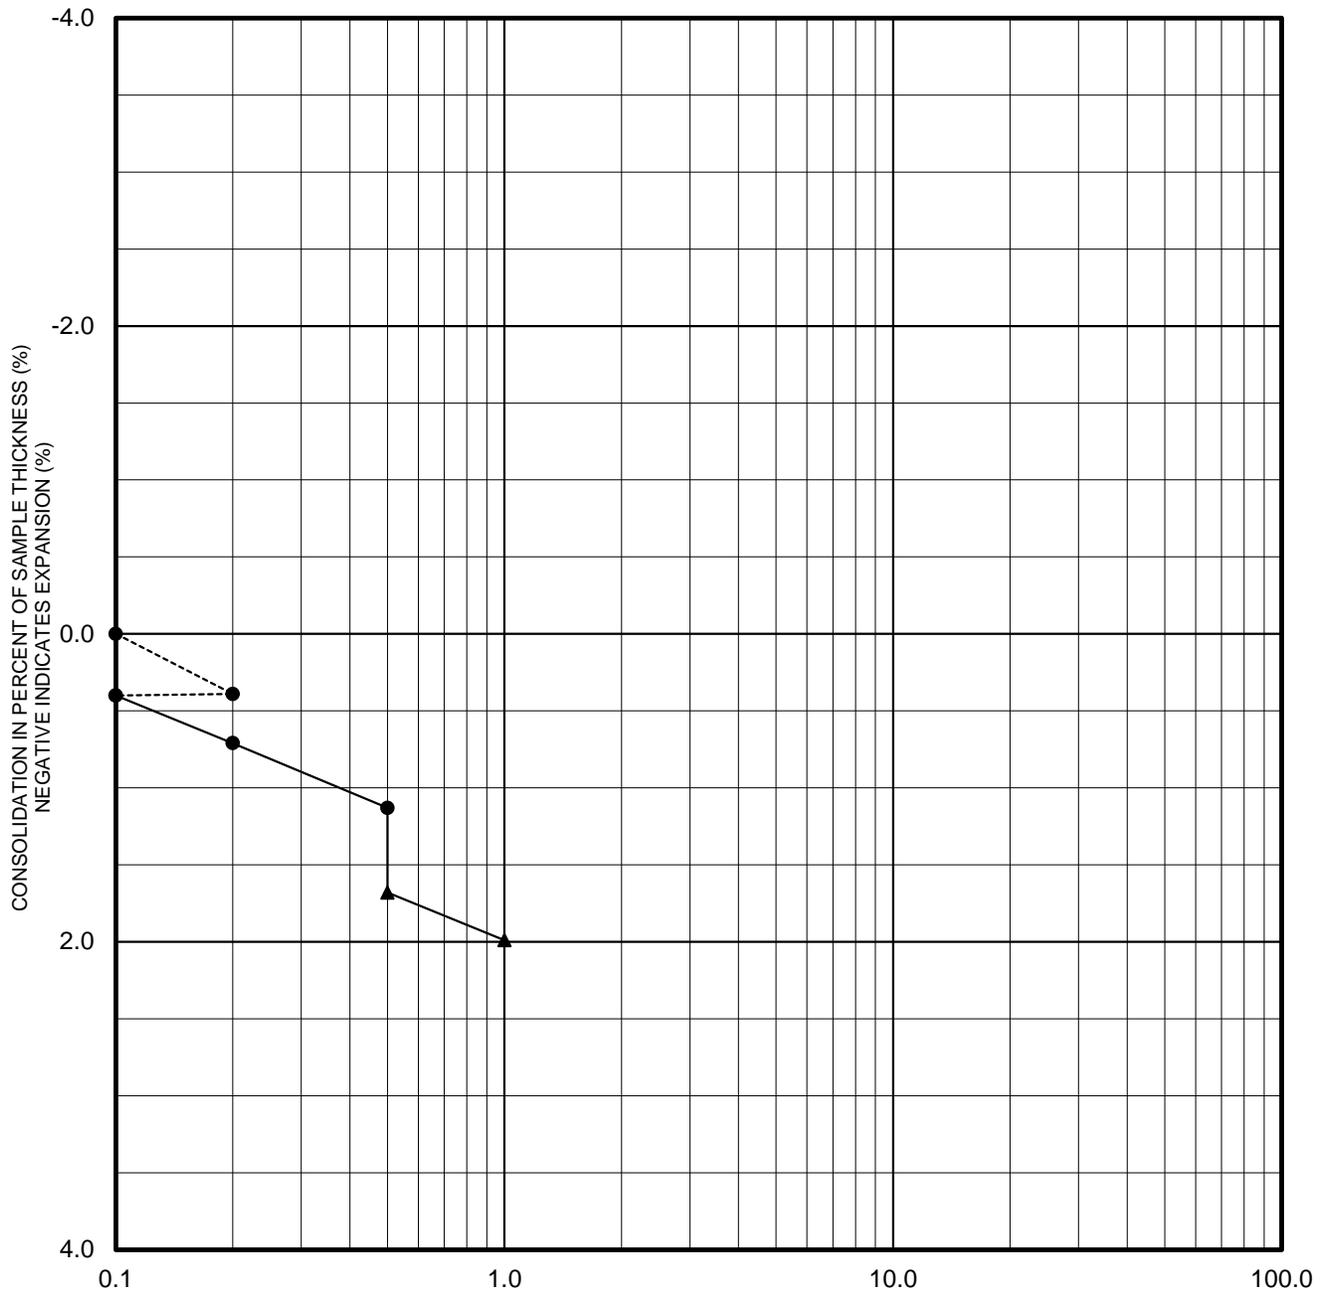
- Seating Cycle
 - Loading Prior to Inundation
 - ▲— Loading After Inundation
 - ▲--- Rebound Cycle
- Sample Location B-1
 Depth (ft.) 14.0-14.5
 Soil Type SANDSTONE

PERFORMED IN GENERAL ACCORDANCE WITH ASTM D 4546

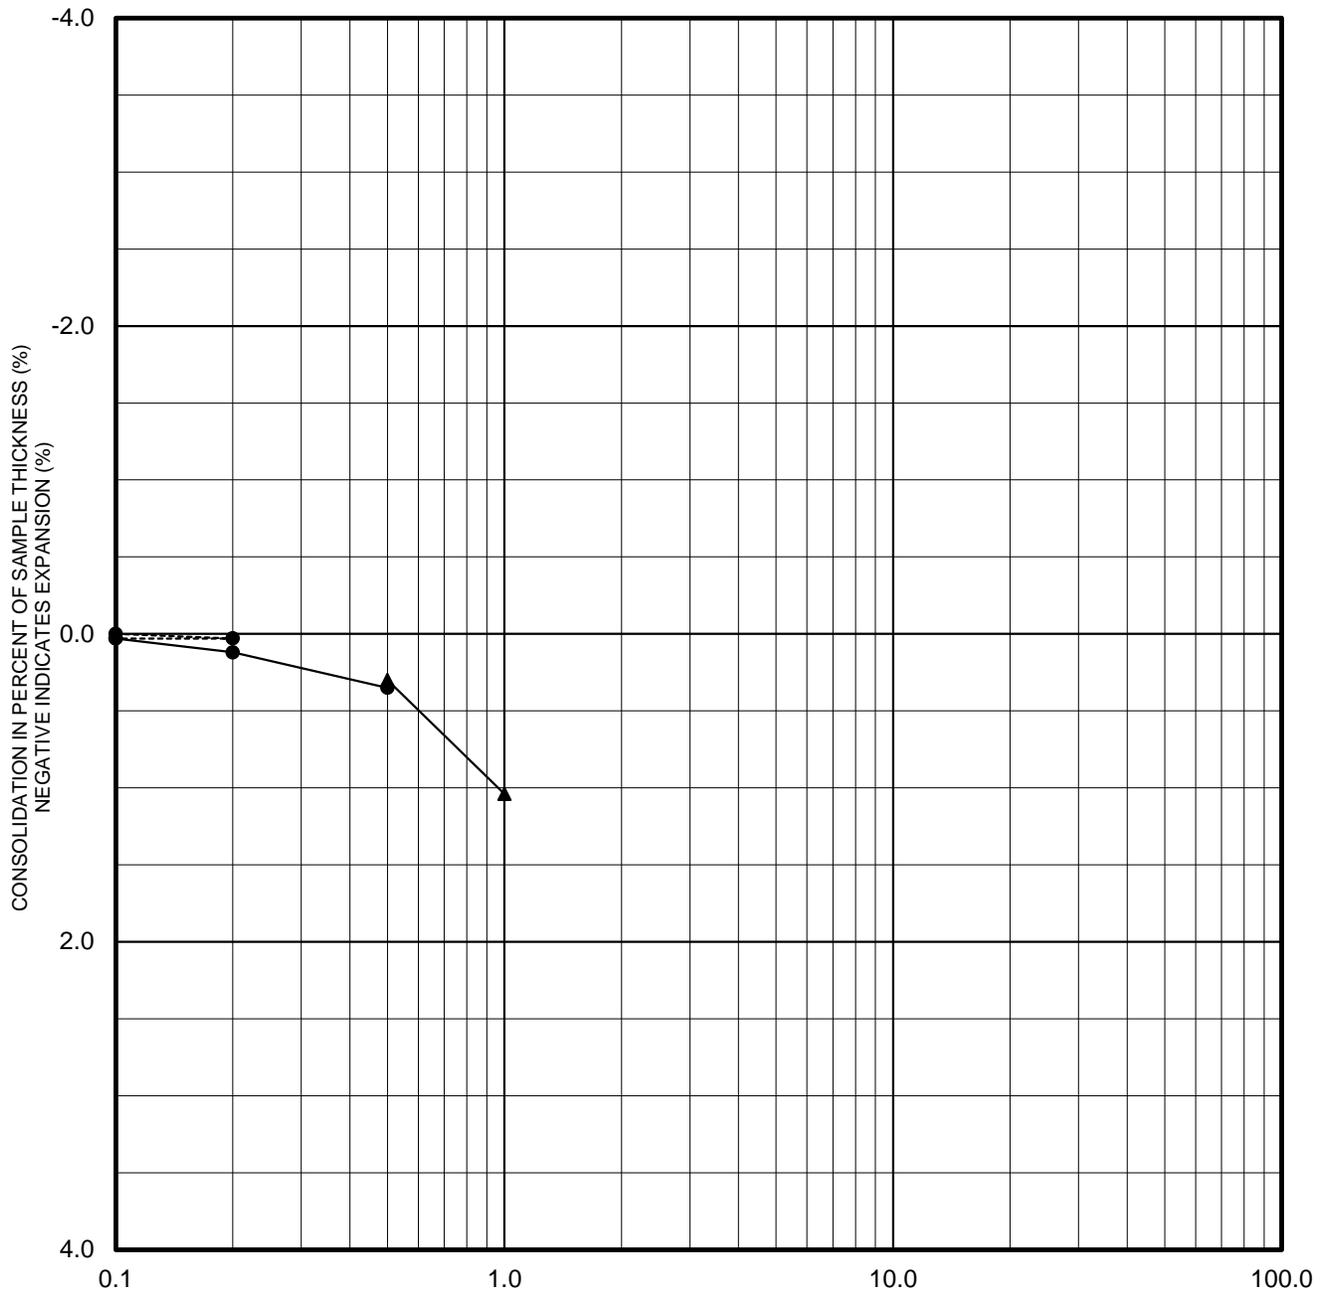
- Seating Cycle
 - Loading Prior to Inundation
 - ▲— Loading After Inundation
 - ▲--- Rebound Cycle
- Sample Location B-3
 Depth (ft.) 14.0-14.3
 Soil Type SANDSTONE

PERFORMED IN GENERAL ACCORDANCE WITH ASTM D 4546
