**GEOLOGIC HAZARD EVALUATION AND  
PRELIMINARY GEOTECHNICAL INVESTIGATION  
GRANDVIEW RESERVE, PHASE 2  
EASTONVILLE ROAD AND U.S. HIGHWAY 24  
FALCON, COLORADO**

Project No. CS19345.300-115-R3

December 20, 2023  
Revised February 27, 2024  
Revised August 13, 2024  
Revised January 23, 2025

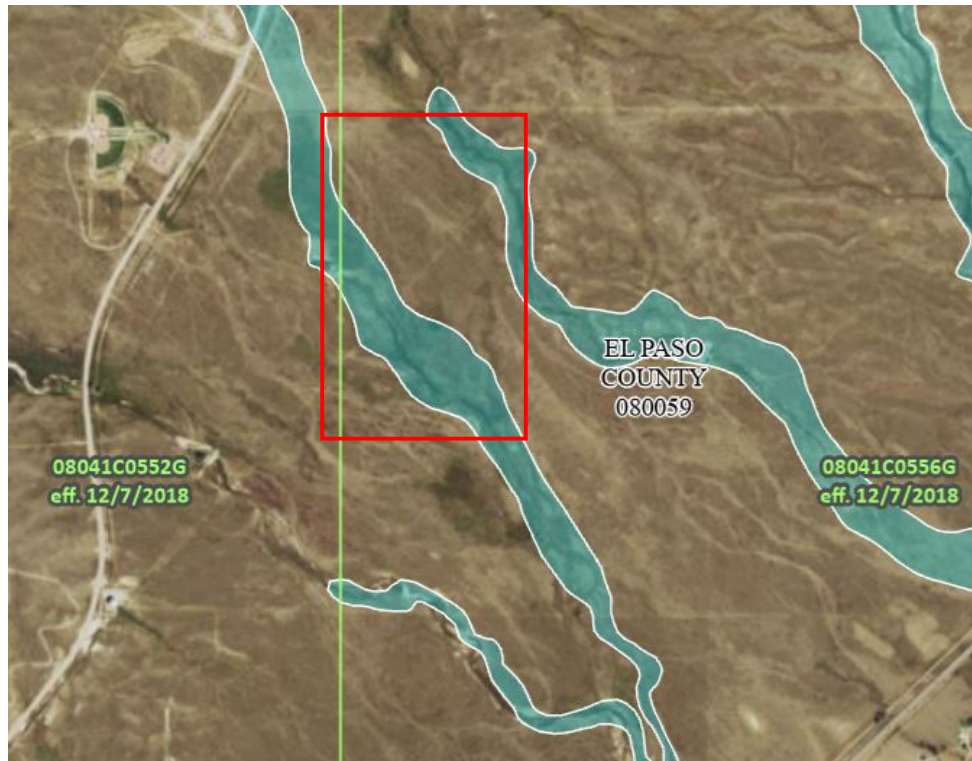
Excerpt from FEMA National Flood Hazard Layer Viewer, General Site Area is Depicted in Red

The majority of the site lies within Zone D (undetermined flood hazard), as shown on FIRM Community Map Number 08041C0556G, revised December 7, 2018. Zone D indicates floods are possible, but not likely. Some portions of the site within drainage areas lie within Zone A as shown below.

Based on the topography at the site, the potential for a flood to impact the majority of the site area is low. During peak precipitation events, some accumulation of surface sheet flow in drainages is expected with possible inundation within the Zone A areas that are identified in the bluish-green color shown above. Development will increase the relative area of impervious surfaces, which can lead to drainage problems and erosion if surface water flow is not adequately designed. Surface drainage design and evaluation of flood potential should be performed by a civil engineer as part of the project design.
