**GEOLOGIC HAZARD EVALUATION AND
PRELIMINARY GEOTECHNICAL INVESTIGATION
GRANDVIEW RESERVE, PHASE 2
EASTONVILLE ROAD AND U.S. HIGHWAY 24
FALCON, COLORADO**

Project No. CS19345-115-R3

December 20, 2023

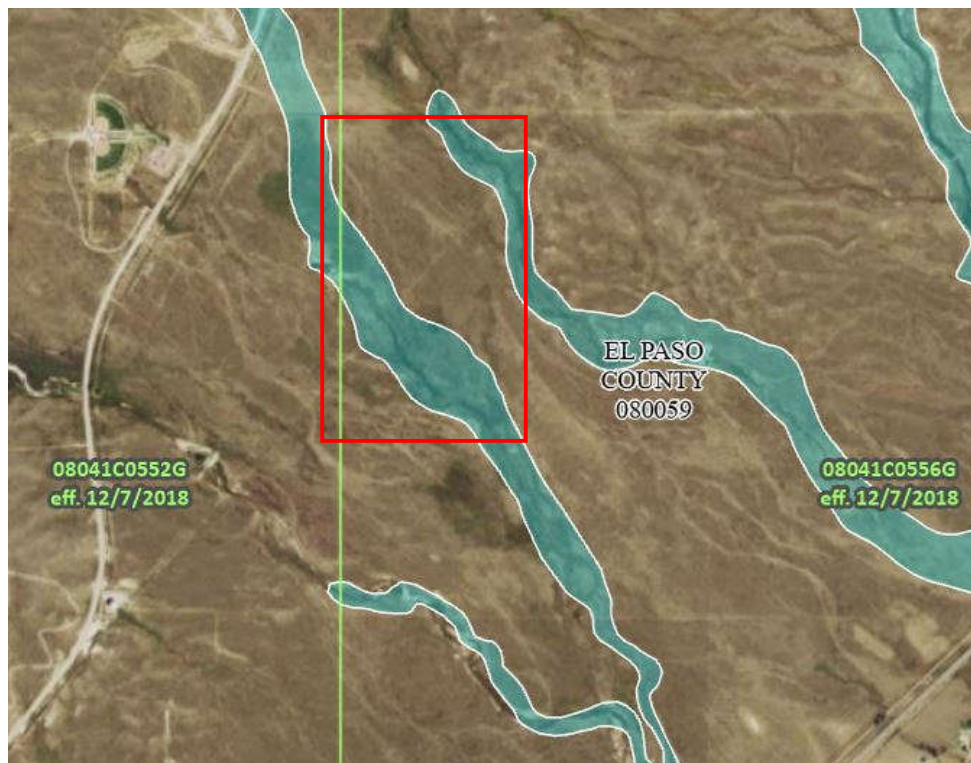
The majority of the site lies within Zone D (undetermined flood hazard), as shown on FIRM Community Map Number 08041C0556G, revised December 7, 2018. Zone D indicates floods are possible, but not likely. Some portions of the site within drainage areas lie within Zone A as shown below.

Excerpt from FEMA National Flood Hazard Layer Viewer, General Site Area is Depicted in Red

Based on the topography at the site, the potential for a flood to impact the majority of the site area is low. During peak precipitation events, some accumulation of surface sheet flow in drainages is expected with possible inundation within the Zone A areas that are identified in the bluish-green color shown above. Development will increase the relative area of impervious surfaces, which can lead to drainage problems and erosion if surface water flow is not adequately designed. Surface

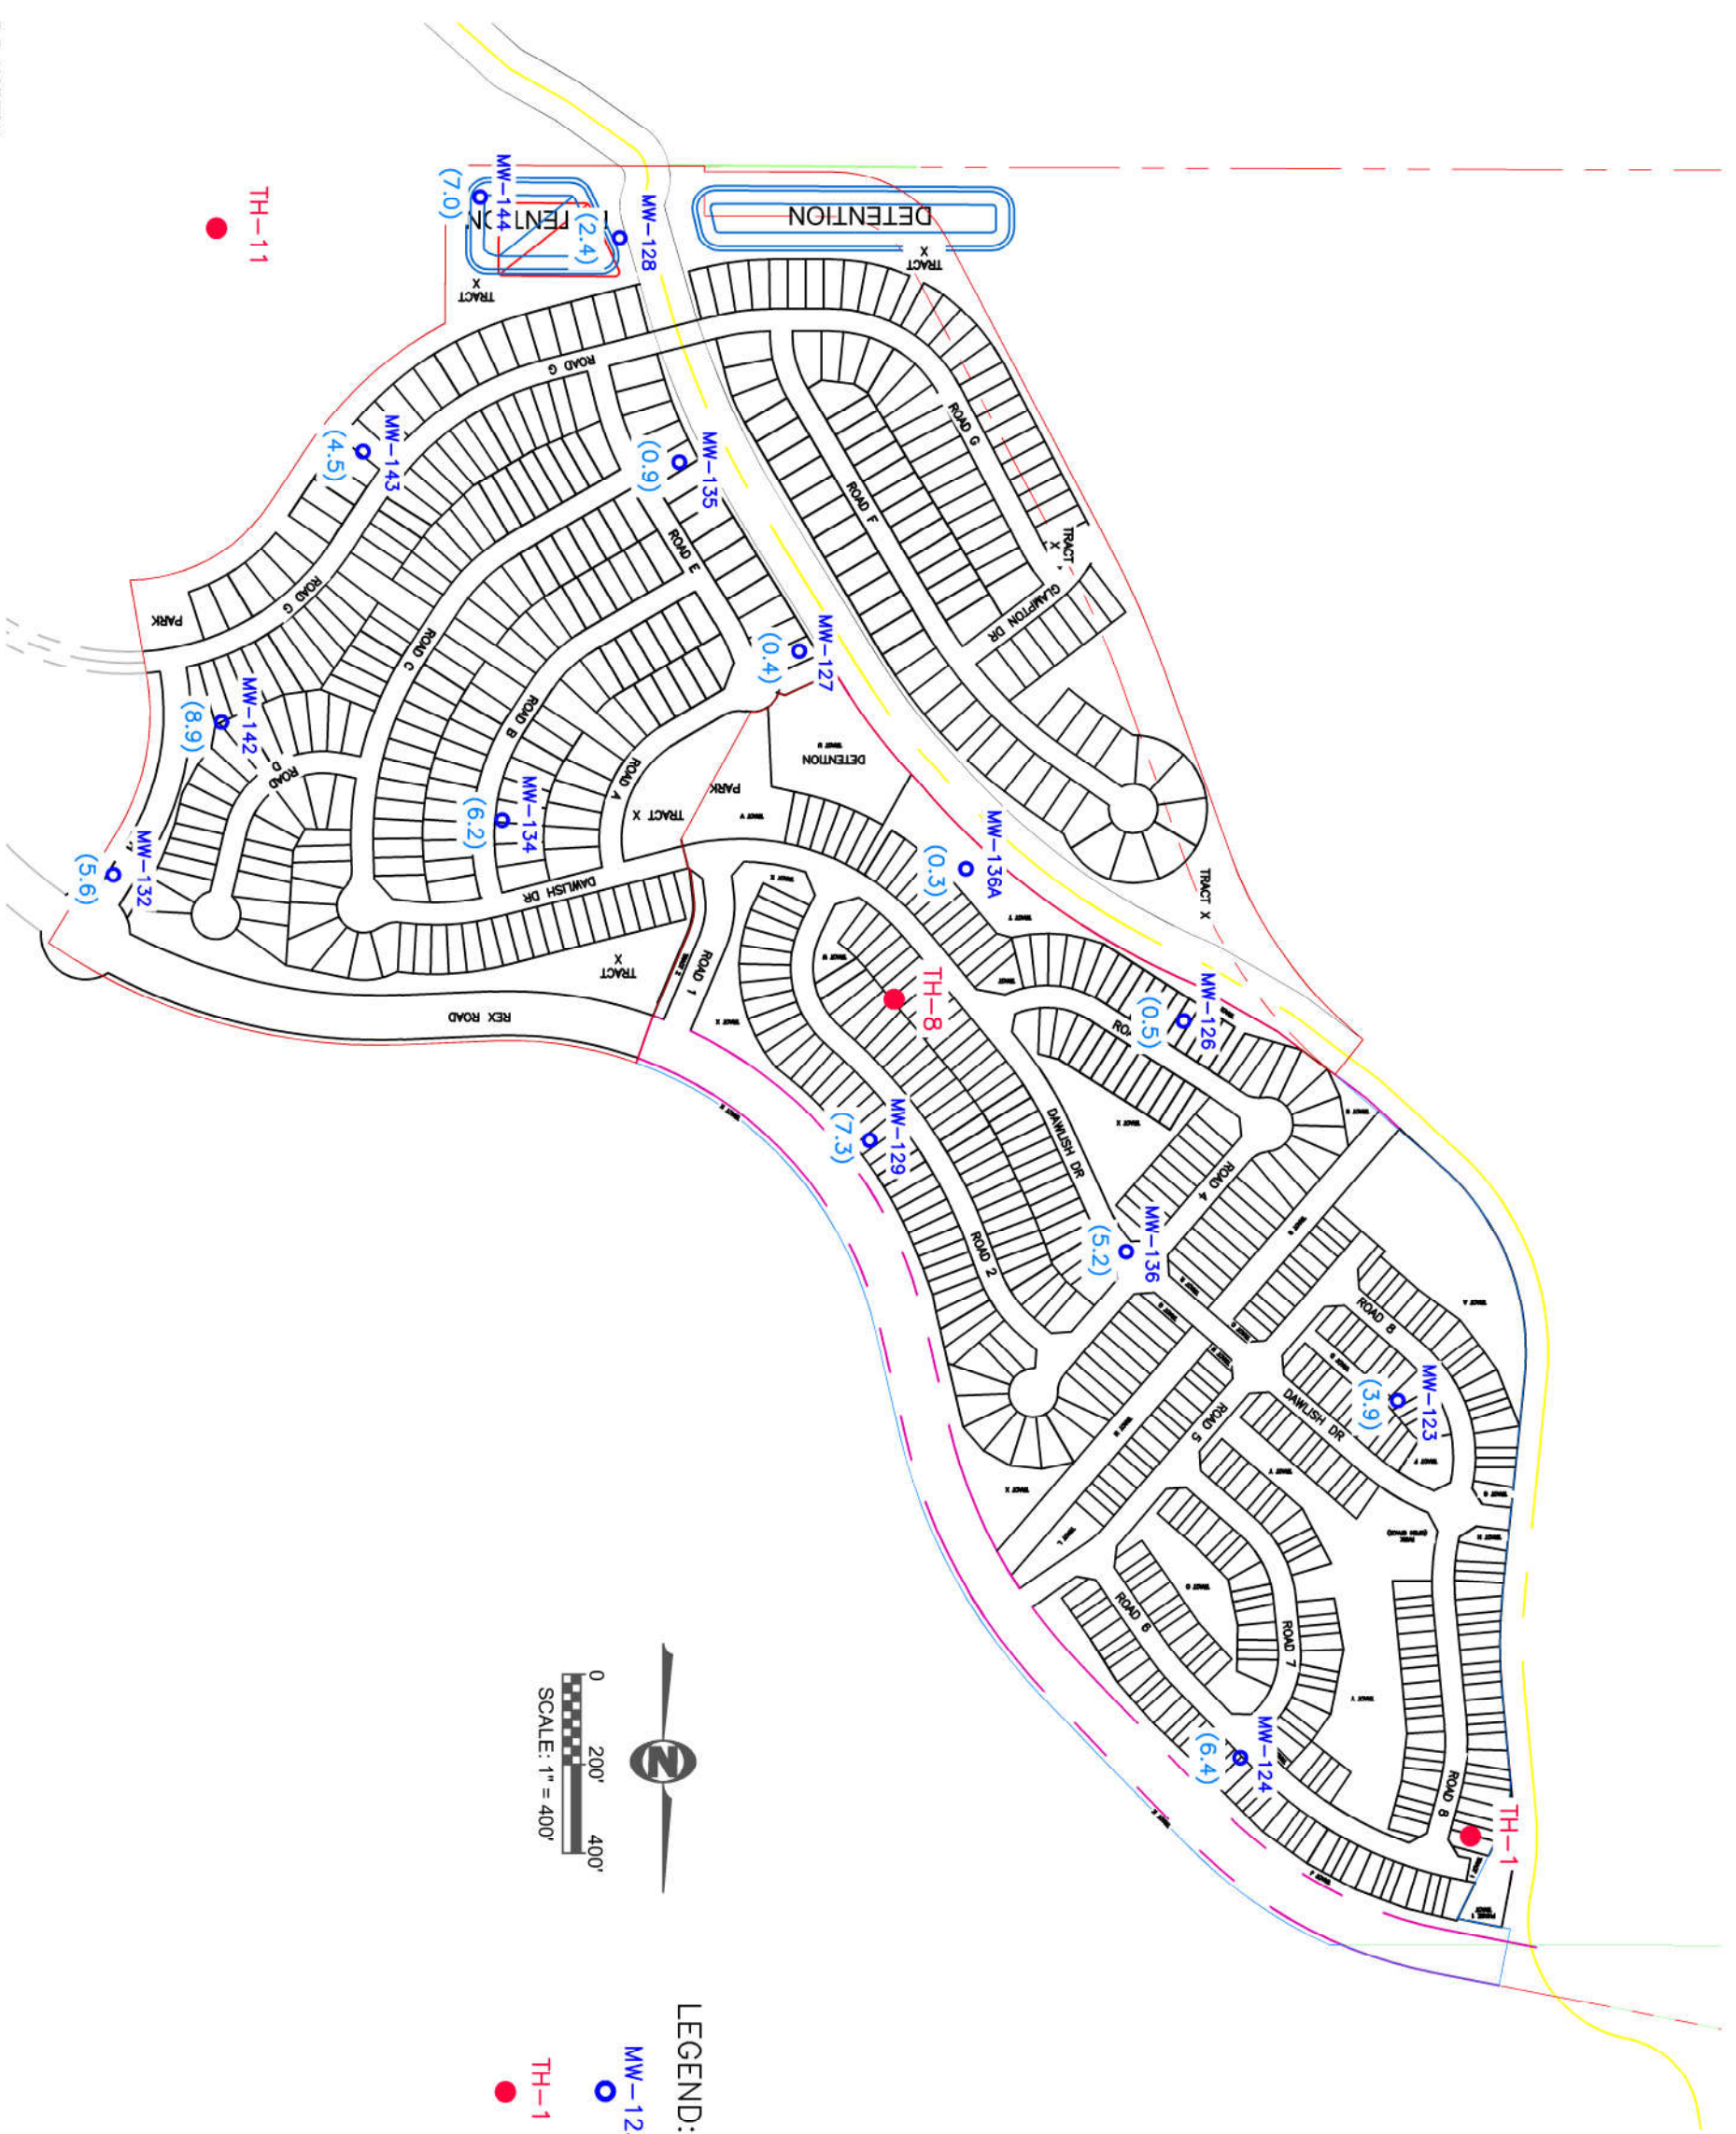
Location of
Exploratory
Borings FIG. 1

- LEGEND:
- MW-123 APPROXIMATE LOCATION OF EXPLORATORY BORING
 - TH-1 APPROXIMATE LOCATION OF EXPLORATORY BORING DRILLED DURING PREVIOUS INVESTIGATION; REPORTS DATED DECEMBER 23, 2020 AND JANUARY 6, 2022.

This report presents the results of our Geologic Hazards Evaluation and Preliminary Geotechnical Investigation for Phase 2 of the proposed Grandview Reserve development. The proposed development is located east of Eastonville Road, west of U.S. Highway 24, and north of Stapleton Road in Falcon, Colorado (Fig. 1). We understand you are assessing the land for the construction of single-family residences. The purpose of our investigation was to evaluate the property for the occurrence of geologic hazards and their potential effect on the proposed development, and to evaluate subsurface conditions to assist in planning of residential construction. The report includes descriptions of the subsurface conditions encountered in our exploratory borings, and discussions of construction as influenced by geotechnical considerations. Evaluation of the property for the presence of potentially hazardous materials (Environmental Site Assessment) was not included in our scope.

advanced using solid-stem, continuous-flight auger and a truck-mounted drill rig. The locations were established by the Client's surveyor and are shown in Fig. 1.
