PAVEMENT DESIGN REPORT

Creekside South at Lorson Ranch

El Paso County, Colorado

JOB NO. 178681

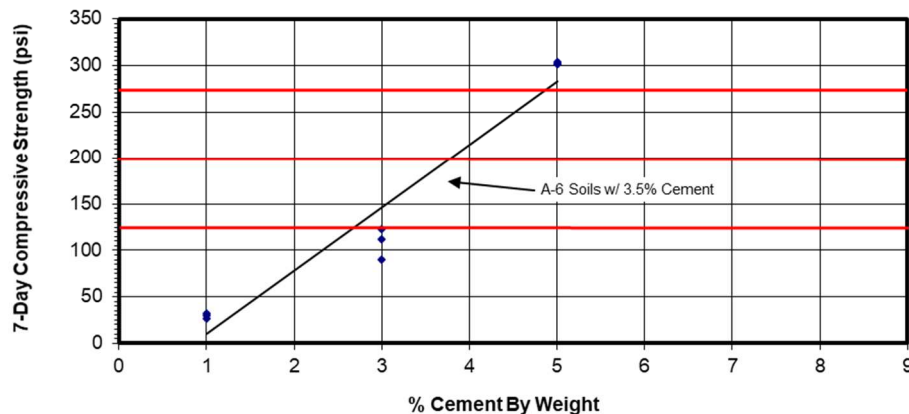
Compressive Strength vs. Cement Content
Creekside South at Lorson Ranch A-6 Soil
RMG Job No. 178681
CTS Mix Design Target Values

The data values were then plotted as a function of “7-day Compressive Strength versus Percent Cement by Weight”. In accordance with the El Paso County Engineering Criteria Manual, the target “percent cement by weight” was selected to obtain strengths in the lower Strength Coefficient (SC) categories (SC = 0.11, 125-200 psi; SC = 0.12, 200-275 psi). A target SC = 0.12 is used for CTS soil in the pavement design procedure presented below. Based upon an evaluation of the test data, a target range of 3.5 percent cement is recommended in all roadway sections to maintain strengths below the 275-psi threshold stipulated in the Engineering Criteria Manual.

Specimens of soil composed of the A-6 subgrade materials and Portland Cement were prepared by varying the “percent cement by weight” at target values of 1, 3, and 5 percent cement. Three specimens (pucks) were prepared for each target cement value, compacted to 95% of the maximum Modified Proctor density and cured in a saturated condition for 7-days. The compressive strength of each specimen was then determined upon completion of the 7-day curing process. The A-6 soil compressive strengths are presented in the table below:

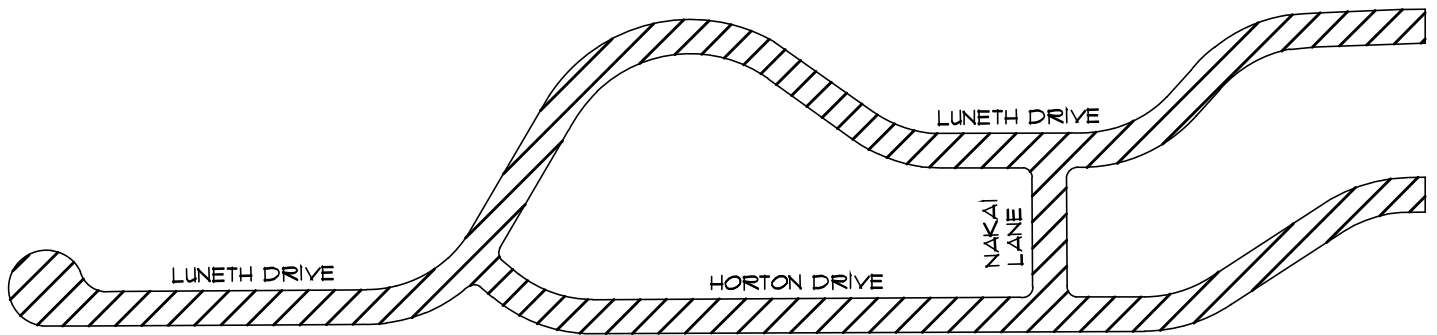
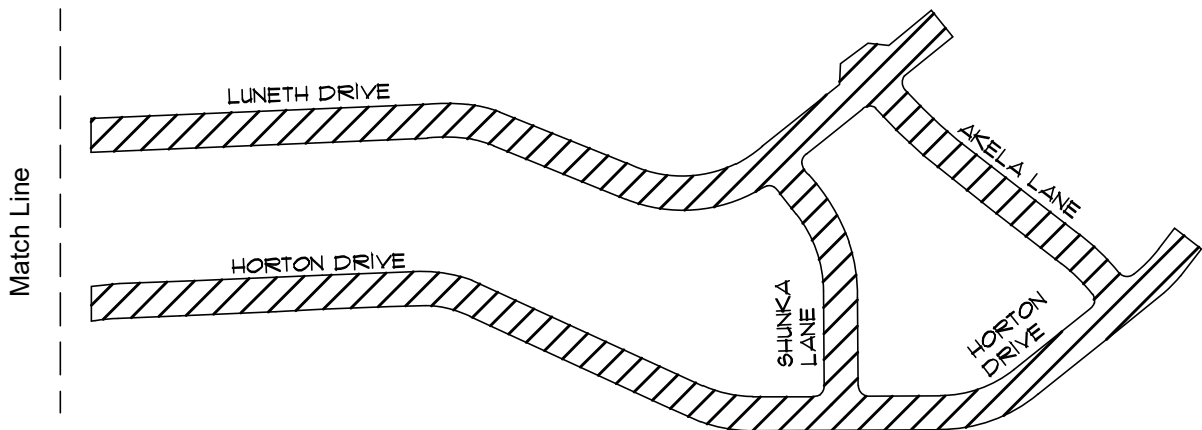
5" HMA
over
12" CTS

PAVEMENT DESIGN
Recommended Pavement Section
CREEKSIDE SOUTH AT LORSON RANCH
EL PASO COUNTY, COLORADO
LANDHUIS COMPANY

The pavement design was performed in accordance with the El Paso County Engineering Criteria Manual, Appendix D. Pavement design parameters and design calculations are presented below utilizing the CBR value for A-6 soil. The recommended pavement sections shown on Figure 2.1 are supported by the calculations below.

Based on the soil types and the design calculations, the recommended pavement section is presented below and on Figure 2.1.

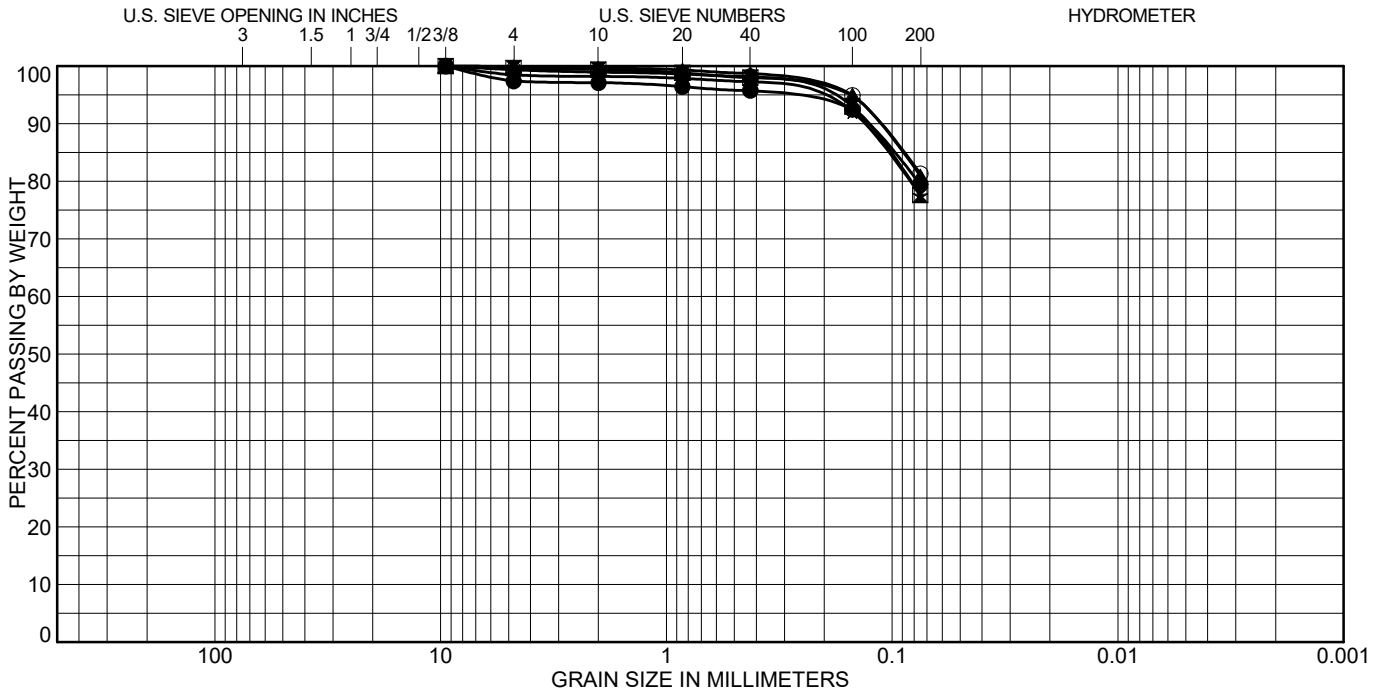
FIGURE No. 15

Test Boring	Depth (ft)	Classification	LL	PL	PI	Cc	Cu
● 1	2.0	A-6 (18)	39	14	25		
☒ 2	2.0	A-6 (15)	36	15	21		
▲ 3	2.0	A-6 (20)	40	13	27		
★ 4	2.0	A-6 (17)	38	14	24		
⊙ 5	2.0	A-6 (20)	40	13	27

The moisture content for the recovered samples was obtained in the laboratory. Grain-size analysis and Atterberg Limits tests were performed on selected samples to classify the soil and to develop pertinent engineering properties. Swell/consolidation tests were performed to determine the expansive potential of the soil. A Summary of Laboratory Test Results is presented in Figure 14 (two pages). Soil Classification Data are presented in Figures 15 through 18.

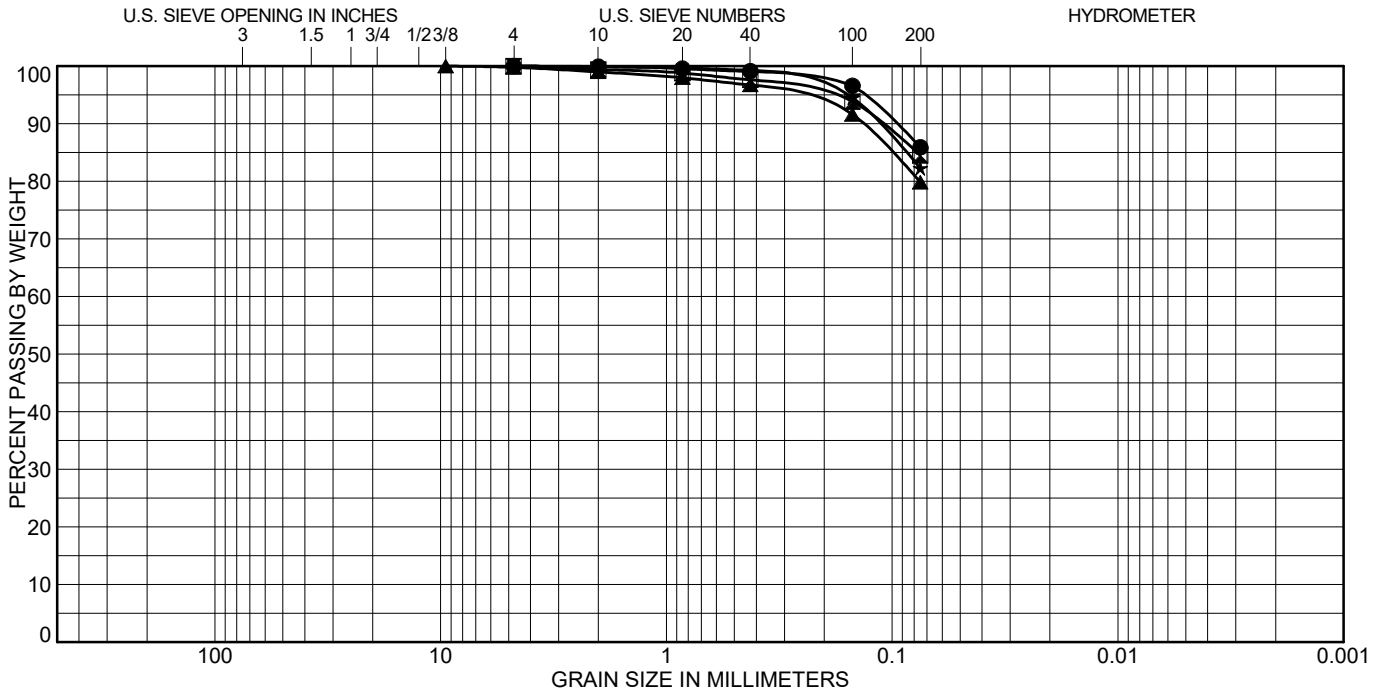
FIGURE No. 16

Test Boring	Depth (ft)	Classification	LL	PL	PI	Cc	Cu
● 6	2.0	A-6 (19)	38	15	23		
☒ 7	2.0	A-7-6 (25)	45	16	29		
▲ 8	2.0	A-6 (17)	36	13	23		
★ 9	2.0	A-7-6 (21)	41	14	27

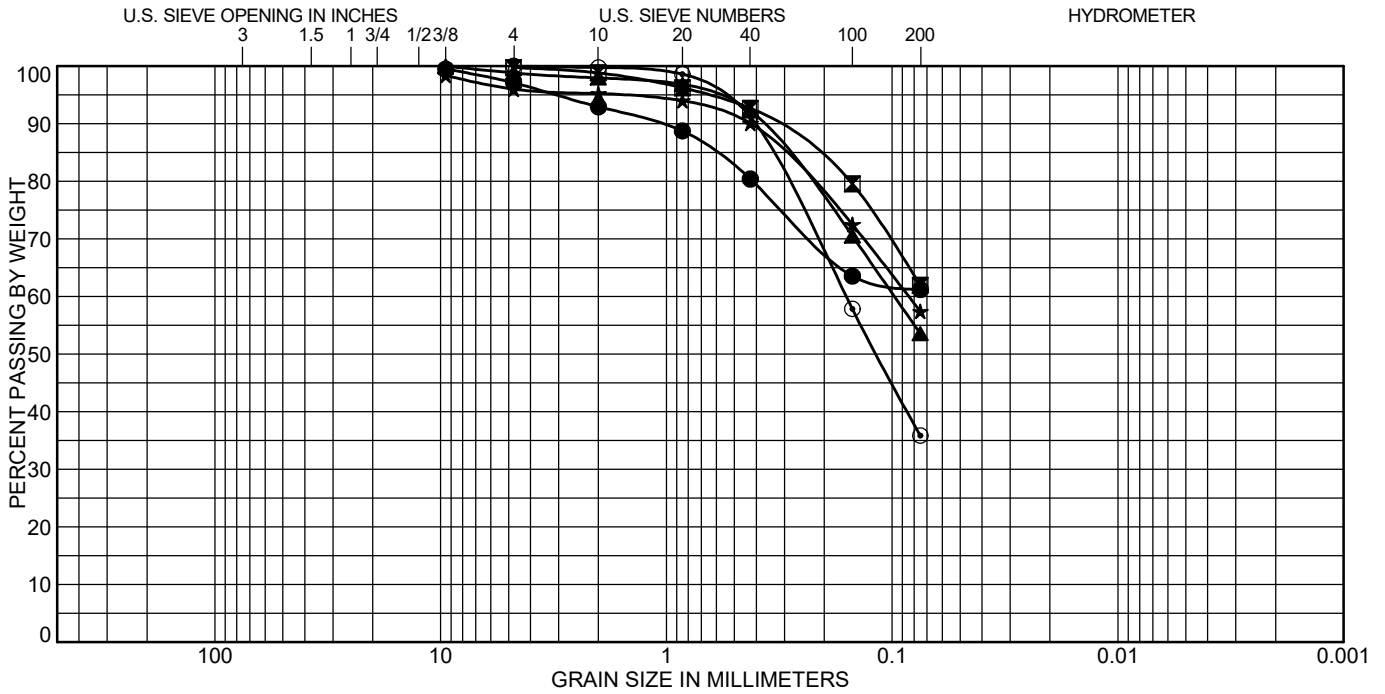
FIGURE No. 17

Test Boring	Depth (ft)	Classification	LL	PL	PI	Cc	Cu
● 10	2.0	()					
☒ 11	2.0	A-6 (9)	34	15	19		
▲ 12	2.0	A-6 (6)	32	14	18		
★ 13	2.0	A-6 (7)	33	15	18		
⊙ 14	2.0	A-6 (1)	29	17	12

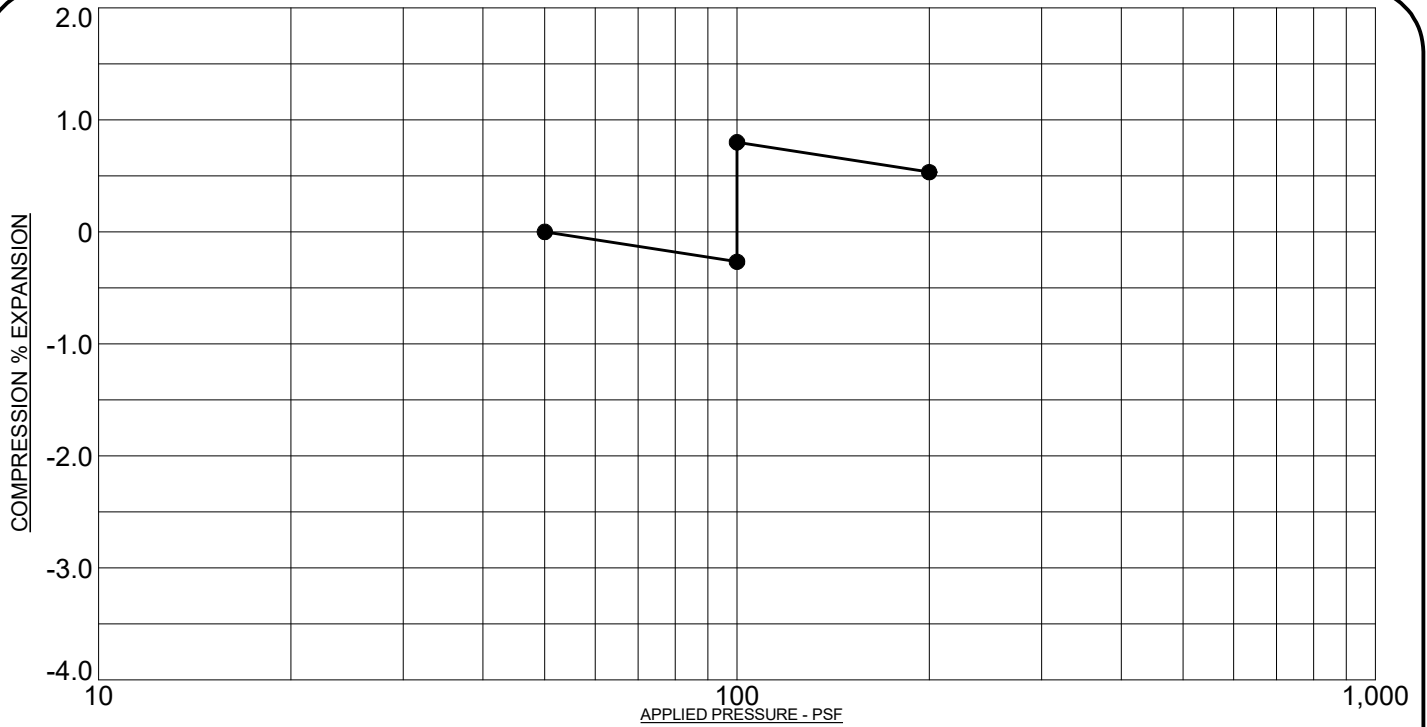
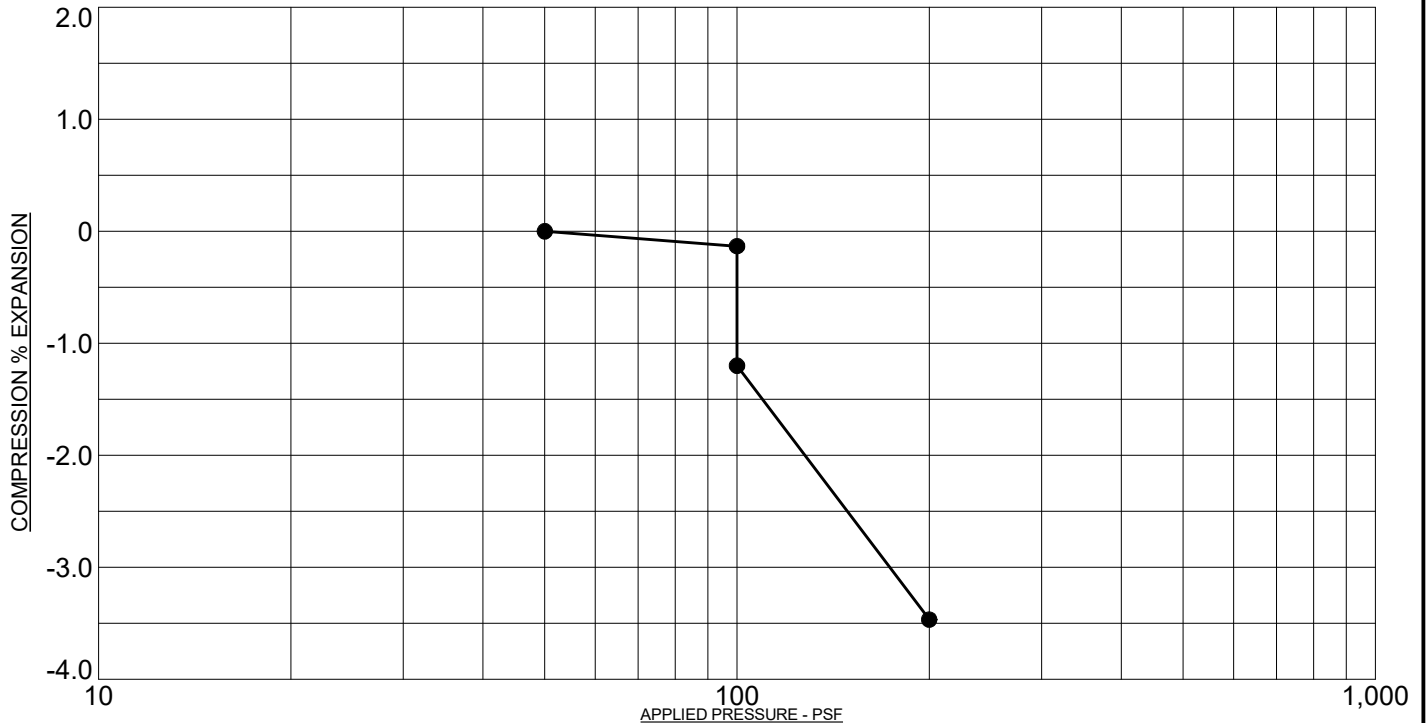
FIGURE No. 19

PROJECT: Creekside South at Lorson Ranch, El Paso County, Colorado
 SAMPLE DESCRIPTION: FILL: CLAY, SANDY
 NOTE: SAMPLE WAS INUNDATED WITH WATER AT 100 PSF

SAMPLE LOCATION: 1 @ 2 FT
 NATURAL DRY UNIT WEIGHT: 103.2 PCF
 NATURAL MOISTURE CONTENT: 13.5%
 PERCENT SWELL/COMPRESSION: 1.1

SAMPLE LOCATION: 2 @ 2 FT
 NATURAL DRY UNIT WEIGHT: 82.5 PCF
 NATURAL MOISTURE CONTENT: 14.3%
 PERCENT SWELL/COMPRESSION: -1.1

Swell potential evaluation based upon laboratory testing indicates the subgrade soil exhibited an average swell potential of 0.8 percent. Swell test results are presented in Figures 19 through 23.

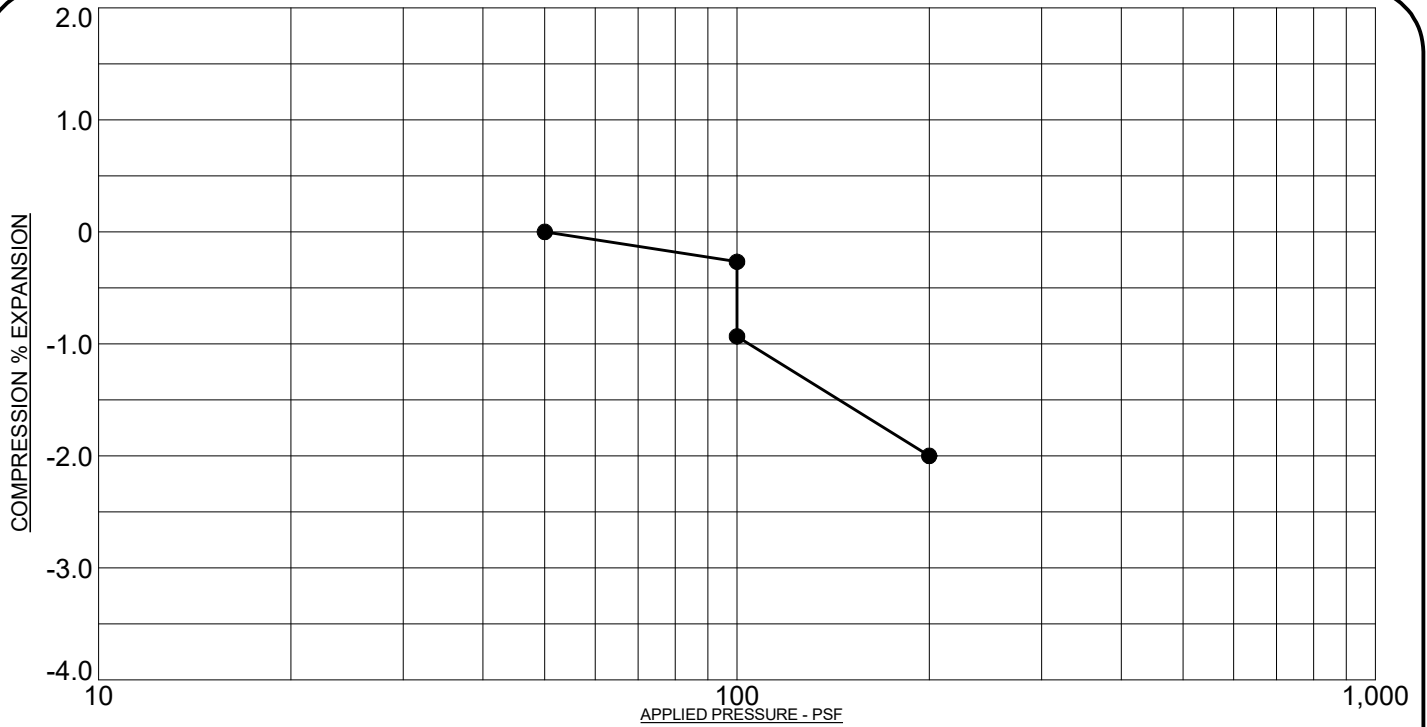
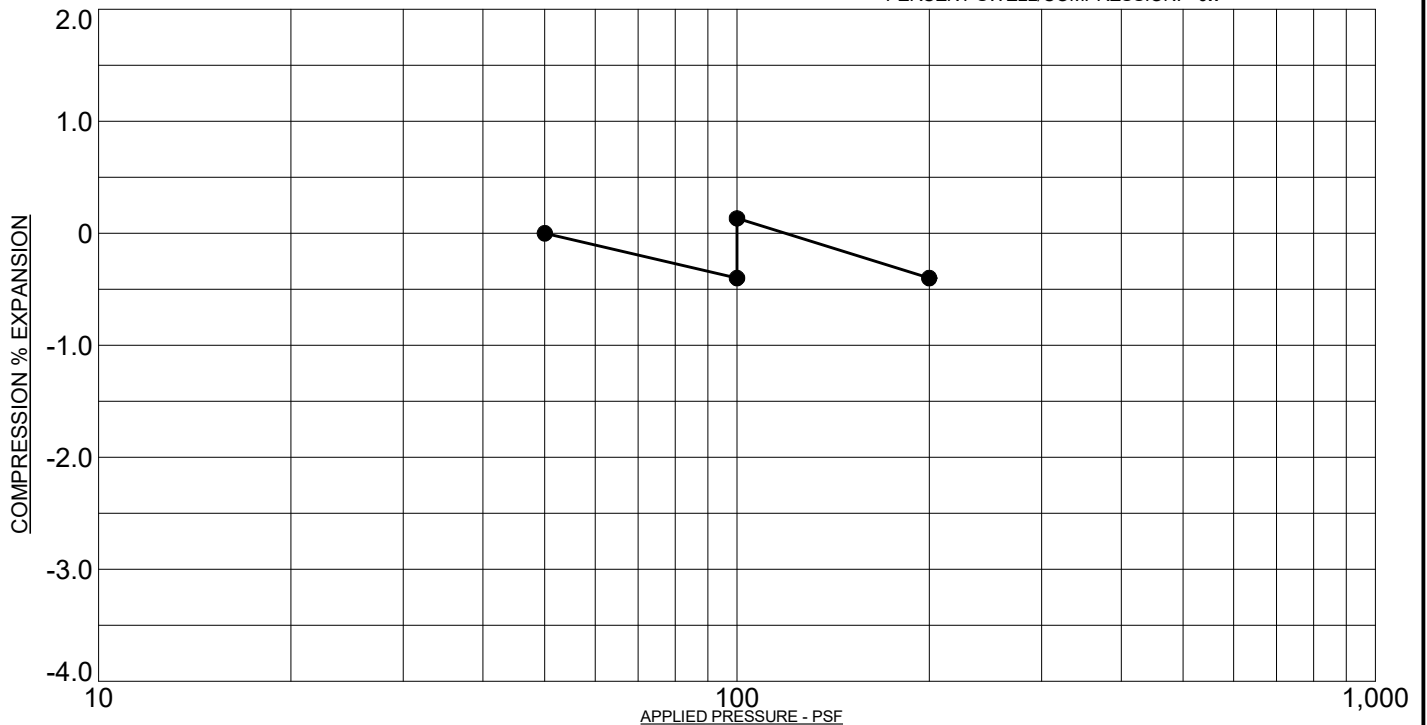
FIGURE No. 20

PROJECT: Creekside South at Lorson Ranch, El Paso County, Colorado
 SAMPLE DESCRIPTION: CLAY, SANDY
 NOTE: SAMPLE WAS INUNDATED WITH WATER AT 100 PSF

SAMPLE LOCATION: 3 @ 2 FT
 NATURAL DRY UNIT WEIGHT: 86.7 PCF
 NATURAL MOISTURE CONTENT: 9.1%
 PERCENT SWELL/COMPRESSION: - 0.7

PROJECT: Creekside South at Lorson Ranch, El Paso County, Colorado
 SAMPLE DESCRIPTION: FILL: CLAY, SANDY
 NOTE: SAMPLE WAS INUNDATED WITH WATER AT 100 PSF

SAMPLE LOCATION: 4 @ 2 FT
 NATURAL DRY UNIT WEIGHT: 80.0 PCF
 NATURAL MOISTURE CONTENT: 18.5%
 PERCENT SWELL/COMPRESSION: 0.5

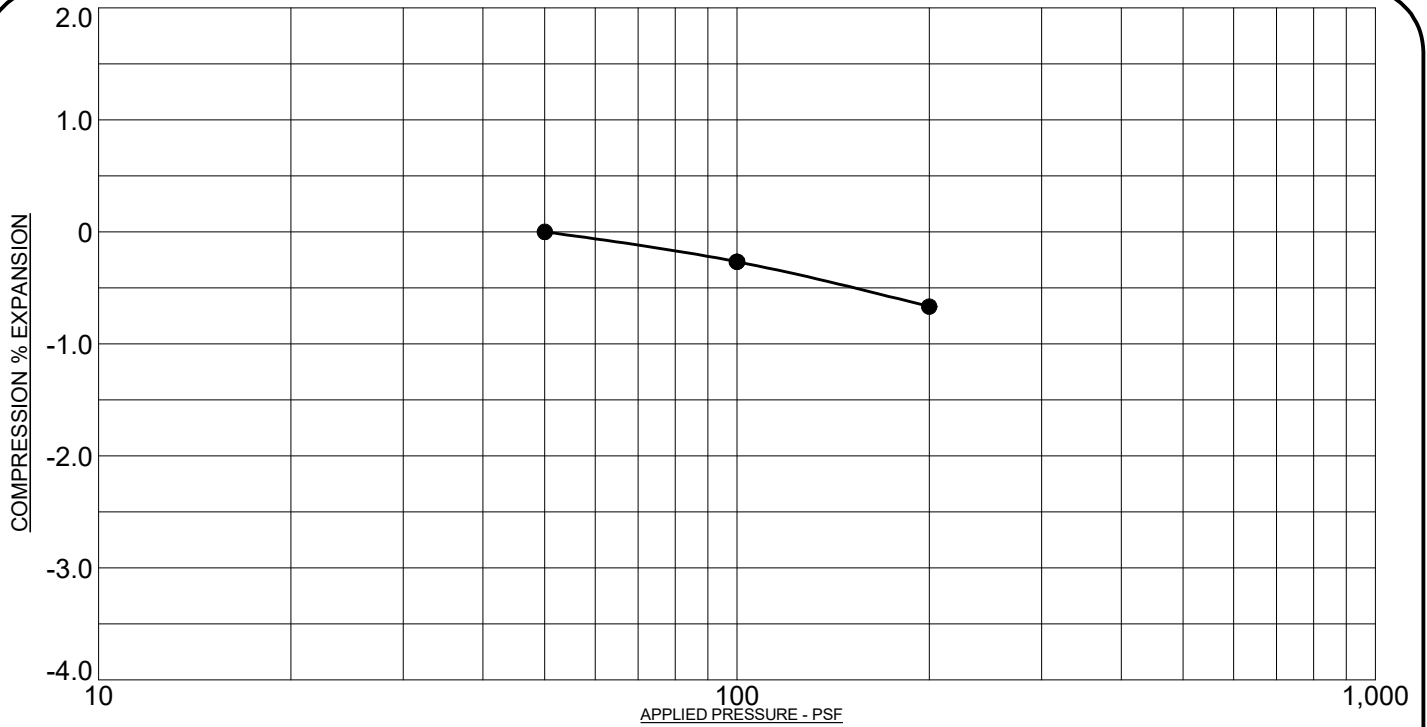
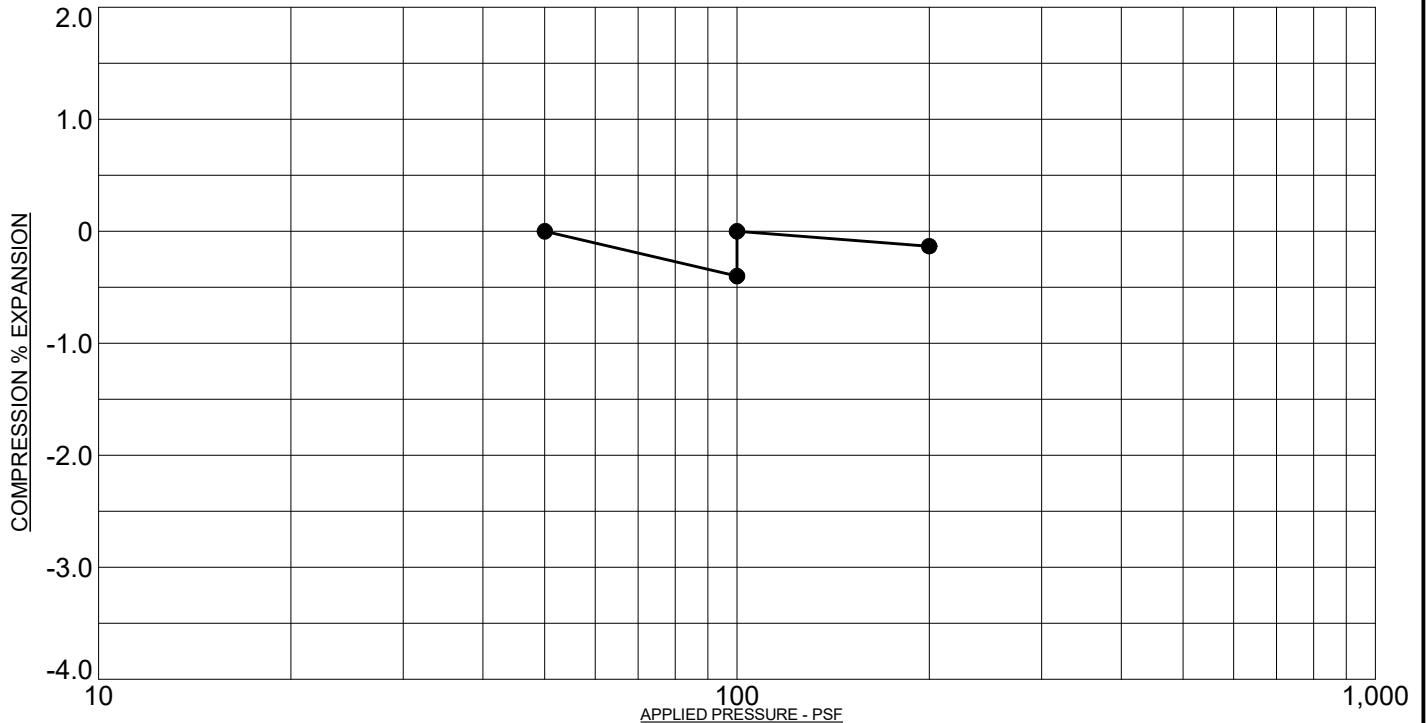
FIGURE No. 21

PROJECT: Creekside South at Lorson Ranch, El Paso County, Colorado
 SAMPLE DESCRIPTION: FILL: CLAY, SANDY
 NOTE: SAMPLE WAS INUNDATED WITH WATER AT 100 PSF

SAMPLE LOCATION: 5 @ 2 FT
 NATURAL DRY UNIT WEIGHT: 83.3 PCF
 NATURAL MOISTURE CONTENT: 13.7%
 PERCENT SWELL/COMPRESSION: 0.0

SAMPLE LOCATION: 6 @ 2 FT
 NATURAL DRY UNIT WEIGHT: 80.7 PCF
 NATURAL MOISTURE CONTENT: 17.5%
 PERCENT SWELL/COMPRESSION: 0.4

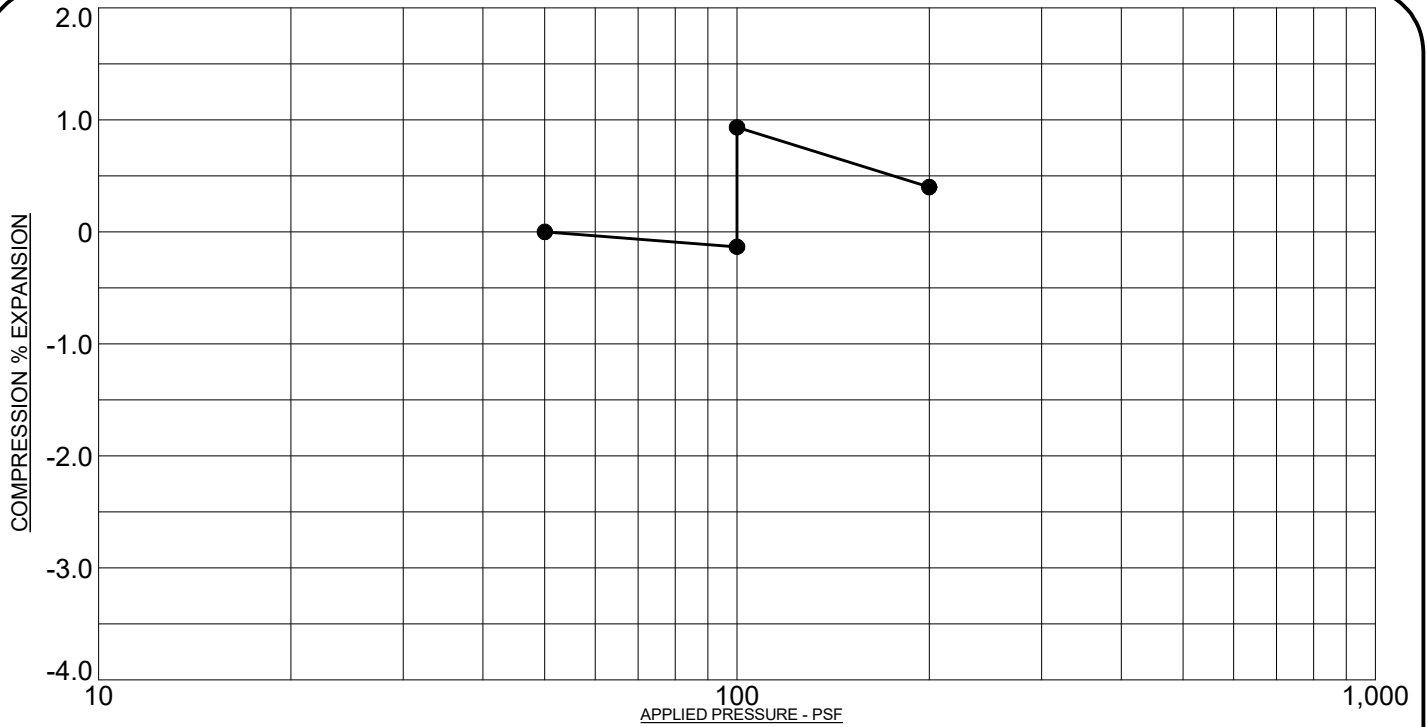
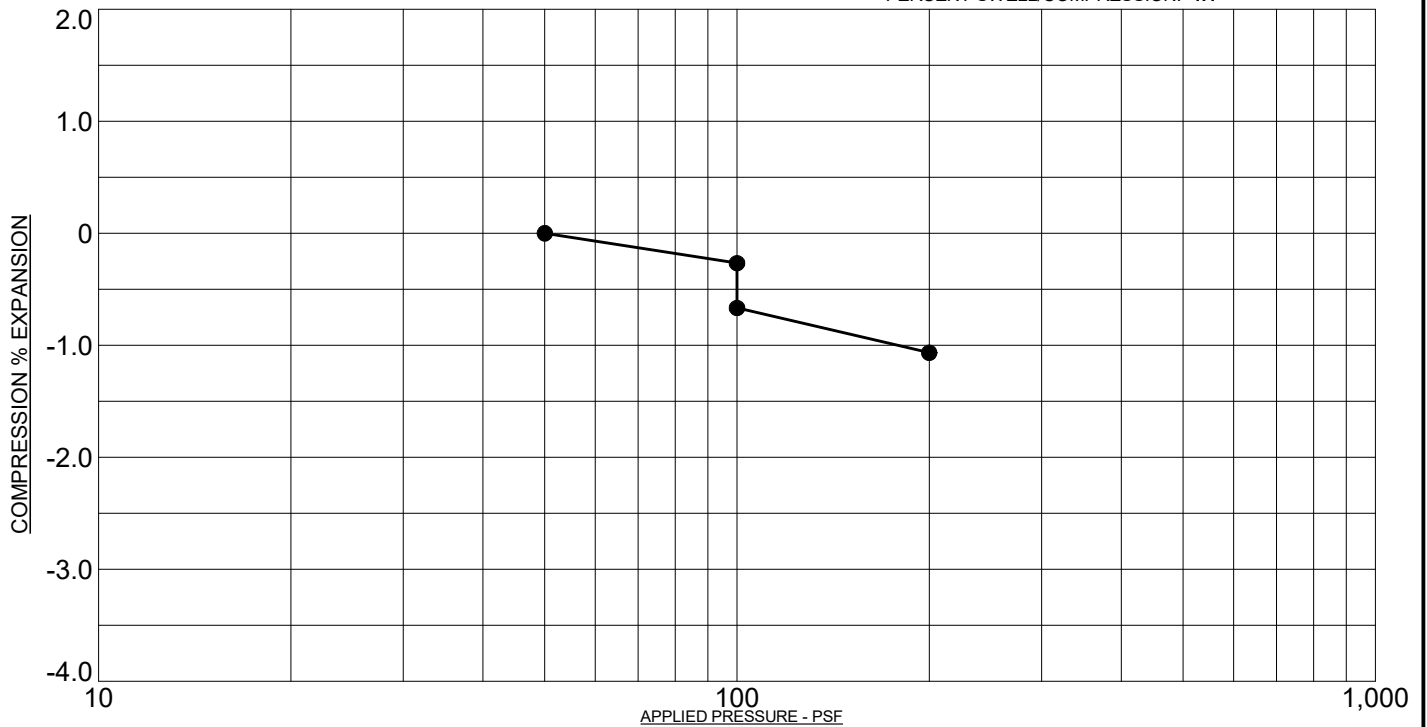
FIGURE No. 22

PROJECT: Creekside South at Lorson Ranch, El Paso County, Colorado
 SAMPLE DESCRIPTION: CLAYSTONE, SANDY
 NOTE: SAMPLE WAS INUNDATED WITH WATER AT 100 PSF

SAMPLE LOCATION: 7 @ 2 FT
 NATURAL DRY UNIT WEIGHT: 84.1 PCF
 NATURAL MOISTURE CONTENT: 11.9%
 PERCENT SWELL/COMPRESSION: 1.1

PROJECT: Creekside South at Lorson Ranch, El Paso County, Colorado
 SAMPLE DESCRIPTION: FILL: CLAY, SANDY
 NOTE: SAMPLE WAS INUNDATED WITH WATER AT 200 PSF

SAMPLE LOCATION: 8 @ 2 FT
 NATURAL DRY UNIT WEIGHT: 83.1 PCF
 NATURAL MOISTURE CONTENT: 15.3%
 PERCENT SWELL/COMPRESSION: -0.4

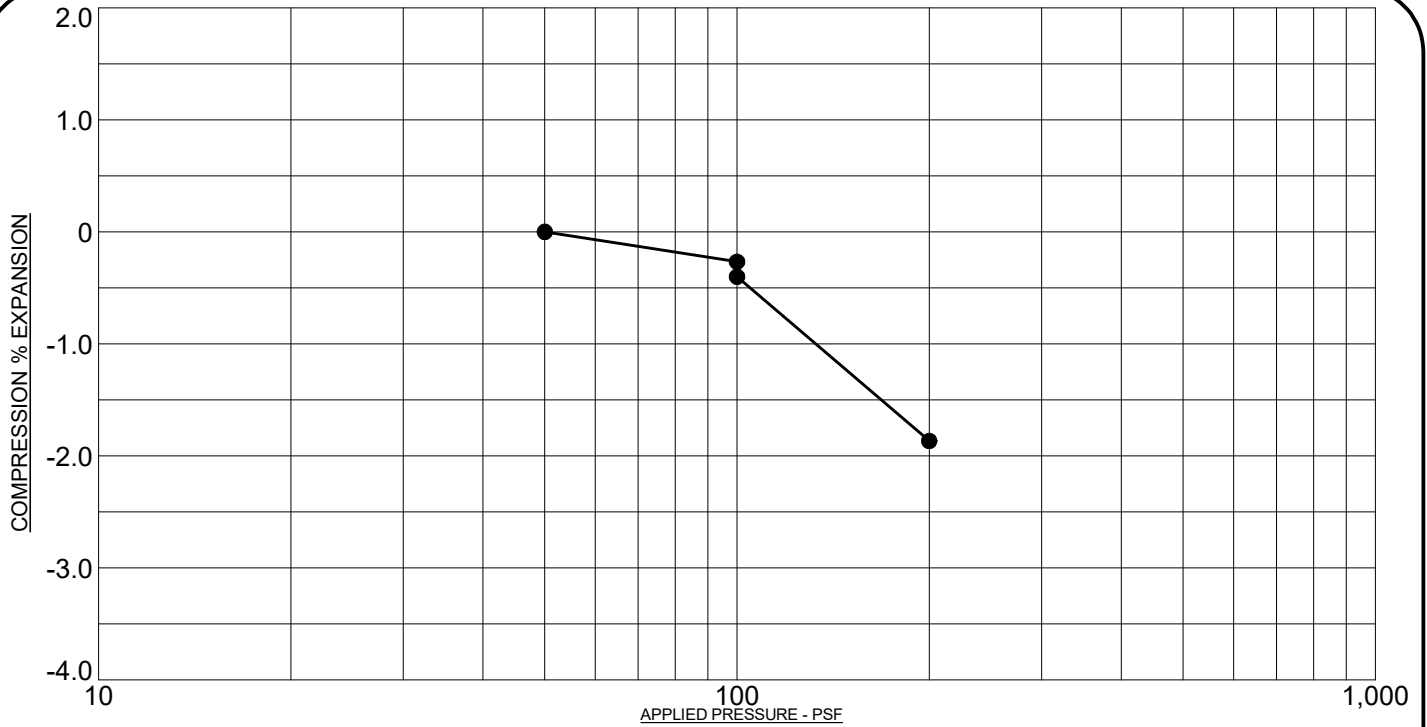
PROJECT: Creekside South at Lorson Ranch, El Paso County, Colorado
 SAMPLE DESCRIPTION: FILL: CLAY, SANDY
 NOTE: SAMPLE WAS INUNDATED WITH WATER AT 100 PSF

SAMPLE LOCATION: 9 @ 2 FT
 NATURAL DRY UNIT WEIGHT: 81.1 PCF
 NATURAL MOISTURE CONTENT: 16.4%
 PERCENT SWELL/COMPRESSION: - 0.1

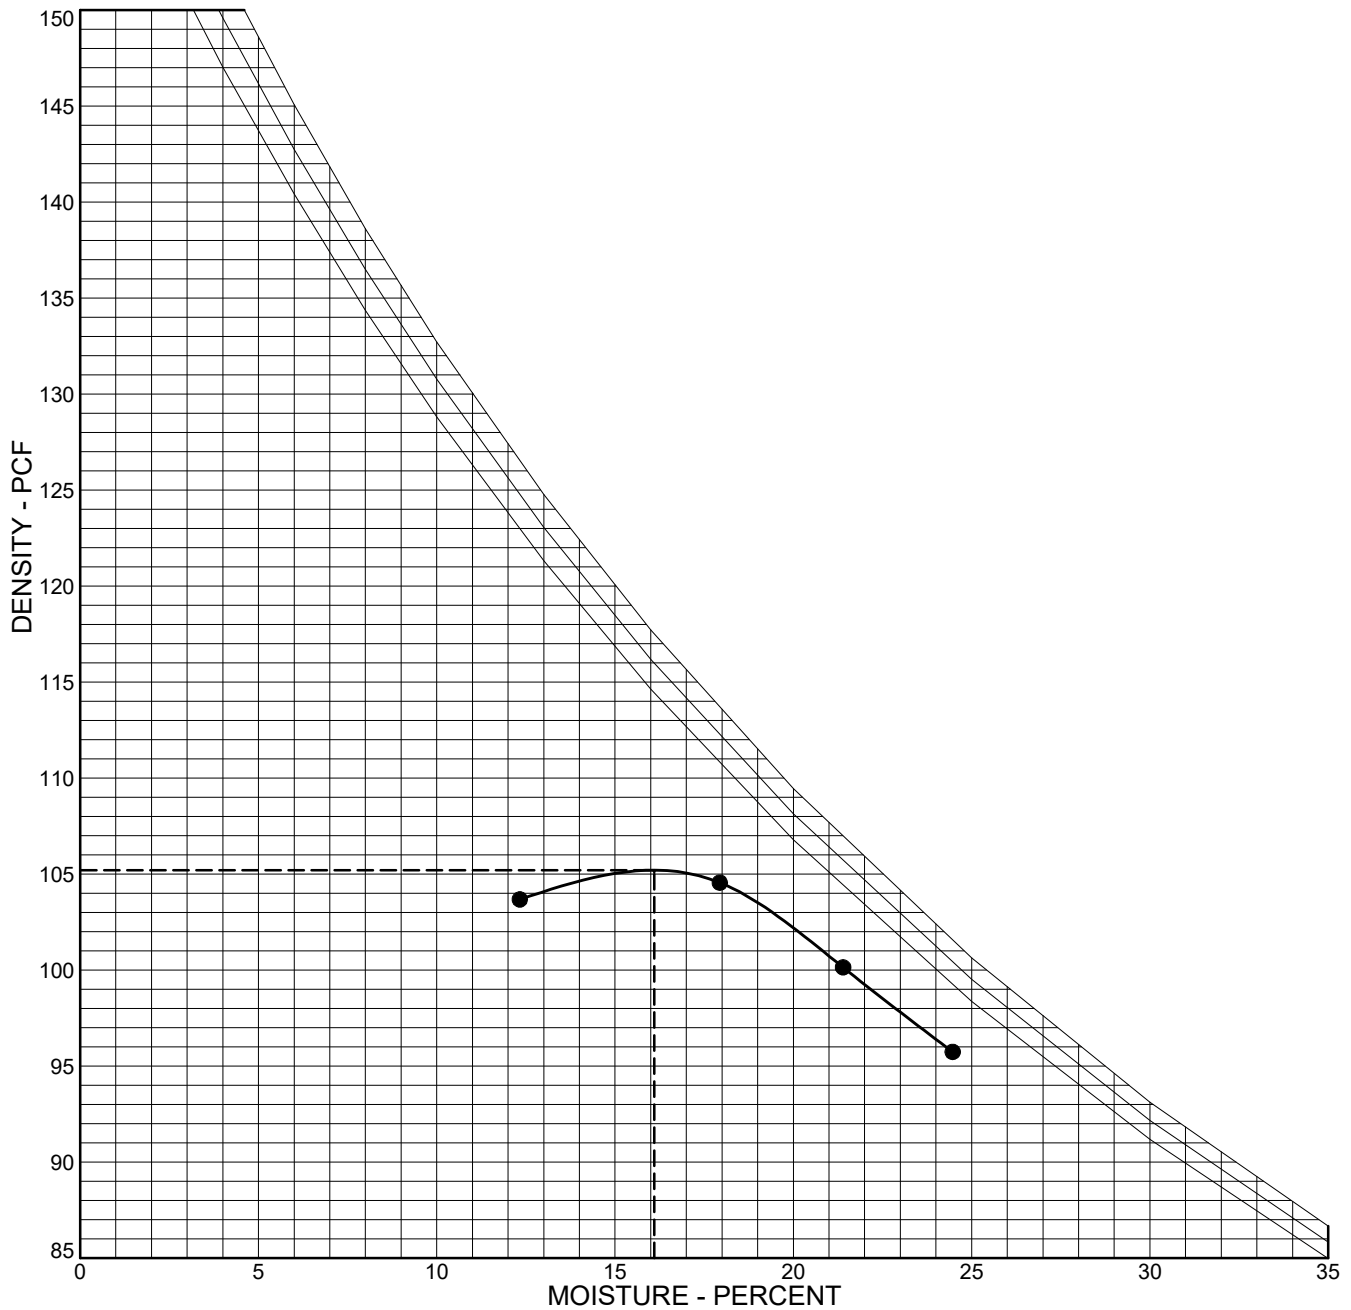
SAMPLE NUMBER: COMBINED A-6 PROCTOR

DESIGNATION **AASHTO 698A**
MAX. DRY DENSITY **105.2 pcf**
OPTIMUM MOISTURE **16.1 %**
FRACTION USED **#4**
MOLD VOLUME **0.0333 cu.ft.**

NOTE:
ZERO AIR VOIDS CURVES
PLOTTED FOR:
Gs = 2.60
Gs = 2.65
Gs = 2.70

California Bearing Ratio tests (CBR) were performed. A Combined bulk sample of A-6 soil was tested to determine the optimum moisture-density relationship in accordance with ASTM D-698 (Standard Proctor compaction test). CBR tests were performed at varying densities with moisture content near optimum. At 95% of the maximum Standard Proctor Density, the CBR of the A-6 soil was 2.5. The Moisture-Density Relation Curve is presented in Figure 24. CBR Test Results are presented in Figures 25 and 26.

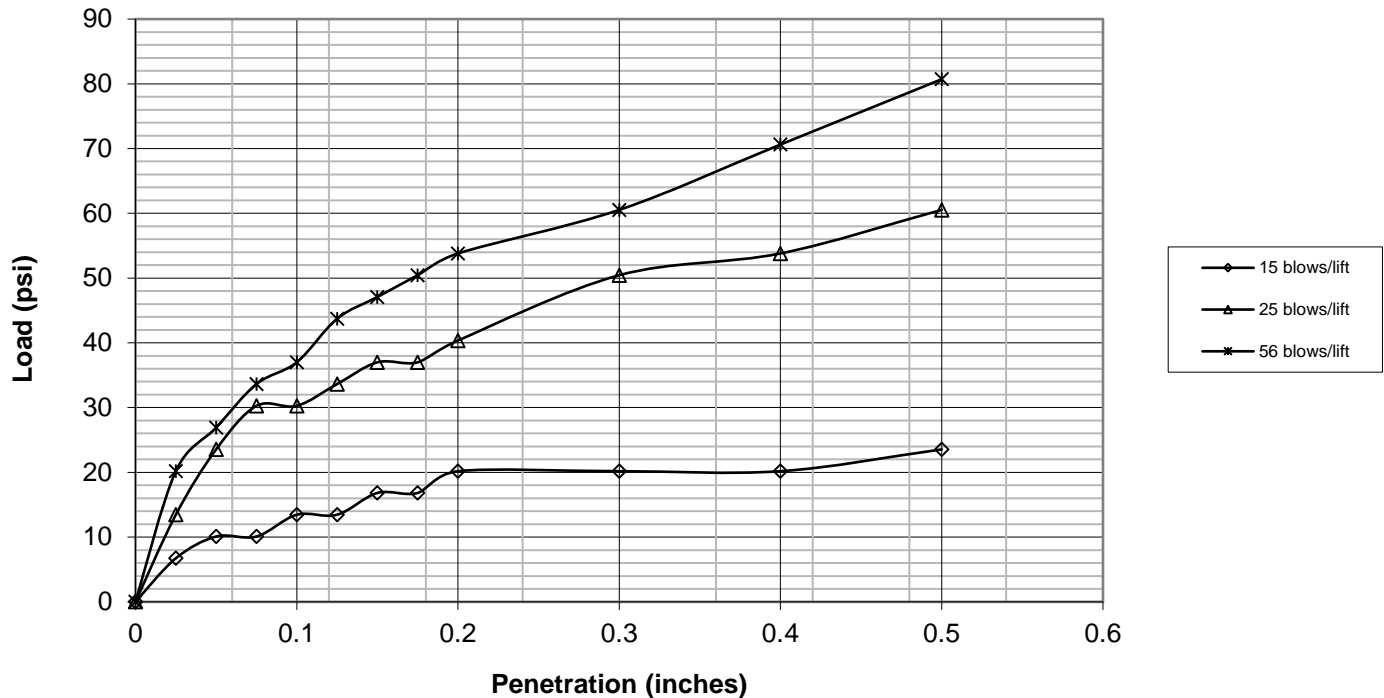
PROJECT: Creekside South at Lorson Ranch
 JOB NUMBER: 178681 TEST DATE: 3/29/2021
 AASHTO: A-6
 SAMPLE NUMBER: CBR
 SAMPLE LOCATION: Combined Bulk Sample
 SOIL DESCRIPTION: Silty and Clayey Sand

Penetration (in)	15 blows/lift	25 blows/lift	56 blows/lift
	Load (psi)	Load (psi)	Load (psi)
0.000	0.0	0.0	0.0
0.025	6.7	13.5	20.2
0.050	10.1	23.5	26.9
0.075	10.1	30.3	33.6
0.100	13.5	30.3	37.0
0.125	13.5	33.6	43.7
0.150	16.8	37.0	47.1
0.175	16.8	37.0	50.4
0.200	20.2	40.4	53.8
0.300	20.2	50.4	60.5
0.400	20.2	53.8	70.6
0.500	23.5	60.5	80.7

Corrected Penetration (in)	15 blows/lift	25 blows/lift	56 blows/lift
	Corrected Load (psi)	Corrected Load (psi)	Corrected Load (psi)
0.1	1.3	3.0	3.7
0.2	1.3	2.7	3.6

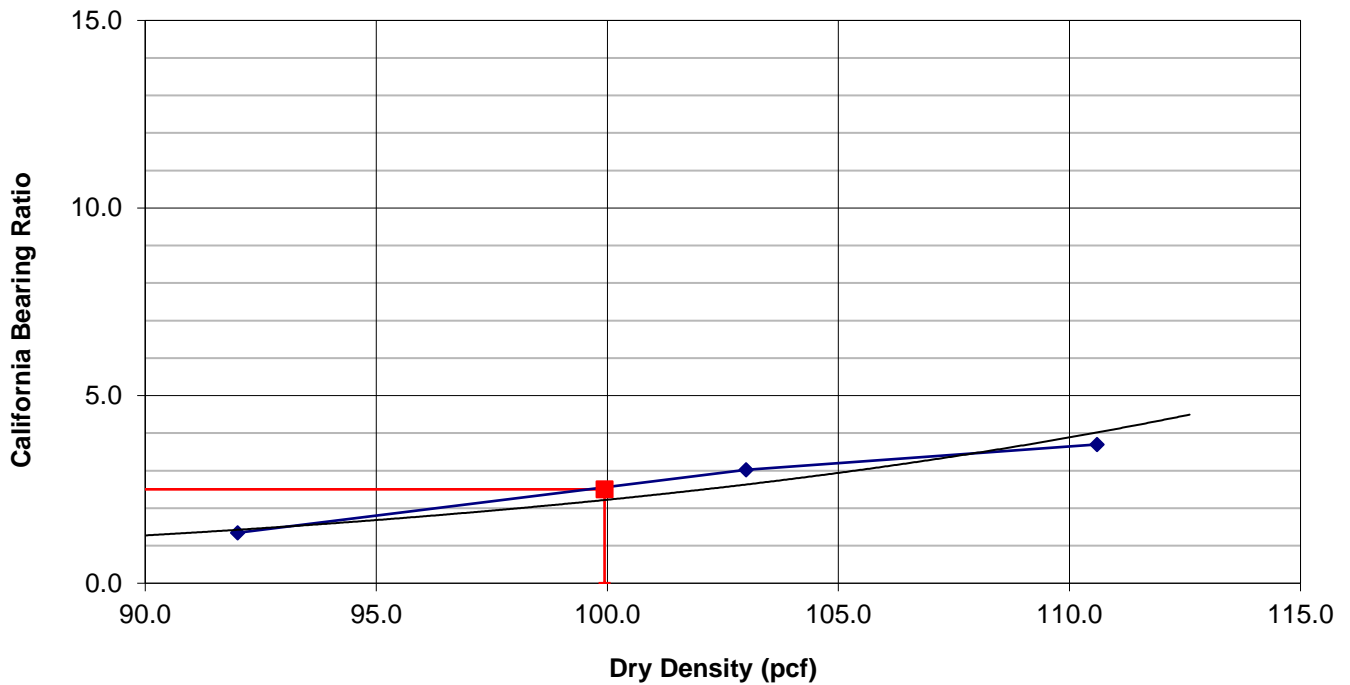
PROJECT:	Creskide South at Lorson Ranch	
JOB NUMBER:	178681	TEST DATE: 3/29/2021
AASHTO CLASSIFICATION:	A-6	
SAMPLE NUMBER:	CBR	
SAMPLE LOCATION:	Combined Bulk Sample	
SOIL DESCRIPTION:	Silty and Clayey Sand

15 blows/lift	25 blows/lift	56 blows/lift
Corrected California Bearing Ratio	1.3	3.0	3.7
Dry Density (pcf)	92.0	103.0	110.6
Percent Compaction	87	98	105
Percent Moisture After Soaking	27.0	29.7	25.9
Percent Expansion/Compression	2.2	2.4	1.3
Surcharge Weight (lbs)	12.60	12.60	12.60

California Bearing Ratio	2.5
Dry Density (pcf)	105.2
Percent Compaction	95.00%
Target Dry Density	99.9
Compaction Test Method	ASTM D-698
Condition of sample	Soaked
