## **GEOLOGY AND SOILS STUDY**

**Lots 1-90  
Townhomes at Ponderosa North  
at Lorson Ranch, Filing No. 3  
El Paso County, Colorado**

**JOB NO. 172414**

**November 7, 2019  
Revised November 8, 2019**

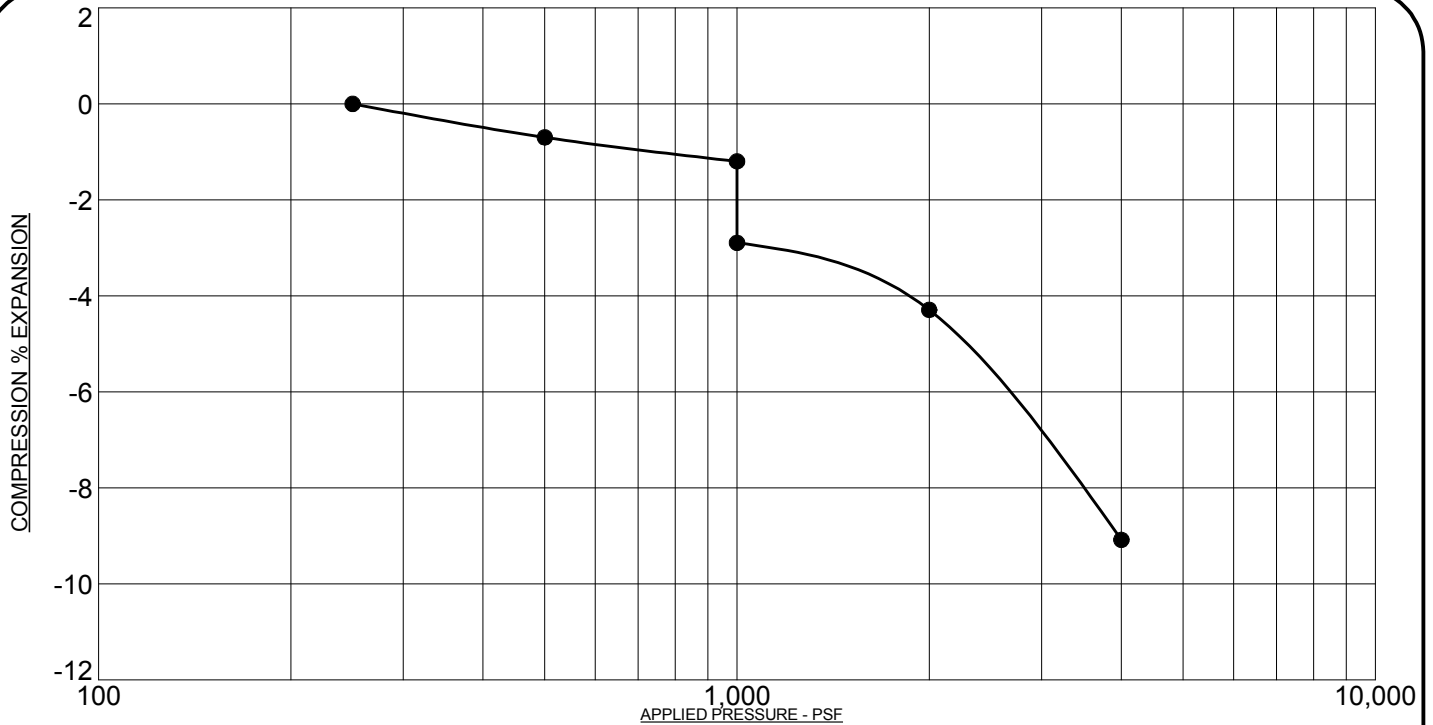
PROJECT: **Ponderosa at Lorson Ranch, Filing No. 3 El Paso County, Colorado**  
 SAMPLE DESCRIPTION: **CLAY, SANDY**  
 NOTE: **SAMPLE WAS INUNDATED WITH WATER AT 1,000 PSF**

SAMPLE LOCATION: **1 @ 14 FT**  
 NATURAL DRY UNIT WEIGHT: **80.9 PCF**  
 NATURAL MOISTURE CONTENT: **25.3%**  
 PERCENT SWELL/COMPRESSION: **- 1.7**

Soil laboratory testing was performed as part of this investigation. The laboratory tests included moisture content, dry density, grain-size analyses, Atterberg Limits, and one Swell/Consolidation test. A Summary of Laboratory Test Results is presented in Figure 6. Soils Classification Data is presented in Figure 7. Swell/Consolidation Test Results are presented in Figure 8.
