# **CROSSROADS CHAPEL – DRAINAGE MEMO**

840 Northgate Boulevard  
Colorado Springs, CO

**COM2522**

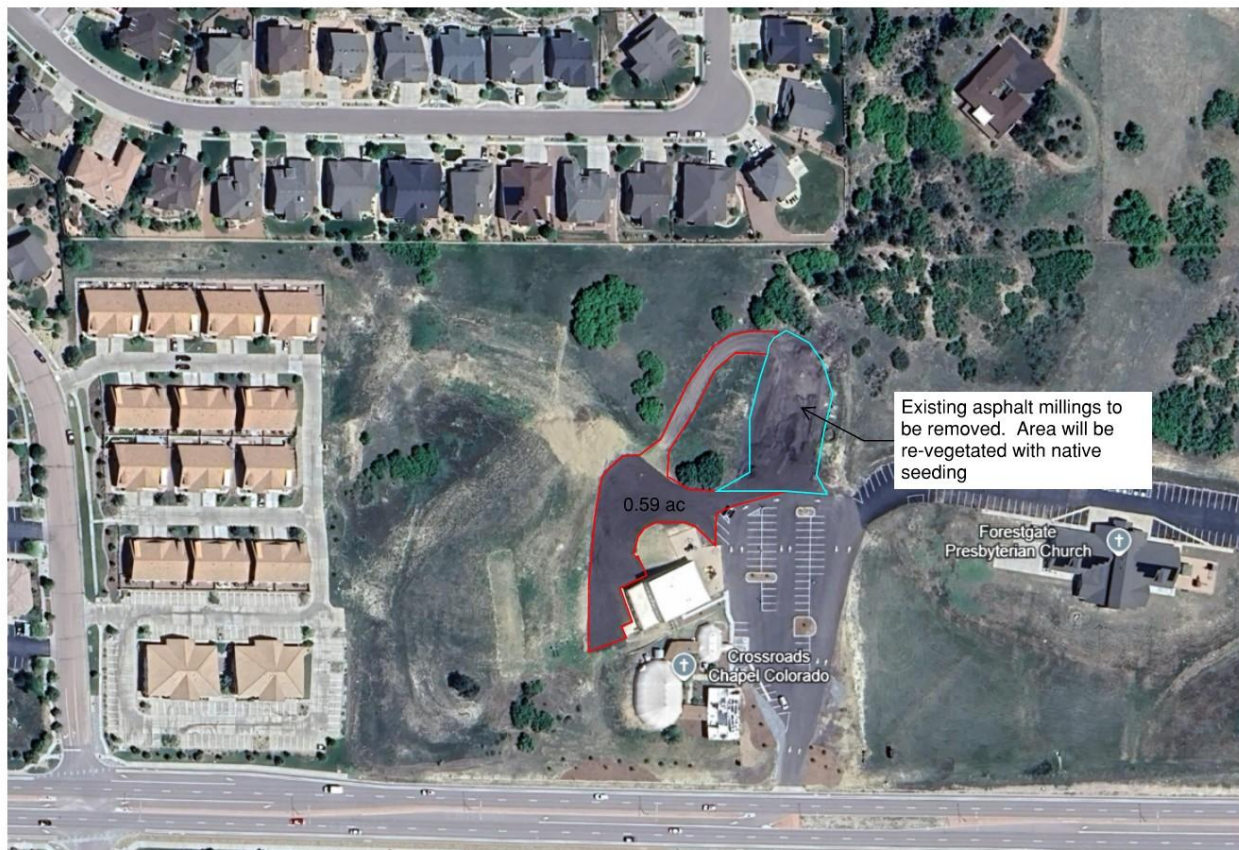
Below is a map showing the two areas where new asphalt millings were placed. The placement of the millings represents the only change between the current and proposed conditions. The red area represents where the asphalt millings will stay, while the aqua area represents the stockpile the owner will remove and clean up. Once the aqua area is cleaned of millings, it will be evaluated for any needed soil amendments, then restored and revegetated with native seed.

Surface runoff from the increased imperviousness on the site (area shown in red) will not adversely impact neighboring or downstream properties.

Using 90% imperviousness of asphalt millings (red area), of 0.59 ac, results in the following changes from Current to Proposed conditions, as shown in the following tables:
