GEOLOGIC HAZARD EVALUATION AND PRELIMINARY GEOTECHNICAL INVESTIGATION GRANDVIEW RESERVE, PHASE 3 EASTONVILLE ROAD AND U.S. HIGHWAY 24 FALCON, COLORADO

Project No. CS19345.300-115

March 12, 2024

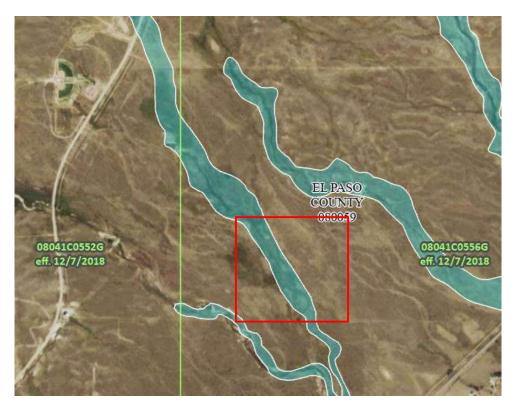
The majority of the site lies within Zone D (undetermined flood hazard), as shown on FIRM Community Map Number 08041C0556G, revised December 7, 2018. Zone D indicates floods are possible, but not likely. Some portions of the site within drainage areas lie within Zone A, as shown below.

Excerpt from FEMA National Flood Hazard Layer Viewer, General Site Area is Depicted in Red

Based on the topography at the site, the potential for a flood to impact the majority of the site area is low. During peak precipitation events, some accumulation of surface sheet flow in drainages is expected with possible inundation within the Zone A areas that are identified in the bluish-green color shown above. Development will increase the relative area of impervious surfaces, which can lead to drainage problems and erosion if surface water flow is not adequately designed. Surface drainage design and evaluation of flood potential should be performed by a civil engineer as part of the project design.

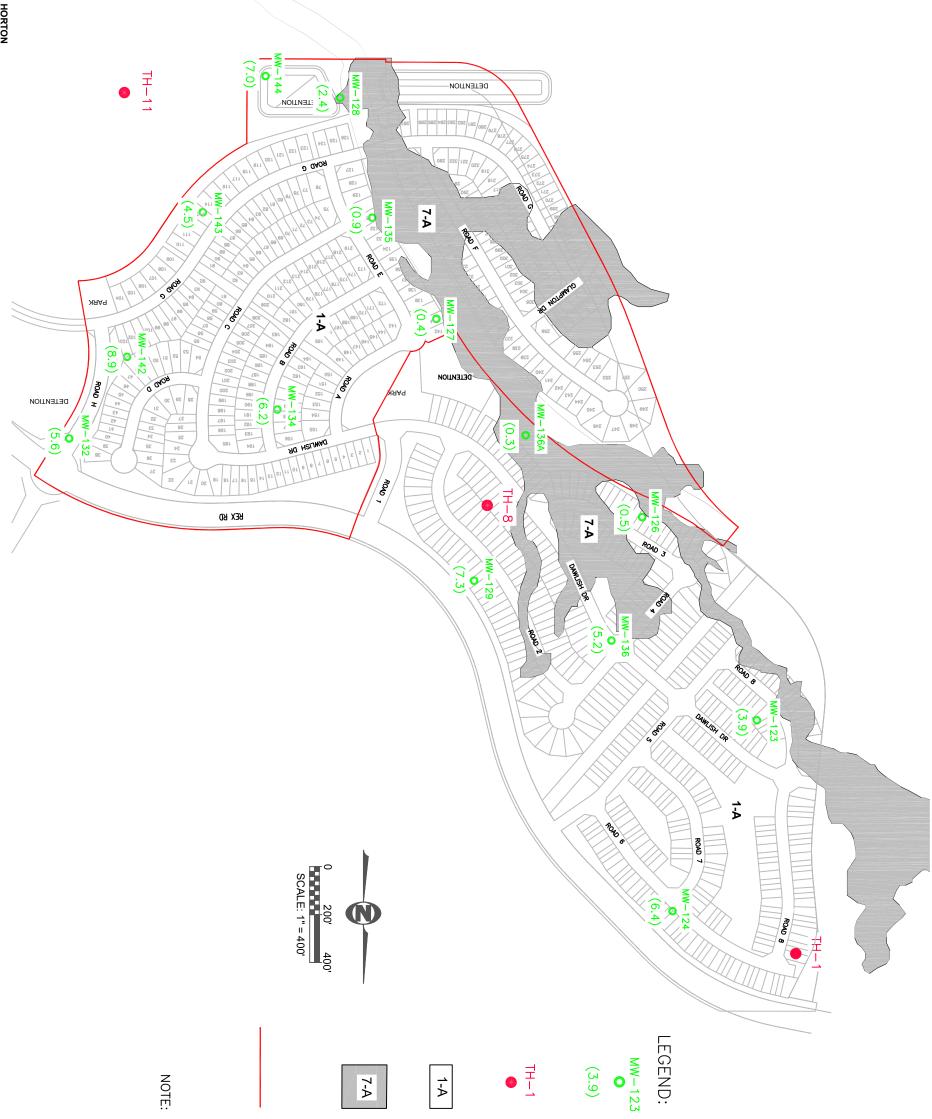
Conditions Geologic **Engineering**

APPROXIMATE LOCATION OF EXPLORATORY BORING

DEPTH TO MEASURED PEAK GROUNDWATER (FEET)

NOTE: E: EXPANSIVE SOILS/BEDROCK WERE FOUND SPORADICALLY ACROSS THE SITE. ALL LOTS MAY BE IMPACTED BY GROUND HEAVE. TOTAL CALCULATED GROUND HEAVE RANGED FROM LESS THAN 0.5 INCHES TO 1 INCH. DEPTH TO GROUNDWATER ARE PEAK LEVELS MEASURED IN MONITORING WELLS BETWEEN SEPTEMBER 2023 AND JANUARY 2024.
