## **SOILS AND GEOLOGY STUDY**

**Peerless Farms  
El Paso County, Colorado**

**JOB NO. 180213**

**April 14, 2021**

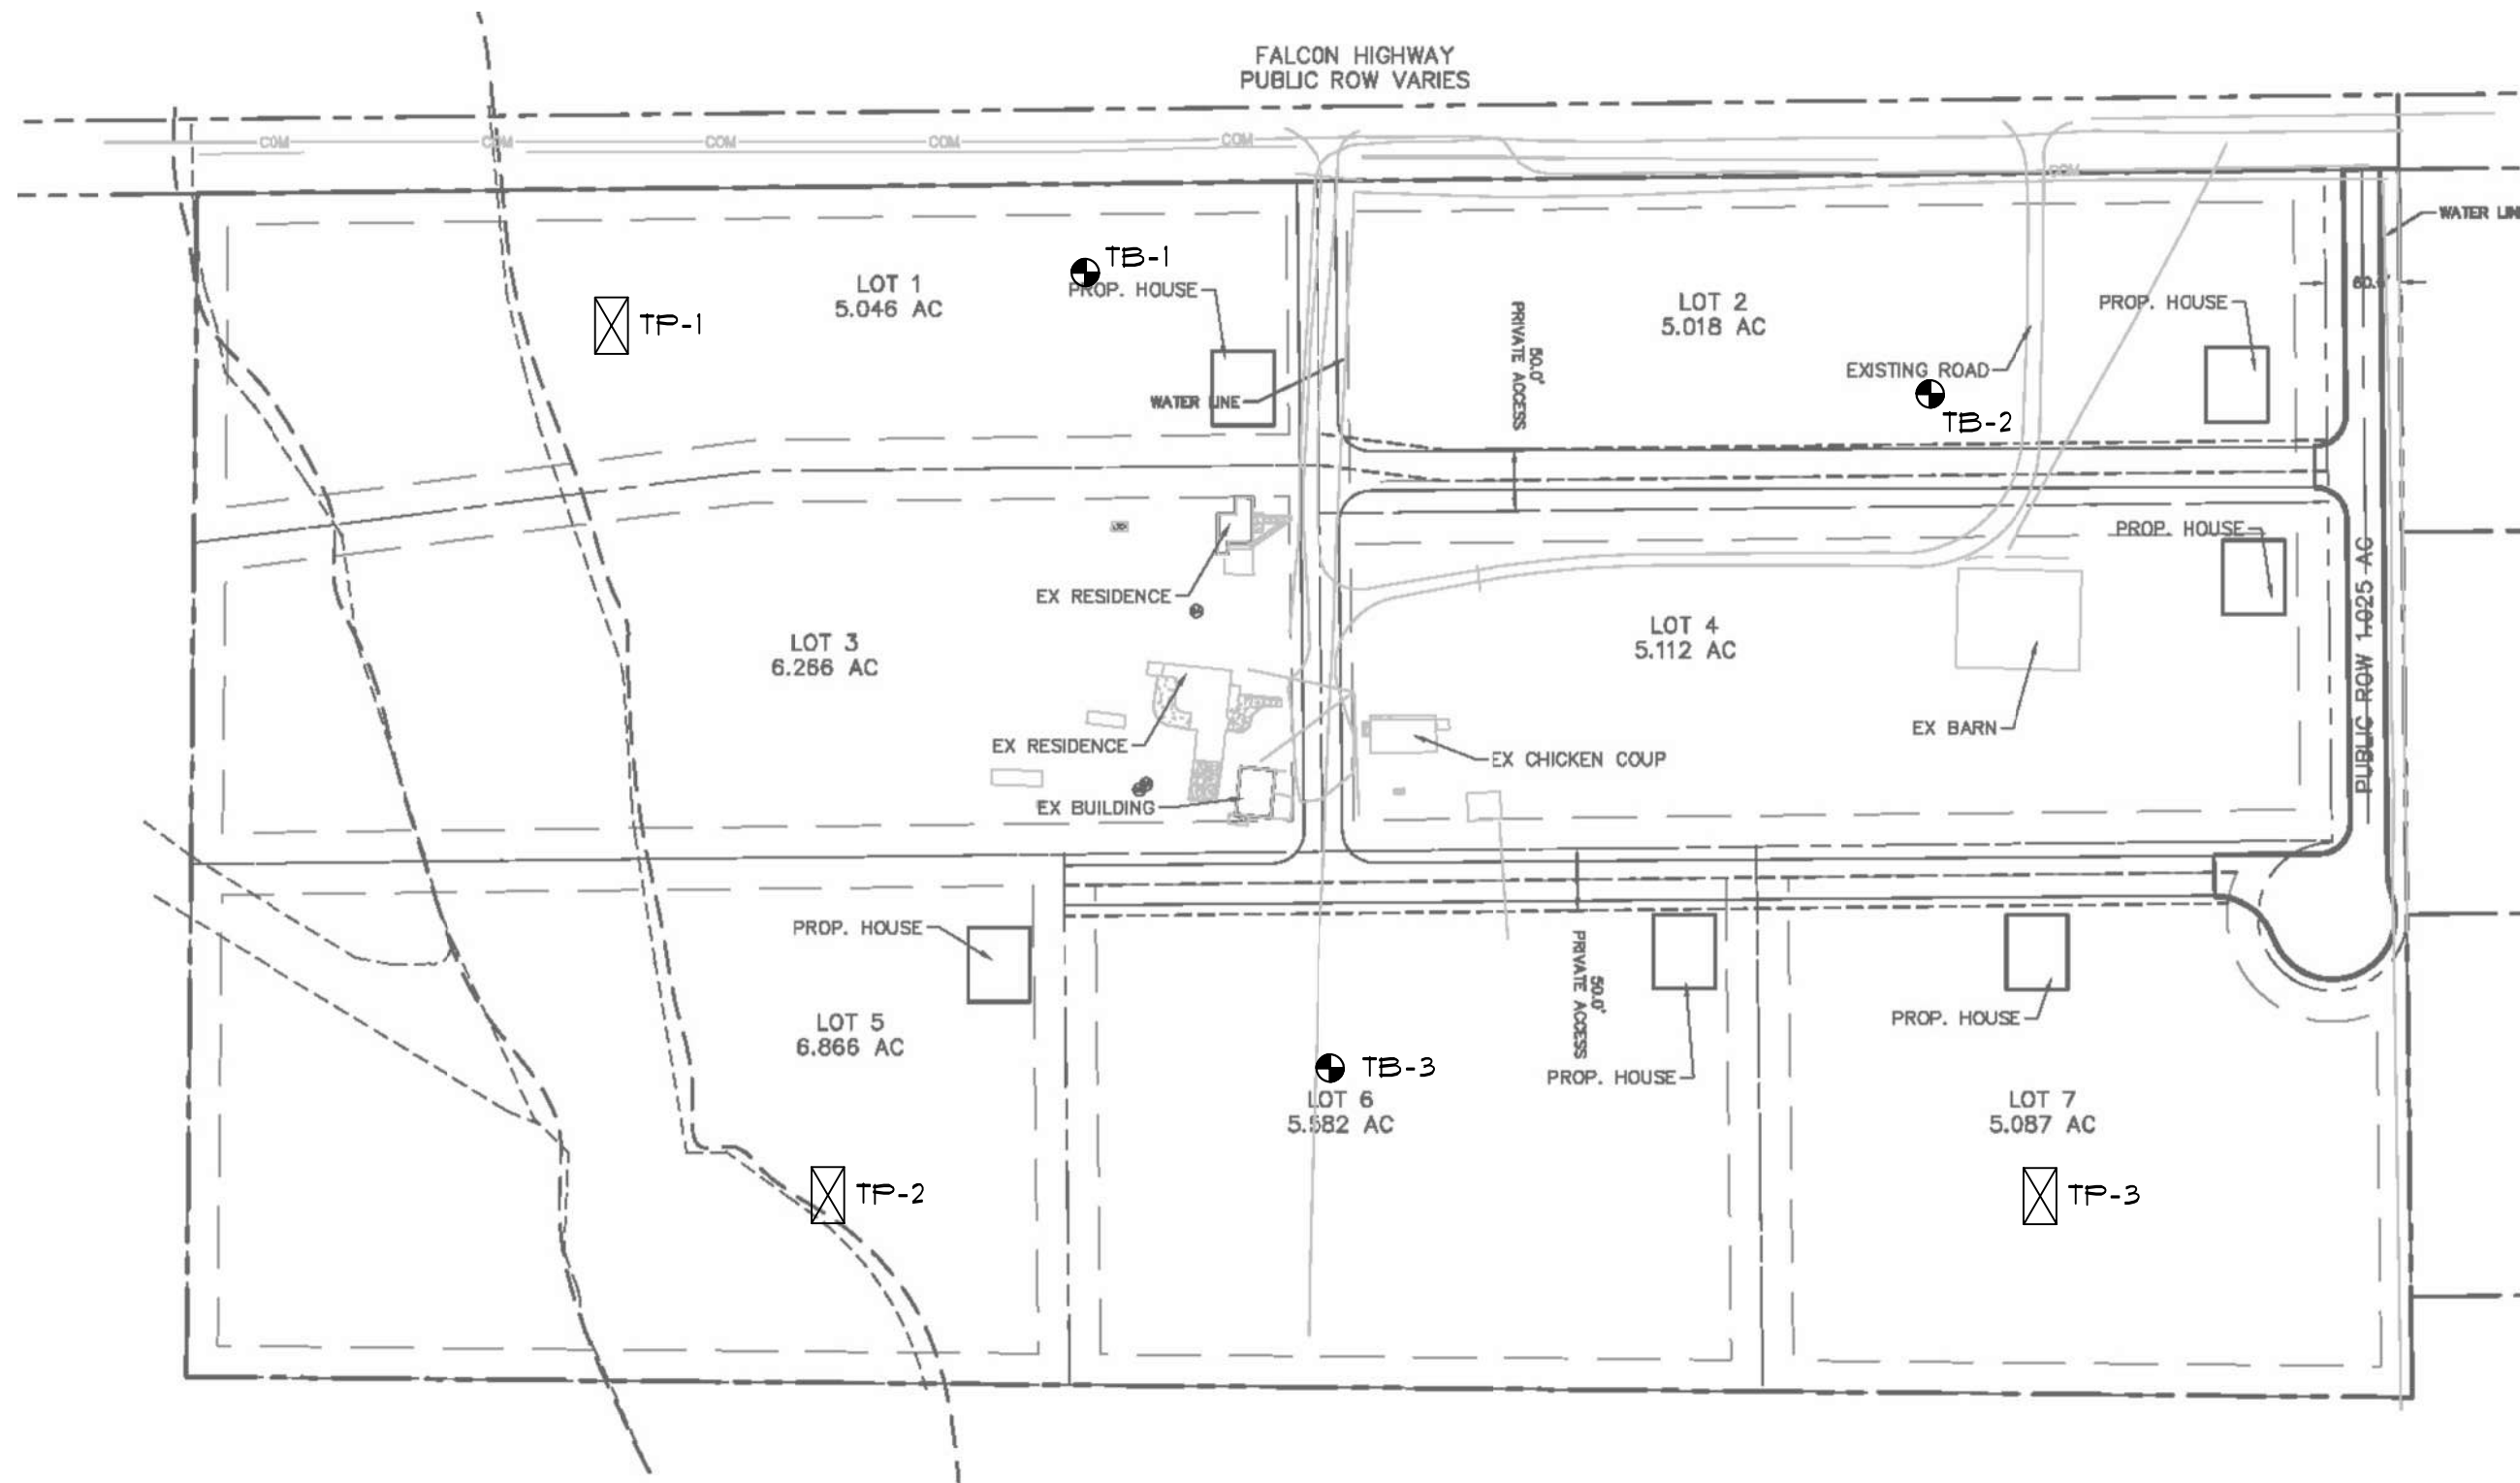
Figure 3?

NOT TO SCALE  
BASE MAP PROVIDED BY KIMLEY HORN

The subsurface conditions within the property were explored by drilling a total of three (3) exploratory borings and observing (3) test pits. The three test borings were drilled on March 4, 2021 and the three test pits were observed on February 26, 2021. The approximate location of the test borings and test pits are presented on the Test Boring and Test Pit Location Plan, Figure 3.

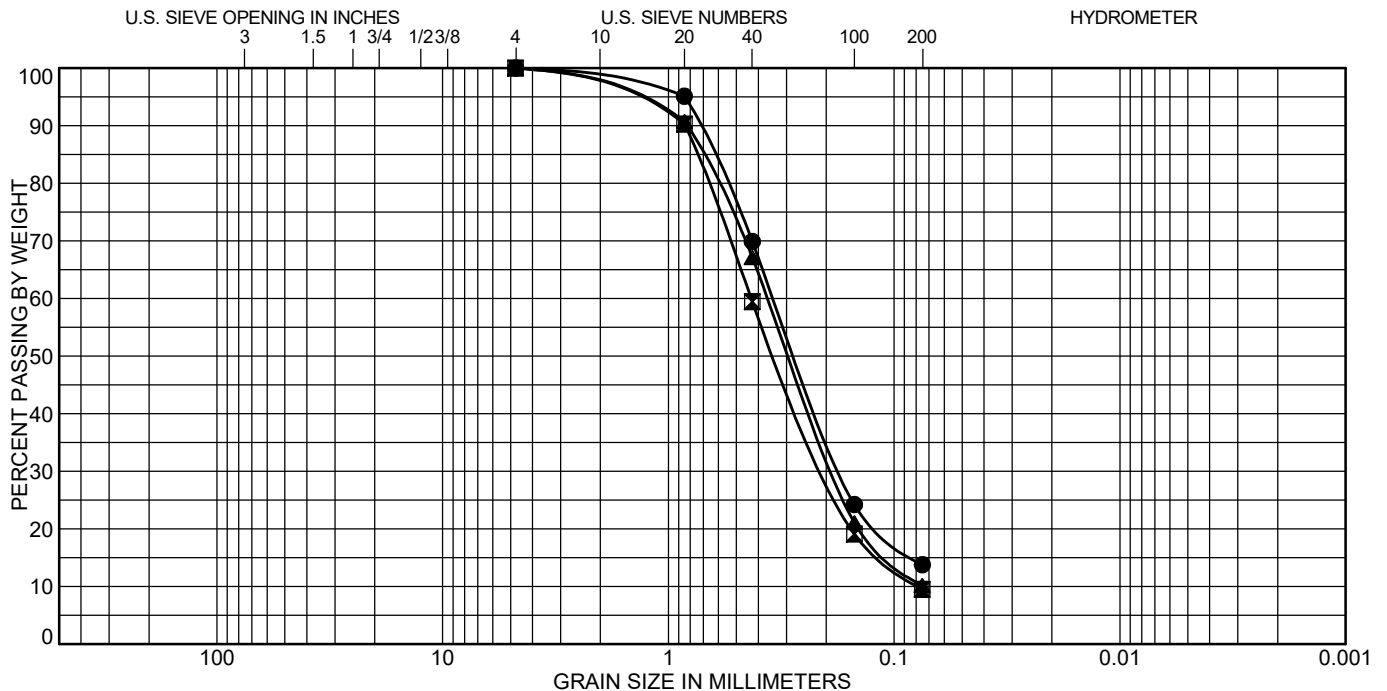
JOB No. 180213  
FIGURE No. 8  
PAGE 1 OF 1  
DATE Apr/15/2021

## SUMMARY OF LABORATORY TEST RESULTS

COBBLES	GRAVEL		SAND			SILT OR CLAY
	coarse	fine	coarse	medium	fine

Test Boring	Depth (ft)	Classification	LL	PL	PI
● 1	4.0	SILTY SAND(SM)	NP	NP	NP
⊠ 2	9.0	POORLY GRADED SAND with SILT(SP-SM)	NP	NP	NP
▲ 3	14.0	POORLY GRADED SAND with SILT(SP-SM)	NP	NP	NP

Soil laboratory testing was performed as part of this investigation. The laboratory tests included moisture content, dry density, grain-size analyses and Atterberg Limits. Swell/Consolidation tests were not performed on the onsite non-expansive silty sand. A Summary of Laboratory Test Results is presented in Figure 8. Soils Classification Data is presented in Figure 9.

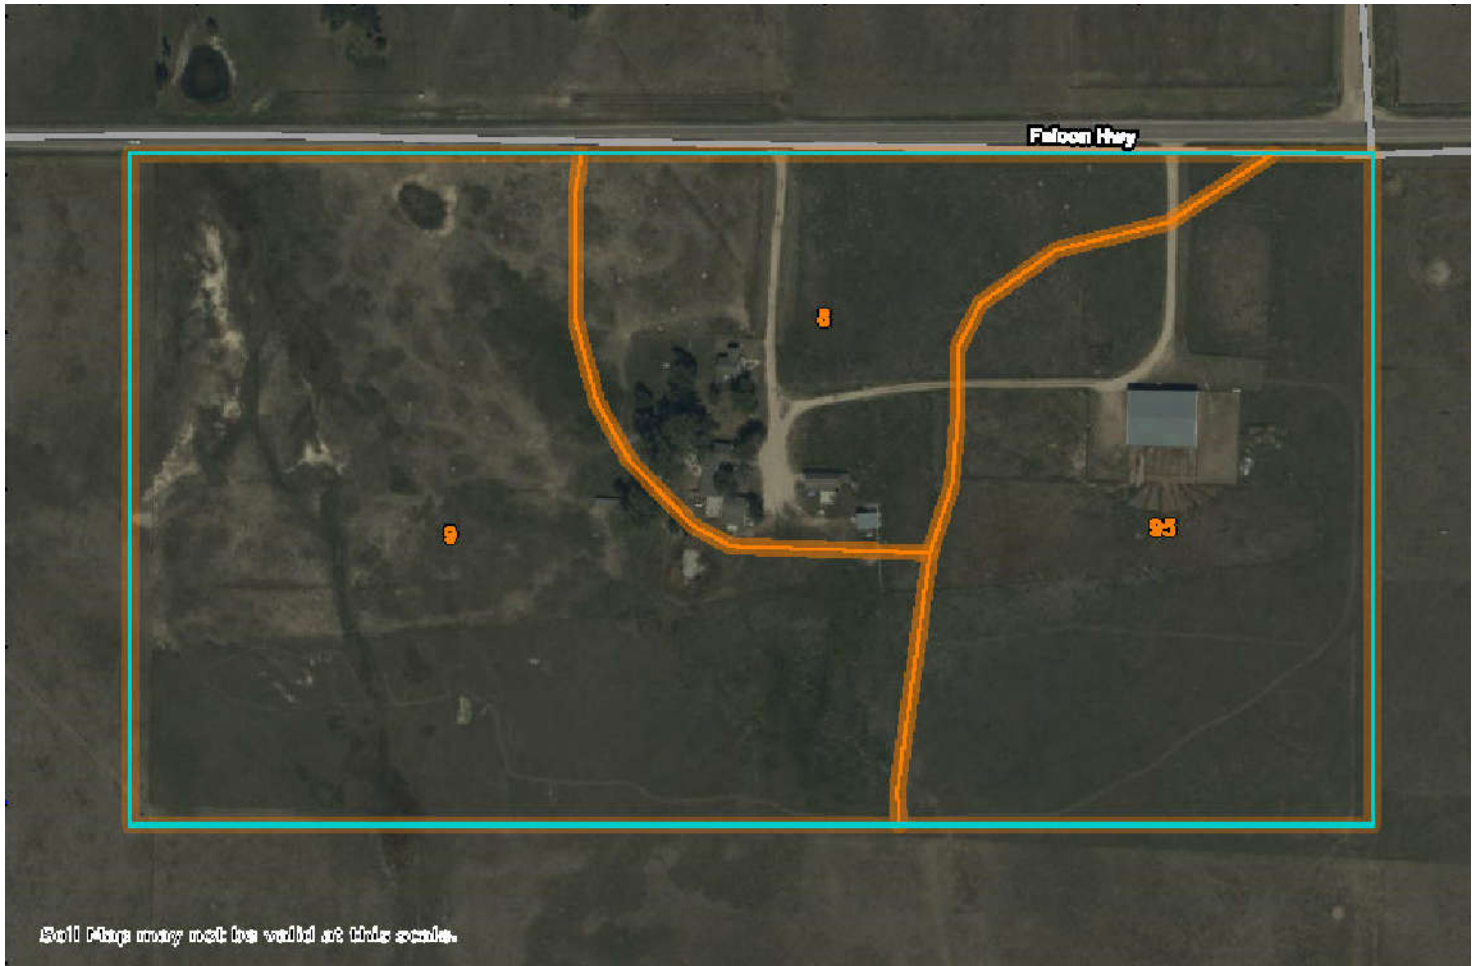
FIGURE No. 9

- 8 - Blakeland loamy sand, (1 to 9 percent slopes)
- 9 - Blakeland Fluvaquentic Haplaquolis
- 95 - Truckton loamy sand, 1 to 9 percent slopes

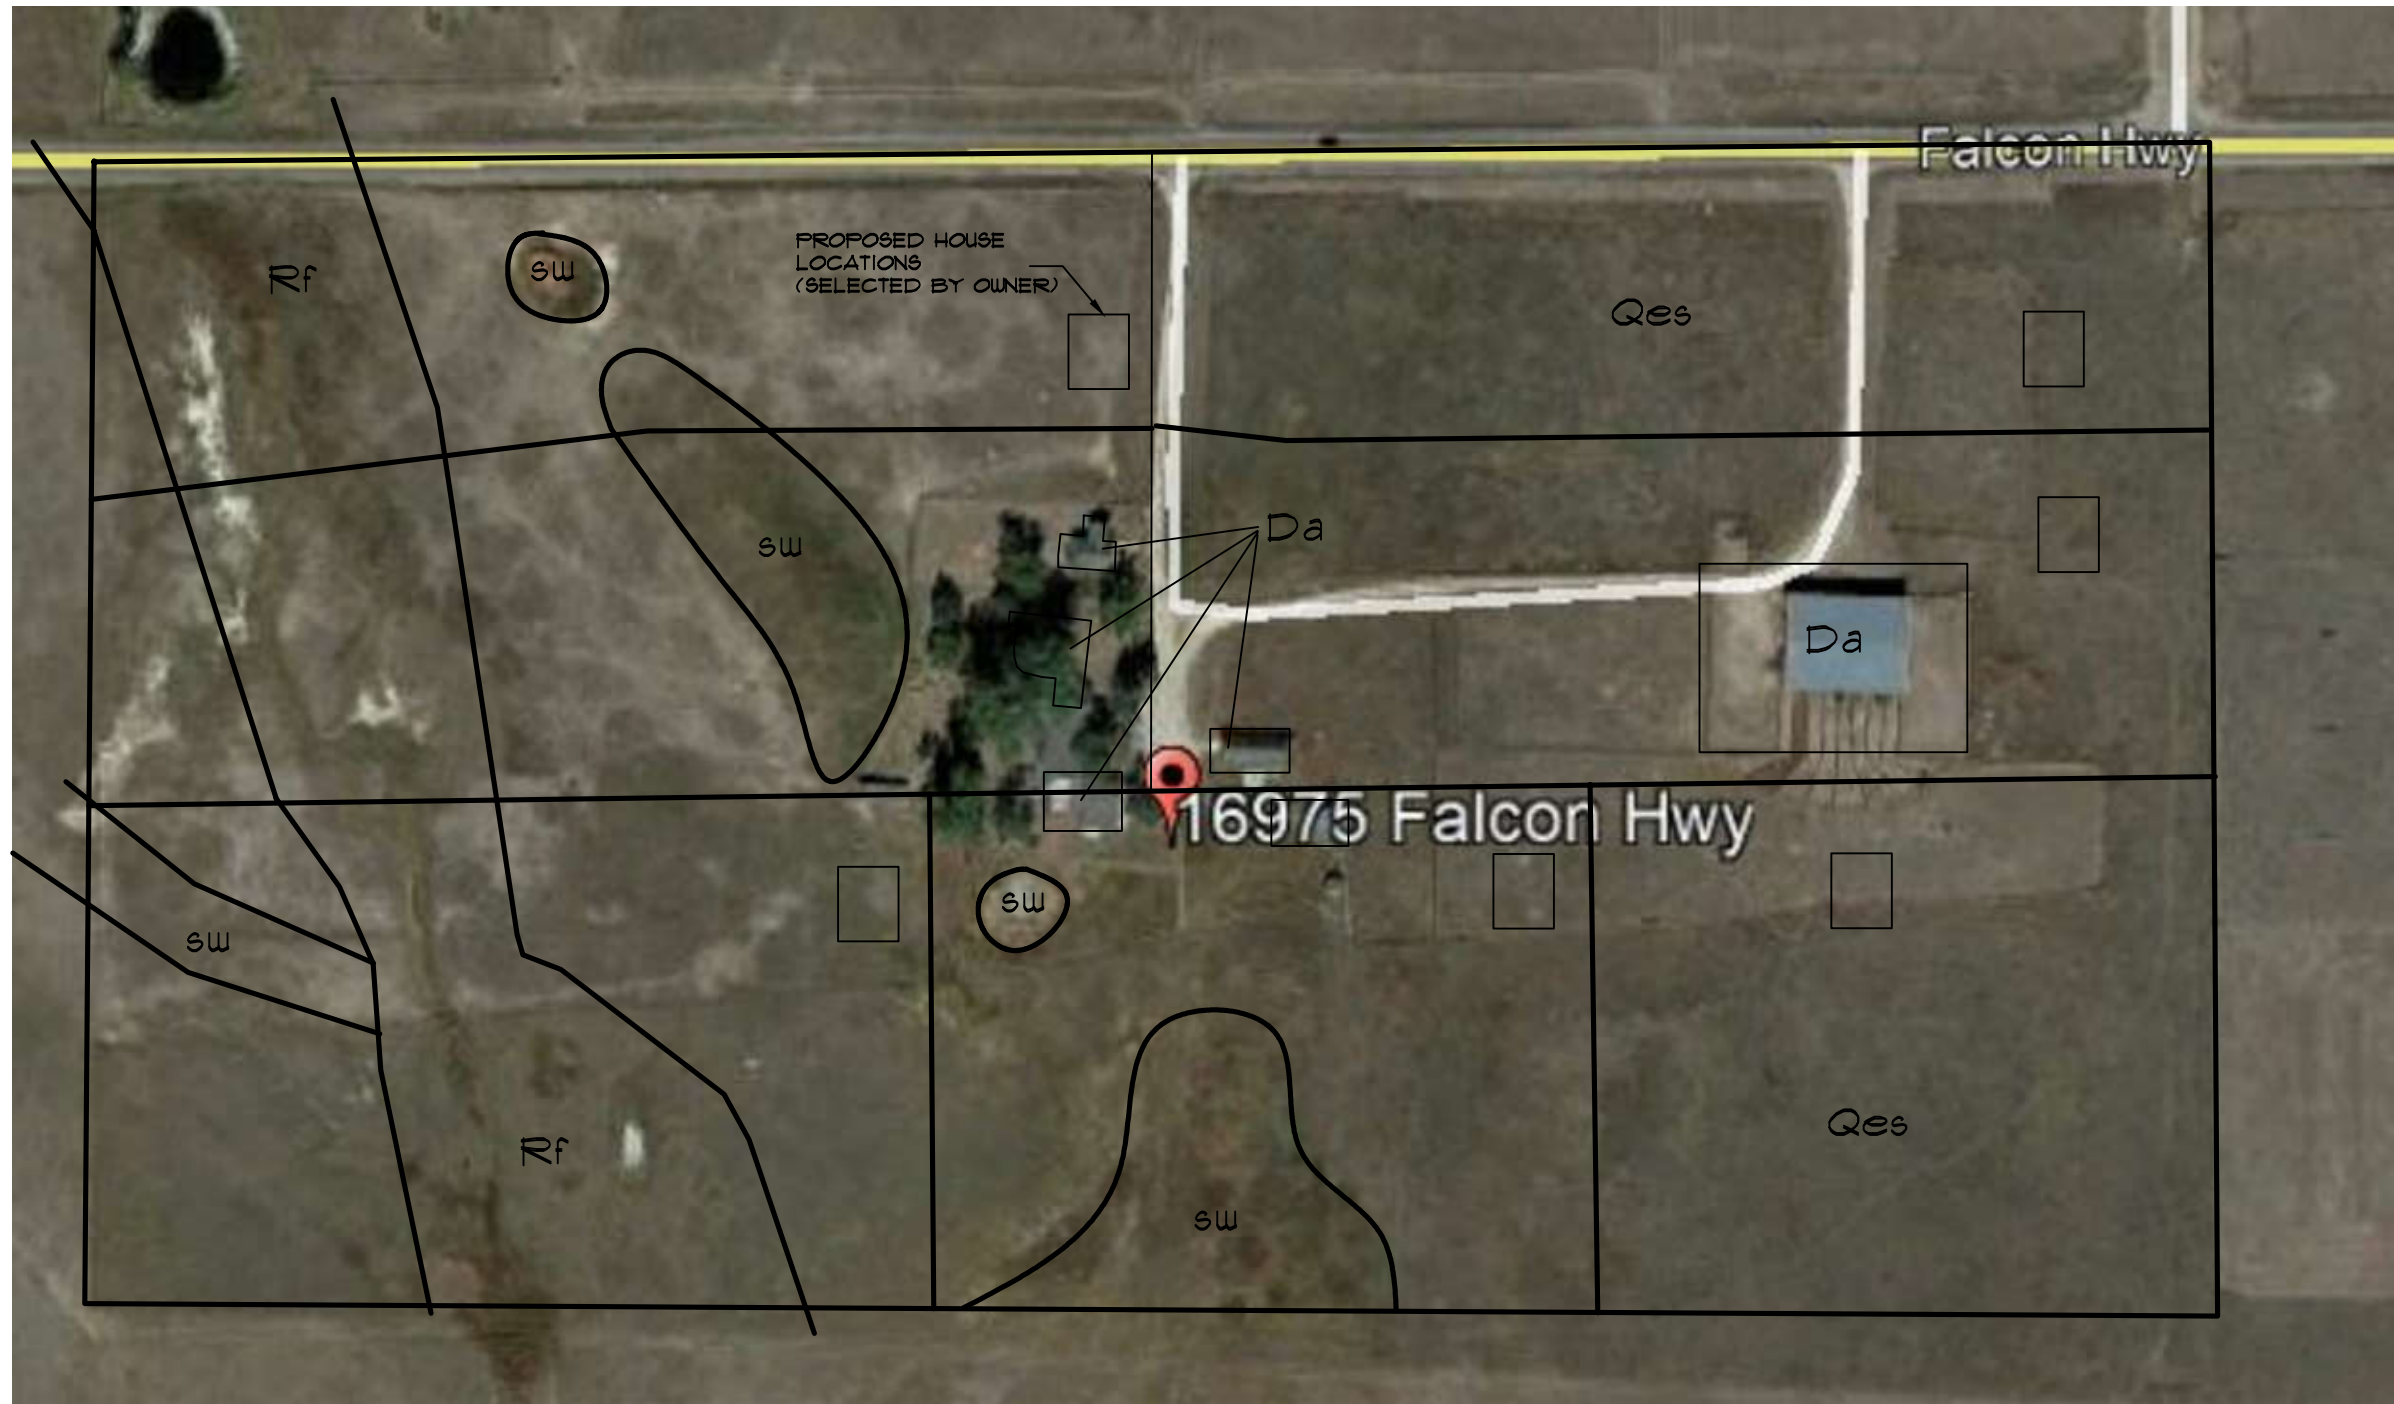
FIG-11

GEOLOGIC UNITS

- *Qes* - *eolian sand (Holocene to upper Pleistocene)* - Eolian sand is moderately compacted, easily excavated, and drains well. Eolian sand was encountered in all three test borings to depths of approximately 20 feet.
- *Da* - *disturbed areas* - areas that are no longer in their native state, soils have been removed and/or replaced for the existing driveway, existing residence, existing OWTS, and utility easements.

Based on our field observations and review of relevant geologic maps, a geologic map was prepared which identifies the geologic conditions affecting the development. The geologic units present on the site are presented in the Engineering and Geology Map, Figure 11.

All construction should remain outside the unnamed creek drainageway. It is recommended the unnamed creek drainageway be identified as a “No Build Area” unless additional studies are performed, in conjunction with the drainage engineer, prior to any new construction. This area is shown on Figure 11.

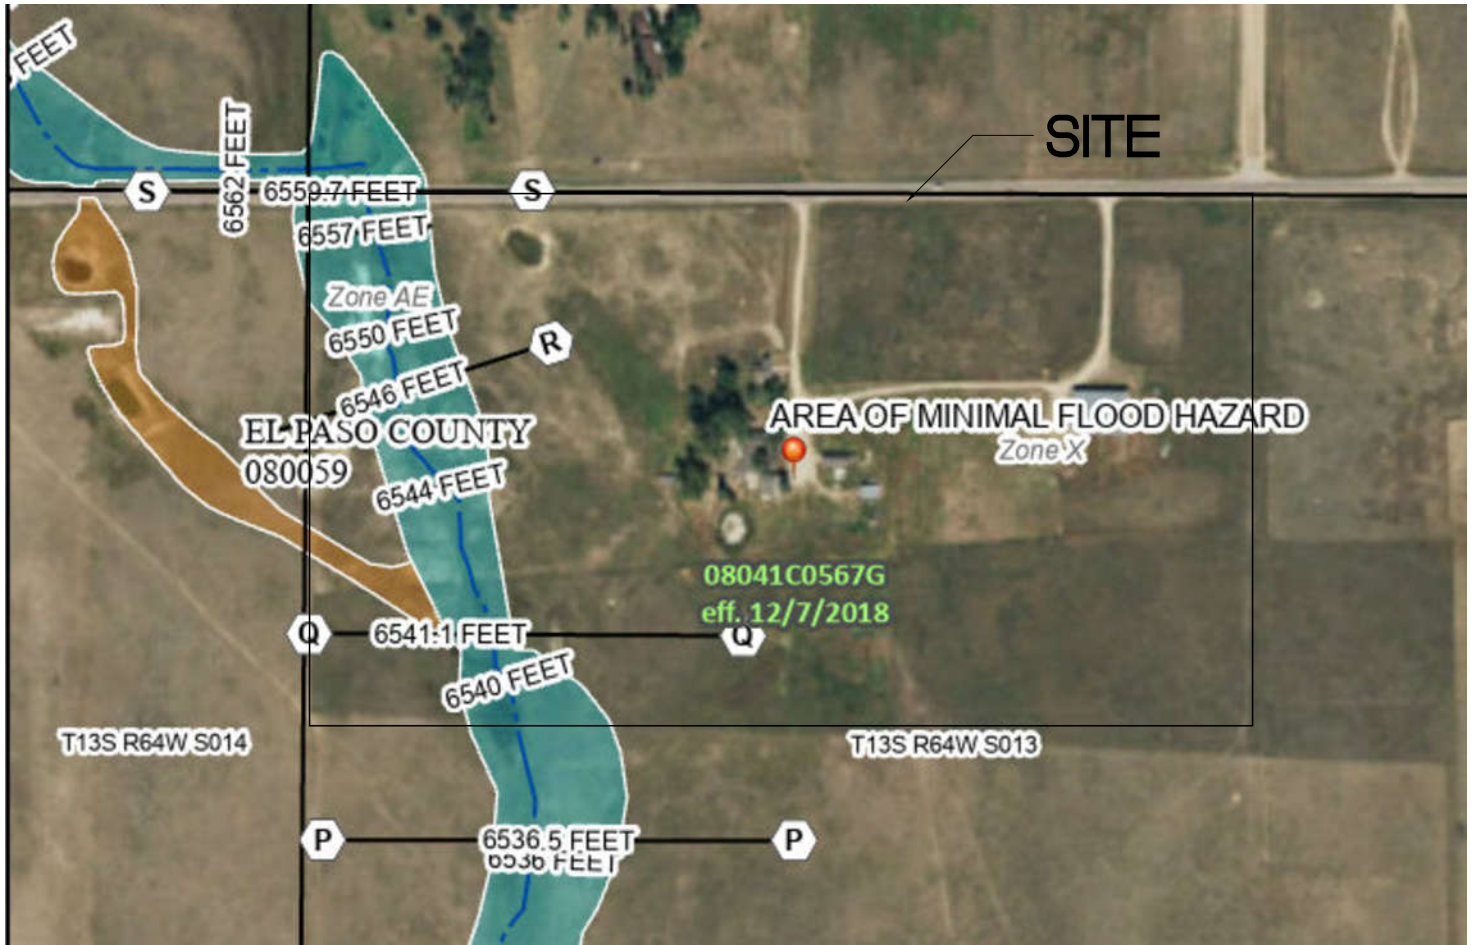
FEMA FIRM Map?

NOT TO SCALE  
BASE MAP PROVIDED BY FEMA

need to take into account the BFE at the time of construction. The FEMA Map is presented in Figure 12.

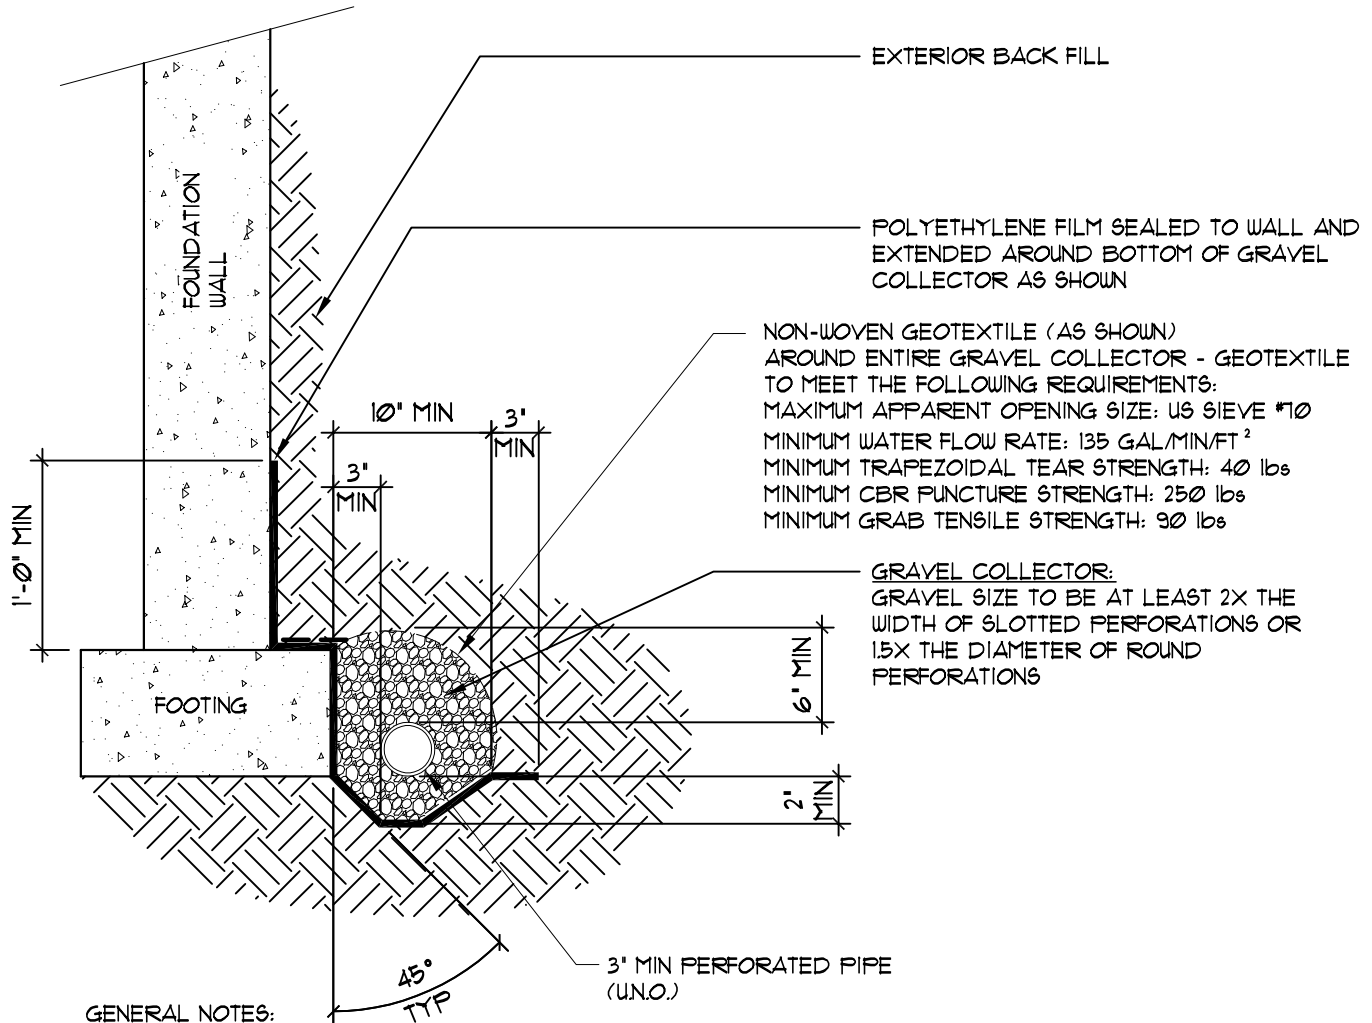
1. BOTTOM OF DRAIN PIPE SHALL BE AT OR BELOW BOTTOM OF FOOTING AT ALL LOCATIONS
2. ALL DRAIN PIPE SHALL BE PERFORATED PLASTIC, WITH THE EXCEPTION OF THE DISCHARGE PORTION WHICH SHALL BE SOLID, NON-PERFORATED PIPE.

3. DRAIN PIPE SHALL HAVE POSITIVE FALL THROUGHOUT.
4. DRAIN PIPE SHALL BE PROVIDED WITH A FREE GRAVITY OUTFALL, IF POSSIBLE. IF A GRAVITY OUTFALL CANNOT BE ACHIEVED, THEN A SUMP PIT AND PUMP SHALL BE USED. THE OUTFALL SHOULD EXTEND PAST BACKFILL ZONES AND DISCHARGE TO A LOCATION THAT IS GRADED TO DIRECT WATER OFF-SITE.

5. ALL DRAIN COMPONENTS SHALL BE RATED/APPROVED BY THE MANUFACTURER FOR THE INSTALLED DEPTH AND APPLICATION
6. DRAIN SYSTEM, INCLUDING THE OUTFALL OF THE DRAIN, SHALL BE OBSERVED BY QUALIFIED PERSONNEL PRIOR TO BACKFILLING TO VERIFY INSTALLATION.

7. A VERTICAL SEGMENT OF PERFORATED DRAIN PIPE, CAPPED AT THE TOP, SHALL EXTEND TO FINISH GRADE WITHIN ALL WINDOW WELLS.

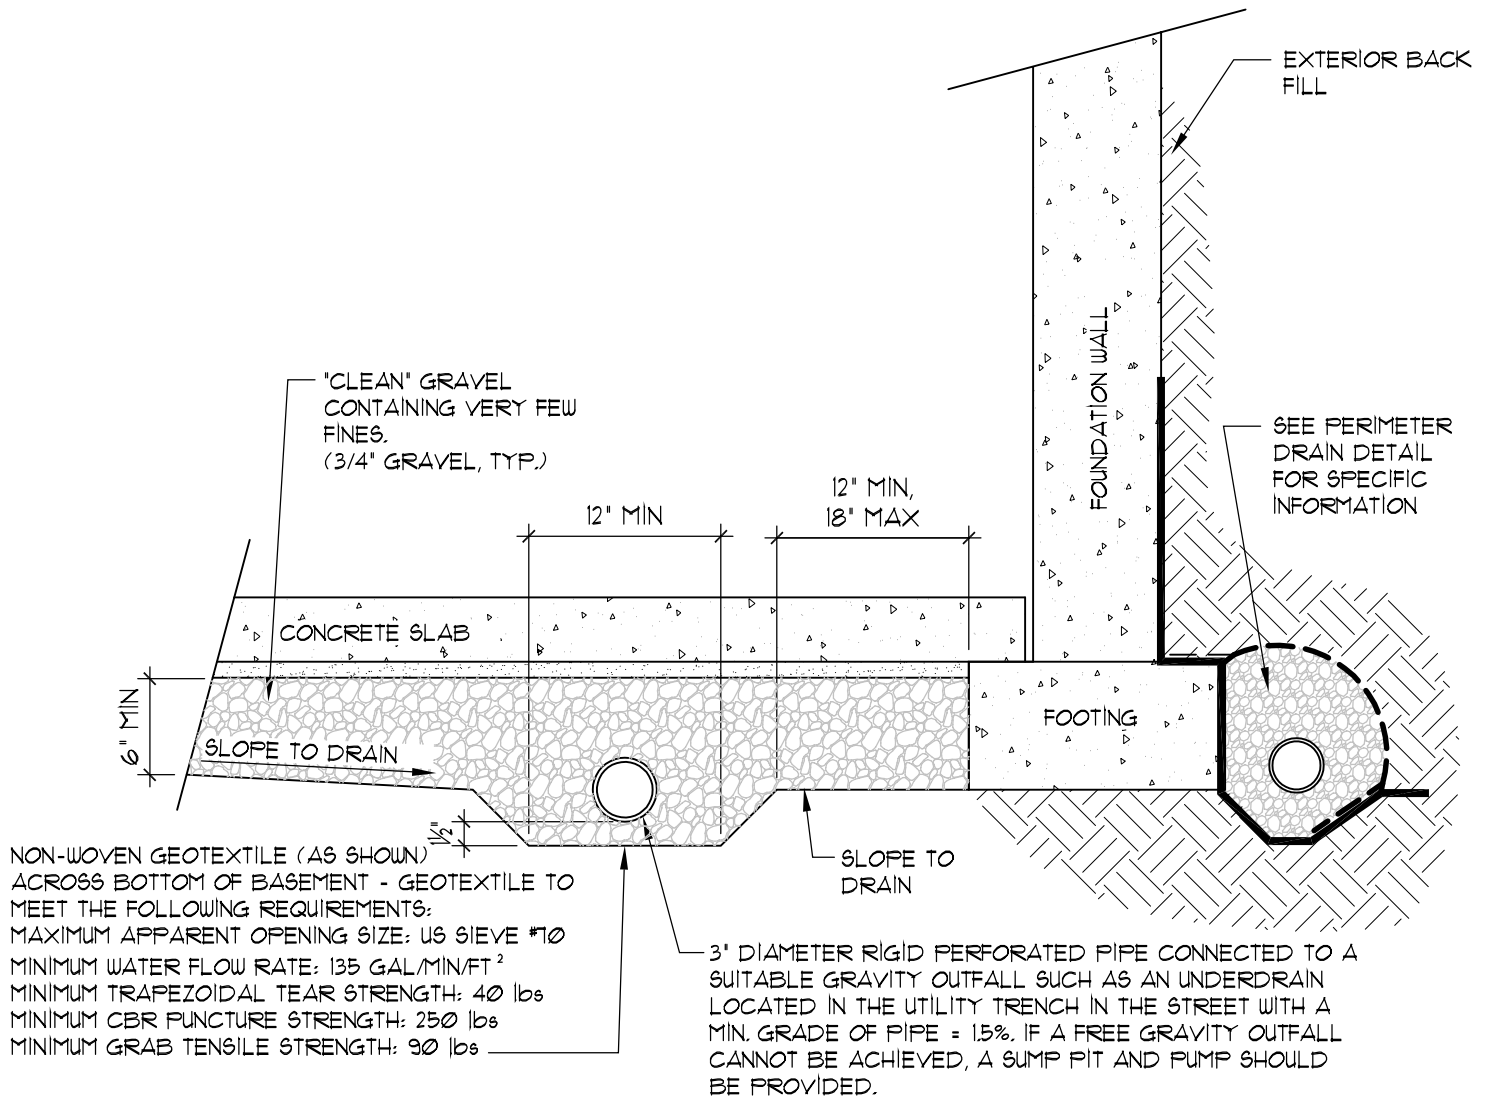
1. ALL DRAIN PIPE SHALL BE PERFORATED PLASTIC, WITH THE EXCEPTION OF THE DISCHARGE PORTION WHICH SHALL BE SOLID, NON-PERFORATED PIPE.
2. DRAIN PIPE SHALL HAVE POSITIVE FALL THROUGHOUT.
3. DRAIN PIPE SHALL BE PROVIDED WITH A FREE GRAVITY OUTFALL, IF POSSIBLE. IF A GRAVITY OUTFALL CANNOT BE ACHIEVED, THEN A SUMP PIT AND PUMP SHALL BE USED. THE OUTFALL SHOULD EXTEND PAST BACKFILL ZONES AND DISCHARGE TO A LOCATION THAT IS GRADED TO DIRECT WATER OFF-SITE.
4. ALL DRAIN COMPONENTS SHALL BE RATED/APPROVED BY THE MANUFACTURER FOR THE INSTALLED DEPTH AND APPLICATION
5. DRAIN SYSTEM, INCLUDING THE OUTFALL OF THE DRAIN, SHALL BE OBSERVED BY QUALIFIED PERSONNEL PRIOR TO BACKFILLING TO VERIFY INSTALLATION.

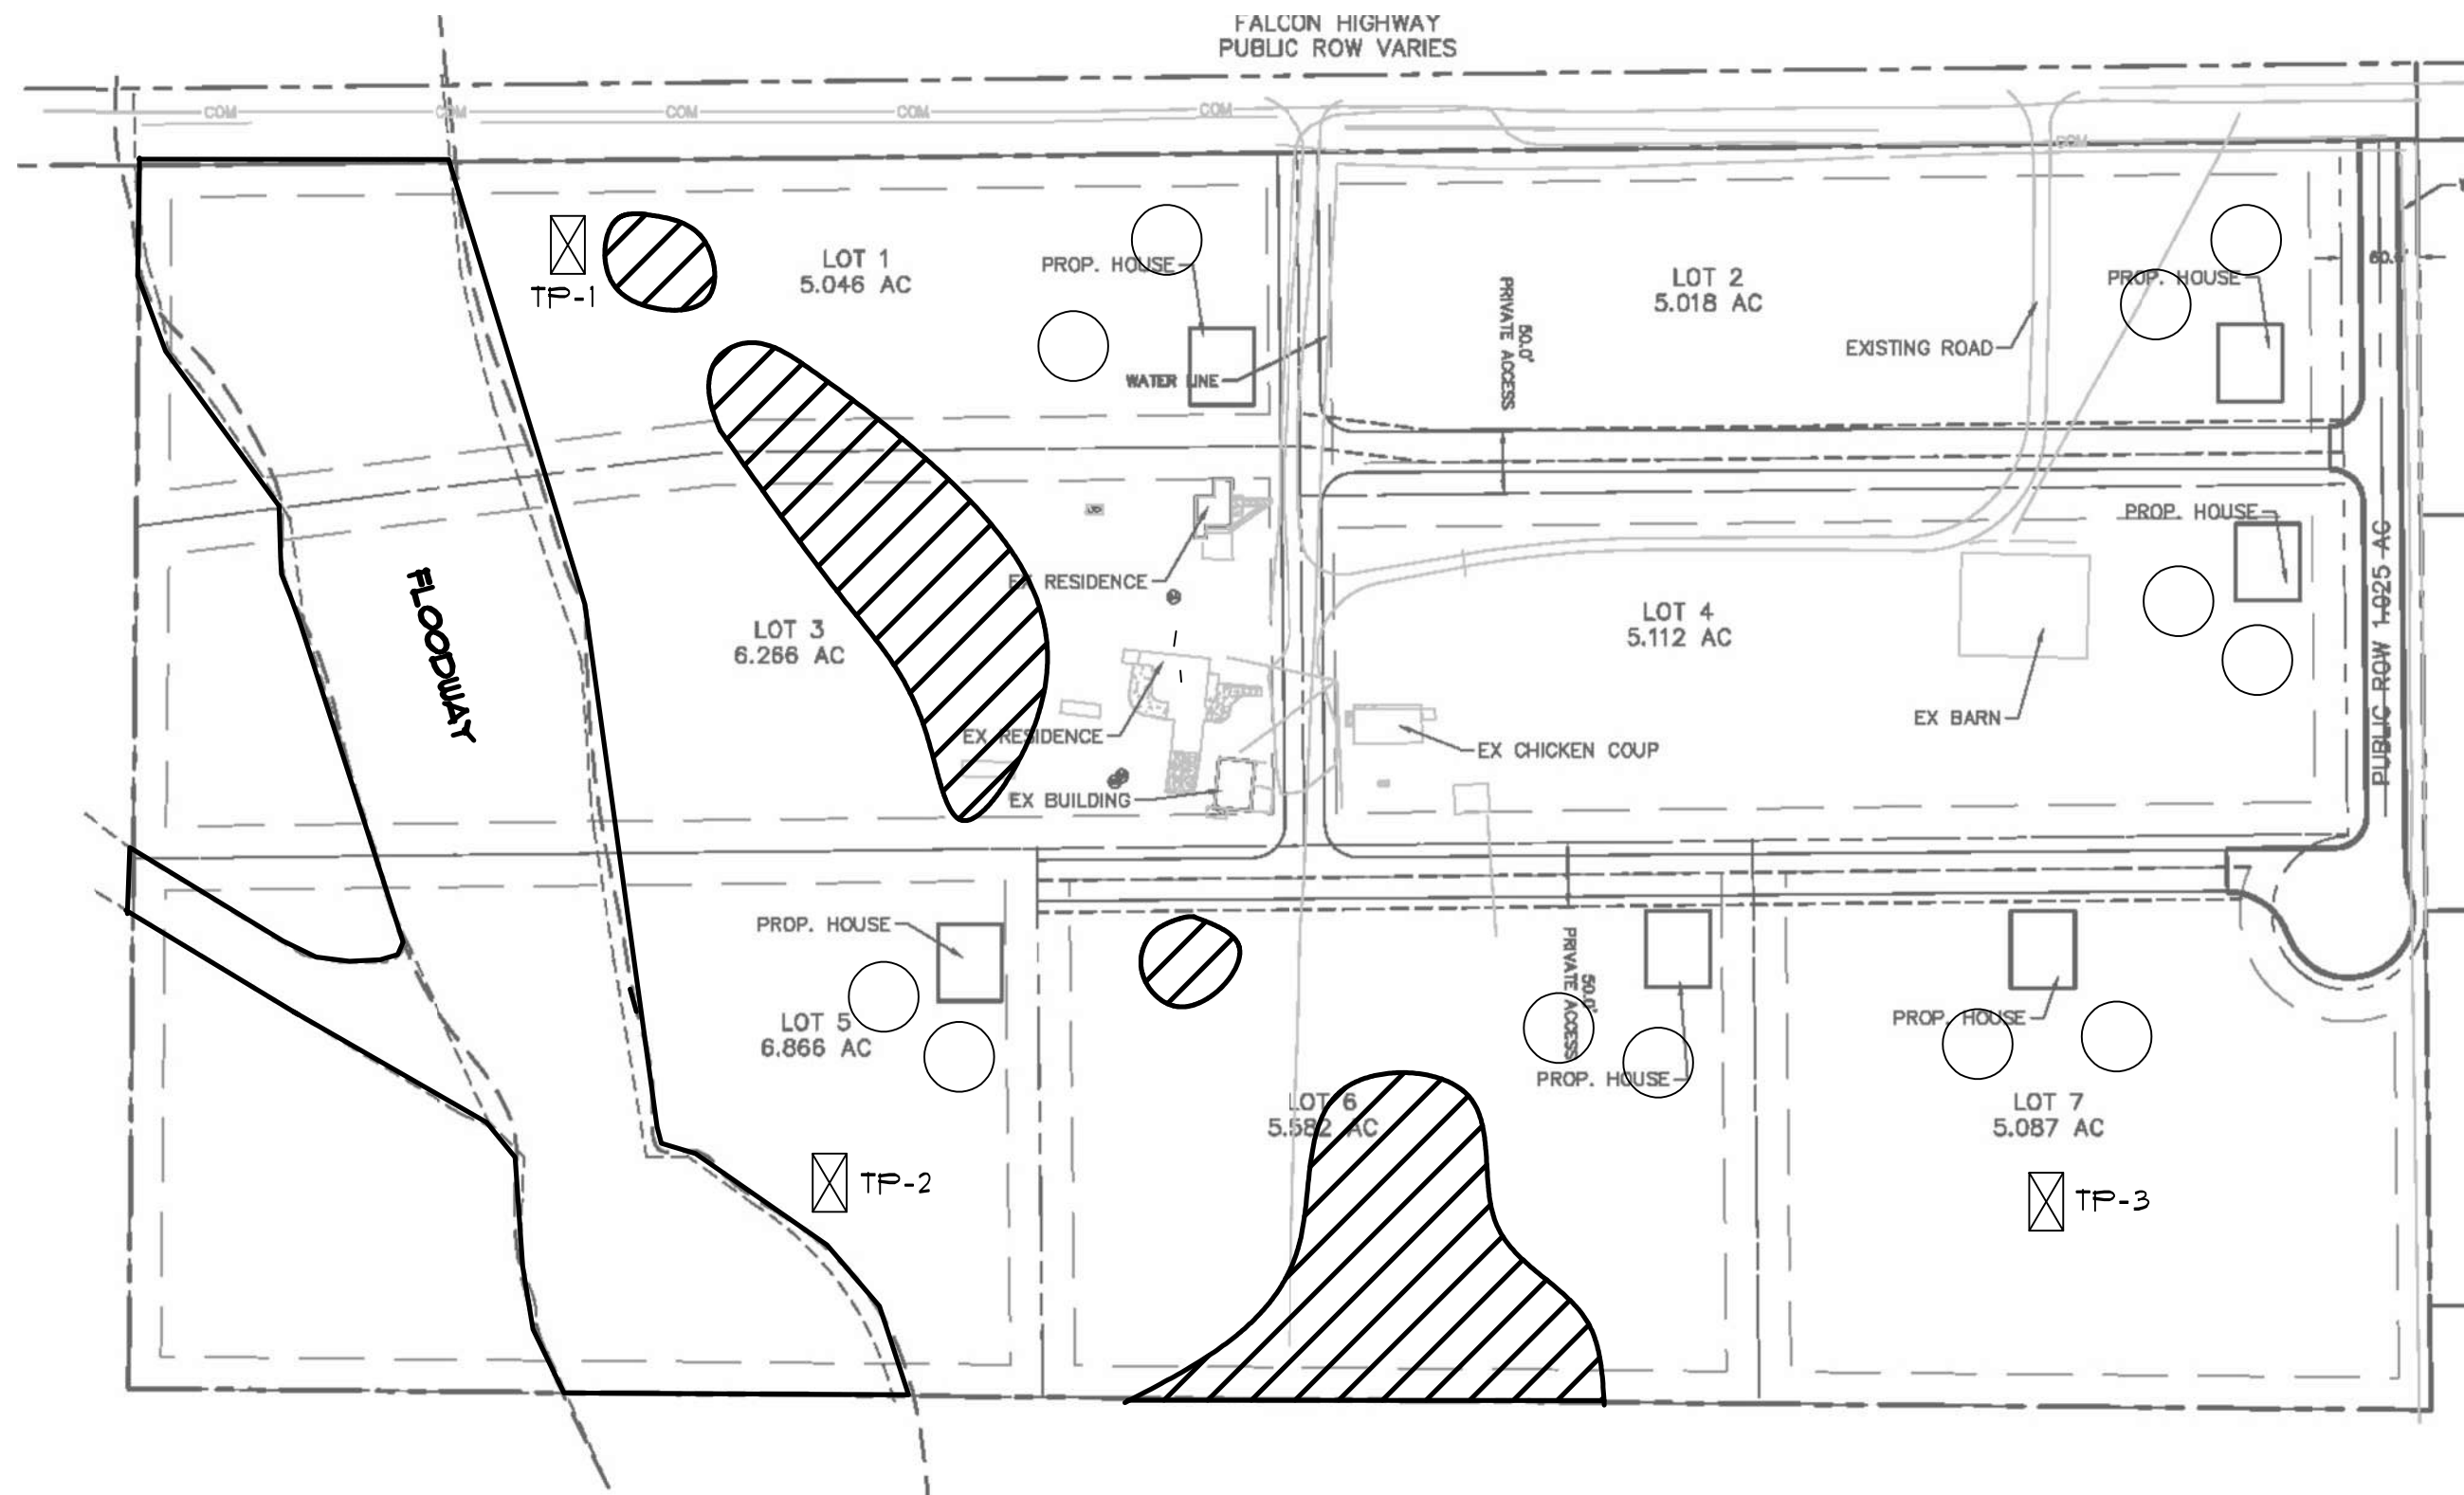
FIG-5

○ SELECTED AREAS THAT ARE SUITABLE FOR THE LOCATION OF  
A NEW ON-SITE WASTEWATER TREATMENT SYSTEM (OWTS)

▨ AREAS TO AVOID WITH THE PLACEMENT OF A NEW OWTS

Personnel of RMG performed a soil evaluation to include three 8-foot deep test pits, on February 26, 2021 (TP-1, TP-2, and TP-3), utilizing the visual and tactile method for the evaluation of the site soils. The test pits were excavated in areas that appeared most likely to be used for residential OWTS placement. Test Pit Logs are presented in Figures 3 and 4. A Septic Suitability map is presented in Figure 5.
