GEOLOGY AND SOILS STUDY

**Lots 1-90
Townhomes at Ponderosa North
at Lorson Ranch, Filing No. 3
El Paso County, Colorado**

JOB NO. 172414

**November 7, 2019
Revised November 8, 2019**

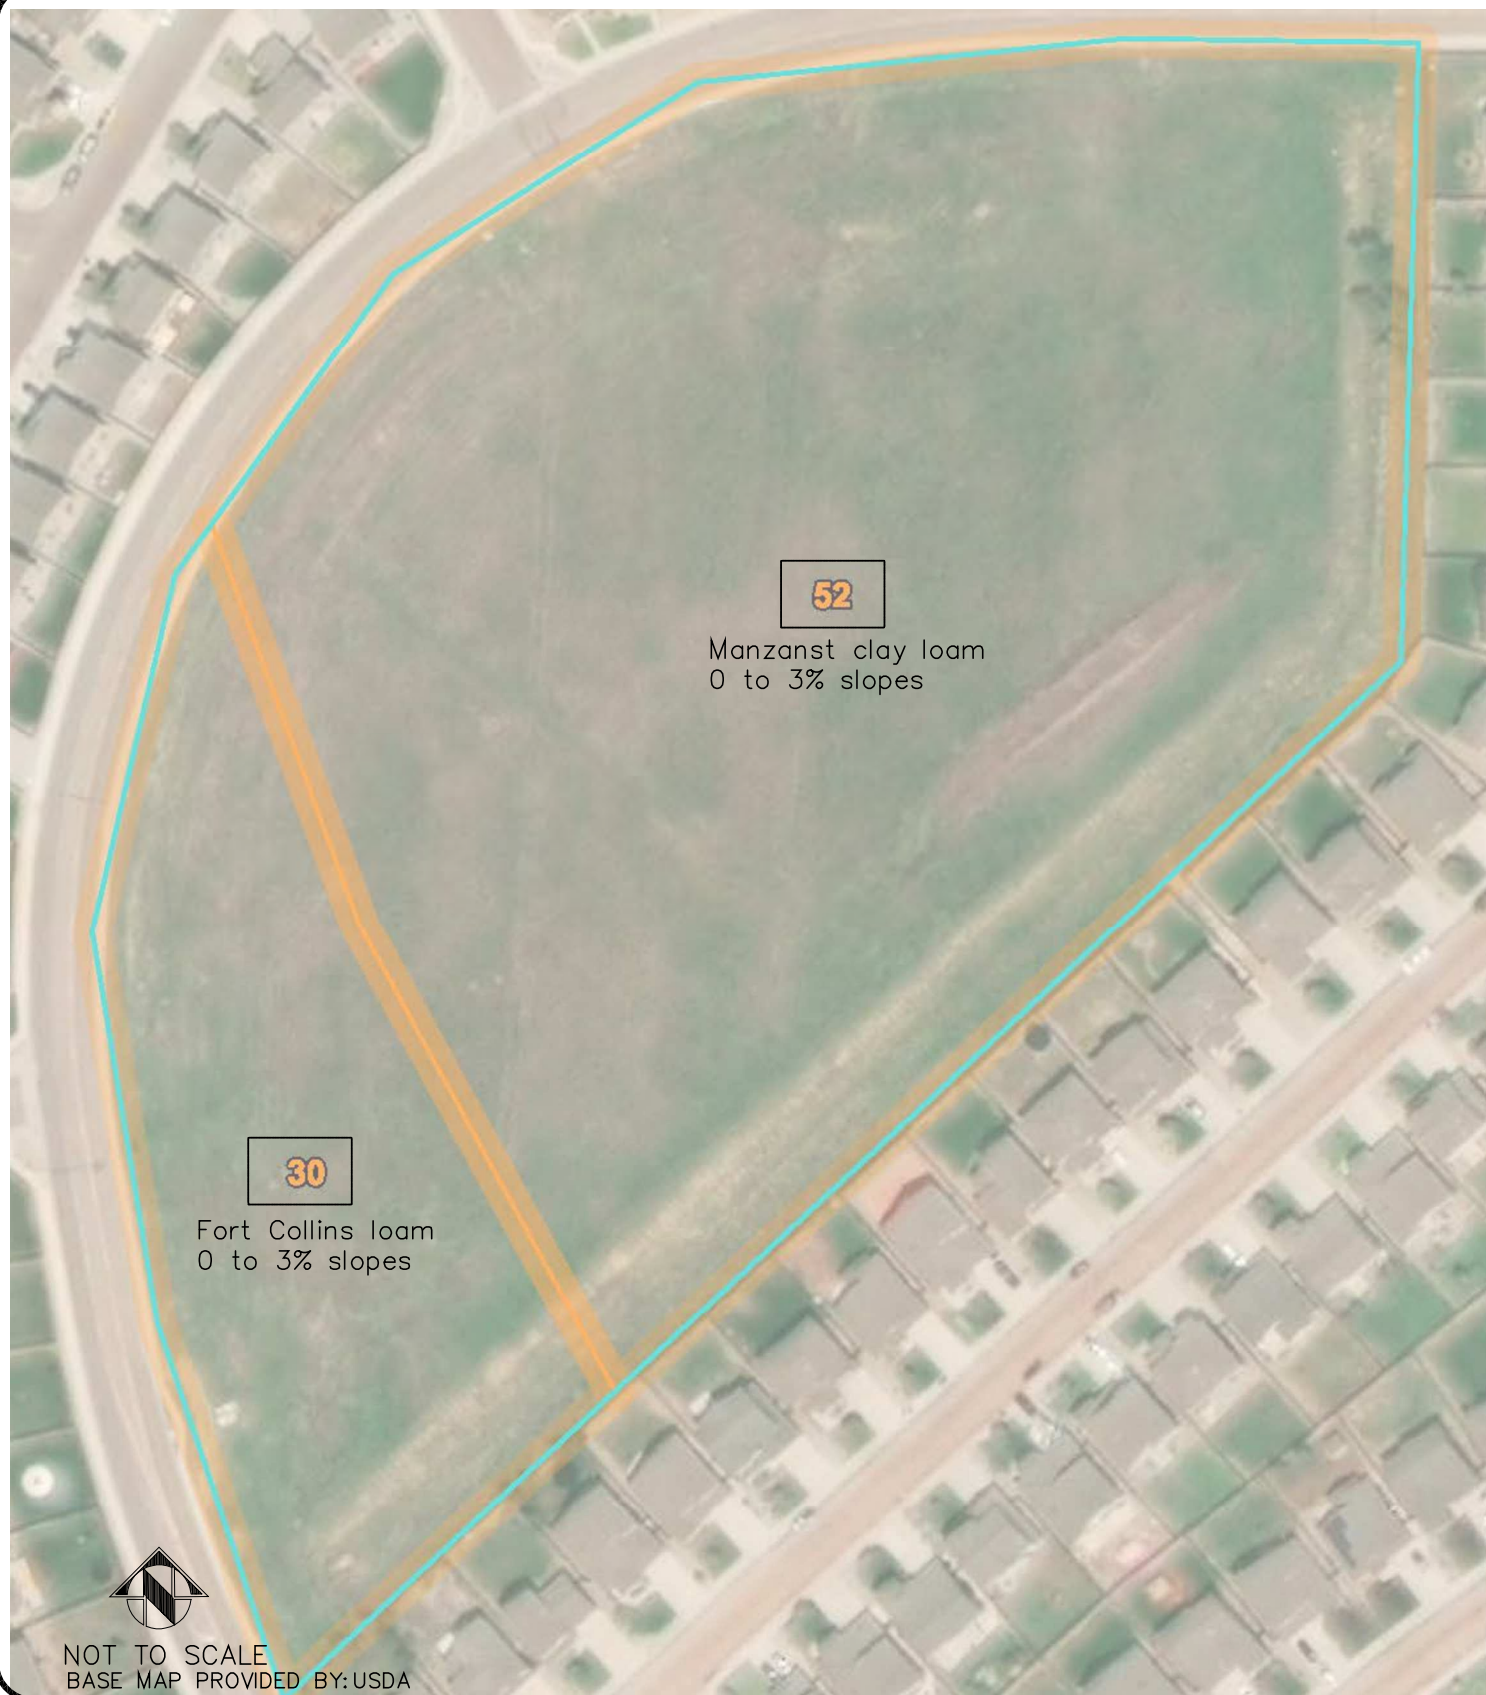
FIG No. 10

NOT TO SCALE
BASE MAP PROVIDED BY: USDA

The USDA Soil Survey Map is presented in Figure 10.
