**ENTECH**  
ENGINEERING, INC.

**SOIL, GEOLOGY, AND GEOLOGIC HAZARD  
SPRINGS AT WATERVIEW EAST  
SOUTH POWERS BOULEVARD AND BRADLEY ROAD  
EL PASO COUNTY, COLORADO**

**Dakota Springs Engineering, Inc.**  
31 North Tejon Street, Suite 500  
Colorado Springs, Colorado 80903

April 25, 2017  
Revised February 21, 2018

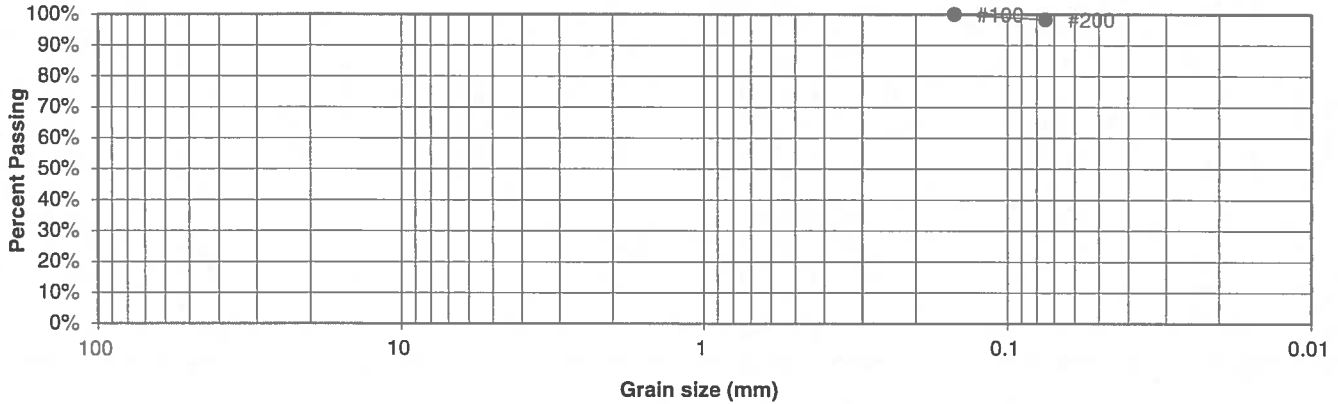
<u>UNIFIED CLASSIFICATION</u>	CL	<u>CLIENT</u>	DAKOTA SPRINGS ENGINEERING
<u>SOIL TYPE #</u>	3	<u>PROJECT</u>	SPRINGS AT WATERVIEW
<u>TEST BORING #</u>	6	<u>JOB NO.</u>	170039
<u>DEPTH (FT)</u>	20	<u>TEST BY</u>	BL

**Sieve Analysis  
Grain Size Distribution**

<u>U.S. Sieve #</u>	<u>Percent Finer</u>
3"	
1 1/2"	
3/4"	
1/2"	
3/8"	
4	
10	
20	
40	
100	100.0%
200	98.3%

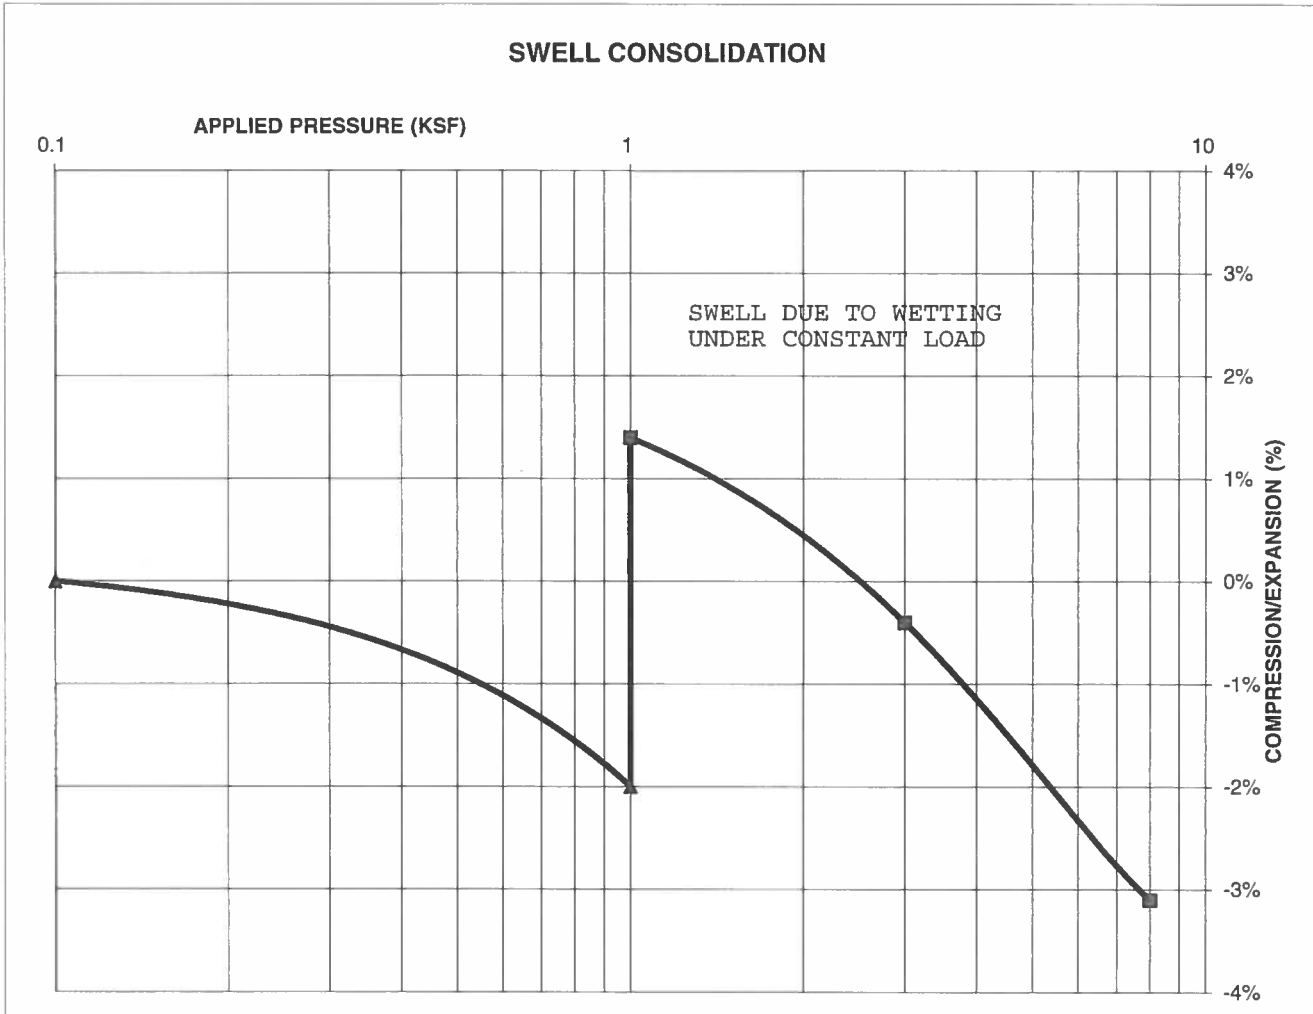
TEST BORING #	4	DEPTH(ft)	5
DESCRIPTION	CH	SOIL TYPE	3
NATURAL UNIT DRY WEIGHT (PCF)	114		
NATURAL MOISTURE CONTENT	16.9%		
SWELL/CONSOLIDATION (%)	3.4%

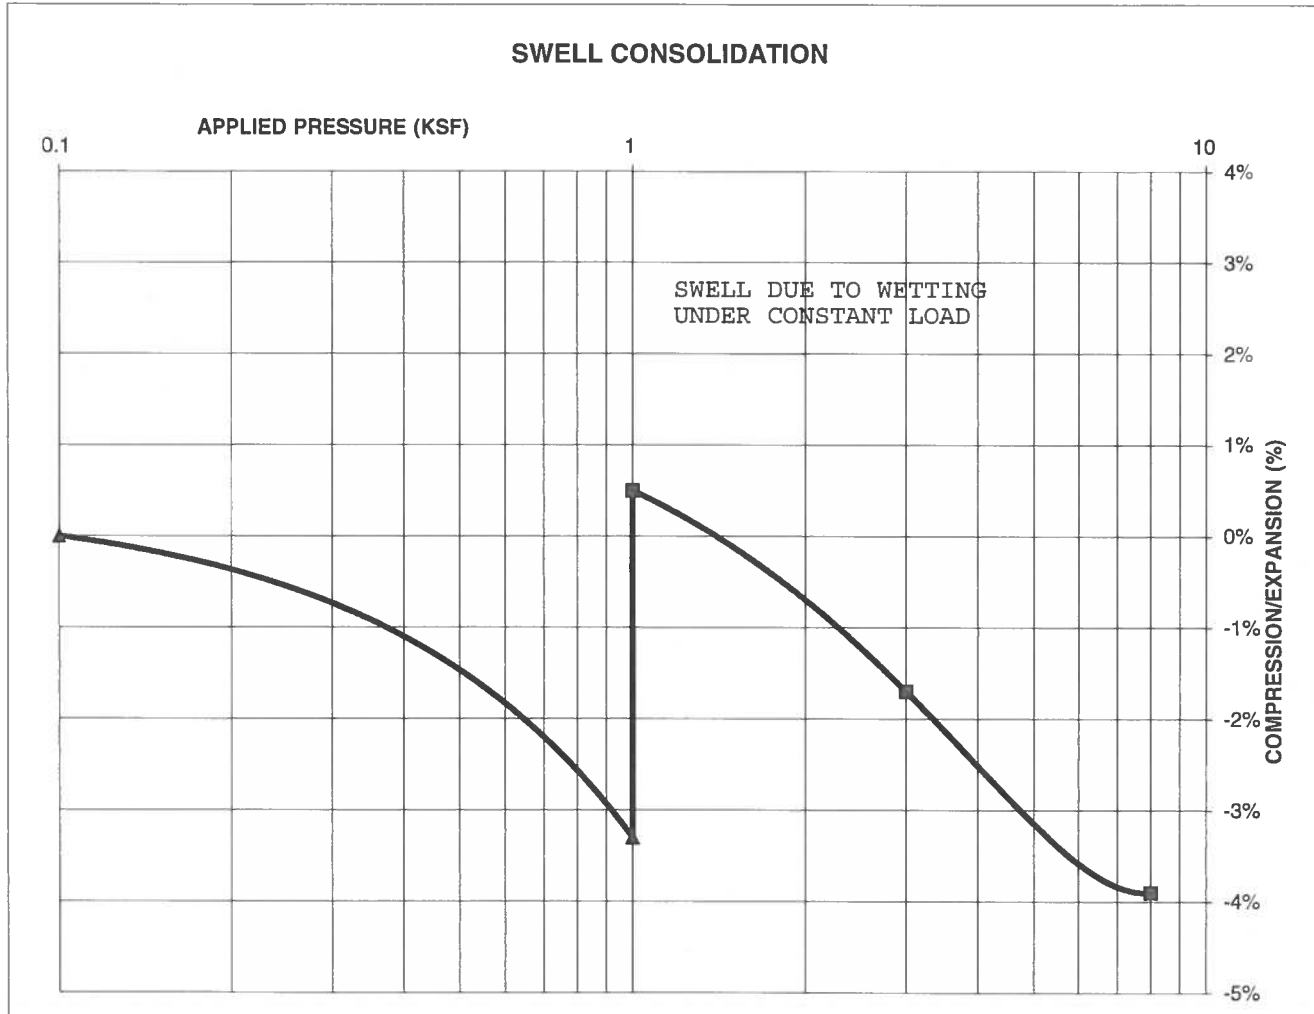
TEST BORING #	6	DEPTH(ft)	20
DESCRIPTION	CL	SOIL TYPE	3
NATURAL UNIT DRY WEIGHT (PCF)			111
NATURAL MOISTURE CONTENT			19.0%
SWELL/CONSOLIDATION (%)			3.8%
