## SOILS AND GEOLOGY STUDY

**Lots 1-224, Paint Brush Hills, Filing No. 14  
El Paso County, Colorado**

**JOB NO. 179012**

**October 16, 2020**

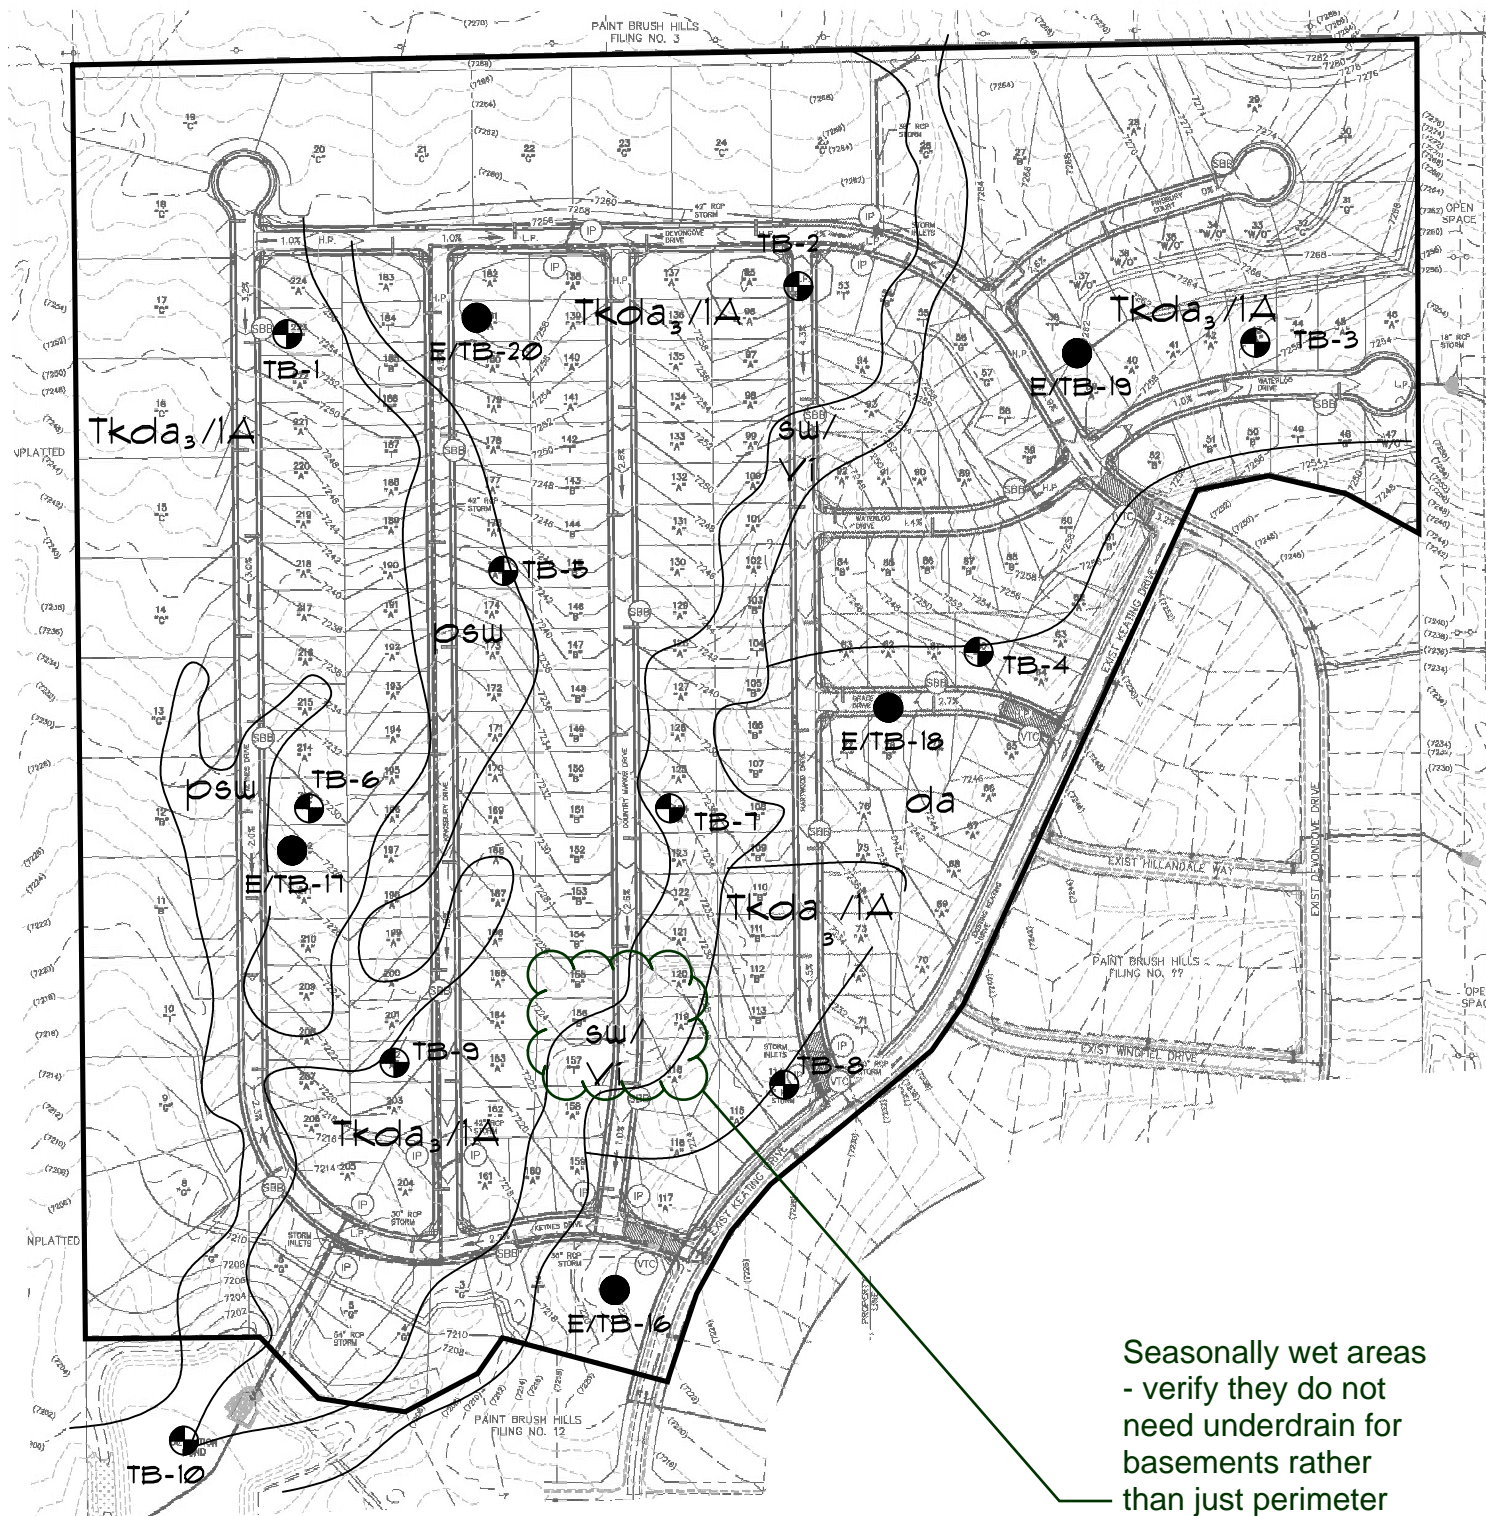
Seasonally wet areas - verify they do not need underdrain for basements rather than just perimeter drain. Alternatively basements can be prohibited on affected lots.
