SOIL AND GEOLOGY STUDY

**Antlers Range Subdivision
NE Corner of Meridian Road and Ayer Road
El Paso County, Colorado**

JOB NO. 198281

January 28, 2025

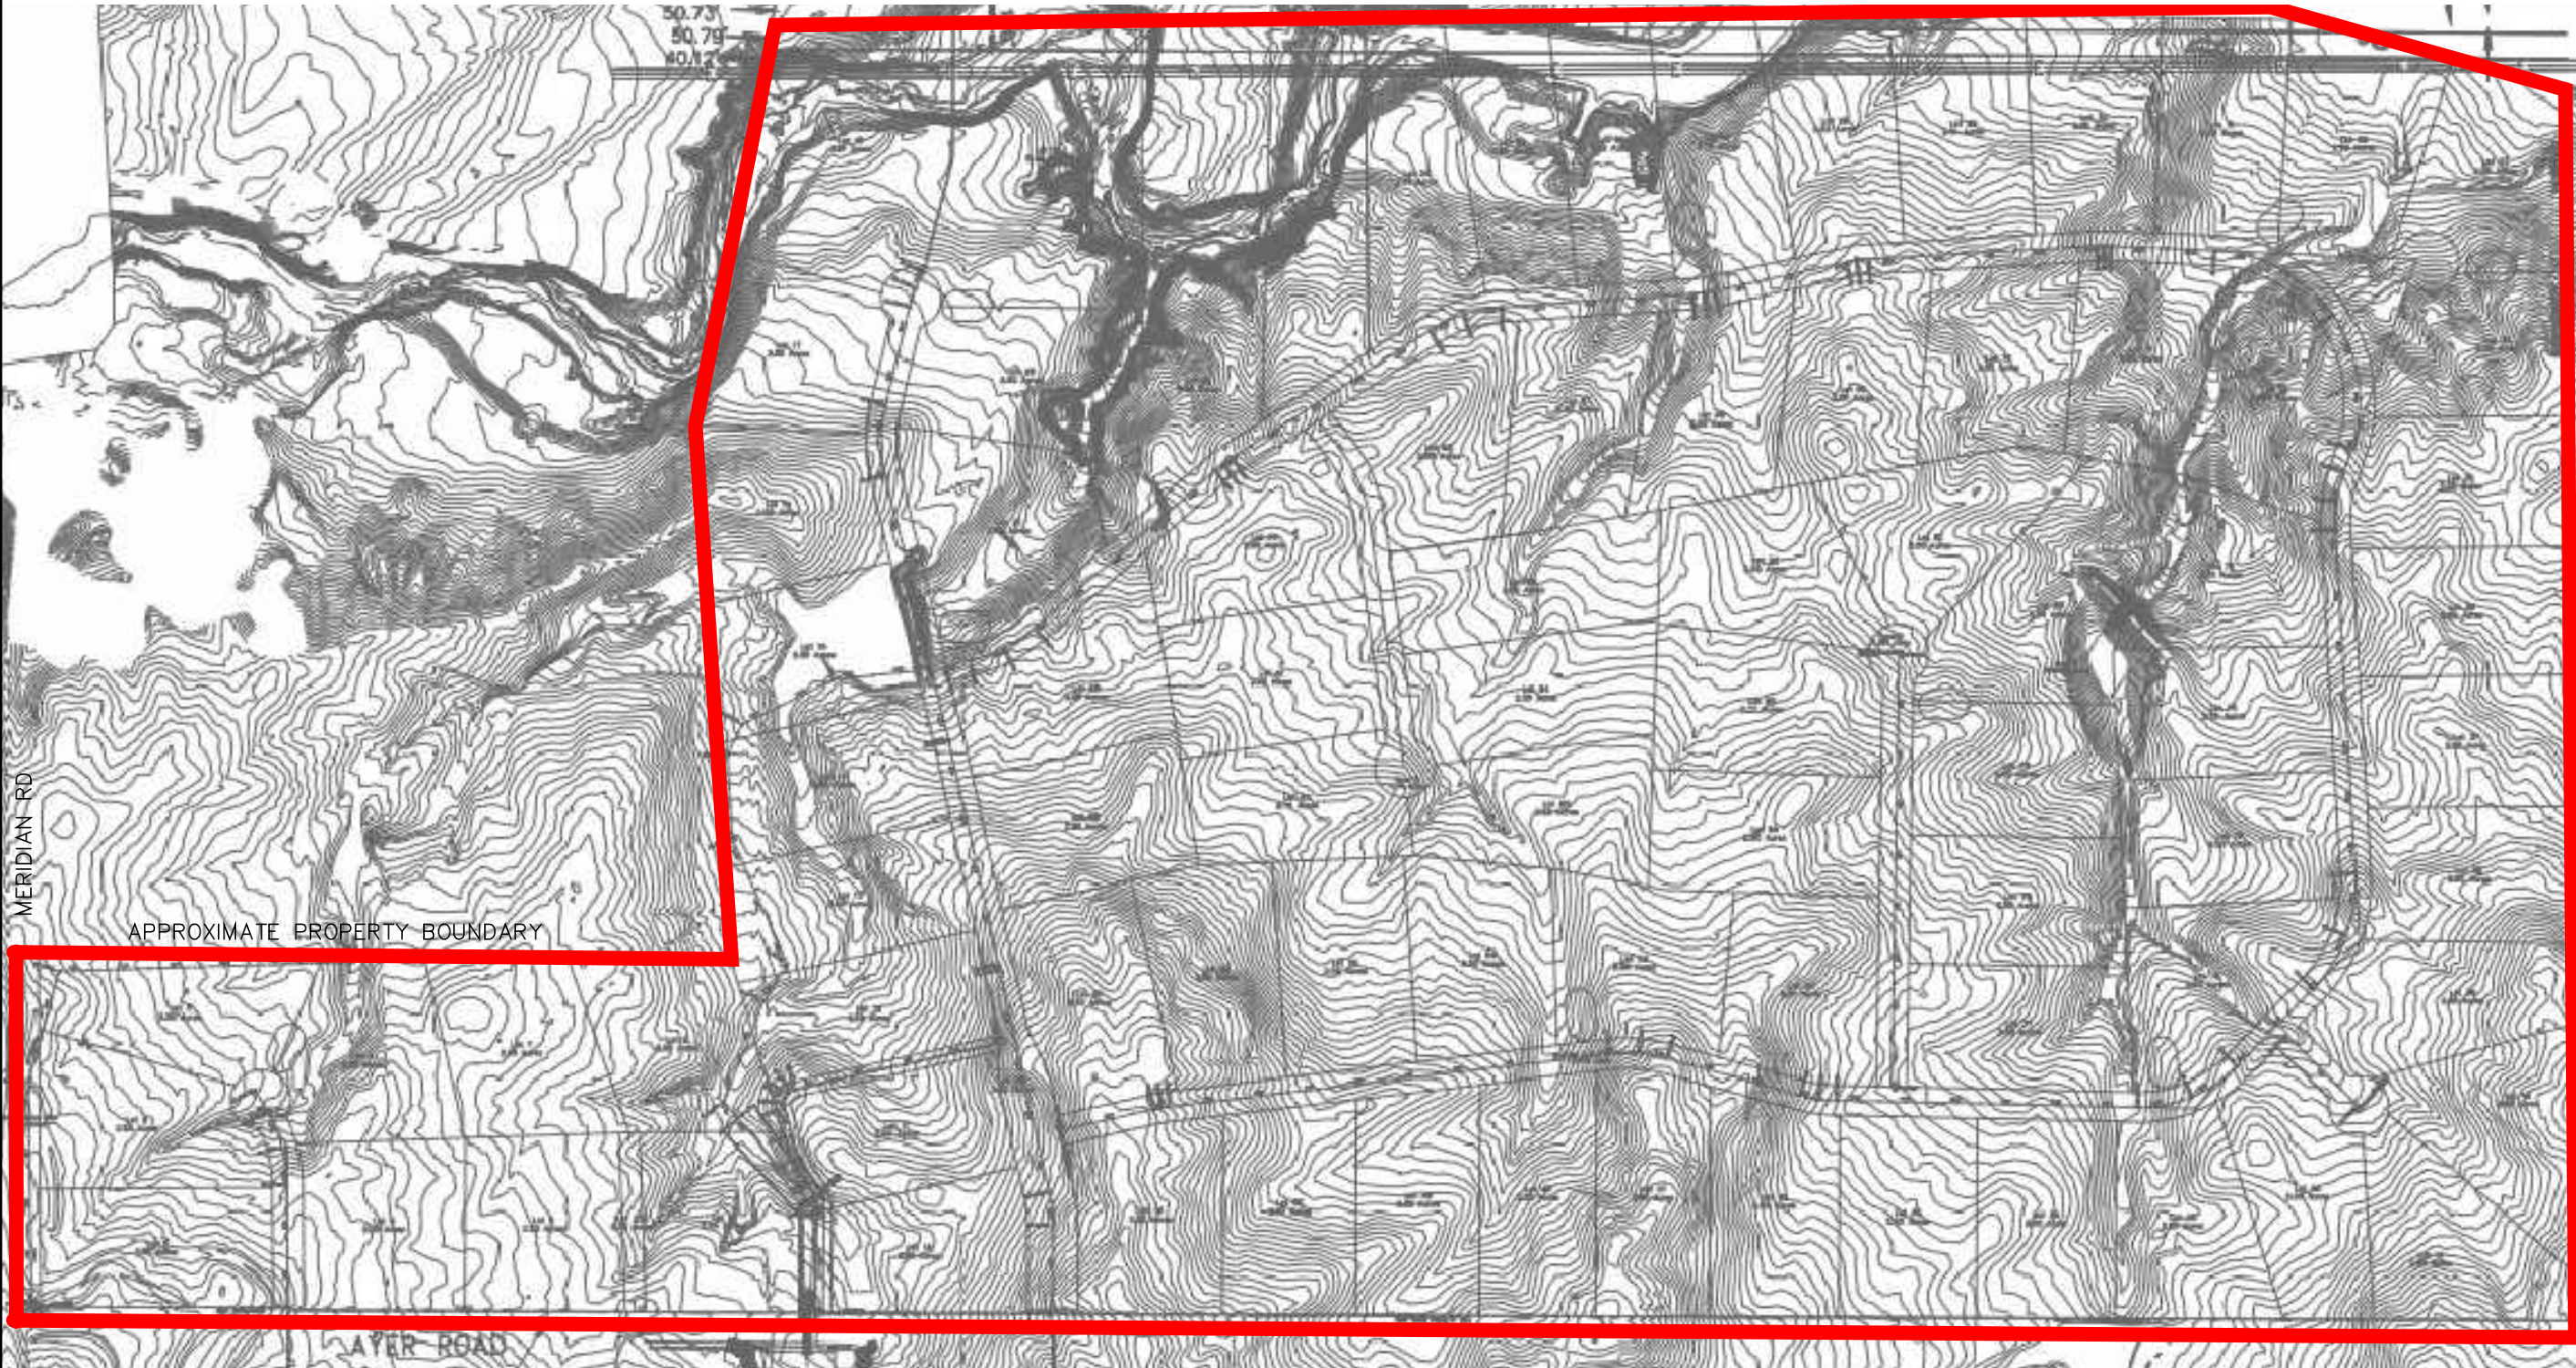
SHEET No.
FIG-2

PROPOSED LOT
LAYOUT

It is our understanding that the parcel is to be subdivided into 84 2.5 acre lots. The subdivision is to be accessed from Ayer Road, east of Meridian Road. Each lot is to be serviced by an individual wastewater treatment system and well. Preliminary grading plans were still in process at the time of this study, but it is our understanding that grading is anticipated to be minor, with construction occurring near the existing grades. The Proposed Lot Layout, Figure 2, outlines the proposed subdivision and the general boundaries of our investigation.

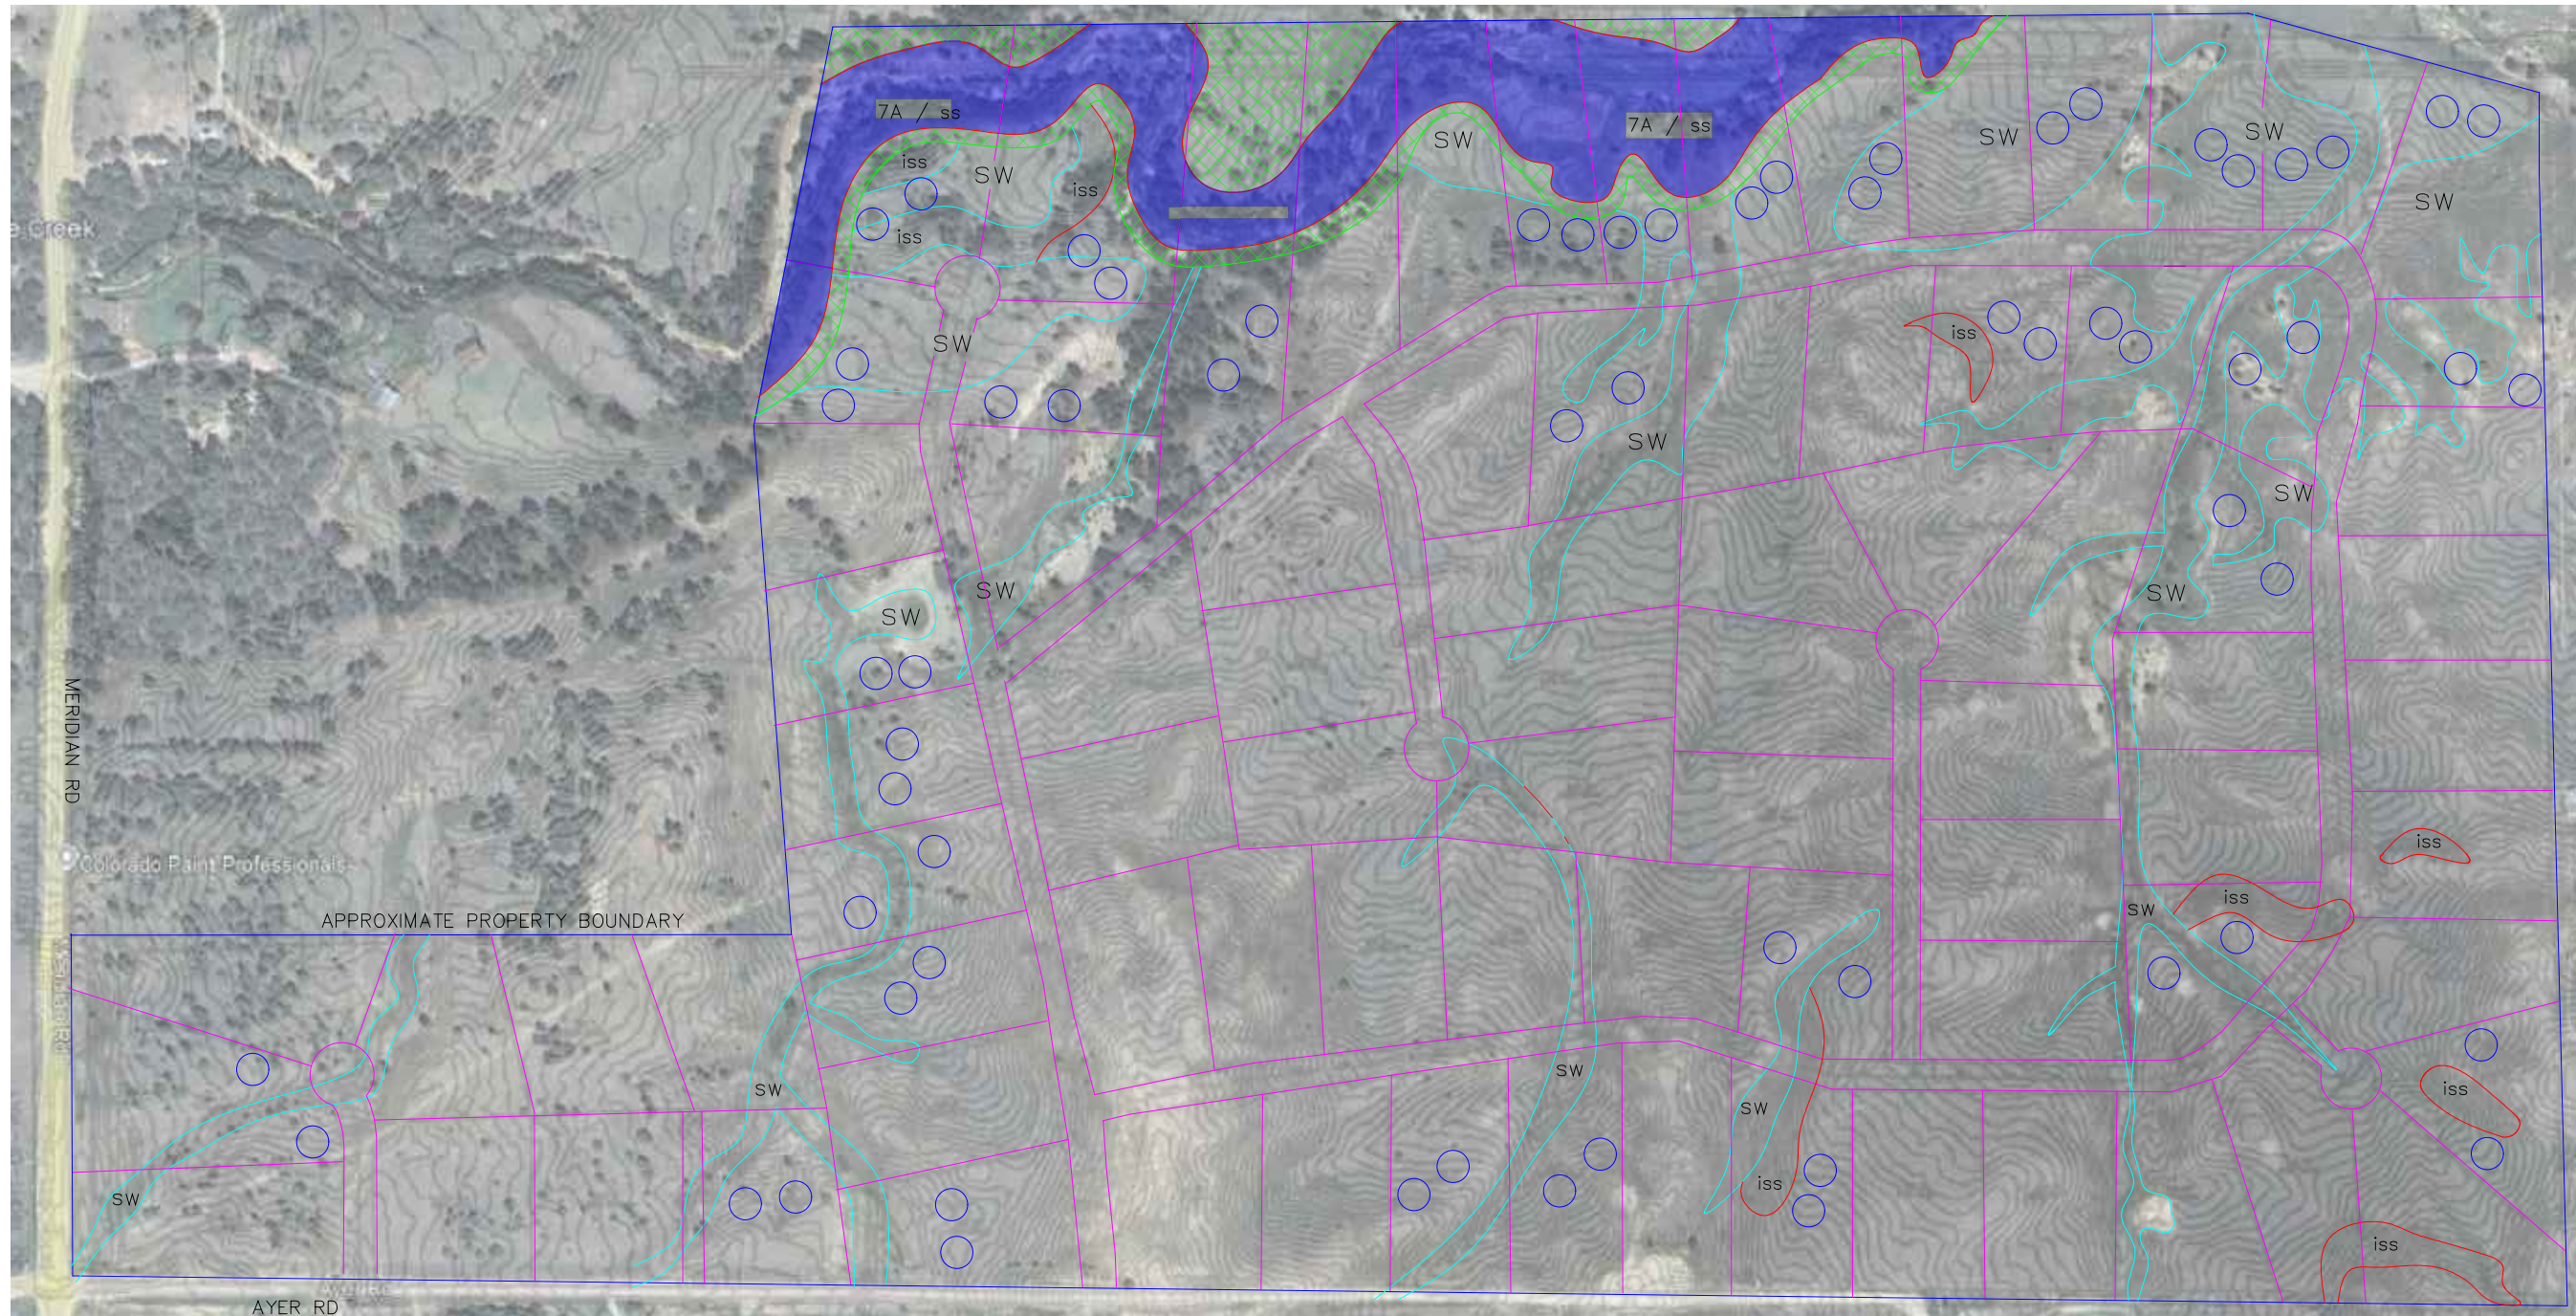
SHEET No.
FIG-14

- *fw* - Regulatory floodway as designated by FEMA. This area is to be designated a "No Build Area" until further investigations are completed.
- *sw* - seasonally wet - areas that may collect surface water during heavy precipitation events
- *iss* - isolated steep slopes that can be regarded as needed during construction of the individual residences

Personnel of RMG performed soil evaluations in 17 test pits ranging in depths between 3.5 and 8 feet on December 23, 2024, utilizing the visual and tactile method for the evaluation of the site soils. The test pits were excavated in areas that appeared most likely to be problematic areas for future OWTS. The Explanation of Test Pit Logs and the Test Pit Logs are presented in Figures 3-13. A Septic Suitability map is presented in Figure 14.
