ENTECH
ENGINEERING, INC.

**SOILS AND GEOLOGY STUDY
VILLAS AT ASPEN TRAILS
PARCEL NO. 55092-00-002
SEC OF BRADLEY ROAD AND LEGACY HILL ROAD
EL PASO COUNTY, COLORADO**

June 20, 2023

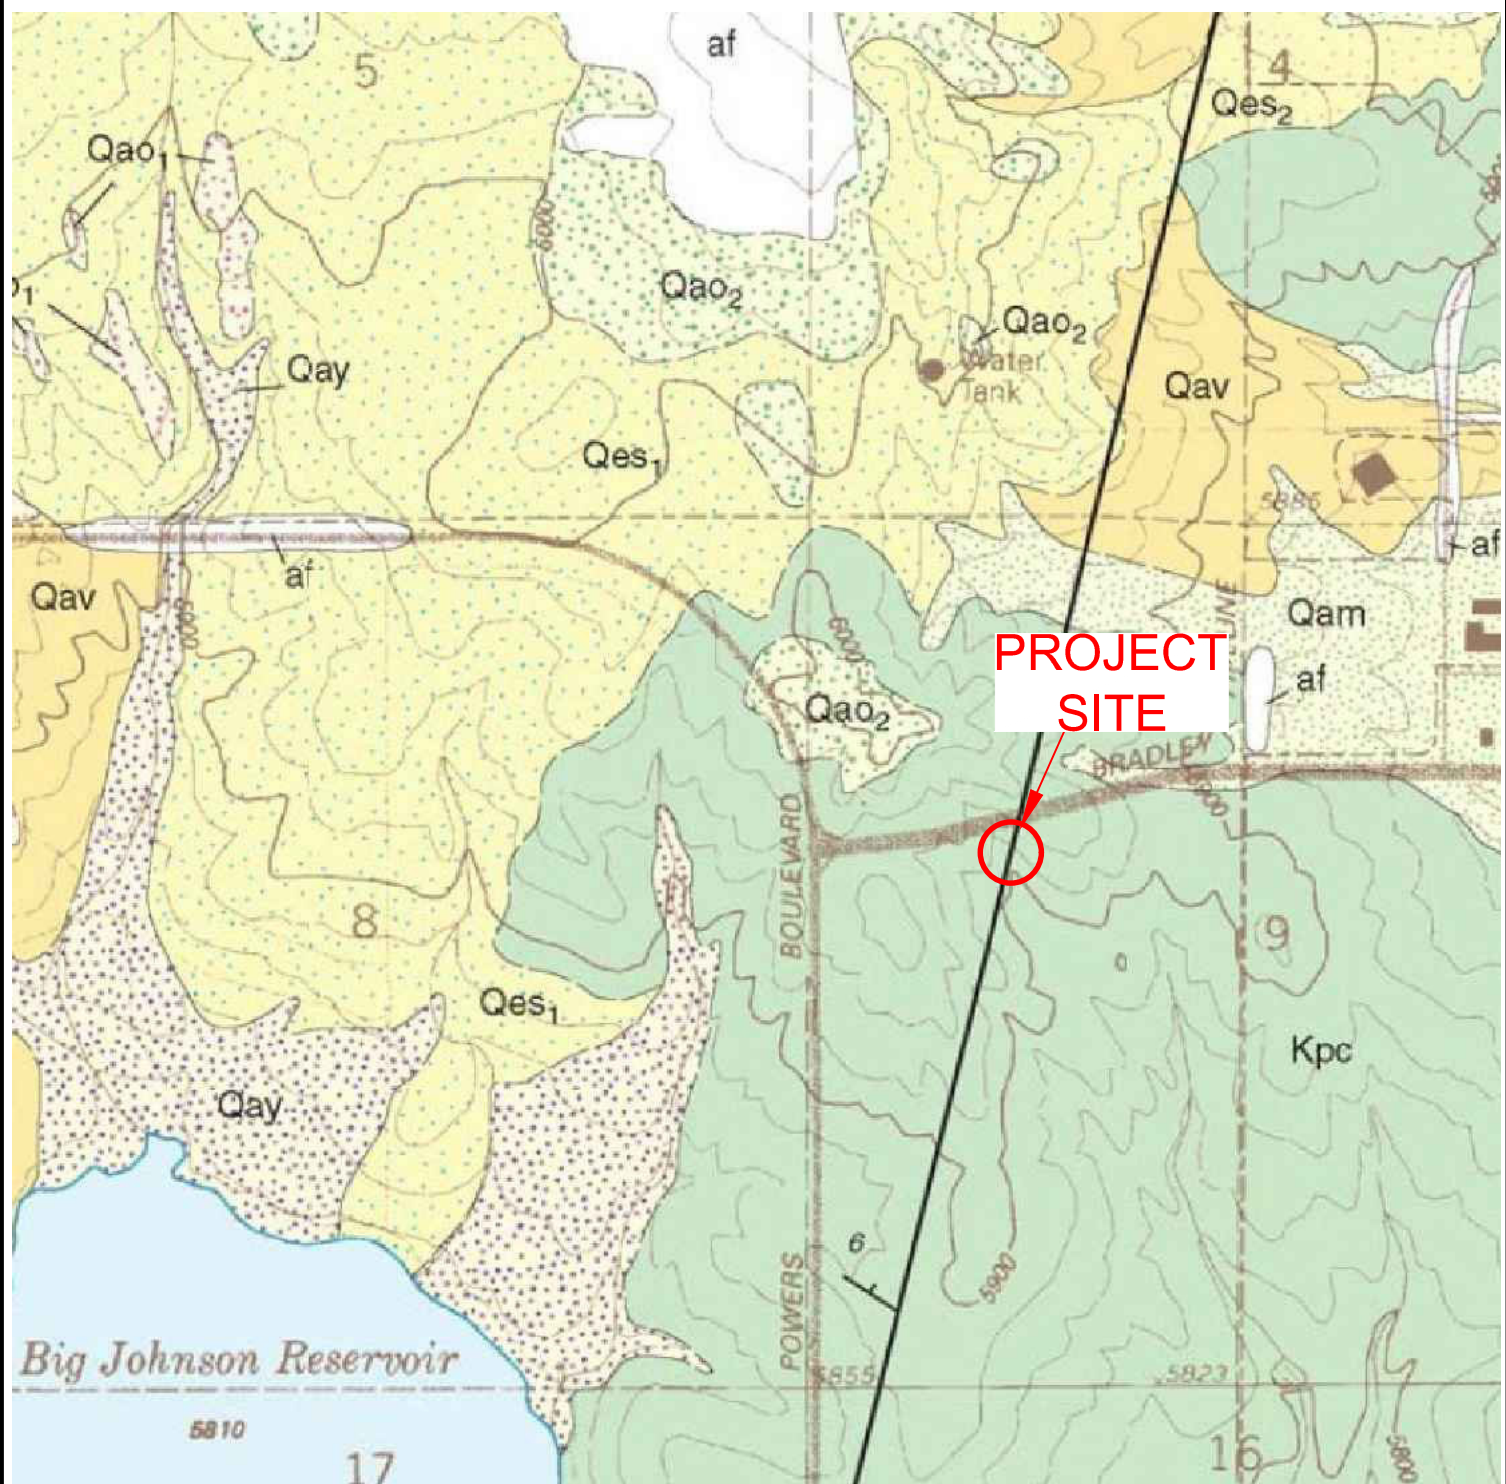
JOB NO.
230745
FIG. 5

ELSMERE QUADRANGLE GEOLOGIC MAP
VILLAS AT ASPEN TRAILS
RJ DEVELOPMENT

The Elsmere Quadrangle Geology Map showing the site is presented in (Figure 5, Reference 4). The Geology/Engineering Geology Map prepared for the site is presented in Figure 6. Two mappable units were identified on this site which are described as follows:
