**ENTECH**  
ENGINEERING, INC.

Re: Wastewater Study  
Settlers Ranch Filing No. 3  
Parcel Nos. 61230-04-048, 61240-05-001, 61240-05-003, & 61230-07-024  
El Paso County, Colorado  
Entech Job No. 230662

#### **GENERAL SITE CONDITIONS AND PROJECT DESCRIPTION**

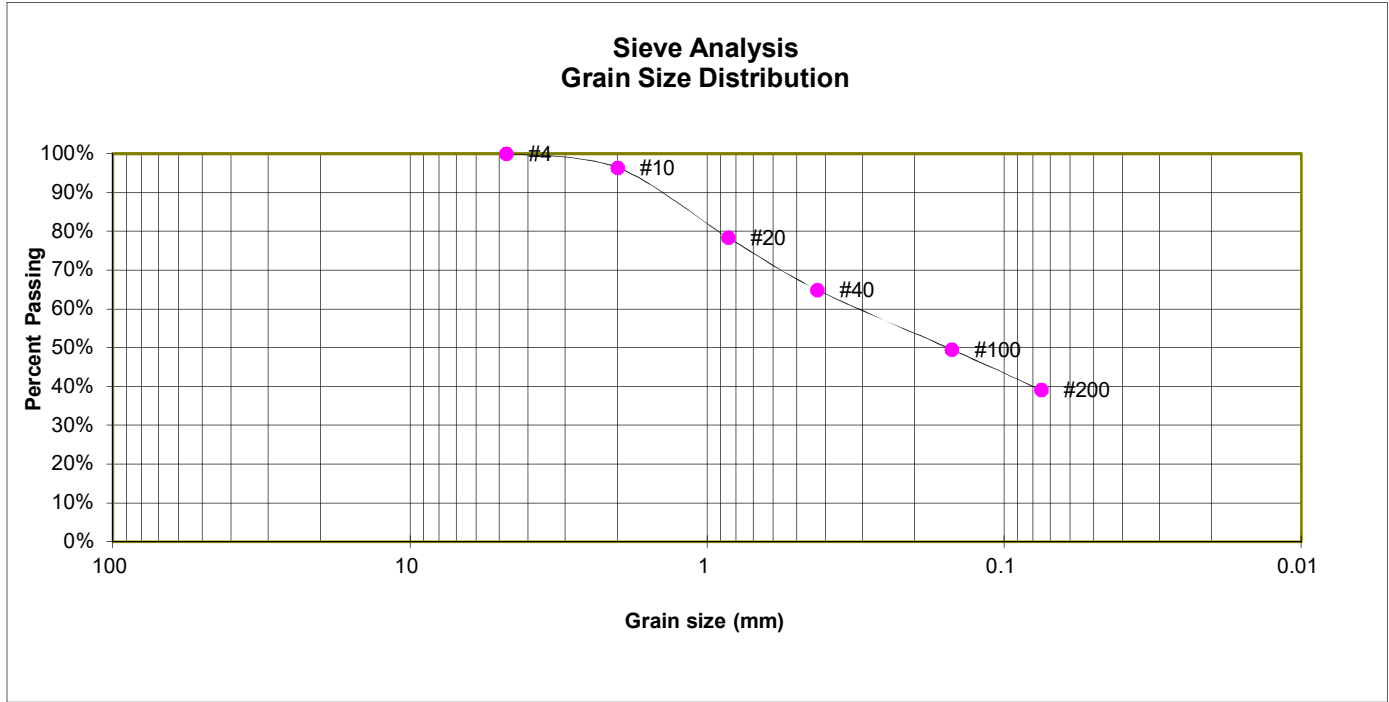
**FIG. B-1**

<u>TEST PIT</u>	TP-1	<u>SOIL DESCRIPTION</u>	SANDY CLAY LOAM
<u>DEPTH (FT)</u>	2.5	<u>USDA SOIL TYPE</u>	3

<u>U.S. Sieve #</u>	<u>Percent Finer</u>
3"	
1 1/2"	
3/4"	
1/2"	
3/8"	
4	100.0%
10	96.4%
20	78.4%
40	64.9%
100	49.5%
200	39.1%

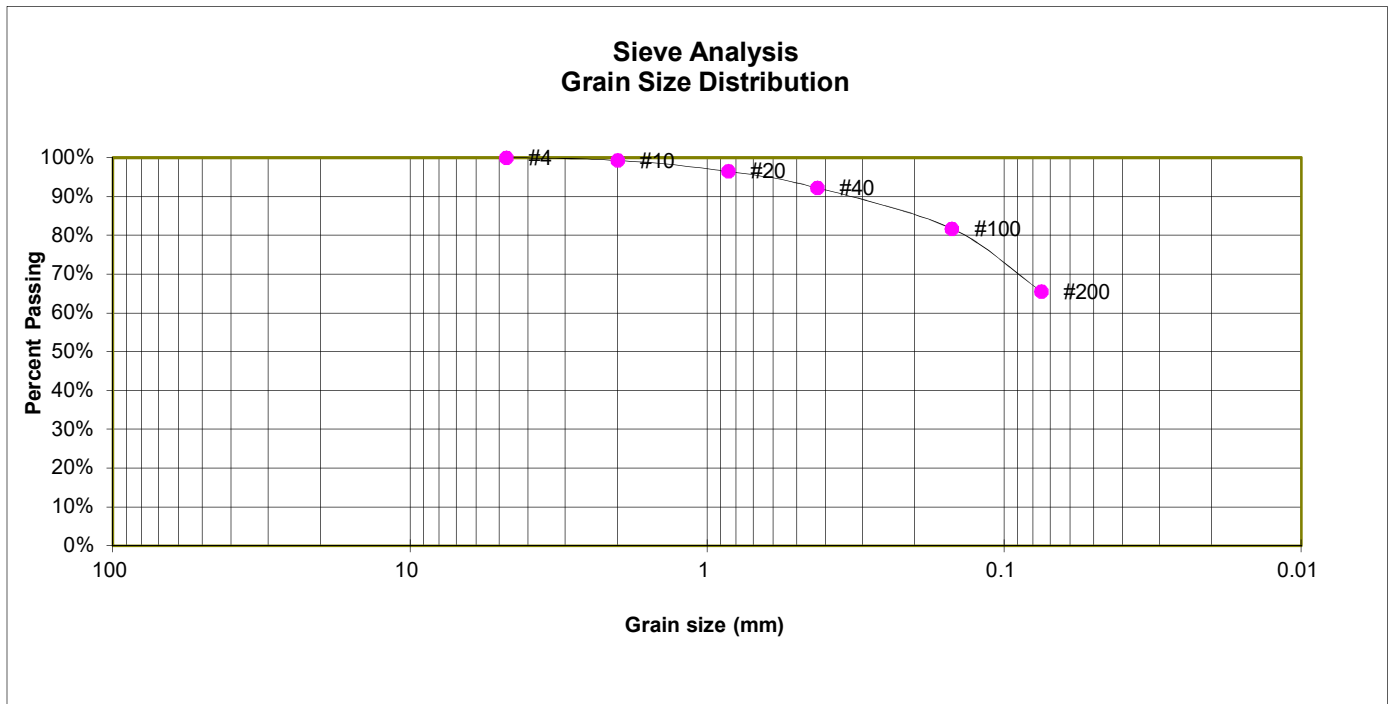
<u>TEST PIT</u>	TP-2	<u>SOIL DESCRIPTION</u>	SANDY CLAY
<u>DEPTH (FT)</u>	4	<u>USDA SOIL TYPE</u>	4

<u>U.S. Sieve #</u>	<u>Percent Finer</u>
3"	
1 1/2"	
3/4"	
1/2"	
3/8"	
4	100.0%
10	99.3%
20	96.5%
40	92.2%
100	81.7%
200	65.5%

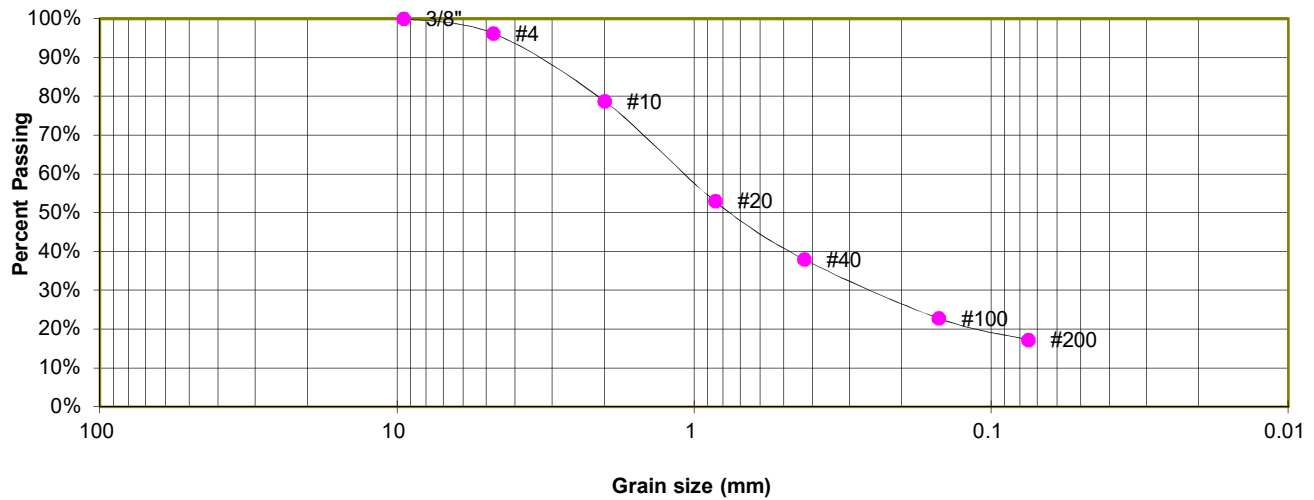
**FIG. B-3**

SOIL DESCRIPTION SANDY LOAM  
USDA SOIL TYPE 2

**Sieve Analysis  
Grain Size Distribution**

U.S. Sieve #	Percent Finer
3"	
1 1/2"	
3/4"	
1/2"	
3/8"	100.0%
4	96.2%
10	78.7%
20	52.9%
40	37.9%
100	22.8%
200	17.3%

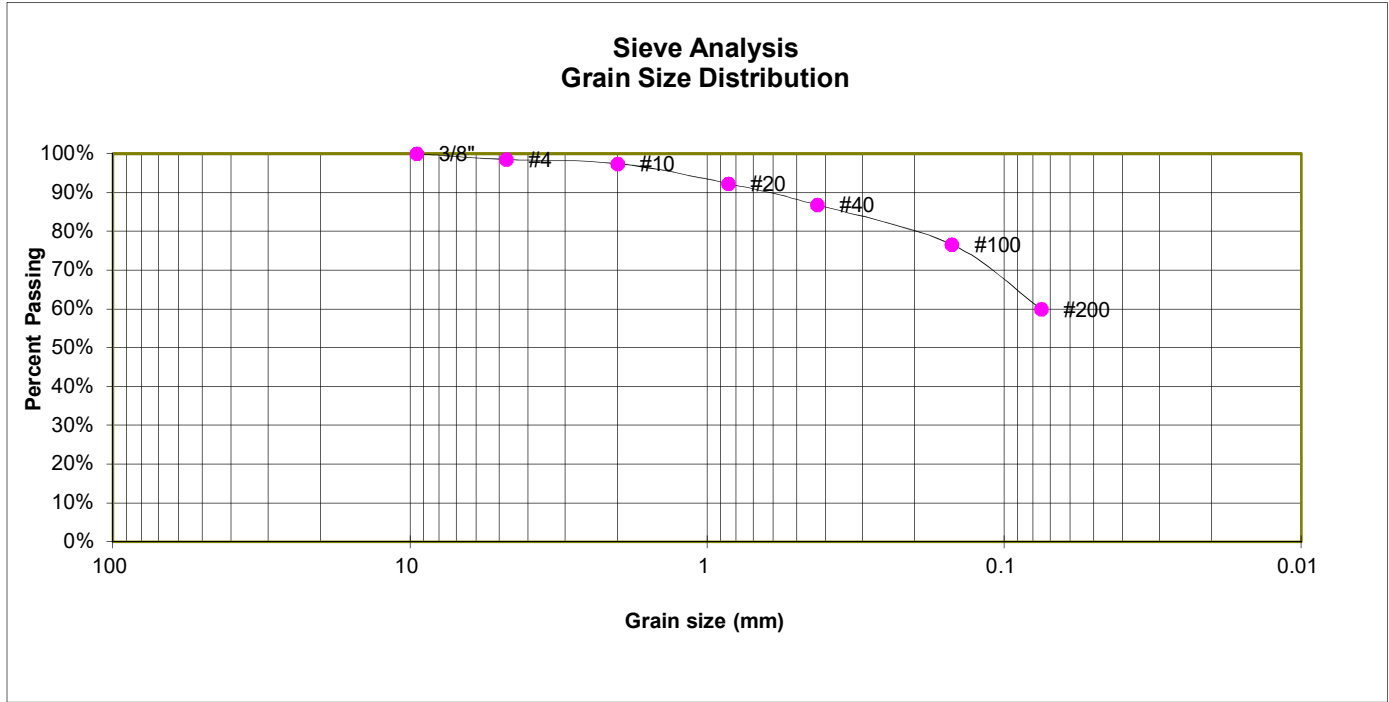
**FIG. B-4**

<u>TEST PIT</u>	TP-4	<u>SOIL DESCRIPTION</u>	SANDY CLAY LOAM
<u>DEPTH (FT)</u>	3	<u>USDA SOIL TYPE</u>	3A

<u>U.S. Sieve #</u>	<u>Percent Finer</u>
3"	
1 1/2"	
3/4"	
1/2"	
3/8"	100.0%
4	98.5%
10	97.4%
20	92.3%
40	86.8%
100	76.6%
200	59.9%

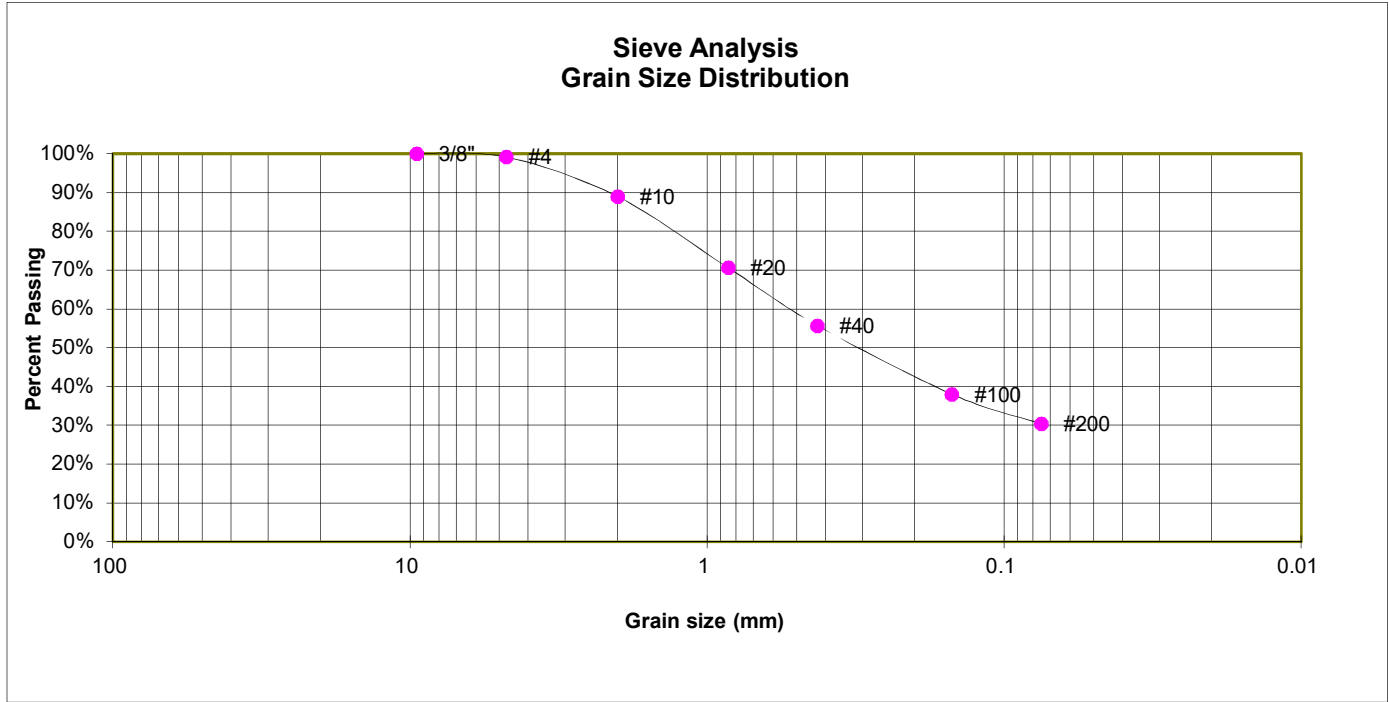
<u>TEST PIT</u>	TP-5	<u>SOIL DESCRIPTION</u>	SANDY LOAM
<u>DEPTH (FT)</u>	5.5	<u>USDA SOIL TYPE</u>	2A

<u>U.S. Sieve #</u>	<u>Percent Finer</u>
3"	
1 1/2"	
3/4"	
1/2"	
3/8"	100.0%
4	99.2%
10	89.0%
20	70.6%
40	55.7%
100	38.0%
200	30.3%

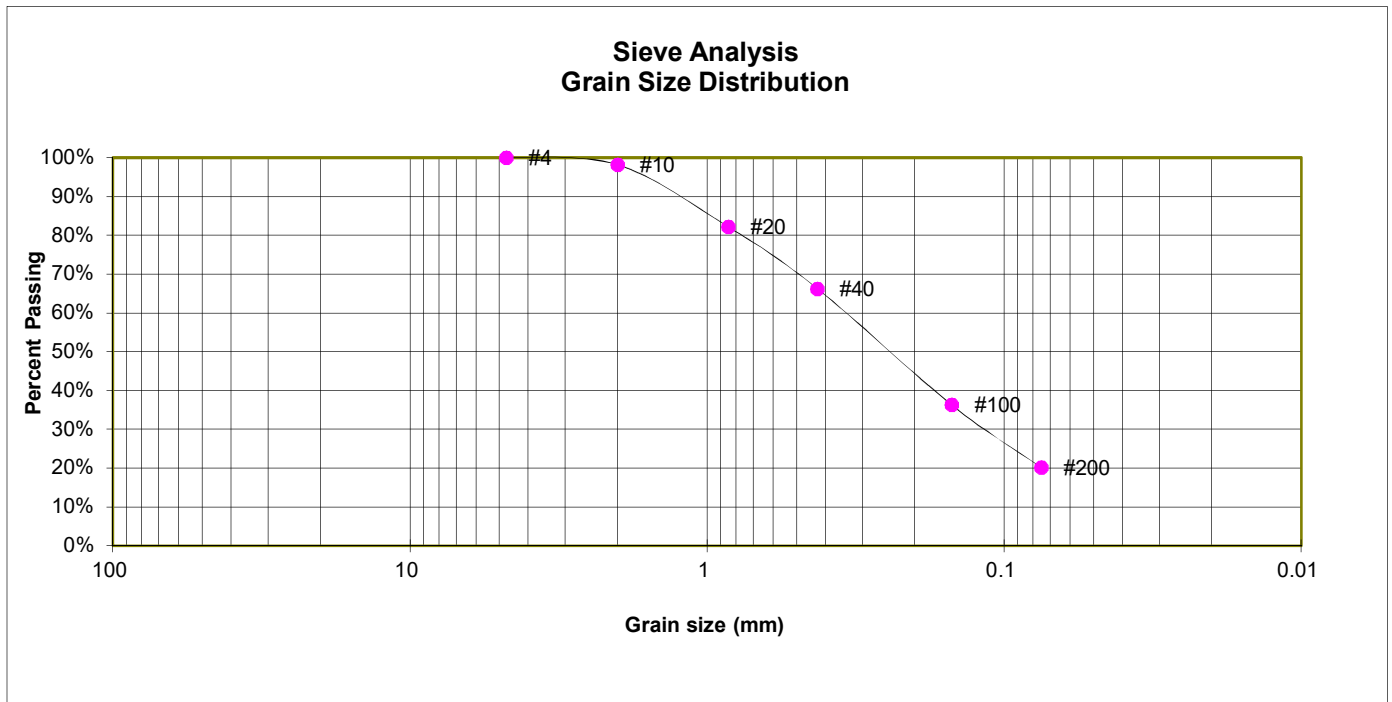
TEST PIT TP-6  
 DEPTH (FT) 2  
 USDA SOIL TYF 2A

SOIL DESCRIPTION SANDY LOAM  
 USDA SOIL TYPE SM

U.S. Sieve #	Percent Finer
3"	
1 1/2"	
3/4"	
1/2"	
3/8"	
4	100.0%
10	98.2%
20	82.2%
40	66.2%
100	36.3%
200	20.1%
