PAVEMENT DESIGN REPORT

Meadowbrook Parkway El Paso County, Colorado

JOB NO. 188737

August 24, 2022 Revised: September 13, 2022

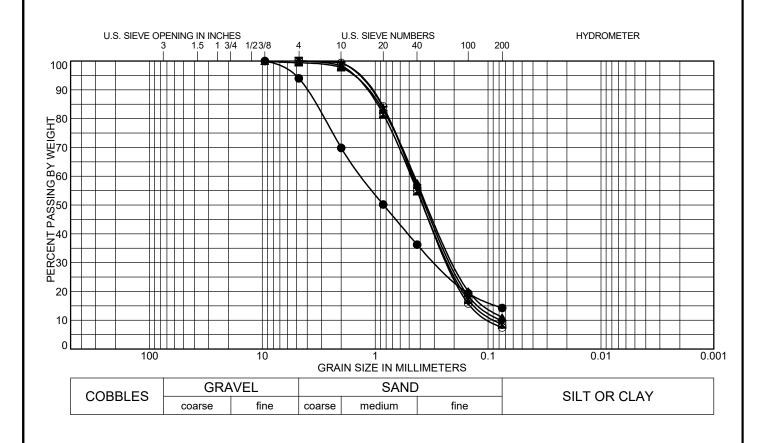
Test Boring	Depth (ft)		Classification					PL	PI
	1	2.0		SILTY SAND(SM)					NP	NP
	x 2	2.0		POORLY GRADED SAND with SILT(SP-SM)					NP	NP
4	A 3	2.0		WELL-GRADED SAND with SILT(SW-SM)					NP	NP
7	* 4	2.0		WELL-GRADED SAND with SILT(SW-SM)					NP	NP
(9 5	2.0		POORLY GRADED SAND with SILT(SP-SM)				NP	NP	NP
	Test Boring	Depth (ft)	%Gravel	%Sand	%Silt	%Clay

Test Boring	Depth (ft)	%Gravel	%Sand	%Silt	%Clay
•	1	2.0	6.0	79.7	14	.2
×	2	2.0	0.0	91.4	8.	.6
▲	3	2.0	0.6	88.4	11	.1
*	4	2.0	0.0	90.2	9.	.8
\odot	5	2.0	0.0	92.5	7.	.5

Grain-size analyses and Atterberg limits tests were performed on the combined samples obtained from the borings for purposes of classification and obtaining pertinent engineering parameters. A moisture-density relationship curve and a California Bearing Ratio (CBR) test were performed on a composite bulk sample obtained from all six Test Borings, TB-1 through TB-6. A Summary of Laboratory Test Results is presented in Figure 7. Soil Classification Data are presented in Figures 8 and 9. The Moisture Density Relationship Curve is presented in Figure 10. The CBR Test Results are presented in Figures 11 and 12.

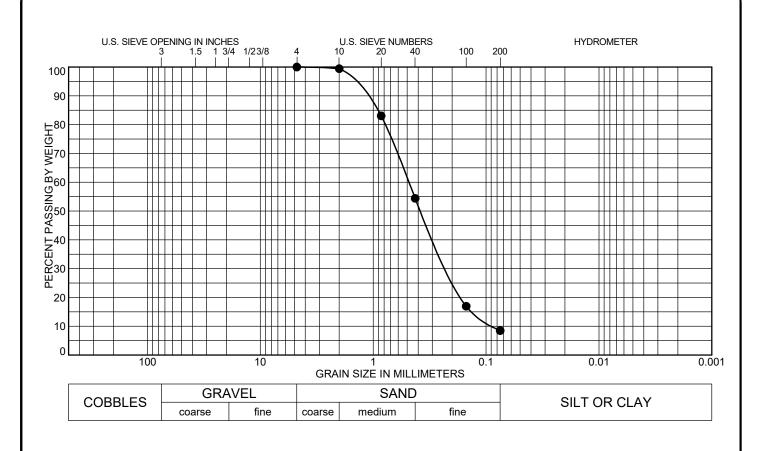
Test Boring	Depth (ft)	Classification	LL	PL	PI
6	2.0	POORLY GRADED SAND with SILT(SP-SM)	NP	NP	NP

1	Test Boring	Depth (ft)	%Gravel	%Sand	%Silt	%Clay	
•	6	2.0	0.0	91.5	8.5

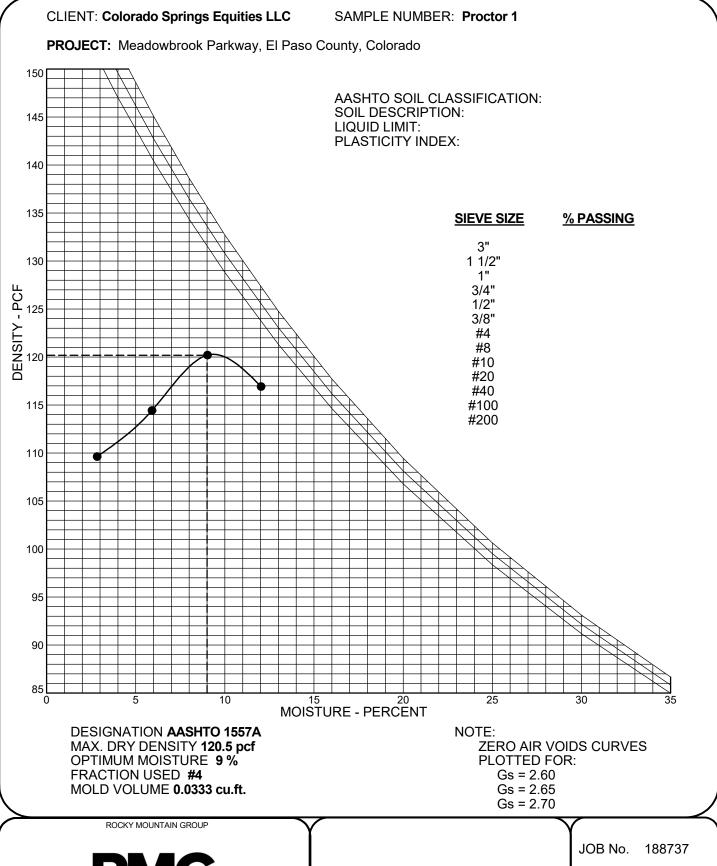
MOISTURE-DENSITY RELATION CURVE

Sample Location: Combined Bulk Sample Soil Description: Silty Sand

A composite bulk sample from the six Test Borings, A-1-b/A-2/A-3 (0) soil, was tested to determine its moisture-density relationship curve in accordance with ASTM D1557A (Modified Proctor compaction test). Maximum Dry Density proved to be 120.5 pcf at 9.0 percent moisture. A CBR test was performed in accordance with Appendix D.2.4 of the El Paso County Engineering Criteria Manual (EPCECM) at varying densities at moisture content near optimum. At 95% of the maximum Modified Proctor density, 120.5 pcf, the CBR of the bulk sample was 20.9.

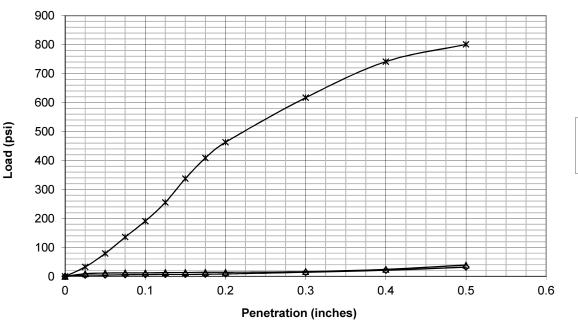
10 blows/lift	25 blows/lift	56 blows/lift
Penetration			
(in)	Load (psi)	Load (psi)	Load (psi)
0.000	0.0	0.0	0.0
0.025	4.0	9.1	32.6
0.050	4.4	11.4	78.9
0.075	5.7	12.1	135.7
0.100	6.0	12.1	190.8
0.125	6.7	13.1	255.3
0.150	6.7	13.4	337.6
0.175	7.4	14.1	408.8
0.200	8.4	14.1	462.9
0.300	14.1	16.5	616.8
0.400	21.2	24.2	741.4
0.500	31.9	39.0	800.9

Corrected Penetration Corrected Load (in) (psi) 0.6

10 blows/lift 0.100 25 blows/lift 0.100 1.2 56 blows/lift 0.125 25.5

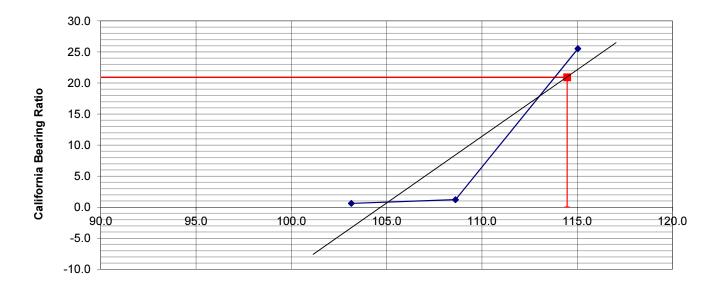
10 blows/lift	25 blows/lift	56 blows/lift
Corrected California Bearing Ratio	0.6	1.2	25.5
Dry Density (pcf)	103.1	108.6	115.0
Percent Compaction	86	90	95
Percent Moisture After Soaking	12.4	11.3	12.4
Percent Expansion (+) / Compression (-)	-0.3%	-0.1%	0.0%
Surcharge Weight (lbs)	12.60	12.60	12.60

Dry Density (pcf)

California Bearing Ratio	20.9
Dry Density (pcf)	120.5
Percent Compaction	95%
Target Dry Density	114.5
Compaction Test Method	ASTM D-1557A
Condition of sample	Soaked
