Kumar & Associates, Inc.®
Geotechnical and Materials Engineers
and Environmental Scientists

GEOLOGIC HAZARDS STUDY
PROPOSED APARTMENT DEVELOPMENT
AKERS DRIVE AND CONSTITUTION AVENUE
COLORADO SPRINGS, COLORADO

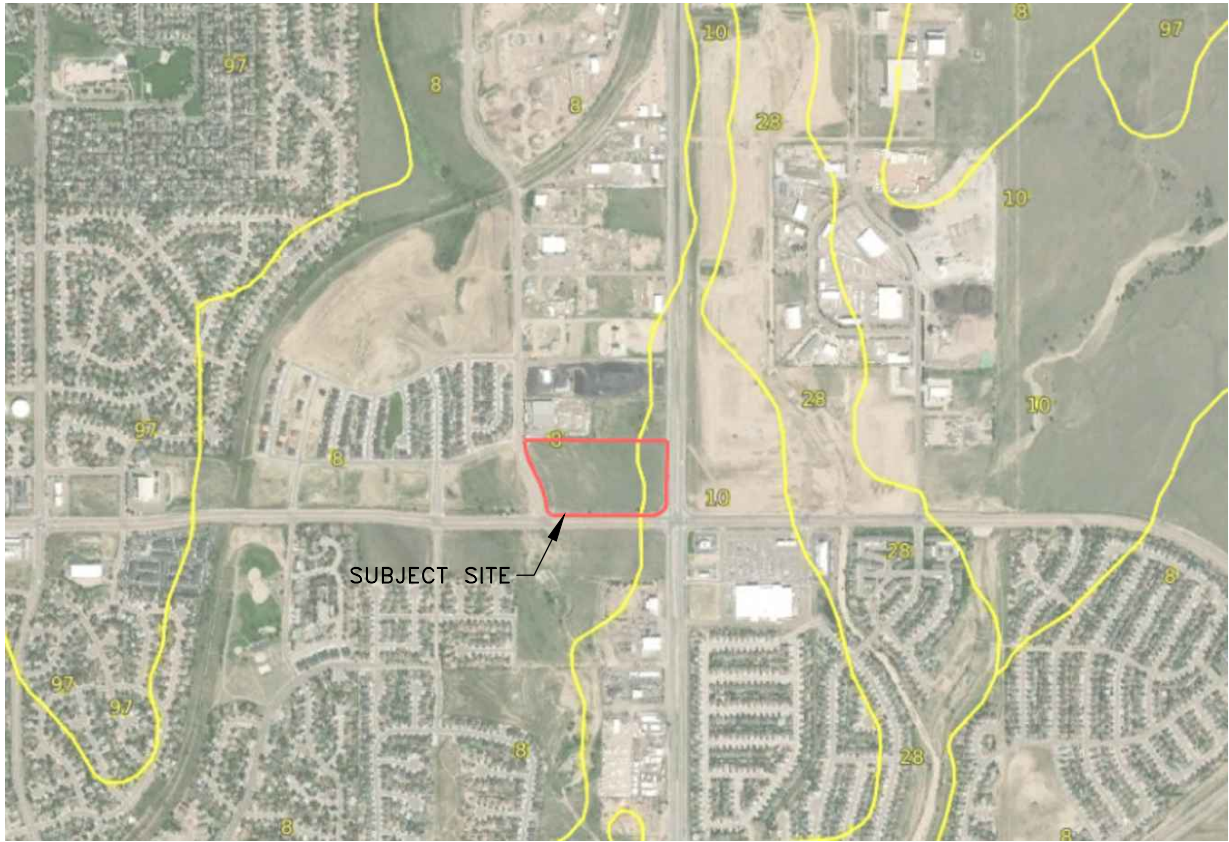
LEGEND:

- 8: Blakeland loamy sand
- 10: Blendon sandy loam
- 28: Ellicott loamy coarse sand
- 97: Truckton sandy loam
