**Stormwater Best Management Practices  
Operations and Maintenance Manual (O&M Manual)**

***Viewpoint Estates***

***21209 & 21307 Chesley Drive***

***January 3, 2024***

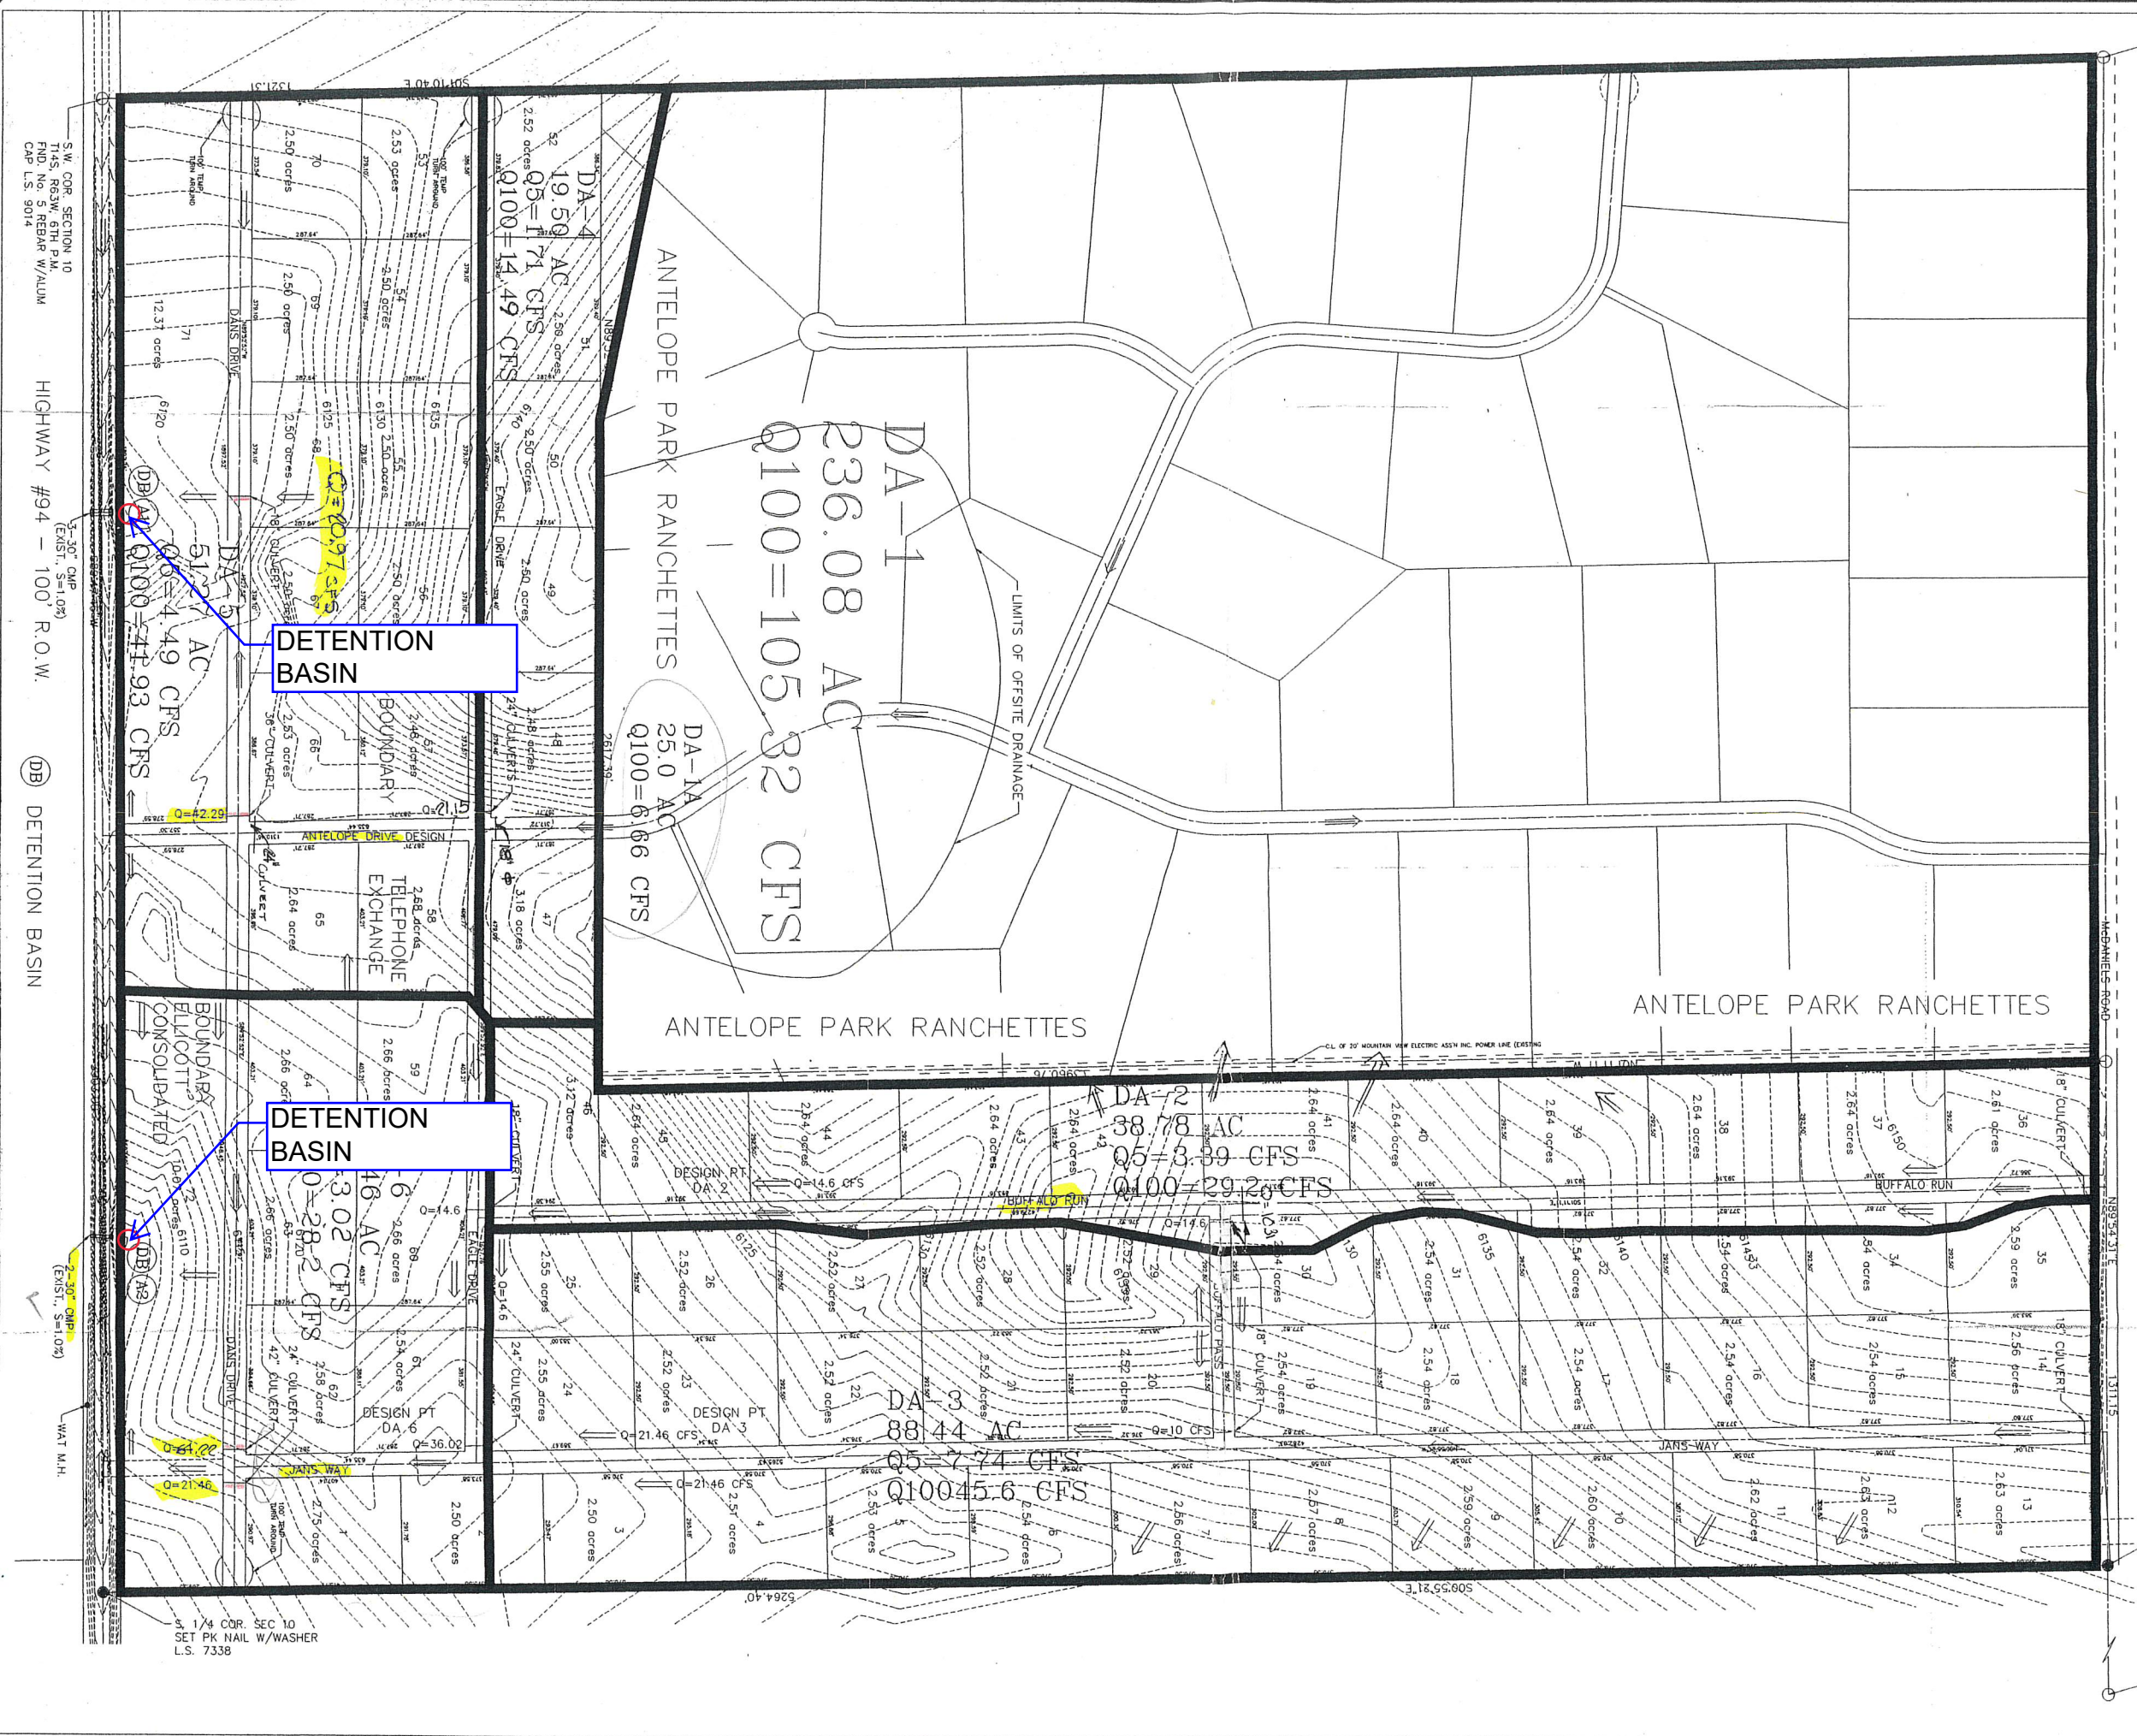
### **STORMWATER FACILITIES MAP**

HIGHWAY #94 - 100' R.O.W.  
 (DB) DETENTION BASIN
