ENTECH
ENGINEERING, INC.

Re: Wastewater Study
Viewpoint Estates Filing No. 2
Highway 94 & Antelope Drive
Tax Schedule Nos. 34100-10-001 & 34100-09-001
El Paso County, Colorado

Total acreage involved in the proposed subdivision is 24.33-acres. Seven residential lots are proposed as part of the replat. The proposed lot sizes range from 2.5 to 4.7-acres. The lots will be serviced by individual on-site wastewater treatment systems and municipal water. The Site Plan is presented in Figure 3.

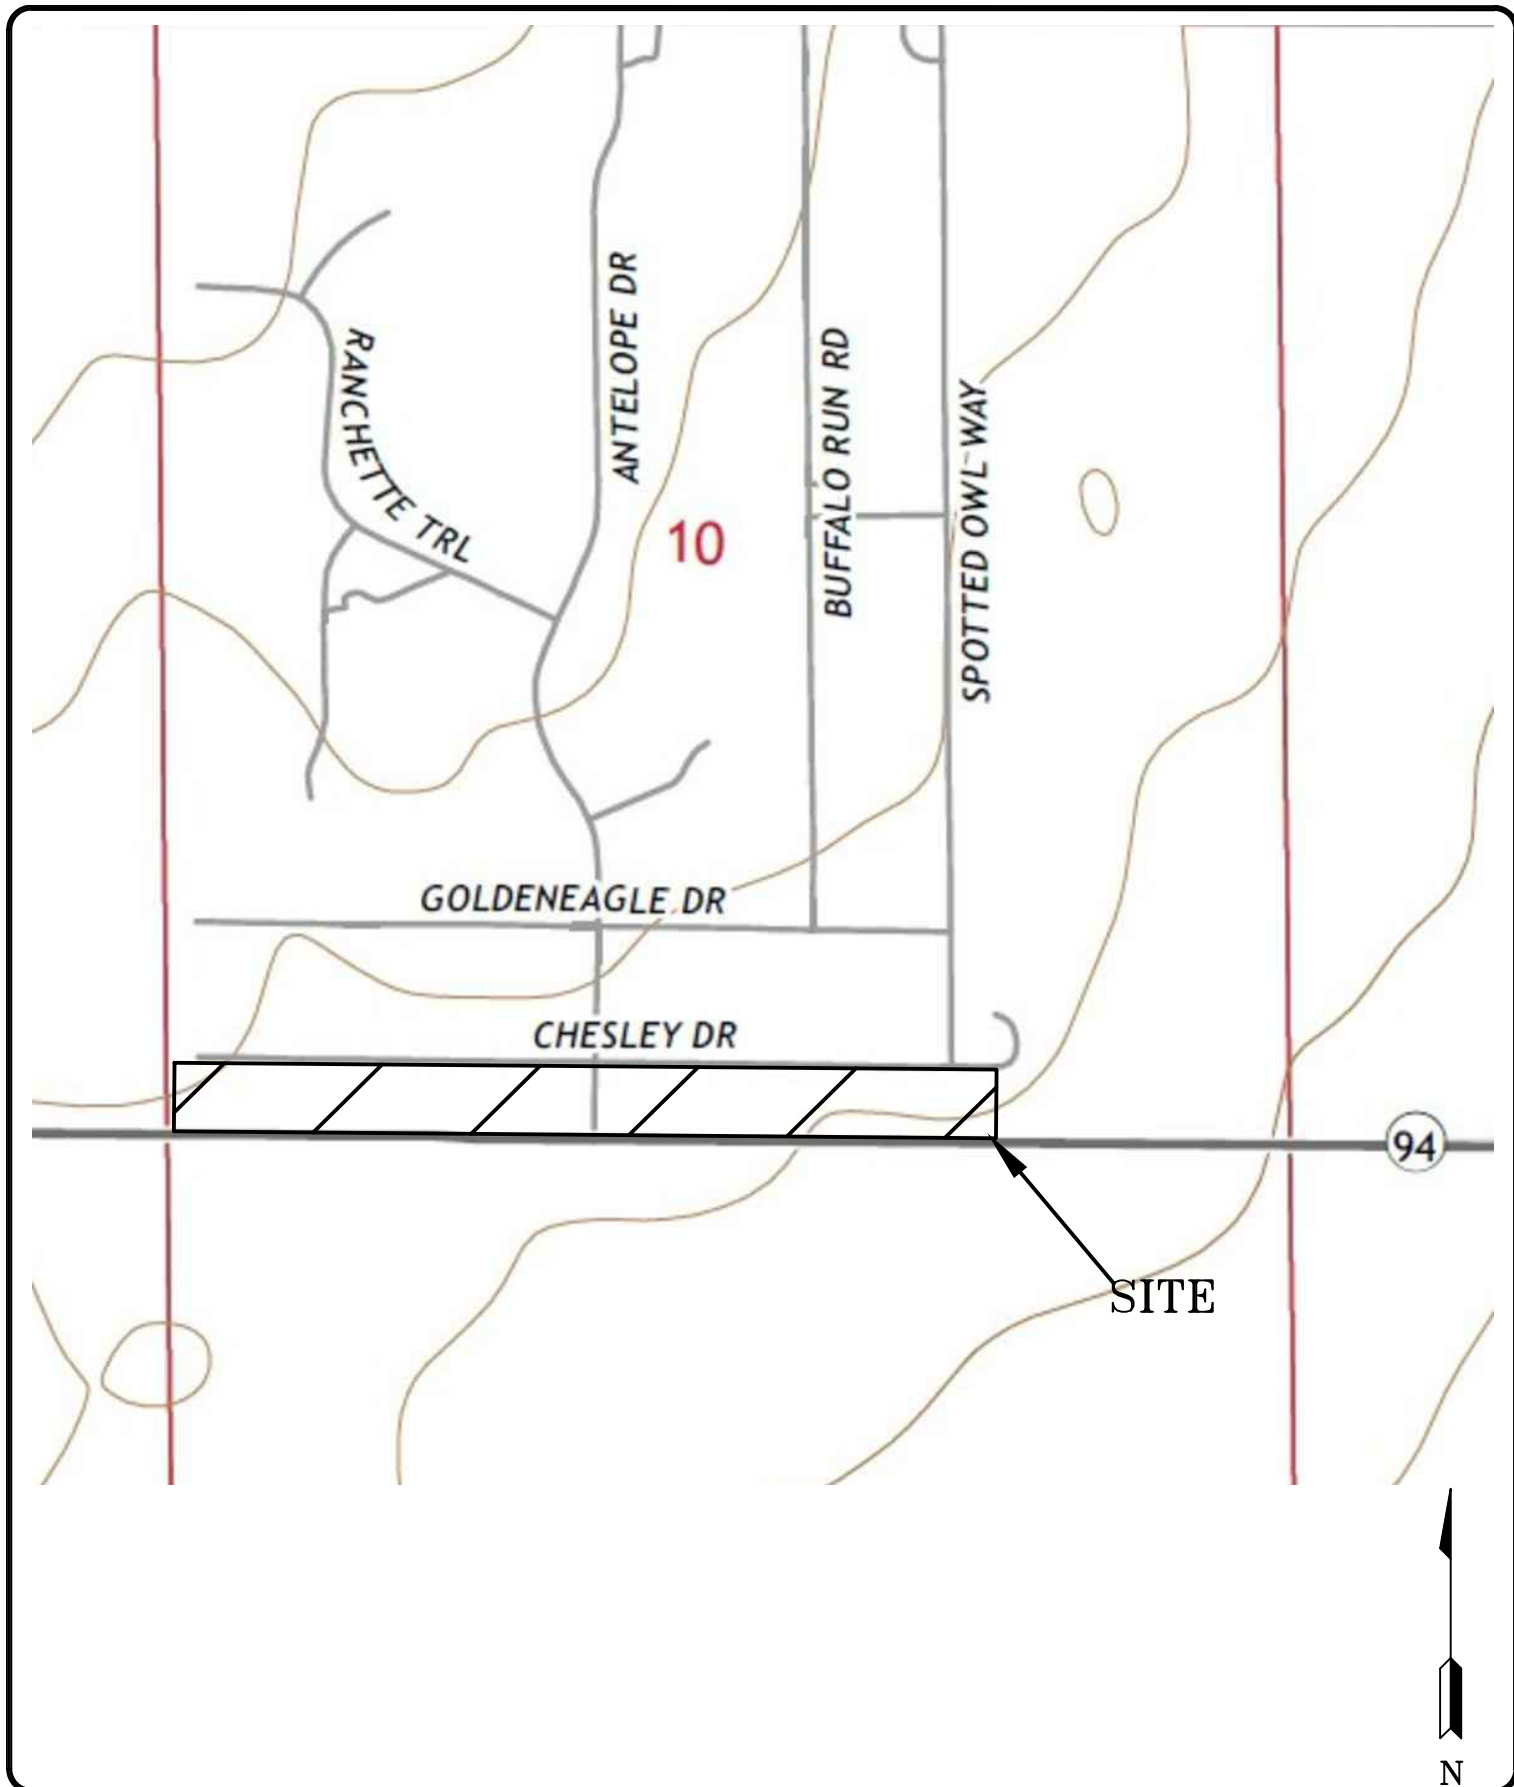
FIG NO.:
2

USGS MAP TOPOGRAPHY MAP
VIEWPOINT ESTATES FILING NO. 2
HWY 94 & ANTELOPE DRIVE
EL PASO COUNTY, CO.
FOR: MVE, INC.
