ENTECH
ENGINEERING, INC.

Re: Wastewater Study
Viewpoint Estates Filing No. 2
Highway 94 & Antelope Drive
Tax Schedule Nos. 34100-10-001 & 34100-09-001
El Paso County, Colorado

GENERAL SITE CONDITIONS AND PROJECT DESCRIPTION:

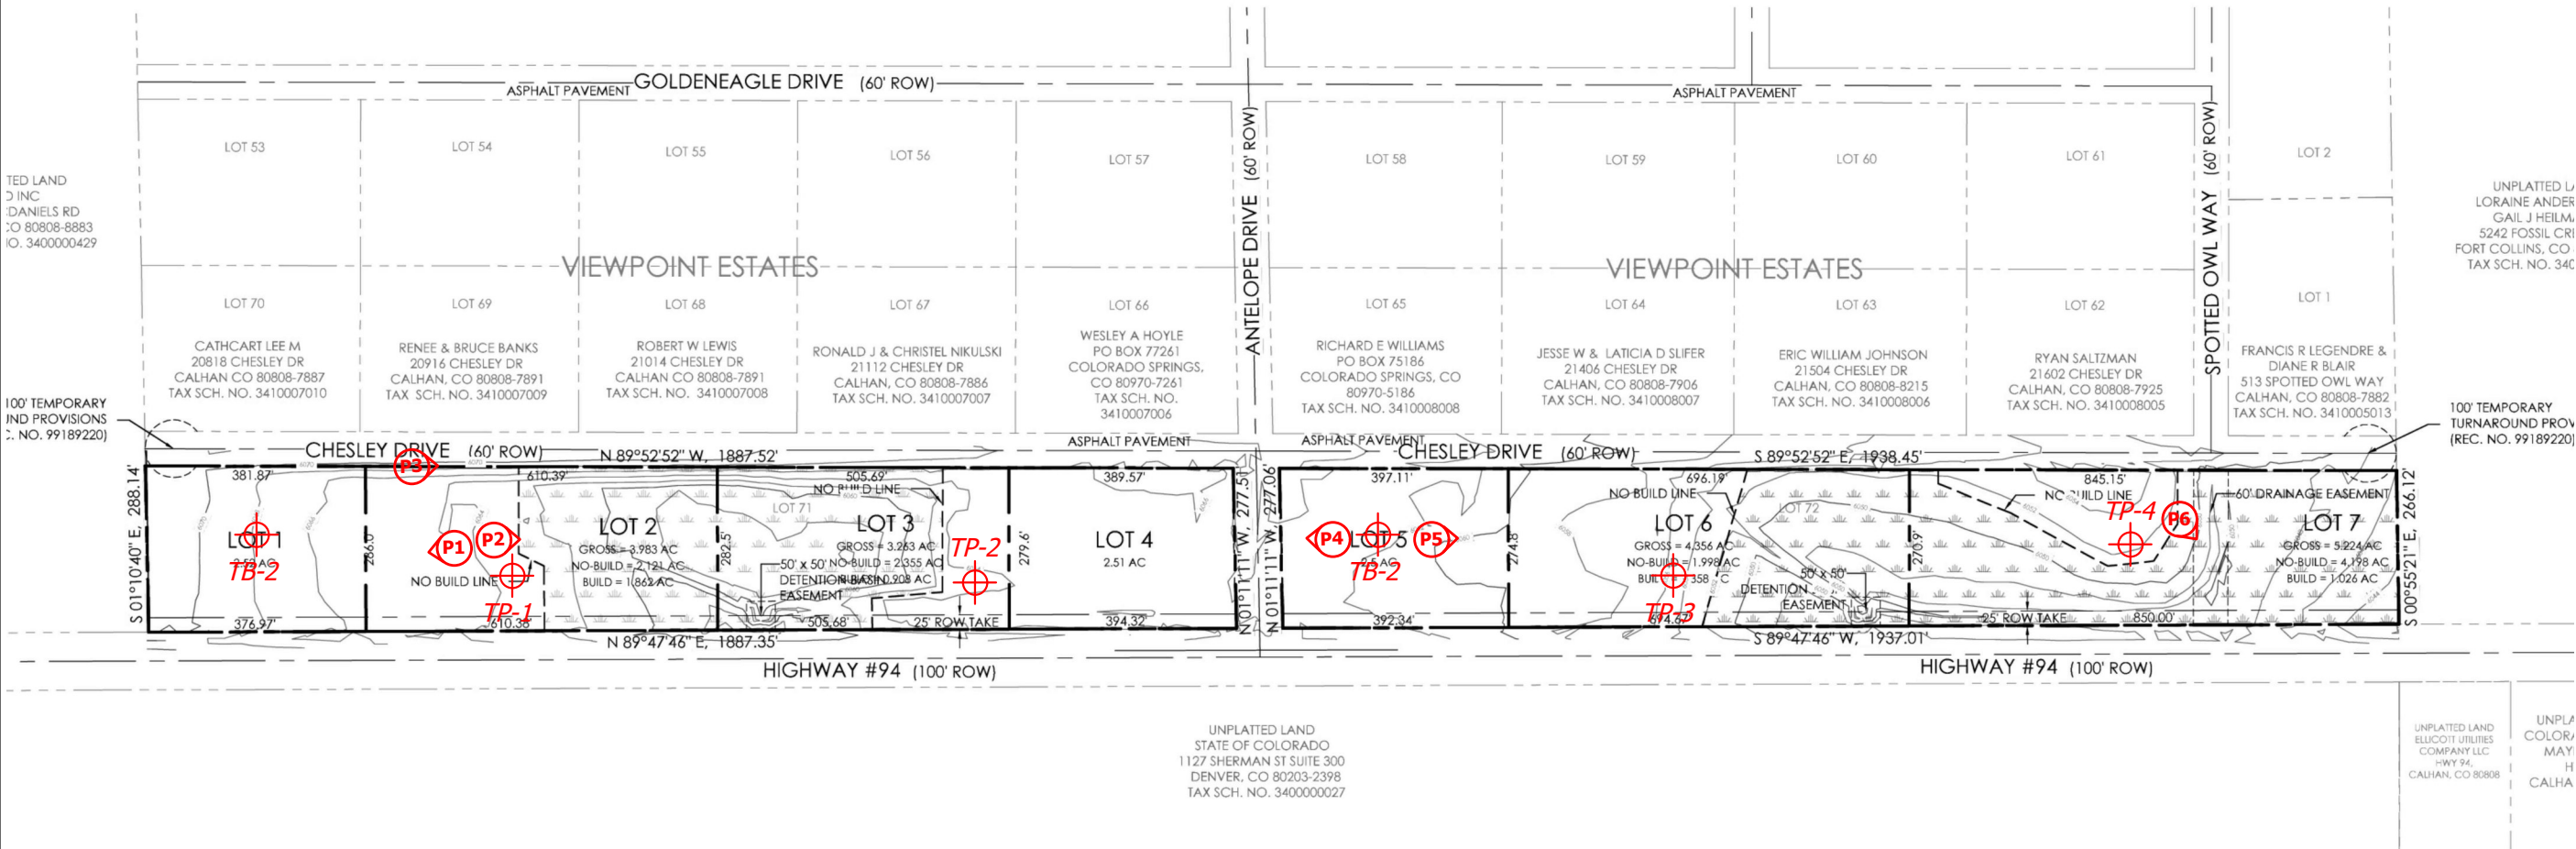
DRAWN LLL CHECKED
DATE 9/27/21
SCALE AS SHOWN
JOB NO. 212316
FIGURE No. 3

- ⊕ - APPROXIMATE TEST PIT LOCATION
- Ⓟ - APPROXIMATE PHOTOGRAPH LOCATION AND DIRECTION

SITE PLAN/TESTING LOCATION MAP
VIEWPOINT ESTATES FILING NO. 2
HWY 94 & ANTELOPE DRIVE
EL PASO COUNTY, CO.
FOR: MVE, INC.

Total acreage involved in the proposed subdivision is 24.33-acres. Seven residential lots are proposed as part of the replat. The proposed lot sizes range from 2.5 to 4.7-acres. The lots will be serviced by individual on-site wastewater treatment systems and municipal water. The Site Plan is presented in Figure 3.

Two test borings were drilled and four test pits were excavated on the site to determine general suitability of the soil characteristics for residential construction and on-site wastewater treatment systems. The locations of the test pits are indicated on the Site Plan/Test Boring Location Map, Figure 3. The Test Boring and Test Pit Logs are presented in Appendix B, and Laboratory Testing results are included in Appendix C.

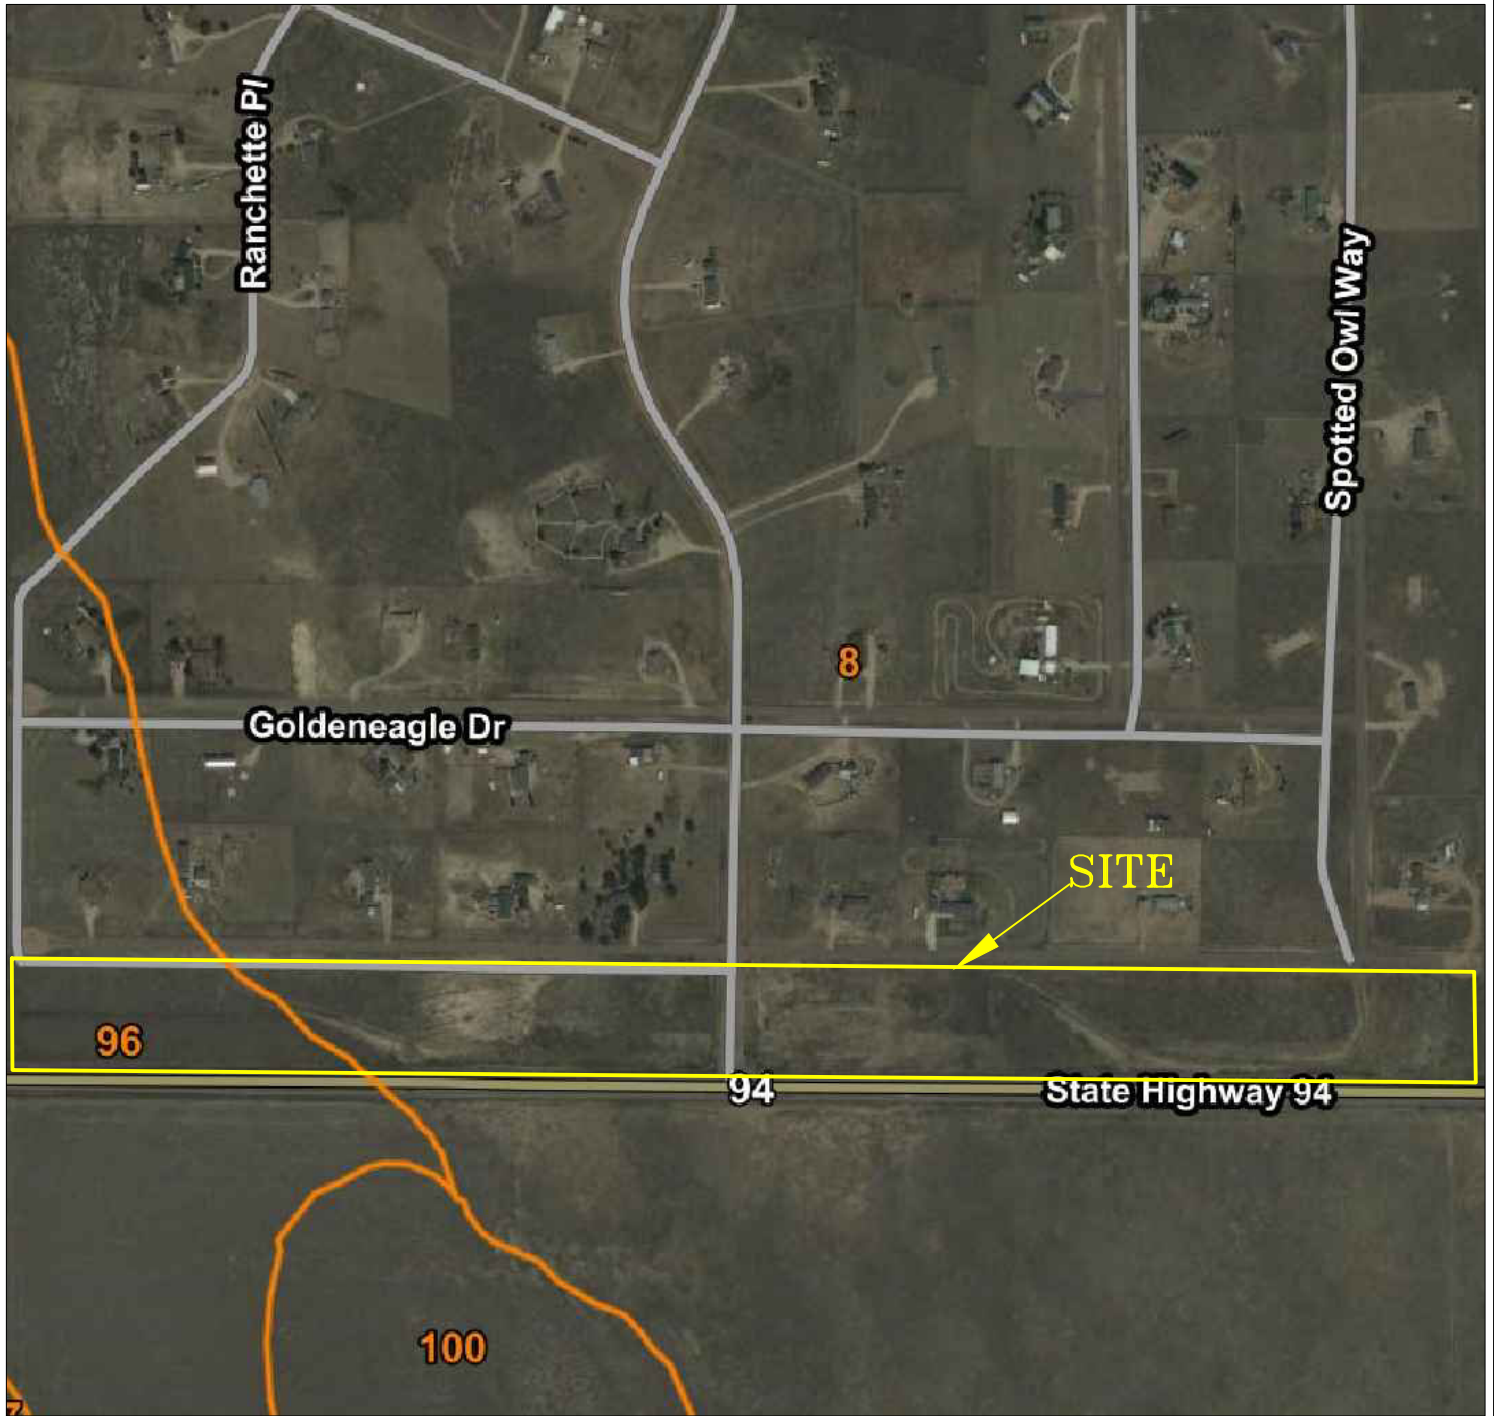
FIG NO.:
4

SOIL SURVEY MAP
VIEWPOINT ESTATES FILING NO. 2
HWY 94 & ANTELOPE DRIVE
EL PASO COUNTY, CO.
FOR: MVE, INC.

The soils have been described to have moderate to rapid permeabilities. The soils are described as well suited for use as home sites. Possible hazards with soils erosion are present on the site. The erosion potential can be controlled with vegetation. The soils have been described to have moderate erosion hazards (Reference 2).

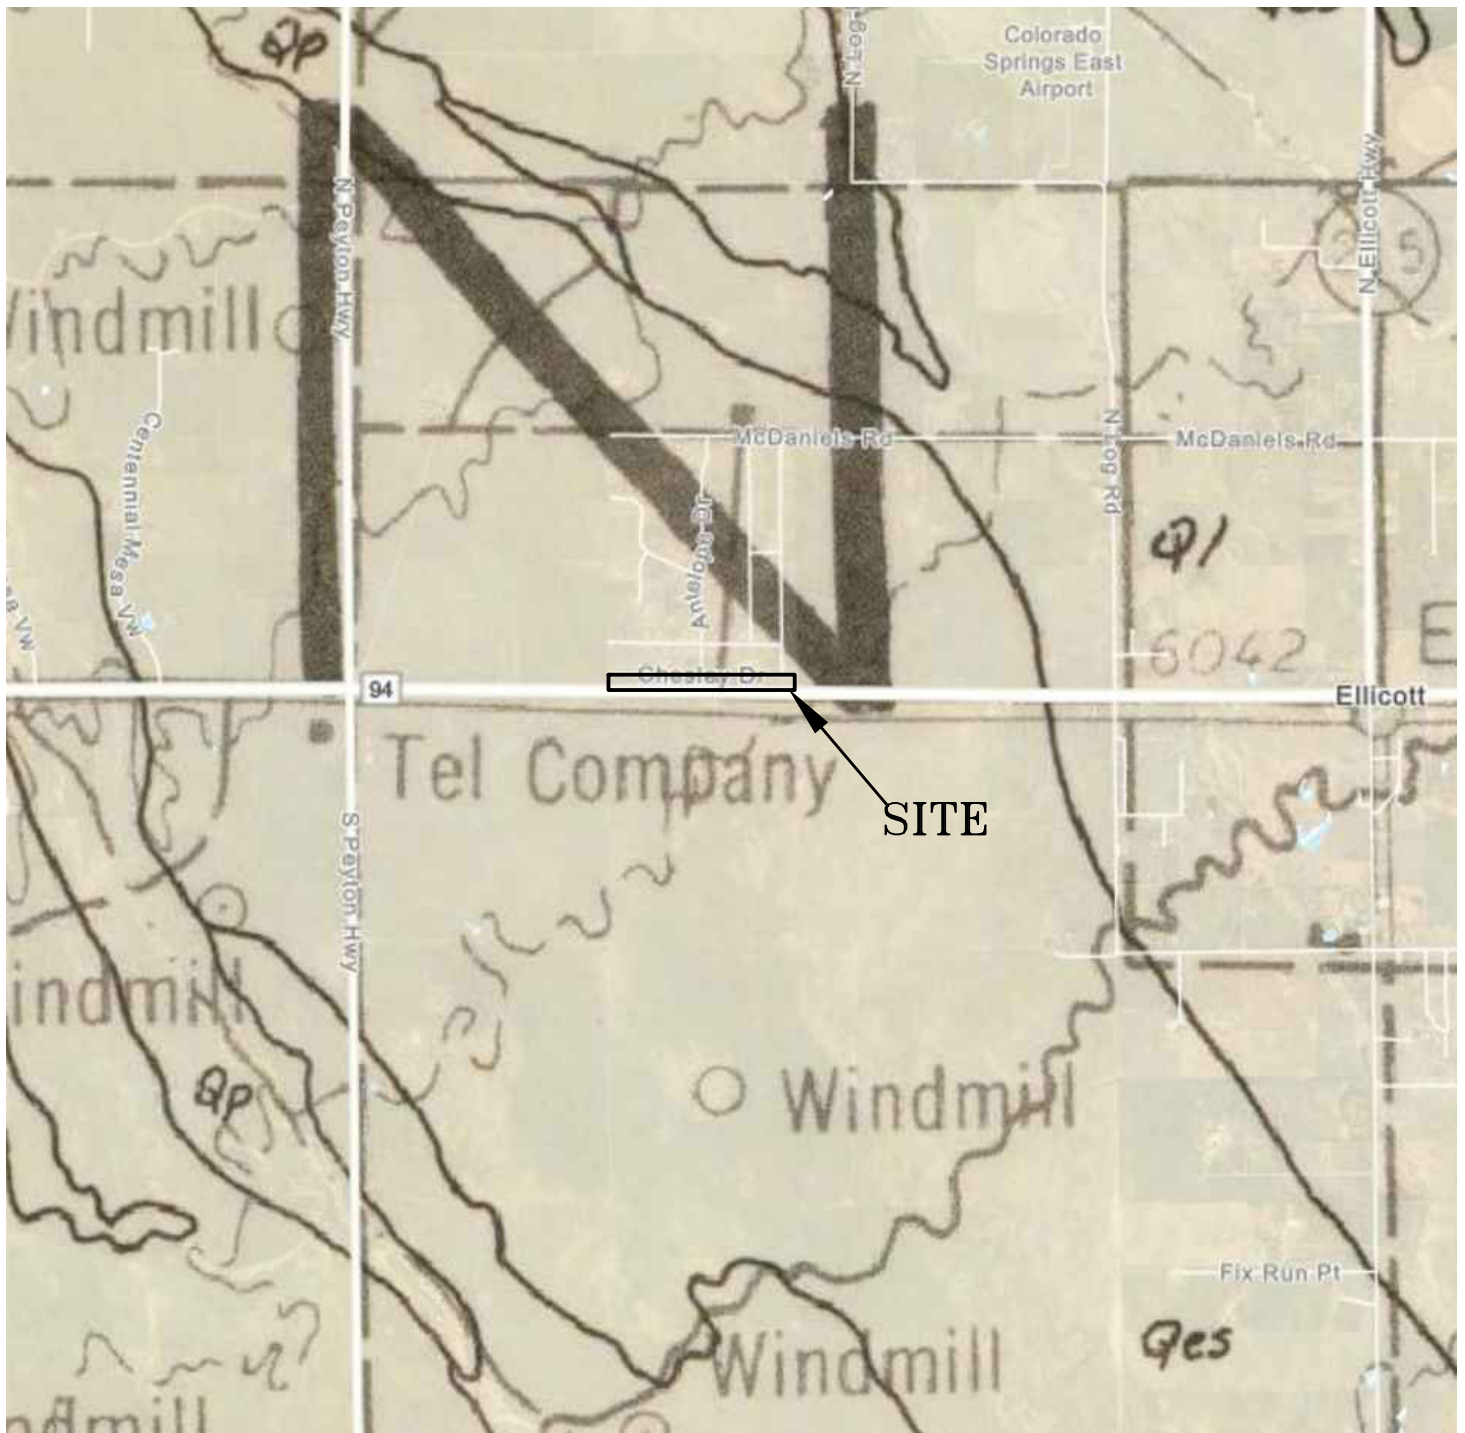
FIG NO.:
5

GEOLOGIC MAP OF THE PUEBLO 1° X 2° QUADRANGLE
VIEWPOINT ESTATES FILING NO. 2
HWY 94 & ANTELOPE DRIVE
EL PASO COUNTY, CO.
FOR: MVE, INC.

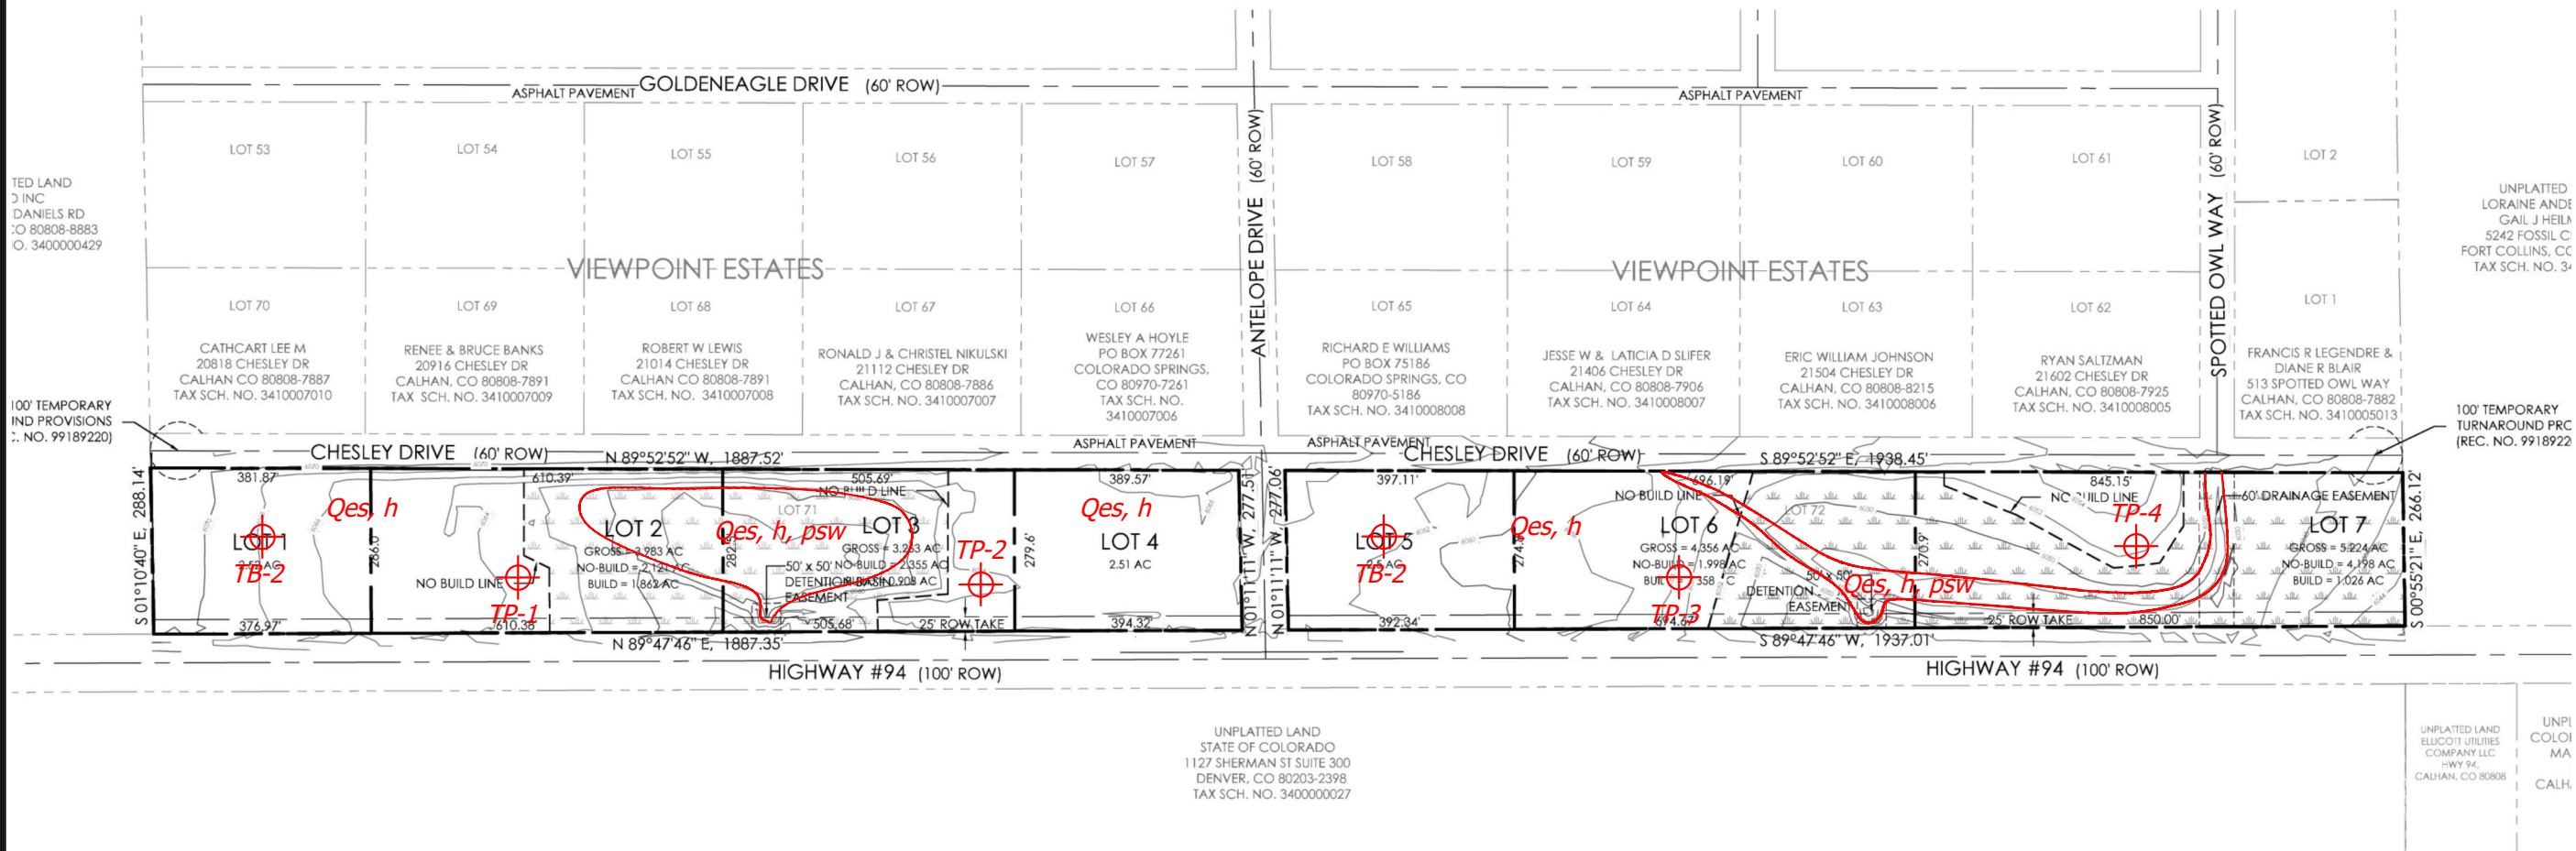
Legend:
Qes - Eolian Sands of Quaternary Age:
wind blown sediments
psw - potentially seasonally wet
h - hydrocompactive soil

ENGINEERING GEOLOGY/GEOLOGY MAP
VIEWPOINT ESTATES FILING NO. 2
HWY 94 & ANTELOPE DRIVE
EL PASO COUNTY, CO.
FOR: MVE, INC.

Drainage areas located in the portions of Lots 2 and 3 and Lots 6 and 7, and located within drainage easements/no-build areas. The drainages flow in a southerly direction, and water was not observed in the drainages at the time of this investigation. Portions of the drainage easement area have been mapped as potentially seasonal shallow groundwater areas. These areas are indicated in the Geology/Engineering Geology Map (Figure 6) and are discussed below. These areas are located within the no-build area and will be avoided. The proposed building areas are not affected by these areas.

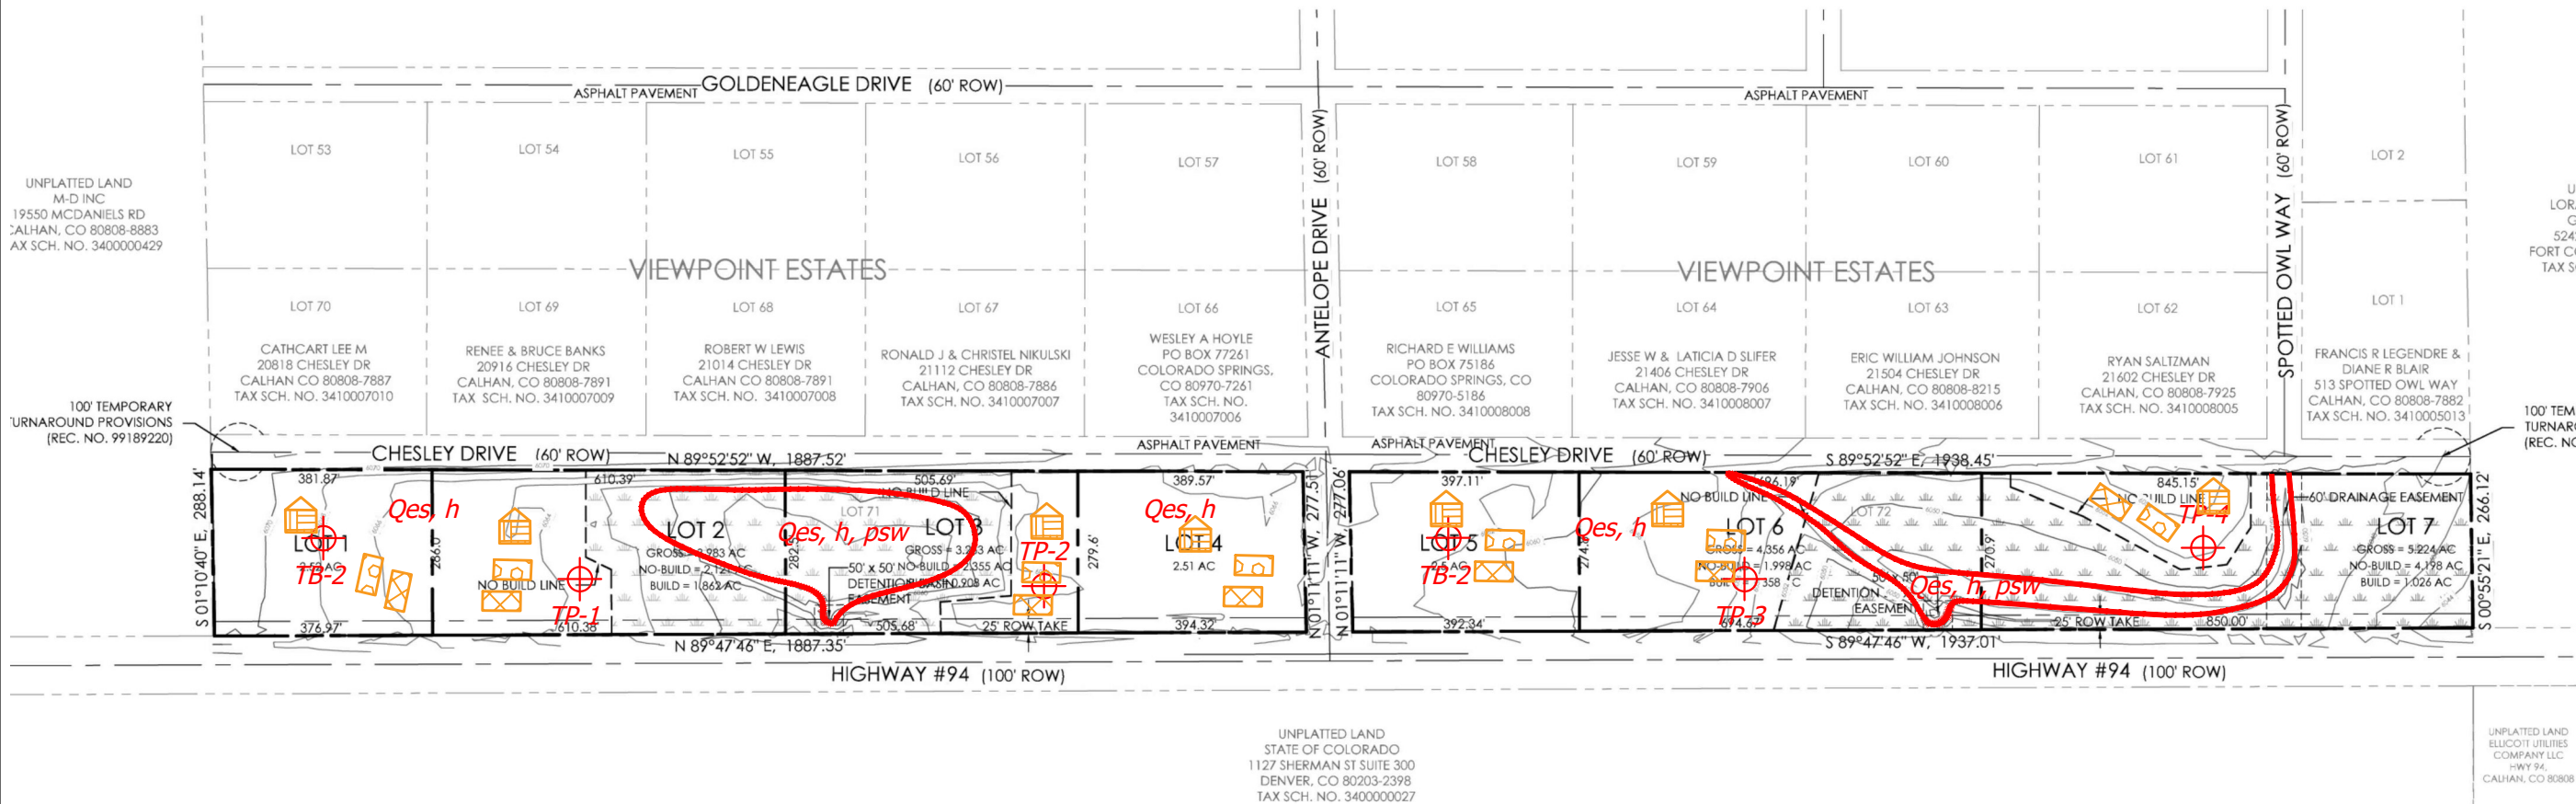
DRAWN L.L.L. CHECKED
DATE 9/27/21
SCALE AS SHOWN
JOB NO. 212316
FIGURE NO. 8

- OWTS ARE NOT RECOMMENDED IN AREAS OF
POTENTIALLY SEASONAL SHALLOW GROUNDWATER (PSW) OR
WITHIN THE NO-BUILD DRAINAGE EASEMENT

In summary, it is our opinion the site is suitable for individual on-site wastewater treatment systems (OWTS) and that contamination of surface and subsurface water resources should not occur provided the OWTS sites are evaluated and installed according to El Paso County and State Guidelines and properly maintained. Based on the testing performed designed systems would likely be required for the majority of the lots, some lots may be suitable for conventional systems provided shallow bedrock, restrictive clay soils, groundwater evidence or groundwater are not encountered in the soil treatment areas. The Septic Suitability Map is presented in Figure 8. Possible house locations with water wells, and two septic sites for the lots are indicated on Figure 8. Areas that should be avoided by septic systems are indicated on the septic suitability map.

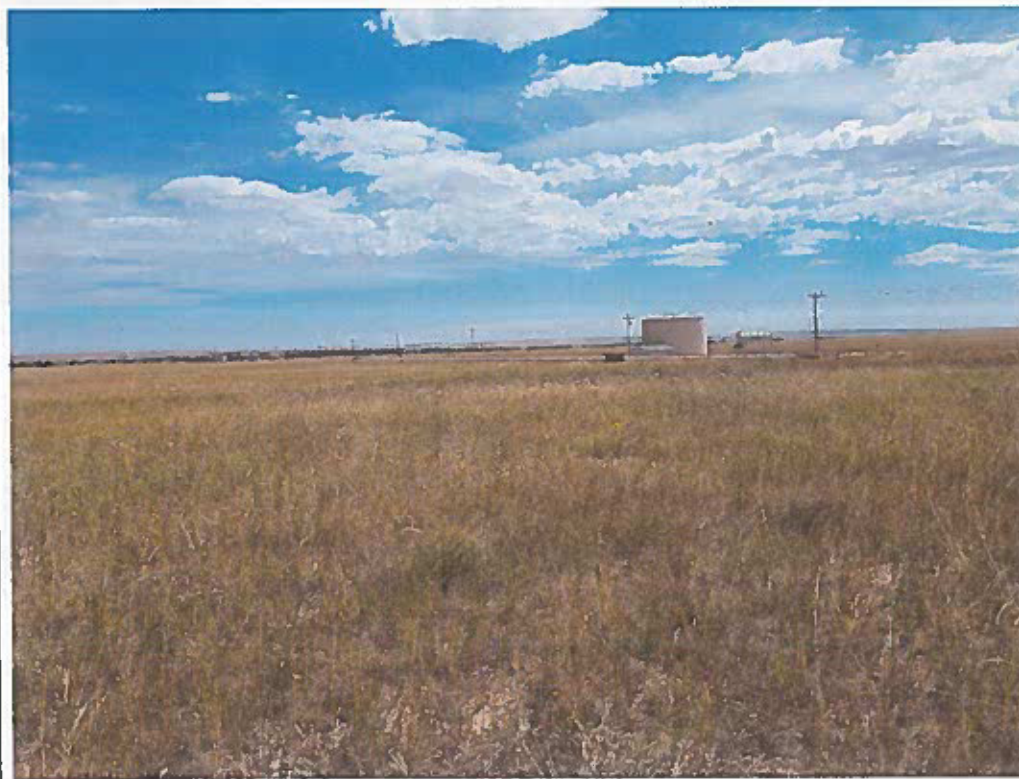
**Looking southeast
towards minor
drainage easement in
the eastern portion of
Lot 7.**

The topography of the site is gradually sloping to the south-southeast. Two minor drainage swales are located on portions of Lots 2 and 3, and Lots 6 and 7 within the designated drainage easement. The drainage swales flow in a southerly direction. Water was not observed in the drainages at the time of this investigation. The site boundaries are indicated on the USGS Map, Figure 2. Previous land uses have included agricultural grazing and undeveloped land. The site contains primarily field grasses, weeds, yucca and cacti. Site photographs, taken August 28, 2021, are included in Appendix A.

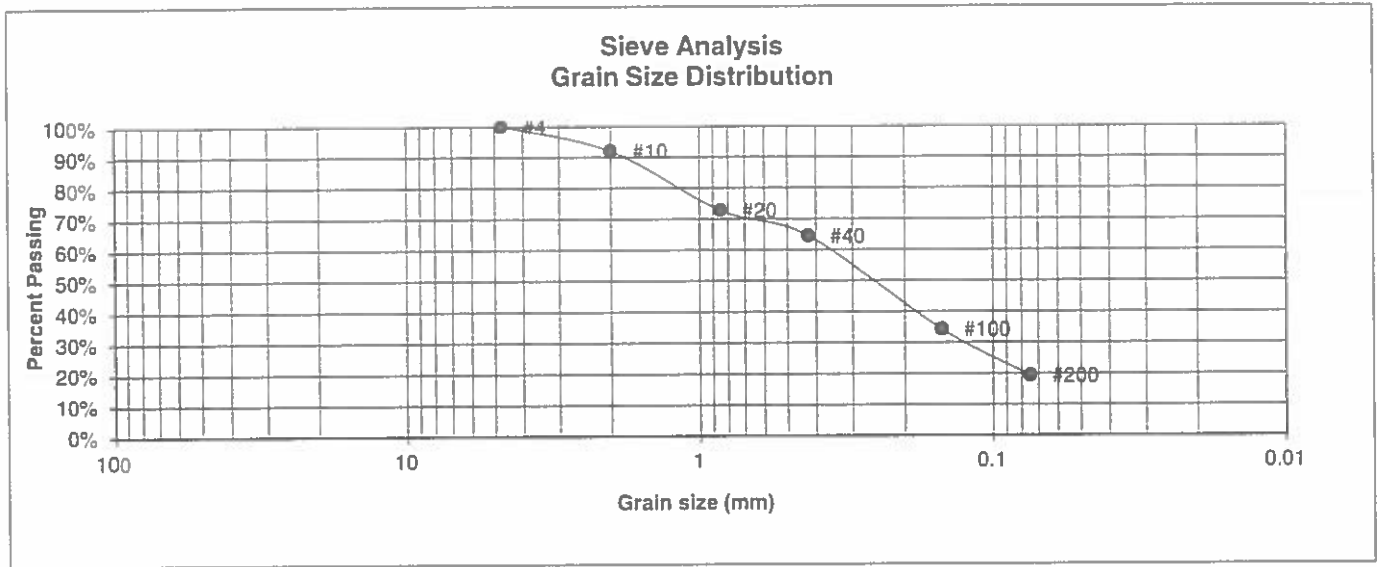
FIG NO.
C-1

BORING NO.	TP-1, LOT 1	UNIFIED CLASSIFICATION	SM	TEST BY	BL
DEPTH(ft)	2.5	AASHTO CLASSIFICATION		JOB NO.	212316
CLIENT	MVE, INC				
PROJECT	HIGHWAY 94 & ANTELOPE DRIVE

U.S. Sieve #	Percent Finer
3"	
1 1/2"	
3/4"	
1/2"	
3/8"	
4	100.0%
10	92.0%
20	72.8%
40	64.5%
100	34.3%
200	19.4%

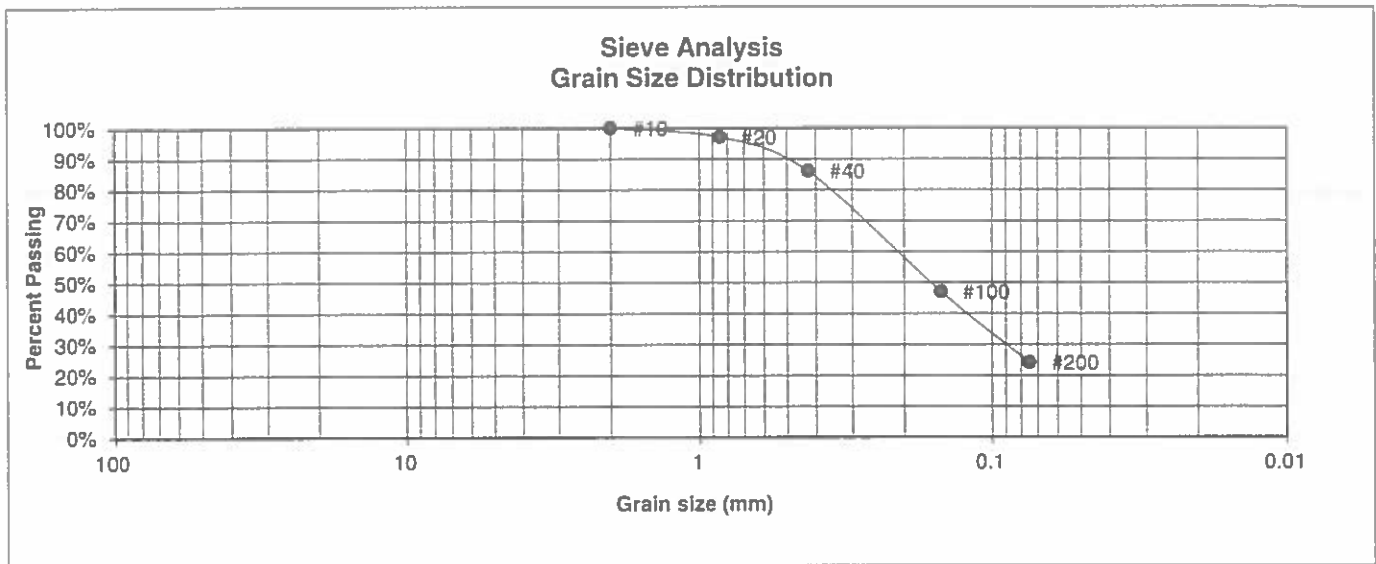
FIG NO.
C-2

BORING NO.	TP-2, LOT 2	UNIFIED CLASSIFICATION	SM	TEST BY	BL
DEPTH(ft)	5	AASHTO CLASSIFICATION		JOB NO.	212316
CLIENT	MVE, INC				
PROJECT	HIGHWAY 94 & ANTELOPE DRIVE

U.S. Sieve #	Percent Finer
3"	
1 1/2"	
3/4"	
1/2"	
3/8"	
4	
10	100.0%
20	97.1%
40	86.1%
100	47.1%
200	24.2%

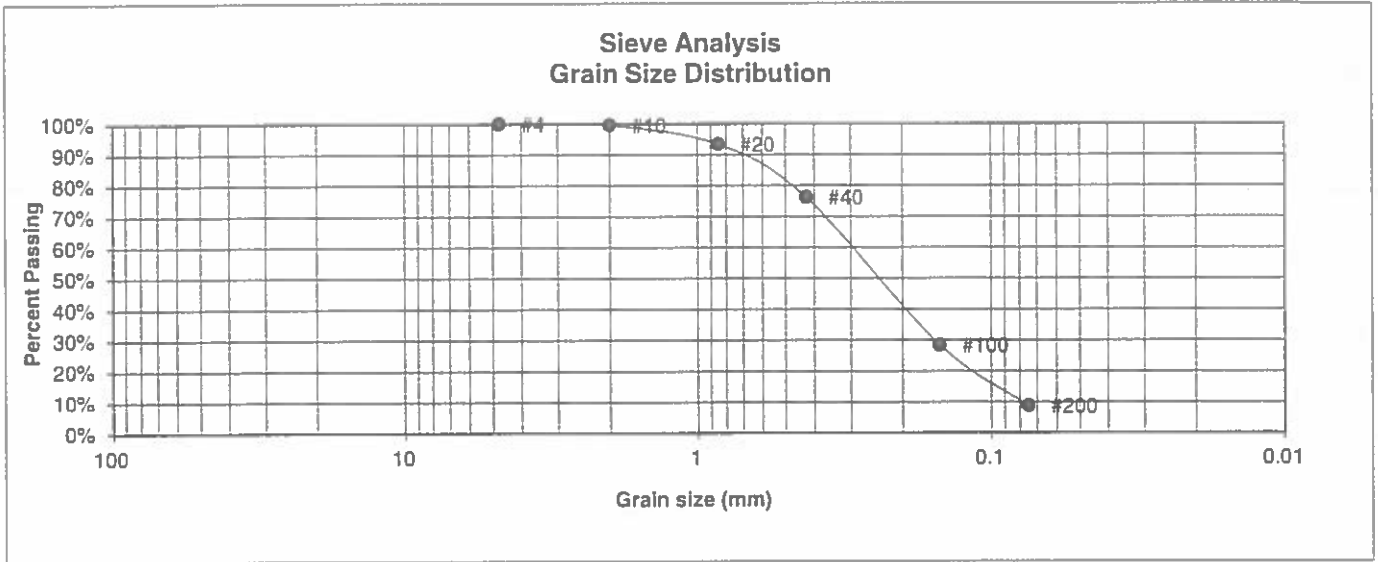
FIG NO.
C-3

BORING NO.	TP-3, LOT 1	UNIFIED CLASSIFICATION	SM-SW	TEST BY	BL
DEPTH(ft)	3	AASHTO CLASSIFICATION		JOB NO.	212316
CLIENT	MVE, INC				
PROJECT	HIGHWAY 94 & ANTELOPE DRIVE

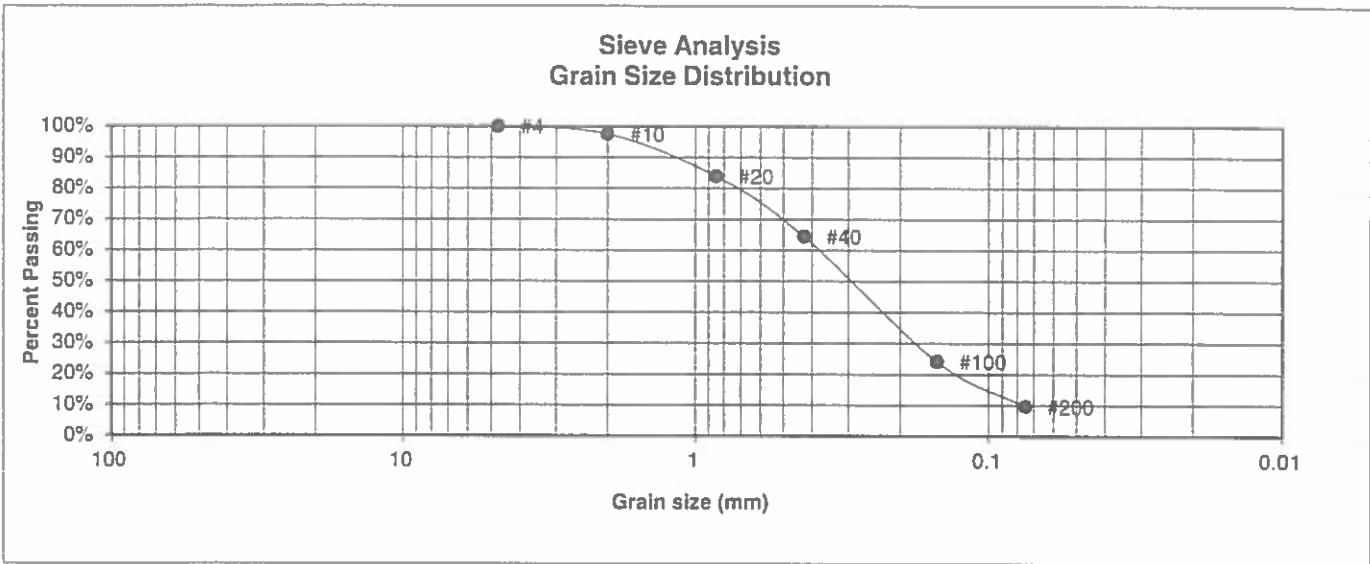
BORING NO.	TP-4, LOT 2	UNIFIED CLASSIFICATION	SM-SW	TEST BY	BL
DEPTH(ft)	4	AASHTO CLASSIFICATION		JOB NO.	212316
CLIENT	MVE, INC				
PROJECT	HIGHWAY 94 & ANTELOPE DRIVE
