GEOLOGIC HAZARD EVALUATION AND PRELIMINARY GEOTECHNICAL INVESTIGATION

PETERSON ROAD SUBDIVISION
PETERSON ROAD AND HIGHWAY 24
COLORADO SPRINGS, COLORADO

Project No. CS19836-115

August 6, 2024

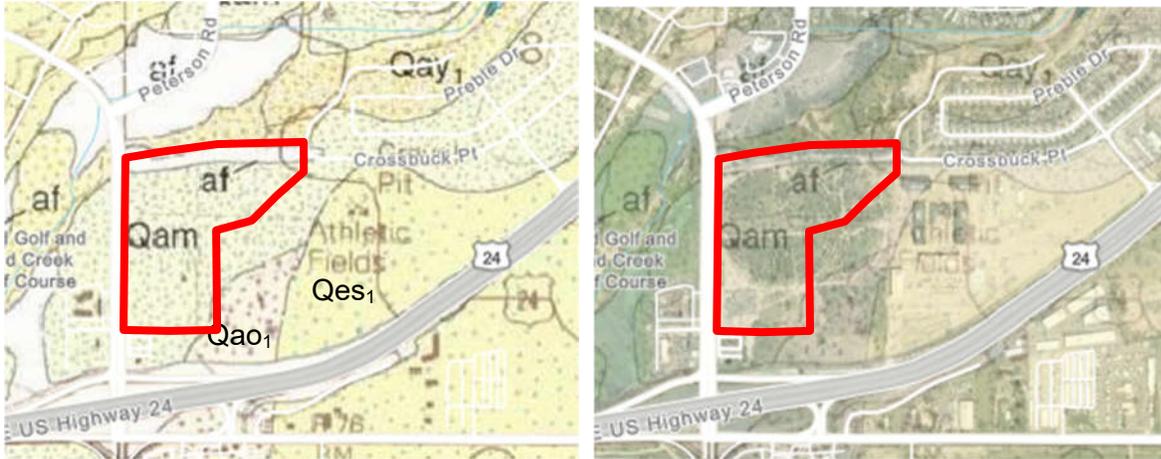
Excerpt from the Elsmere Quadrangle with the approximate project area shown in red

The surficial geology at the site was evaluated by reviewing published geologic maps and our site reconnaissance and subsurface exploration. The Colorado Springs Quadrangle map published by the Colorado Geological Survey (CGS), by Richard F. Madole, and Jon P. Thorson, 2002¹ was reviewed for the project site. Our borings generally confirm the CGS mapping. The various deposits mapped at the site are described in more detail based on the Geologic Map descriptions in the following sections. Mapping shown was obtained from the USGS National Geologic Map Database.

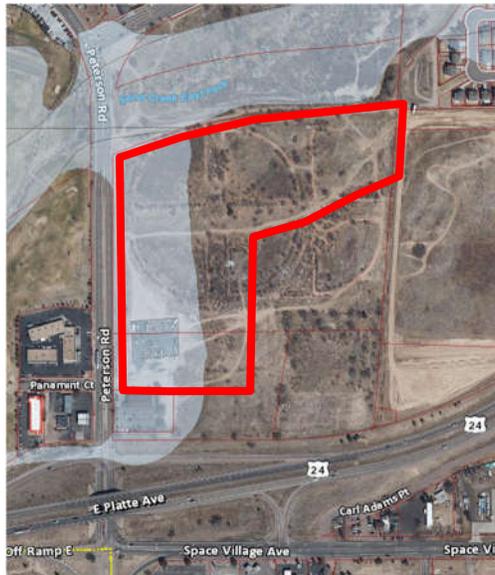
Clip from online City of Colorado SpringsView mapping, 100-year floodplain in grey, approximate project area outlined in red

Geologic Hazard mapping for El Paso County is limited in availability. While the site is outside of the City of Colorado Springs boundary, it is close to the boundary and some of the City of Colorado Springs GIS mapping data, available on the SpringsView website, covers the project site. The western side of the project area is shown within the 100-year floodplain as shown on zoning layers on the SpringsView webpage. The mapping of the 100-year floodplain is roughly equivalent to the Zone AE mapping in the FEMA panels.
