CROSSROADS CHAPEL BUILDING ADDITION

DRAINAGE REPORT

Strategic Land Solutions, Inc. JN: 20-0033-01

Report Date/History: March 29, 2021

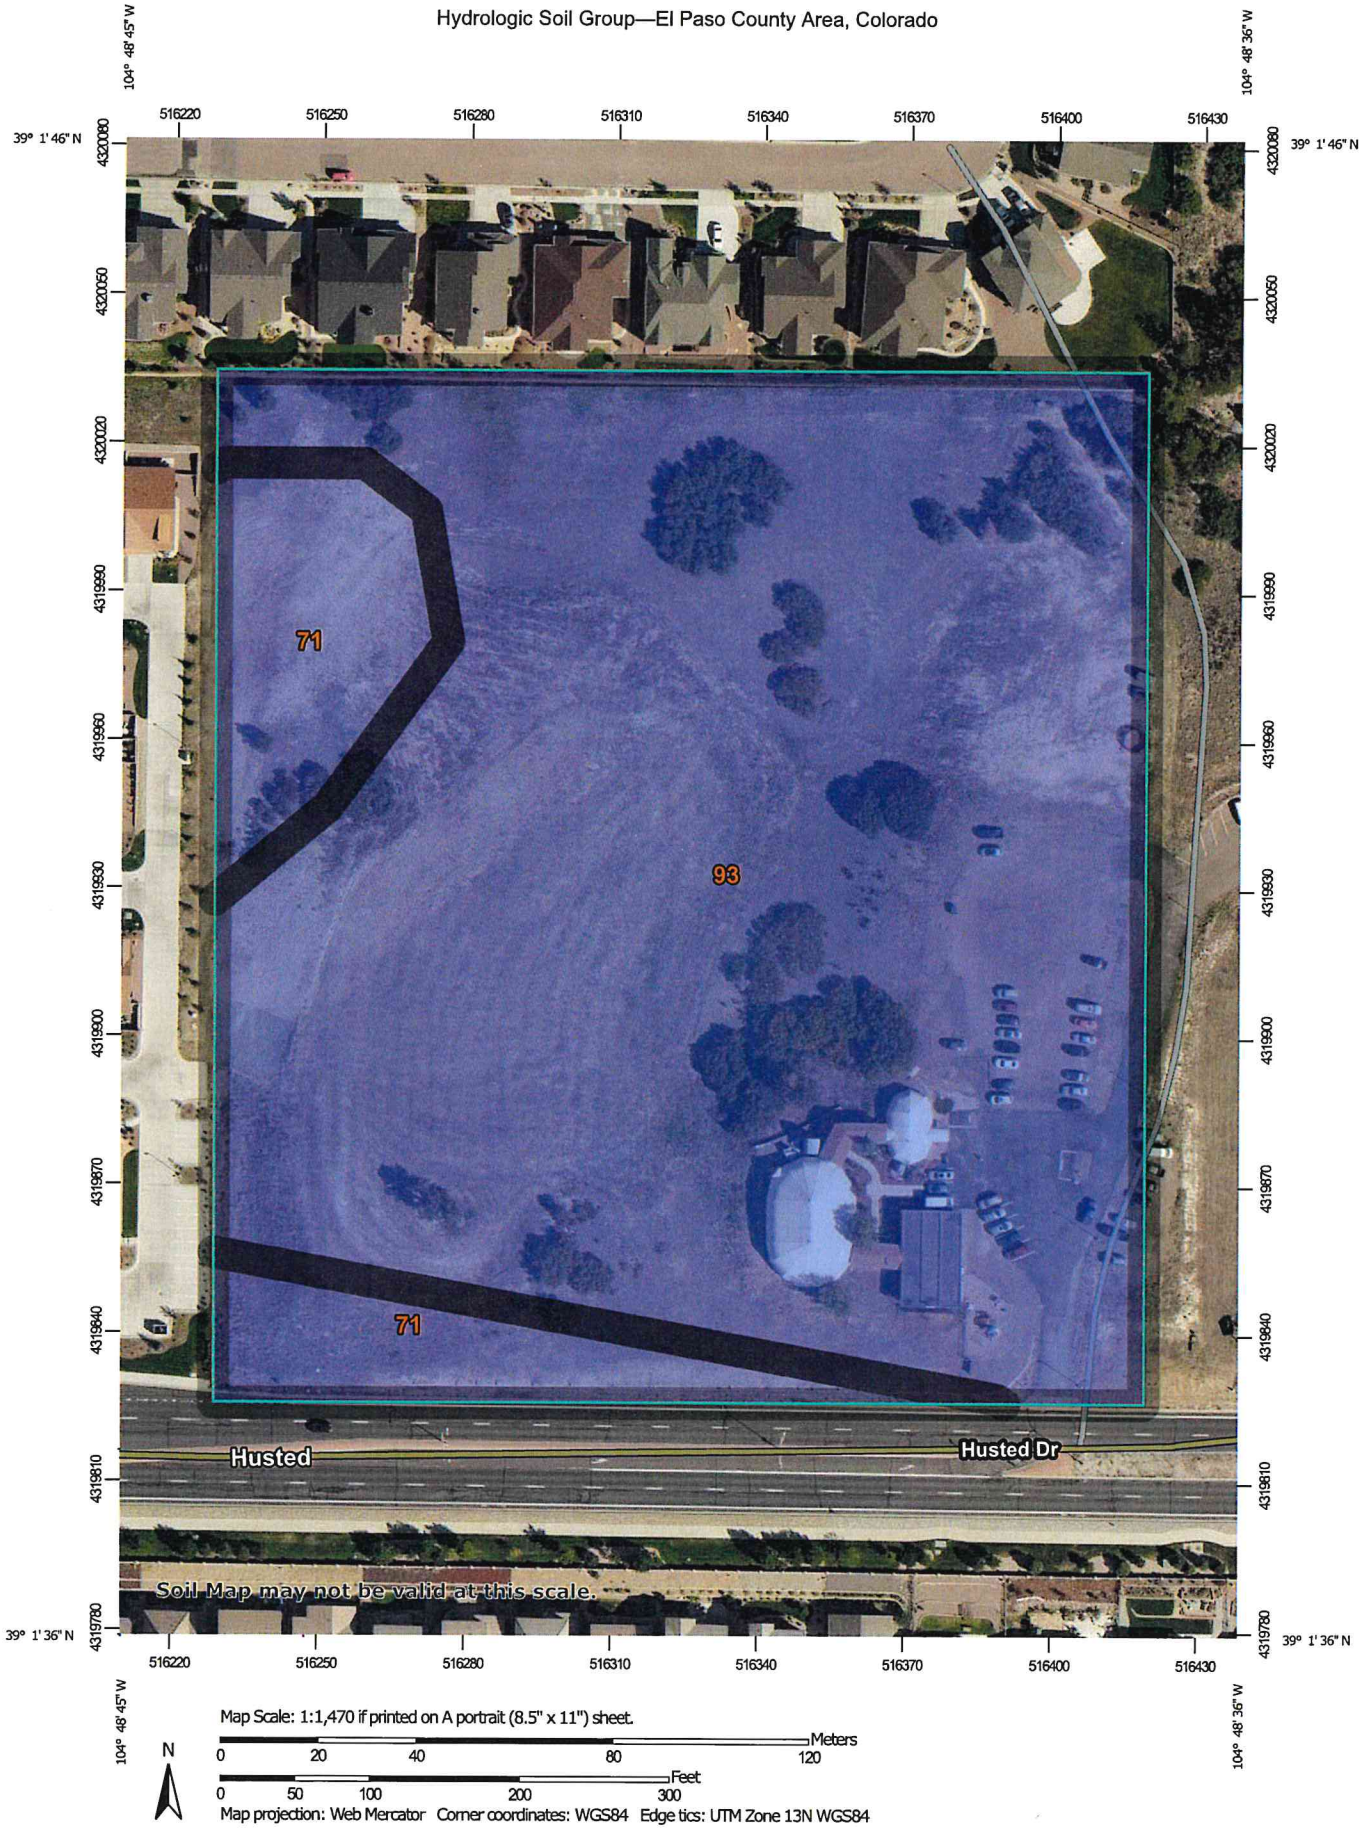
Hydrologic Soil Group—El Paso County Area, Colorado

Enlargement of maps beyond the scale of mapping can cause misunderstanding of the detail of mapping and accuracy of soil line placement. The maps do not show the small areas of contrasting soils that could have been shown at a more detailed scale.

Hydrologic soil groups are based on estimates of runoff potential. Soils are assigned to one of four groups according to the rate of water infiltration when the soils are not protected by vegetation, are thoroughly wet, and receive precipitation from long-duration storms.

Group A. Soils having a high infiltration rate (low runoff potential) when thoroughly wet. These consist mainly of deep, well drained to excessively drained sands or gravelly sands. These soils have a high rate of water transmission.

Group B. Soils having a moderate infiltration rate when thoroughly wet. These consist chiefly of moderately deep or deep, moderately well drained or well drained soils that have moderately fine texture to moderately coarse texture. These soils have a moderate rate of water transmission.

Group C. Soils having a slow infiltration rate when thoroughly wet. These consist chiefly of soils having a layer that impedes the downward movement of water or soils of moderately fine texture or fine texture. These soils have a slow rate of water transmission.

If a soil is assigned to a dual hydrologic group (A/D, B/D, or C/D), the first letter is for drained areas and the second is for undrained areas. Only the soils that in their natural condition are in group D are assigned to dual classes.
