ENTECH ENGINEERING INC.

SOIL, GEOLOGY, GEOLOGIC HAZARD, AND WASTEWATER STUDY, SADDLEHORN RANCH SUBDIVISION EL PASO COUNTY, COLORADO

April 29, 2019

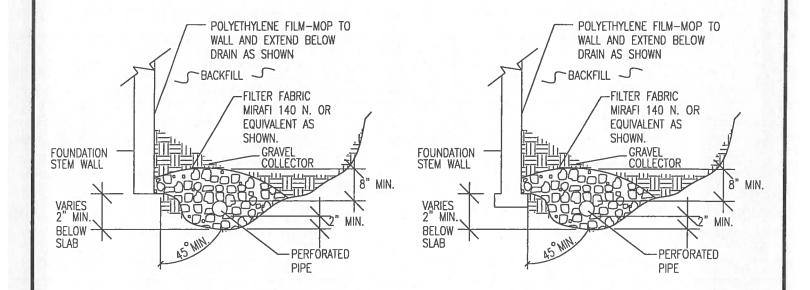
- -GRAVEL SIZE IS RELATED TO DIAMETER OF PIPE PERFORATIONS-85% GRAVEL GREATER THAN 2x PERFORATION DIAMETER.
- -PIPE DIAMETER DEPENDS UPON EXPECTED SEEPAGE. 4-INCH DIAMETER IS MOST OFTEN USED.
- -ALL PIPE SHALL BE PERFORATED PLASTIC. THE DISCHARGE PORTION OF THE PIPE SHOULD BE NON-PERFORATED PIPE.
- -FLEXIBLE PIPE MAY BE USED UP TO 8 FEET IN DEPTH, IF SUCH PIPE IS DESIGNED TO WITHSTAND THE PRESSURES. RIGID PLASTIC PIPE WOULD OTHERWISE BE REQUIRED.
- -MINIMUM GRADE FOR DRAIN PIPE TO BE 1% OR 3 INCHES OF FALL IN 25 FEET.
- -DRAIN TO BE PROVIDED WITH A FREE GRAVITY OUTFALL, IF POSSIBLE. A SUMP AND PUMP MAY BE USED IF GRAVITY OUT FALL IS NOT AVAILABLE.

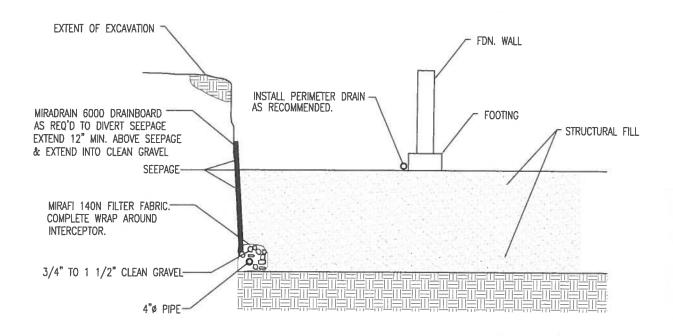
INTERCEPTOR DRAIN DETAIL N.T.S.

NOTE: EXTEND INTERCEPTOR DRAIN TO DAYLIGHT

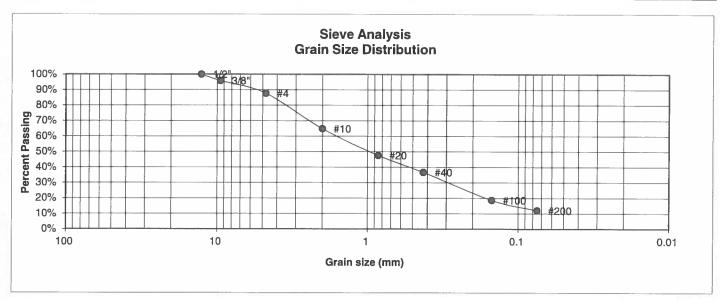
UNIFIED CLASSIFICATION	SM	CLIENT	WILLIAM GUMAN
SOIL TYPE #	1	PROJECT	CURTIS AND JUDGE ORR
TEST BORING #	1	JOB NO.	181823
DEPTH (FT)	2-3	TEST BY	BL

U.S. <u>Sieve #</u> 3" 1 1/2" 3/4" 1/2" 3/8"	Percent <u>Finer</u> 100.0% 95.8%	Atterberg <u>Limits</u> Plastic Limit NP Liquid Limit NV Plastic Index NP
4	87.7%	<u>Swell</u>
10	64.8%	Moisture at start
20	47.7%	Moisture at finish
40	36.7%	Moisture increase
100	18.7%	Initial dry density (pcf)
200	12.0%	Swell (psf)
200	12.070	Owen (psi)

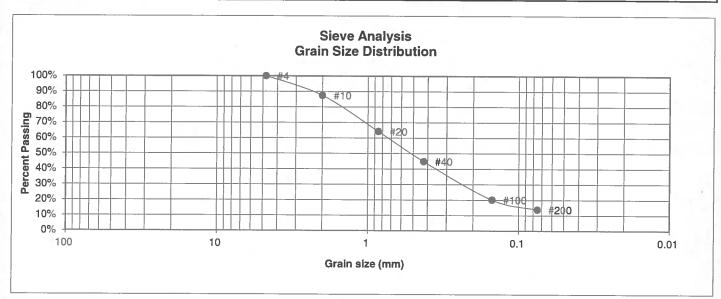
UNIFIED CLASSIFICATION	SM	CLIENT	WILLIAM GUMAN
SOIL TYPE #	1	PROJECT	CURTIS AND JUDGE ORR
TEST BORING #	2	JOB NO.	181823
DEPTH (FT)	5	TEST BY	BL

U.S. Sieve #	Percent <u>Finer</u>	Atterberg <u>Limits</u>
3"		Plastic Limit
1 1/2"		Liquid Limit
3/4"		Plastic Index
1/2"		
3/8"		
4	100.0%	Swell
10	87.5%	Moisture at start
20	64.2%	Moisture at finish
40	44.8%	Moisture increase
100	20.1%	Initial dry density (pcf)
200	13.8%	Swell (psf)

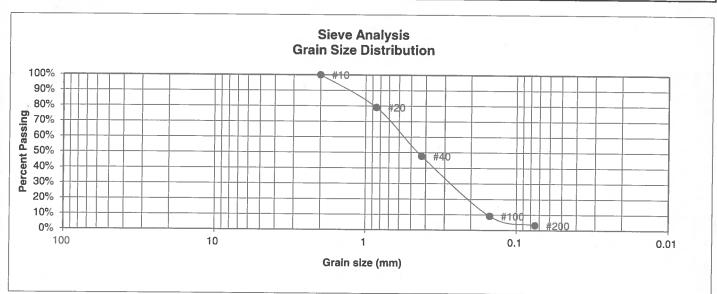
UNIFIED CLASSIFICATION	SW	CLIENT	WILLIAM GUMAN
SOIL TYPE #	1	PROJECT	CURTIS AND JUDGE ORR
TEST BORING #	4	JOB NO.	181823
DEPTH (FT)	2-3	TEST BY	BL

U.S. Sieve # 3" 1 1/2" 3/4" 1/2"	Percent <u>Finer</u>	Atterberg <u>Limits</u> Plastic Limit Liquid Limit Plastic Index
3/8"		
4		<u>Swell</u>
10	100.0%	Moisture at start
20	79.1%	Moisture at finish
40	47.7%	Moisture increase
100 200	9.1% 3.2%	Initial dry density (pcf) Swell (psf)

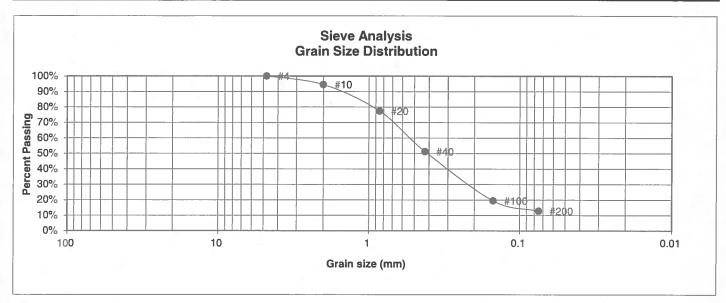
UNIFIED CLASSIFICATION	SM	CLIENT	WILLIAM GUMAN
SOIL TYPE #	3	PROJECT	CURTIS AND JUDGE ORR
TEST BORING #	3	JOB NO.	181823
DEPTH (FT)	10	TEST BY	BL

U.S. <u>Sieve #</u> 3" 1 1/2" 3/4" 1/2"	Percent <u>Finer</u>	Atterberg <u>Limits</u> Plastic Limit Liquid Limit Plastic Index	NP NV NP
3/8"		_ = -	
4	100.0%	<u>Swell</u>	
10	94.5%	Moisture at start	
20	77.4%	Moisture at finish	ı
40	51.2%	Moisture increas	е
100	19.5%	Initial dry density	(pcf)
200	12.9%	Swell (psf)	. ,
		ν,

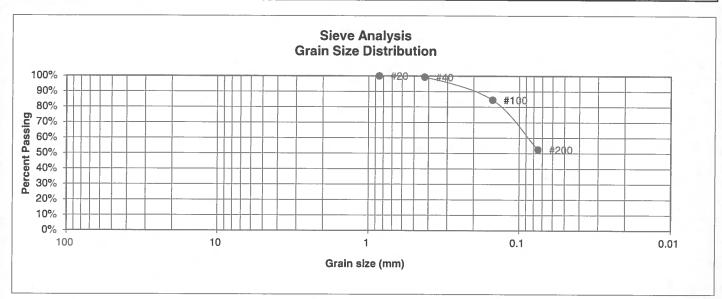
UNIFIED CLASSIFICATION	ML	CLIENT	WILLIAM GUMAN
SOIL TYPE #	3	PROJECT	CURTIS AND JUDGE ORR
TEST BORING #	4	JOB NO.	181823
DEPTH (FT)	20	TEST BY	BL

U.S. <u>Sieve #</u> 3" 1 1/2" 3/4" 1/2" 3/8"	Percent <u>Finer</u>		Atterberg <u>Limits</u> Plastic Limit NP Liquid Limit NV Plastic Index NP
4 10			<u>Swell</u> Moisture at start
20 40	100.0% 99.2%		Moisture at finish Moisture increase
100 200	84.5% 52.5%		Initial dry density (pcf) Swell (psf)

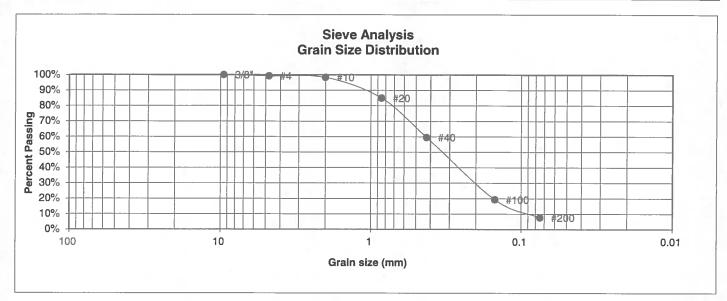
UNIFIED CLASSIFICATION	SM-SW	CLIENT	GUMAN AND ASSOCIATES
SOIL TYPE #	1	PROJECT	CURTIS RD AND JUGRE ORR RD
TEST PIT #	2	JOB NO.	181823
DEPTH (FT)	2-3	TEST BY	BL

Percent <u>Finer</u>	Atterberg <u>Limits</u> Plastic Limit Liquid Limit Plastic Index
100.0%	
99.3%	Swell
98.3%	Moisture at start
85.0%	Moisture at finish
59.6%	Moisture increase
19.3% 7.6%	Initial dry density (pcf) Swell (psf)
	Finer 100.0% 99.3% 98.3% 85.0% 59.6% 19.3%

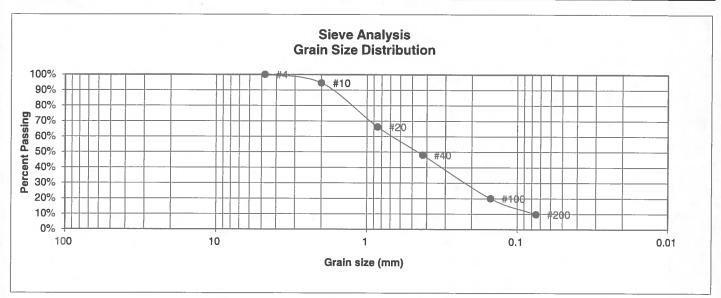
UNIFIED CLASSIFICATION	SM-SW	CLIENT	GUMAN AND ASSOCIATES
SOIL TYPE #	1	PROJECT	CURTIS RD AND JUGRE ORR RD
TEST PIT #	3	JOB NO.	181823
DEPTH (FT)	5-6	TEST BY	BL

U.S. <u>Sieve #</u> 3" 1 1/2" 3/4" 1/2"	Percent <u>Finer</u>	Atterberg <u>Limits</u> Plastic Limit Liquid Limit Plastic Index
3/8"	100.0~	
4	100.0%	<u>Swell</u>
10	94.6%	Moisture at start
20	66.2%	Moisture at finish
40	48.0%	Moisture increase
100 200	20.0% 9.8%	Initial dry density (pcf) Swell (psf)

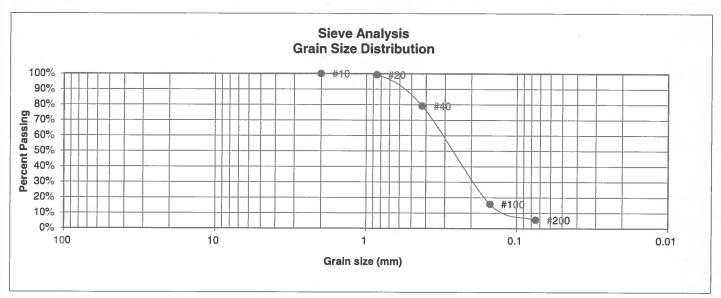
UNIFIED CLASSIFICATION	SM-SW	CLIENT	GUMAN AND ASSOCIATES
SOIL TYPE #	1	PROJECT	CURTIS RD AND JUGRE ORR RD
TEST PIT #	6	JOB NO.	181823
DEPTH (FT)	4-6	TEST BY	BL

U.S. <u>Sieve #</u> 3" 1 1/2" 3/4" 1/2" 3/8"	Percent <u>Finer</u>	Atterberg <u>Limits</u> Plastic Limit Liquid Limit Plastic Index
4		Swell
10	100.0%	Moisture at start
20	99.3%	Moisture at finish
40	79.1%	Moisture increase
100 200	15.7% 5.5%	Initial dry density (pcf) Swell (psf)

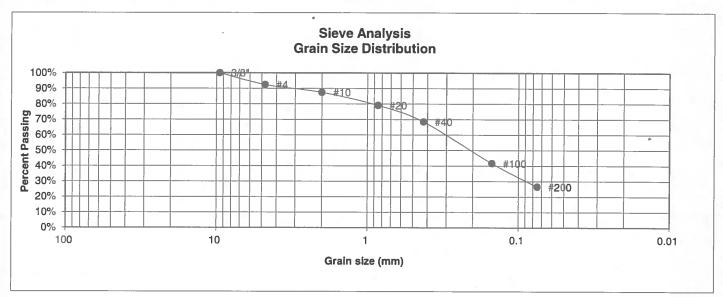
UNIFIED CLASSIFICATION	SC	CLIENT	GUMAN AND ASSOCIATES
SOIL TYPE #	1	PROJECT	CURTIS RD AND JUGRE ORR RD
TEST PIT #	9	JOB NO.	181823
DEPTH (FT)	2-3	TEST BY	BL

U.S. <u>Sieve #</u> 3" 1 1/2" 3/4" 1/2"	Percent <u>Finer</u>	Atterberg <u>Limits</u> Plastic Limit Liquid Limit Plastic Index
3/8"	100.0%	
4	92.4%	<u>Swell</u>
10	87.4%	Moisture at start
20	79.0%	Moisture at finish
40	68.4%	Moisture increase
100	41.7%	Initial dry density (pcf)
200	26.5%	Swell (psf)

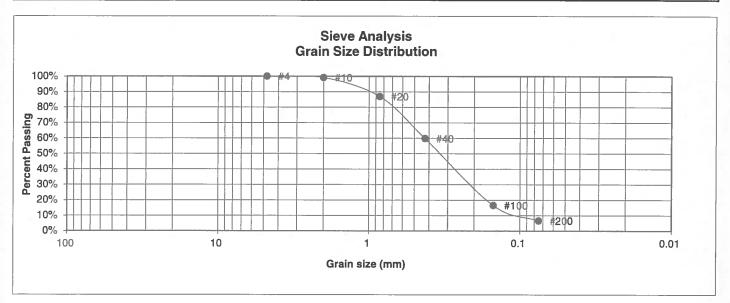
UNIFIED CLASSIFICATION	SM-SW	CLIENT	GUMAN AND ASSOCIATES
SOIL TYPE #	1	PROJECT	CURTIS RD AND JUGRE ORR RD
TEST PIT #	12	JOB NO.	181823
DEPTH (FT)	2-3	TEST BY	BL

U.S. <u>Sieve #</u> 3" 1 1/2" 3/4" 1/2" 3/8"	Percent <u>Finer</u>	Atterberg <u>Limits</u> Plastic Limit Liquid Limit Plastic Index
4	100.0%	<u>Swell</u>
10	99.2%	Moisture at start
20	86.9%	Moisture at finish
40	59.8%	Moisture increase
100	16.5%	Initial dry density (pcf)
200	6.6%	Swell (psf)

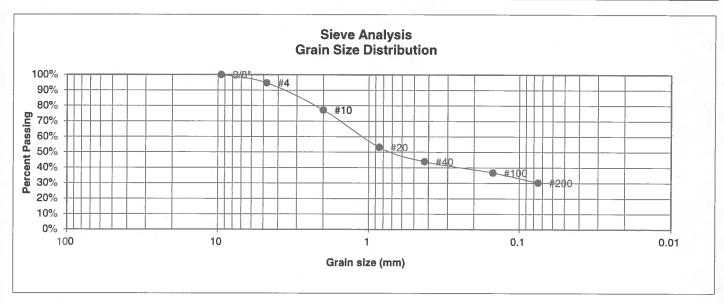
UNIFIED CLASSIFICATION	SC	CLIENT	GUMAN AND ASSOCIATES
SOIL TYPE #	1	PROJECT	CURTIS RD AND JUGRE ORR RD
TEST PIT #	13	JOB NO.	181823
DEPTH (FT)	5-6	TEST BY	BL

U.S. <u>Sieve #</u> 3" 1 1/2" 3/4" 1/2"	Percent <u>Finer</u>	Atterberg <u>Limits</u> Plastic Limit Liquid Limit Plastic Index	14 25 11
3/8" 4 10	100.0% 94.7% 77.2%	Swell Moisture at start	
20 40 100 200	53.2% 43.9% 36.7% 30.3%	Moisture at finish Moisture increase Initial dry density (pcf) Swell (psf)

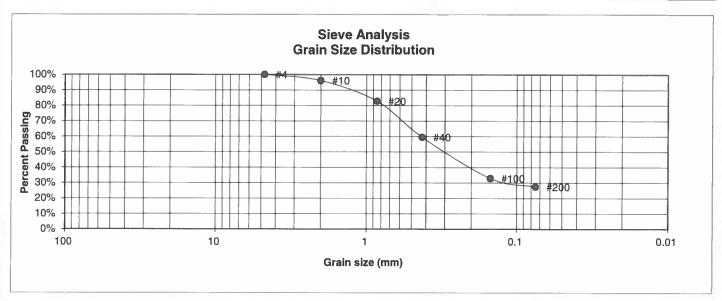
UNIFIED CLASSIFICATION	SC	CLIENT	GUMAN AND ASSOCIATES
SOIL TYPE #	1	PROJECT	CURTIS RD AND JUGRE ORR RD
TEST PIT #	15	JOB NO.	181823
DEPTH (FT)	2-3	TEST BY	BL

U.S. <u>Sieve #</u> 3" 1 1/2" 3/4" 1/2" 3/8"	Percent <u>Finer</u>	Atterberg <u>Limits</u> Plastic Limit Liquid Limit Plastic Index	
4 10	100.0% 96.2%	<u>Swell</u> Moisture at start	9.2%
20	82.8%	Moisture at finish	15.5%
40	59.6%	Moisture increase	6.3%
100	32.9%	Initial dry density (pcf)	112
200	27.5%	Swell (psf)	820

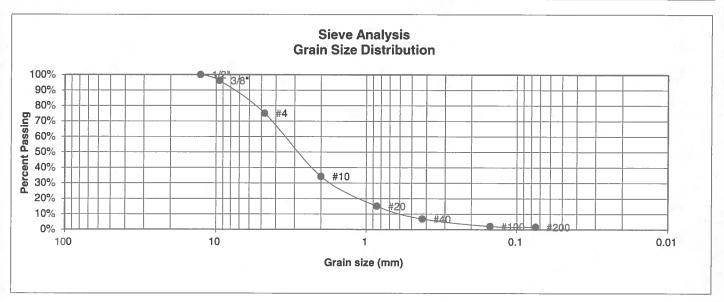
UNIFIED CLASSIFICATION	SW	CLIENT	GUMAN AND ASSOCIATES
SOIL TYPE #	1	PROJECT	CURTIS RD AND JUGRE ORR RD
TEST PIT #	18	JOB NO.	181823
DEPTH (FT)	5-6	TEST BY	BL

U.S. <u>Sieve #</u> 3"	Percent <u>Finer</u>	Atterberg <u>Limits</u> Plastic Limit
1 1/2"		Liquid Limit
3/4"		Plastic Index
1/2"	100.0%	
3/8"	96.2%	
4	75.1%	<u>Swell</u>
10	34.2%	Moisture at start
20	15.1%	Moisture at finish
40	6.8%	Moisture increase
100	2.1%	Initial dry density (pcf)
200	1.6%	Swell (psf)

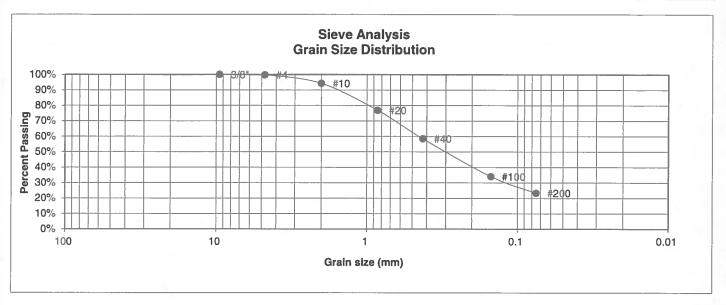
UNIFIED CLASSIFICATION	SC	CLIENT	GUMAN AND ASSOCIATES
SOIL TYPE #	1	PROJECT	CURTIS RD AND JUGRE ORR RD
TEST PIT #	21	JOB NO.	181823
DEPTH (FT)	5-6	TEST BY	BL

U.S. Sieve #	Percent <u>Finer</u>	Atterberg <u>Limits</u>
3" 1 1/2"		Plastic Limit
3/4"		Liquid Limit Plastic Index
1/2"		
3/8"	100.0%	
4	99.8%	<u>Swell</u>
10	94.3%	Moisture at start
20	76.9%	Moisture at finish
40	58.5%	Moisture increase
100	34.1%	Initial dry density (pcf)
200	23.4%	Swell (psf)

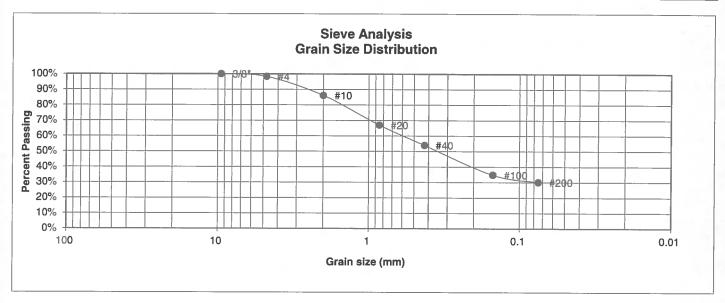
UNIFIED CLASSIFICATION	SM	CLIENT	GUMAN AND ASSOCIATES
SOIL TYPE #	1	PROJECT	CURTIS RD AND JUGRE ORR RD
TEST PIT #	37	JOB NO.	181823
DEPTH (FT)	6-7	TEST BY	BL

U.S.	Percent	Atterberg	
Sieve #	<u>Finer</u>	<u>Limits</u>	
3"		Plastic Limit 16	
1 1/2"		Liquid Limit 19	
3/4"		Plastic Index 3	
1/2"			
3/8"	100.0%		
4	98.3%	<u>Swell</u>	
10	86.2%	Moisture at start	6.5%
20	67.0%	Moisture at finish	20.5%
40	53.9%	Moisture increase	14.0%
100	34.8%	Initial dry density (pcf)	100
200	30.1%	Swell (psf)	430

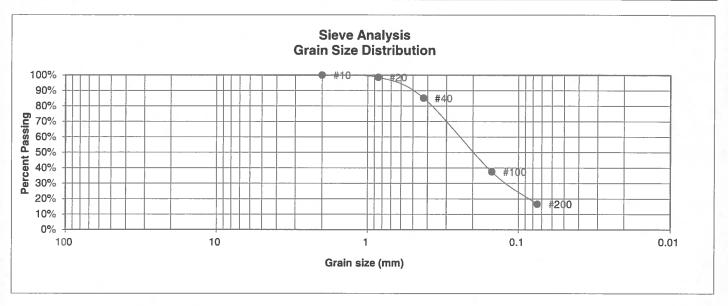
UNIFIED CLASSIFICATION	SM	CLIENT	GUMAN AND ASSOCIATES
SOIL TYPE #	1	PROJECT	CURTIS RD AND JUGRE ORR RD
TEST PIT #	31	JOB NO.	181823
DEPTH (FT)	2-3	TEST BY	BL

U.S. <u>Sieve #</u> 3" 1 1/2" 3/4" 1/2" 3/8"	Percent <u>Finer</u>	Atterberg <u>Limits</u> Plastic Limit Liquid Limit Plastic Index
4		<u>Swell</u>
10	100.0%	Moisture at start
20	98.6%	Moisture at finish
40	85.1%	Moisture increase
100 200	37.4% 16.6%	Initial dry density (pcf) Swell (psf)

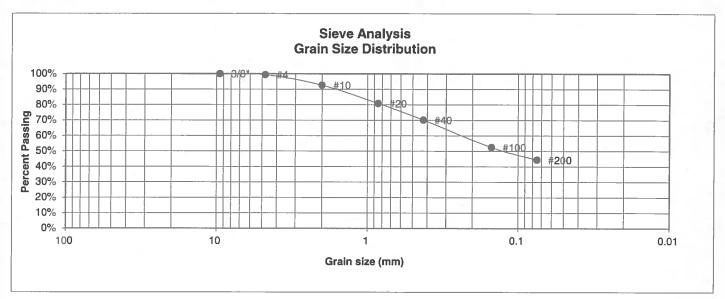
C-16

UNIFIED CLASSIFICATION	SC	CLIENT	GUMAN AND ASSOCIATES
SOIL TYPE #	1	PROJECT	CURTIS RD AND JUGRE ORR RD
TEST PIT #	32	JOB NO.	181823
DEPTH (FT)	4-5	TEST BY	BL

U.S. <u>Sieve #</u> 3"	Percent <u>Finer</u>	Atterberg <u>Limits</u> Plastic Limit
1 1/2"		Liquid Limit
3/4" 1/2"		Plastic Index
3/8"	100.0%	
4	99.4%	<u>Swell</u>
10	92.6%	Moisture at start
20	80.8%	Moisture at finish
40	70.2%	Moisture increase
100	52.5%	Initial dry density (pcf)
200	44.3%	Swell (psf)

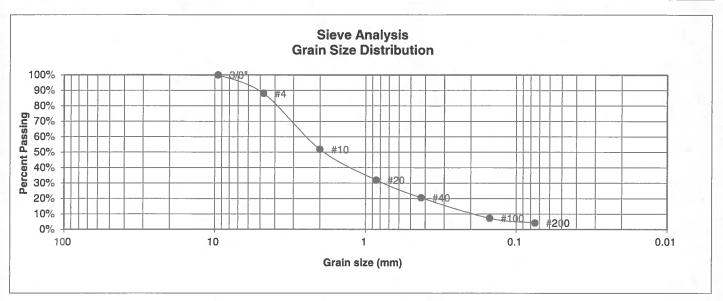
UNIFIED CLASSIFICATION	SW	CLIENT	GUMAN AND ASSOCIATES
SOIL TYPE #	1	PROJECT	CURTIS RD AND JUGRE ORR RD
TEST PIT #	33	JOB NO.	181823
DEPTH (FT)	2-3	TEST BY	BL

U.S. Sieve # 3" 1 1/2"	Percent <u>Finer</u>	Atterberg <u>Limits</u> Plastic Limit Liquid Limit
3/4"		Plastic Index
1/2"		
3/8"	100.0%	
4	88.0%	<u>Swell</u>
10	51.8%	Moisture at start
20	32.0%	Moisture at finish
40	20.5%	Moisture increase
100 200	7.2% 4.3%	Initial dry density (pcf) Swell (psf)

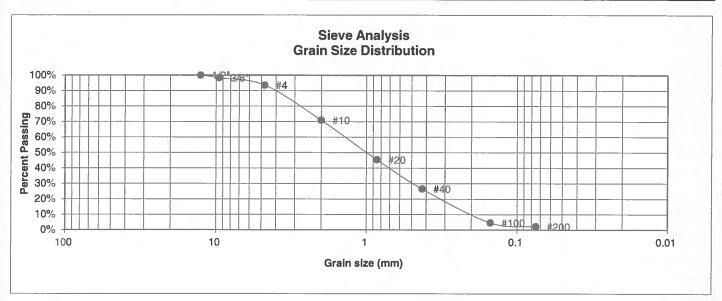
UNIFIED CLASSIFICATION	SW	CLIENT	GUMAN AND ASSOCIATES
SOIL TYPE #	1	PROJECT	CURTIS RD AND JUGRE ORR RD
TEST PIT #	35	JOB NO.	181823
DEPTH (FT)	5-6	TEST BY	BL

U.S.	Percent	Atterberg
Sieve #	<u>Finer</u>	<u>Limits</u>
3"		Plastic Limit
1 1/2"		Liquid Limit
3/4"		Plastic Index
1/2"	100.0%	
3/8"	98.3%	
4	93.6%	<u>Swell</u>
10	70.9%	Moisture at start
20	45.4%	Moisture at finish
40	26.5%	Moisture increase
100	4.7%	Initial dry density (pcf)
200	2.2%	Swell (psf)

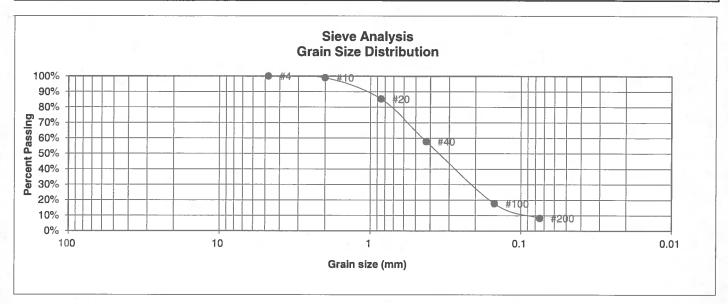
UNIFIED CLASSIFICATION	SM-SW	CLIENT	GUMAN AND ASSOCIATES
SOIL TYPE #	1	PROJECT	CURTIS RD AND JUGRE ORR RD
TEST PIT #	36	JOB NO.	181823
DEPTH (FT)	2-3	TEST BY	BL

U.S. <u>Sieve #</u> 3" 1 1/2" 3/4" 1/2" 3/8"	Percent <u>Finer</u>	Atterberg <u>Limits</u> Plastic Limit Liquid Limit Plastic Index
3/6 4	100.0%	Swell
10	98.9%	Moisture at start
20 40	85.3% 57.8%	Moisture at finish Moisture increase
100 200	17.7% 8.2%	Initial dry density (pcf) Swell (psf)

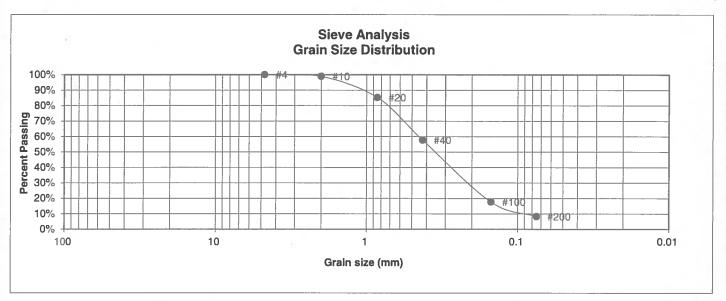
UNIFIED CLASSIFICATION	SM-SW	CLIENT	GUMAN AND ASSOCIATES
SOIL TYPE #	1	PROJECT	CURTIS RD AND JUGRE ORR RD
TEST PIT #	36	JOB NO.	181823
DEPTH (FT)	2-3	TEST BY	BL

U.S. <u>Sieve #</u> 3" 1 1/2" 3/4" 1/2" 3/8"	Percent <u>Finer</u>	Atterberg Limits Plastic Limit Liquid Limit Plastic Index
4	100.0%	Swell
10	98.9%	Moisture at start
20	85.3%	Moisture at finish
40	57.8%	Moisture increase
100	17.7%	Initial dry density (pcf)
200	8.2%	Swell (psf)

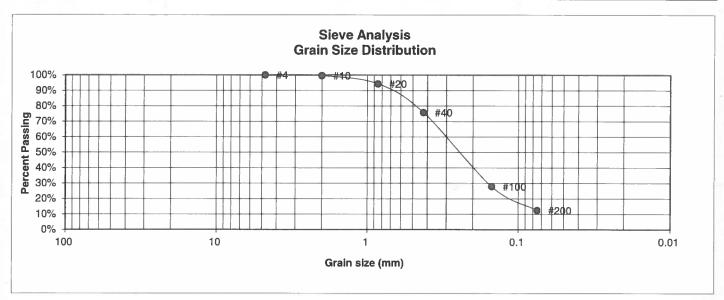
UNIFIED CLASSIFICATION	SM	CLIENT	GUMAN AND ASSOCIATES
SOIL TYPE #	1	PROJECT	CURTIS RD AND JUGRE ORR RD
TEST PIT #	39	JOB NO.	181823
DEPTH (FT)	5-6	TEST BY	BL

U.S. <u>Sieve #</u> 3" 1 1/2"	Percent <u>Finer</u>	Atterberg <u>Limits</u> Plastic Limit
3/4"		Liquid Limit Plastic Index
1/2" 3/8"		
4	100.0%	Swell
10	99.6%	Moisture at start
20	94.3%	Moisture at finish
40	75.8%	Moisture increase
100 200	27.9% 12.4%	Initial dry density (pcf) Swell (psf)

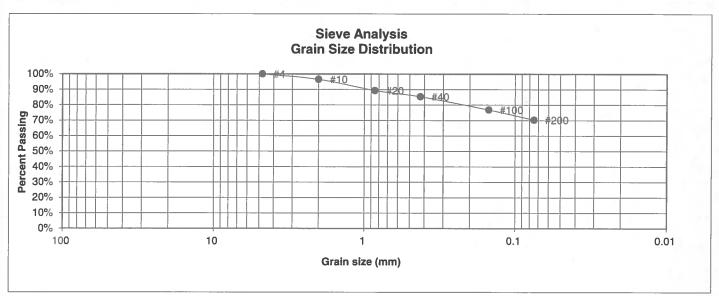
UNIFIED CLASSIFICATION	CL	CLIENT	GUMAN AND ASSOCIATES
SOIL TYPE #	2	PROJECT	CURTIS RD AND JUGRE ORR RD
TEST PIT #	1	JOB NO.	181823
DEPTH (FT)	7-8	TEST BY	BL

U.S. <u>Sieve #</u> 3" 1 1/2" 3/4" 1/2" 3/8"	Percent <u>Finer</u>	Atterberg <u>Limits</u> Plastic Limit Liquid Limit Plastic Index	18 49 31	
4	100.0%	<u>Swell</u>		
10	96.6%	Moisture at start		11.4%
20	89.3%	Moisture at finish		19.8%
40	85.4%	Moisture increase		8.4%
100	76.9%	Initial dry density (pcf)		99
200	70.3%	Swell (psf)		1360

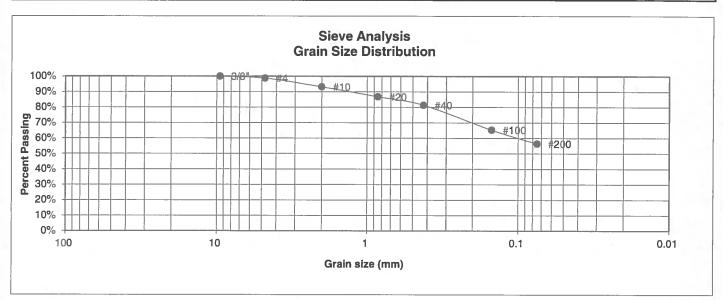
UNIFIED CLASSIFICATION	CL	CLIENT	GUMAN AND ASSOCIATES
SOIL TYPE #	2	PROJECT	CURTIS RD AND JUGRE ORR RD
TEST PIT #	4	JOB NO.	181823
DEPTH (FT)	2-3	TEST BY	BL

U.S. <u>Sieve #</u> 3" 1 1/2" 3/4" 1/2"	Percent <u>Finer</u>	Atterberg <u>Limits</u> Plastic Limit Liquid Limit Plastic Index
3/8"	100.0%	
4	98.8%	<u>Swell</u>
10	93.1%	Moisture at start
20	86.8%	Moisture at finish
40	81.4%	Moisture increase
100 200	65.3% 56.4%	Initial dry density (pcf) Swell (psf)

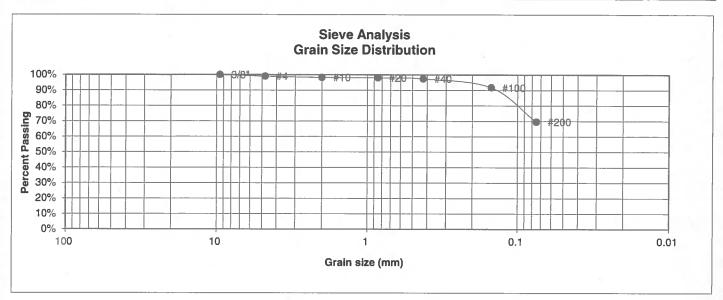
UNIFIED CLASSIFICATION	CL	CLIENT	GUMAN AND ASSOCIATES
SOIL TYPE #	2	PROJECT	CURTIS RD AND JUGRE ORR RD
TEST PIT #	5	JOB NO.	181823
DEPTH (FT)	7-8	TEST BY	BL

U.S.	Percent	Atterberg	
Sieve #	Finer	<u>Limits</u>	
3"		Plastic Limit 13	
1 1/2"		Liquid Limit 32	
3/4"		Plastic Index 19	
1/2"			
3/8"	100.0%		
4	99.1%	Swell	
10	98.3%	Moisture at start	12.5%
20	98.1%	Moisture at finish	20.6%
40	97.4%	Moisture increase	8.1%
100	91.8%	Initial dry density (pcf)	104
200	69.6%	Swell (psf)	880

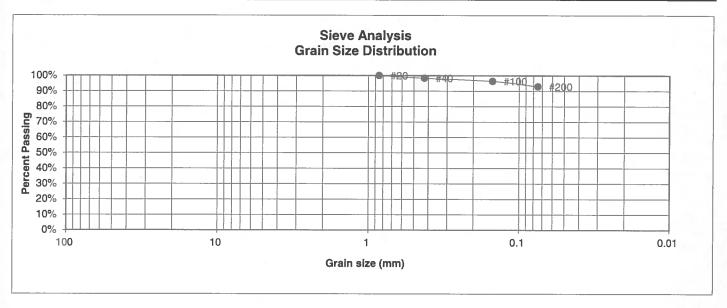
UNIFIED CLASSIFICATION	CL	CLIENT	GUMAN AND ASSOCIATES
SOIL TYPE #	2	PROJECT	CURTIS RD AND JUGRE ORR RD
TEST PIT #	16	JOB NO.	181823
DEPTH (FT)	7-8	TEST BY	BL

U.S.	Percent	Atterberg	
Sieve #	<u>Finer</u>	<u>Limits</u>	
3"		Plastic Limit	
1 1/2"		Liquid Limit	
3/4"		Plastic Index	
1/2"			
3/8"			
4		Swell	
10		Moisture at start	17.8%
20	100.0%	Moisture at finish	33.1%
40	98.3%	Moisture increase	15.3%
100	96.4%	Initial dry density (pcf)	92
200	92.9%	Swell (psf)	4420

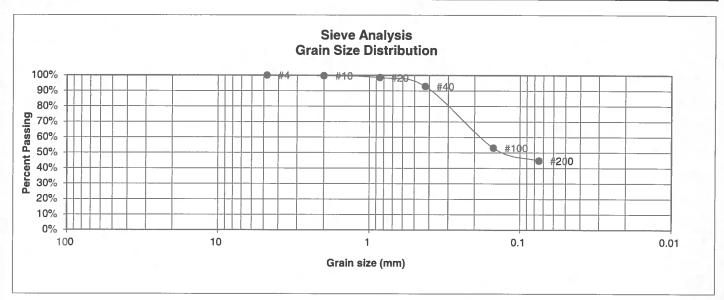
UNIFIED CLASSIFICATION	SC	CLIENT	GUMAN AND ASSOCIATES
SOIL TYPE #	3	PROJECT	CURTIS RD AND JUGRE ORR RD
TEST PIT #	8	JOB NO.	181823
DEPTH (FT)	4-5	TEST BY	BL

U.S. <u>Sieve #</u> 3" 1 1/2" 3/4" 1/2" 3/8"	Percent <u>Finer</u>	Atterberg <u>Limits</u> Plastic Limit Liquid Limit Plastic Index
4	100.0%	Swell
10	99.7%	Moisture at start
20	98.5%	Moisture at finish
40	92.9%	Moisture increase
100 200	53.2% 44.8%	Initial dry density (pcf) Swell (psf)

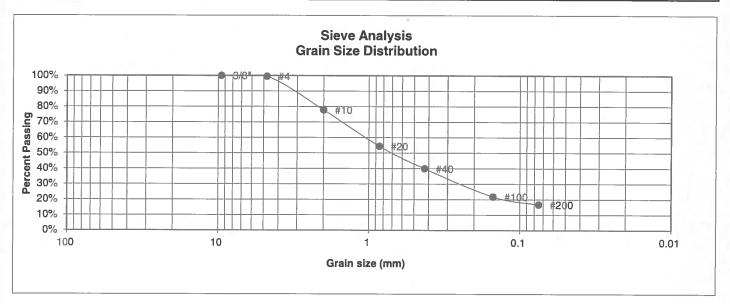
UNIFIED CLASSIFICATION	SM	CLIENT	GUMAN AND ASSOCIATES
SOIL TYPE #	3	PROJECT	CURTIS RD AND JUGRE ORR RD
TEST PIT #	10	JOB NO.	181823
DEPTH (FT)	5-6	TEST BY	BL

U.S.	Percent	Atterberg
Sieve #	<u>Finer</u>	<u>Limits</u>
3"		Plastic Limit
1 1/2"		Liquid Limit
3/4"		Plastic Index
1/2"		
3/8"	100.0%	
4	99.5%	Swell
10	77.8%	Moisture at start
20	54.4%	Moisture at finish
40	39.9%	Moisture increase
100	21.8%	Initial dry density (pcf)
200	16.6%	Swell (psf)

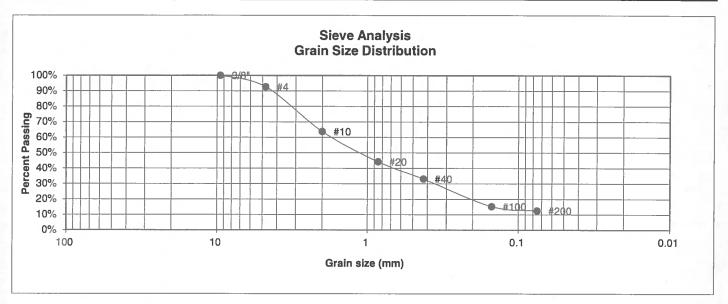
FIG NO.: C-28

UNIFIED CLASSIFICATION	SM	CLIENT	GUMAN AND ASSOCIATES
SOIL TYPE #	3	PROJECT	CURTIS RD AND JUGRE ORR RD
TEST PIT #	17	JOB NO.	181823
DEPTH (FT)	5-6	TEST BY	BL

U.S. <u>Sieve #</u> 3"	Percent <u>Finer</u>	Atterberg <u>Limits</u> Plastic Limit
1 1/2"		Liquid Limit
3/4"		Plastic Index
1/2"		
3/8"	100.0%	
4	92.7%	Swell
10	63.7%	Moisture at start
20	44.2%	Moisture at finish
40	33.1%	Moisture increase
100	15.3%	Initial dry density (pcf)
200	12.6%	Swell (psf)

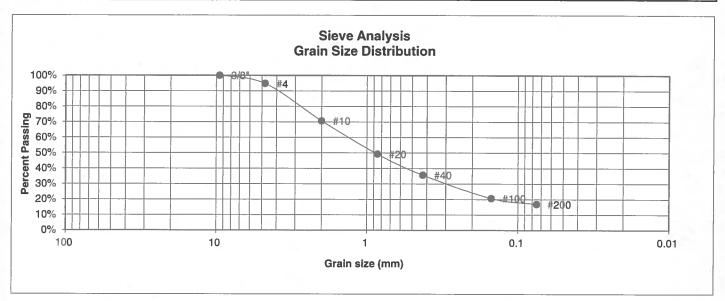
UNIFIED CLASSIFICATION	SM	CLIENT	GUMAN AND ASSOCIATES
SOIL TYPE #	3	PROJECT	CURTIS RD AND JUGRE ORR RD
TEST PIT #	34	JOB NO.	181823
DEPTH (FT)	5-6	TEST BY	BL

U.S. <u>Sieve #</u> 3" 1 1/2" 3/4"	Percent <u>Finer</u>	Atterberg <u>Limits</u> Plastic Limit Liquid Limit Plastic Index
1/2" 3/8" 4 10	100.0% 94.8% 70.7%	<u>Swell</u> Moisture at start
20 40 100 200	49.2% 35.7% 20.7% 16.9%	Moisture at finish Moisture increase Initial dry density (pcf) Swell (psf)

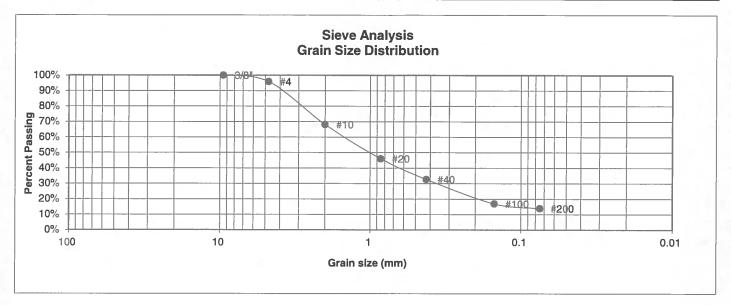
UNIFIED CLASSIFICATION	SM	CLIENT	GUMAN AND ASSOCIATES
SOIL TYPE #	3	PROJECT	CURTIS RD AND JUGRE ORR RD
TEST PIT #	40	JOB NO.	181823
DEPTH (FT)	5-6	TEST BY	BL

U.S. <u>Sieve #</u> 3" 1 1/2" 3/4" 1/2"	Percent <u>Finer</u>		Atterberg <u>Limits</u> Plastic Limit Liquid Limit Plastic Index
3/8"	100.0%		
4	95.9%		<u>Swell</u>
10	68.2%		Moisture at start
20	46.1%		Moisture at finish
40	32.7%		Moisture increase
100	17.0%		Initial dry density (pcf)
200	13.9%		Swell (psf)

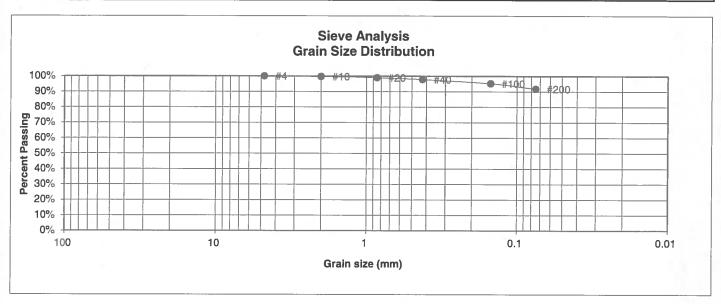
UNIFIED CLASSIFICATION	CL	CLIENT	GUMAN AND ASSOCIATES
SOIL TYPE #	4	PROJECT	CURTIS RD AND JUGRE ORR RD
TEST PIT #	7	JOB NO.	181823
DEPTH (FT)	6-7	TEST BY	BL

U.S. <u>Sieve #</u> 3" 1 1/2" 3/4" 1/2" 3/8"	Percent <u>Finer</u>	<u>Limit</u> Plast Liqui	rberg t <u>s</u> tic Limit id Limit tic Index	
4	100.0%	Swel	<u>II</u>	
10	99.7%	Mois	sture at start 17.8%	
20	99.0%	Mois	sture at finish 27.8%	
40	97.8%	Mois	sture increase 10.0%	
100	95.2%	Initial	ll dry density (pcf) 94	
200	91.8%	Swel	II (psf) 2300

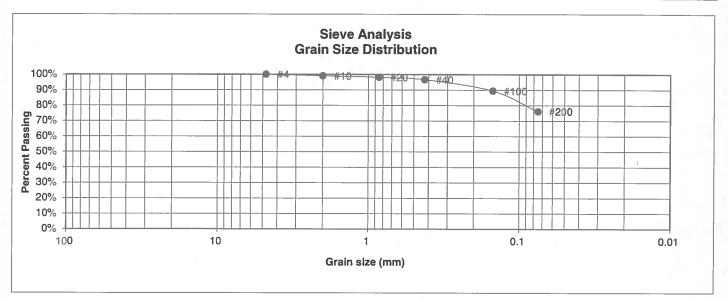
C-37

UNIFIED CLASSIFICATION	CL	CLIENT	GUMAN AND ASSOCIATES
SOIL TYPE #	4	PROJECT	CURTIS RD AND JUGRE ORR RD
TEST PIT #	14	JOB NO.	181823
DEPTH (FT)	4-5	TEST BY	BL

U.S. <u>Sieve #</u> 3" 1 1/2" 3/4" 1/2" 3/8"	Percent <u>Finer</u>	Atterberg Limits Plastic Limit 24 Liquid Limit 47 Plastic Index 23	
4	100.0%	Swell	15 50
	99.1%	Moisture at start	15.5%
20	98.2%	Moisture at finish	29.0%
40	96.7%	Moisture increase	13.5%
100	89.5%	Initial dry density (pcf)	95
200	76.1%	Swell (psf)	3160

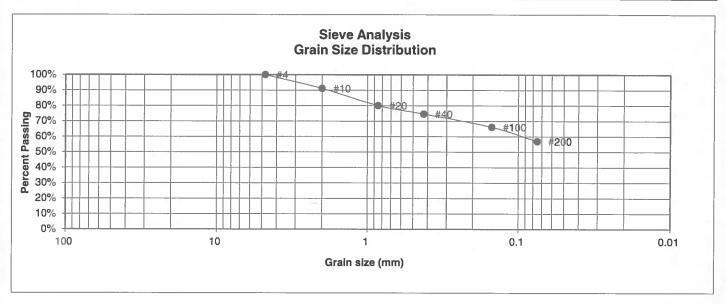
UNIFIED CLASSIFICATION	CL	CLIENT	GUMAN AND ASSOCIATES
SOIL TYPE #	4	PROJECT	CURTIS RD AND JUGRE ORR RD
TEST PIT #	23	JOB NO.	181823
DEPTH (FT)	5-6	TEST BY	BL

U.S. <u>Sieve #</u> 3" 1 1/2" 3/4" 1/2" 3/8"	Percent <u>Finer</u>	Atterberg Limits Plastic Limit Liquid Limit Plastic Index	
4	100.0%	Swell	
10	91.1%	Moisture at start	10.0%
20	80.1%	Moisture at finish	16.1%
40	74.6%	Moisture increase	6.2%
100	66.2%	Initial dry density (pcf)	109
200	57.0%	Swell (psf)	450

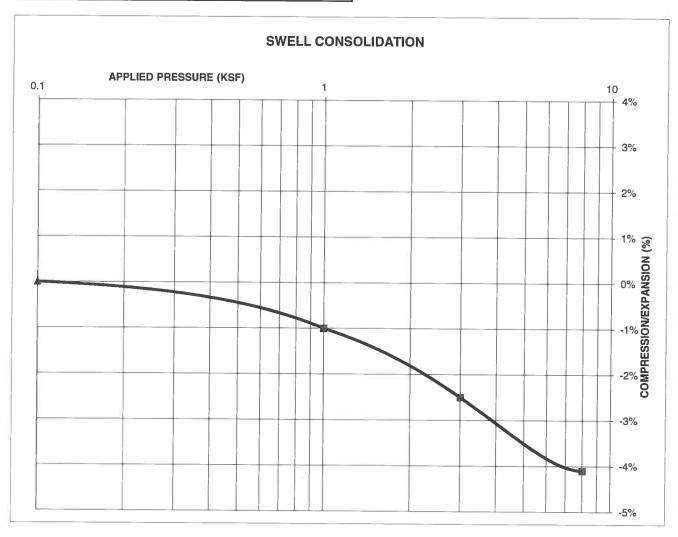
SWELL CONSOLIDATION
TEST RESULTS

TEST BORING # 4 DEPTH(ft) 20
DESCRIPTION ML SOIL TYPE 3
NATURAL UNIT DRY WEIGHT (PCF) 104
NATURAL MOISTURE CONTENT 21.4%
SWELL/CONSOLIDATION (%) 0.0%

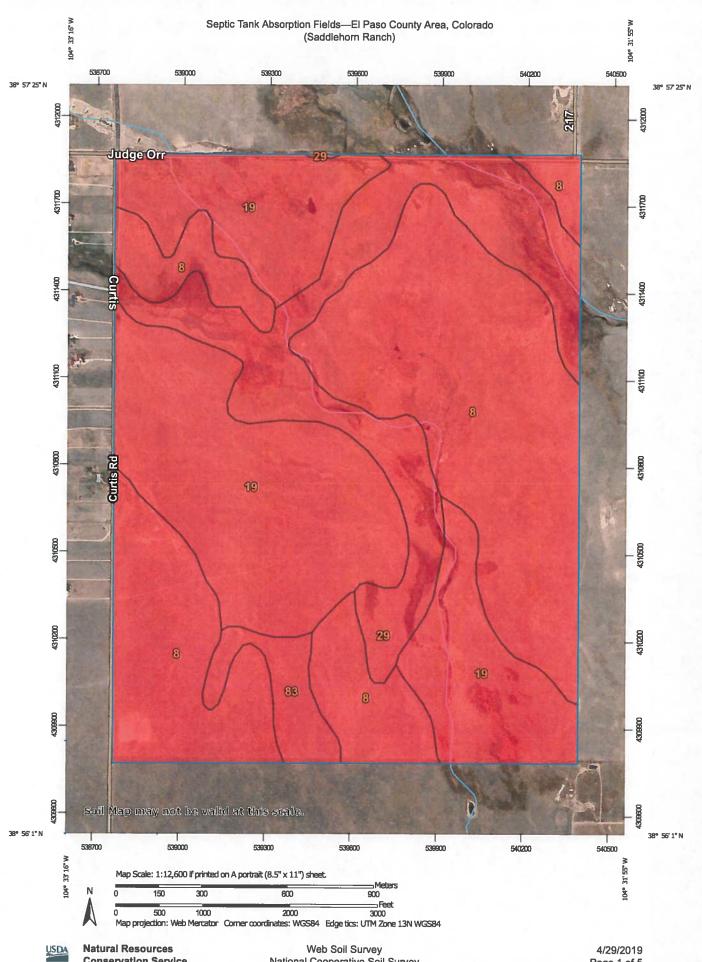
APPENDIX E: NRCS Septic Tank Absorption Field Soil Rating

Some soils are underlain by loose sand and gravel or fractured bedrock at a depth of less than 4 feet below the distribution lines. In these soils the absorption field may not adequately filter the effluent, particularly when the system is new. As a result, the ground water may become contaminated.
