## **SUBSURFACE SOIL INVESTIGATION**

**Lot 14, Blk 15, Park Vista Estates Addition  
El Paso County, Colorado**

**JOB NO. 193526**

**July 13, 2023**

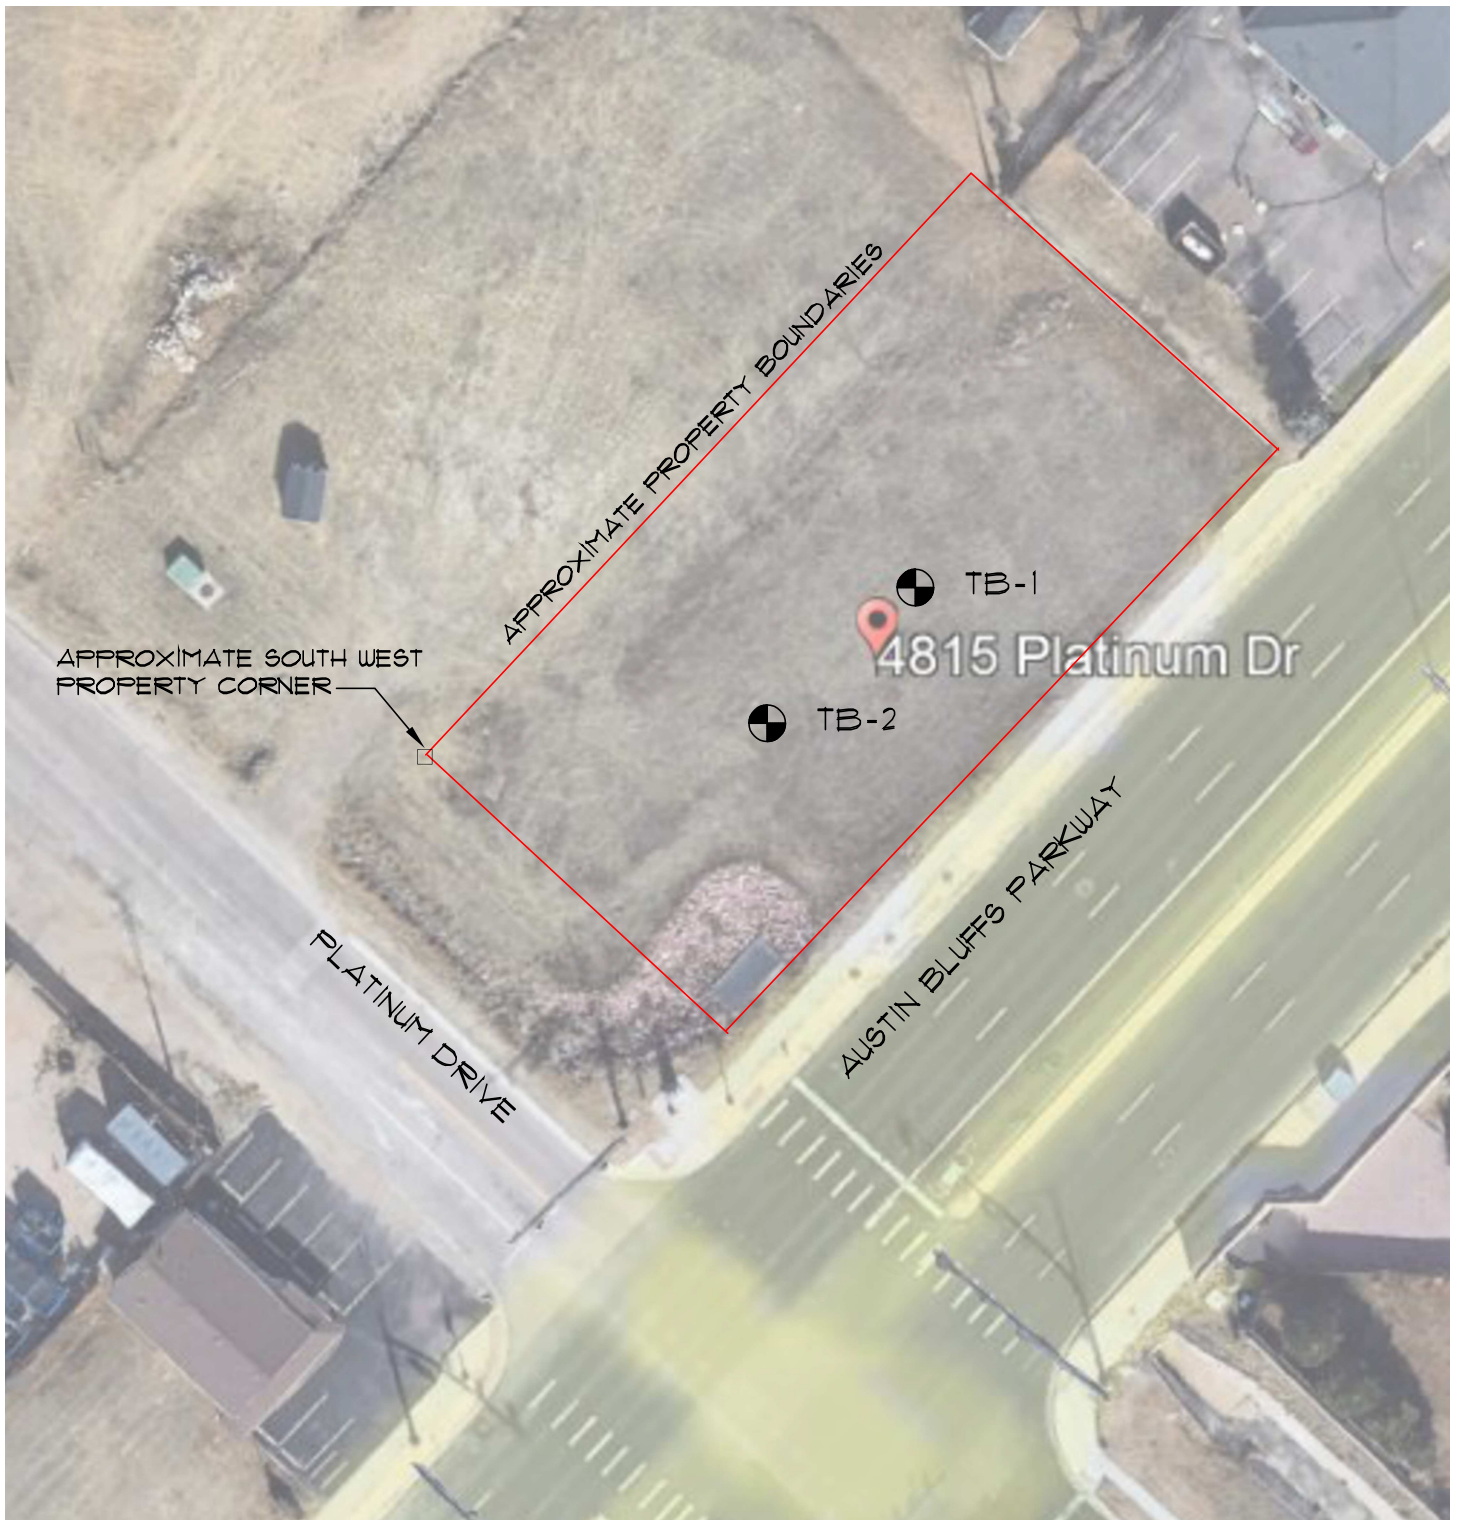
⊙ DENOTES APPROXIMATE LOCATION OF TEST BORINGS

The subsurface conditions on the site were investigated by drilling two exploratory test borings. Additionally, two test borings were performed on Lot 13 to the east of the site. The information obtained from these test borings were considered in preparation of this report. The approximate locations of the test borings are presented in the Test Boring Location Plan, Figure 2.

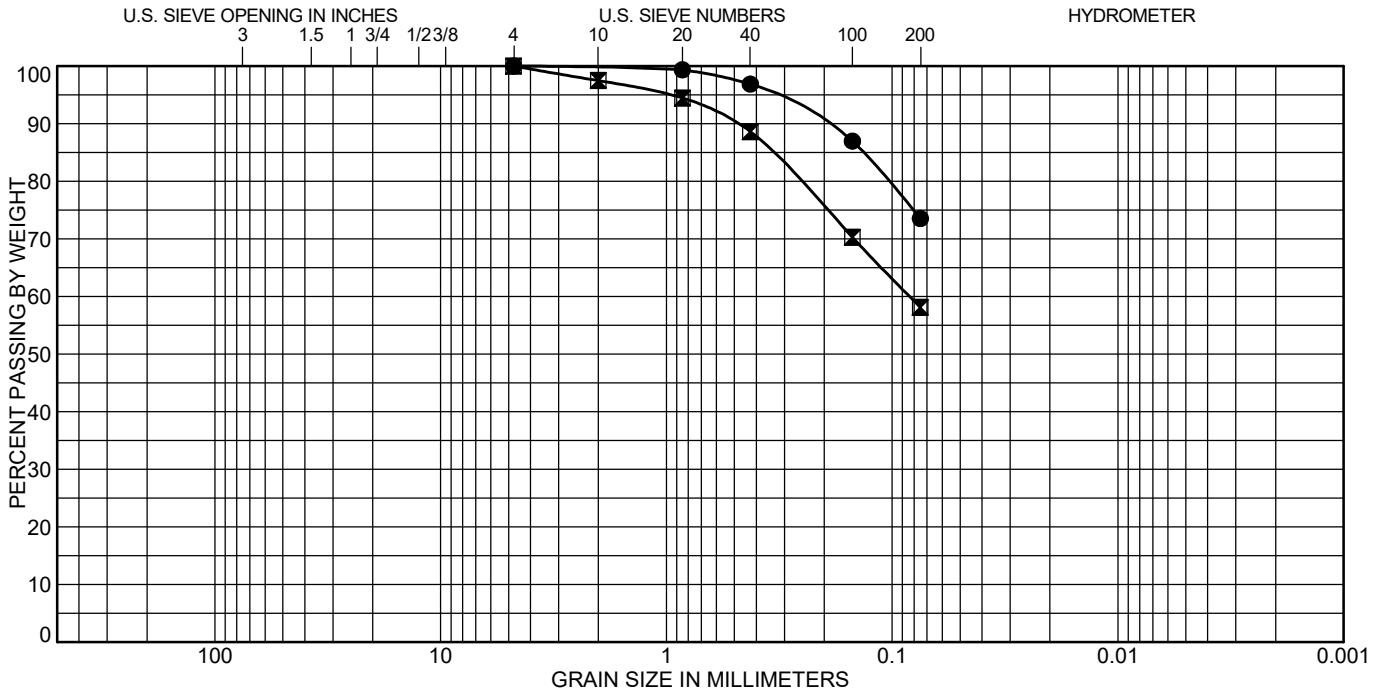
FIGURE No. 6

COBBLES	GRAVEL		SAND			SILT OR CLAY
	coarse	fine	coarse	medium	fine

Test Boring	Depth (ft)	Classification	LL	PL	PI
● 1	9.0				
■ 2	2.0

samples for purposes of classification and to develop pertinent engineering properties. A Summary of Laboratory Test Results is presented in Figure 5. Soil Classification Data are presented in Figure 6. Swell/Consolidation tests were not performed on this site. However, one swell test was performed on Lot 13 (TB-4835-2) at a depth of 2 feet. That swell test result is presented in Figure 7.

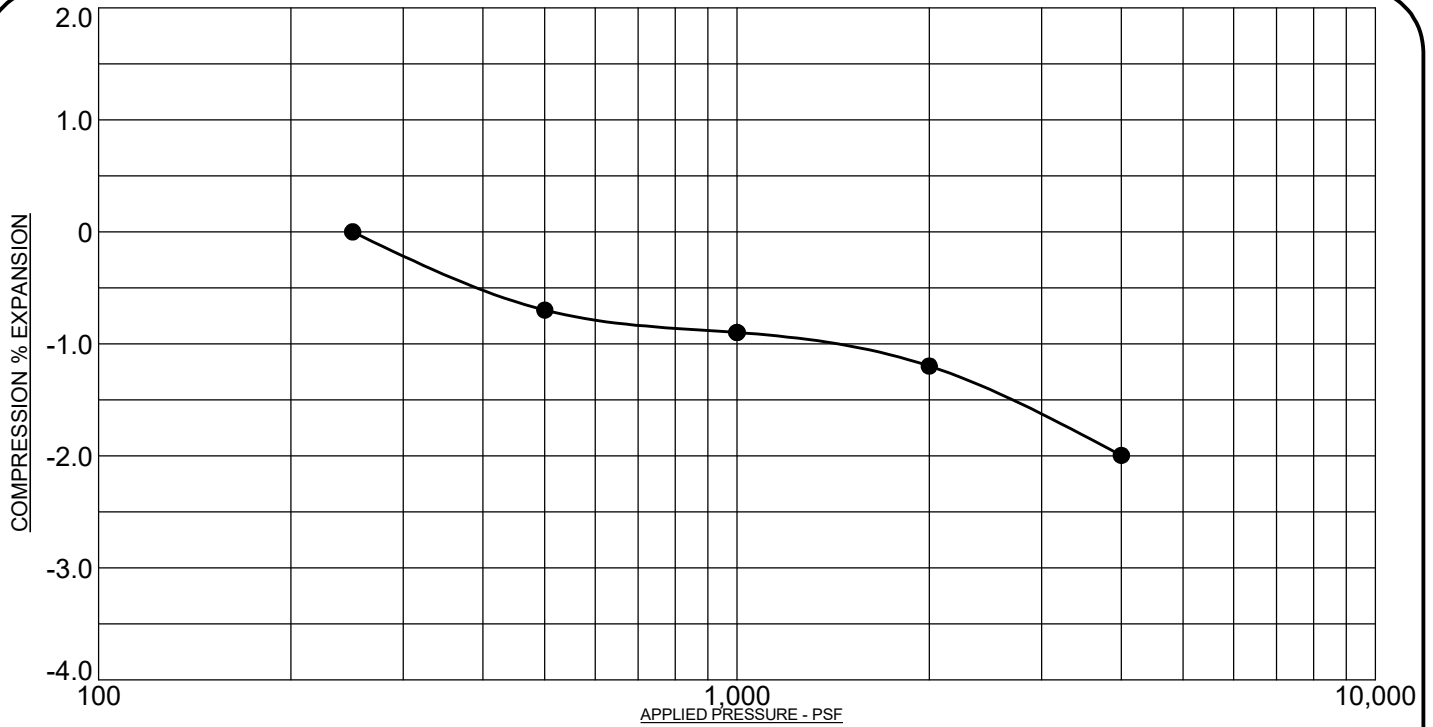
PROJECT: 4835 Platinum Drive, Colorado Springs, Colorado  
 SAMPLE DESCRIPTION: FILL: CLAY, SANDY  
 NOTE: SAMPLE WAS INUNDATED WITH WATER AT 1,000 PSF

SAMPLE LOCATION: 2 @ 2 FT  
 NATURAL DRY UNIT WEIGHT: 111.9 PCF  
 NATURAL MOISTURE CONTENT: 14.5%  
 PERCENT SWELL/COMPRESSION: 0.0
