**Preliminary Geotechnical Evaluation
18950 Base Camp Road
Monument, Colorado**

Prepared For:
**Central Development
1660 South Abilene Street, Suite 200
Denver, Colorado 80222**

Job Number: 23-8001

March 29, 2023

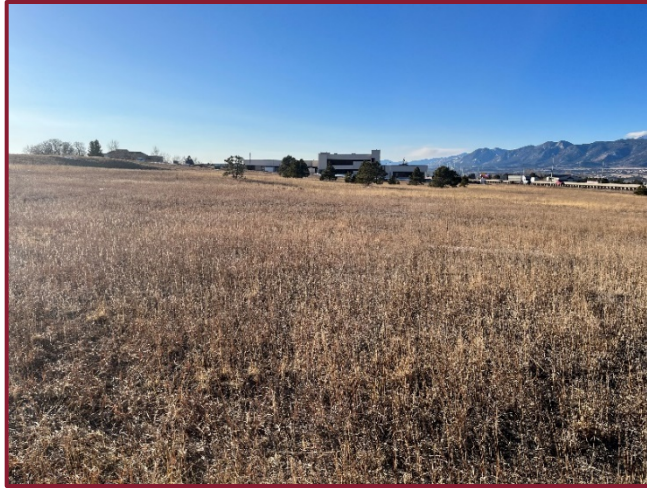
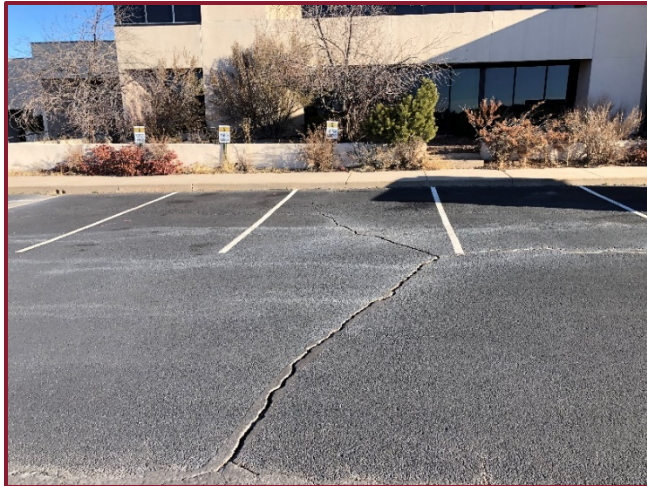
At the time of our subsurface exploration program, the project site was split into two parcels. The northern parcel consisted of vacant, undeveloped land with medium to tall grasses and scattered evergreen trees. The southern parcel consisted of an existing building with associated asphalt-paved parking areas, drive lanes, concrete flatwork, and an undeveloped area south of the building. Surveys depicting the existing topography of the site were unavailable at the time of this report preparation. Based on a USGS topographic map of the area², the site sloped from north to south and approximately 40 feet of relief was exhibited across the site.

Based on our cursory observations, the parking lot around the existing building at the site was in moderate condition, with some areas showing signs of thermal cracking. The existing building appeared to be in relatively good condition as viewed from the exterior.

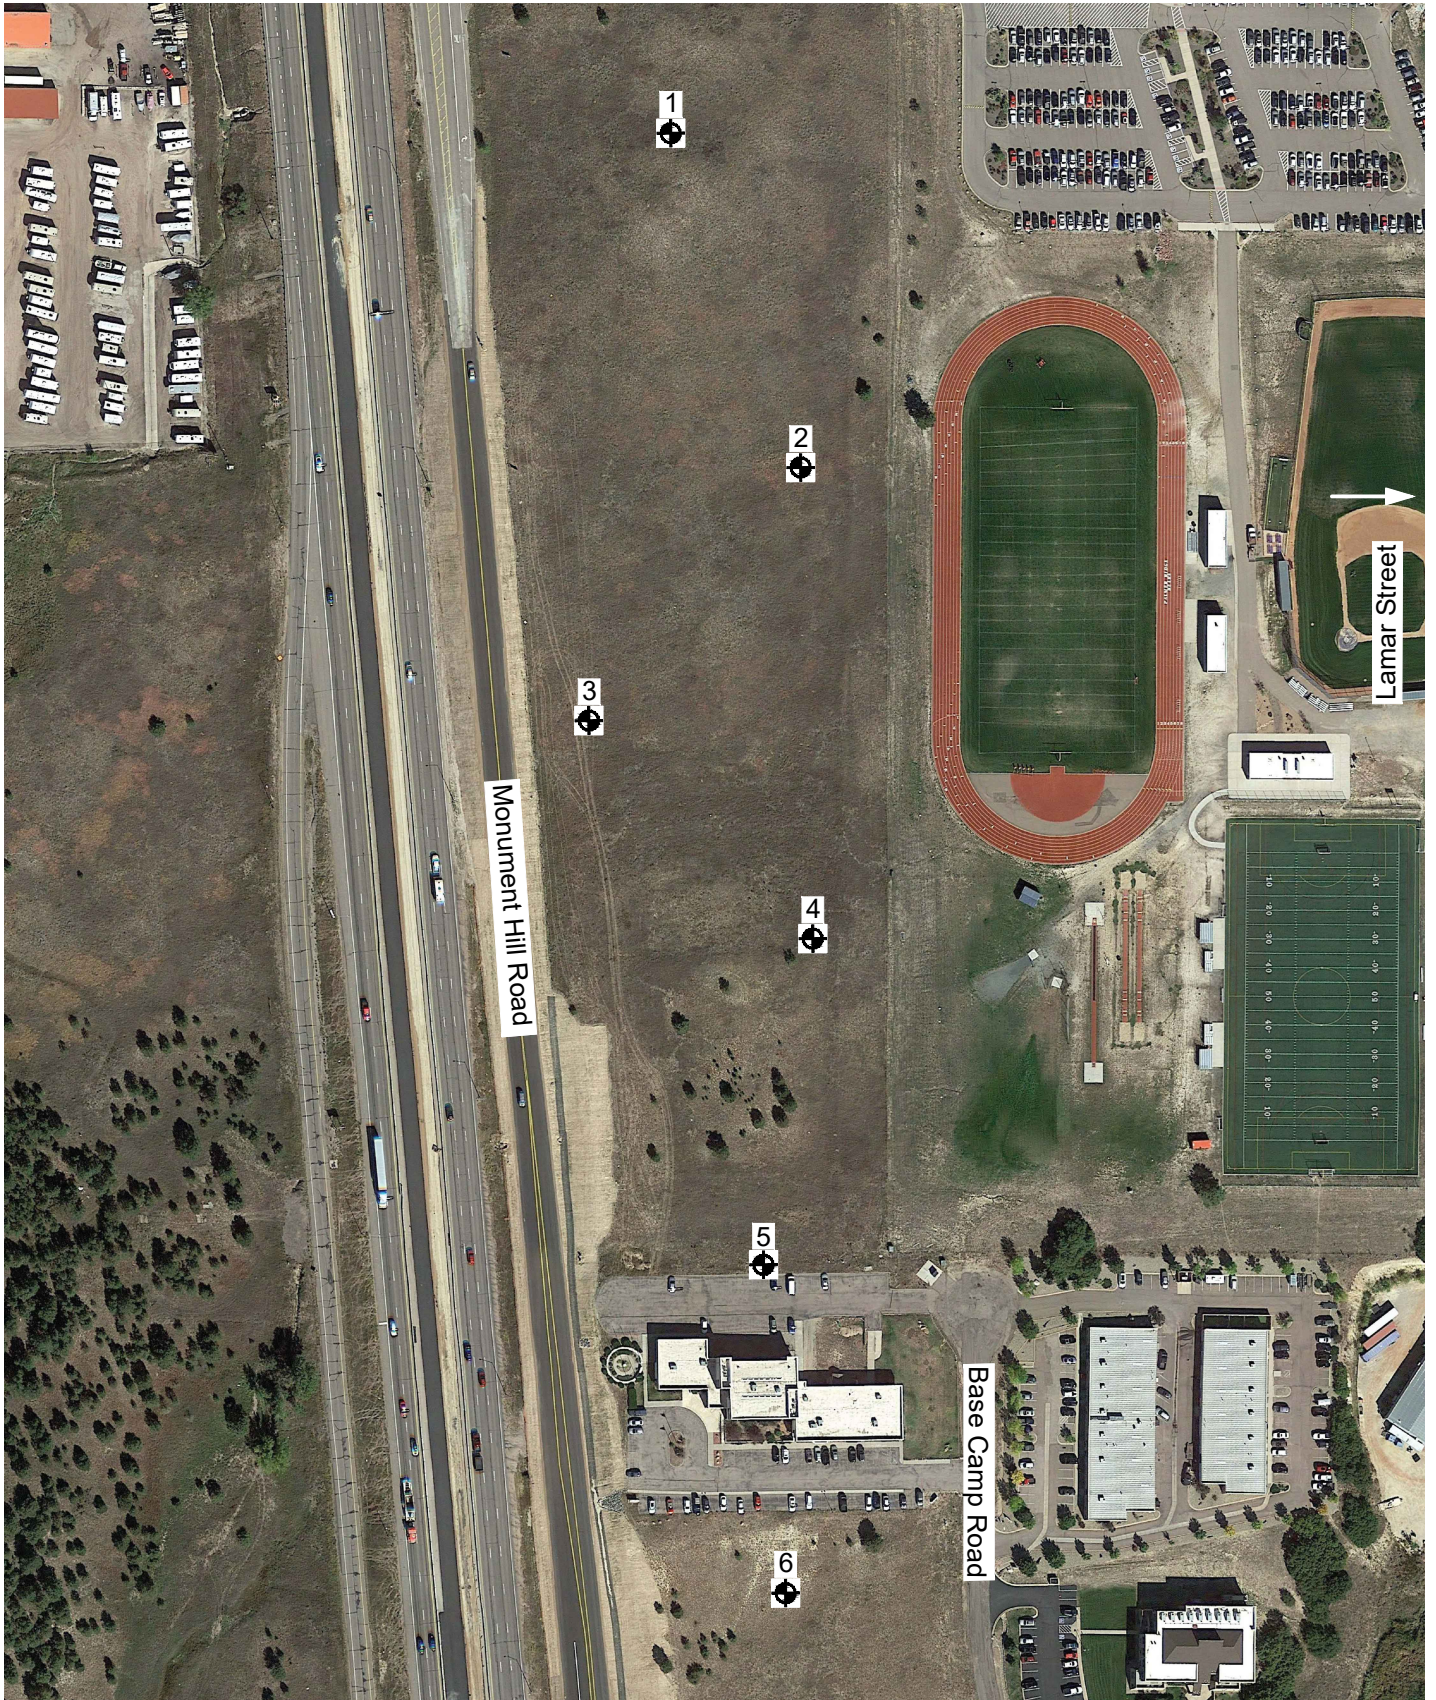
GOOGLE EARTH AERIAL IMAGE (10/06/2019)

6
 ◆ Indicates test hole numbers and approximate locations.

GROUND utilized the Client-provided parcel map indicating existing features, Google Earth imagery, and a hand-held GPS device to determine the locations of the test holes. The approximate locations of the test holes are shown on Figure 1. Logs of the test holes are presented on Figure 2 and Appendix A. Explanatory notes and a legend are provided on Figure 3.

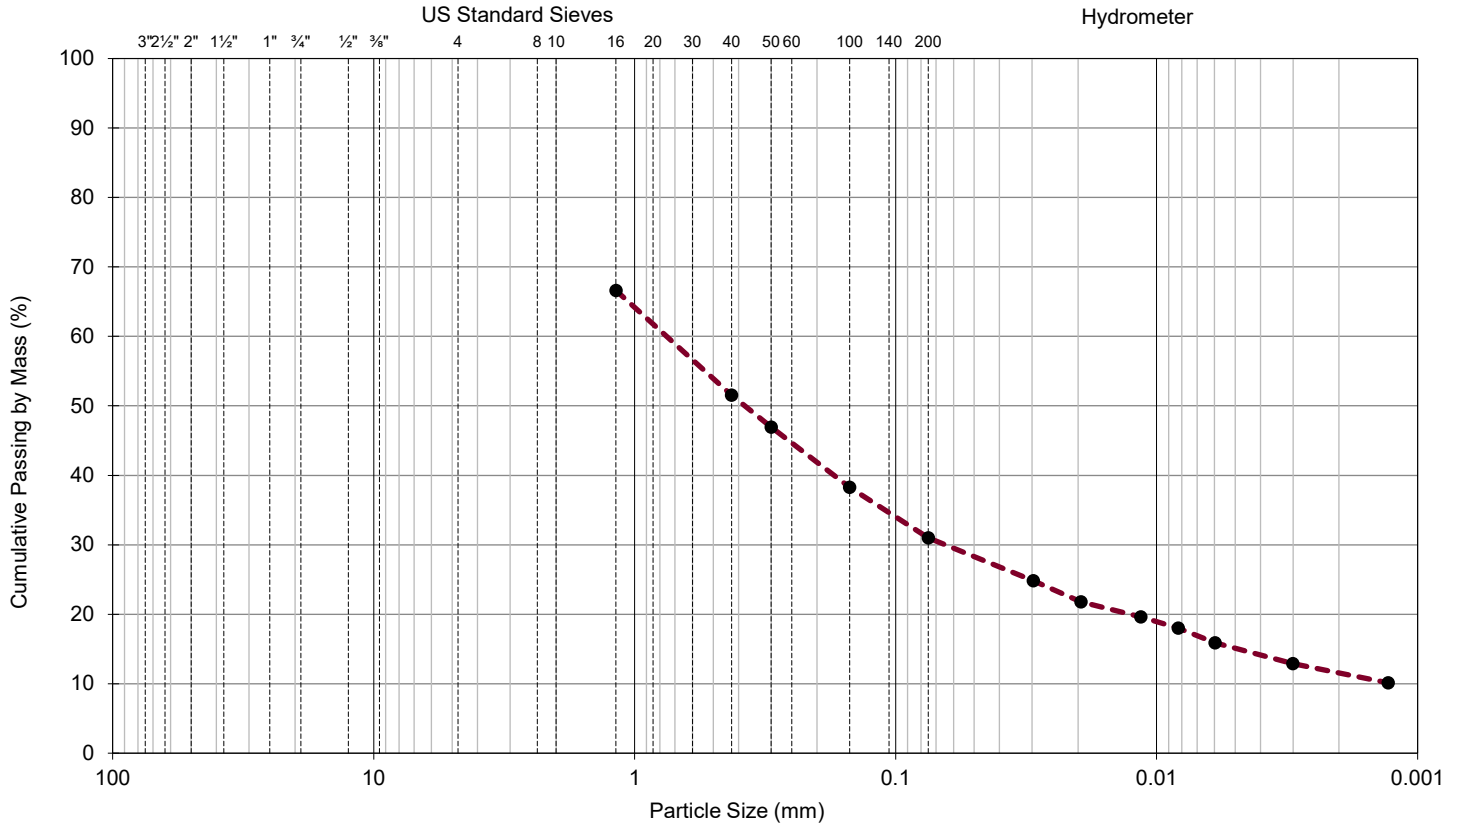
Gradation and Hydrometer (ASTM D422-63[2007])

Coarse Gradation			Fine Gradation			Hydrometer		Grading	
US Standard Sieve	Particle Size (mm)	Passing by Mass (%)	US Standard Sieve	Particle Size (mm)	Passing by Mass (%)	Particle Size (mm)	Passing by Mass (%)	Coefficient	Value
6 in	150	-	No. 4	4.75	-	0.030	25	D90	#N/A
5 in	125	-	No. 8	2.36	-	0.019	22	D85	#N/A
4 in	100	-	No. 10	2.00	-	0.012	20	D80	#N/A
3 in	75	-	No. 16	1.18	67	0.008	18	D60	0.754
2.5 in	63	-	No. 20	0.85	-	0.006	16	D50	0.378
2 in	50	-	No. 30	0.60	-	0.003	13	D40	0.172
1.5 in	37.5	-	No. 40	0.425	52	0.001	10	D30	-
1 in	25.0	-	No. 50	0.300	47	-	-	D15	-
3/4 in	19.0	-	No. 60	0.250	-	-	-	D10	-
1/2 in	12.5	-	No. 100	0.150	38	-	-	D05	-
3/8 in	9.5	-	No. 140	0.106	-	-	-	Cu	-
No. 4	4.75	-	No. 200	0.075	31.0	-	-	Cc	-

Location: 3 at 5 feet
Description: SANDSTONE Bedrock
