WASTEWATER DISPOSAL REPORT

***PT Overlook, LLC
Overlook Subdivision***

OVERLOOK SUBDIVISION

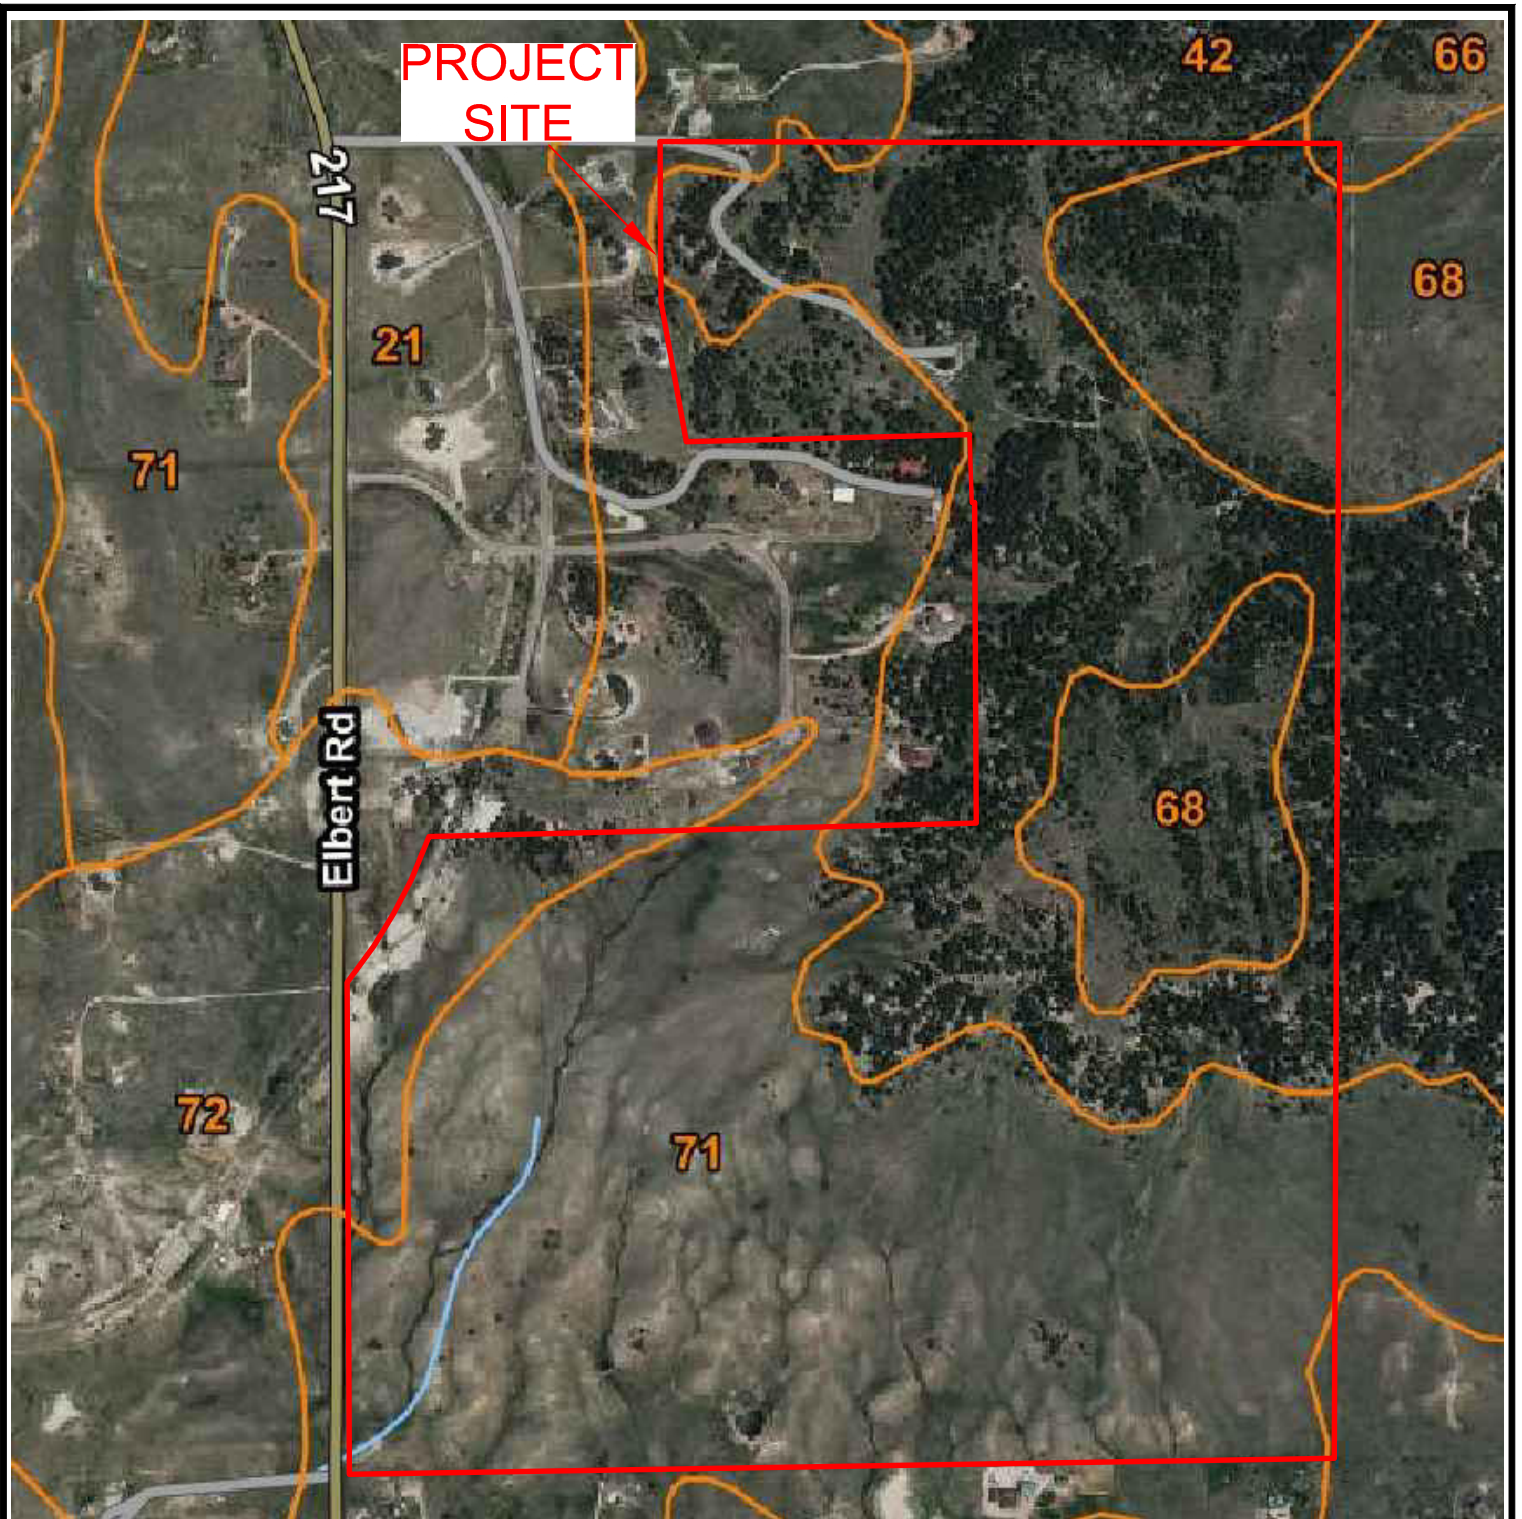
FIG. 4

SOIL SURVEY MAP
OVERLOOK AT HOMESTEAD
EL PASO COUNTY, COLORADO
PT OVERLOOK, LLC

The Natural Resource Conservation Service (Reference 2), previously the Soil Conservation Service (Reference 3) has mapped four soil types on the site (Figure 4). In general, the soils classify as coarse sandy loam, sandy loam, and rock outcrops. The soils are described as follows:

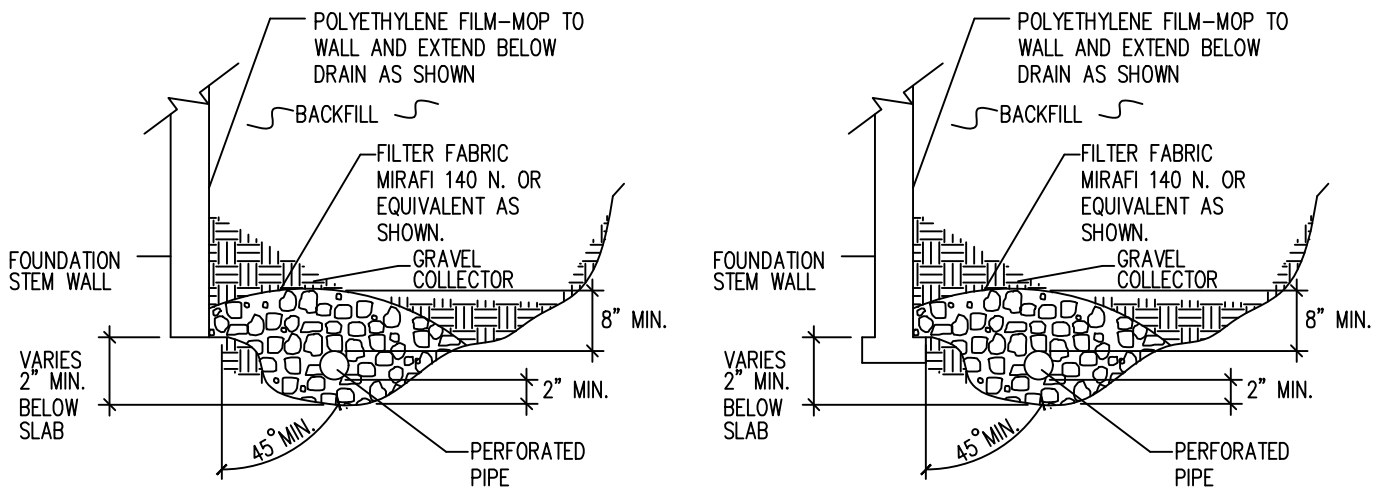
FIG. 9

-GRAVEL SIZE IS RELATED TO DIAMETER OF PIPE PERFORATIONS-85% GRAVEL GREATER THAN 2x PERFORATION DIAMETER.

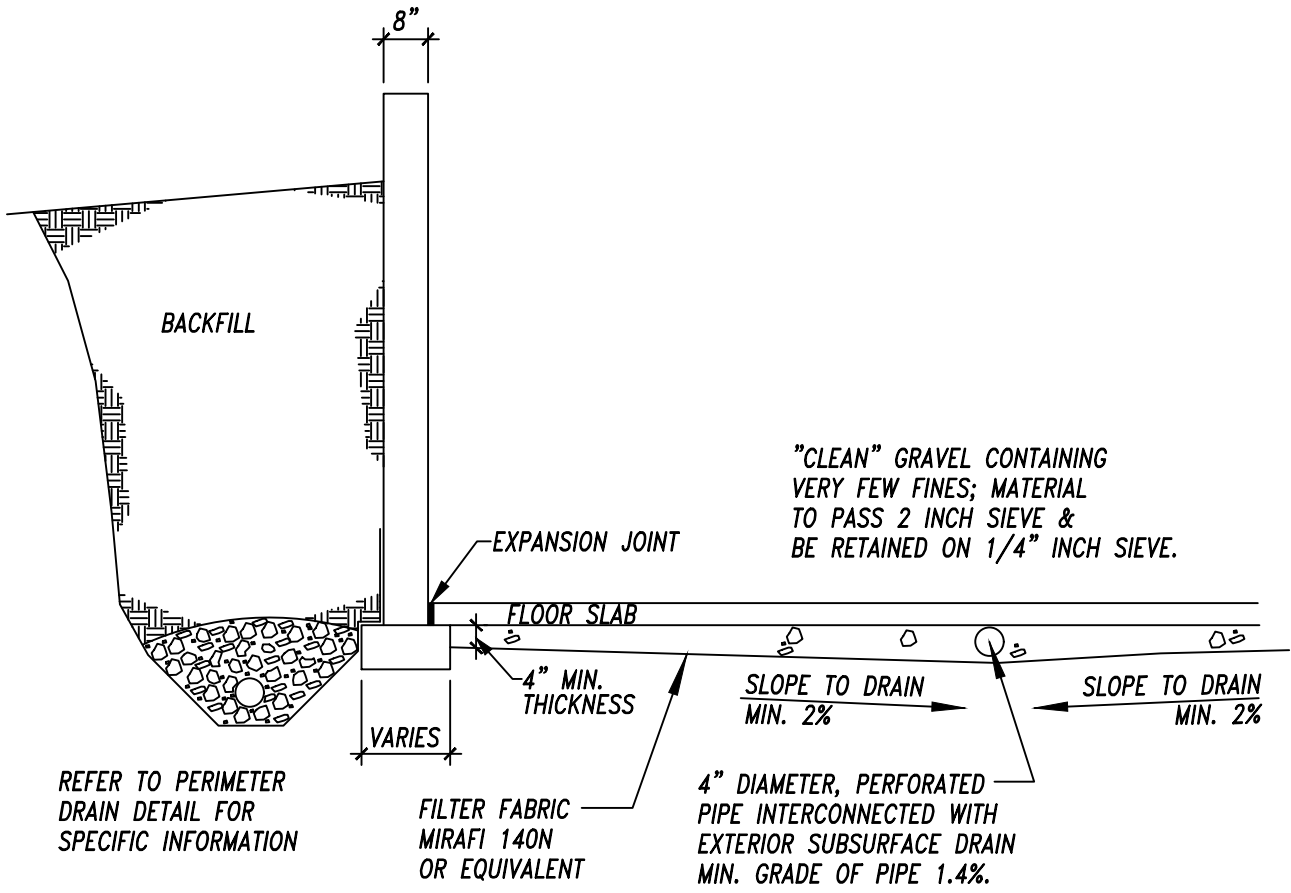
FIG. 10

**TYP. UNDERSLAB DRAINAGE LAYER
(CAPILLARY BREAK)**
 OVERLOOK AT HOMESTEAD
 EL PASO COUNTY, COLORADO
 PT OVERLOOK, LLC

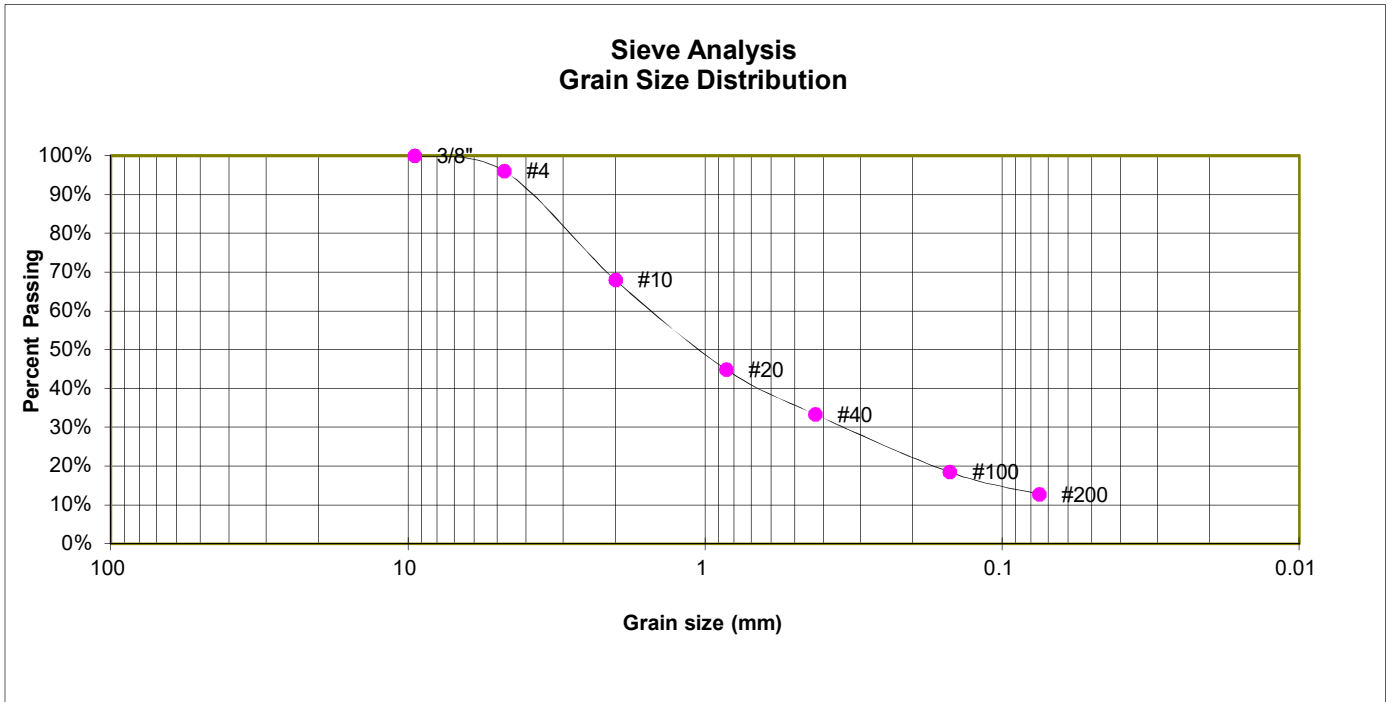
TEST BORING 6
DEPTH (FT) 2-3
SOIL TYPE 1

SOIL DESCRIPTION SAND, SILTY
USCS CLASSIFICATION SM

U.S. Sieve #	Percent Finer
3"	
1 1/2"	
3/4"	
1/2"	
3/8"	100.0%
4	96.1%
10	67.9%
20	44.9%
40	33.3%
100	18.4%
200	12.7%

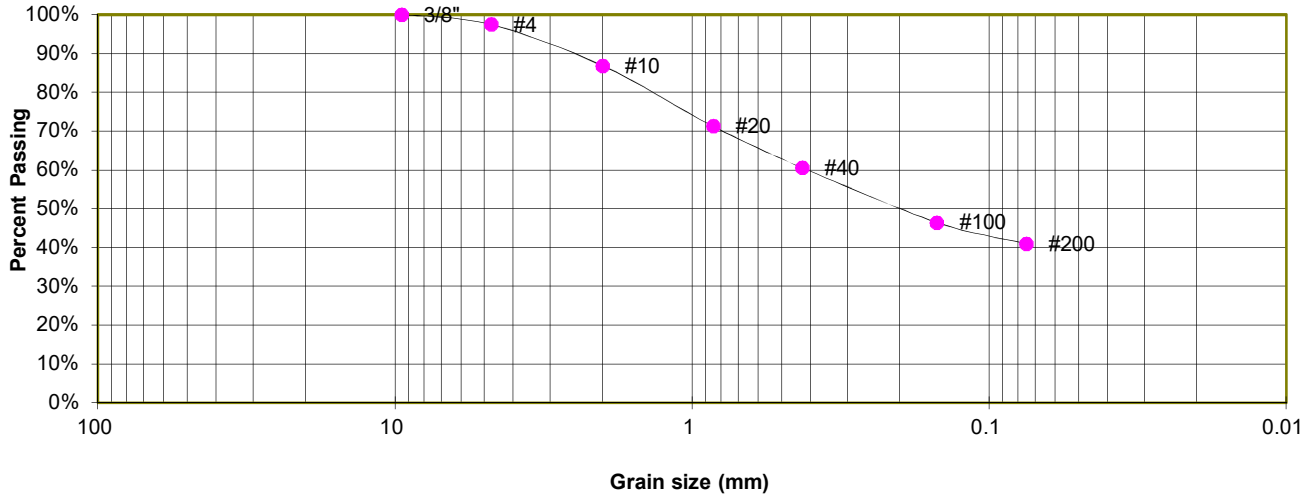
Sieve Analysis Grain Size Distribution

SOIL DESCRIPTION SAND, SILTY
USCS CLASSIFICATION SM

U.S. Sieve #	Percent Finer
3"	
1 1/2"	
3/4"	
1/2"	
3/8"	100.0%
4	97.5%
10	86.8%
20	71.3%
40	60.5%
100	46.5%
200	41.0%

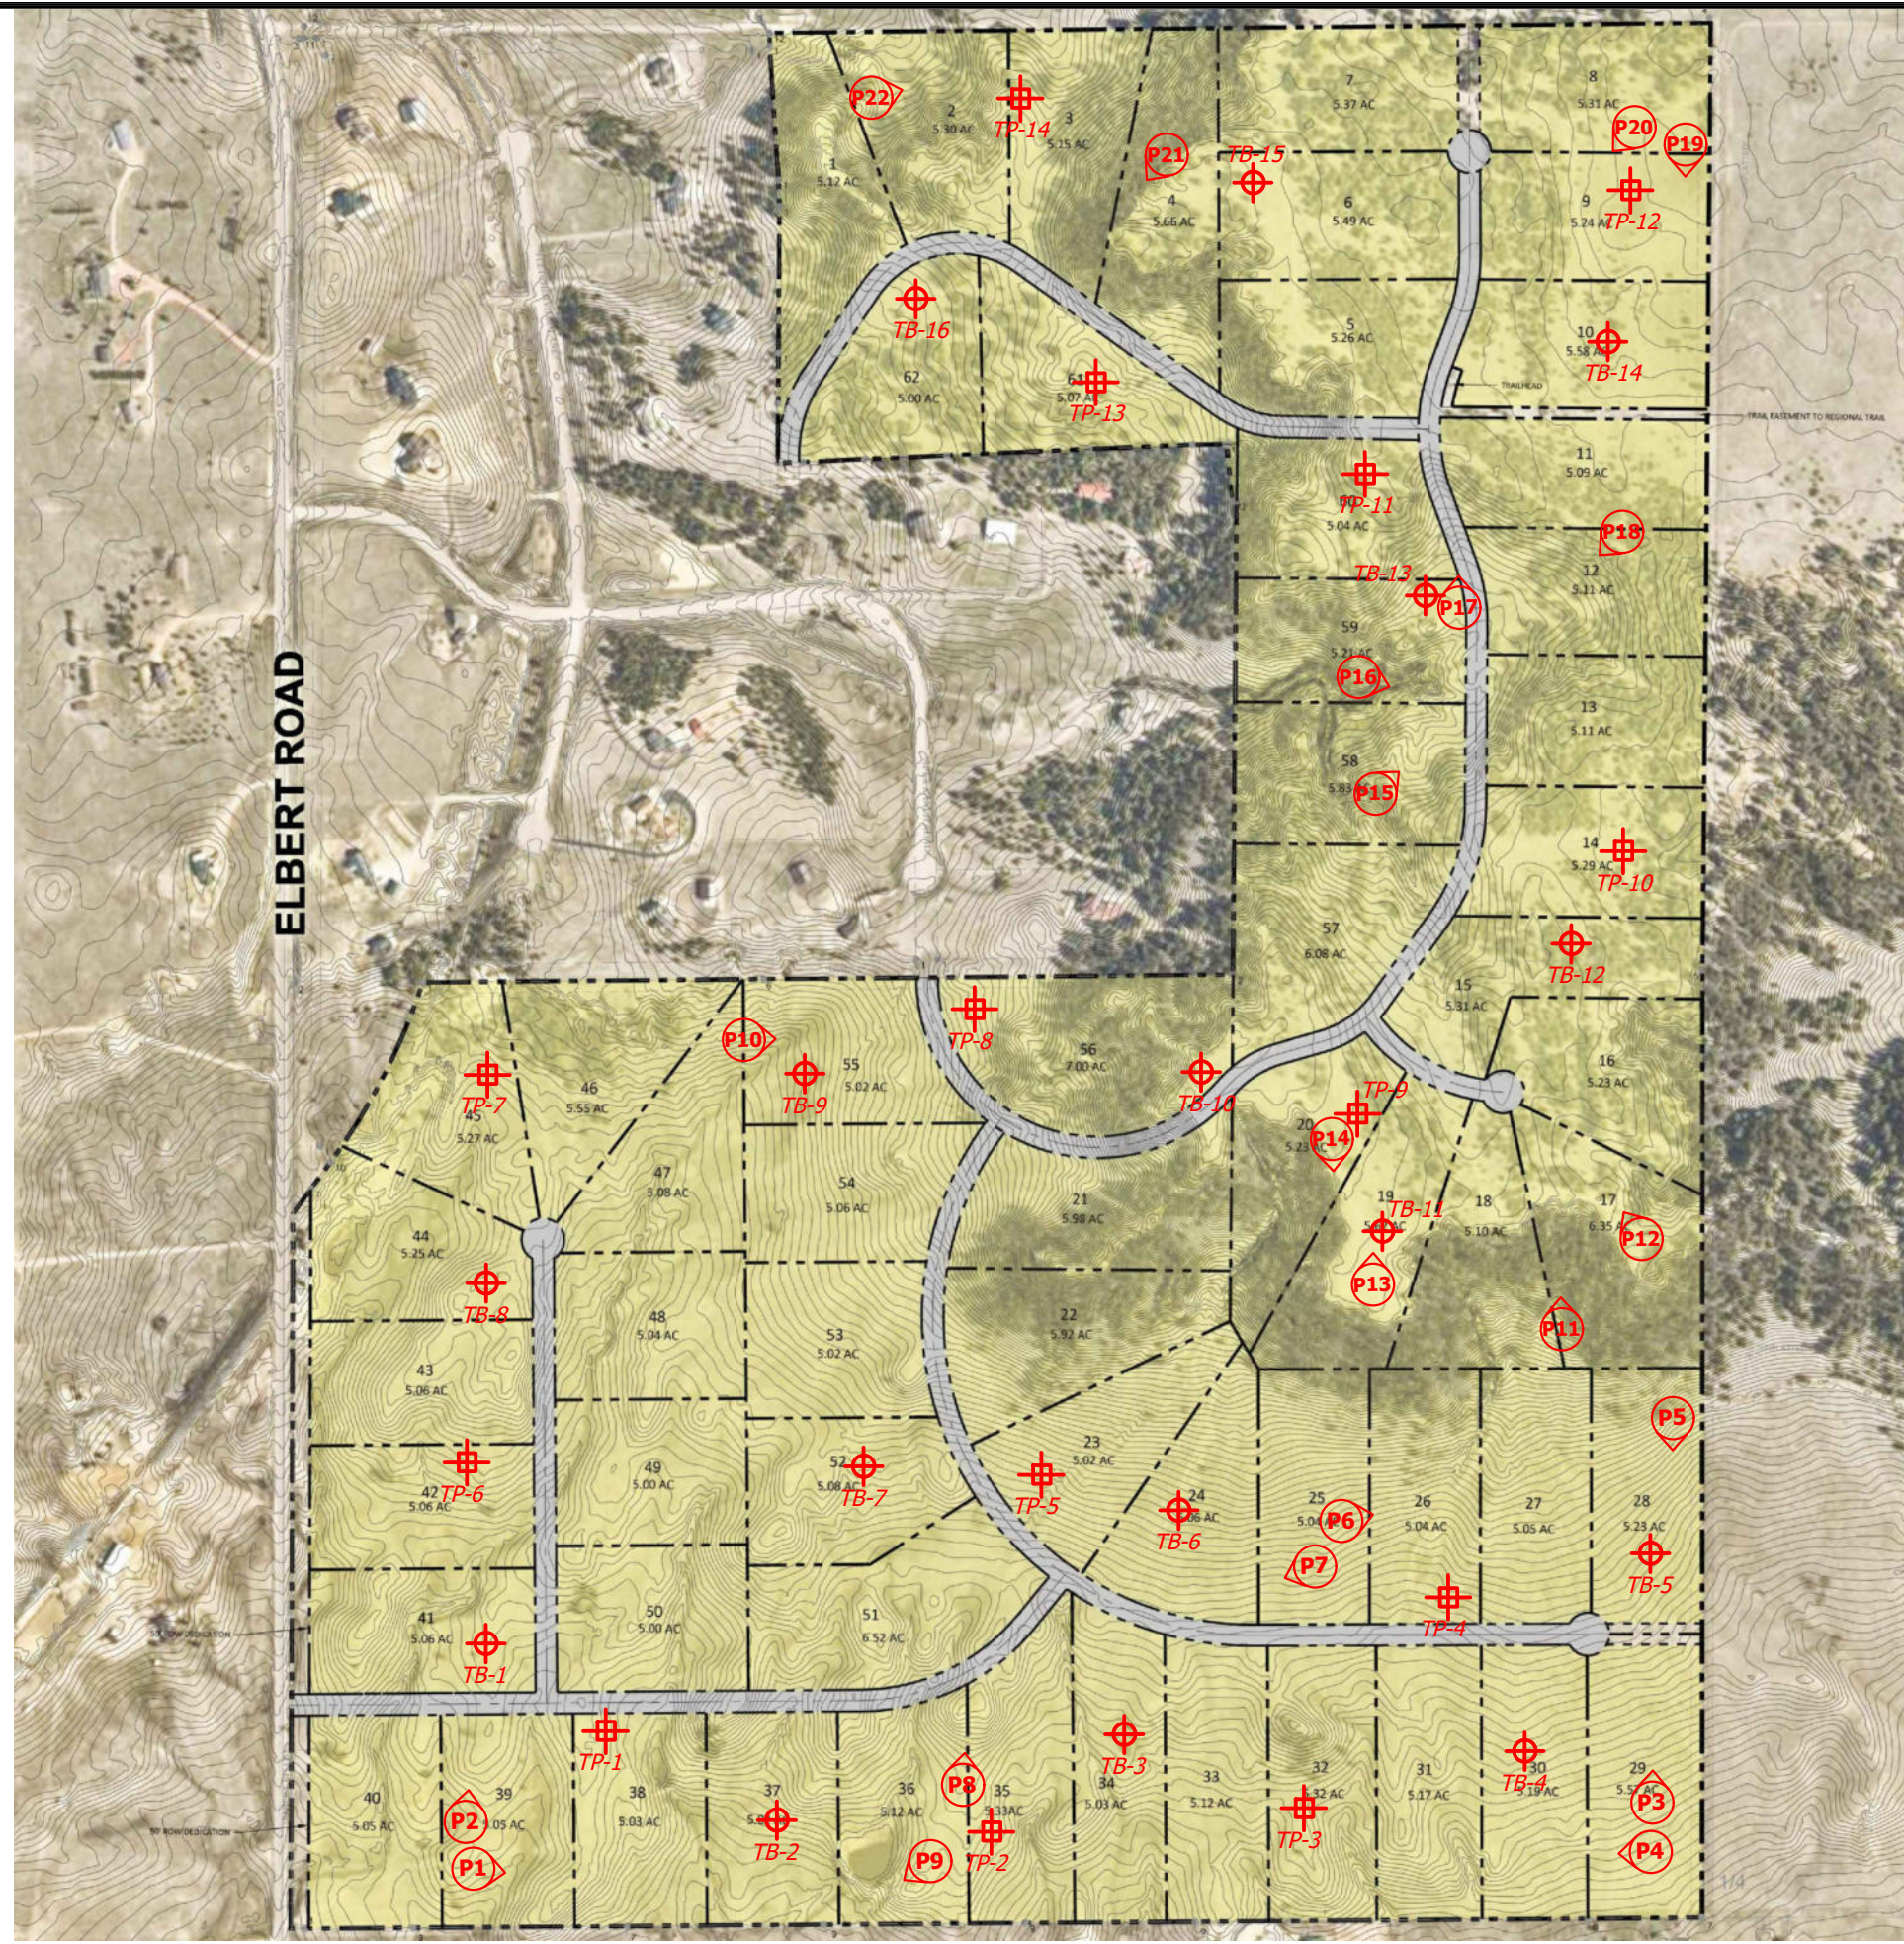
JOB NO.
230677
FIG. 3

SITE PLAN/TESTING LOCATION MAP
 OVERLOOK AT HOMESTEAD
 EL PASO COUNTY, COLORADO
 PT OVERLOOK, LLC

- APPROXIMATE TEST BORING LOCATION AND NUMBER
- APPROXIMATE PHOTOGRAPH LOCATION AND NUMBER

Total acreage involved in Overlook at Homestead Subdivision is approximately 346 acres. Sixty-two (62) single-family rural residential lots are proposed. Grading plans were not available at the time of this report. Grading is expected to be primarily associated with the construction of roads. The Development Plan/Test Boring Location Map is presented in Figure 3.

Boring Location Map, Figure 3. The Test Pit Logs are presented in Appendix B, and Summarized on Table B-1. Results of this testing will be discussed later in this report.

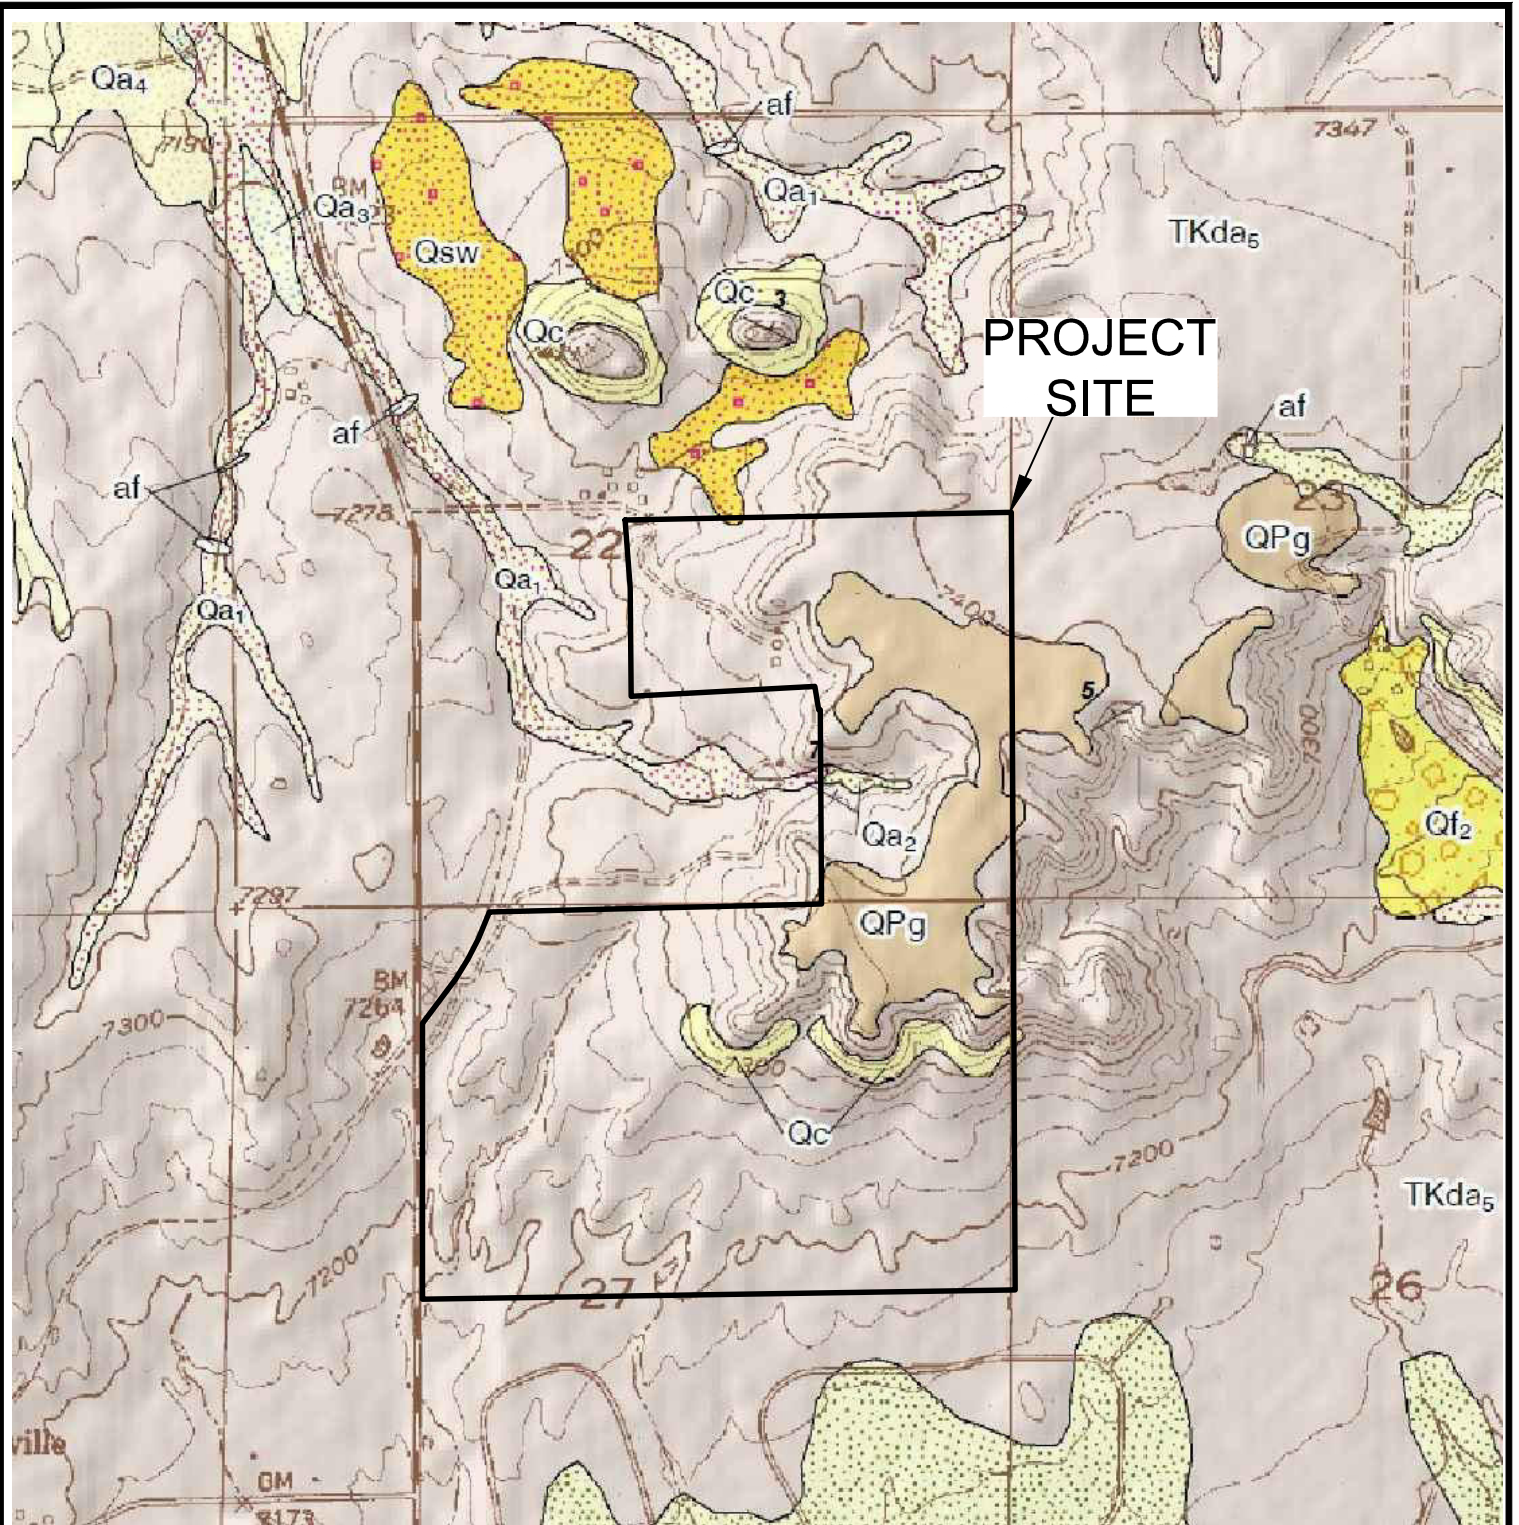
FIG. 5

EASTONVILLE QUADRANGLE GEOLOGIC MAP

OVERLOOK AT HOMESTEAD
 EL PASO COUNTY, COLORADO
 PT OVERLOOK, LLC

The Eastonville Quadrangle Geology Map showing the site is presented in (Figure 5, Reference 4). The Geology Map prepared for the site is presented in Figure 6. Five mappable units were identified on this site which are described as follows:

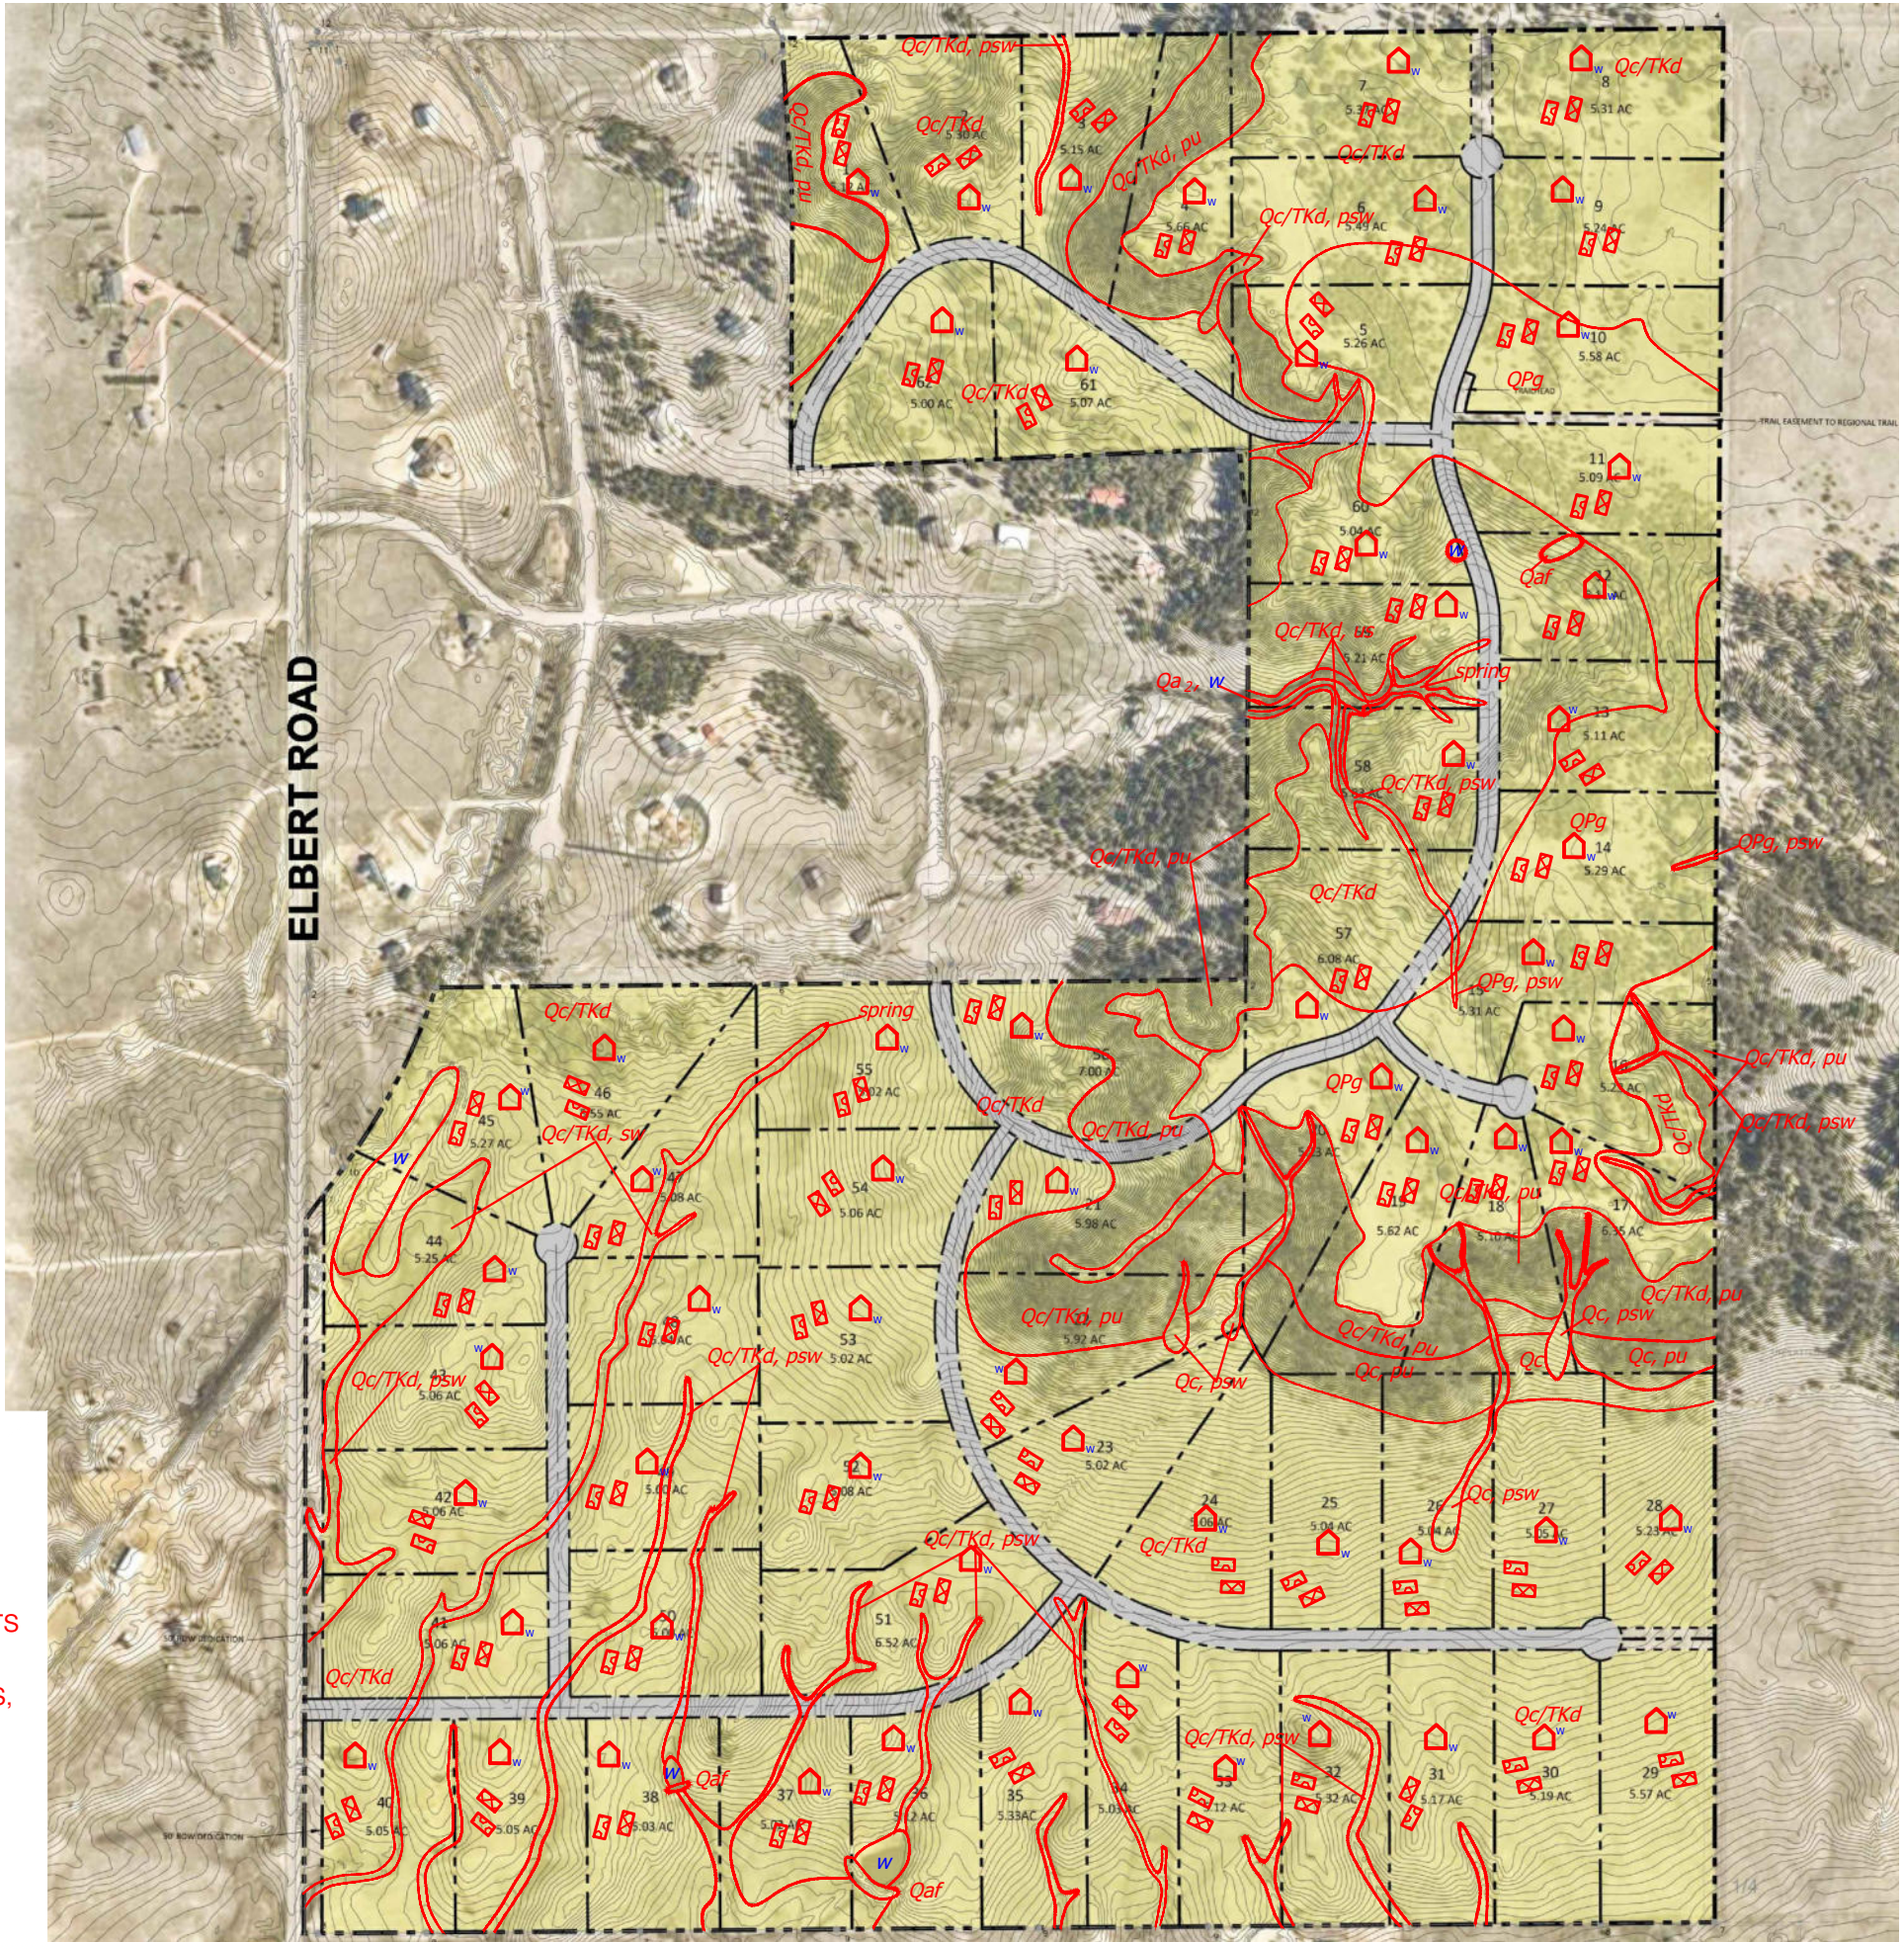
TP- APPROXIMATE TEST PIT LOCATION AND NUMBER

The site was evaluated for individual on-site wastewater treatment systems in accordance with El Paso Land Development Code. Fourteen (14) tactile test pits were excavated across the site. The test pits were located in potential locations of future systems. The approximate locations of the Test Pits are indicated on Figure 3, and on the Septic Suitability Map, Figure 8. A table showing the results of the Tactile Test Pits is presented in Table B-1. Test Pit Logs are included in Appendix B, and Laboratory Test Results in Appendix C. A Summary of Laboratory Test Results, and Test Pit Logs from the previous investigation are included in Table C-1.

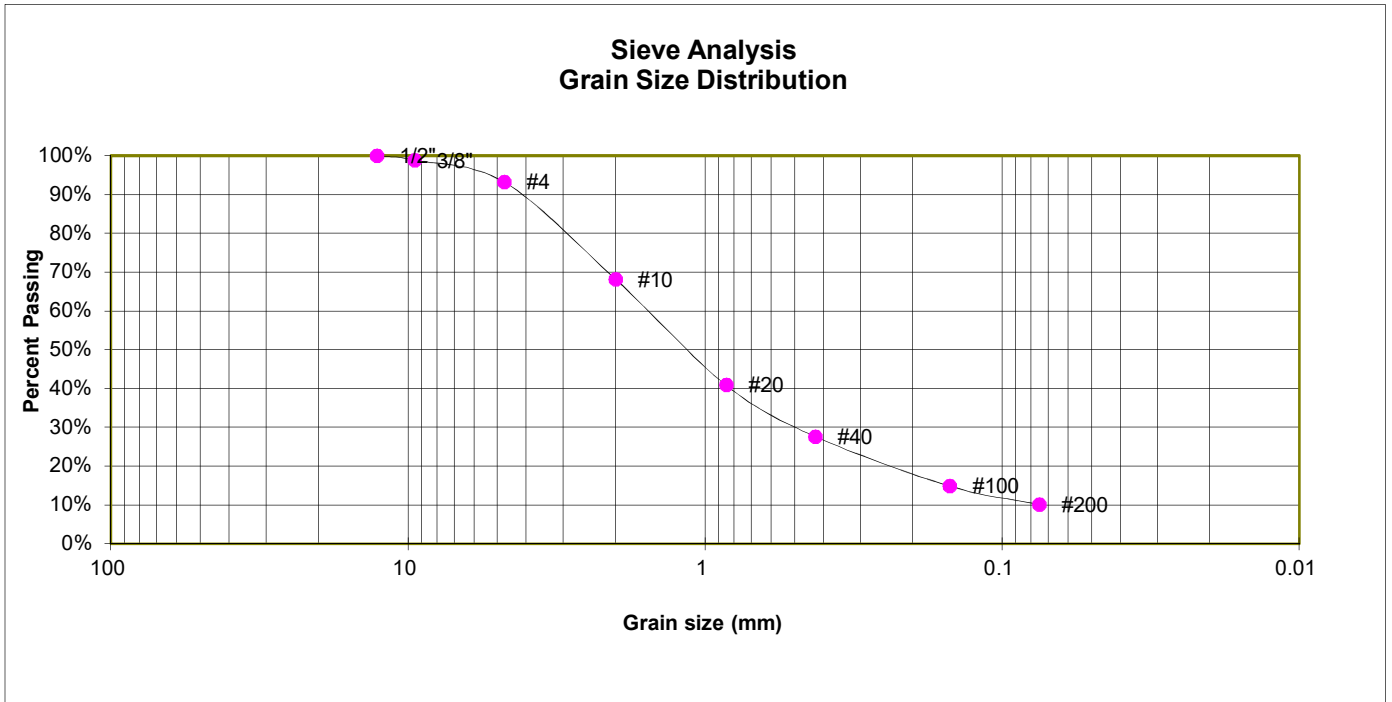
TEST BORING TP-13
DEPTH (FT) 2-4
SOIL TYPE 2A

SOIL DESCRIPTION SAND, WITH SILT
USCS CLASSIFICATION SM-SW

<u>U.S. Sieve #</u>	<u>Percent Finer</u>
3"	
1 1/2"	
3/4"	
1/2"	100.0%
3/8"	98.9%
4	93.2%
10	68.1%
20	40.9%
40	27.6%
100	14.8%
200	10.1%

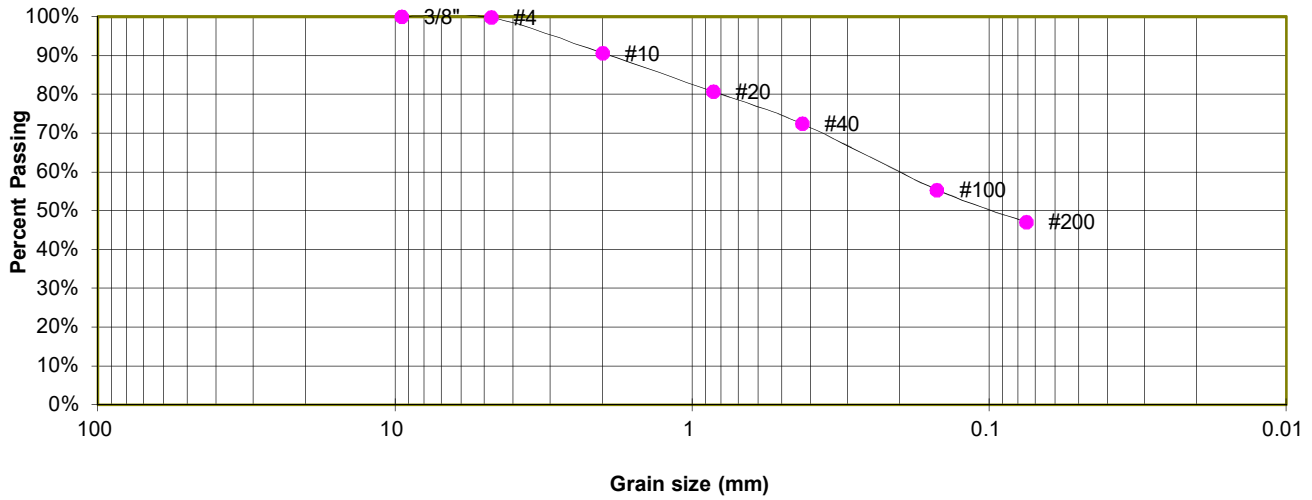
Sieve Analysis Grain Size Distribution

SOIL DESCRIPTION SAND, CLAYEY
USCS CLASSIFICATION SC

U.S. Sieve #	Percent Finer
3"	
1 1/2"	
3/4"	
1/2"	
3/8"	100.0%
4	99.8%
10	90.6%
20	80.7%
40	72.4%
100	55.4%
200	47.0%

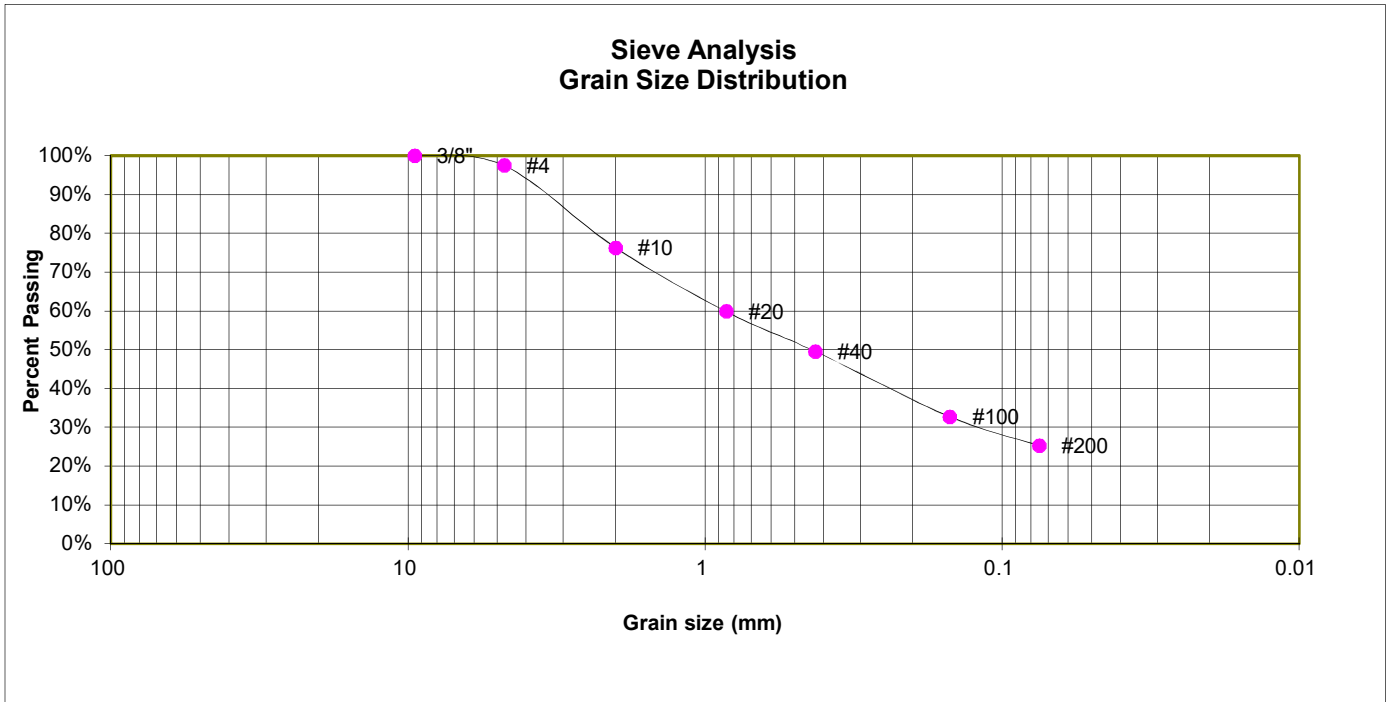
TEST BORING TP-8
 DEPTH (FT) 4-6
 SOIL TYPE 3A

SOIL DESCRIPTION SAND, CLAYEY
 USCS CLASSIFICATION SC

U.S. Sieve #	Percent Finer
3"	
1 1/2"	
3/4"	
1/2"	
3/8"	100.0%
4	97.5%
10	76.3%
20	59.8%
40	49.5%
100	32.7%
200	25.2%

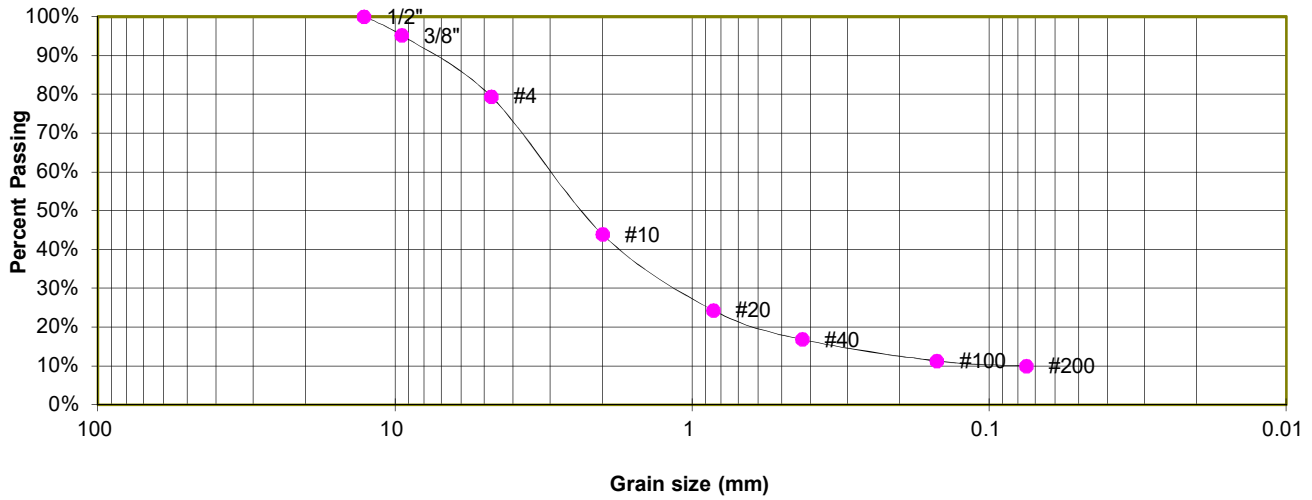
Sieve Analysis Grain Size Distribution

SOIL DESCRIPTION SAND, WITH SILT
USCS CLASSIFICATION SM-SW

U.S. Sieve #	Percent Finer
3"	
1 1/2"	
3/4"	
1/2"	100.0%
3/8"	95.2%
4	79.5%
10	43.9%
20	24.4%
40	16.8%
100	11.3%
200	9.9%

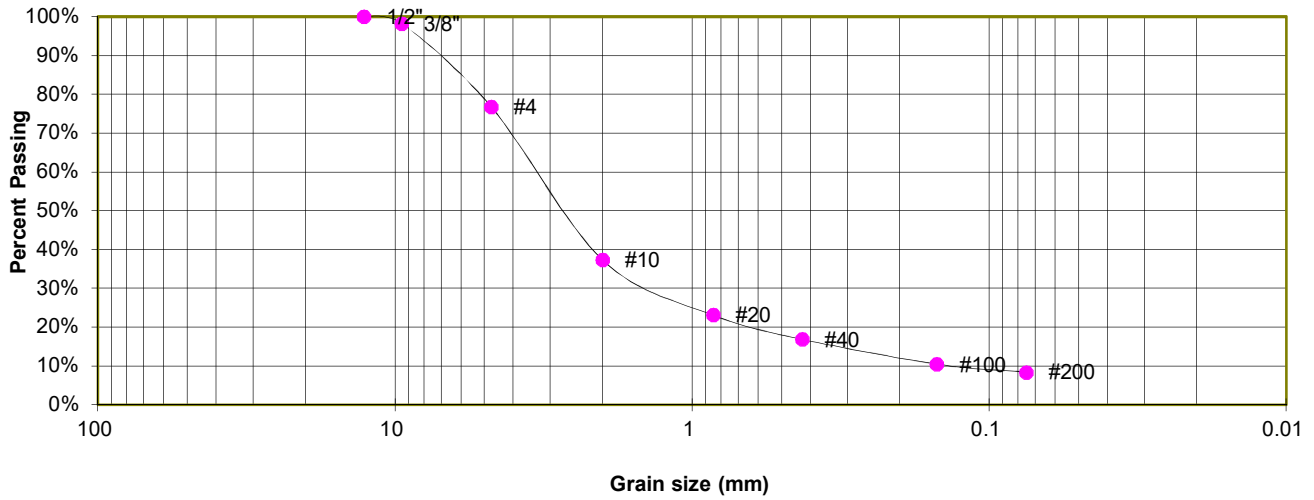
Sieve Analysis Grain Size Distribution

SOIL DESCRIPTION SAND, WITH SILT
USCS CLASSIFICATION SM-SW

U.S. Sieve #	Percent Finer
3"	
1 1/2"	
3/4"	
1/2"	100.0%
3/8"	98.2%
4	76.8%
10	37.3%
20	23.1%
40	16.8%
100	10.4%
200	8.4%

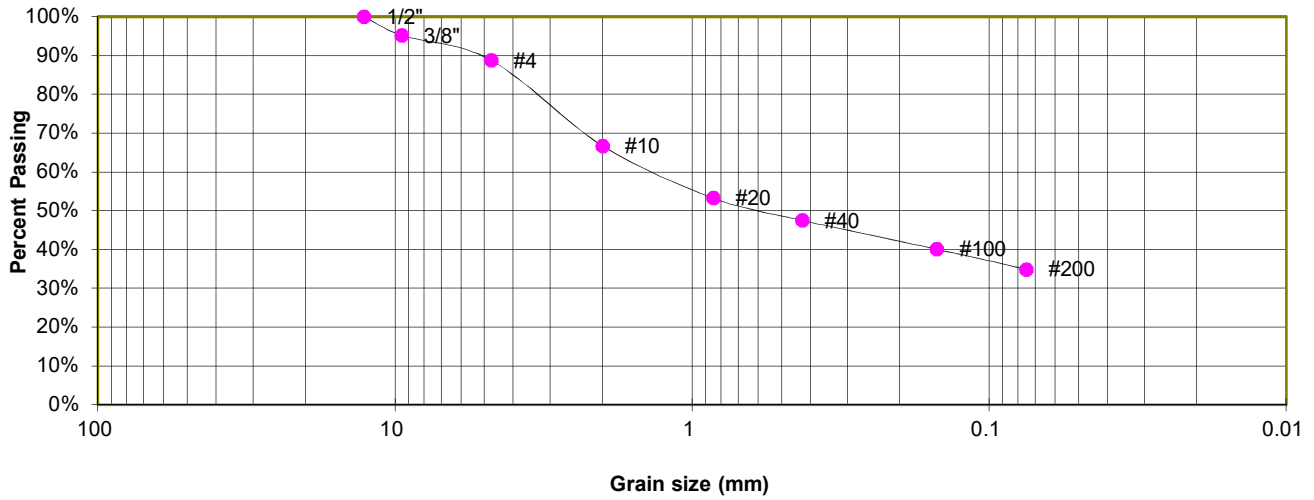
**Sieve Analysis
 Grain Size Distribution**

SOIL DESCRIPTION SAND, CLAYEY
 USCS CLASSIFICATION SC

U.S. Sieve #	Percent Finer
3"	
1 1/2"	
3/4"	
1/2"	100.0%
3/8"	95.2%
4	88.8%
10	66.7%
20	53.3%
40	47.5%
100	40.1%
200	34.9%

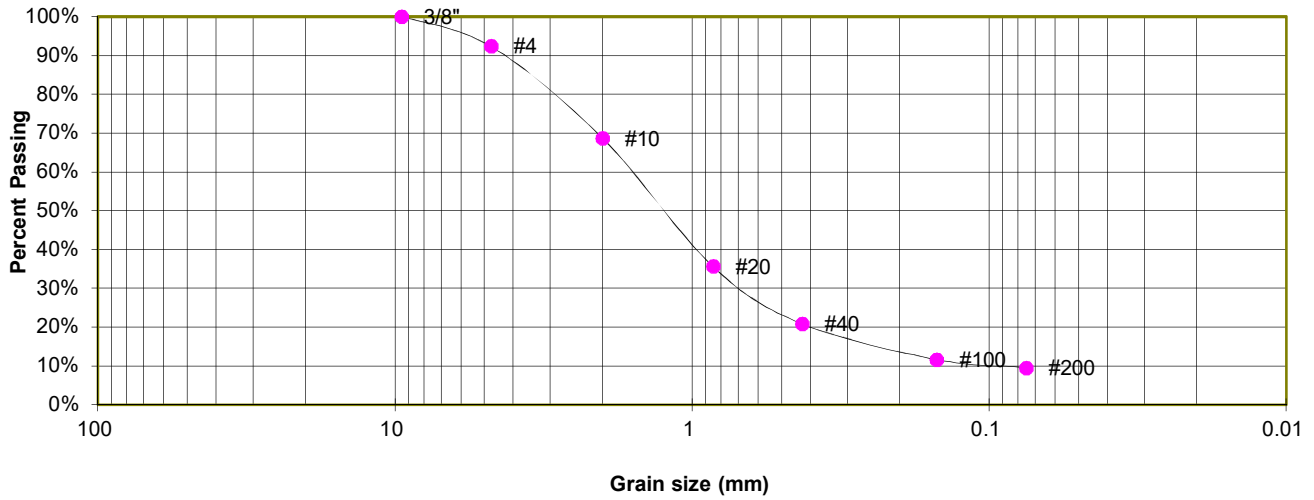
Sieve Analysis Grain Size Distribution

SOIL DESCRIPTION SAND, WITH SILT
USCS CLASSIFICATION SM-SW

U.S. Sieve #	Percent Finer
3"	
1 1/2"	
3/4"	
1/2"	
3/8"	100.0%
4	92.3%
10	68.7%
20	35.6%
40	20.8%
100	11.6%
200	9.5%
