ENTECH
ENGINEERING, INC.

**SOILS AND GEOLOGY STUDY
OVERLOOK AT HOMESTEAD
ELBERT ROAD
EL PASO COUNTY, COLORADO**

August 2, 2023

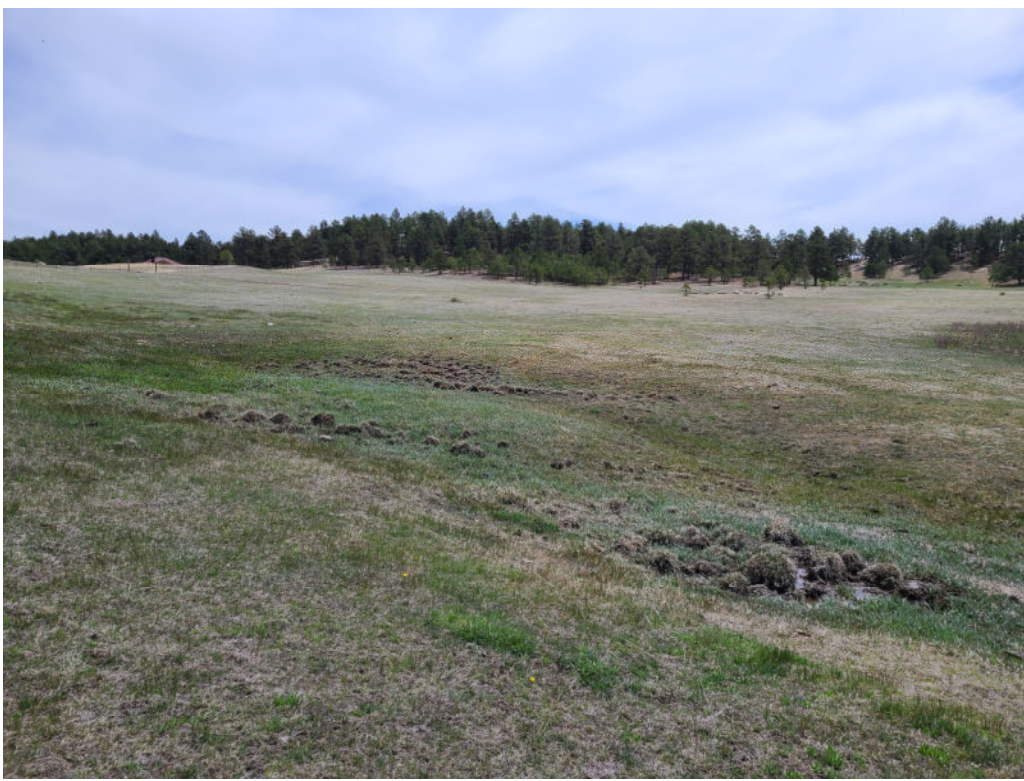
Looking east towards spring in the area of Lots 47 and 55.

Two springs were observed in the west-central portion of the site. The springs should be avoided by development and will likely be located within drainage easements. Springs other than those indicated on Figure 6 may be present on the site.

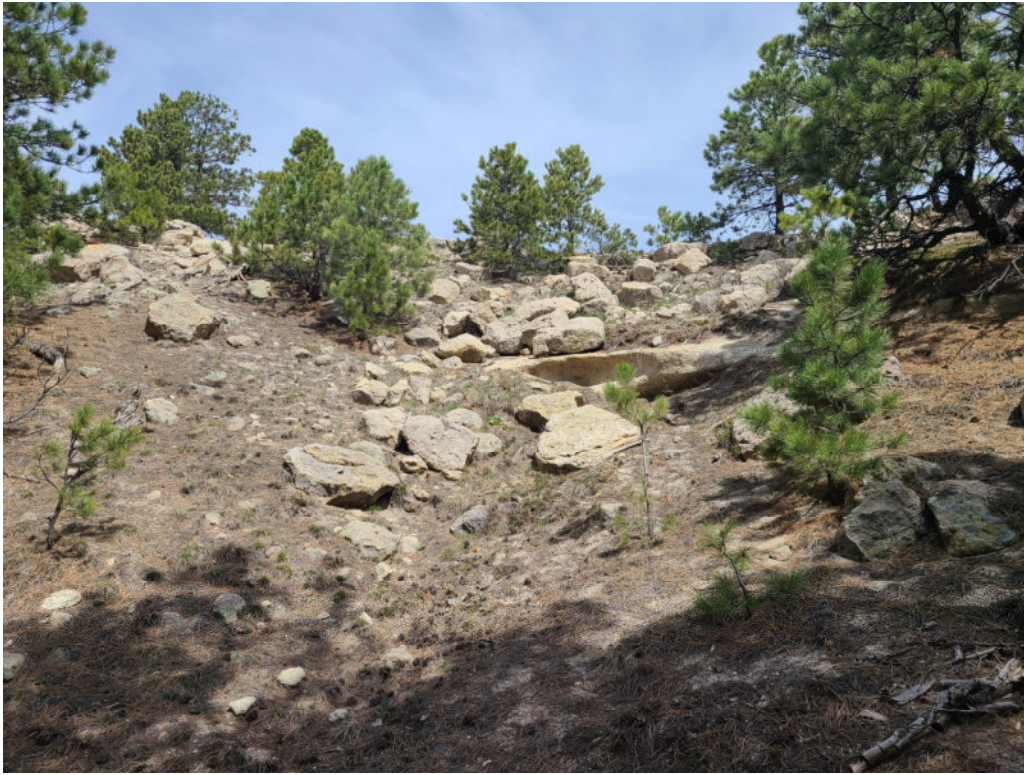
**Looking towards cliff
in the southeastern
portion of the site.**

Based on our site observation, some of the rock outcrops along the mesa have the potential for minor rockfall hazards. These areas are associated with the cliff-forming portions of the Dawson Formation along the slopes of the mesa. These areas have been identified on the Geology/Engineering Geology Map, Figure 6.

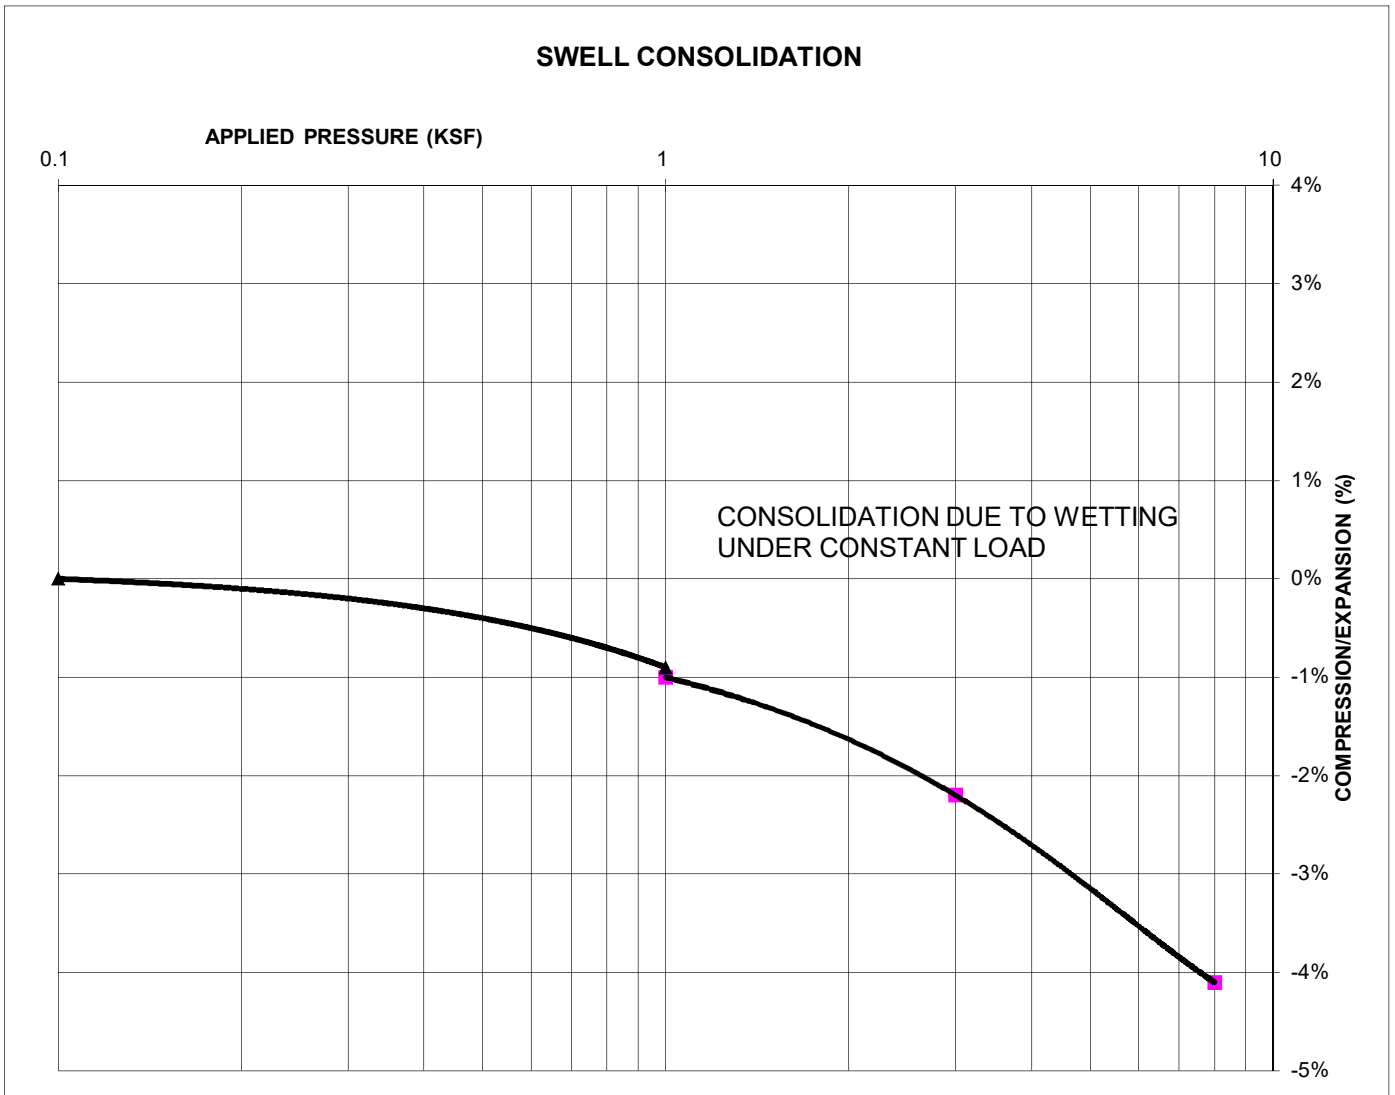
TEST BORING 3
DEPTH (FT) 15

SOIL DESCRIPTION SILTSTONE, SANDY
SOIL TYPE 4

SWELL/CONSOLIDATION TEST RESULTS

NATURAL UNIT DRY WEIGHT (PCF): 108
NATURAL MOISTURE CONTENT: 15.0%
SWELL/CONSOLIDATION (%): -0.1%
