ENTECH
ENGINEERING, INC.

September 22, 2021
Revised June 22, 2023

Re: Wastewater Study
Joyful View Subdivision
Joyful View & Peyton Highway
Schedule Nos. 33000-00-466 & 33000-00-467
El Paso County, Colorado

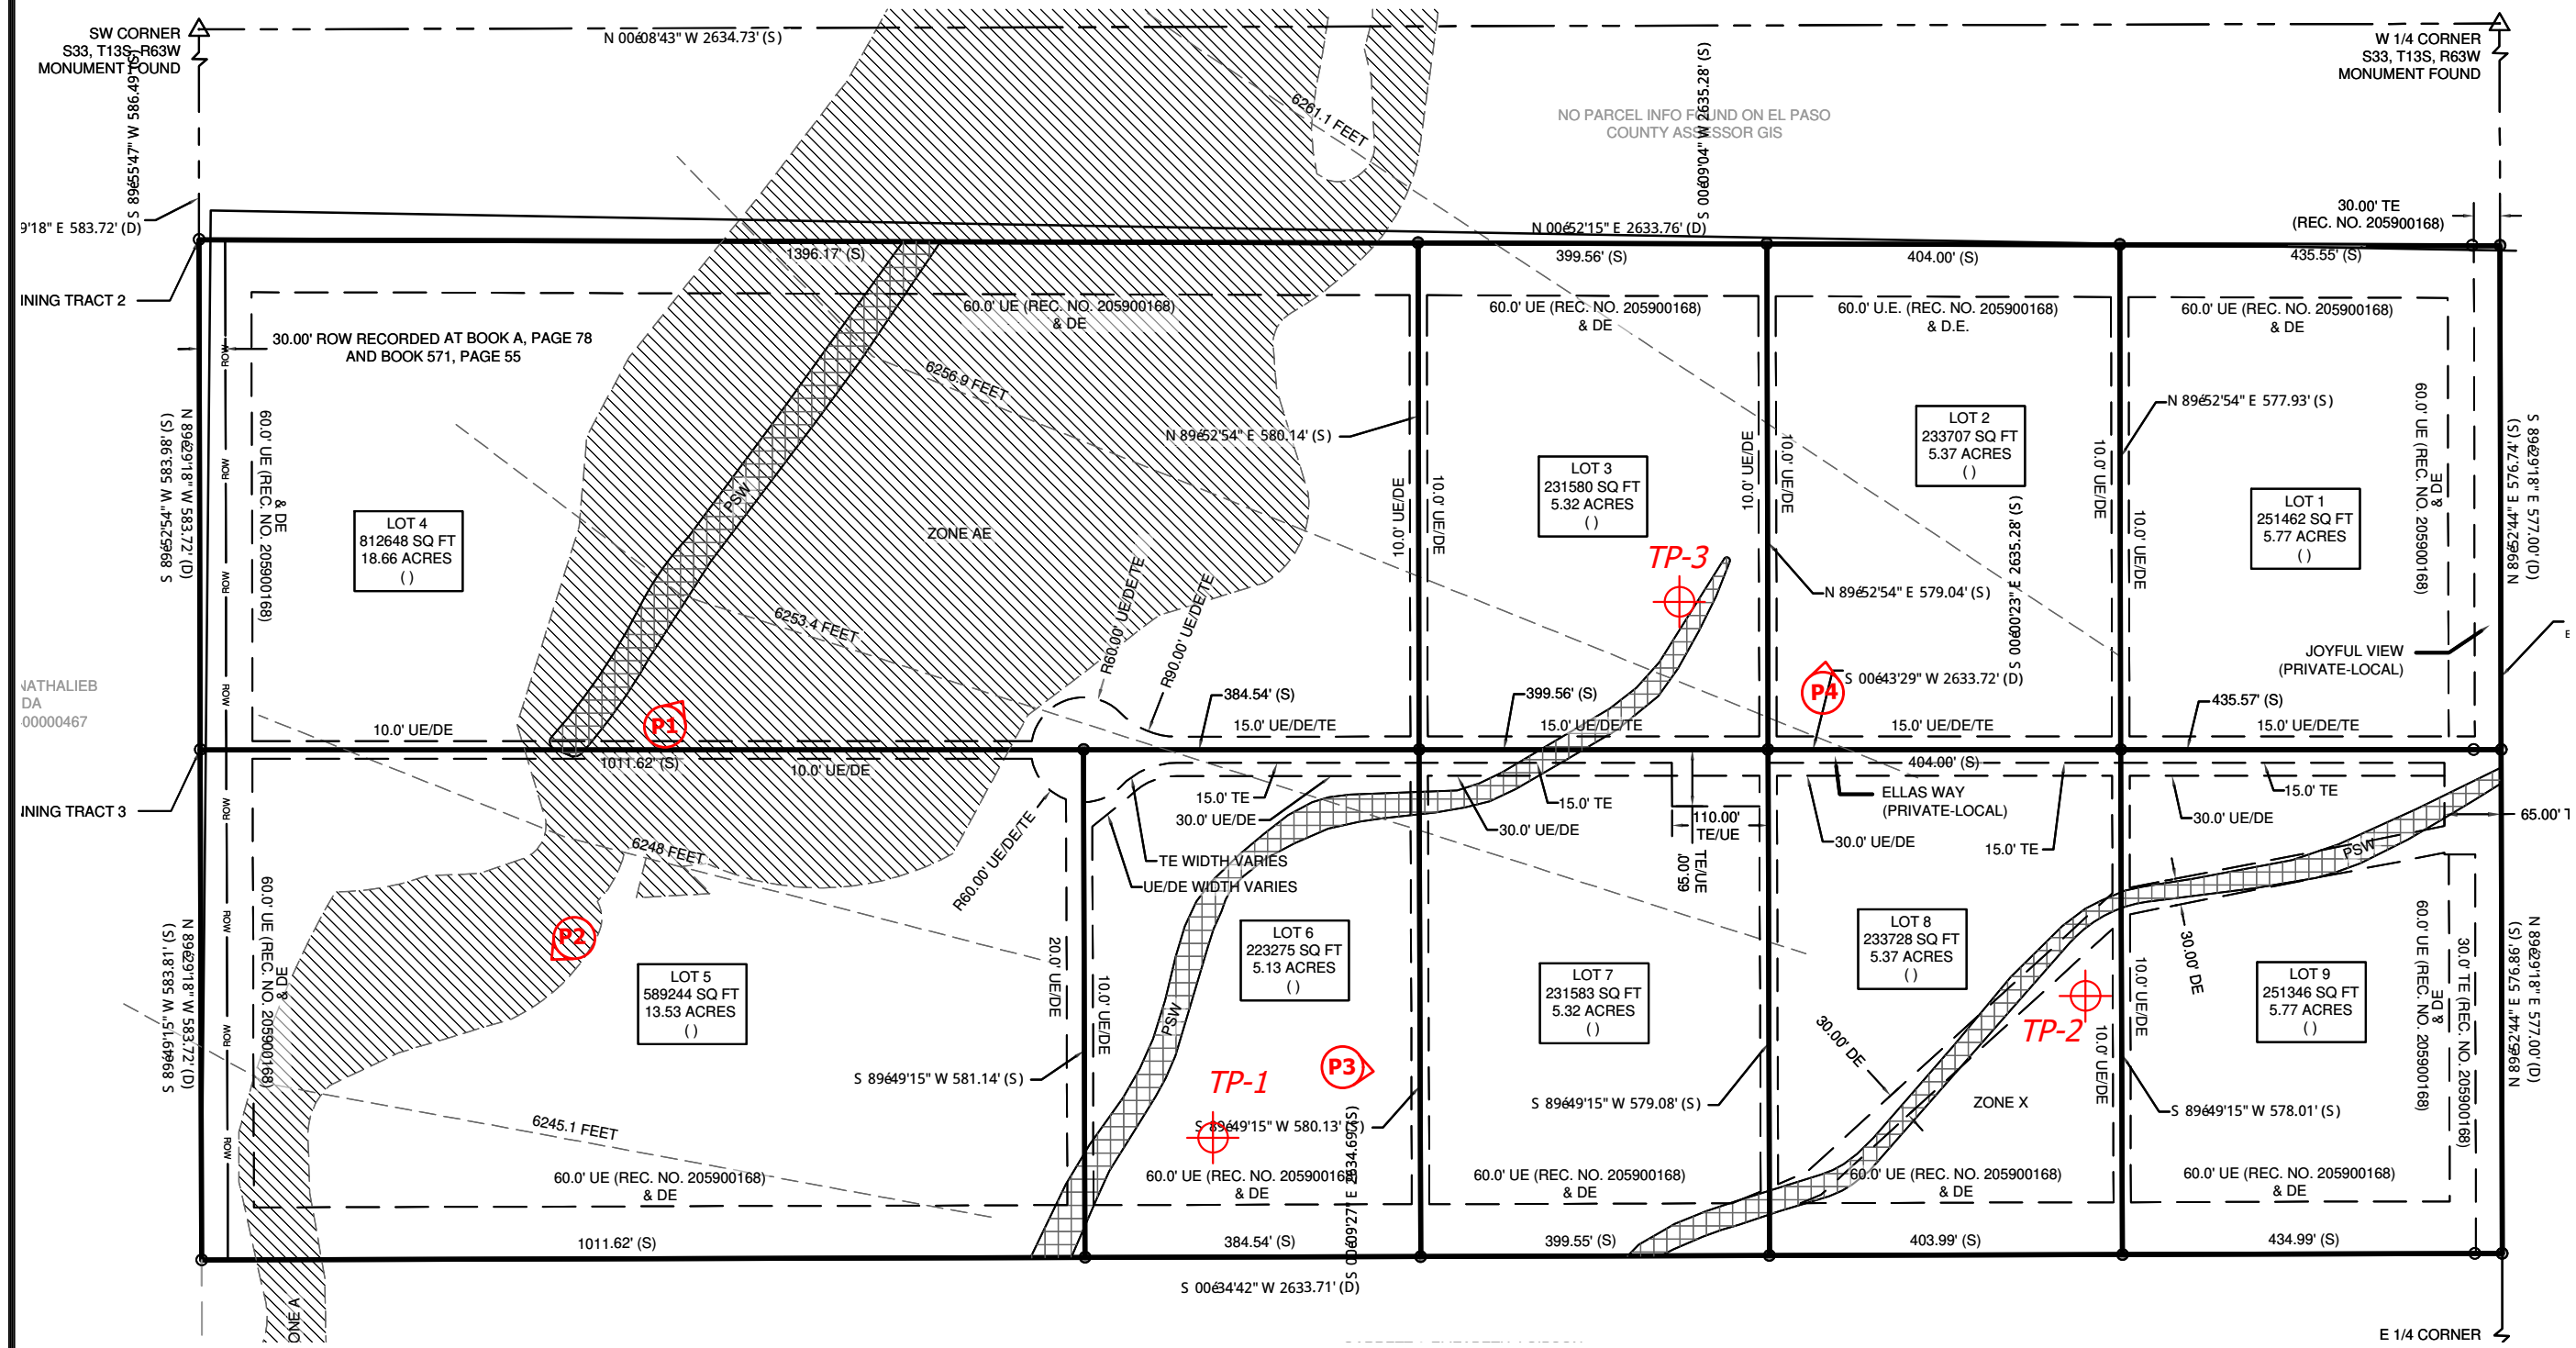
JOB NO.
210182
FIG. 3

⊕ - APPROXIMATE TEST BORING LOCATION AND NUMBER
P1 - APPROXIMATE PHOTOGRAPH LOCATION AND NUMBER

SITE PLANT/TESTING LOCATION MAP
JOYFUL VIEW & PEYTON HIGHWAY
VERTEX CONSULTING

Total acreage involved in the proposed subdivision is 70.19-acres. Nine residential lots are proposed as part of the replat. The proposed lot sizes of 5.1 to 18.6-acres. The lots will be serviced by individual water wells and on-site wastewater treatment systems. The Site Plan is presented in Figure 3.

Three test pits were excavated on the site to determine general suitability of the soil characteristics for residential construction and on-site wastewater treatment systems. The locations of the test pits are indicated on the Site Plan/Test Boring Location Map, Figure 3. The Test Pit Logs are presented in Appendix C, and Laboratory Testing results are included in Appendix D.

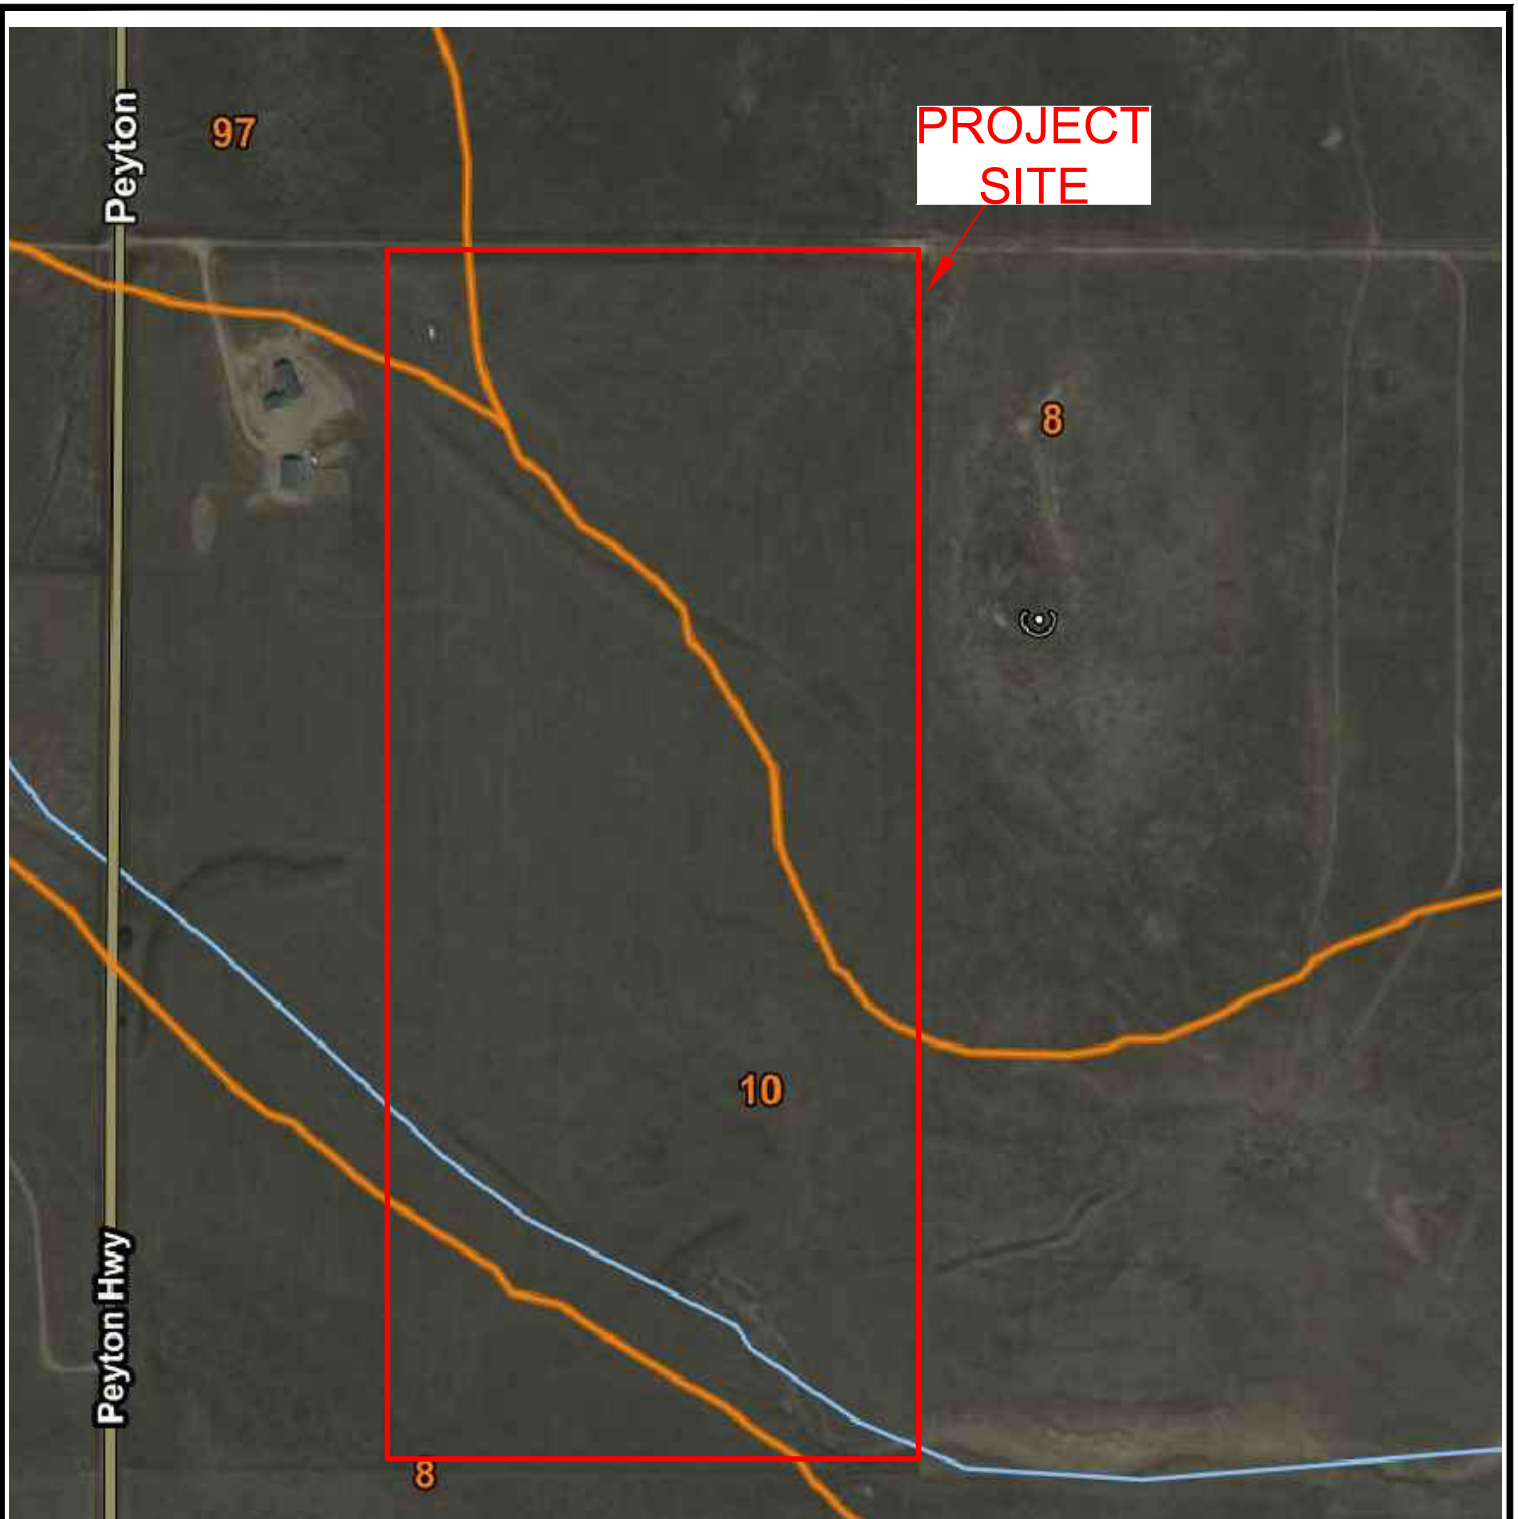
FIG. 4

SOIL SURVEY MAP
JOYFUL VIEW & PEYTON HIGHWAY
VERTEX CONSULTING

The Natural Resource Conservation Service (NRCS) (Reference 2, Figure 4), previously the Soil Conservation Service (Reference 3) has mapped three soil types on the site. Complete descriptions of the soils are presented in Appendix E. In general, the soils consist of sandy loam. The soils are described as follows:

The Natural Resource Conservation Service (Reference 2), previously the Soil Conservation Service (Reference 3) has been mapped with three soil descriptions. The Soil Survey Map (Reference 3) is presented in Figure 4, and the Soil Survey Descriptions (Reference 3) are presented in Appendix E. The soils are described as having moderate to rapid percolation rates.

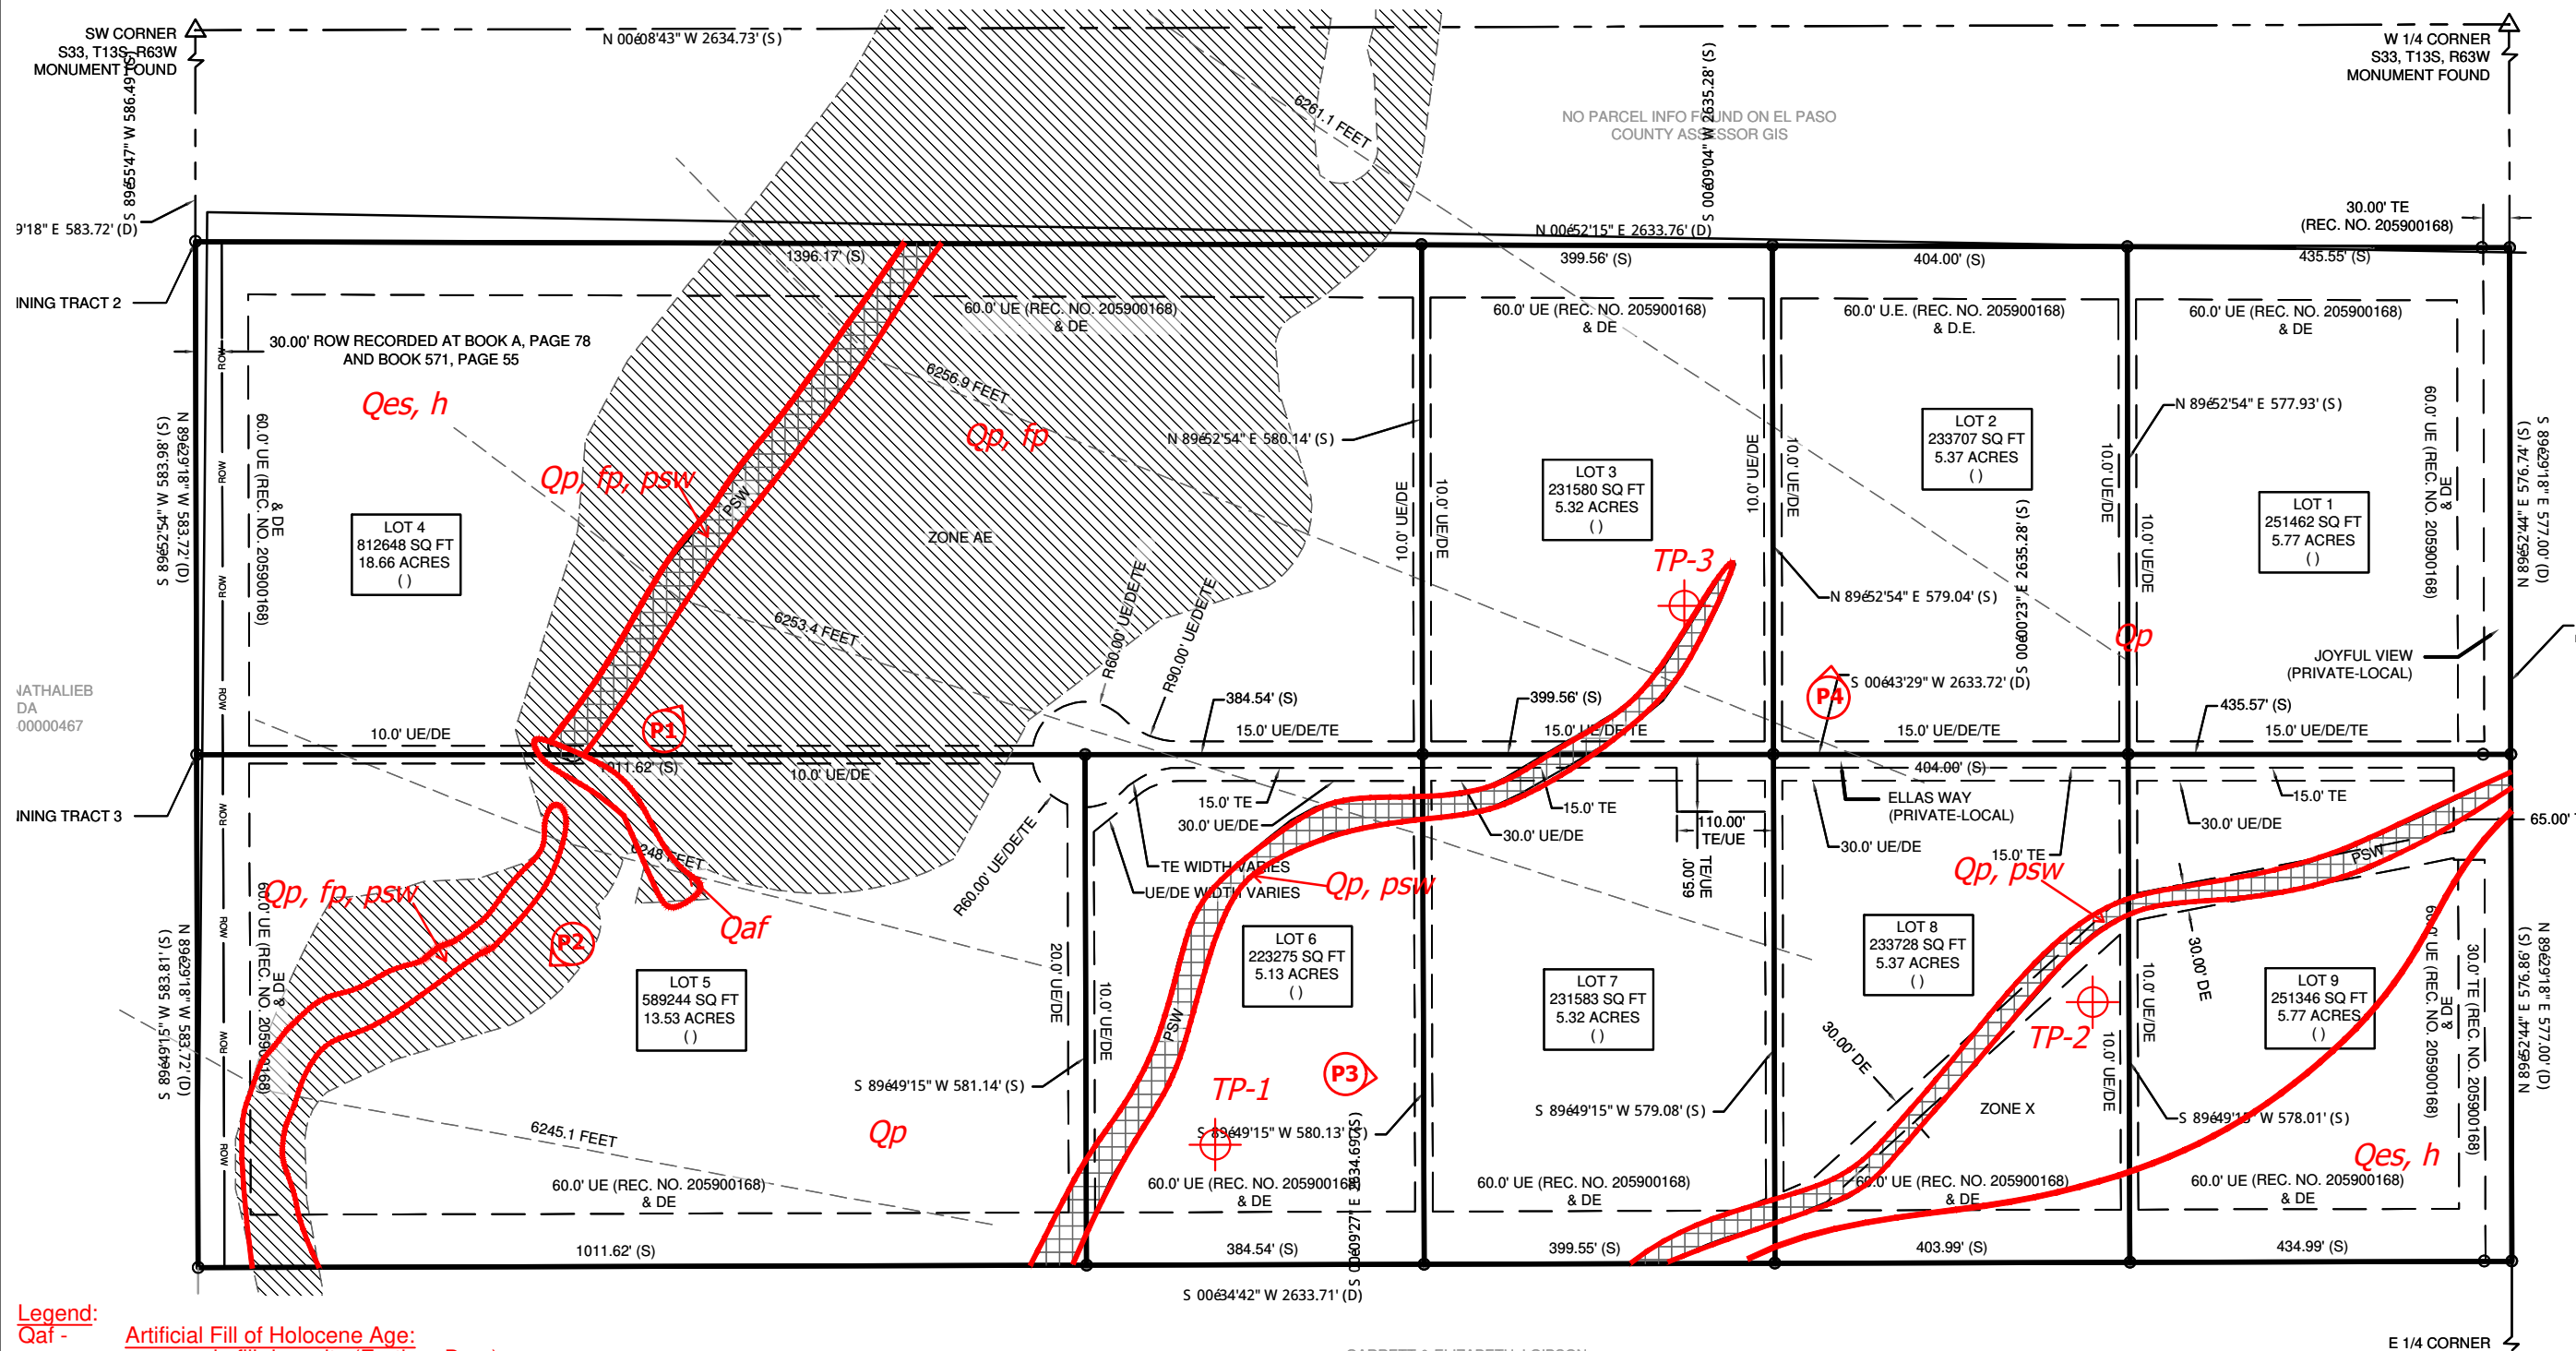
FIG. 6

**GEOLOGY/ENGINEERING
GEOLOGY MAP**
JOYFUL VIEW & PEYTON HIGHWAY
VERTEX CONSULTING

Qaf -	<u>Artificial Fill of Holocene Age:</u> man-made fill deposits (Earthen Dam)
Qp -	<u>Piney Creek Alluvium of Quaternary Age:</u> water deposited sands and clays
Qes -	<u>Eolian Sands of Quaternary Age:</u> wind blown sediments
psw -	potentially seasonally wet
fp -	floodplain
h -	hydrocompactive soil

The geology of the site was evaluated using the *Geologic Map of Pueblo 1-degree x 2-degrees' quadrangle, South-Central Colorado*, by Scott, G.R., et.al. in 1976, (Reference 4). The Geology Map for the site is presented in Figure 6. Three mappable units were identified on this site which is described as follows:

The soils listed above were mapped from site-specific mapping, the *Geologic map of the Pueblo 1-degree x 2-degrees' quadrangle, south-central Colorado* published by the U.S. Geologic Survey in 1976 (Reference 4). The test pits were used in evaluating the site and are included in Appendix B. The Geology Map prepared for the site is presented in Figure 6.

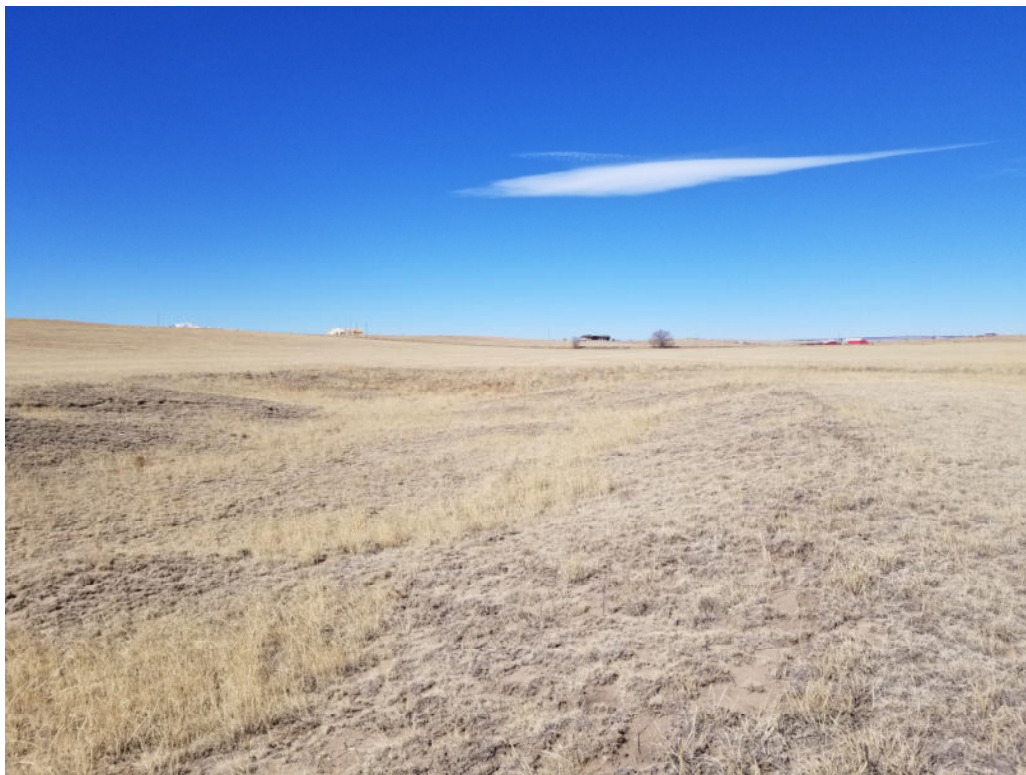
**Looking northwest
along drainage in the
southeastern portion
of the site.**

The topography of the site is gradually sloping to the southeast with moderate slopes the along the drainage in the southeastern portion of the site. A drainage is located along the southern side of the site and a minor drainage swales are located in the northern and central portions of the site. The drainage flows in a southeasterly direction. Water was not observed in the drainages at the time of this investigation. The site boundaries are indicated on the USGS Map, Figure 2. Previous land uses have included agricultural grazing and undeveloped land. The site contains primarily field grasses, weeds, yucca and cacti. Site photographs, taken February 23, 2021, are included in Appendix A.

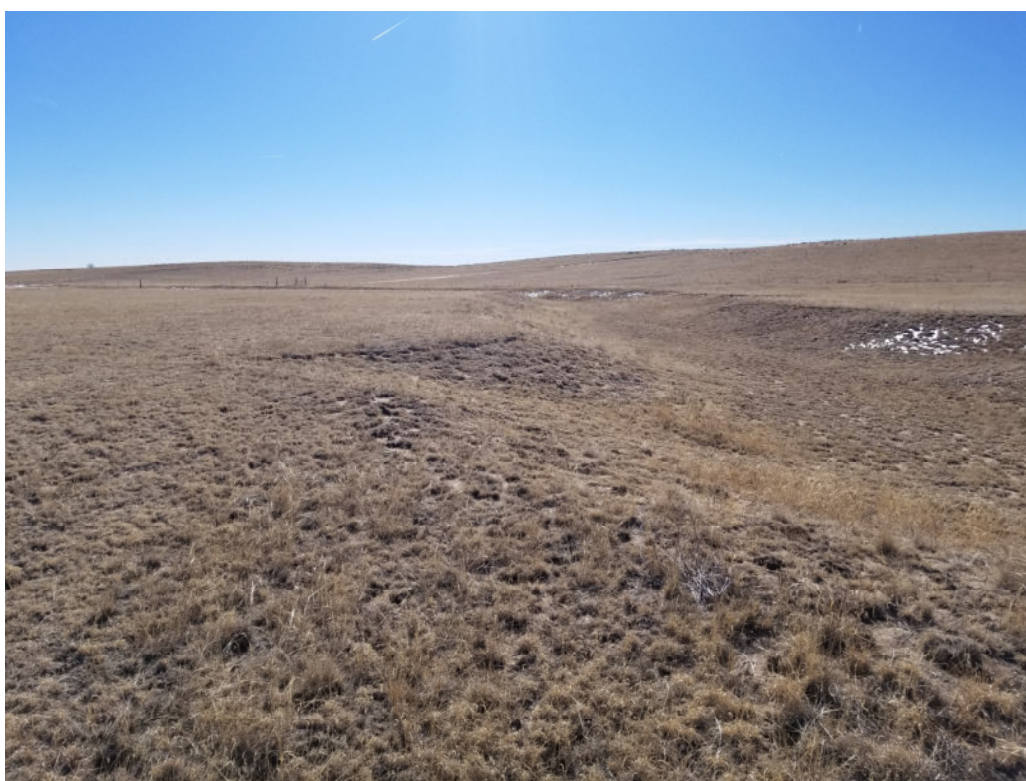
**Looking southeast
along drainage in the
southeastern portion
of the site.**

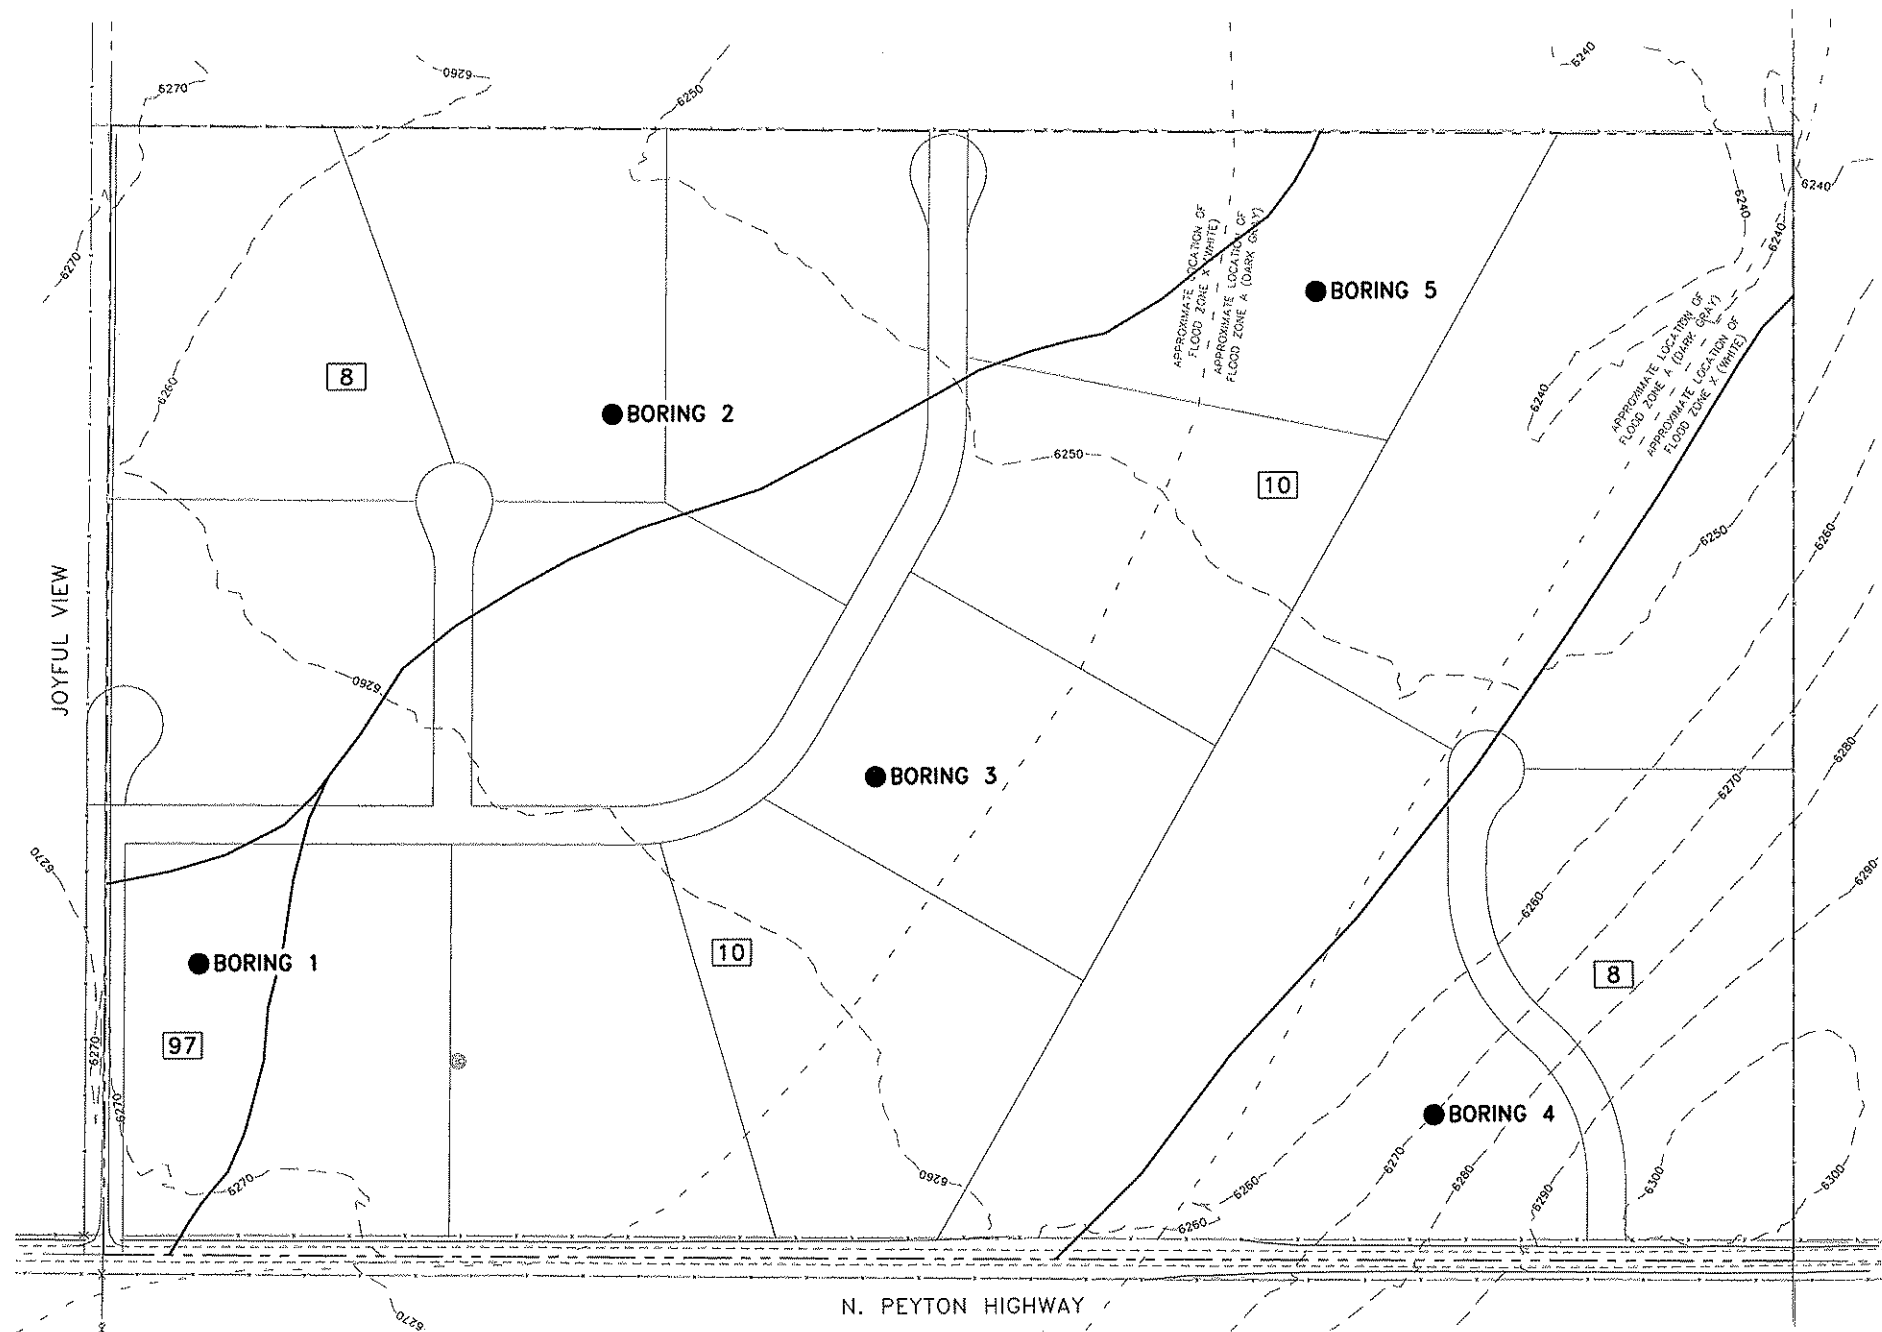
SOIL CONSERVATION SERVICE SOIL UNITS

- 8** BLAKELAND LOAMY SAND, 1% TO 9% SLOPES. SOIL FORMED IN ALLUVIAL OR EOLIAN DEPOSITS ON UPLANDS.
- 10** BLENDON SANDY LOAM, 0% TO 3% SLOPES. SOIL FORMED IN SANDY ARKOSIC ALLUVIUM.
- 97** TRUCKTON SANDY LOAM, 3% TO 9% SLOPES. SOIL FORMED IN ALLUVIUM OR RESIDIUM DERIVED FROM ARKOSIC SEDIMENTARY ROCK ON UPLANDS.
- BORING 4** ● EXPLORATORY BORING (PROFILE HOLE). THREE PERCOLATION TEST HOLES WERE DRILLED ADJACENT TO BORINGS 1-4 IN A TRIANGULAR PATTERN.
- APPROXIMATE CONTACT BETWEEN SOIL UNITS.

1. BASE MAP, TOPOGRAPHY AND FLOODPLAIN BOUNDARIES PROVIDED BY LDC, INC.
2. SOIL UNIT BOUNDARIES ARE APPROXIMATE AND ARE BASED ON OUR INTERPRETATION OF THE SOIL UNITS PRESENTED ON PLATE 19 OF THE UNITED STATES DEPARTMENT OF AGRICULTURE (1981), SOIL CONSERVATION SERVICE MAP.

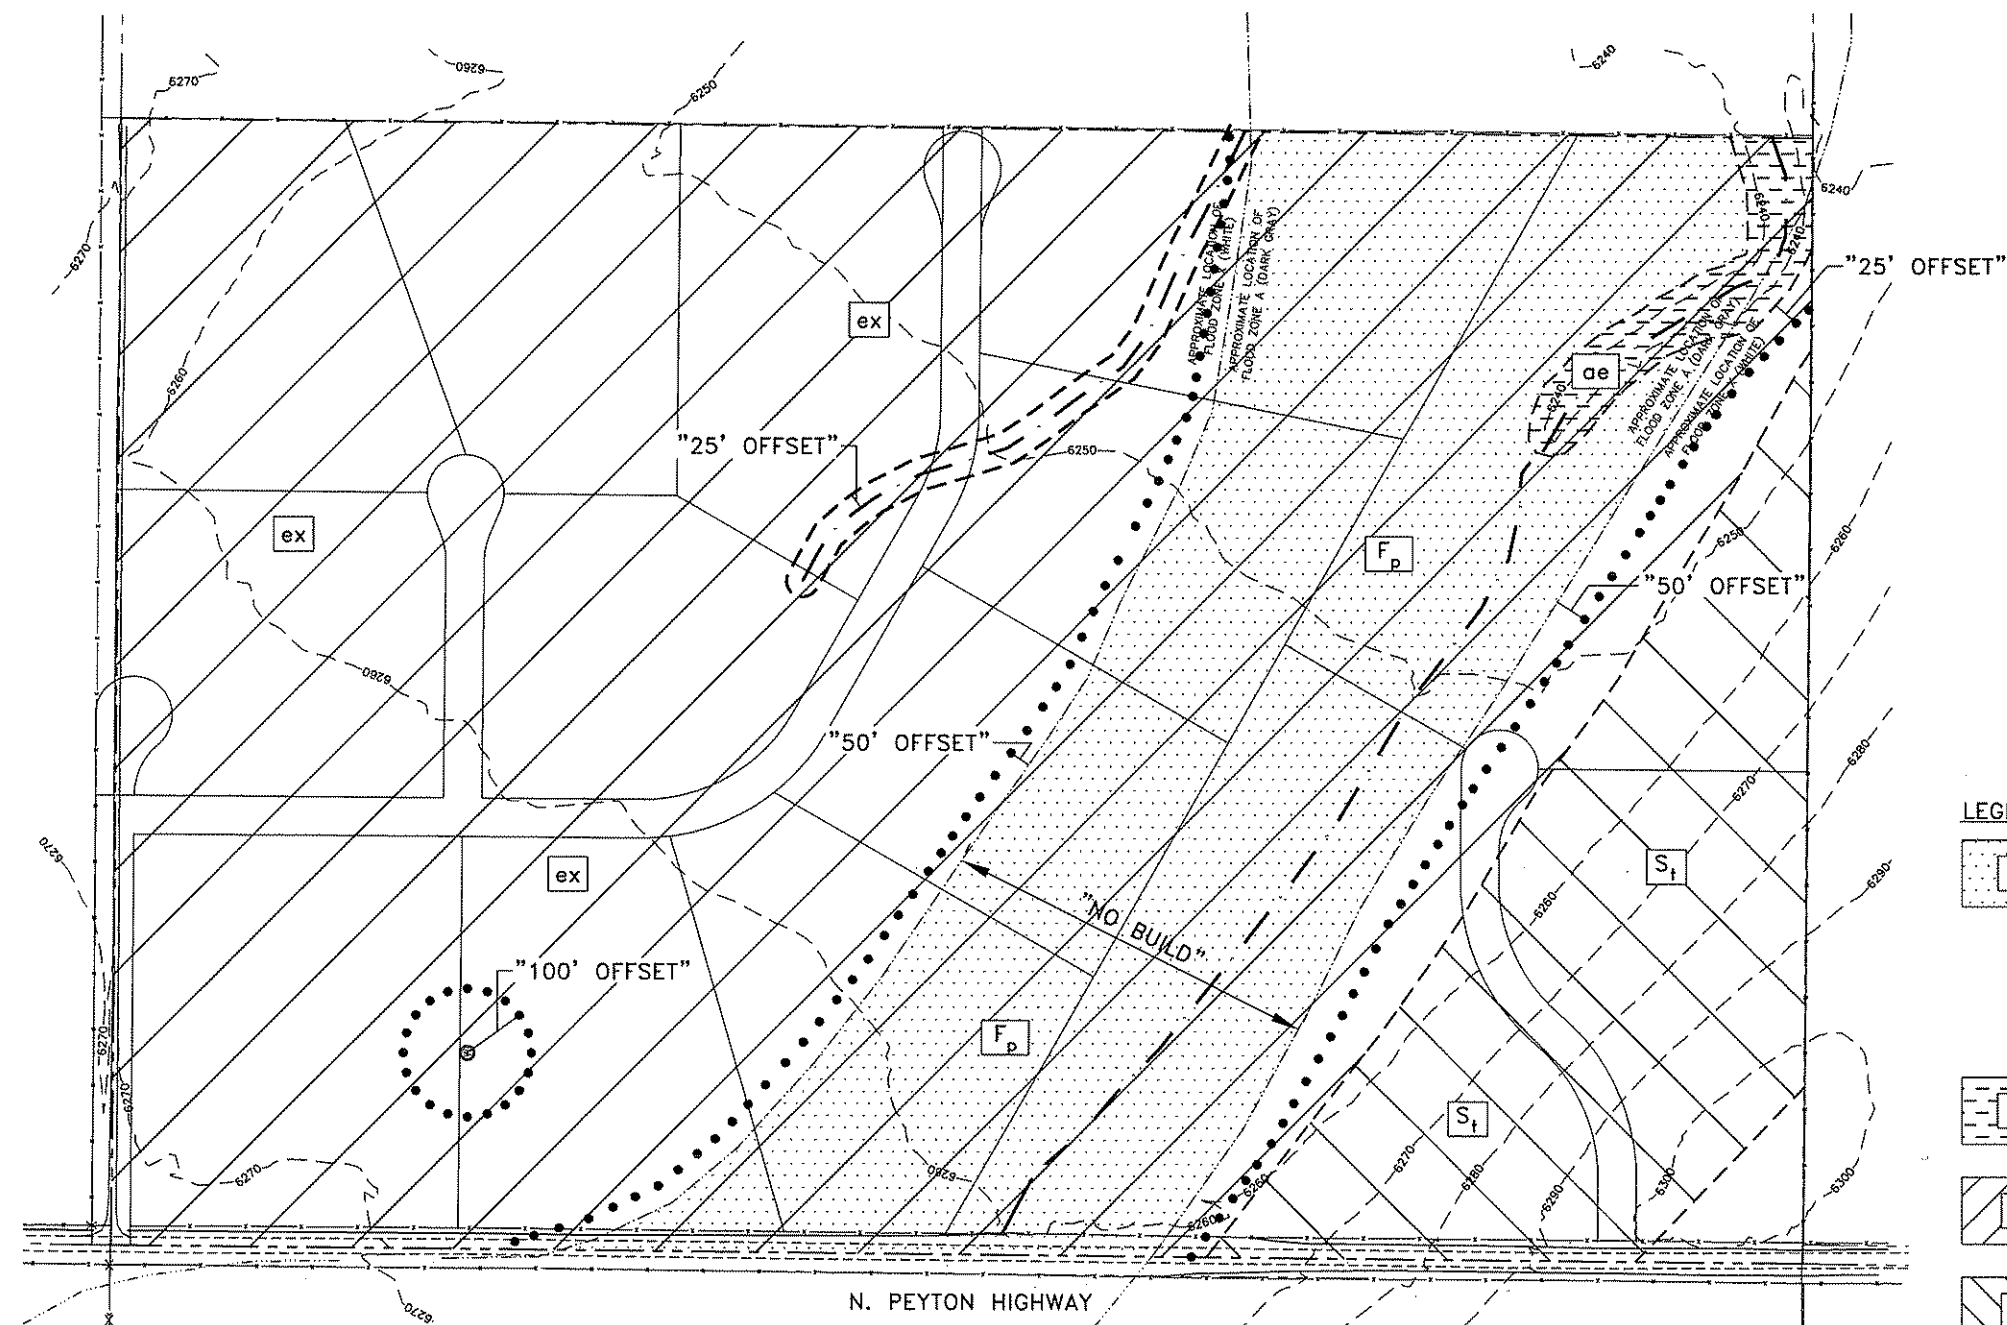
100-YEAR FLOODPLAIN AND ARE PRONE TO EROSION OR SEDIMENTATION. SHOULD BE CONSIDERED A NO BUILD AREA UNLESS ADDITIONAL STUDY DETERMINES THIS AREA IS OUTSIDE OF THE 100-YEAR FLOODPLAIN OR METHODS TO MITIGATE FLOOD, EROSION AND SEDIMENTATION HAZARDS ARE PROVIDED. THE FLOODPLAIN IS CONSIDERED A WATER COURSE FOR PURPOSE OF ABSORPTION FIELDS.

1. BASE MAP, TOPOGRAPHY AND FLOODPLAIN BOUNDARIES PROVIDED BY LDC, INC.
2. GEOLOGIC HAZARDS ARE BASED ON OUR INTERPRATATION OF THE SURFACE AND SUBSURFACE CONDITIONS AND THE PROVIDED LIMITS OF THE 100-YEAR FLOODPLAIN.

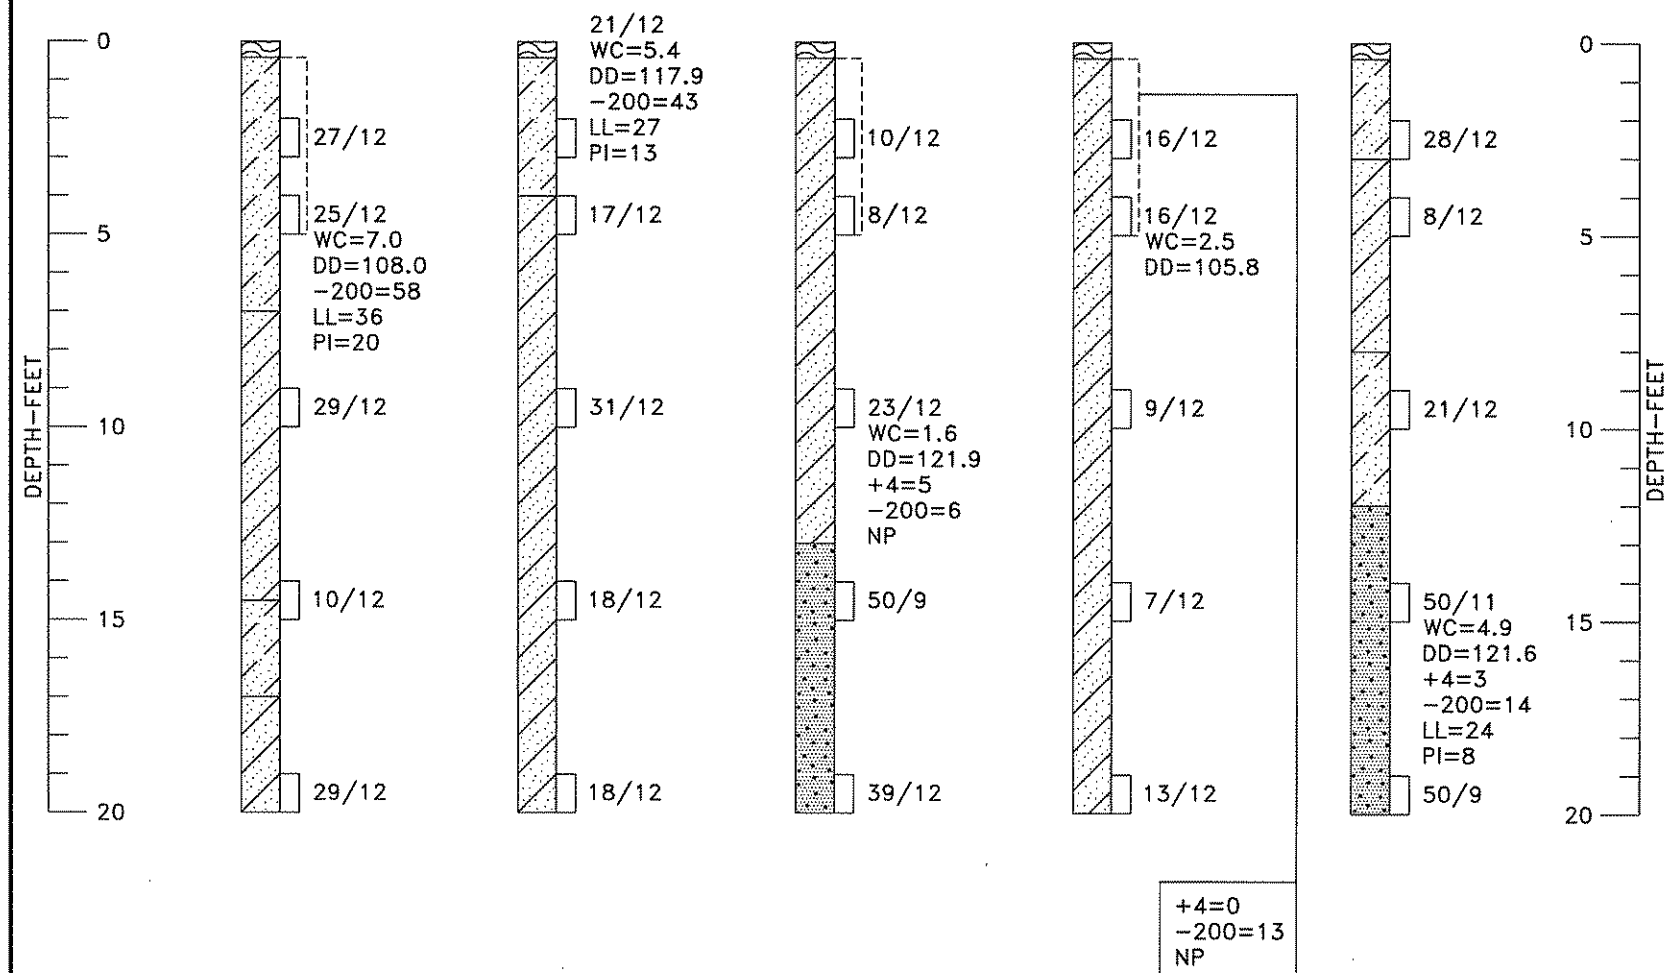
- TOPSOIL.
- CLAYEY SAND (SC), OCCASIONAL THIN LAYERS OR LENSES OF SANDY LEAN CLAY (CL), OCCASIONALLY POROUS, STIFF TO VERY STIFF, DRY TO SLIGHTLY MOIST, BROWN.
- SILTY SAND (SM) AND WELL-GRADED SAND WITH SILT (SW-SM), LOOSE TO DENSE, DRY TO SLIGHTLY MOIST, LIGHT BROWN TO BROWN.
- SANDSTONE, MEDIUM HARD TO HARD, OCCASIONALLY CLAYEY, NON CEMENTED, SLIGHTLY MOIST, GRAYISH BROWN, OCCASIONAL IRON STAINING.
- DRIVE SAMPLE, 2-INCH I.D. CALIFORNIA LINER SAMPLE.
- 27/12 DRIVE SAMPLE BLOW COUNT. INDICATES THAT 27 BLOWS OF A 140-POUND HAMMER FALLING 30 INCHES WERE REQUIRED TO DRIVE THE SAMPLER 12 INCHES.
- DISTURBED BULK SAMPLE.

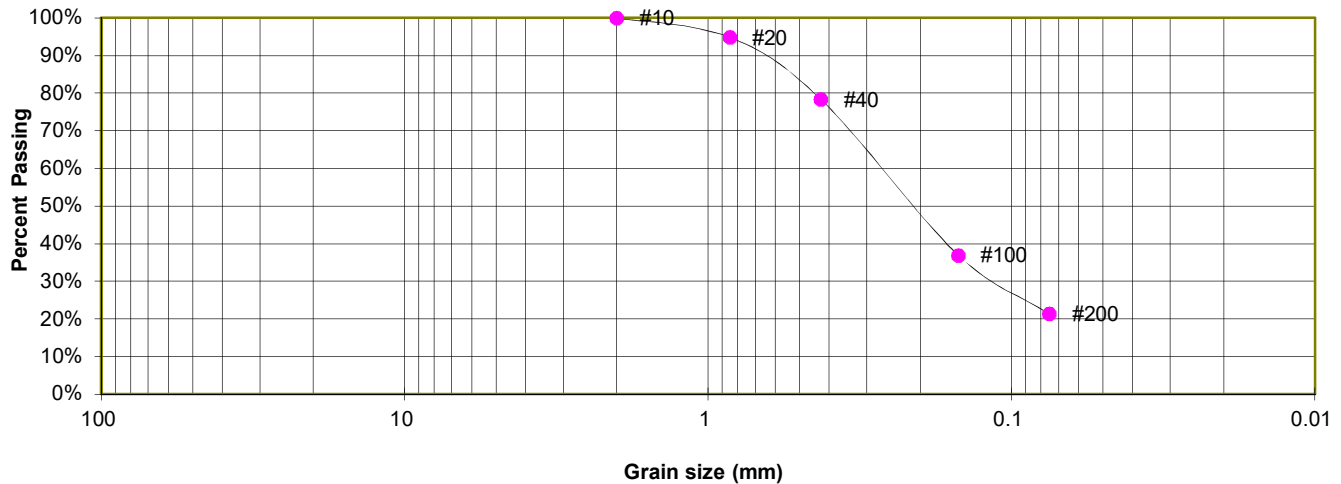
SOIL DESCRIPTION SAND, SILTY

**Sieve Analysis
Grain Size Distribution**

U.S. Sieve #	Percent
3"	
1 1/2"	
3/4"	
1/2"	
3/8"	
4	
10	100.0%
20	94.9%
40	78.4%
100	37.0%
200	21.4%

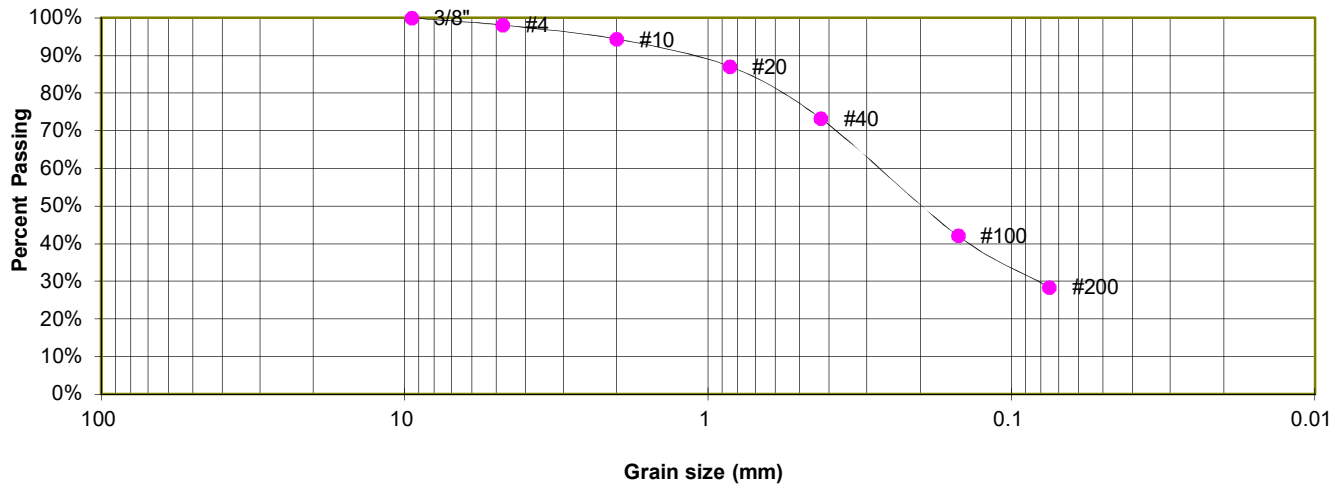
SOIL DESCRIPTION SAND, SILTY

Sieve Analysis Grain Size Distribution

U.S. Sieve #	Percent Finer
3"	
1 1/2"	
3/4"	
1/2"	
3/8"	100.0%
4	98.1%
10	94.3%
20	87.1%
40	73.2%
100	42.1%
200	28.4%

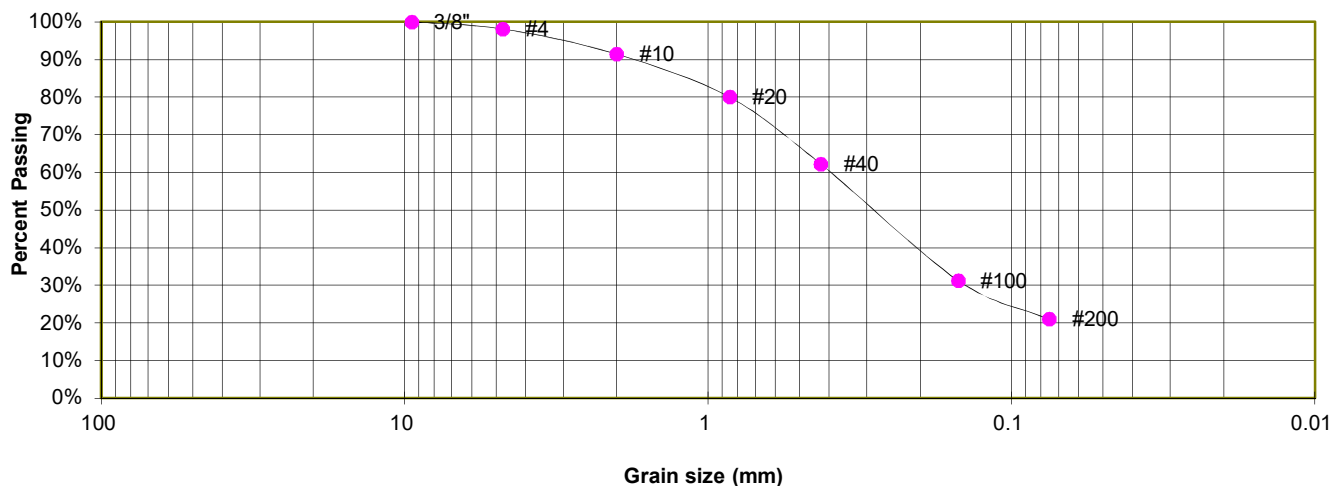
SOIL DESCRIPTION SAND, SILTY

Sieve Analysis Grain Size Distribution

U.S. Sieve #	Percent Finer
3"	
1 1/2"	
3/4"	
1/2"	
3/8"	100.0%
4	98.1%
10	91.5%
20	80.0%
40	62.2%
100	31.3%
200	21.0%

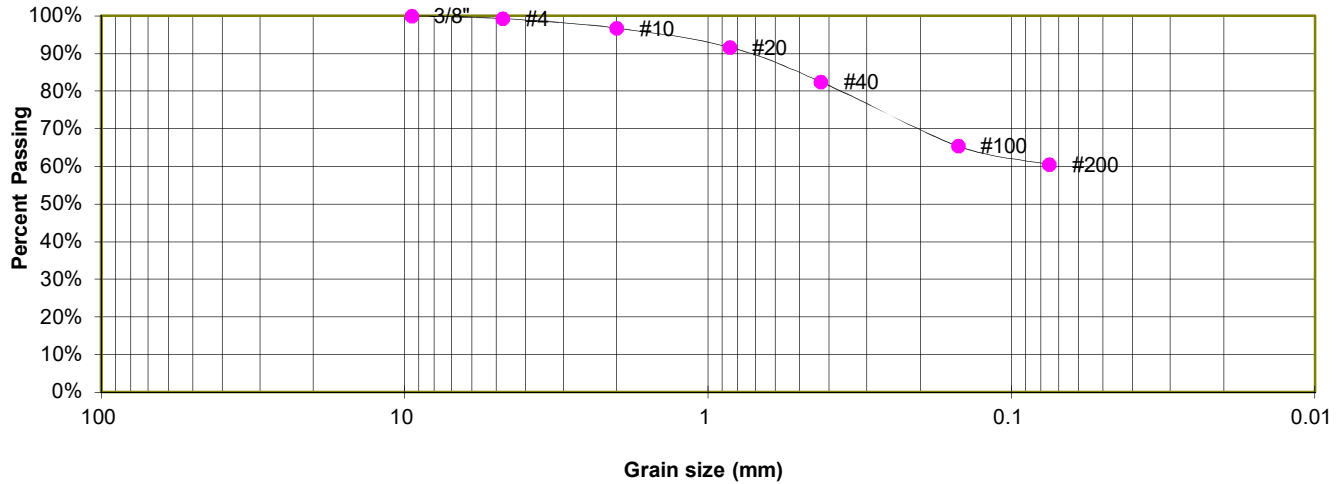
SOIL DESCRIPTION CLAY, SANDY

**Sieve Analysis
Grain Size Distribution**

U.S. Sieve #	Percent Finer
3"	
1 1/2"	
3/4"	
1/2"	
3/8"	100.0%
4	99.3%
10	96.8%
20	91.7%
40	82.5%
100	65.4%
200	60.5%

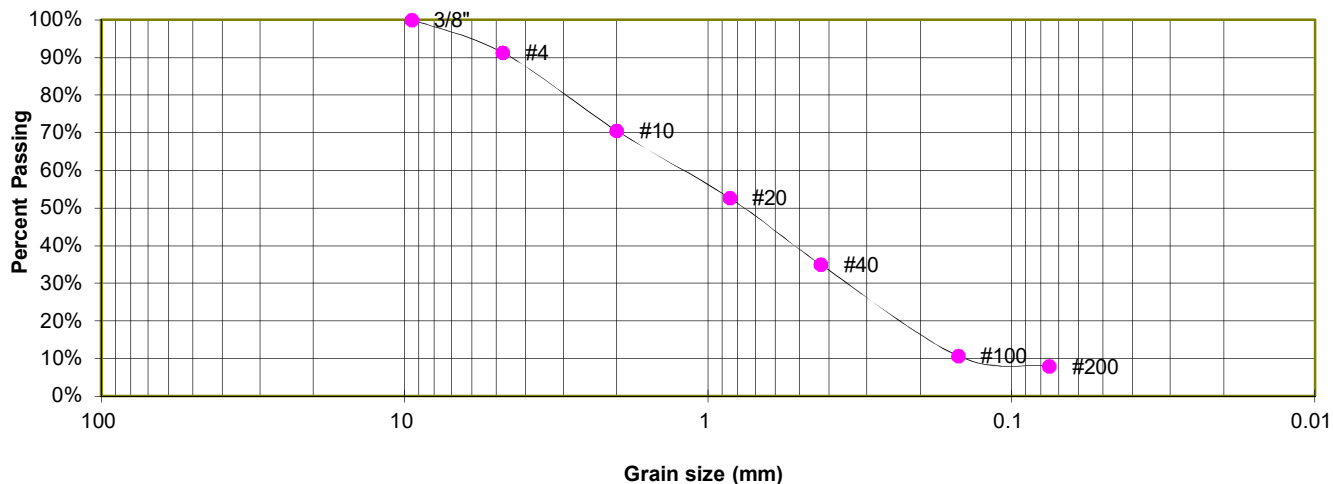
SOIL DESCRIPTION SAND, WITH SILT

**Sieve Analysis
Grain Size Distribution**

U.S. Sieve #	Percent Finer
3"	
1 1/2"	
3/4"	
1/2"	
3/8"	100.0%
4	91.3%
10	70.5%
20	52.7%
40	35.0%
100	10.7%
200	7.9%
