ENTECH
ENGINEERING, INC.

September 22, 2021
Revised June 22, 2023

Re: Wastewater Study
Joyful View Subdivision
Joyful View & Peyton Highway
Schedule Nos. 33000-00-466 & 33000-00-467
El Paso County, Colorado

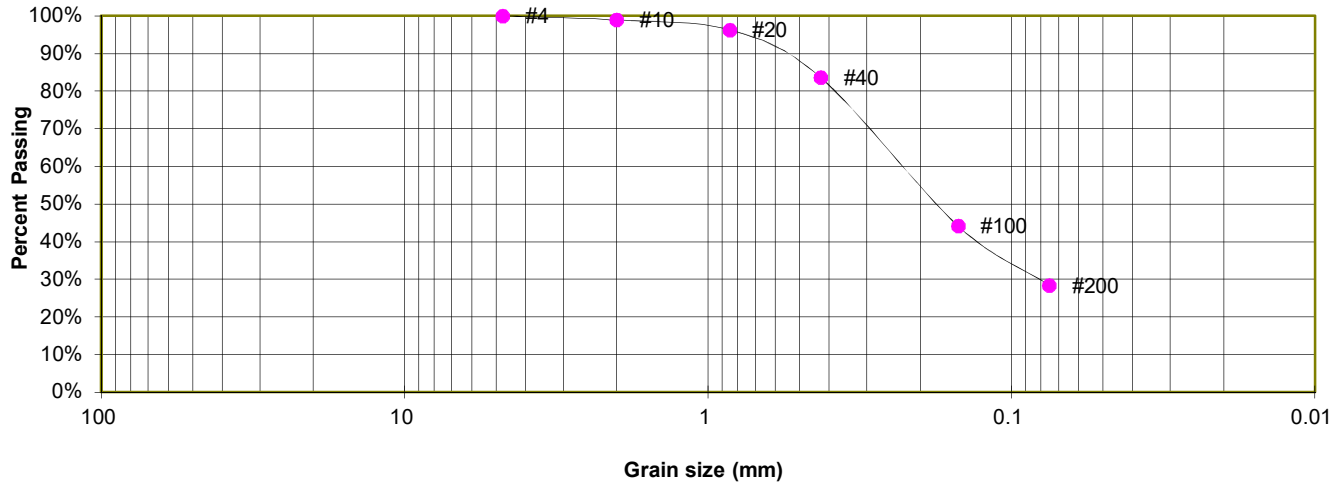
SOIL DESCRIPTION SAND, SILTY

Sieve Analysis Grain Size Distribution

U.S. Sieve #	Percent Finer
3"	
1 1/2"	
3/4"	
1/2"	
3/8"	
4	100.0%
10	98.9%
20	96.3%
40	83.6%
100	44.2%
200	28.4%

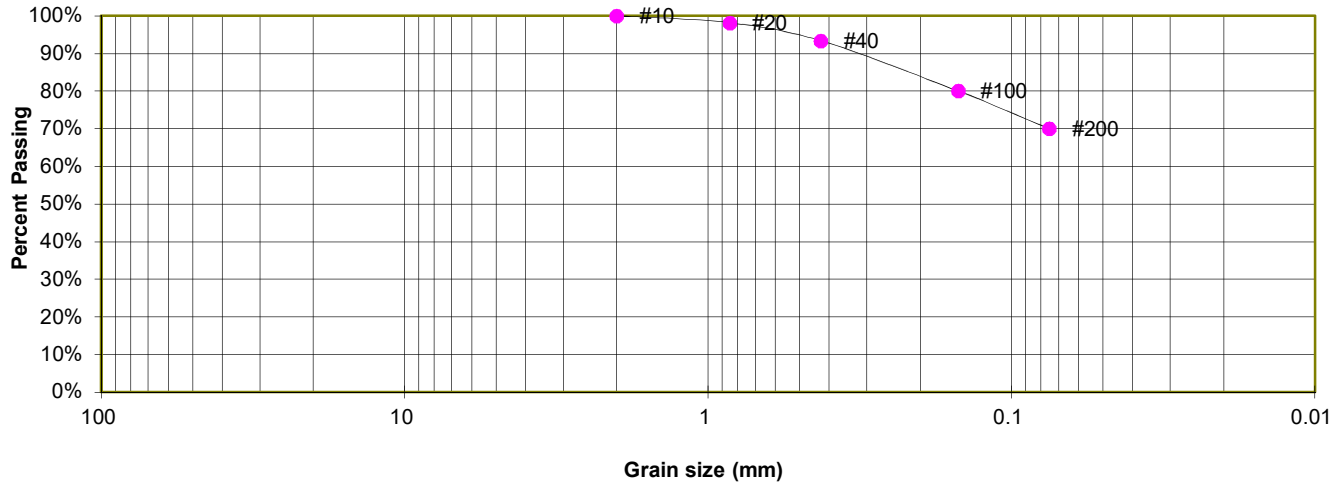
SOIL DESCRIPTION CLAY, WITH SAND

**Sieve Analysis
Grain Size Distribution**

U.S. Sieve #	Percent Finer
3"	
1 1/2"	
3/4"	
1/2"	
3/8"	
4	
10	100.0%
20	98.2%
40	93.4%
100	80.1%
200	70.1%

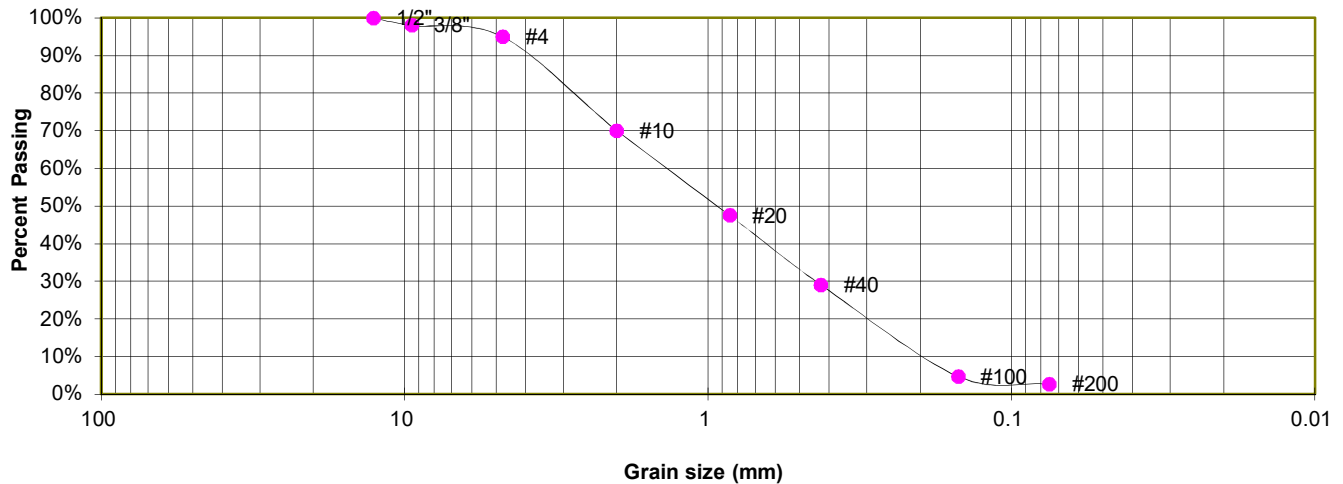
SOIL DESCRIPTION SAND, SLIGHTLY SILTY

**Sieve Analysis
Grain Size Distribution**

U.S. Sieve #	Percent Finer
3"	
1 1/2"	
3/4"	
1/2"	100.0%
3/8"	98.0%
4	95.0%
10	70.1%
20	47.6%
40	29.1%
100	4.7%
200	2.7%
